**KASGRO REPORT 1
METALLURGICAL REPORT**

KASGRO REPORT 3 METALS INVESTIGATION REPORT

Customer Claim - Triad Metals Investigation

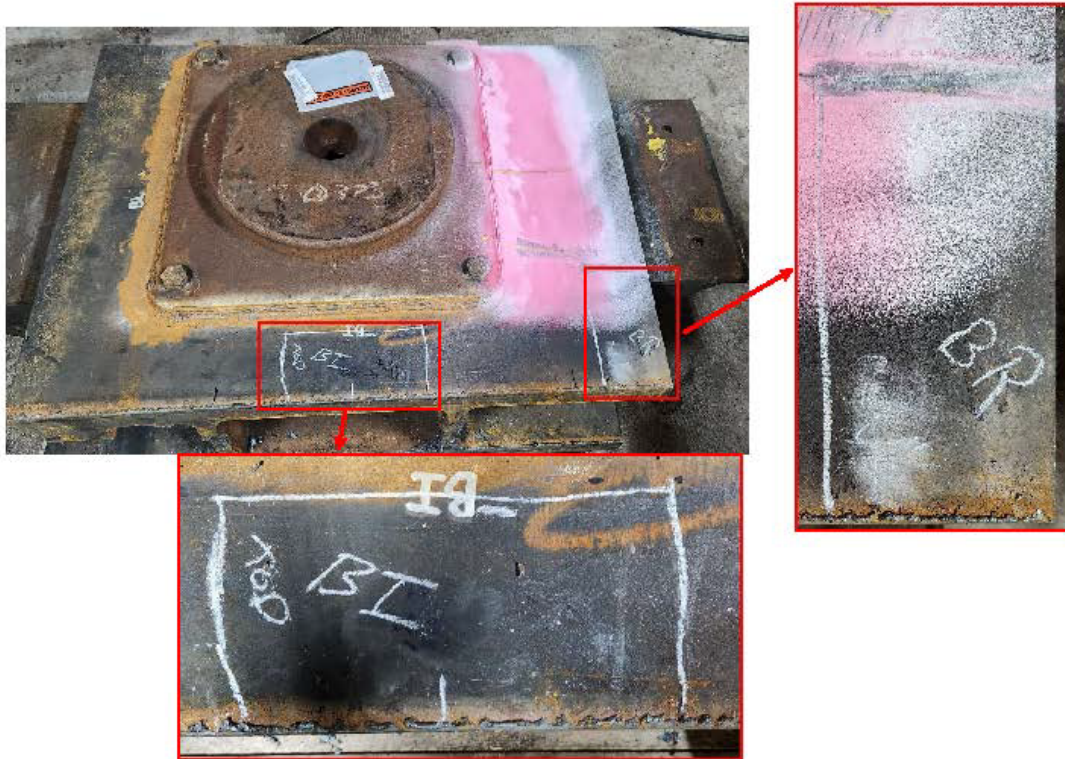
The provided plate was torch cut in two locations as seen in Figure 1. The specimens extracted from the two locations were given the following I.D.s "BI" (S000001) and "BR" (S000002). Samples from both locations were prepared for chemical analysis, tensile and V-Notch Charpy impacts tests. The results of these tests are found in tables 2, 3, and 4.

Figure 1. Cut procedure on the provided plate with labeled I.D.s.
