***Sister Rod
Nondestructive
Examination
Annual Report FY2017***

***Prepared for
US Department of Energy
Spent Fuel and Waste Science and
Technology***

***September 15, 2017
SFWD-SFWST-2017-000003
ORNL/SPR-2017/484***

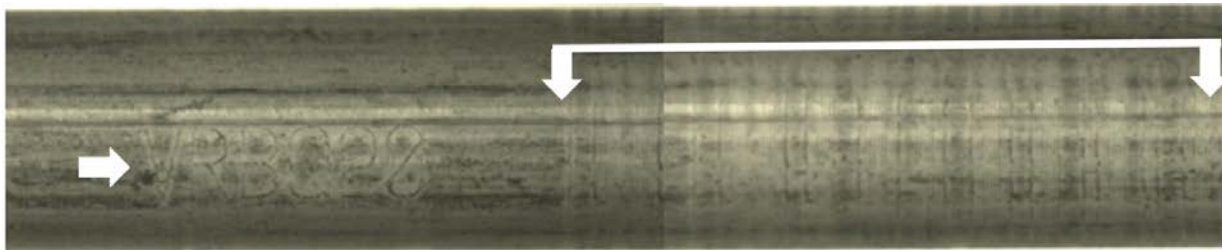
Figure 1. Example of Visible Rod Labeling and Bar Coding (Partial Shown).

No weld failures, obvious cladding breaches, or other significant defects were observed. Rod identification and bar codes are visible on the rods (an example is shown in Figure 1), except on F35P17 and F35K13 since bar codes were not used when these two rods were fabricated. The visual inspection indicated that shallow grid-to-rod fretting (GTRF) marks are common, and a few rods have patches of Chalk River Unidentified Deposits (CRUD) and/or spalling oxide. A typical striated surface texture

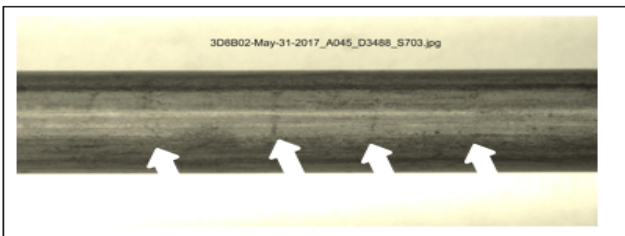
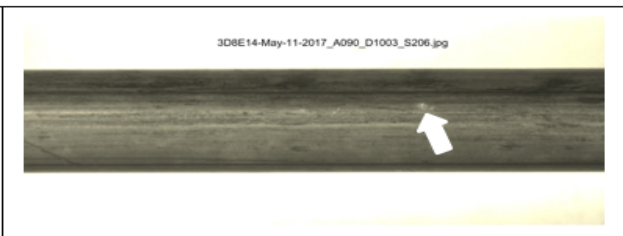
Figure 10. Selected Visual Observations from Assembly 3D8.

<p>(a) Moderate oxide coverage with pellet-pellet interfaces visible.</p>	<p>(b) Possible local corrosion.</p>

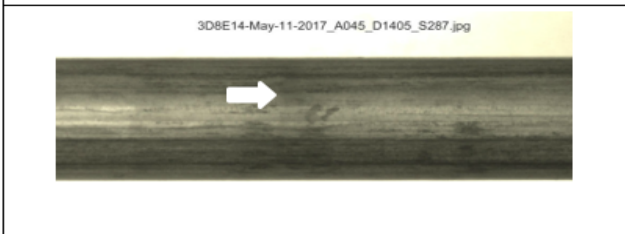
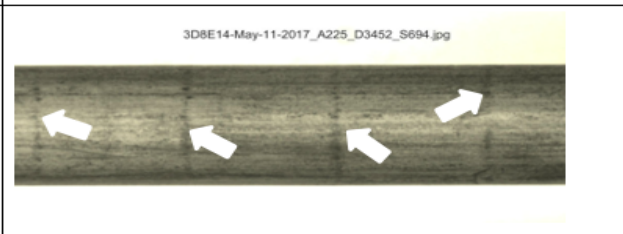
<p>(c) Pellet-pellet interface near a gamma scan reported axial stack gap.</p>	<p>(d) Typical appearance of pellet-pellet interfaces.</p>

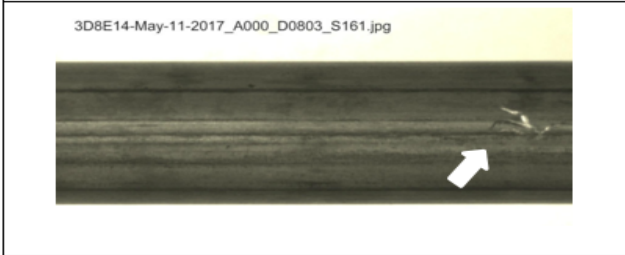
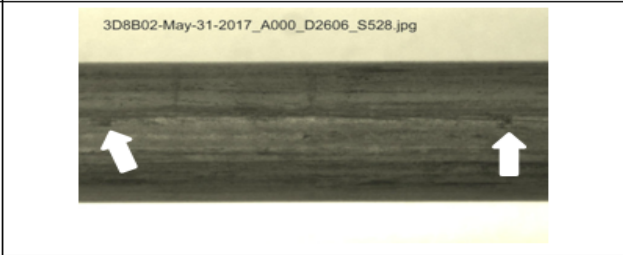
<p>(e) Possible rod removal damage with debris.</p>	<p>(f) Shallow GTRF marks.</p>

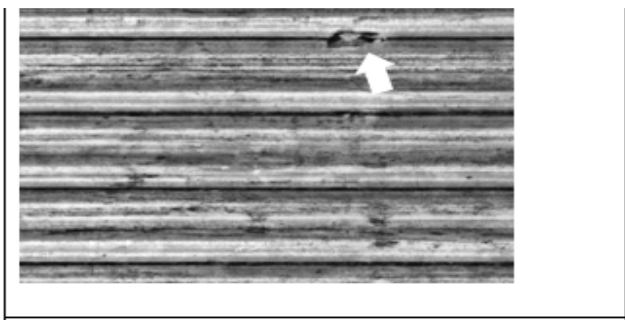
<p>(g) moderate GTRF mark (3D8E14 1204 mm elevation)</p>	<p>(h) Flow markings (3D8B02 3648 mm elevation)</p>

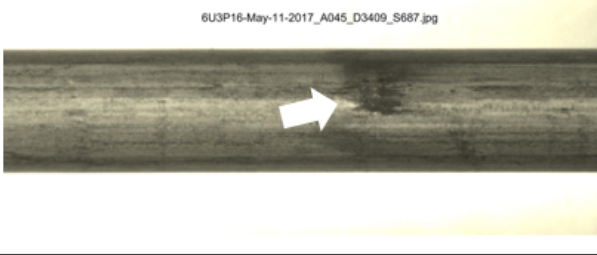
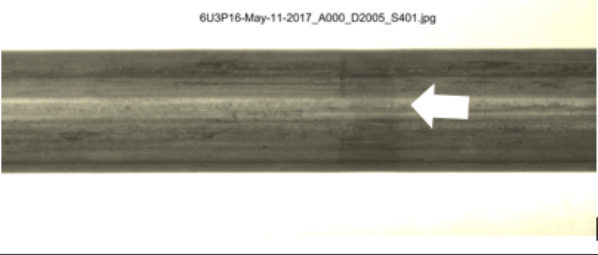
Figure 11. Selected Visual Observations from Assembly 6U3.

(g) Flow marking (darker region) associated with turbulent flow around a spacer grid with a shallow GTRF mark.	(h) Banded region is pellet-pellet gap (~5 mm) noted by gamma scan and measured by profilometry.

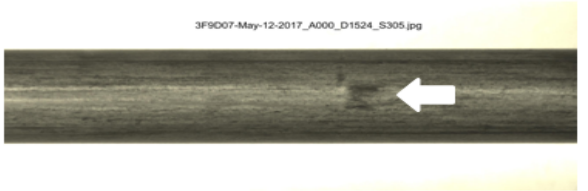
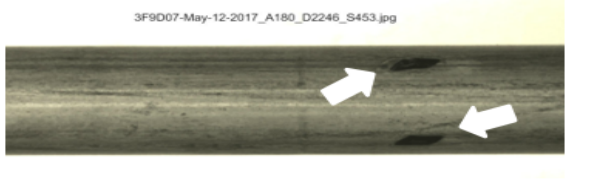
Figure 12. Selected Visual Observations from Assembly 3F9.

<p>(a) Shallow GTRF.</p>	<p>(b) Deep GTRF.</p>

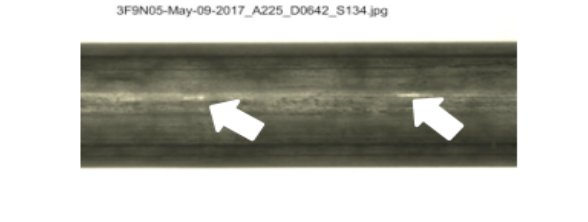
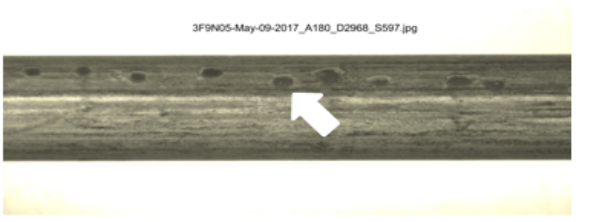
<p>(g) Very shallow apparent GTRF.</p>	<p>(h) Some oxide peeling was noted.</p>

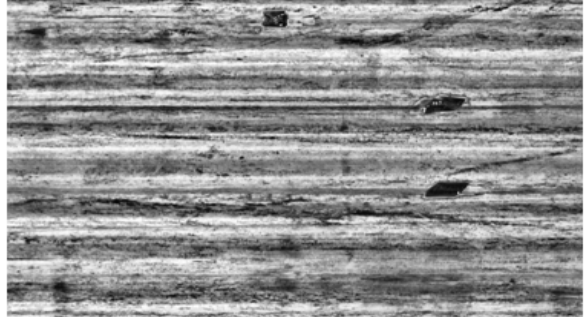
<p>(i) Unwrapped image (all azimuthal locations at 2246 mm elevation) of 3F9D07, moderate to deep fretting wear.</p>

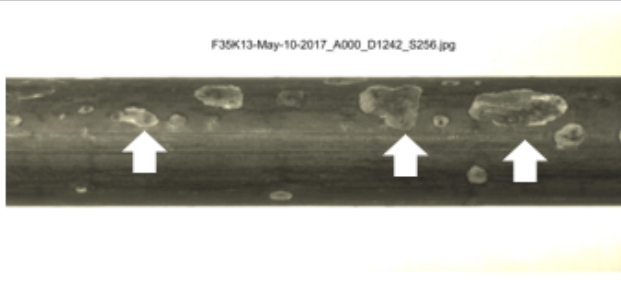
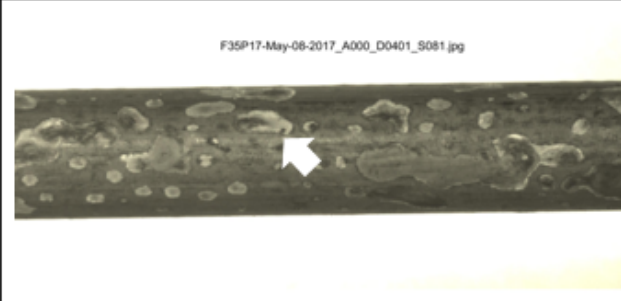
Figure 13. Selected Visual Observations from Assembly F35.

Assemblies 3A1 and F35 (Figure 13 and Figure 14) appeared to have the greatest amount of oxide buildup/spalling. No visible signs of through wall damage or large areas of clad degradation were found. A thin layer of CRUD appears to be visible in spalled regions, having the appearance of a black rim around the base of the spalled area, as shown in Figure 13(d). Some areas of significant oxidation have a flake-like appearance, as shown in 14(g) and (h).

<p>F35P17-May-08-2017_A000_D0401_S081.jpg</p>
<p>(a) Significant oxide spalling; some pellet-pellet interface bands are visible.</p>	<p>(b) Significant oxide spalling.</p>

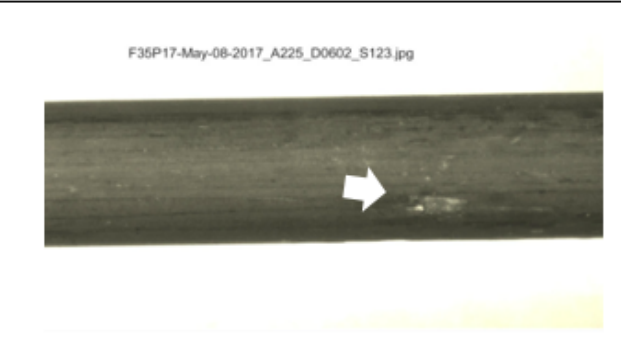
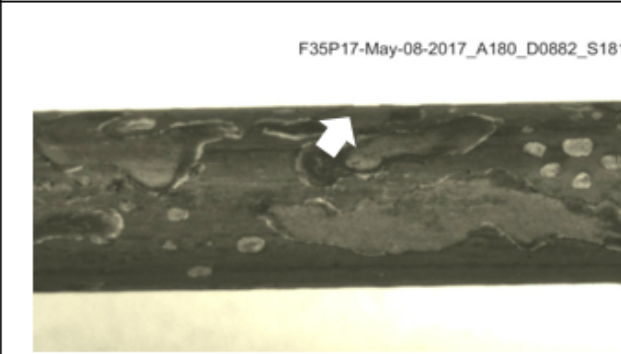
<p>F35P17-May-08-2017_A180_D0882_S181,</p>
<p>(c) Shallow GTRF.</p>	<p>(d) Significant oxide spalling with CRUD; an indication of the oxide thickness is visible at the upper edge of the rod image.</p>

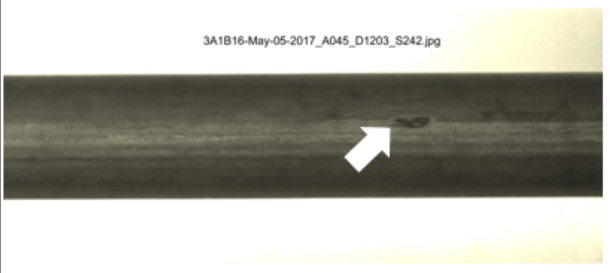
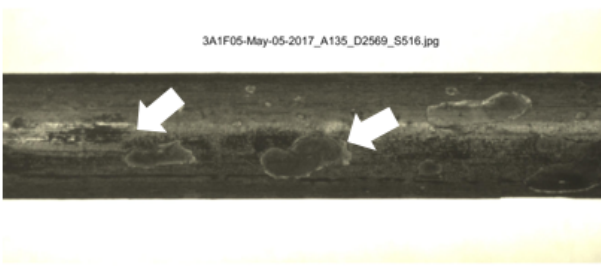
Figure 14. Selected Visual Observations from Assembly 3A1.

<p>(a) Moderate GTRF mark.</p>	<p>(b) Significant oxide spalling with some peeling CRUD.</p>

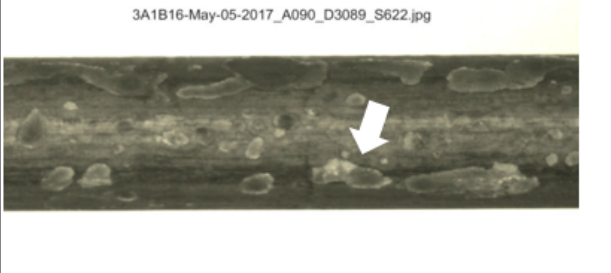
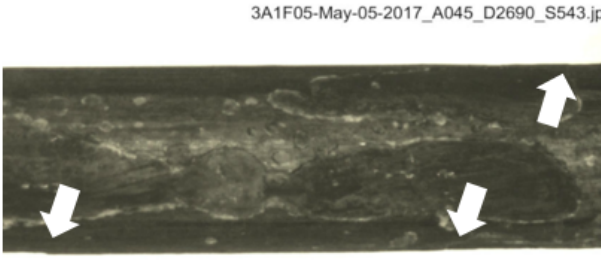
<p>(c) Significant spalling oxide.</p>	<p>(d) Significant oxide spalling with CRUD; an indication of the oxide thickness is visible at the lower and upper edges of the rod image.</p>

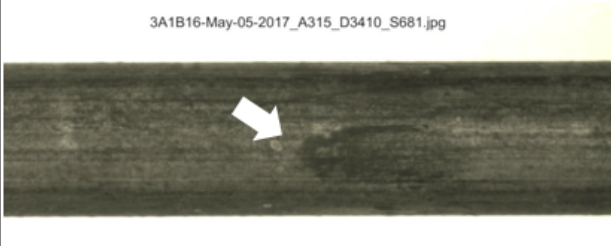
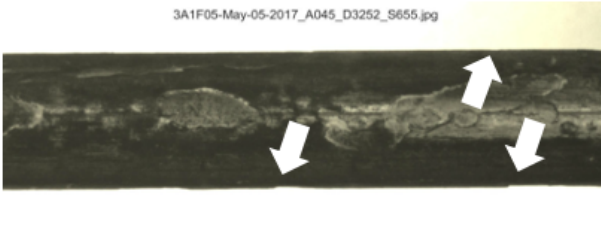
<p>(e) Flow marking.</p>	<p>(f) Significant oxide spalling with CRUD; an indication of the oxide thickness is visible at the upper and lower edges of the rod image.</p>

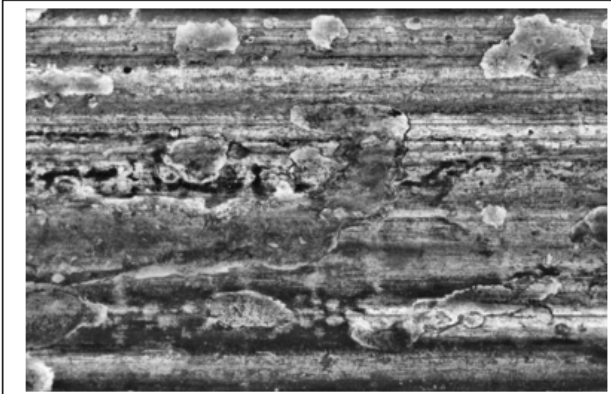
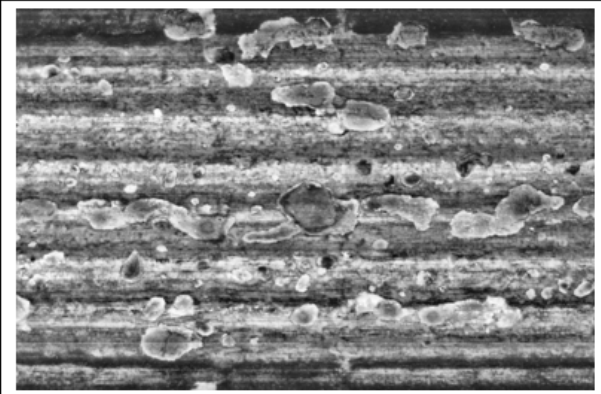
<p>(g) Unwrapped image (full rod circumference shown at 3252 mm elevation) of 3A1F05, heavy oxide layer with spalling.</p>	<p>(h) Unwrapped image (all azimuthal locations at 3089 mm elevation) of 3A1B16, heavy oxide layer with spalling.</p>
