Fukushima Dai-ichi NPS Defueling Status

May 2013
Hitachi-GE Nuclear Energy, Ltd
Takao Shimura

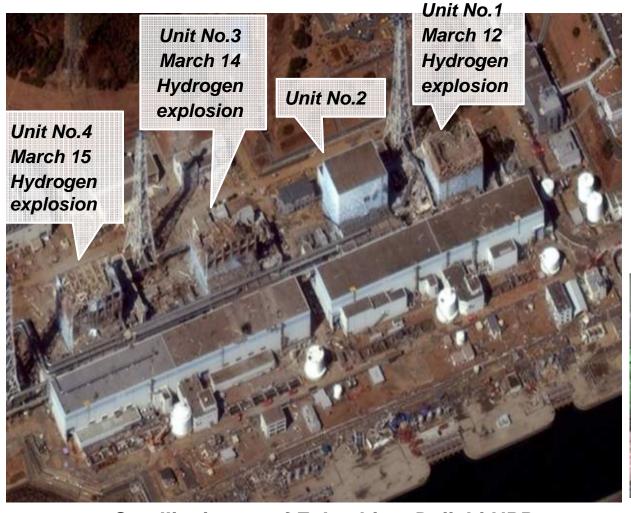
Satellite image of Fukushima Daiichi NPP
(March 18, 2011)

Unit No.3 & 4

Reactor building of Unit No.4

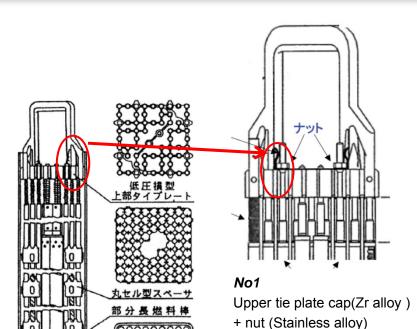
Lower tie plate cap(Zr alloy)

+ tie plate (Stainless alloy)

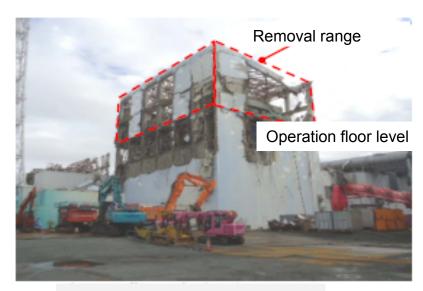
Before rubble removal Sep., 2011

Rubble removal of reactor building started from Sep., 2011 and completed by 2012 autumn.

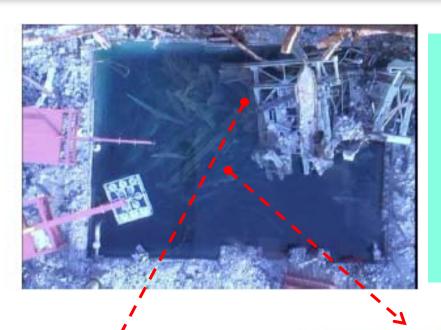
- Observation date:Feb.14, 2013
- FHM and Steel frame structure were observed.
- Fuel, rack, and pool damage was NOT observed.
- Further study for removal of rubble in SFP to be performed
- Defueling to be started at 2014 autumn.
 But progress of as of today, it is around half of a year behind the schedule.

FHM

Steel frames in the SFP

Rubble piled up atop fuel rack

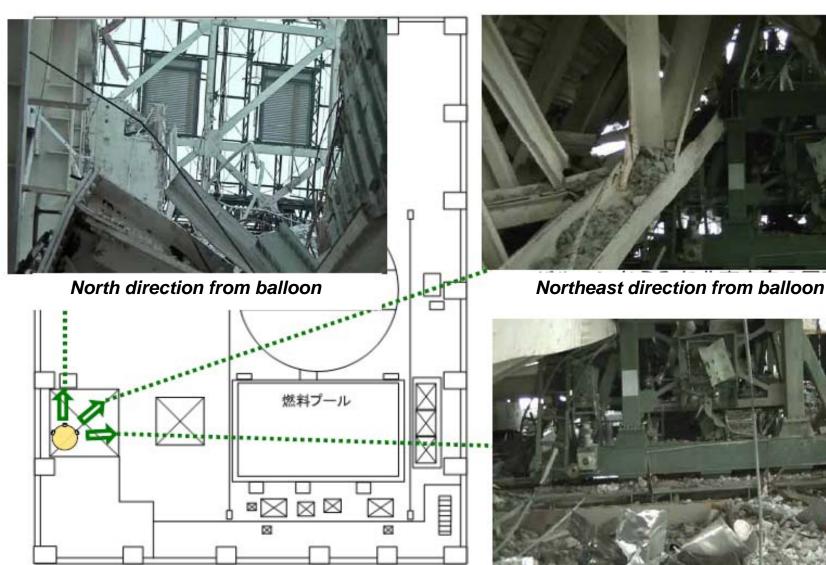
Operation floor of reactor building in Unit 1

East direction from balloon
