***Preliminary Destructive  
Examination Results for  
Sibling Pin Cladding***

**Spent Fuel and Waste Disposition**

***Argonne National Laboratory  
M.C. Billone and T.A. Burtseva***

***March 25, 2020  
M2SF-20AN010201019  
ANL-19/53 Rev. 2***

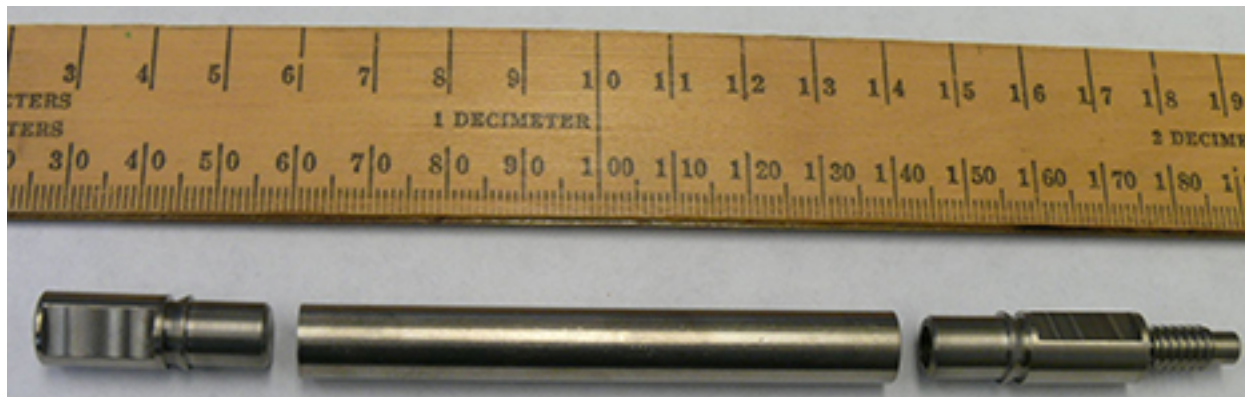
**Figure 5: Rodlet bottom end fixture (redesigned), cladding segment, and top end fixture (redesigned).**

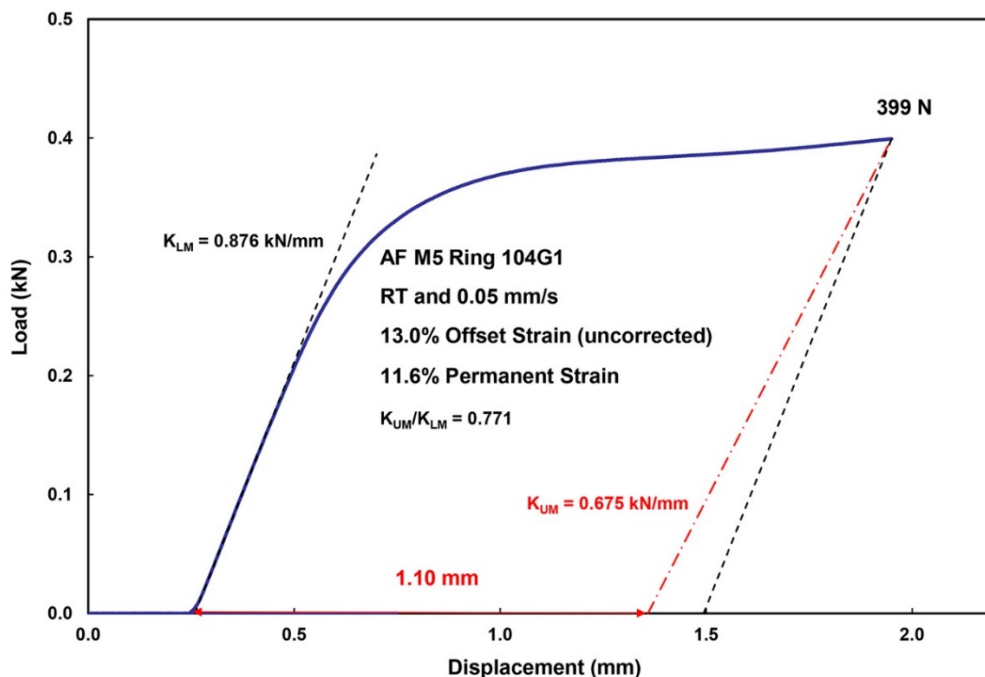
Figure 7: Load-displacement curve for AF M5® ring tested at RT and 0.05 mm/s to 1.7-mm ring displacement.

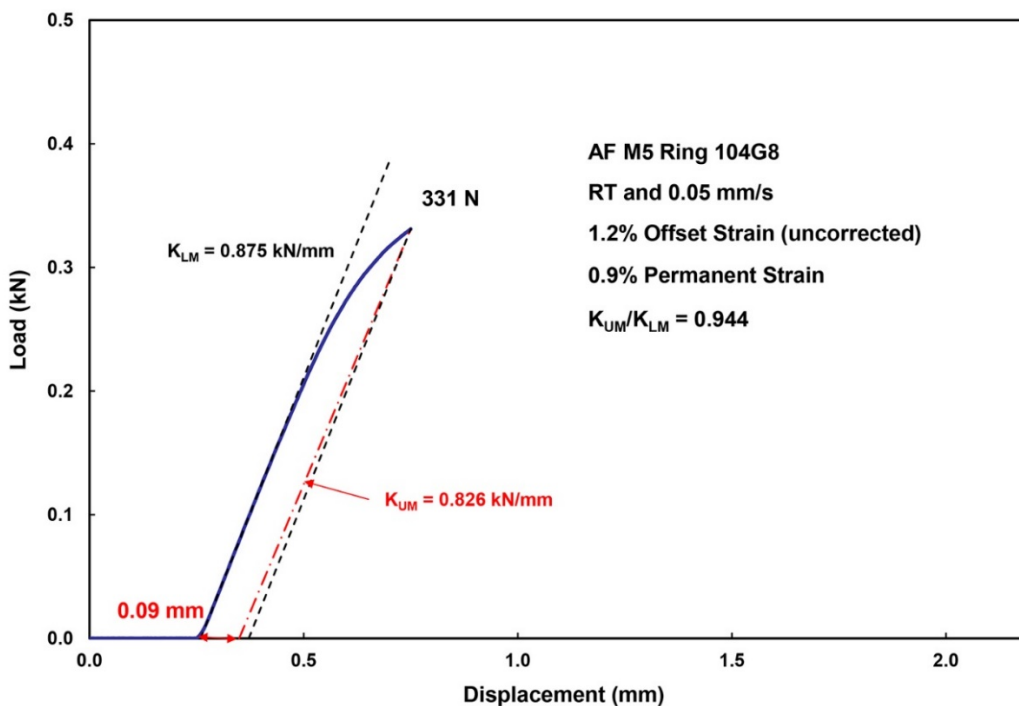
As the total and traditional-offset displacements decrease, the difference between  $\delta_{pt}$  and  $d_p$  decreases. This is shown in Fig. 8 for which  $\delta_{pt}$  is 0.11 mm,  $d_p$  is 0.09 mm, and  $K_{UM}/K_{LM}$  is 0.944.

Figure 8: Load-displacement curve for AF M5® ring tested at RT and 0.05 mm/s to 0.5-mm ring displacement.

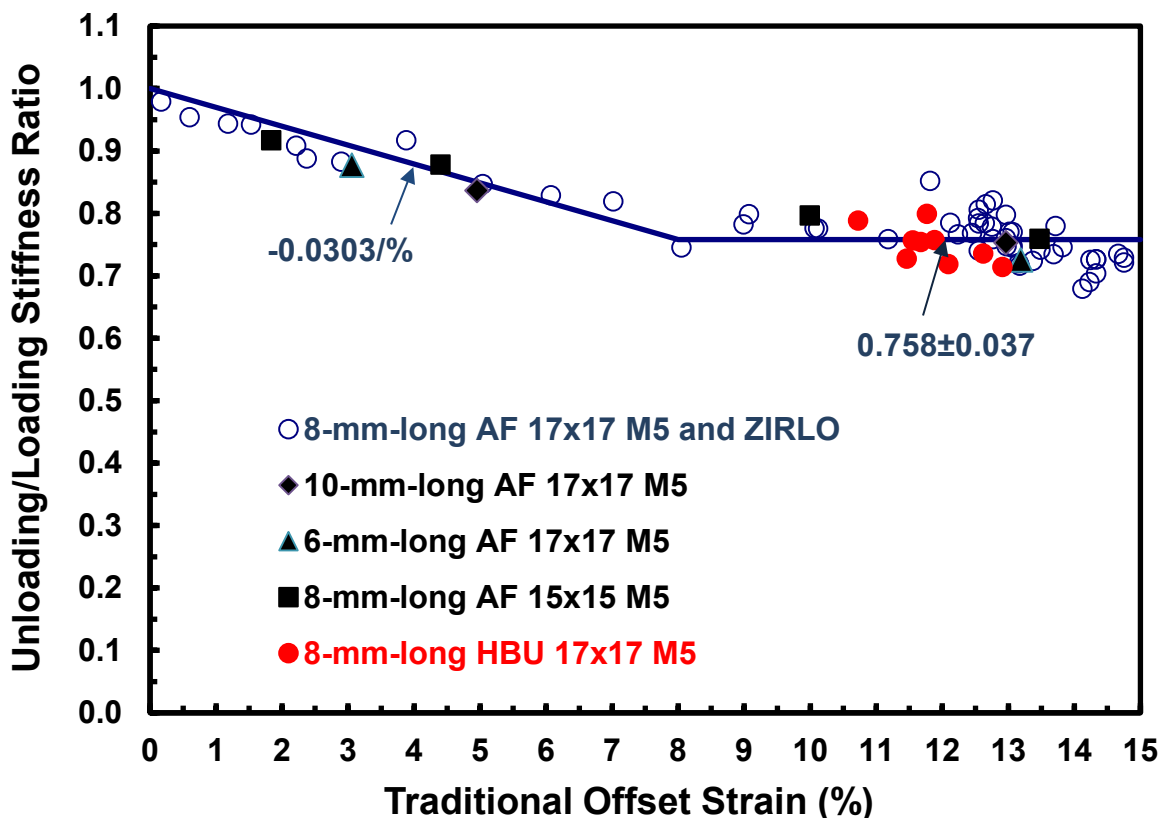
The stiffness ratio for HBU-fuel M5® with >8% traditional offset strain is 0.746, which is in good agreement with the 0.758 determined for AF cladding materials.

Figure 9: RCT benchmark results for determining the ratio of unloading/loading stiffness as a function of the traditional offset strain.

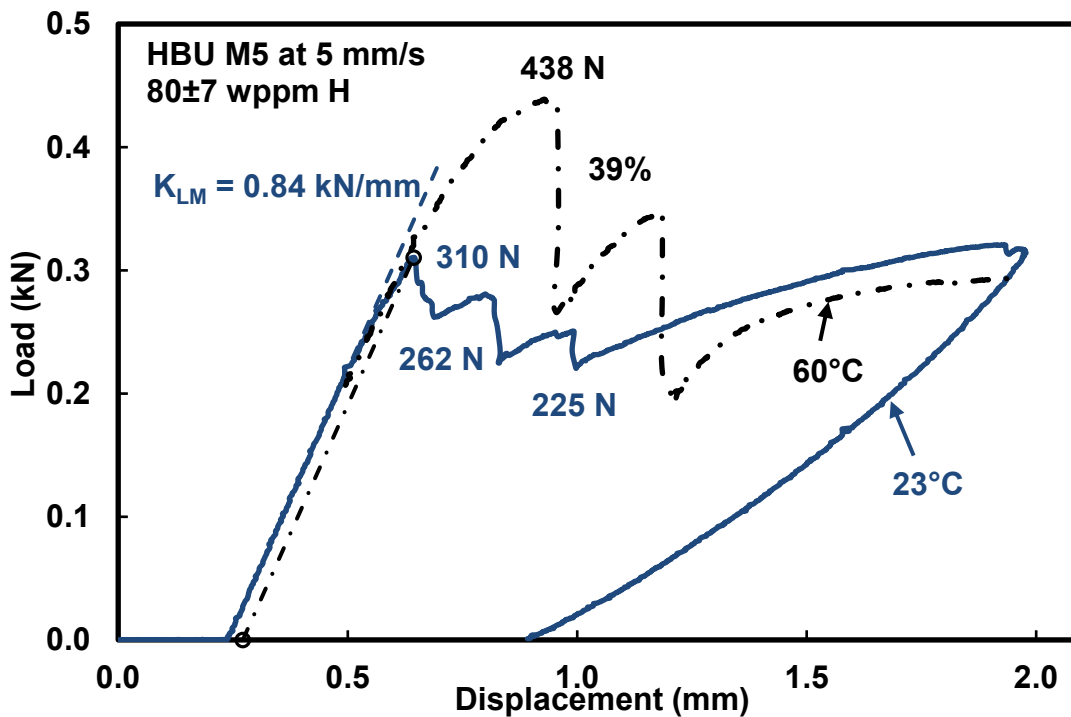
Figure 10: Load-displacement curves for HBU-fuel M5<sup>®</sup> with 80±7 wppm C<sub>H</sub> following RHT at peak conditions of 350°C/89-MPa.

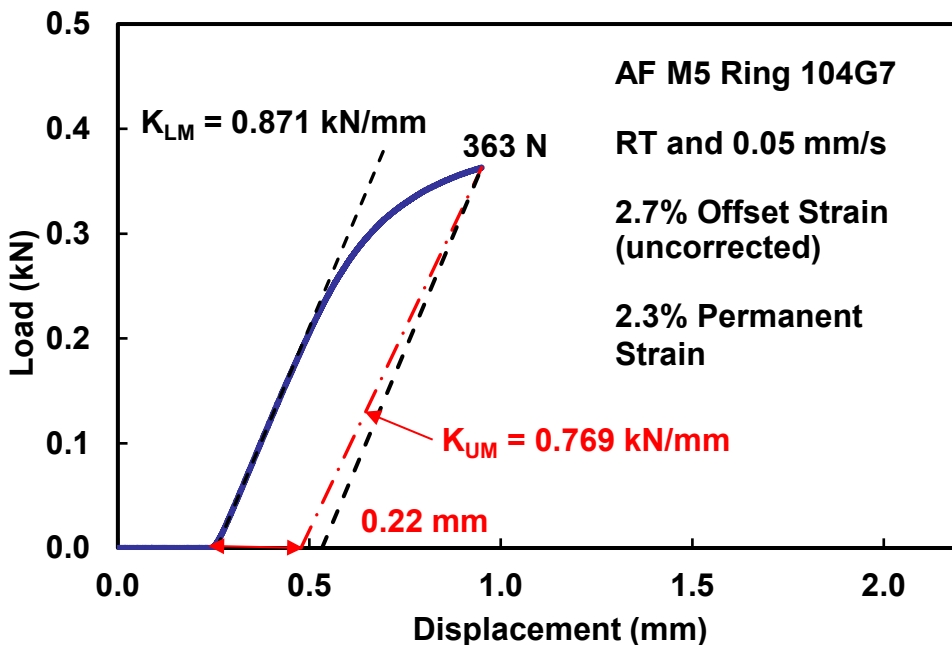
Figure 15: Load-displacement curve for AF 17×17 M5® ring displaced to 0.7 mm at RT and 0.05 mm/s.

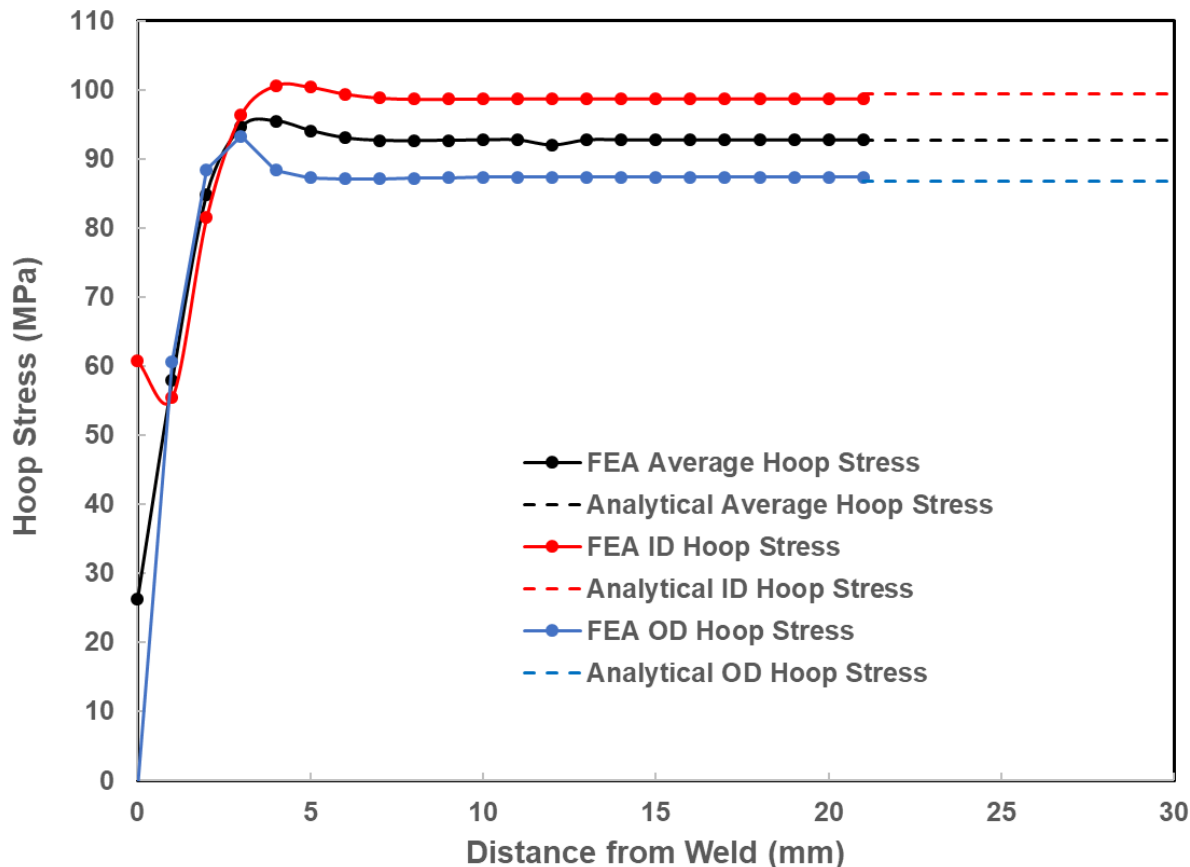
Figure 27: Axial variation of hoop stress near the welded end of a 17×17 AF M5® pressurized tube.

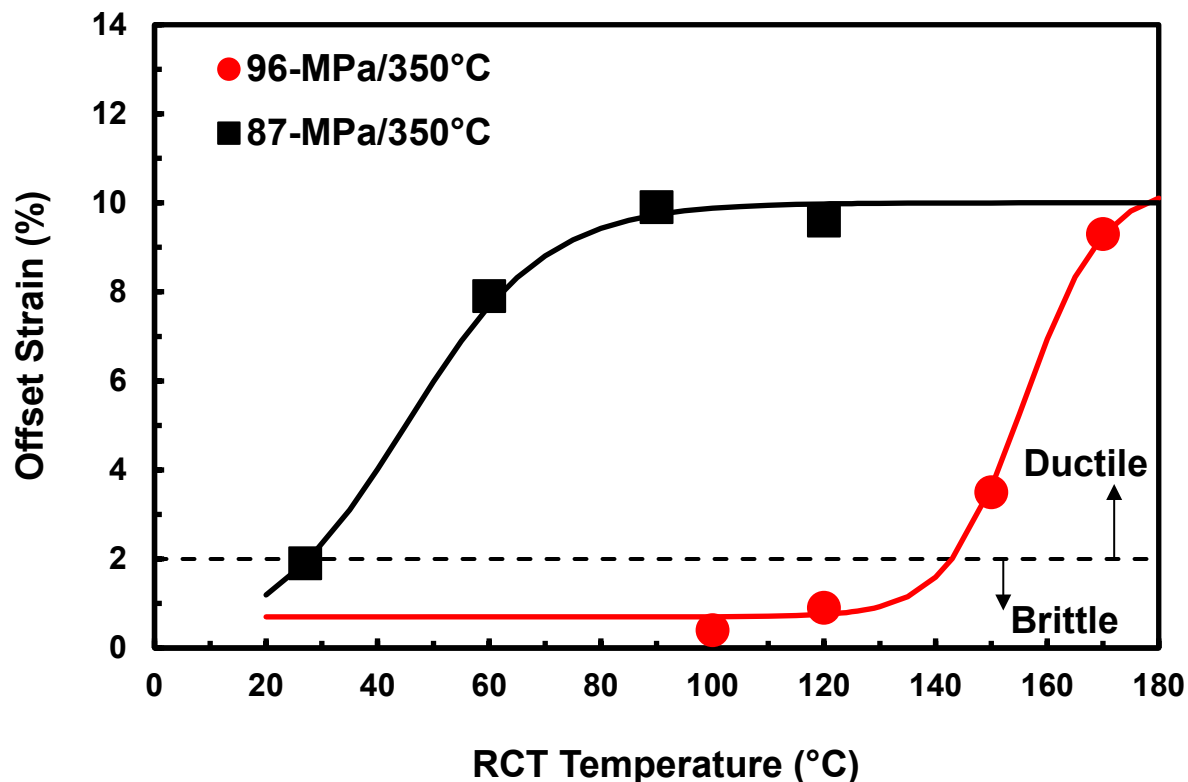
Figure 28: Ductility vs. RCT temperature results for ZIRLO<sup>®</sup> rodlets subjected to 350°C PCT and peak hoop stresses of 87 MPa (646D) and 96 MPa (646B).

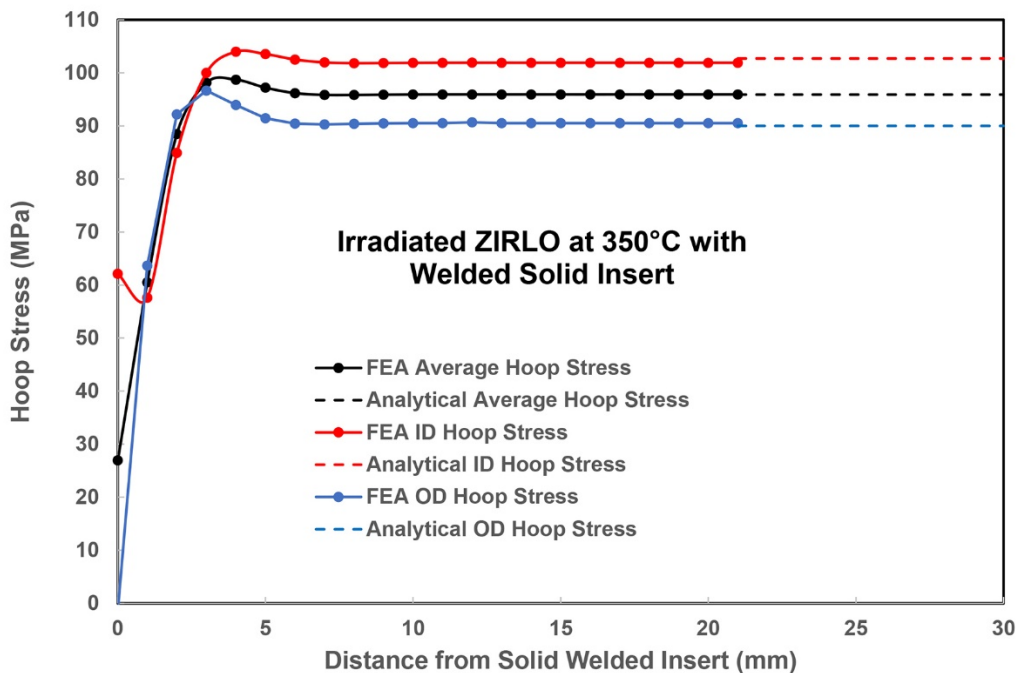
Figure 30: FEA-predicted hoop stresses for rodlet 646B at 350°C with a solid, welded bottom insert.

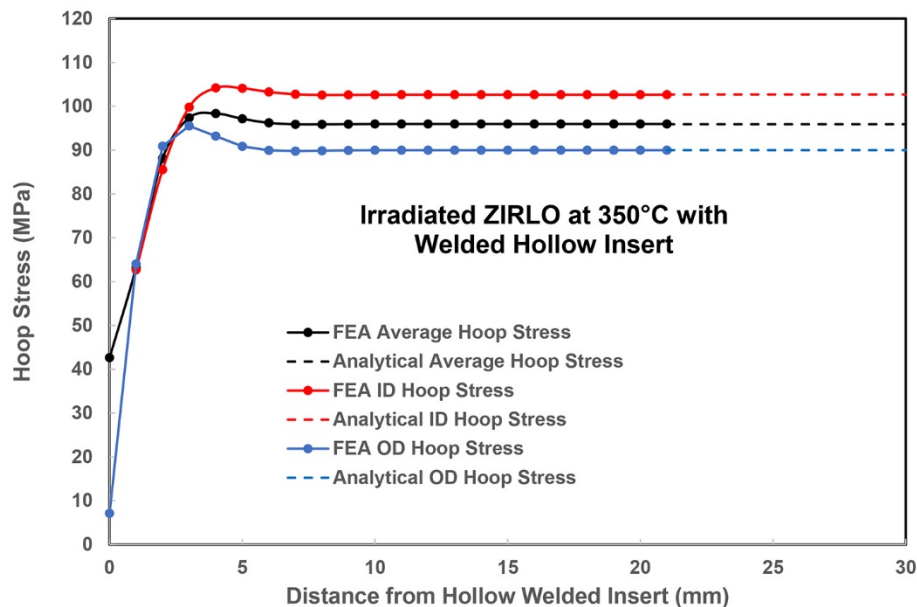
**Figure 31: FEA-predicted hoop stresses for rodlet 646B at 350°C with a hollow, welded top insert.**

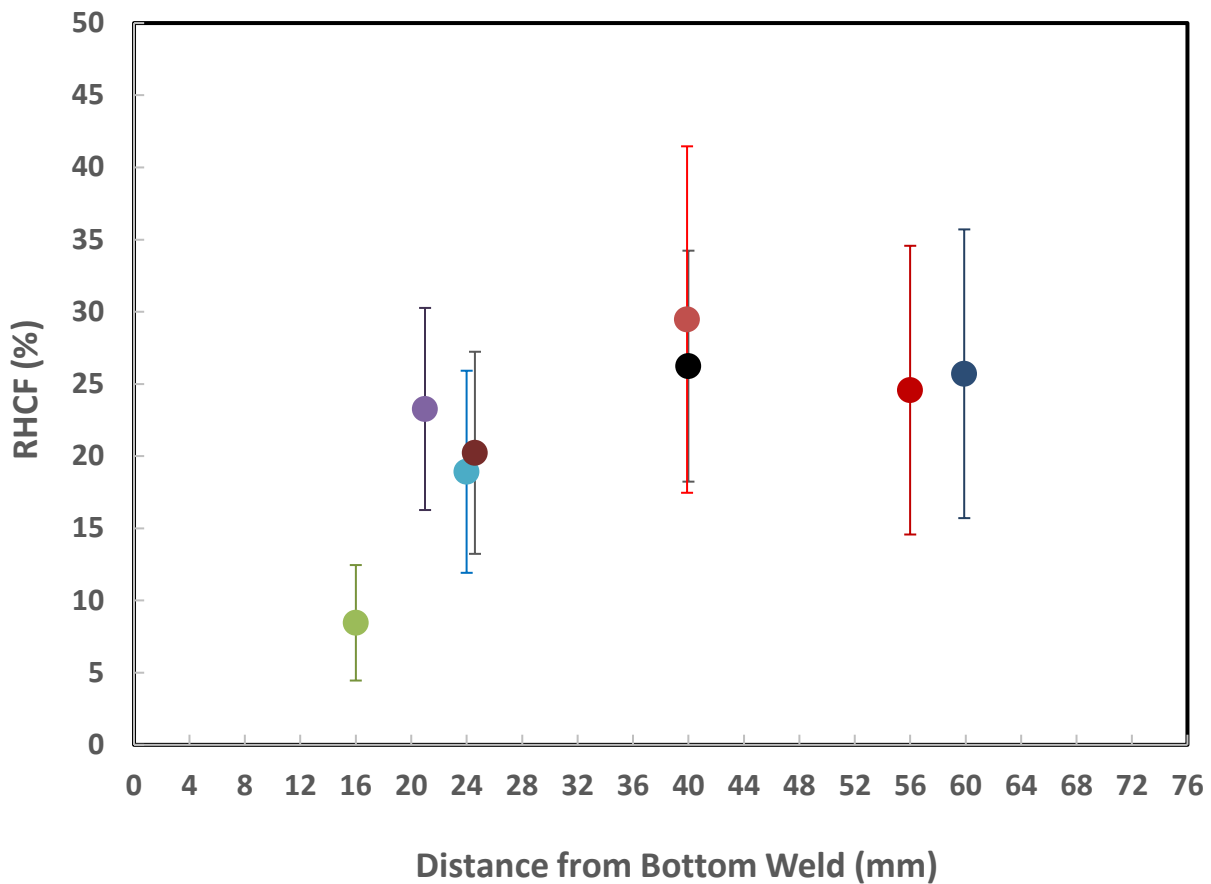
**Figure 50: Axial profile of measured RHCF relative to the bottom weld. The solid weld insert was 10 mm from the bottom weld and the data point at about 60 mm was about 6.5 mm from the 10-mm top, hollow insert.**
