***FY16 Status Report:
SNF Interim Storage
Canister Corrosion and
Surface Environment
Investigations***

***Prepared for
U.S. Department of Energy
Spent Fuel and Waste Science and
Technology***

***Charles Bryan and David Enos
Sandia National Laboratories***

FCRD-UFD-2016-000429

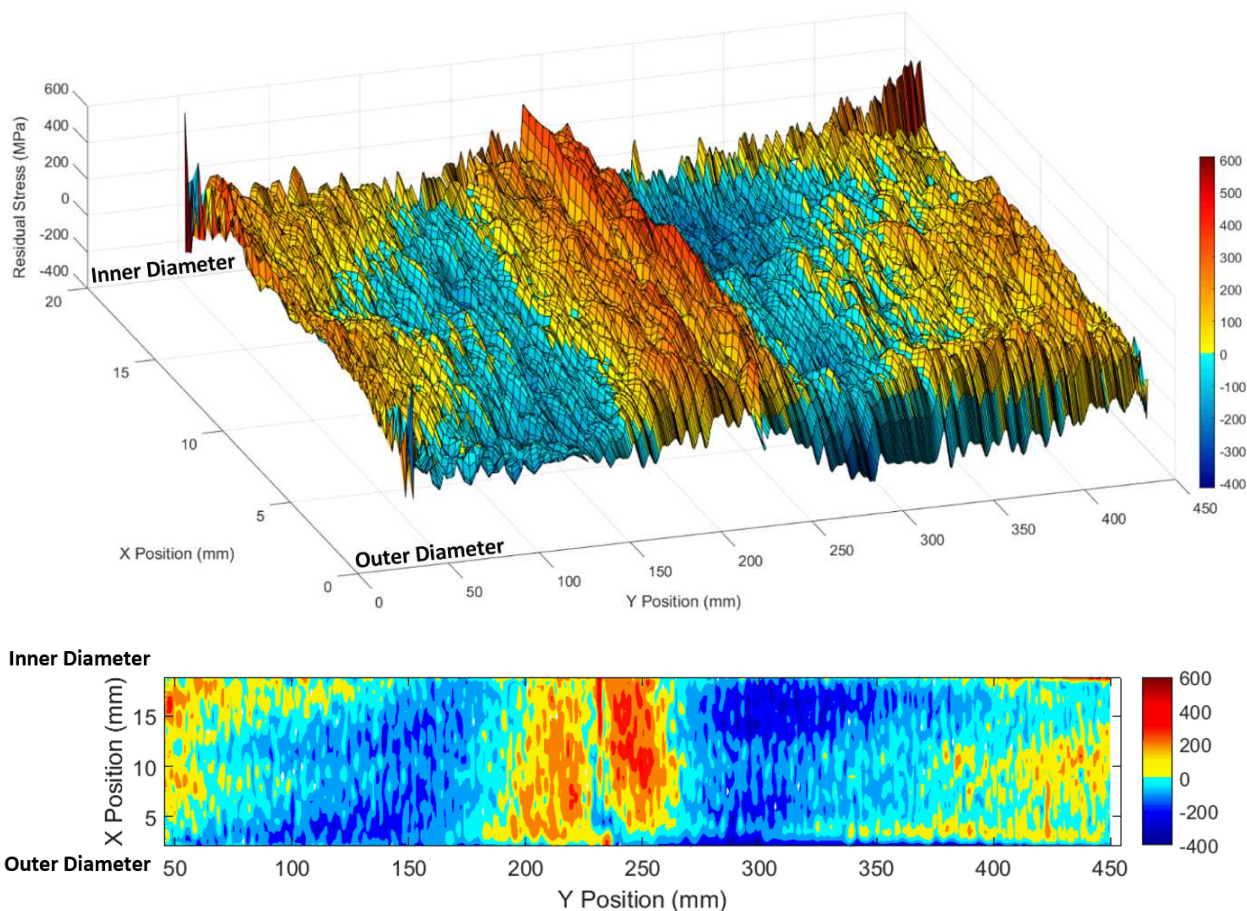
Figure 15: Contour measurement through the intersection of a longitudinal weld with a circumferential weld. The contour is centered on the circumferential weld, with the longitudinal weld being to the right, and the lower container shell to the left.

A final contour measurement was made at the intersection of a circumferential weld with a longitudinal weld, shown in the form of both a surface plot and a contour plot in **Figure 15**. As seen in the figure, the distribution is markedly different than the cross section through the circumferential weld presented in **Figure 13**. While the magnitude appears similar, the stress field extends further from the FZ centerline, and appears to be biased towards the inner diameter of the container. In addition, the hoop stress in the longitudinal weld centerline has become compressive, unlike the tensile stress field illustrated for regions far from the weld intersection, and illustrated via iDHD in **Figure 9**.

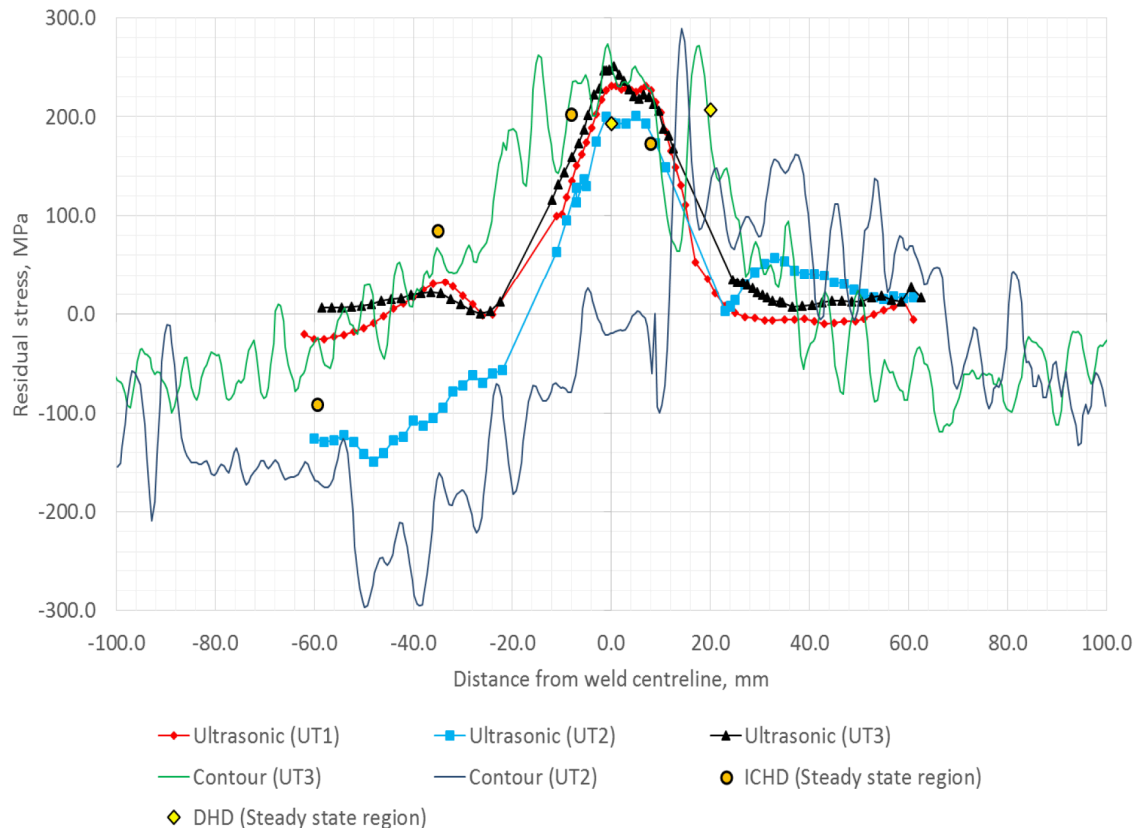
Figure 16: Comparison of ultrasonic measurements to those obtained through contour measurements and hole drilling measurements. UT1 is a transect across a circumferential weld; UT2, a transect across the intersection of the longitudinal and circumferential welds; and UT3, a transect across a longitudinal weld.

In **Figure 16**, it can be seen that the peak stress at the primary weld centerline for each ultrasonic measurement location was comparable. The difference seen both by deep hole drilling and the contour measurement method was not observed. Aside from that, the shape and relative magnitude of the stresses reported from the ultrasonic measurements were comparable to those obtained via other techniques. As such, it appears that the ultrasonic measurement technique offers great promise as a non-destructive stress measurement method, with the potential to offer a precision comparable to other techniques that, while they yield a more complete map (e.g., contour measurement or deep hole drilling), are destructive in nature and as such may not be used in many applications. As an example, an immediate application for this technique would be to evaluate new storage containers for repair regions that result in an unacceptably high residual stress state. This would allow the end user to then either reject the container, or apply a stress mitigation method to the region with a highly elevated stress state.

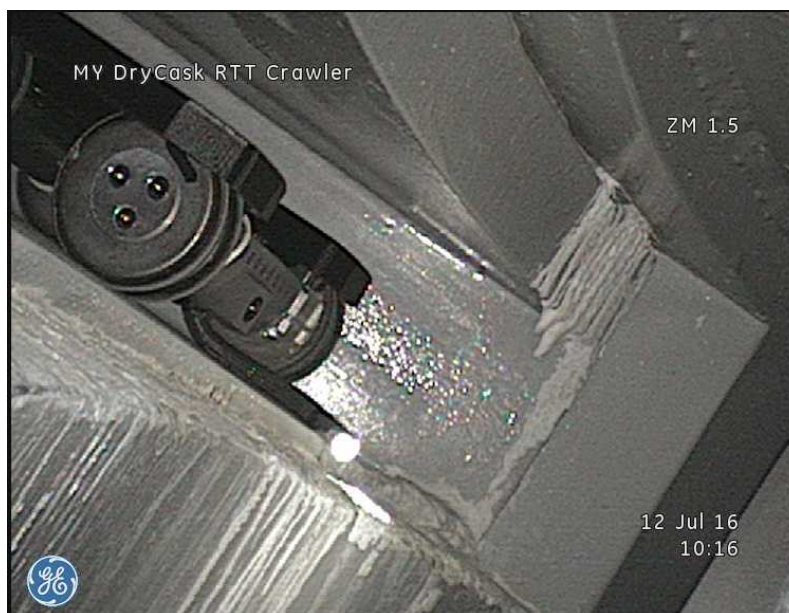
Figure 29. Video image of white crusts of cementitious material on the inner surface of the overpack, located near an outlet vent.

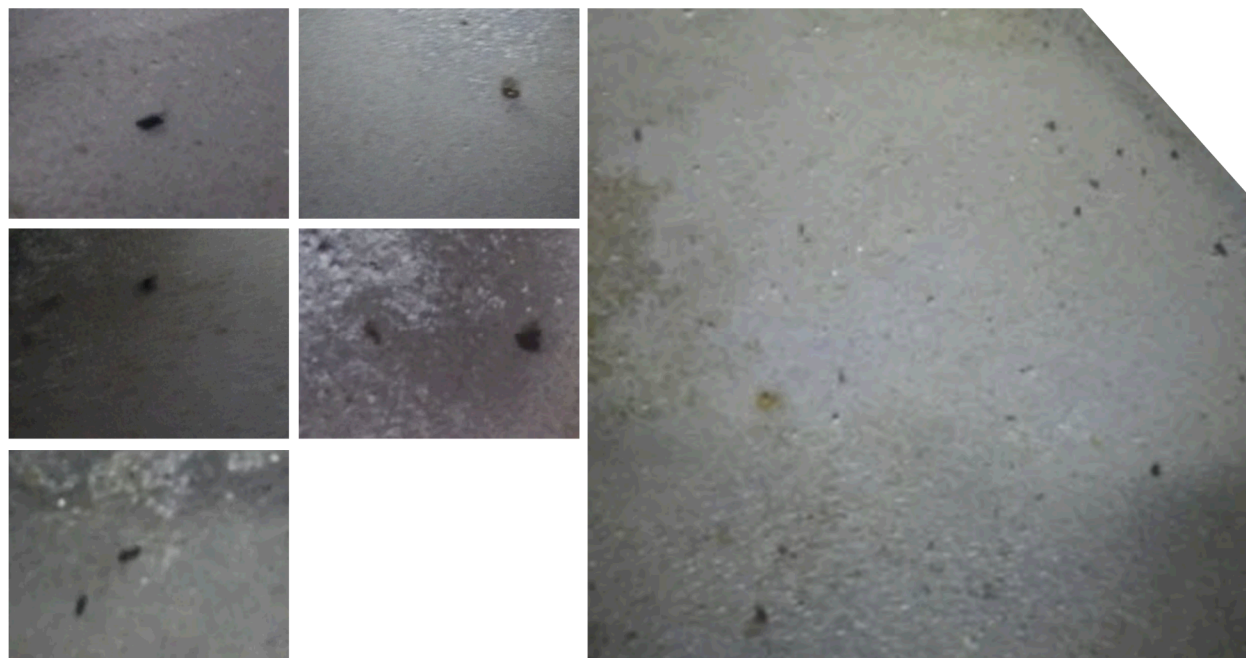
Figure 40. Boroscope camera images of insects on the floor of the HBU storage cask. The scale is not provided in the images, but comparison with structural features in the images (not shown), indicates that the insects are 2-4 mm in size.
