***Large Plate Experiment of
Chloride-induced Stress Corrosion
Cracking in Spent Nuclear Fuel
Storage Canisters***

***Prepared for
U.S. Department of Energy
Spent Fuel and Waste Science and Technology***

***Poh-Sang Lam
Andrew J. Duncan
Robert L. Sindelar
Savannah River National Laboratory***

***September 5, 2020
Milestone No. M3SF-20SR010207022
SRNL-STI-2020-00315***

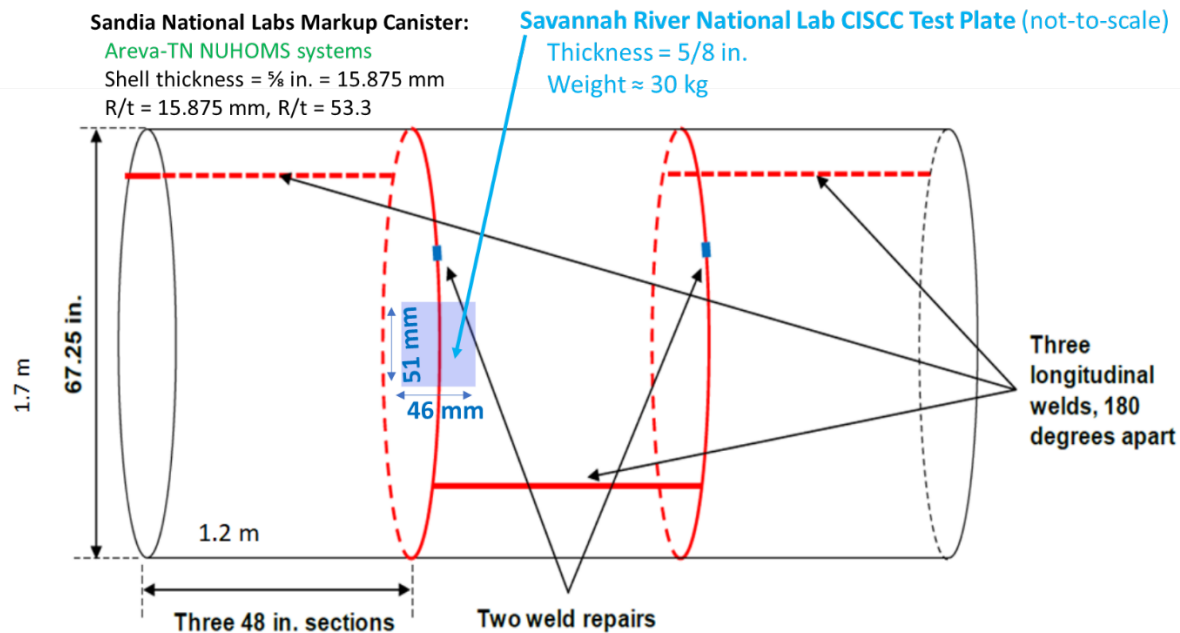
Figure 1. A sketch of the full size mockup canister showing the fabrication welds and the representative location where the SRNL large plate was harvested.

inch.) with a thickness of 16 mm ($\frac{5}{8}$ inch.) and its weight is approximately 30 kg. The objective of the demonstration is to verify the potential for continual crack growth as well as the crack growth characteristics (such as direction and branching, etc.); and if possible, to quantify the averaged CGR and to validate the CGR model [3,5] used to support the development of ASME Section XI Code Case N-860 [2]. The SRNL large plate test was initiated in May 2019.

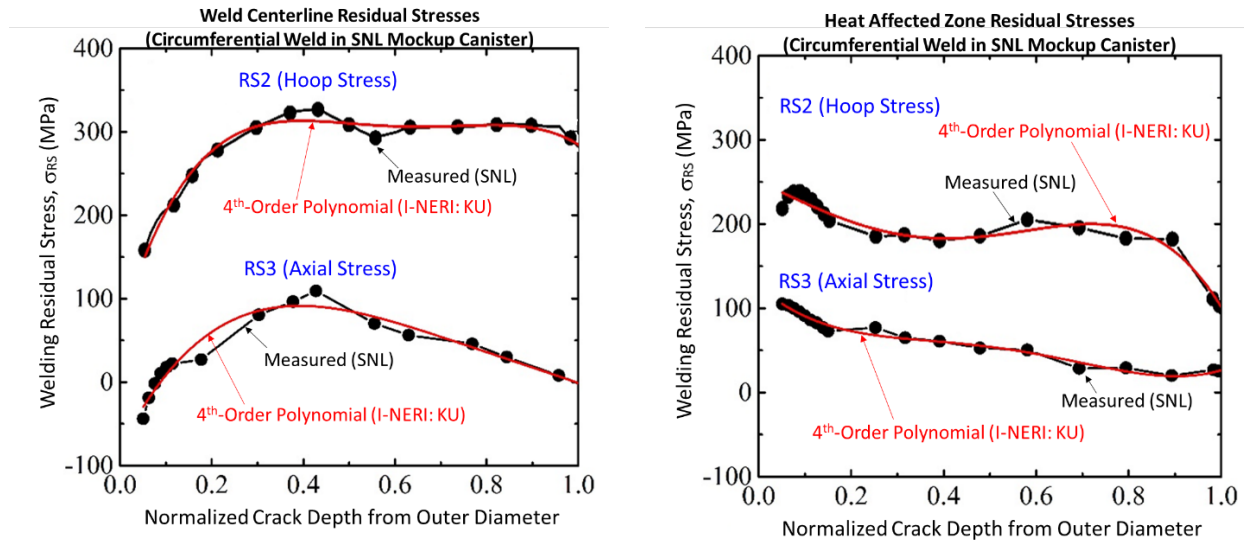
Figure 2. Welding residual stresses associated with the canister circumferential weld. The Weld Centerline and the Heat Affected Zone Residual Stresses were measured at the approximate center of the weld, and at 4 mm from the weld toe (fusion line) into the base material, respectively [6]

welding procedure documented in a previous report [6], and are in good agreement with the experimental results. The designations of these welding residual stresses are shown in Figure 3, where RS2 is the WRS component parallel to the weld and tends to open an axial crack, and RS3 is the WRS perpendicular to the weld and is responsible for opening a circumferential crack.

Location of WRS	WRS Component (see Figure 3)	Location of Max. Stress (see Figure 2)	Maximum Stress (1.0 PS = 261 MPa)
Weld Centerline	RS2 (WRS // Weld)	6 mm from OD	330 MPa (1.25 PS)
	RS3 (WRS ⊥ Weld)	7 mm from OD	110 MPa (0.42 PS)
Heat Affected Zone	RS2 (WRS // Weld)	1 mm from OD	210 MPa (0.80 PS)
	RS3 (WRS ⊥ Weld)	1 mm from OD	110 MPa (0.42 PS)

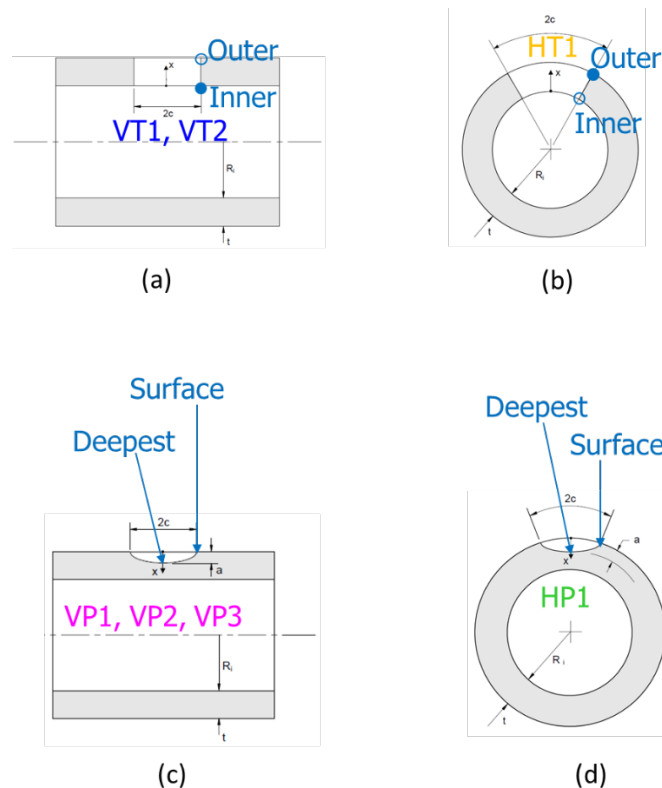
Figure 6. Large plate starter crack configurations: Type (a) VT1, VT2: through-wall crack across the weld; Type (b) HT1: through-wall crack parallel to the weld edge; Type (c) VP1, VP2, VP3: semicircular ($a = c$) part-through-wall crack perpendicular to the weld edge; and Type (d) HP1: semi-circular ($a = c$) part-through-wall crack parallel to the weld edge

The starter crack layout and orientation is schematically shown in Figure 5. Each type of the EDM crack configuration is shown in Figure 6. When these cracks are overlaid over the contour map of the residual stress parallel to the circumferential weld [6], the WRS loading of these cracks can be seen in Fig. 7. The starter crack tips are located in the weld/HAZ region. Note that the stress contour in Figure 7 only applied to the starter cracks that are perpendicular to the weld (i.e., VT1, VT2, VP1, VP2, and VP3).

The through-wall cracks (VT1, VT2, and HT1) were fabricated with EDM wires of 0.25 mm (0.010 in.) diameter (65% copper and 35% zinc). The resulting width (burn gap) on the plate surface (corresponding to the outer surface of the canister) is approximately 0.43 mm by measurement. For the semicircular, part-through-wall cracks (VP1, VP2, VP3, and HP1),

graphite ram EDM electrodes with width 0.51 mm (0.02 in.) were used. The machined starter crack width on the plate surface is about 0.81 mm.

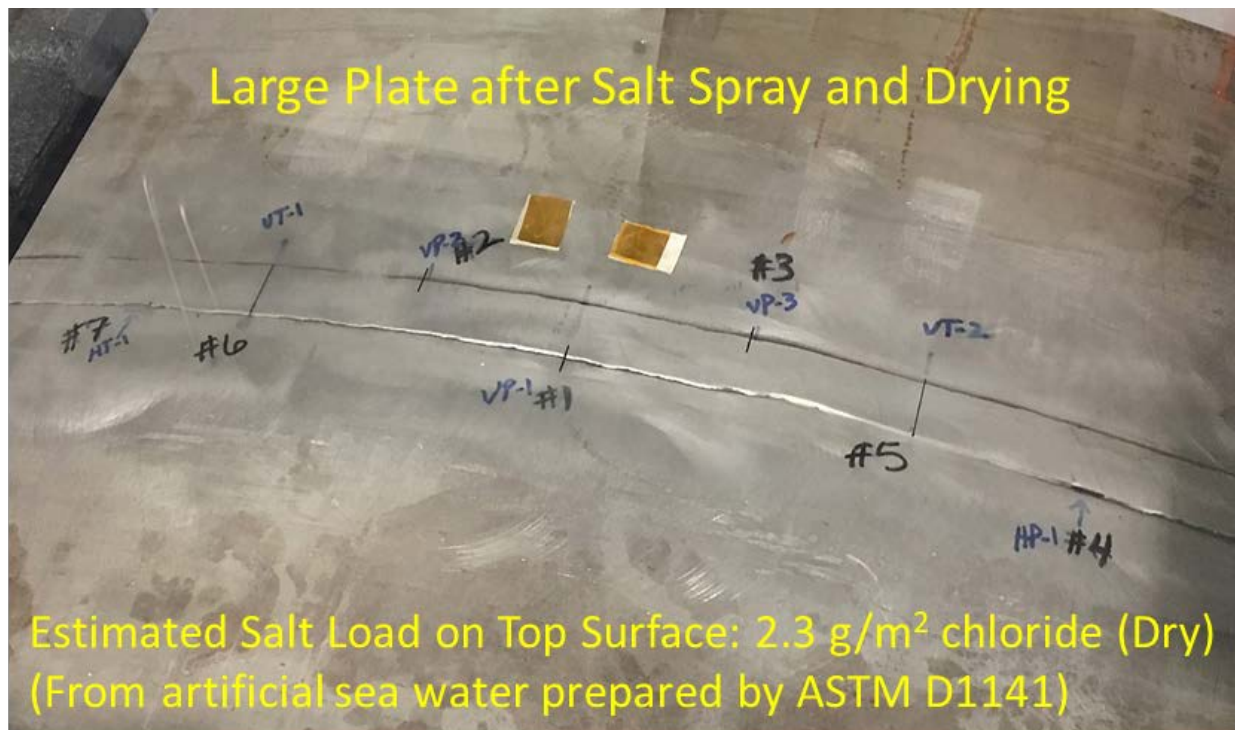
Figure 8. Large plate with EDM starter cracks after salt spray and drying

Artificial sea salt was prepared by following the procedure recommended by ASTM D1141, then deposited on the outer surface of the plate in the welded region with an air brush. The estimated salt load on the plate top surface was 2.3 g/m^2 chloride (dry). The salt coating procedure, as outlined in ASTM G41, "Standard Practice for Determining Cracking Susceptibility of Metals Exposed under Stress to a Hot Salt Environment," was used to create an evenly distributed salt layer over the plate surface. Figure 8 shows the large plate after salt spray and drying, ready for placing inside the test cell.

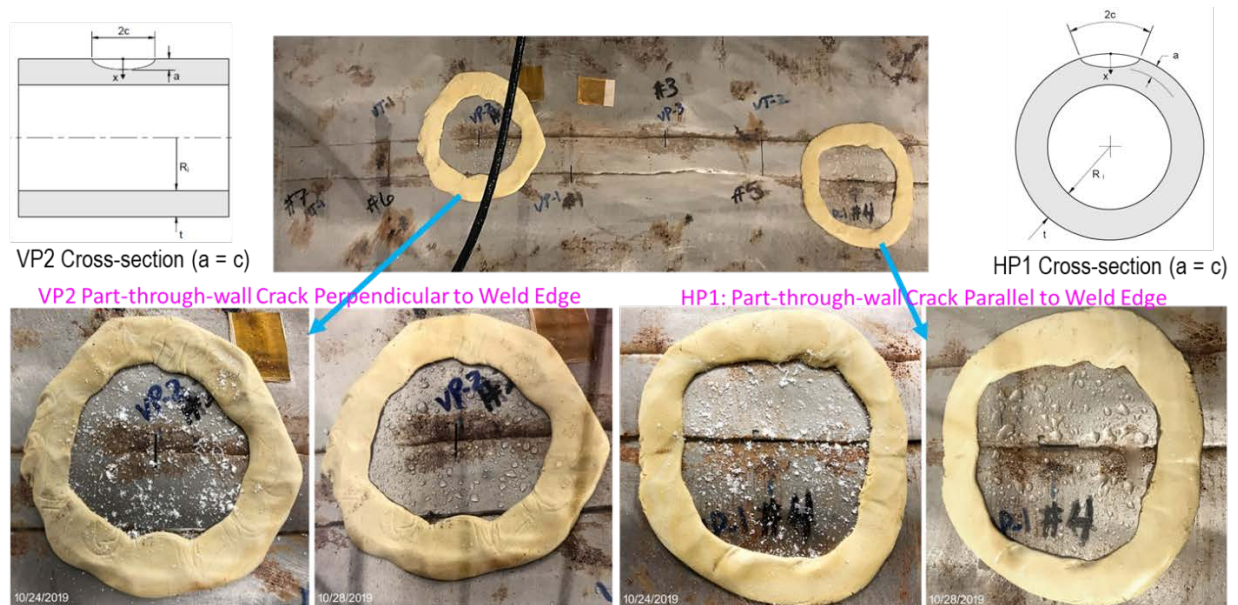
Figure 12. Additional salt applied to selected starter cracks (VP2 and HP1).

Because no cracking was observed after 5 months of exposure with the initial salt load of 2.3 grams Cl^-/m^2 on the plate surface, two starter cracks (VP2 and HP1) were selected to receive additional salt load, where VP2 is a semicircular surface crack perpendicular to the weld, and HP1 is a semicircular surface crack parallel to the weld edge. The original crack lengths are both 12 mm on the plate surface. As seen in Figure 12, these two cracks were isolated with putty material (yellow) from the other starter cracks and the extra salt was applied to the enclosed areas on October 24, 2019). The deliquesced salt brine droplets can be seen in Figure 12.

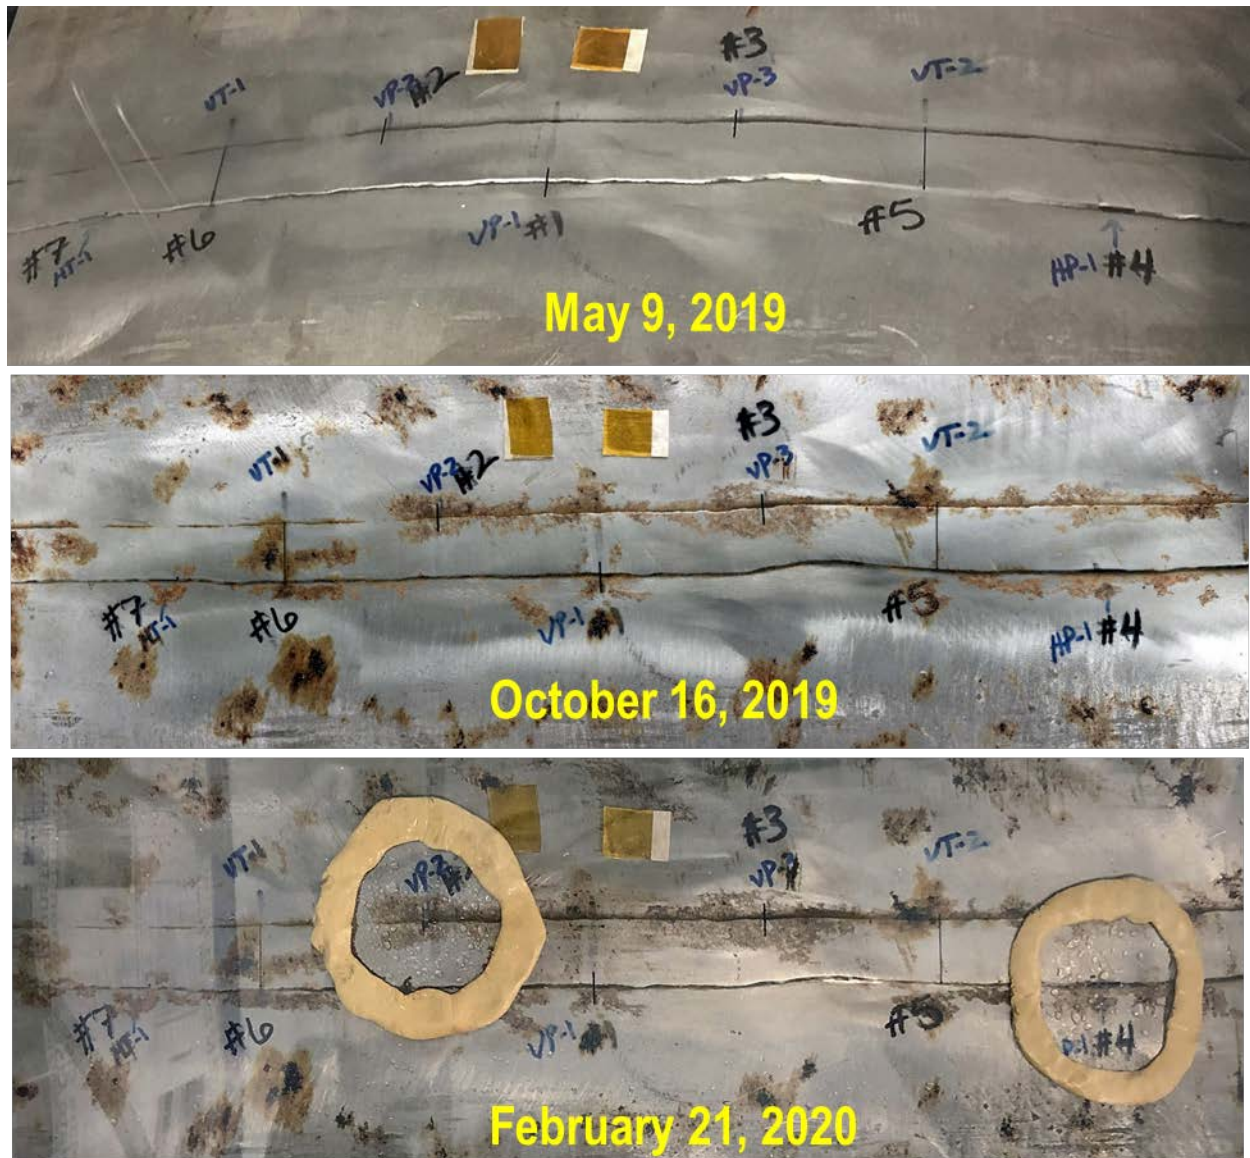
Figure 14. Evolution of general corrosion on the large plate in weld region

A comparison of general corrosion in the weld region across the width of the entire large plate from May 9, 2019 (test initiation date) through February 21, 2020 is shown in Figure 14. It can be seen that the corrosion pattern appears to be stabilized quickly (sometime between May and October 2019). Even with extra salt applied to two of the starter cracks on October 2019, it seems that the appearance of general corrosion was not affected (Figure 14). Of course, in the very close vicinities around those two starter cracks with extra salt load, the corrosion remains relatively active (see VP2 in Figure 13).

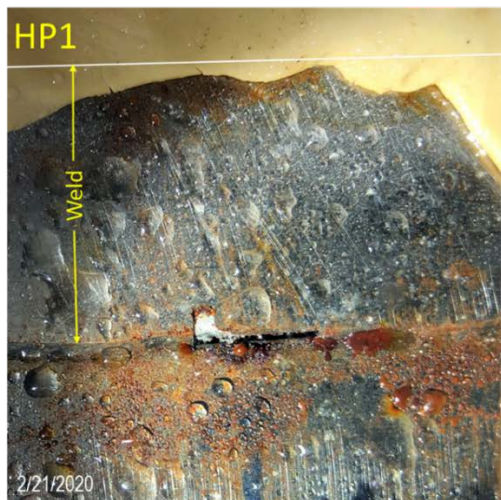
Figure 17. Stress intensity factor solutions for the starter cracks HP1 and HT1, and the images of these cracks after 9.5 months of exposure (HP1 is a semicircular part-through-wall surface cracks parallel to the weld; and HT1 is a through-wall crack parallel to the weld).

Welding Residual Stress	Crack Tip Location	Stress Intensity Factor (MPa√m)
Weld Centerline	Outside Surface	6.5
	Inside Surface	6.7
Heat Affected Zone	Outside Surface	13.3
	Inside Surface	1.9

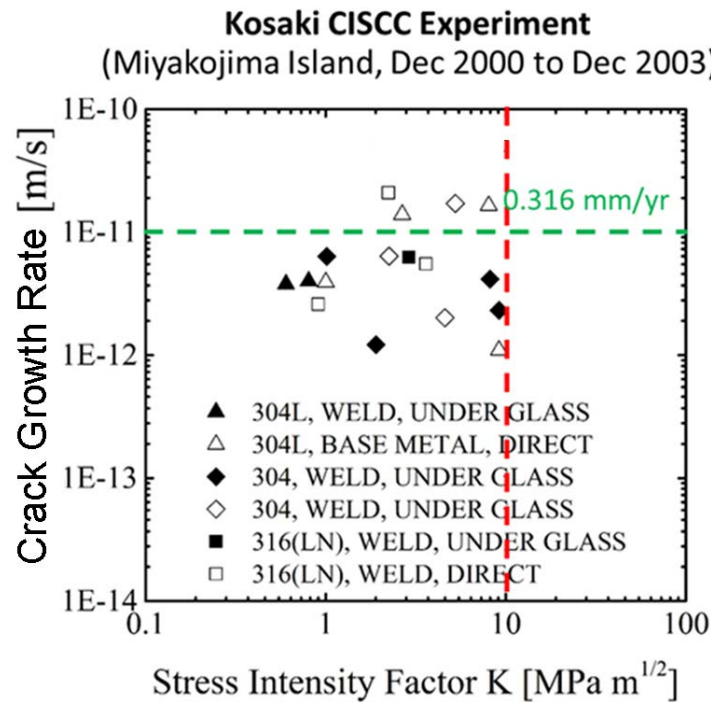
Figure 18. Crack growth rates from natural exposure on Miyakojima [17,18] (Courtesy of Korea University under I-NERI/USA-ROK)

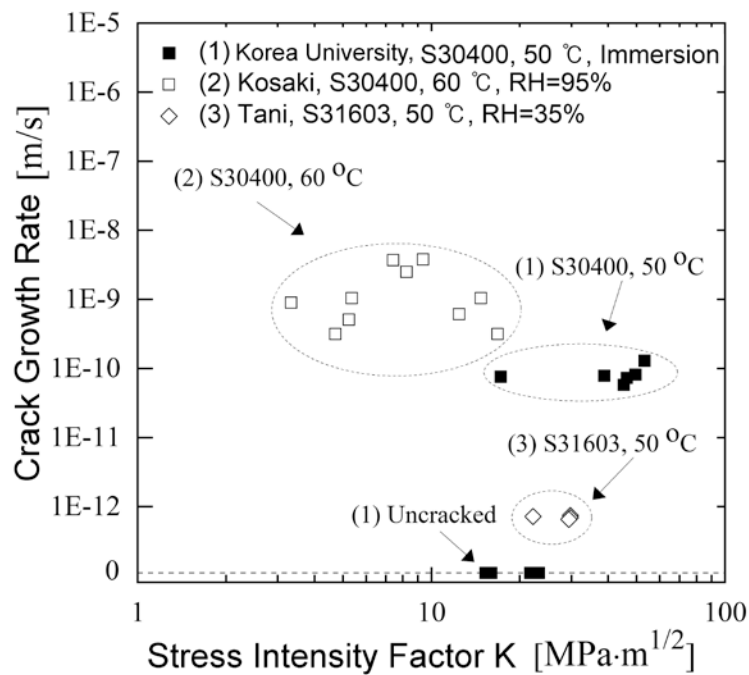
Figure 19. Crack growth rates from laboratory tests for stainless steels at 50 and 60°C under various CISC conditions [22].
