Project No. 33486

# Neutron Absorber Material Corrosion Testing Final Report FY2021

**Neutron Absorber Material Corrosion  
Testing Report**

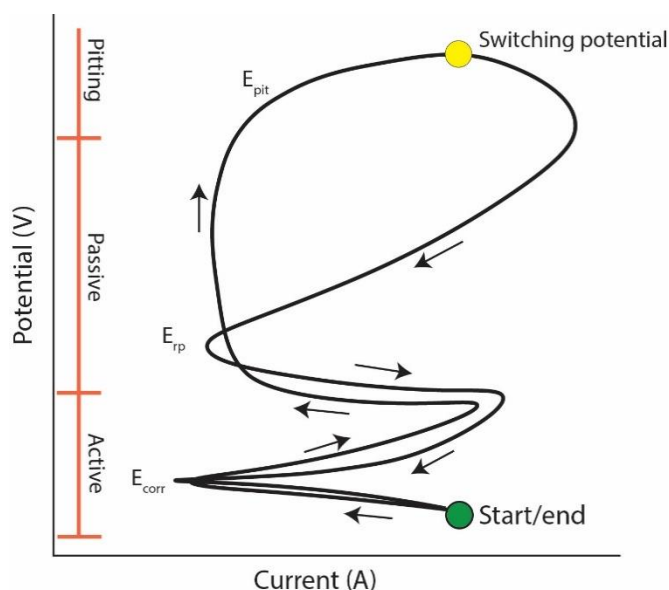
**Figure 1.** Diagram of a generic CPP curve.

down into three regions: the active region, the passive region, and the pitting region. The current is plotted as an absolute value in log scale. The active region is centered around  $E_{\text{corr}}$ , which is defined by a complex balance of chemical reactions that sets the potential relative to a reference electrode. It is the point where currents for these reactions are balanced—such that, when the potential is manipulated (using a potentiostat and electrochemical cell), the net current increases in either direction. The scan is initiated negative of the measured  $E_{\text{corr}}$  in the positive direction. After passing through  $E_{\text{corr}}$  (note that, in this study, we report  $E_{\text{corr}}$  with air purge and not based on the CPP curve), the net current flips from cathodic to anodic, and, depending on the environment, a broad hump may be observed which is the anodic dissolution of the metal in what is called the “active” region. This peak often decreases as the oxide layer reforms in the passive region, the oxide layer being stabilized by the more positive potential. In relatively benign environments (for the metal/alloy), the current in the active region may be very small, without a defined peak. The current will eventually increase in the passive region, either due to pitting corrosion or, in some cases, transpassive corrosion (often more positive in non-pitting alloy/environment conditions). The initiation of pitting corrosion is often preceded by noise spikes in current, due to pit initiation and repassivation before stable pitting sets in. Deeper into the pitting region, the current increases, and the sweep is reversed at the switching potential. If pitting has initiated on the specimen, the current will remain high on the return sweep until the potential is insufficient to sustain the pitting.  $E_{\text{rp}}$  is a potential assigned to describe when pits have repassivated on the return sweep. Going back to the switching potential, if the current decreases quickly and closely tracks the forward sweep, it is likely the specimen is not susceptible to localized corrosion under the tested conditions. In that case, the current observed is either oxide film growth or transpassive corrosion. The remainder of the sweep may show features similar to the forward sweep. Once the potential reaches the starting potential, the test is stopped.

Two important parameters are obtained from the CPP curves: the pitting potential ( $E_{pit}$ ) and  $E_{rp}$ .  $E_{pit}$  is defined as the point at which a sharp increase in current is observed in the forward sweep, where pitting is initiated.  $E_{rp}$  is defined as the point at which the current from pitting has subsided—typically the point at which the current switches sign (net current is negative) or crosses the forward sweep. This would indicate the point at which the material is defined as being stable (to pitting corrosion). Stability is assessed by comparing measured  $E_{rp}$  to  $E_{corr}$ , where the more positive  $E_{rp}$  is relative to  $E_{corr}$ , the less likely pitting corrosion will occur. Conversely, if  $E_{corr}$  is similar to or more positive than  $E_{rp}$ , the alloy and environment are considered incompatible, as localized corrosion is likely to occur. This was the basis for evaluating Alloy 22 as a WPOB material, with a parameterized model formulated and used to predict crevice corrosion [2].

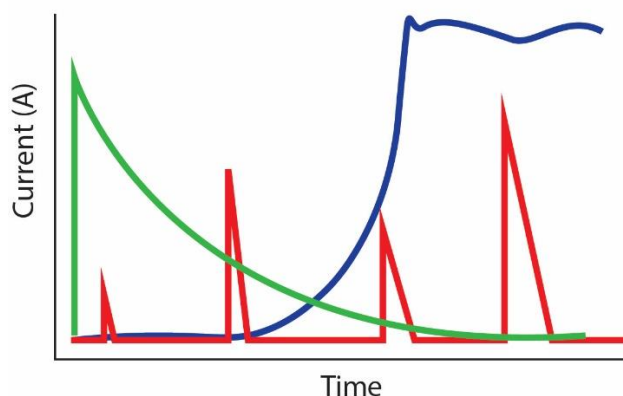
**Figure 2.** Diagram of PS tests for three different cases (see text).

Potentiostatic (PS) tests were performed to evaluate corrosion at specific potentials over time. The potential is selected based on values that are either near or somewhat positive of the  $E_{corr}$  value. If positive of the  $E_{corr}$  value, the tests provide a bounding case for corrosion or allow alloys to be compared under aggressive or accelerated conditions. The electrochemical cell and specimen geometry is the same as used for CPP tests. Figure 2 shows a diagram of a PS test for three different cases. The red curve is for a specimen that shows initiation but not sustained corrosion. Depending on the magnitude of current and duration, this could be minimal to significant corrosion but is where the specimen is on the edge of stability. This could be the case for stainless steel below the  $E_{pit}$  (see Figure 1) and positive of the  $E_{rp}$ . The blue line is an example of a specimen that has a short period of stability before corrosion initiates, but

then increases to significant and sustained corrosion, clearly unstable under the selected conditions. As pitting is a probabilistic, PS tests provide a longer time for pitting to initiate than in CPP tests. The green curve is a unique case which was observed for ANA specimens in previous work, where the secondary phase is preferentially dissolved, but corrosion slowly decreases as the secondary phase available to react at the surface decreases. The magnitude of current at the end of the test provides an indication for tendency to repassivate (reform protective oxide) following the secondary phase dissolution.

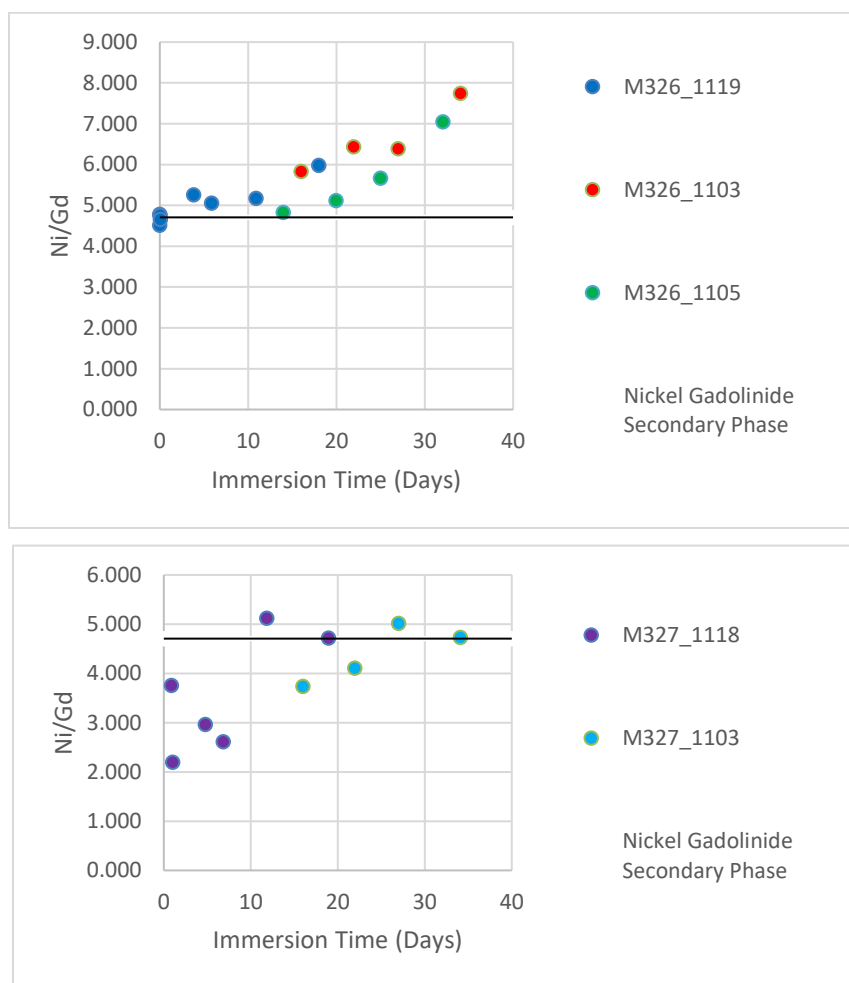
**Figure 3.** Evolution of Ni/Gd molar ratio in M326 (top) and M327 (bottom) acid pickling solution.

In the case of M327 (Figure 3), the Ni/Gd molar ratio appears lower than that of the secondary phase for unknown reasons. After 12-20 days, the Ni/Gd molar ratio stabilizes around that which would be expected for dissolution of the gadolinide phase alone. This suggests that the gadolinides in the M327 material intersecting the surface dissolve but does not proceed further. Figure 5 shows the Ni and Gd content versus pickling time. Note that the level of Ni and Gd are over an order of magnitude lower. Cr

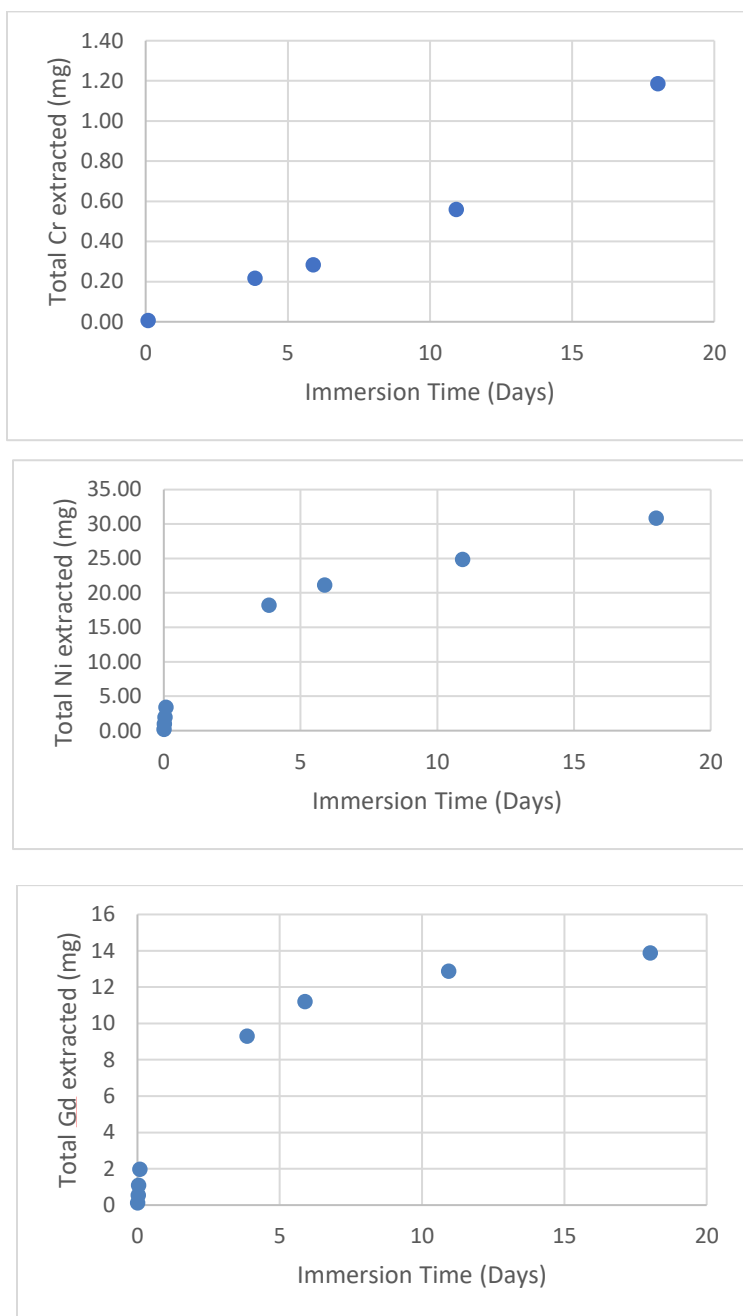
**Figure 4.** Total Cr, Ni and Gd extracted from M326 specimen during acid pickling.

$\text{Ni}_5\text{Gd}$  (2.41% by weight [14-15]), were detected in the M326 pickling solution. This is shown in Figure 4, where the Cr concentration steadily increased with exposure time. For M326, the Ni and Gd continues to increase with exposure, however the Gd level appears to reach a plateau. This suggest further testing for longer periods would be required to assess if gadolinide dissolution was quenched. M326 exhibits some form of continuous corrosion, either the Gd rich secondary phase or some combination with the primary phase beyond 2 weeks. However, the rate of Gd dissolution appears to be tapering off near the end of this period. The highest extracted mass of Gd in any M326 pickling sample corresponds to 6.48% of the total Gd content, indicating  $\text{Ni}_5\text{Gd}$  corrosion is penetrating beyond that intersecting the specimen surface.

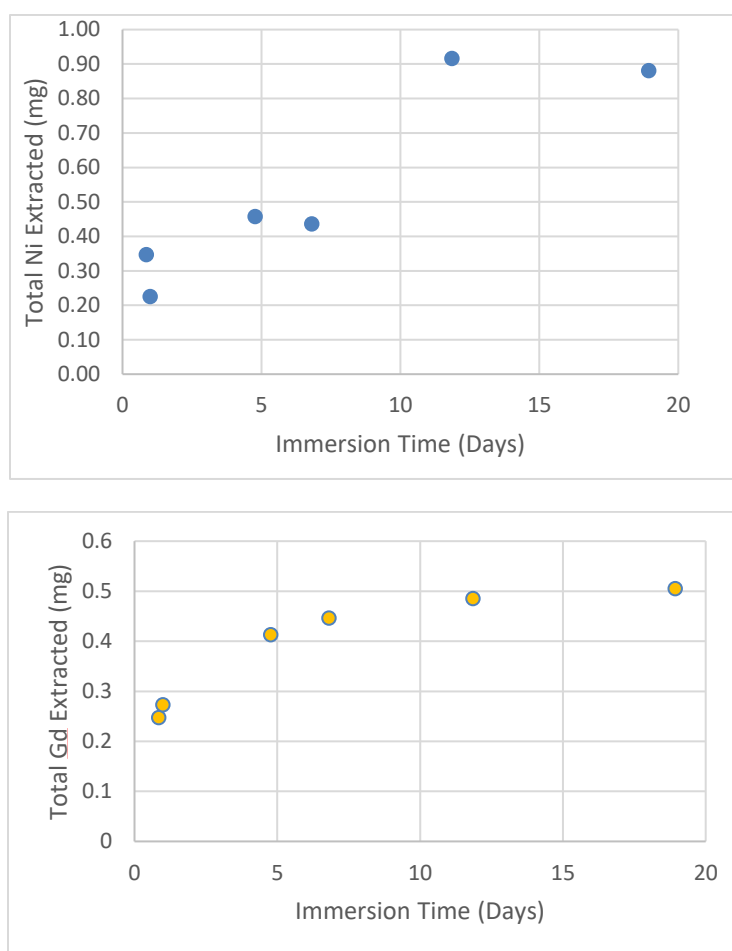
**Figure 5.** Total Ni and Gd extracted versus time for the M327 specimen during acid pickling.

was not observed in the M327 acid pickling solution above the detection limit, further indicating that the primary phase remained stable in such a harsh environment. The results point to primarily Ni<sub>5</sub>Gd dissolution, which is not only significantly reduced in magnitude compared to M326, but also more definitively slow after 10 days. This is likely due to the higher Cr content in M327 stabilizing the primary phase. This could also be a microstructural effect involving the degree of interconnection for the gadolinides that needs further examination. The highest extracted mass of Gd in any M327 pickling sample corresponds to 0.23% of the total Gd content, indicating Gd loss was limited compared to that of M326. A calculation was made using the measured Gd in solution for each alloy and the specimen dimensions. The M326 which lost 6.2% of Gd weight indicated an impact depth of 78 μm, while M327 with 0.23% of Gd was impacted to a depth of 2.8 μm. This calculation assumes a uniform impact.

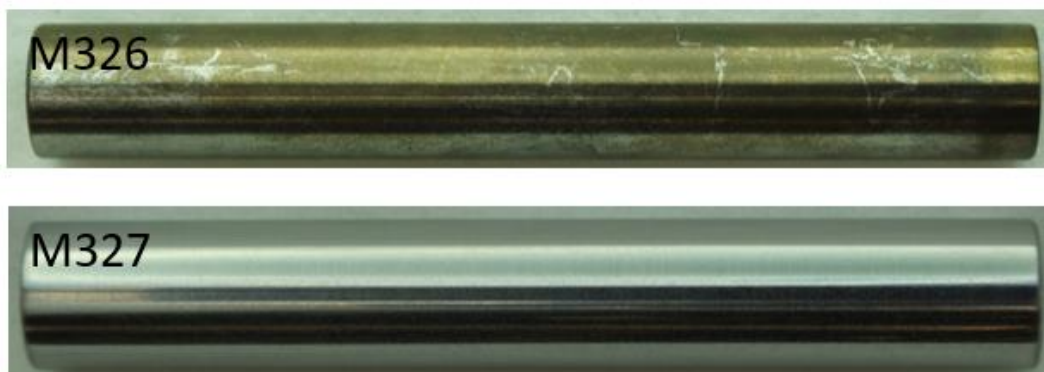
**Figure 6.** Images of specimens after acid pickling in 1.0 M HCl for 42 days.

apparent in the case of M326. Figure 6 shows images of the specimens after exposure. The M326 specimens shows significant coloration on the surface while M327 is relatively devoid of staining.

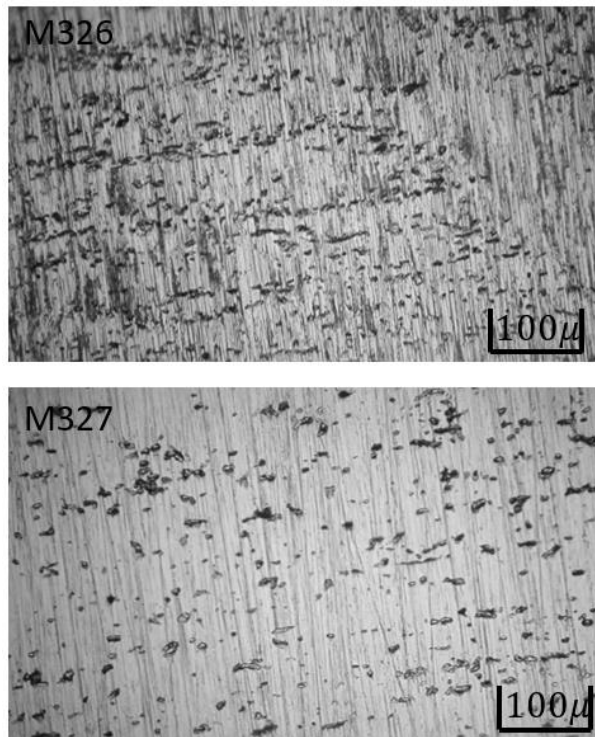
**Figure 7.** Optical microscopy images of M326 (top) and M327 (bottom) after acid pickling in 1.0 M HCl for 42 days.

Optical microscopy was used to examine the specimens after testing with examples shown in Figure 7. Both specimens show the typical secondary phase attack. M326 damage appears more extensive with pits more connected. An analysis of both specimens for the secondary phase distribution would be needed to make additional use of this data for assessment.

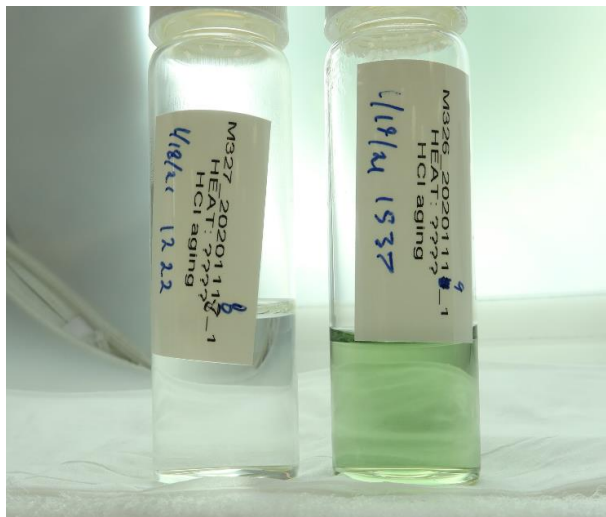
**Figure 8.** Solutions retained from pickling M327 (left) and M326 (right).

Figure 8 shows images of M326 and M327 after pickling experiments. Only the M326 shows definite color due to ions dissolved in solution. The green color is from dissolved nickel and chromium ions.

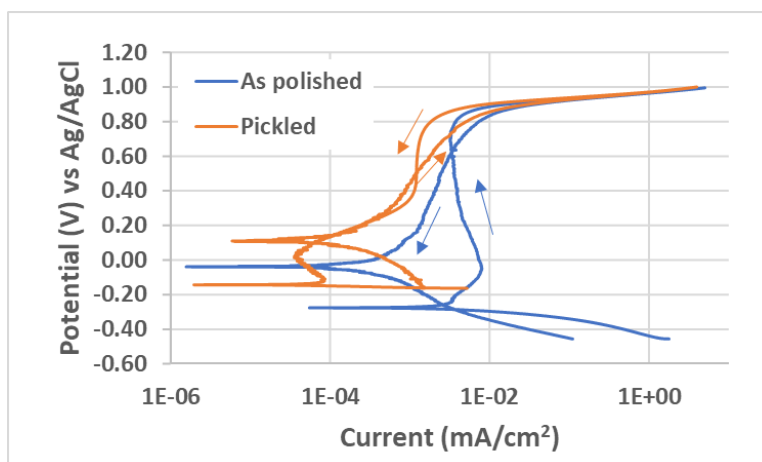
**Figure 9.** CPP curves for M327 in 0.1 M HCl with and without acid pickling.

After pickling, ANA specimens were examined with CPP testing to assess how removing the gadolinide phase affects the curves. Figures 9-10 show CPP curves in 0.1 M HCl for M327 and M326 after pickling with as polished results provided for comparison. In both cases, the curves for pickled specimens are lower in current, supporting the idea that the current observed across passive range is due to the secondary phase corrosion. Note that the  $E_{rp}$  (sharp point at low current on the return sweep) shifts positive for the pickled specimens, another indication of improving corrosion characteristics upon removing the secondary phases. The curve for M327 (and M326 to some extent) resembles that of Alloy 22 [15].

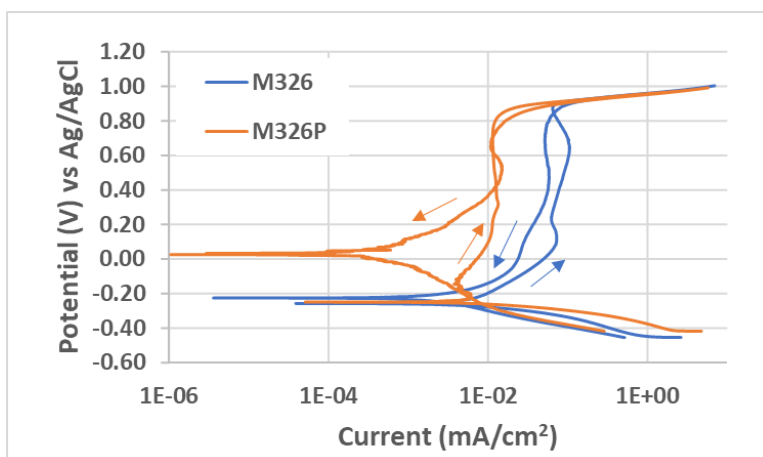
**Figure 10.** CPP curves for M326 in 0.1 M HCl with and without acid pickling.

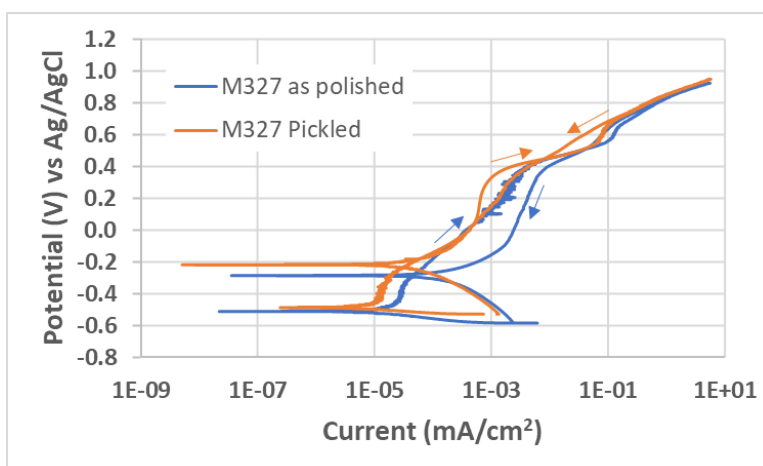
**Figure 11.** CPP curves for M327 in seawater with and without acid pickling.

Similar tests were performed for acid pickled specimens in seawater, shown in Figures 11-12. It is interesting that for M327 (Figure 11), there was not as significant a difference in the forward curve but a bit greater difference on the return sweep. There is a shift in  $E_{rp}$ , but it is not nearly as great (or as positive) as observed in 0.1 M HCl. In seawater, we suspect that the secondary phase dissolves much slower in the passive region (supported by the current for as polished specimens in Figure 9 vs Figure 11). Therefore, the differences in current are less for pickled vs as polished. For M326 in Figure 12, the pickled specimen shows much lower current in both directions, with current being significantly greater than the as polished M327.

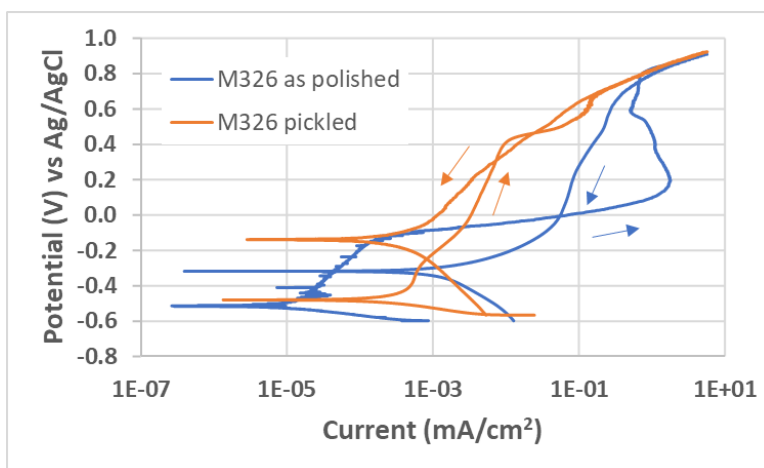
**Figure 12.** CPP curves for M326 in seawater with and without acid pickling.

For M326, a greater difference was observed for the pickled specimen which appears to be from an increased current for the as polished specimen, where the pickled specimen had only a slightly higher current than M327 (Figure 11).

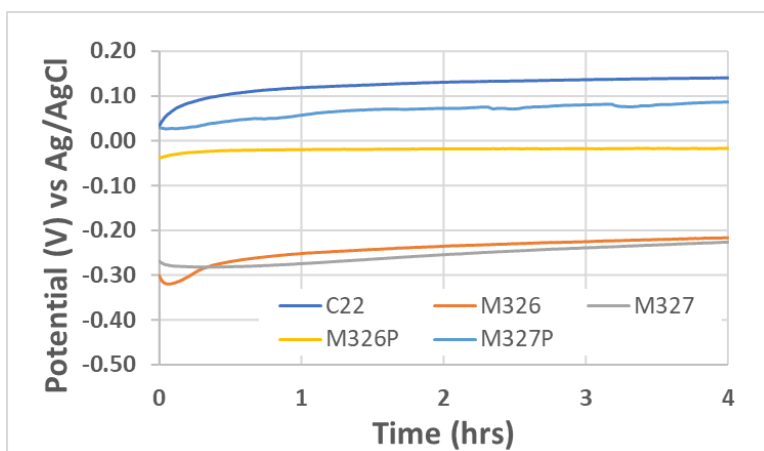
**Figure 13.**  $E_{\text{corr}}$  of Ni alloys in 0.1 M HCl with and without pickling.

Figure 13-14 shows  $E_{\text{corr}}$  curves taken before testing for pickled and as polished specimens in 0.1 HCl and seawater respectively. Note that in 0.1 M HCl, the pickled specimens show a significant positive shift and are similar to Alloy 22 (C22). In general, positive shifts in  $E_{\text{corr}}$  are indications of improved corrosion resistance. For seawater, the curves are smooth, however are shifted negative compared to the as polished specimens.  $E_{\text{corr}}$  is the measured rest potential of specimens in the environment, defined by the balance point between possible cathode and anodic reactions. The corrosion of gadolinides at  $E_{\text{corr}}$  in seawater for the as polished specimens is the likely reason for this inversion of trend.

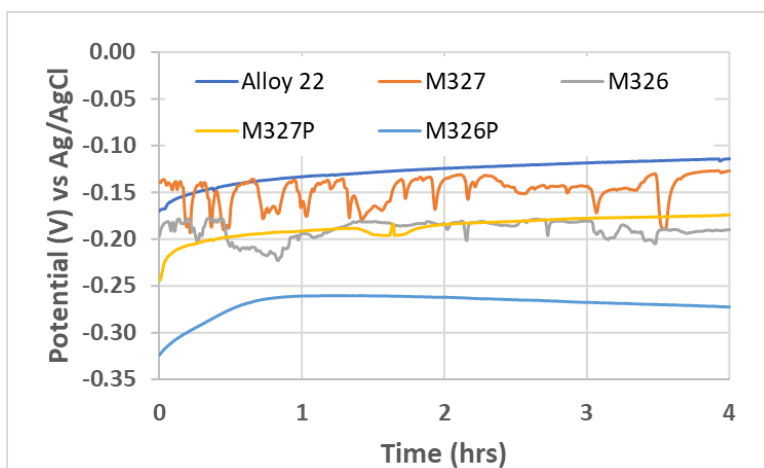
**Figure 14.**  $E_{\text{corr}}$  of Ni alloys in seawater with and without pickling.

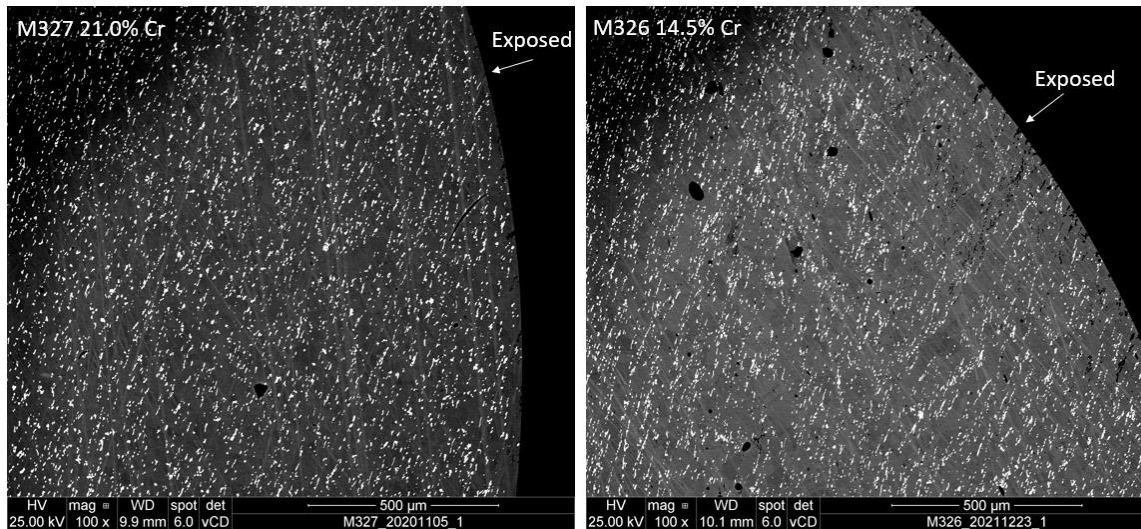
**Figure 15.** SEM images (backscatter mode) of the cross-section of M327 and M326 specimens after pickling and CPP testing in 0.1 M HCl.

Figure 15 shows a cross-sectional SEM images for M326 and M327 specimens after pickling and CPP testing in 0.1 M HCl (Figure 9-10). On the images, the curved surface to the right is the exposed surface. Bright regions are gadolinide particles and dark regions are presumed to be areas where gadolinides have been dissolved. For M326, several dark regions exist near the exposed edge of the specimen. In some cases, these appear to be deep into the specimen. The M327 specimen appears to show only loss of gadolinides close to the surface. A quantitative assessment of these images has not yet been performed, but generally this appears to support that the secondary phase is removed deep into the specimen for M326 and not M327, as discussed in Section 3.1.1.

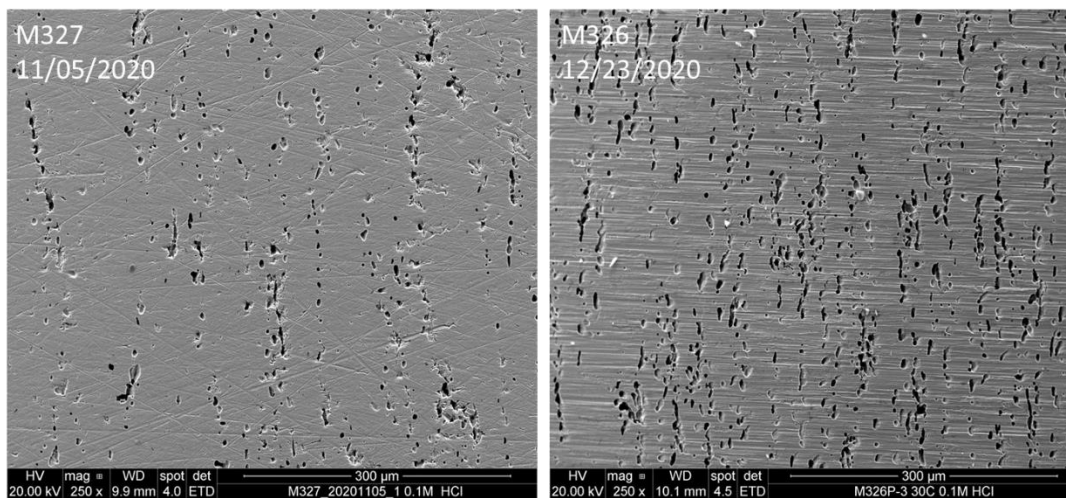
**Figure 16.** SEM images of M327 and M326 specimens after pickling and CPP testing in 0.1 M HCl.

Figure 16 shows SEM images of the exposed surface of ANA specimens (same as in Figure 15). These images show small pits which have been reported for ANA previously [16]. These small pits are where gadolinide particles had dissolved.

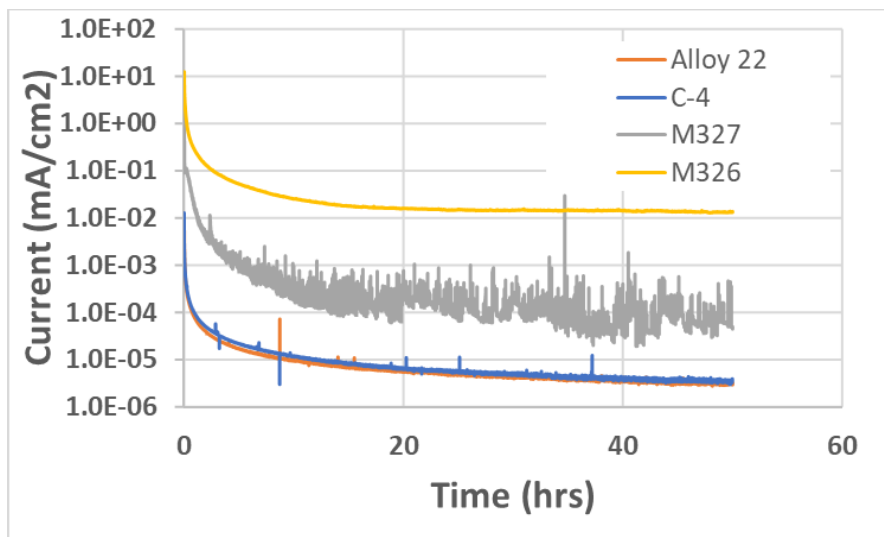
**Figure 17.** Current vs time curves for M326, M327, Alloy 22 and Alloy C-4 in seawater.

This suggests that for this condition the additional Cr in Alloy 22 is not providing any significant benefit.

This suggests that the additional chromium (14.7% vs 21%) is quite beneficial.

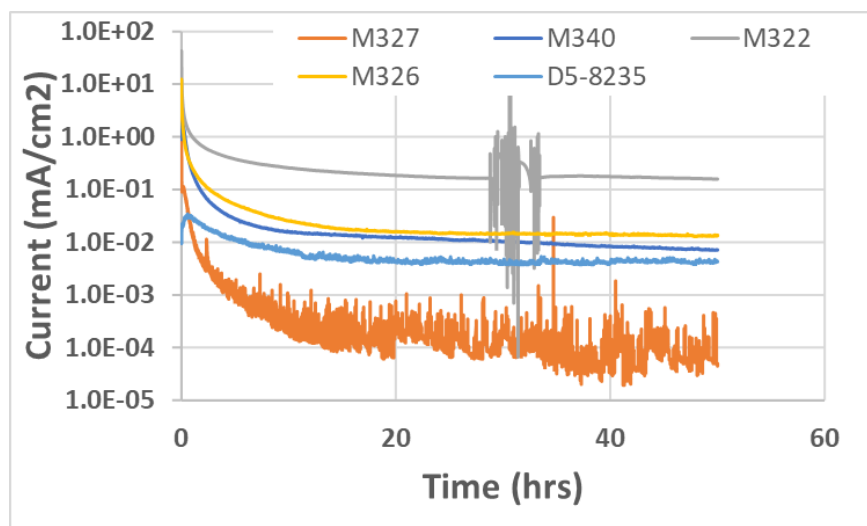
**Figure 18.** Current vs. time curves for various ANA specimens in seawater.

The benefit of additional Cr in ANA was further considered by examining available ANA materials from previous efforts. Figure 18 shows a series of curves from these tests including the same curves from M327 and M326 shown in Figure 17. Unfortunately, there were not any alloys with Cr above 16.75% (except M327), so this analysis is limited. Also note that M322 has 2.38% Gd and D5-8235 has 1.89% Gd. In general, the current drops with increasing Cr content, approximately 0.5 orders of magnitude between M326 (14.7% Cr) and D5-8235 (16.75% Cr). This current was converted to a corrosion rate (assuming general corrosion) using ASTM G102 and plotted versus Cr content in Figure 19 [13]. The two red points are the benchmark alloys showing the lowest corrosion rates. The highest rate was for M322 (2.38% Gd). Although it would be helpful to have a better distribution of Cr composition, the rates for ANA decrease with Cr composition.

Figure 18. The corrosion rates were determined before and after the PS tests using LPR. The LPR determined rates before testing generally follow the level of Cr but not as dramatically as the PS current. The rates after testing were greater for all ANA specimens, indicating that the new surface produced from gadolinide dissolution could be considered less passive as the original surface. This could be from insufficient time for passivation to occur after being in an accelerated corrosion state. The values for M327 are the exception, where the values are essentially the same. This is also the case for the benchmark alloys, another indicator that M327 behave more like the benchmark alloys than the lower Cr ANA specimens.

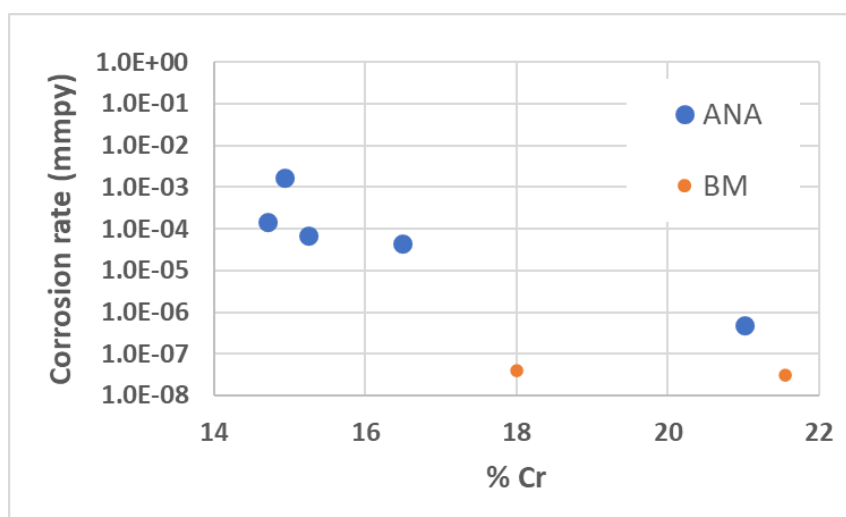
**Figure 19.** Plots of corrosion rates calculated from the final current data point from PS tests in seawater for ANA (blue) and benchmark alloys (red).

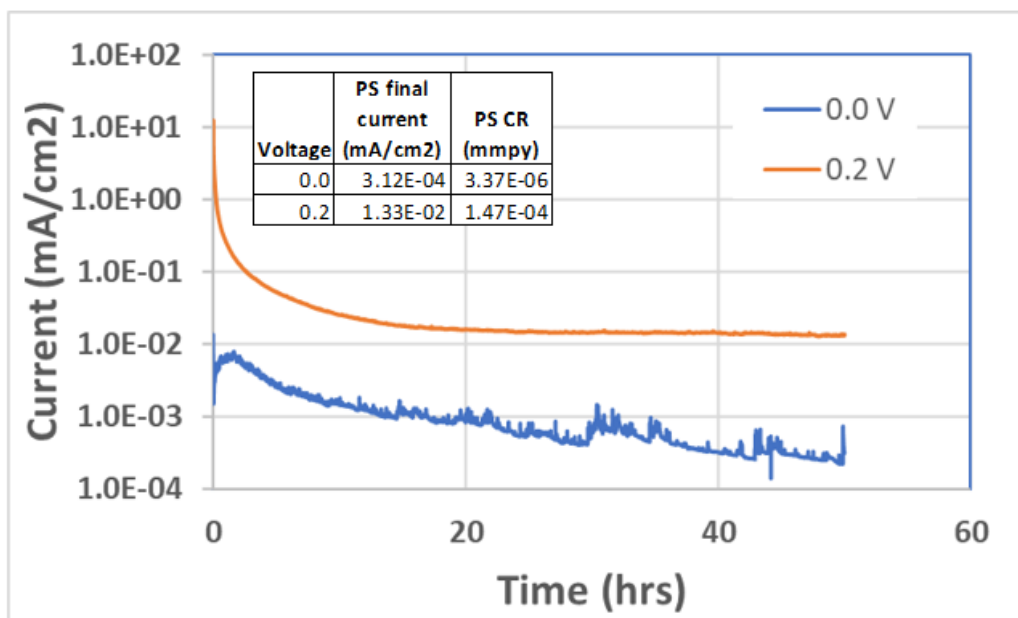
**Figure 20.** PS tests of M326 at 0 V vs Ag/AgCl in seawater. Inset shows the final current and calculated corrosion rate.

A test was also performed for M326 at 0 V as shown in Figure 20. This voltage is closer but still positive of the range of  $E_{\text{corr}}$  values measured for acid pickled specimens (Figure 14)[15]. This experiment showed much lower charge and the corrosion rate based on the PS current was almost 2 orders of magnitude lower. The LPR determined corrosion rate after the test was also lower, suggesting less damage to the specimen. This agrees with the very low weight loss observed. SEM analysis of the specimen held at 0 V indicates that the gadolinide phase is mostly intact (Figure 23).

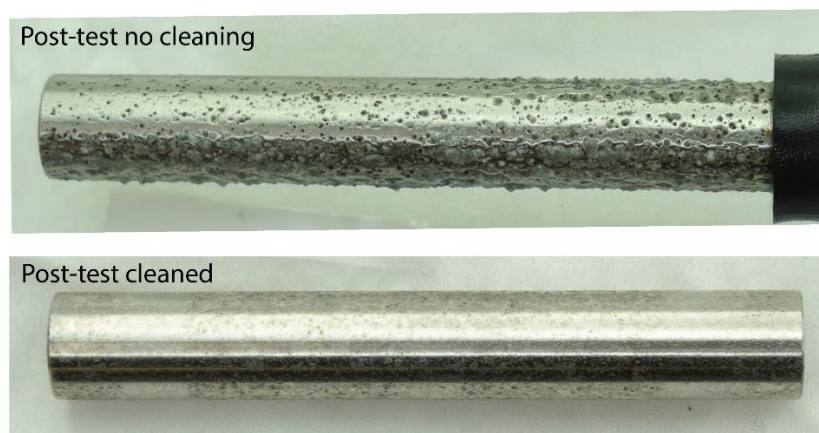
**Figure 21.** Images of M326 specimen immediately after testing and after cleaning specimen.

Figure 21 shows images of M326 specimen immediately after a PS test at 0.2 V. After testing, ANA specimens were found to have a white coating and black particles on the surface as shown in the top image. This deposit is easily removed in the cleaning procedure (only sonication in water) to reveal a specimen with many small pits on the surface as has been observed previously [15]. The white deposit could be the result of sulfate and/or fluoride ions present in seawater resulting in precipitation with dissolving metal ions. Figure 22 shows an image of the M322 specimen after the PS test before removing from the corrosion vessel. This specimen showed the greatest corrosion of all specimens (with the highest Gd content at 2.38%) and as a result has significant amounts of the white flocculent precipitate. In this test the precipitate appeared to largely fall off during removal. It is known that rare earth elements such as Gd have limited solubility at neutral pH values with sulfate and fluoride present [16]. Gadolinium sulfate is sparingly soluble at 3 g per 100 mL while gadolinium fluoride is very insoluble with a solubility product of  $6.7 \times 10^{-17}$ . White precipitate was collected for x-ray diffraction (XRD) analysis, but no database matches were obtained.

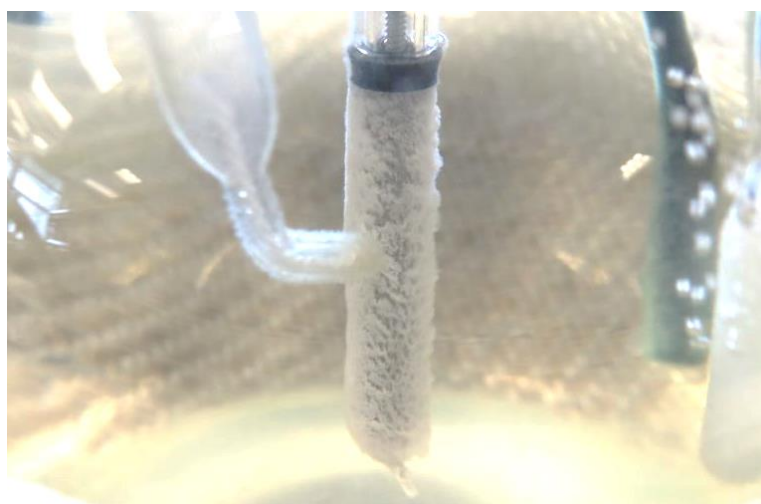
**Figure 22.** Image of M322 after PS testing before removal from the test vessel showing a significant amount of white corrosion product.

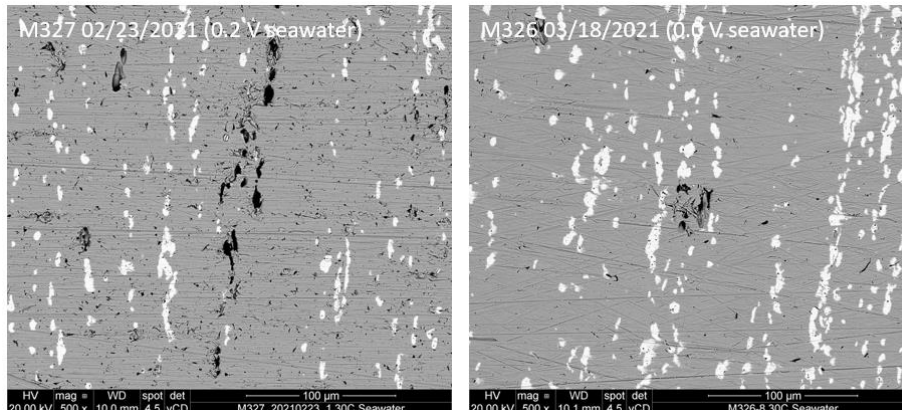
**Figure 23.** SEM images (backscatter mode) for PS tested specimens in seawater. Left: M327 at 0.2 V and Right: M326 at 0.0 V.

Figure 23 presents two SEM (backscatter mode) images of specimens tested in seawater. On the left image, an M327 specimen was tested at 0.2 V shows that despite a long test period (50 hrs), not all gadolinides (showing up as bright areas) have dissolved (areas that are dark) in seawater. The image on the right shows M326 poised at a more positive potential in seawater, showing very little dissolution of gadolinides, which agrees with the current curve in Figure 20.

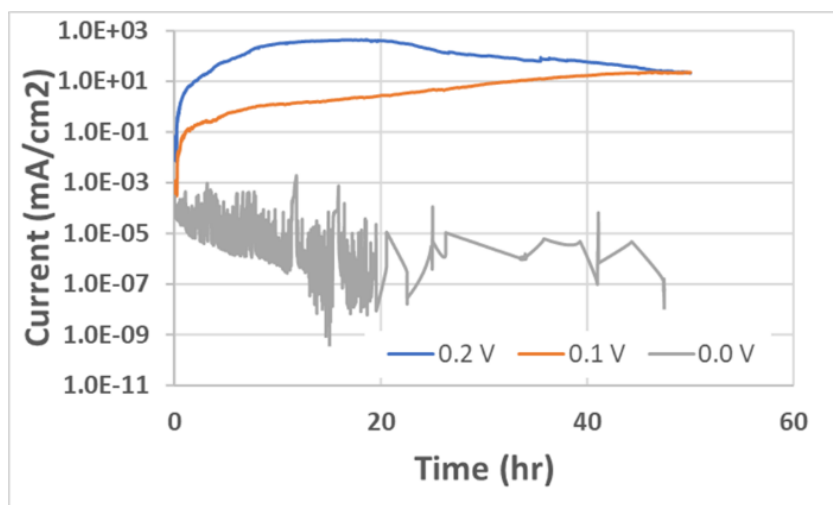
**Figure 24.** Potentiostatic tests for 304L in seawater at 0, 0.1 and 0.2 V vs Ag/AgCl.

PS tests were performed at various potentials just positive of the measured  $E_{\text{corr}}$  values for benchmark stainless steel specimens 304L and 316L in seawater. These specimens were used as surrogates, as a limited amount of Grade A BSS specimens remain and these tests, due to the incurred damage, often prevent reuse. These tests can be useful from a bounding perspective, in that these would represent the best performance and that B addition would only diminish from these results. Recent results also showed that BSS specimens performed similar to 304L [15]. Figure 24 shows three curves for 304L at 0.0, 0.1 and 0.2 V, shown in log scale due to range of data observed. Figure 25 shows the associated images post-test. At 0.0 V, there were small current transients present but the baseline current was very low. For 0.1 and 0.2 V, very large current and catastrophic damage was observed as shown in Figure 25. The fact that the current increases 4 orders of magnitude for only 0.1 V of potential highlights the sensitivity of stainless steel to pitting corrosion in chloride environments. Also note that the  $E_{\text{pit}}$  value from FY2020 testing was 0.156 V and 0.107 V [15], which is positive of 0.1 V but one would assume the point of minimal stability (pit initiation without passivation) is somewhere between 0.0 and 0.1 V.

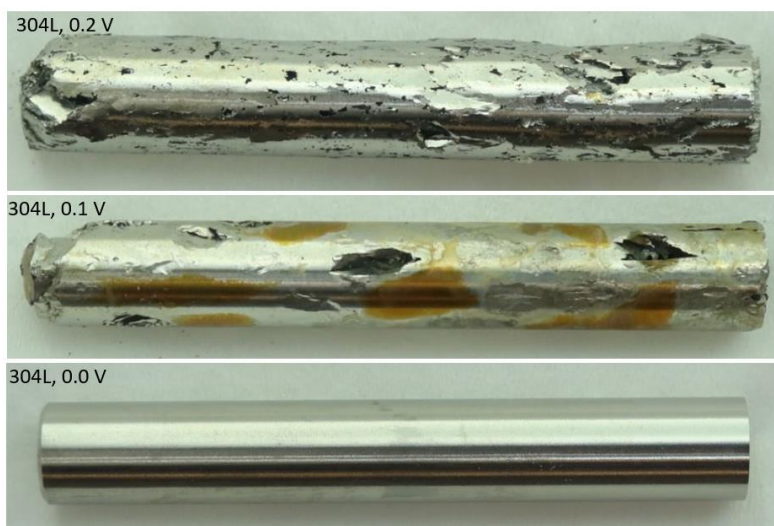
**Figure 25.** Images of 304L specimens from Figure 1.

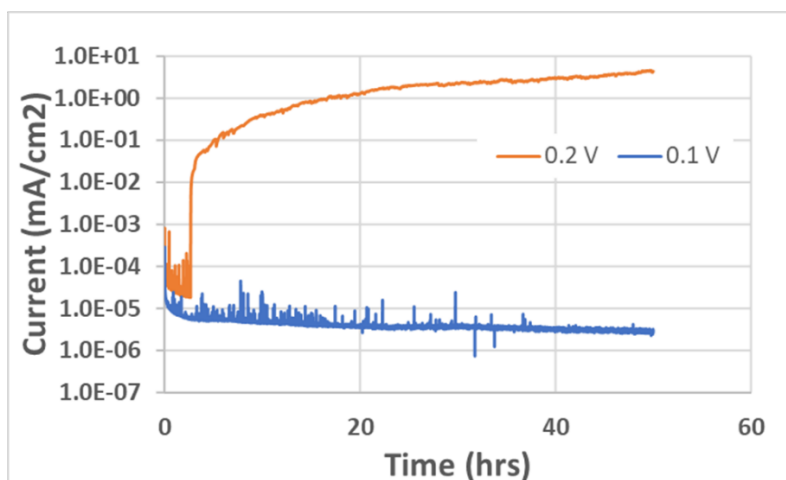
**Figure 26.** PS tests performed for 316L at 0.1 and 0.2 V vs Ag/AgCl.

Similar tests were performed for 316L at 0.1 and 0.2 V as shown in Figure 26 and associated post-test images are shown in Figure 27. For 0.1 V, the results were very similar to those observed for 304L at 0.0 V with metastable pit initiation and passivation. At 0.2 V, significant corrosion was observed at 0.1 and 0.2 V for 304L. For 316L, there was an initiation period of over an hour at the start of the test. In CPP tests presented in the FY2020 report, the  $E_{\text{pit}}$  values were 0.365 V and 0.348 V [15], significantly higher than 0.2 V. This illustrates that pitting corrosion is a challenge to evaluate using only one method and that  $E_{\text{pit}}$  is useful for comparison purposes, but the actual potential of stability to pitting is more negative due to the latent or dormant nature of corrosion.

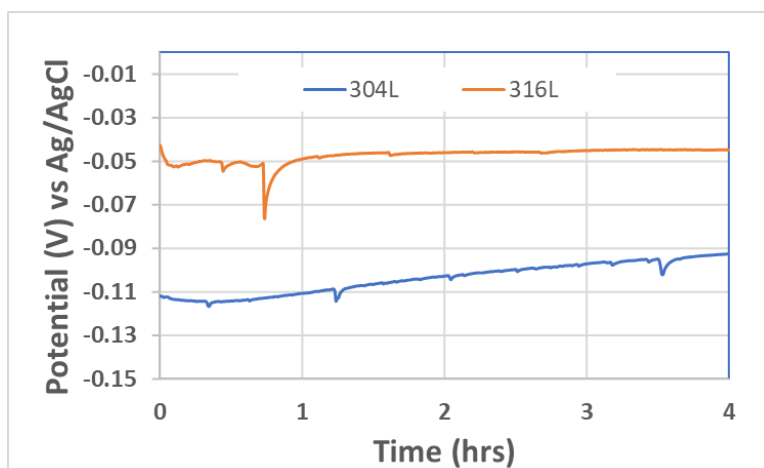
**Figure 28.**  $E_{\text{corr}}$  values for 304L and 316L in seawater.

Figure 28 shows the  $E_{\text{corr}}$  data for 304L and 316L for two of the tests above. For 304L, curves tended to slowly increase during the test and a rate of 6.28 mV/hr was determined for the data in Figure 28 after the initial ~40 min equilibration period. The  $E_{\text{corr}}$  values for 316L tended to be slightly more positive and showed more steady behavior. Both curves do show negative spikes in voltage which are indicative of pitting initiation/passivation.

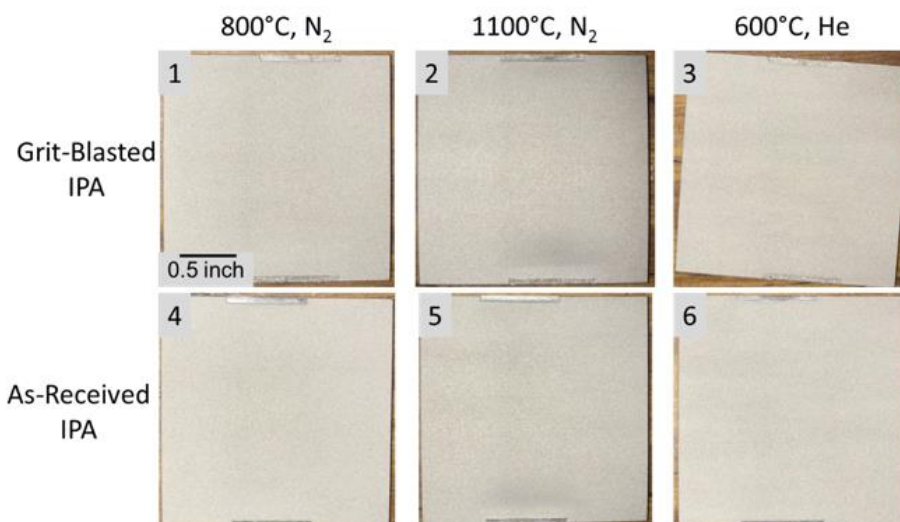
**Figure 29.** Optical images of specimens coated by cold spray of C22Gd alloy.

Analysis of specimens after spraying was performed at SNL and communicated through a short report [19]. This section provides images and data from that analysis. Figure 29 shows images of the specimens sent to INL for testing.

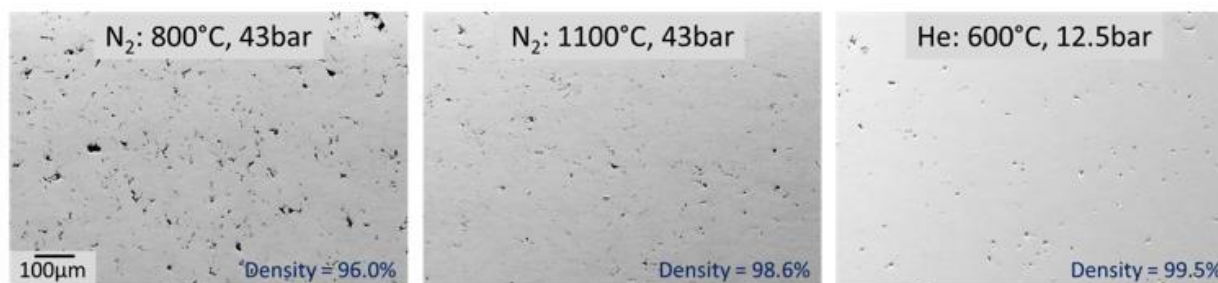
**Figure 30.** SEM images of the cross-section of C22Gd coatings.

SNL performed cross-sectional analysis of coatings using the same conditions used to produce the specimens as shown in Figure 30. SEM images show darker areas that can be ascribed to porosity in the coatings. Image analysis was used to estimate the density of the specimens presented on the images, which all exceed 96%.

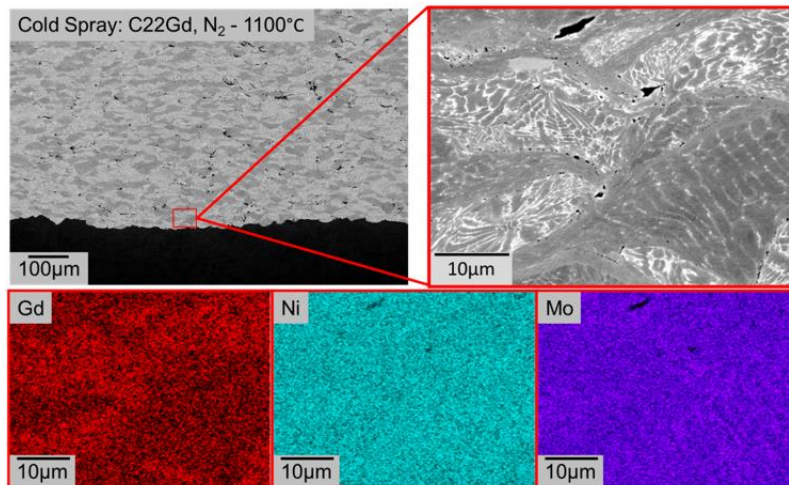
**Figure 31.** SEM backscatter imaging and EDS analysis of the chemical distribution for a small area of the surface.

Figure 31 shows SEM images and corresponding energy dispersive spectroscopy (EDS) analysis of a specimen coated at 1100 °C. This condition was chosen as the most likely to show secondary phase precipitation. The backscatter image in the upper right shows some differences which could be density related. In the upper right image, the defined borders are particle boundaries which agrees with the powder particle size (~25 µm). Wrought material with defined gadolinide particles registered those as

brighter areas in SEM backscatter images [11]. However, EDS imaging did not pick up any strong correlation for these bright areas and abundance of Gd. While there is some variation of Gd among particles, there is not a strong correlation. This suggests that the gadolinide phase is highly dispersed in the specimens.

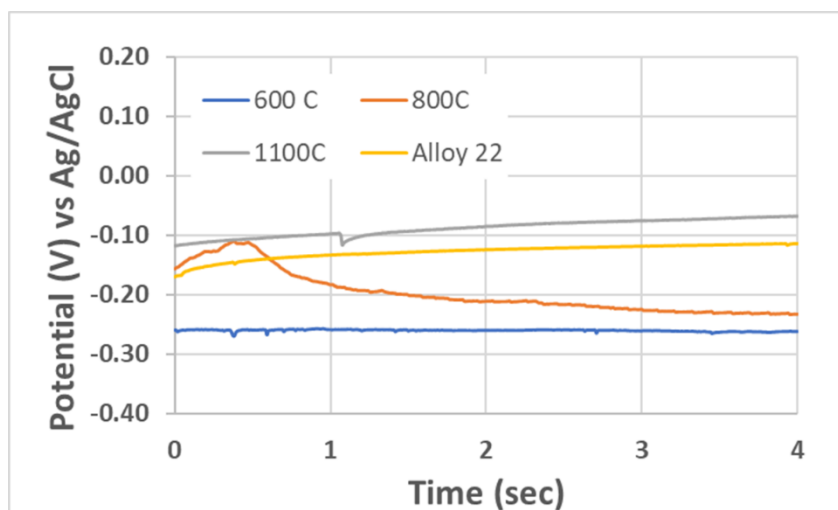
**Figure 32.**  $E_{\text{corr}}$  measurements performed in seawater before CPP testing. Alloy 22 from previous tests was included for reference.

CPP tests were performed using the flat specimen holder in seawater. Figure 32 show  $E_{\text{corr}}$  plots for materials at the three conditions used for coating as well as Alloy 22 from previous testing. The coated specimens all showed hints of pit initiation but not nearly as pronounced as shown in Figure 14 for wrought ANA specimens.

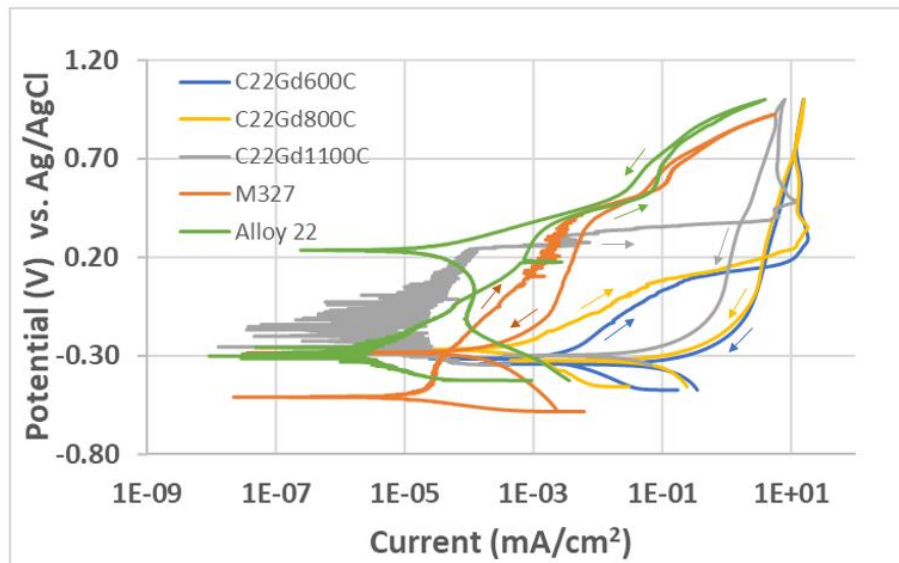
**Figure 33.** CPP tests performed in seawater for C22Gd coatings with M327 and Alloy 22 added for reference.

Figure 33 shows CPP curves for the three materials as well as Alloy 22 and M327 for reference. The C22Gd coated at the two lower temperatures shows current increase starting around -0.3 V as is common for ANA but is certainly much greater than M327. Interesting, the C22Gd coated at the highest temperature had a delayed increase in current to ~-0.25 V, where it increased rapidly to near that of the lower temperature specimens. On the return sweep, there was hysteresis observed, with current remaining at high levels until approximately -0.3 V. Overall, the 1100 °C specimen showed lower current and charge as shown in Table 4.

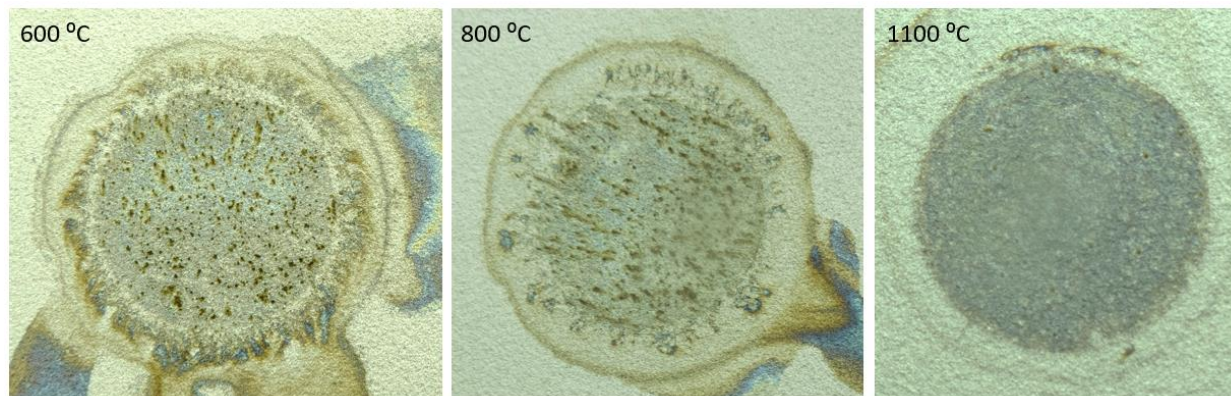
**Figure 34.** Photographs of specimens after CPP testing in seawater.

Figure 34 shows photographs of the exposed areas after CPP testing. For the specimens coated at the two lower temperatures, there are darker (red-brown) spots on the surface that appear to be pits. Closer examination with a microscope was inconclusive if these were pits or stains due to the rough nature of the coatings. The 1100°C specimen showed a more uniform grey appearance after testing. Note that the coatings have a high degree of surface roughness, making it a challenge to capture optical microscopy images on a conventional microscope. SEM images were not yet available for this report and will be added in a revision to this document.

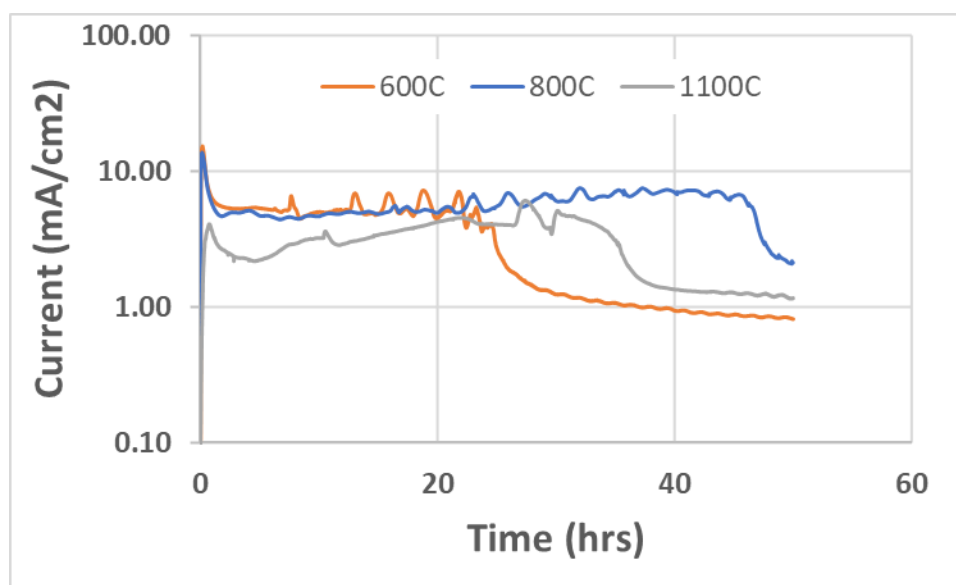
**Figure 35.** PS curves for C22Gd coatings in seawater at 0.2 V vs Ag/AgCl.

Figure 35 shows PS curves for C22Gd coatings held at 0.2 V vs Ag/AgCl. The specimens at low temperature show greater initial current which is sustained at a fairly high level for most of the test. All specimens show almost an order of magnitude drop in current during the test, with the 600 °C specimen falling to the lowest current and continually dropping. The 1100 °C specimen showed lower current initially but the current drop comes later than observed for the 600 °C specimen. The 800 °C specimen sustains high current through most of the test, dropping in current just before the test ends. Data obtained from the PS curves is summarized in Table 5. The final current was used for calculating the corrosion rate, which is significantly higher than for wrought ANA materials.
