Project No. 33486

# Neutron Absorber Material Corrosion Testing Final Report FY2021

**Neutron Absorber Material Corrosion  
Testing Report**

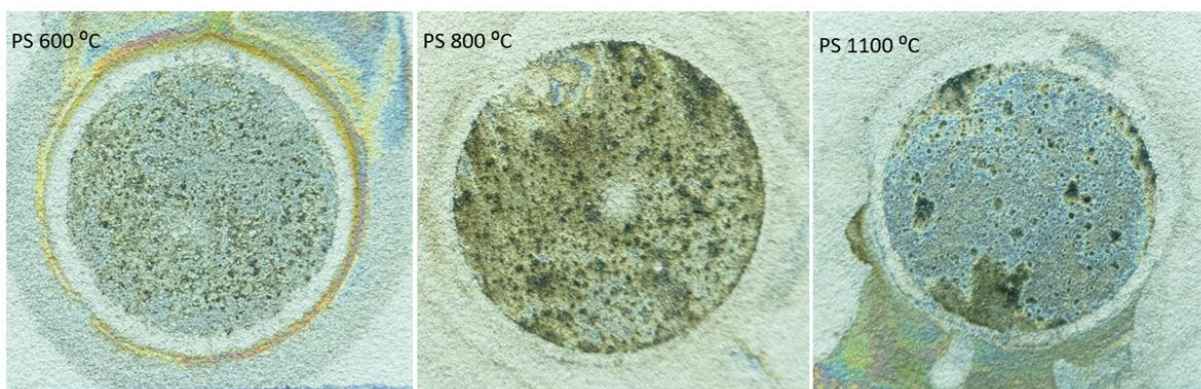
**Figure 36.** Images of specimens after PS testing.

Figure 36 shows images of the specimens after PS testing shown in Figure 35. Significant changes to the surface are evident in all specimens. The roughness of the as coated specimens make assessment a challenge, but it appears significant pitting has occurred. SEM images were not yet available for this report and will be added in a revision to this document.

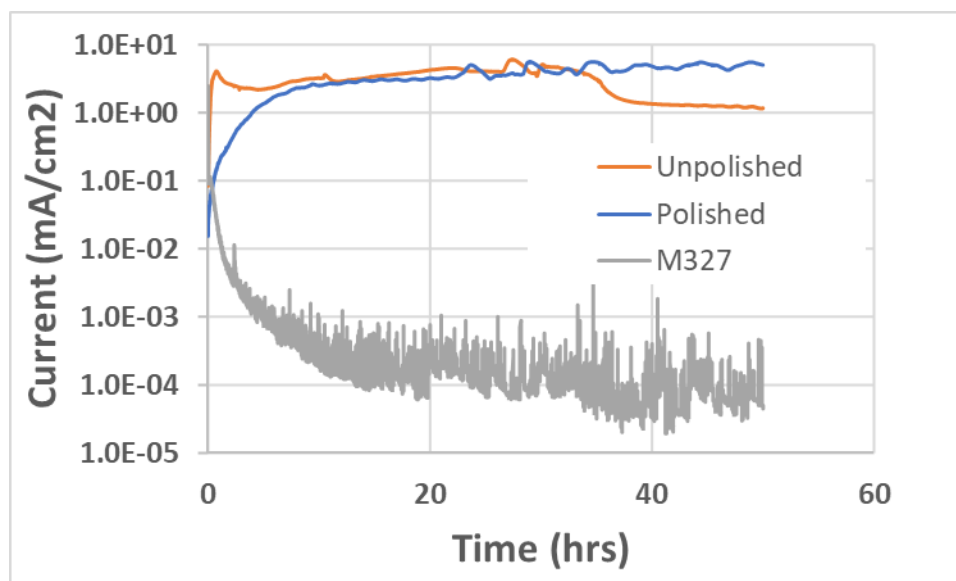
**Figure 37.** PS curves for unpolished and polished 1100 °C C22Gd coatings with M327 presented for reference.

The roughness of the as received specimens suggested that a portion of the increased current observed is related to the roughness of the as received coatings. The specimens were carefully abraded with 600 grit sandpaper to remove the coarse outer layer while attempting to avoid breaking through to the 316L base material. Figure 37 shows PS curves for as received and polished specimens as well as an M327 specimen taken using a conventional cylindrical specimen. While the polished specimen shows slightly decreased current initially, it eventually reaches and exceeds that of the as received specimen. Figure 37 also shows the great decrease in performance over the M327 specimen, where current is 4 to 5 orders of magnitude lower.

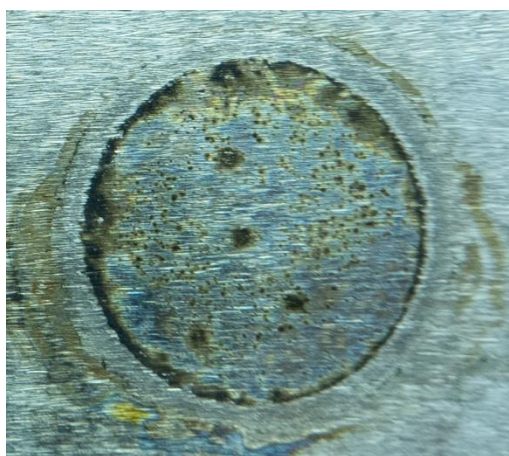
**Figure 38.** Image of polished C22Gd (1100°C) specimen after PS testing (Figure 37).

Figure 38 shows an image of the 1100 °C C22Gd specimen tested in Figure 37, where pitting and crevice attack are observed around almost the entire circumference. Note that the M327 specimen was of the cylindrical type and no crevice was imposed. However, it is unlikely the crevice contributed that significantly to the decreased performance as pits are present away from the gasket edge. SEM images were not yet available for this report and will be added in a revision to this document.
