USED FUEL DISPOSITION CAMPAIGN

Instrumentation: Nondestructive Examination for Verification of Canister and Cladding Integrity -FY2013 Status Update

September 13, 2013

PNNL-22734

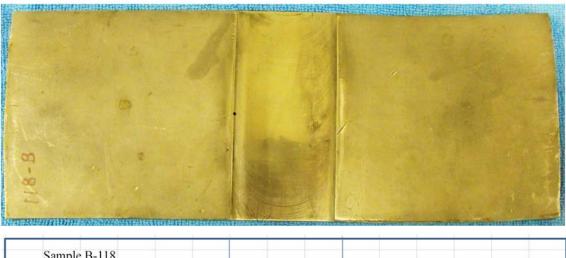
Figure A.8. Thermal Fatigue Crack Specimen B-118

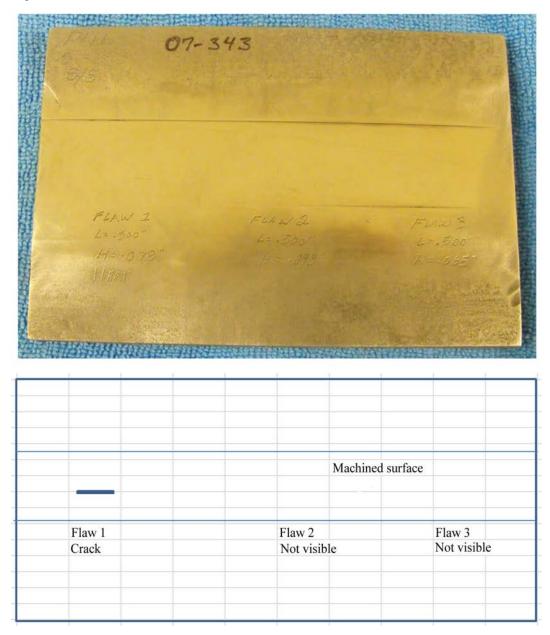
Figure A.11. Crack Specimen 07-343

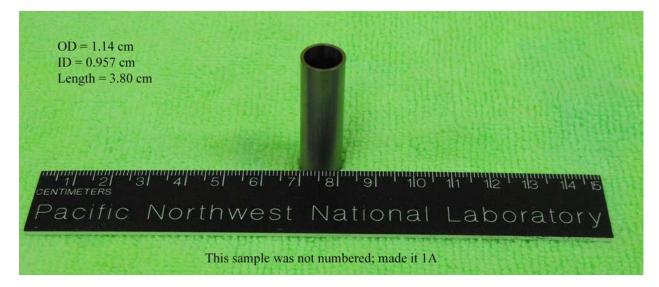
Figure D.1. Photograph of Zr-4 Tube Specimen 1A (vertical orientation)
