# Results of NDE Technique Evaluation of Clad Hydrides

**INL/EXT-14-33270**

**Fuel Cycle Research & Development**

***Prepared for  
U.S. Department of Energy  
Campaign or Program  
Dennis C. Kunerth  
National Laboratory  
September 2014  
FCRD-UFD-2014-000486***

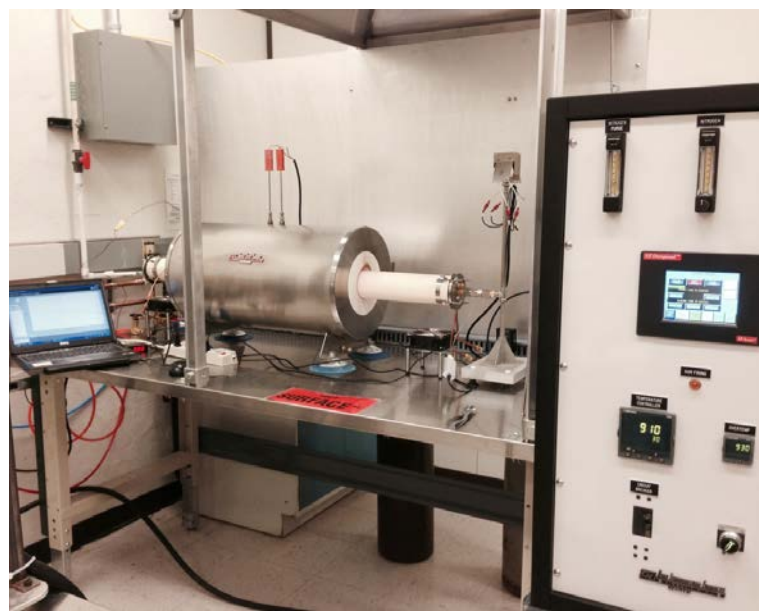
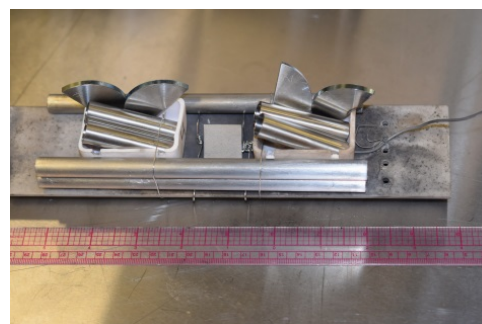
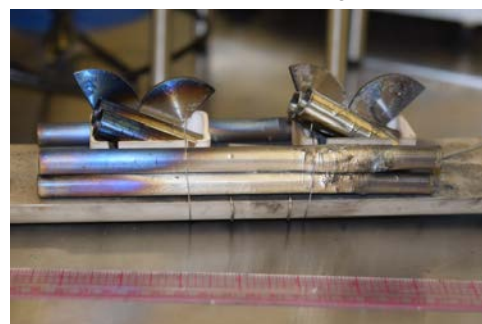
Figure 1. Laboratory system used to hydride test samples. Right: Test samples before and after processing.

A thermal process was used to develop hydride test samples in which the test samples of interest are placed in a tube furnace containing a flowing cover gas of pure hydrogen. The temperature is then elevated and held at a constant temperature or cycled with a narrow temperature range near the upper set point. The specific zirconium alloy cladding test samples on which the eddy current and ultrasonic measurements are presented in this document are pictured in Fig. 1. These samples were raised to a temperature of 470° C at 10° C/min immediately followed by a cool down at 10° C/min. The hydrogen cover gas was changed to nitrogen during cool down. Due to the nature of the processing, an axial hydrogen/hydride gradient is formed in the test samples. As observed in Fig. 1 the test samples are severely degraded towards the inflow of the hydrogen gas. The severely degraded sections were removed prior to making measurements. Fig. 2 shows the condition of the cladding test samples used for measurements.

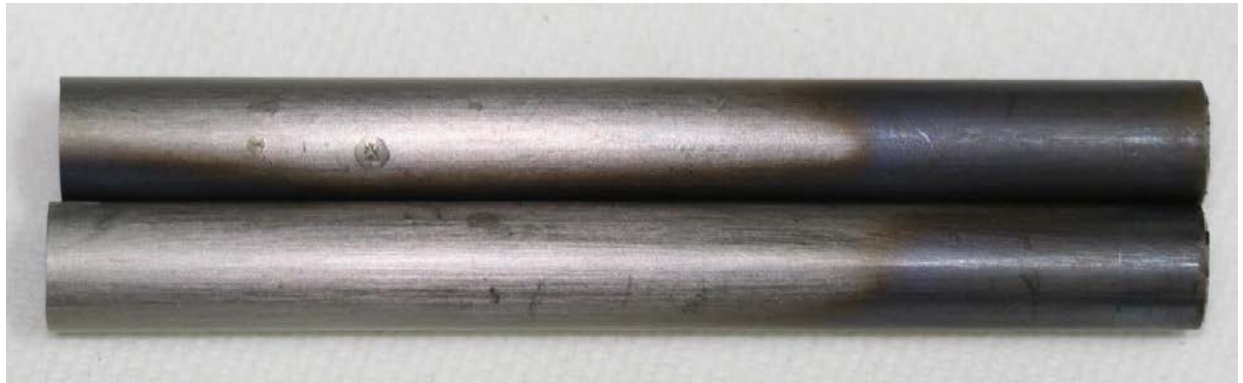
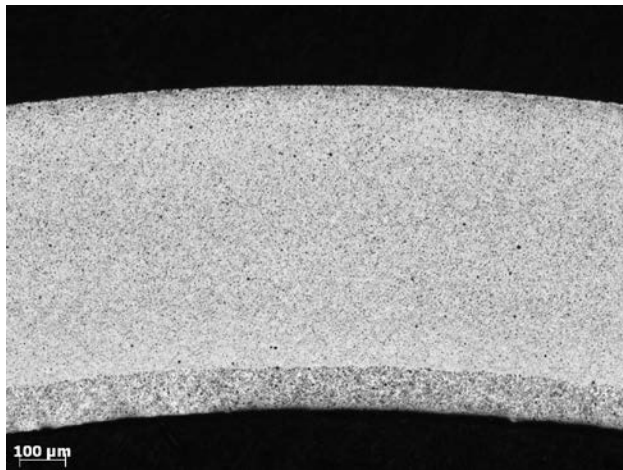
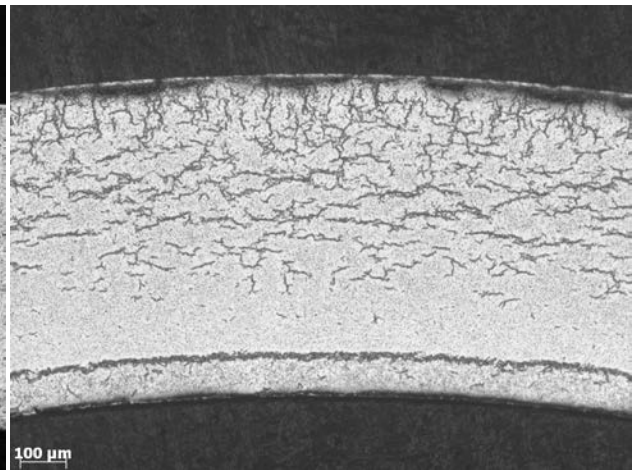
Figure 2. Cladding test samples used during evaluation of the nondestructive evaluation approaches.  
Bottom: Microstructure of unprocessed reference cladding and a hydrided test sample.

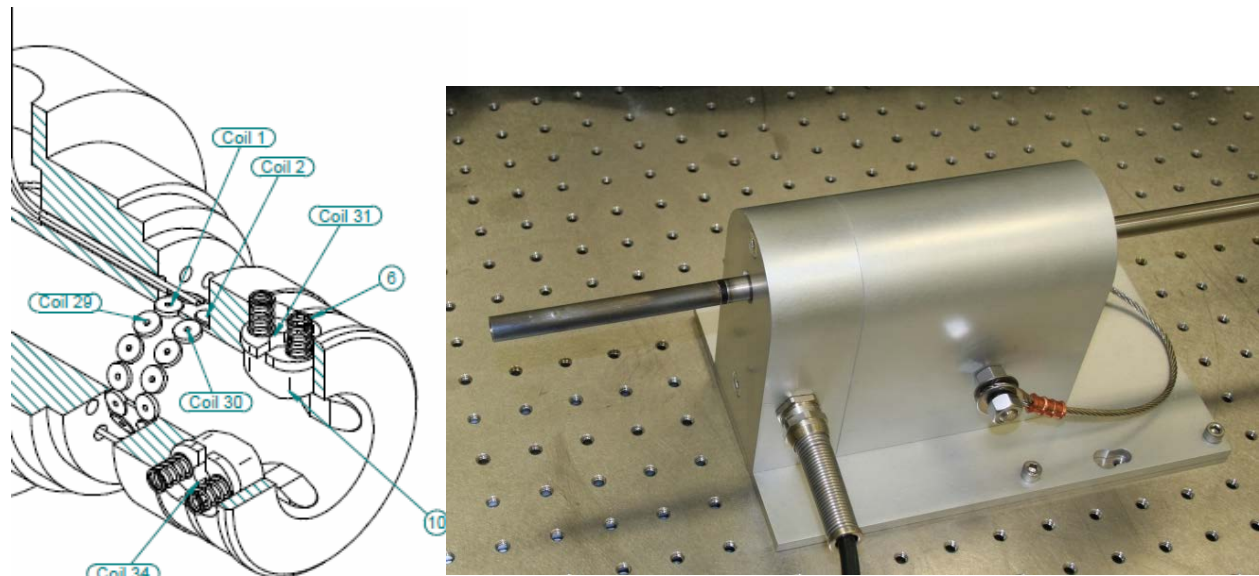
Figure 3. Basic coil arrangement and image the array eddy current probe used to scan the cladding test samples.

Eddy current techniques have been used to evaluate nuclear fuel and indirectly determine loss of wall thickness and hydrogen concentration via measurement of the oxide thickness layer formed during oxidation.[1-3] For this evaluation, a commercial array eddy current instrument and probe was used to inspect hydrided zirconium alloy cladding test samples. The array probe was designed to inspect 11.2 mm diameter cladding using a circumferential array of 30 transmit-receive coils and 4 absolute located 90° apart, see Fig. 3. The transmit-coils are intended for defect detection while the absolute coils are intended for oxide thickness measurements. However, due to the nature of the absolute coils, they sense not only the liftoff used to determine oxide thickness but at lower test frequencies, the changes in clad material electrical conductivity due to hydrogen and hydride content. Fig. 4 contains the transverse C-Scan image from the 30 coil transmit-receive array of a short section of hydrided cladding. The transmit-receive coil

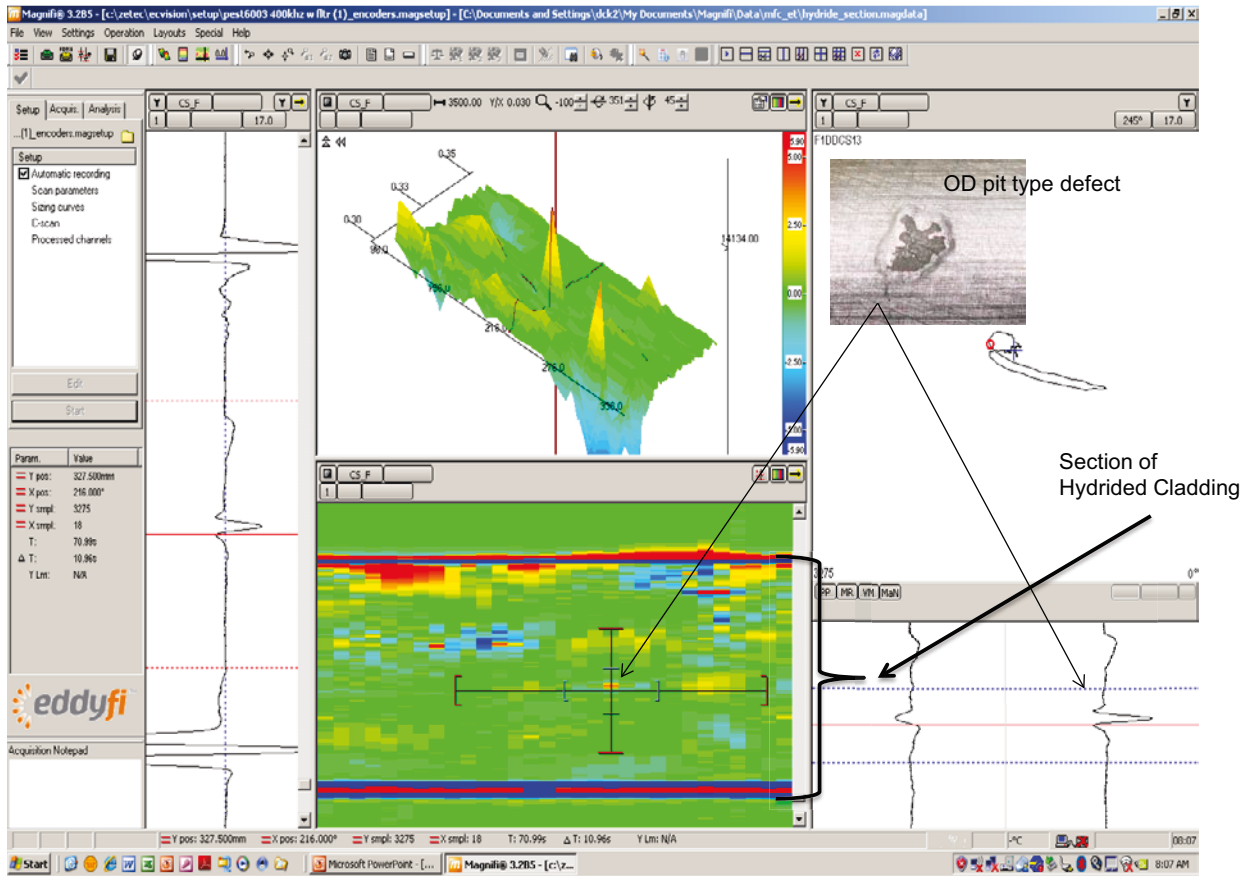
Figure 4. Transverse C-Scan image of a hydrided test sample. The central colored coded images are the 2D and isometric C-Scan images. On the right are the impedance plane response with the individual 0° and 90° impedance component traces provided below. The left hand window is the expanded view of the 90° component trace. The cursor in the C-Scan is centered over the response of the outside diameter defect pictured in the impedance plane window. Besides the isolated surface defect highlighted, various other flaw indications are present in the C-Scan image.

arrangement allows transverse and axial C-Scan data to be collected during a single scan. The transverse coils are most sensitive to defects with a transverse orientation while the axial coils are most sensitive to defects with an axial orientation. As demonstrated, this type of eddy current coil arrangement is well suited to detect the physical defects in the tubes as well as pickup anomalous regions due to severe hydriding, fretting damage, or other material conditions that significantly affect electrical conductivity. Fig. 5 contains the signal traces for the absolute coils. It can be observed that there is a gradual increase in signal strength along the axis of the test sample. This is in response to the gradient in hydrogen and hydride concentration generated by the thermal hydriding treatment. This indicates that eddy current inspection technologies can be used for defect detection such as blisters, pitting, and crack as well as provide information about the changes in electrical conductivity of the cladding material due to absorbed hydrogen and hydride formation. Eddy current inspection technologies also have the potential to evaluate the orientation of the hydride phase, e.g. circumferential versus radial.[4, 5] This will require appropriate coil configurations to permit the determination of anisotropic electrical conductivity.

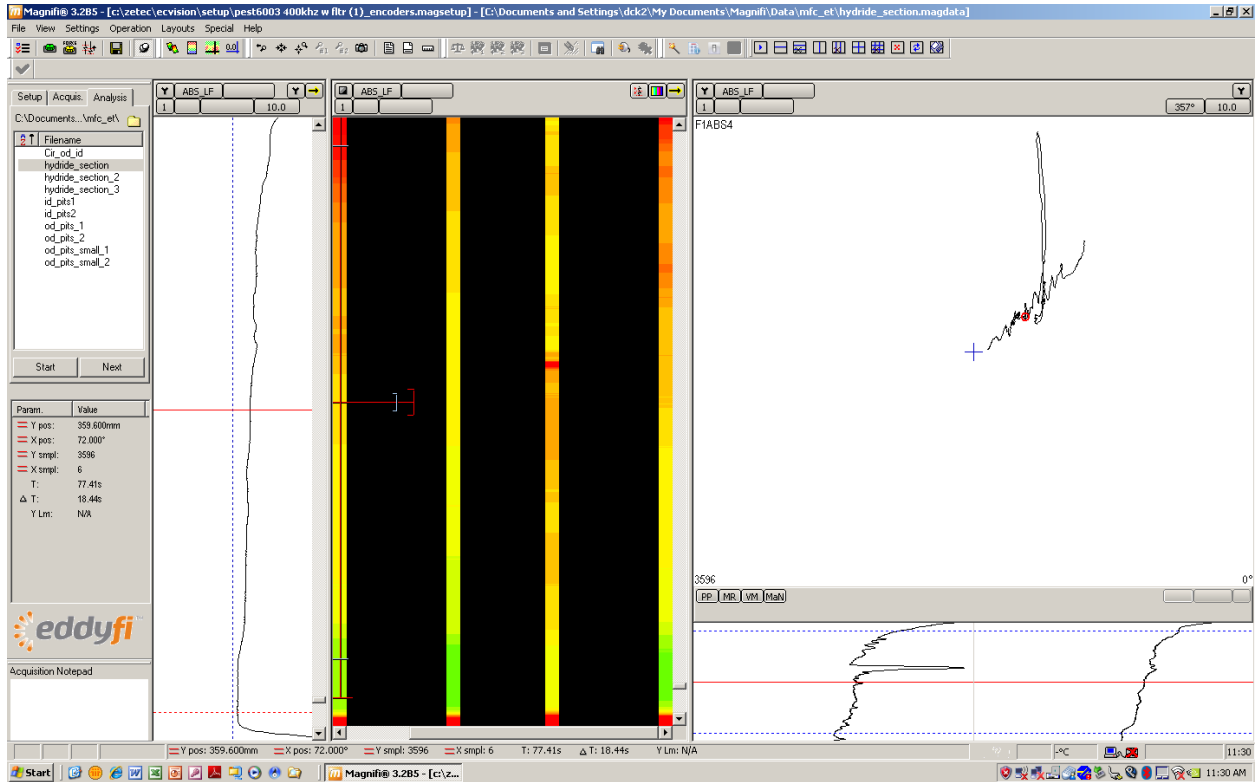
Figure 5. Scan traces for the four absolute coils in the array eddy current probe. The cursor is centered over the 0° coil trace exemplifying the gradual change in response along the scan direction. The gradual change in signal amplitude is indicative of a gradient in electrical conductivity.

However, note that there are various parameters that contribute to the electrical conductivity. Test material phase, temperature, grain size, stress, hydride content and orientation, and hydrogen content all contribute. If a basic understanding of the different parameters can be obtained, a quantitative estimate of a single contribution can be made. To do this, additional information may be required via implementation of complementary inspection technologies.

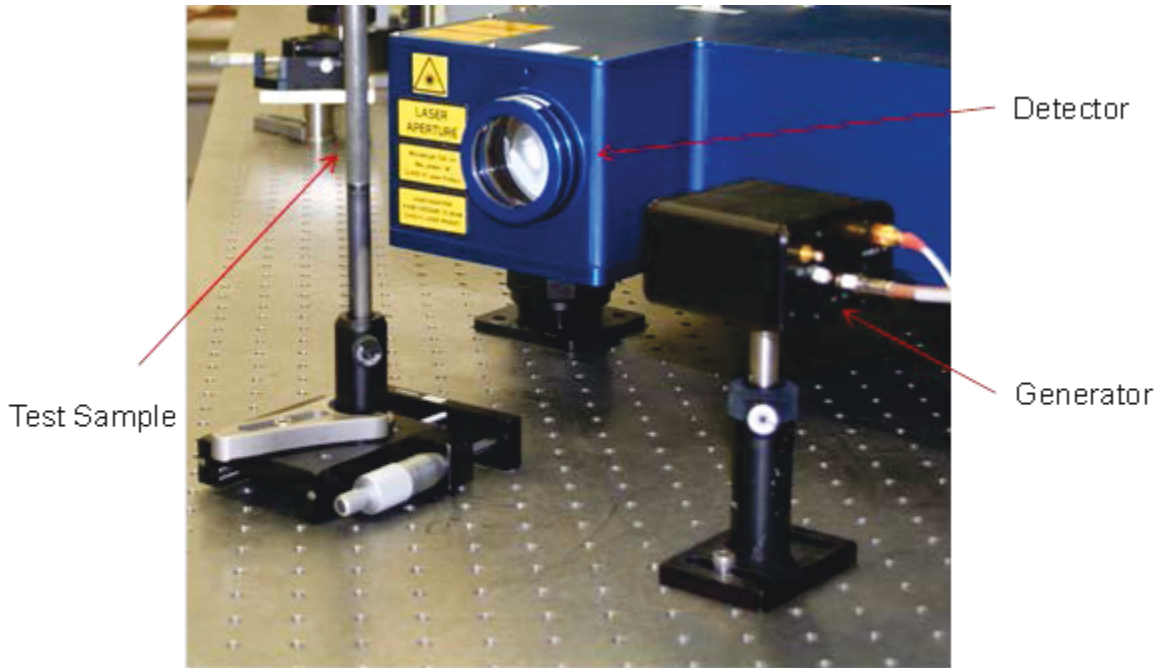
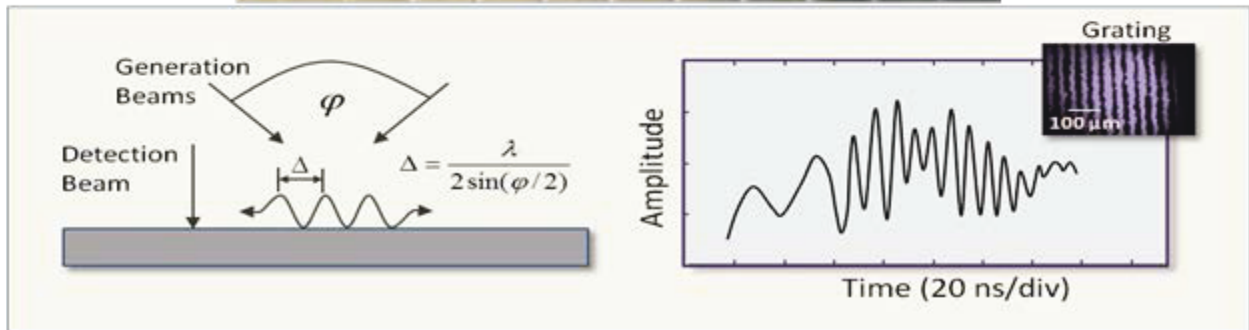
**Figure 6.** Experimental setup for generating narrow band surface acoustic waves. Lower Right: Grating and typical data for laser generated narrowband surface acoustic wave.

Ultrasonic inspection is dependent on the elastic properties of the test material as well as geometry. The presence of absorbed hydrogen and hydride phases will alter the mechanical properties as well as affect the attenuation and scatter of a propagating ultrasonic wave.[6] Besides the results presented here, other researchers have investigated the potential of ultrasonics to detect and characterize hydrides in a zirconium based clad material.[7] Laser based narrow band surface acoustic wave measurements were made on hydrided cladding test samples. The laser ultrasound methods are well established in generating and analyzing surface acoustic waves in materials of the thickness scales comparable to cladding. Laser ultrasonics entails thermoelastic generation of ultrasound by irradiating a specimen with a high intensity laser pulse. Surface waves are confined to propagate along the sample surface and have propagation characteristics that are related to near surface mechanical properties. Lower test frequencies will generate longer wavelengths that penetrate deeper in the test piece. For this measurement, increasing the grid spacing will increase the test wavelength. Fig. 6 provides a description of the narrow band acoustic surface wave measurement, typical response, and experimental setup. Provided in Fig. 7 are the measured results for a hydrided test sample and reference. Although small, there are velocity differences between the two samples. The obvious differences in velocity measured using the two different gratings are the result of dispersion (different wave velocities at different frequencies/wavelengths) and measurement error. Another laser based measurement using a pulsed point source (2.5 mm spot size) and pickup (8 mm separation) generates broadband plate waves. The results of this measurement are provided in Fig. 8. As with the narrow band ultrasonic surface wave measurements, there are differences in the responses. However, the degradation of the inner diameter of the hydrided tube may account for the difference measured by the plate wave. The dispersion in the broad band signals is most noticeable at the lower frequencies (received later in time). The velocity measurements performed are only one type of ultrasonic approach to detecting and characterizing hydrides. Other attributes of the propagating ultrasonic wave such as attenuation or scatter can be added to refine the inspection process.

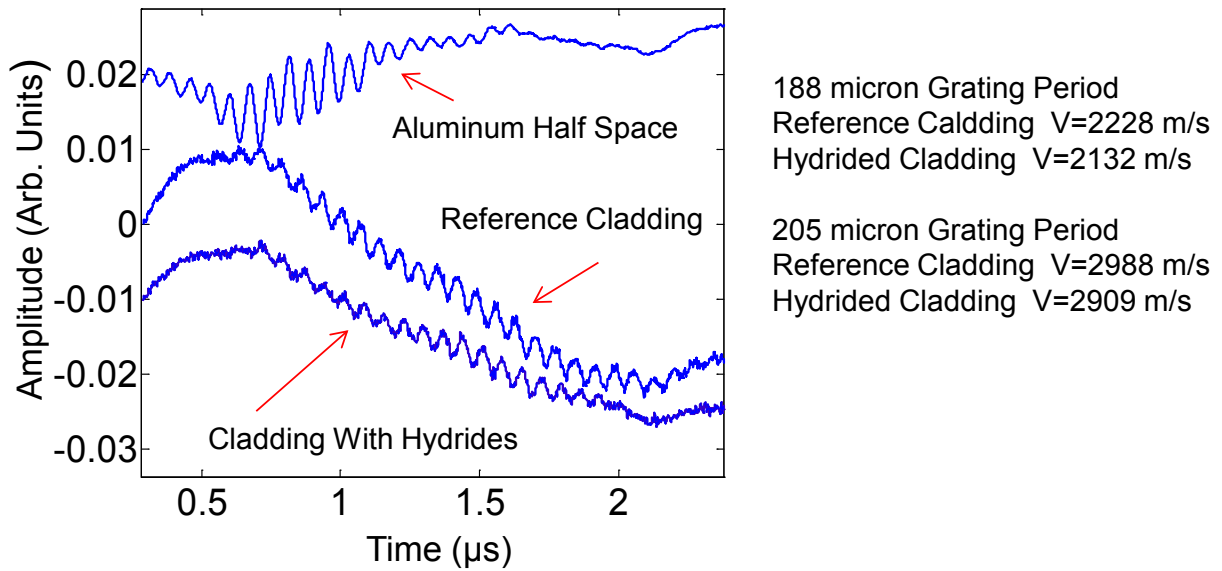
**Figure 7.** Narrow band acoustic surface wave results for reference and hydrided cladding samples. Right: Differences in measured acoustic velocity for two different grating periods. The differences in acoustic velocity between the two different gratings are a result of dispersion and measurement error.

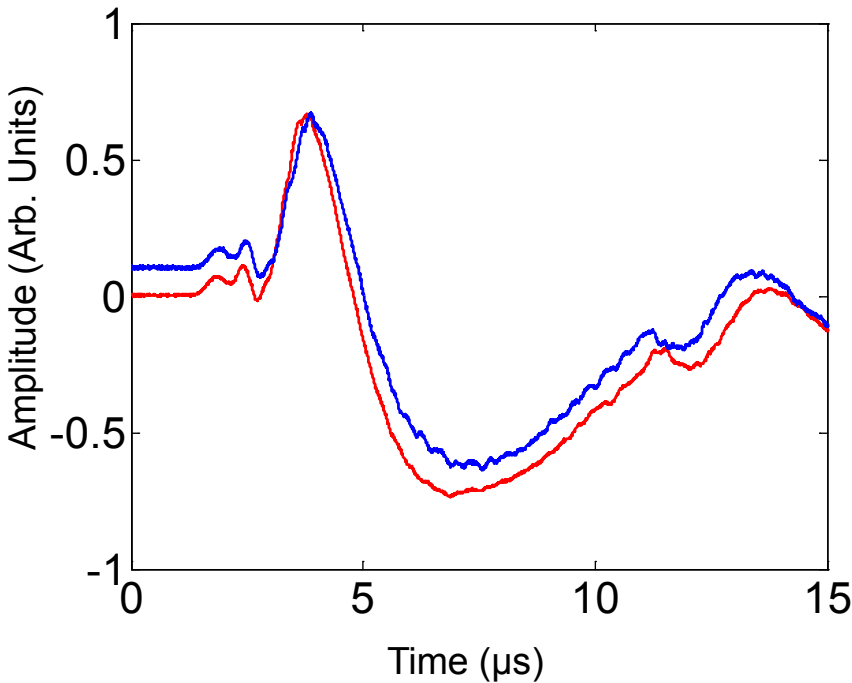
**Figure 8.** Broad band ultrasonic plate wave results for reference and hydrided cladding samples.
