***Test Results and
Comparison of Triaxial
Strength Testing of
Waste Isolation Pilot
Plant Clean Salt***

***Prepared for
US Department of Energy
Spent Fuel and Waste Science and Technology***

***Stuart A. Buchholz
RESPEC***

***December 5, 2016
SFWD-SFWST-2017-000101***

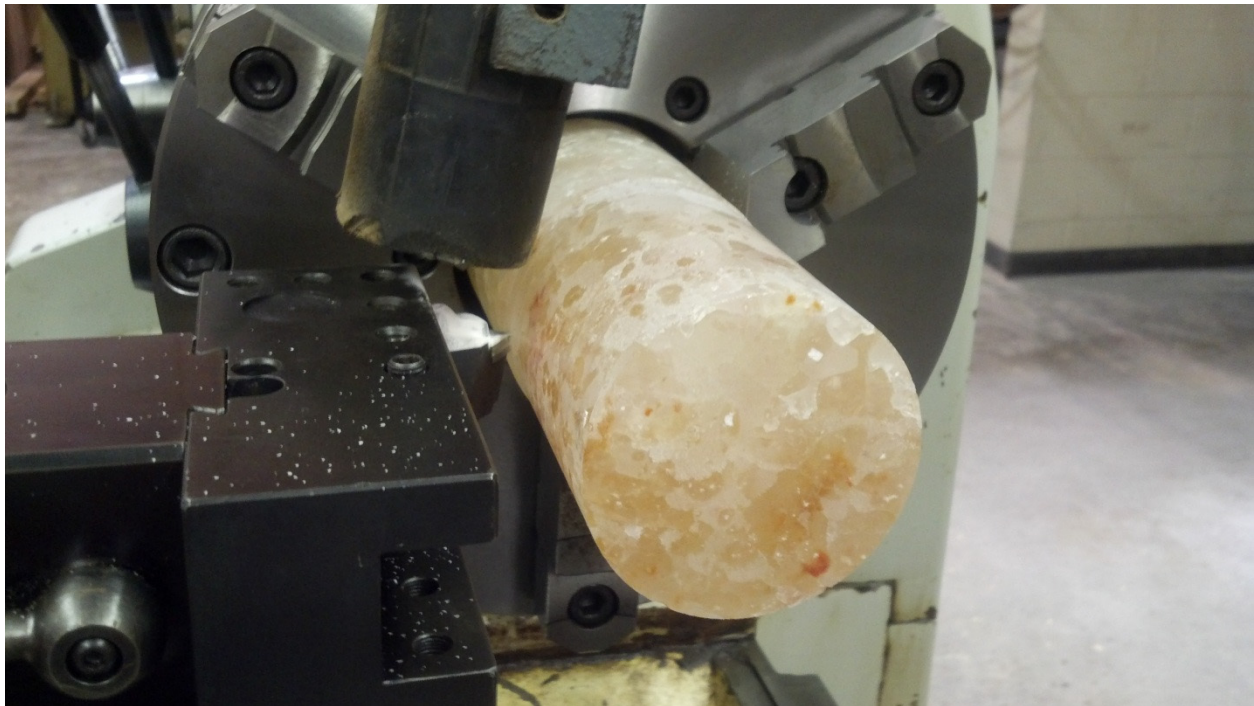
Figure 2. Typical Horizontal Lathe Machining Setup for Preparing Cylindrical Specimens.

To prepare a testable specimen, a piece of salt core was cut to an approximate length-to-diameter ratio (L:D) of 2:1. The walls and ends of the cylinder were then machined in a horizontal lathe to produce a finished right-circular cylinder with ends that were flat, parallel to each other, and perpendicular to the specimen sides. A typical machining setup is shown in Figure 2 where the carbide tooling is visible next to the specimen surface. The finished specimens were then measured to determine their length and diameter. The specimens were also weighed, and a bulk-density was calculated by using the specimen dimensions to determine specimen volume. A summary of the testable specimens that were prepared is presented in Table 1. The bulk-density values are uniform and near the typical value for halite (2.15 grams per cubic centimeter [g/cc]).

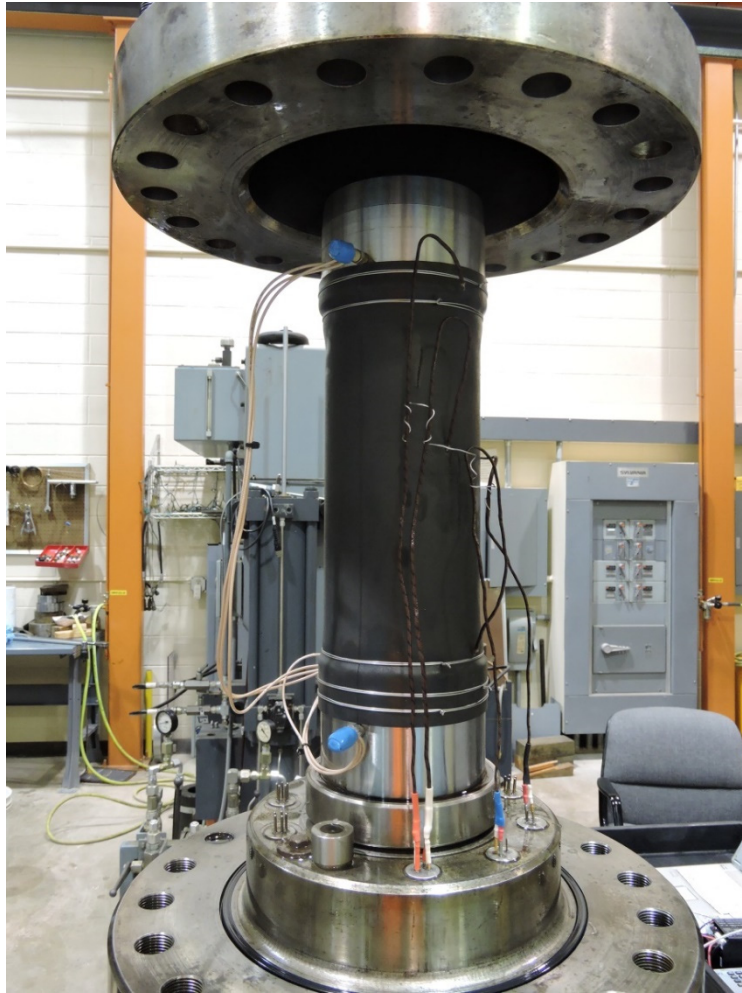
Figure 3. Jacketed Test Specimen in the UTS2 Load Frame With Thermocouples and Acoustic Transducers.

A photograph of the test system is provided in Figure 3, which illustrates four thermocouples placed at the top, middle, and bottom of the test specimen. The fourth thermocouple was placed midheight of the specimen on the opposite side. Before testing, the thermocouples were calibrated, and the readings were used to independently adjust the temperature settings on the heaters to achieve a consistent temperature profile around the specimen.

The ultrasonic velocity setup requires that the standard steel platens in the load frame are replaced with acoustics platens. The acoustics platens shown in Figure 3 have two piezoelectric transducers imbedded in each: one for compressional (P) waves and another for shear (S) waves. The P and S waves are actively fired at 1 megahertz (MHz) from the bottom platen and received in the top platen after traveling through the salt specimen. The data-acquisition system and pulsar shown in Figure 4 beams the ultrasonic waves; listens for the wave's arrival; displays the waveform; and ultimately, outputs a raw-data file. The acoustics system was calibrated by using known aluminum standards.

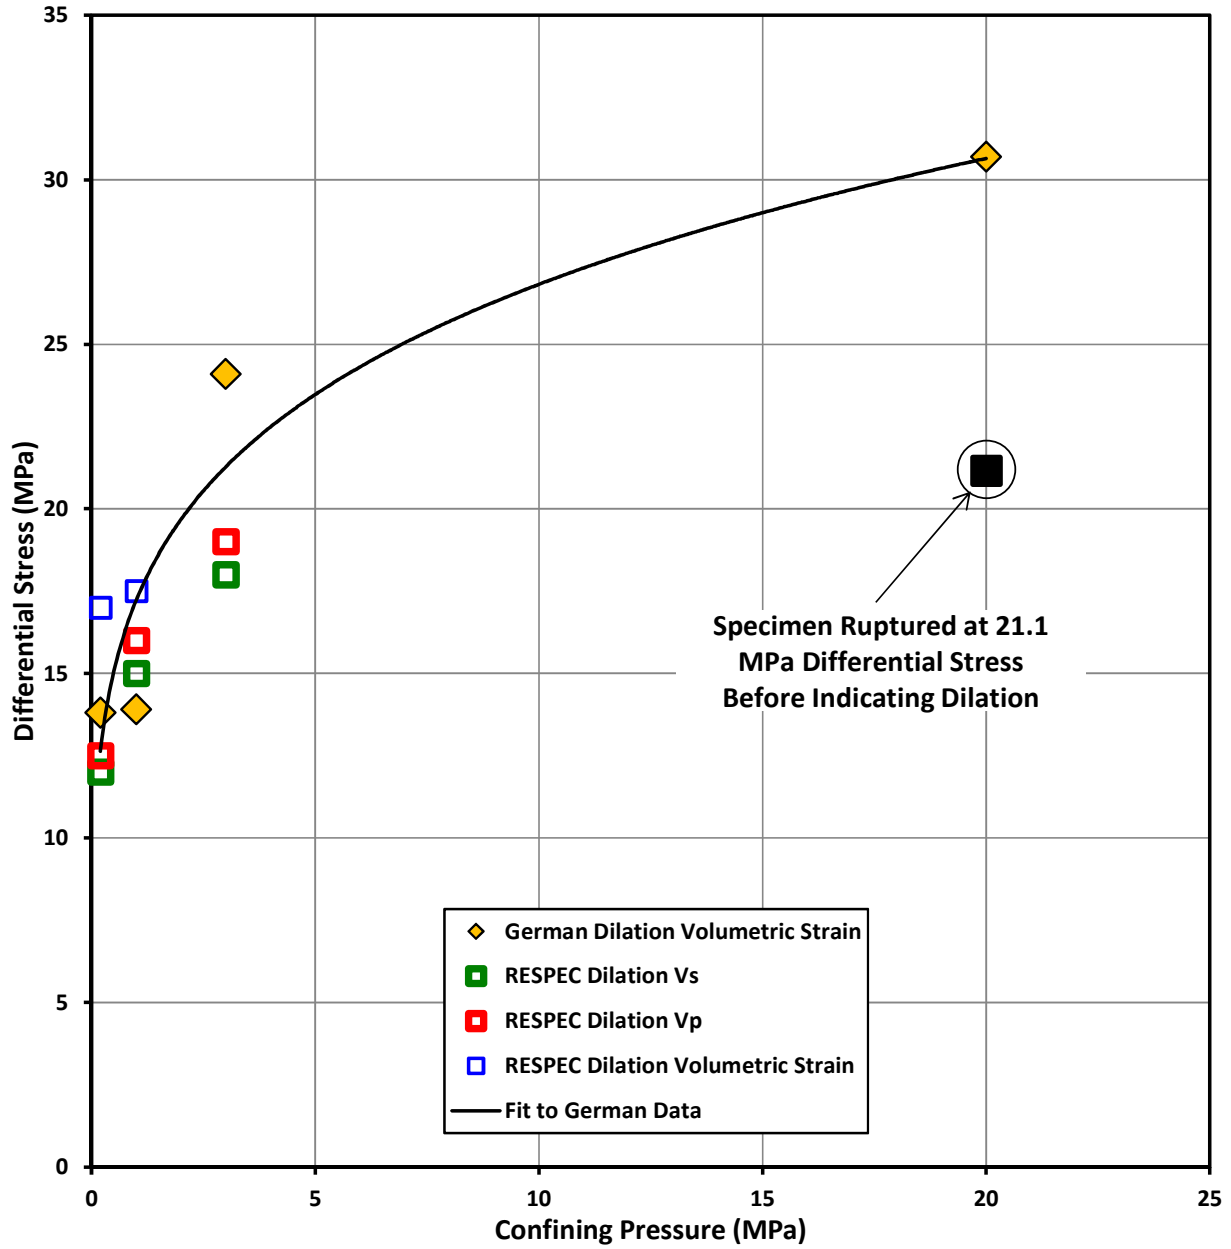
Figure 10. Comparison of the Dilation Strength for the Tests Performed at 100°C.

A plot of the dilation strengths for the tests ran at 100°C is illustrated in Figure 10. Similar to the tests performed at 25°C, dilation was not indicated by the RESPEC volumetric strain data for the test performed at a confining pressure of 3 MPa. The test performed at 20 MPa prematurely ruptured before dilation was indicated by any of the three methods. The dilation strength data lie within the scatter of the German data and do not show consistently higher values as the tests performed at 25°C.

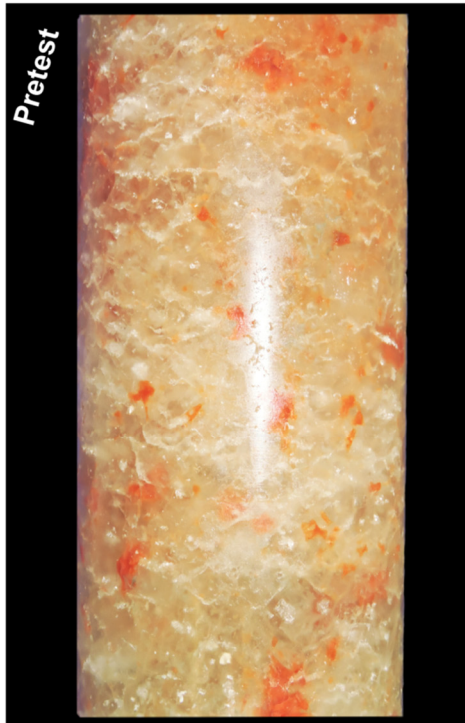
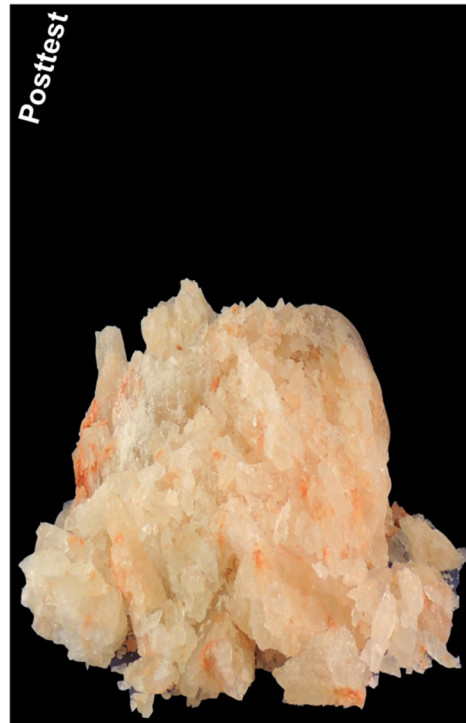
Specimen I.D. WIPP/SNLCH106-4/4.90/2 Confining Pressure 0.2 MPa Strain Rate 10^{-5} /s Temperature 25°C

Figure B-1. Confined Triaxial Compression Test Plot and Pre- and Posttest Photographs for Specimen WIPP/SNLCH106-4/4.90/2.

Dilation characteristics of the salt were determined where dilation implies that the specimen is being damaged through microfracturing (creation of voids). Dilation limits were determined by examining the volumetric strain and ultrasonic velocity responses during testing. The volumetric strain response indicates a small level of compaction at low-to-moderate stress differences, which is consistent with a material that is not dilating. At some elevated stress difference, the slope of the volumetric strain curve changes as the volumetric strain starts becoming more positive, which indicates volumetric expansion. Similarly, ultrasonic *P*- and *S*-wave velocity measurements were examined to determine the point at which the specimens transitioned from the compaction phase (increasing velocity) to creating void space (decreasing velocity) caused by damage. Ultrasonic velocity measurements are more sensitive to salt dilation than traditional volumetric strain measurements and indicate dilation limits at lower differential stresses. In some instances, the volumetric strain measurements did not show dilation during the test; whereas, dilation was indicated from the ultrasonic measurements. In general, dilation is indicated first by the *S*-wave velocity, then by the *P*-wave velocity, and last by the volumetric strain. Ultrasonic velocity measurements were not performed by the German laboratories for this study. Pre- and posttest photographs as well as plots of stress difference versus strain and acoustic velocities are provided in Attachment B for all of the RESPEC tests.

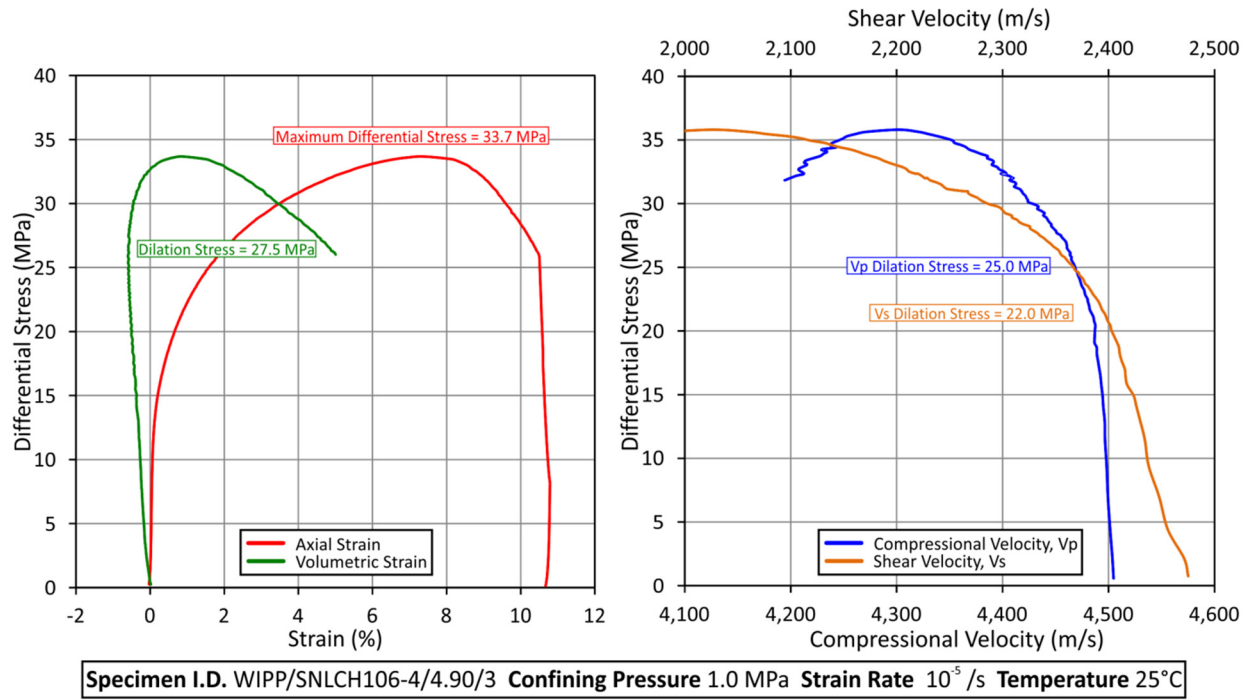
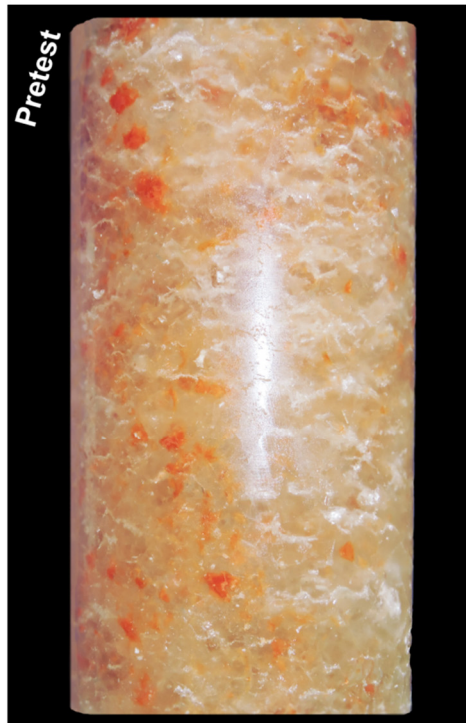
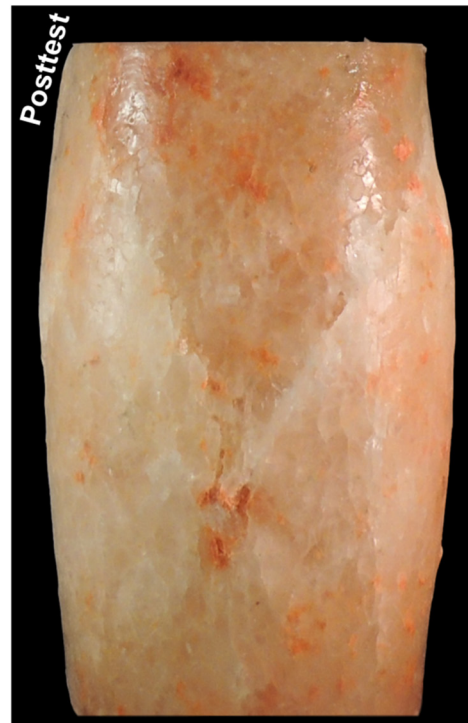
Figure B-2. Confined Triaxial Compression Test Plot and Pre- and Posttest Photographs for Specimen WIPP/SNLCH106-4/4.90/3.

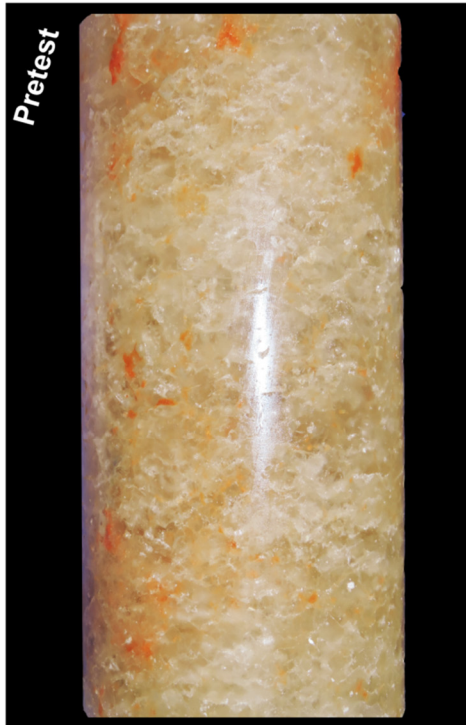
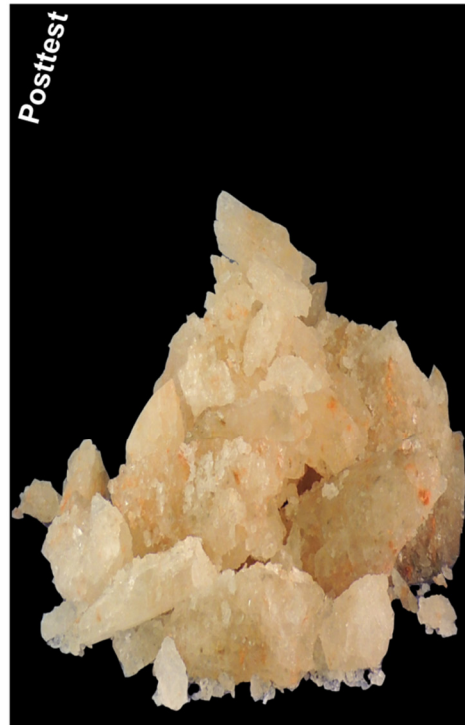
Figure B-3. Confined Triaxial Compression Test Plot and Pre- and Posttest Photographs for Specimen WIPP/SNLCH106-4/5.67/2.

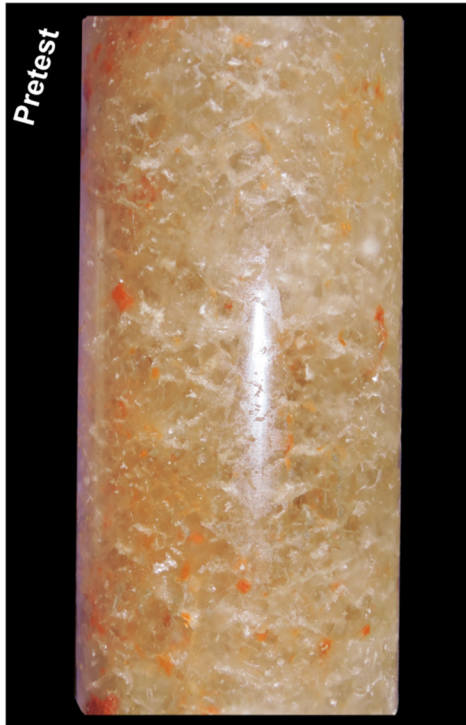
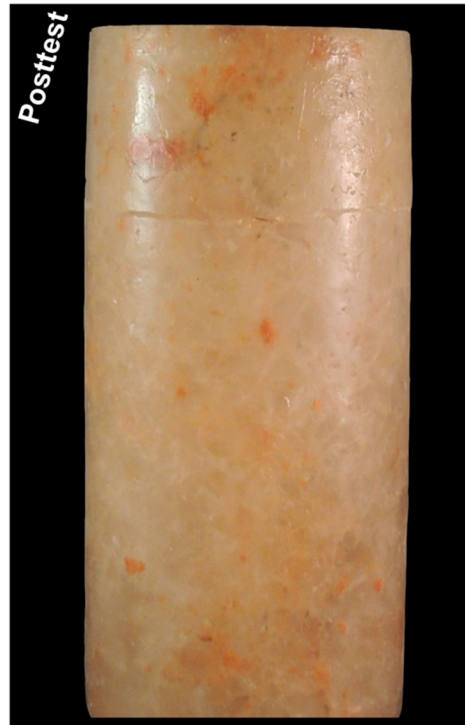
Figure B-4. Confined Triaxial Compression Test Plot and Pre- and Posttest Photographs for Specimen WIPP/SNLCH106-4/5.67/3.

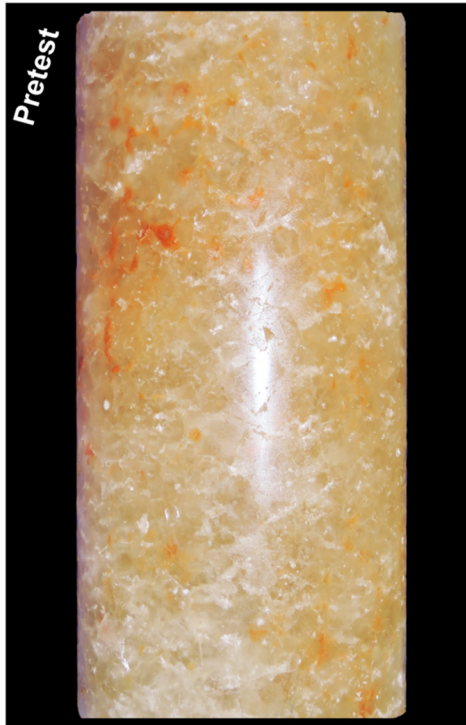
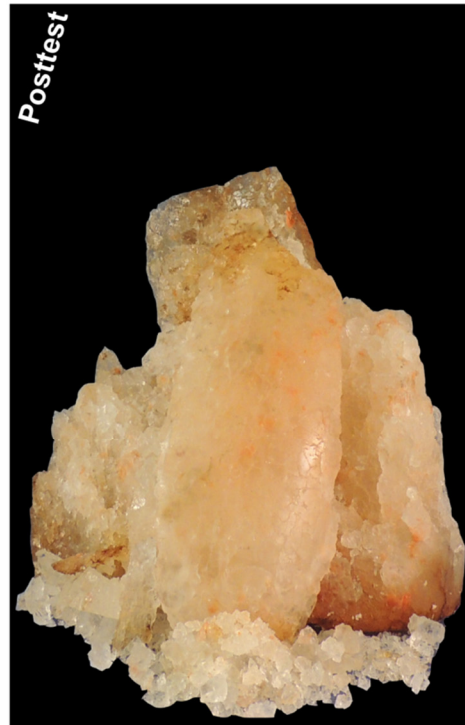
Figure B-5. Confined Triaxial Compression Test Plot and Pre- and Posttest Photographs for Specimen WIPP/SNLCH106-4/5.67/4.

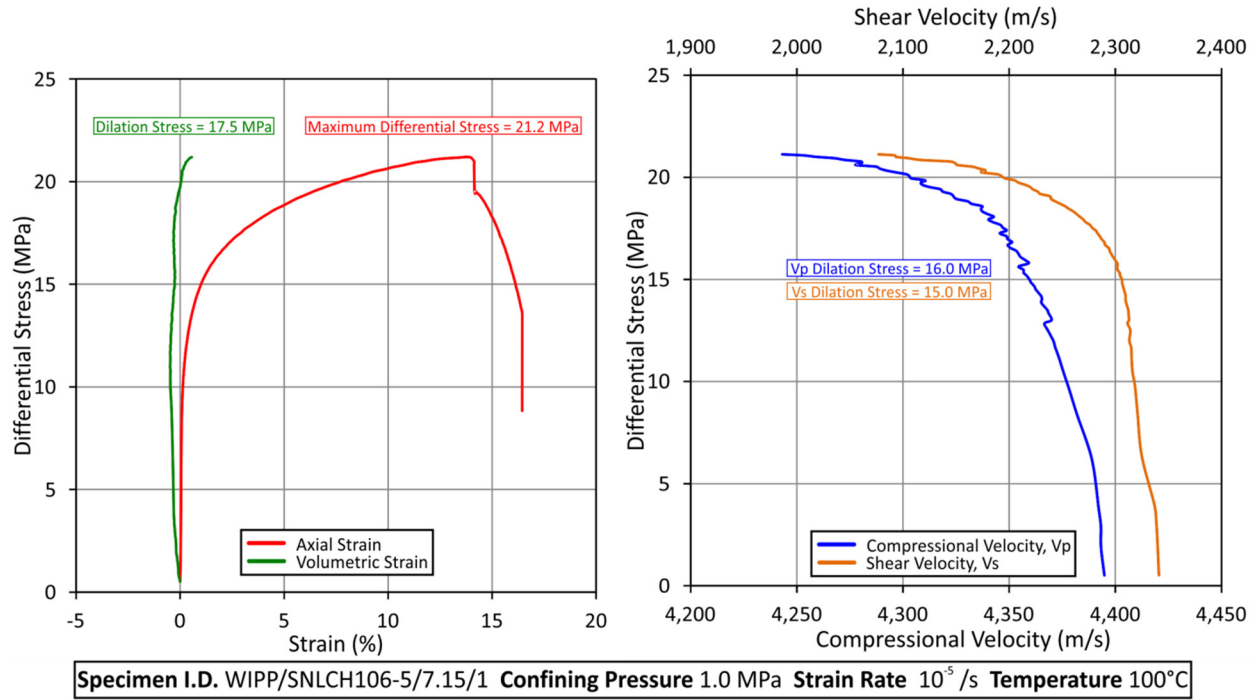
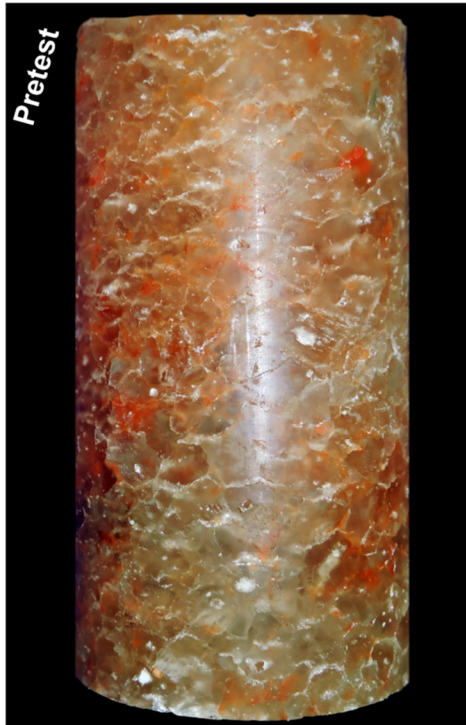
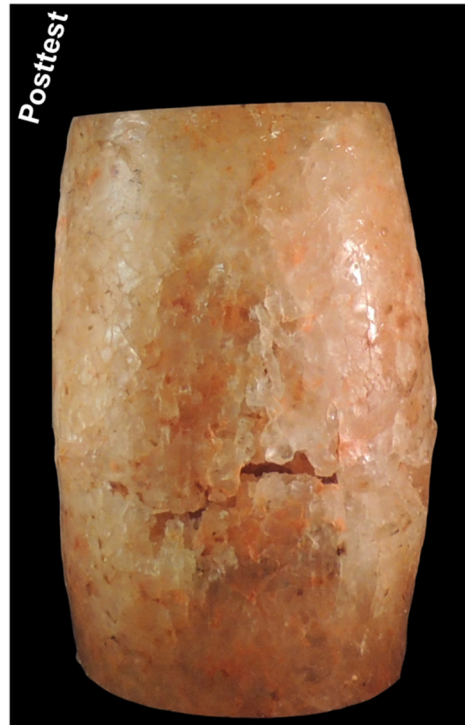
Figure B-6. Confined Triaxial Compression Test Plot and Pre- and Posttest Photographs for Specimen WIPP/SNLCH106-5/7.15/1.

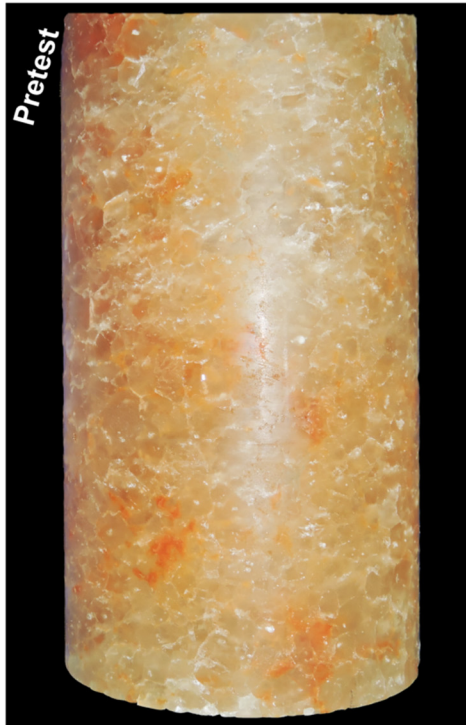
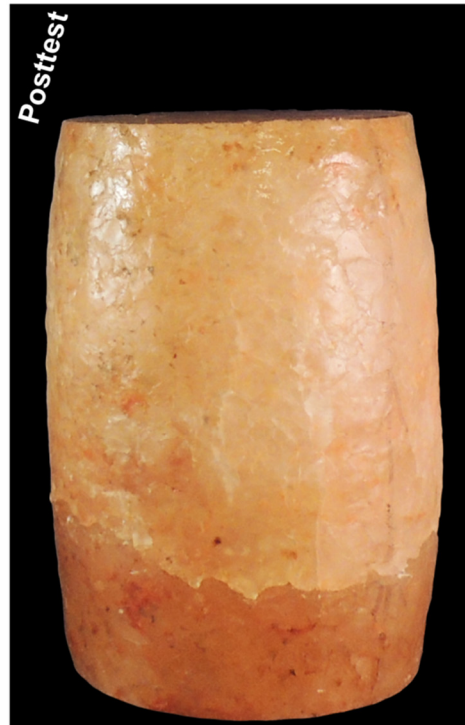
Figure B-7. Confined Triaxial Compression Test Plot and Pre- and Posttest Photographs for Specimen WIPP/SNLCH106-5/7.15/3.

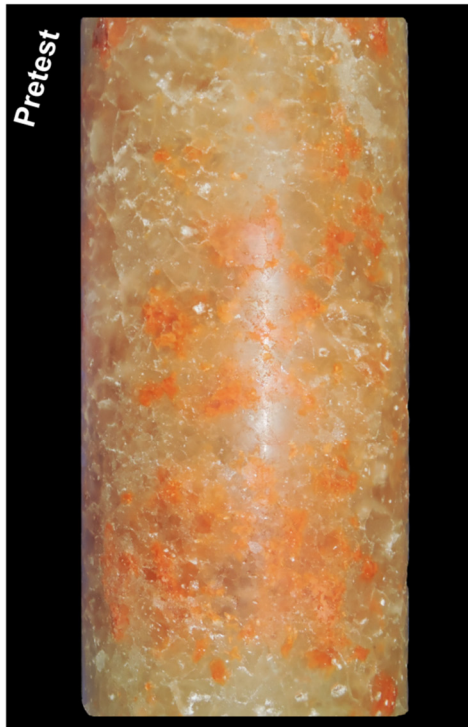
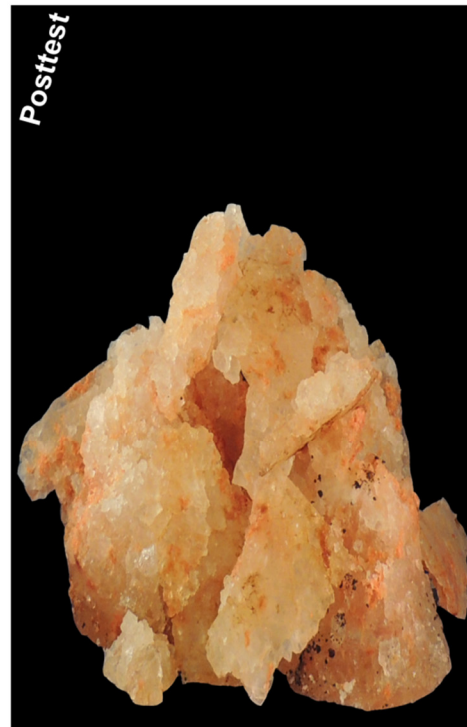
Figure B-8. Confined Triaxial Compression Test Plot and Pre- and Posttest Photographs for Specimen WIPP/SNLCH106-5/7.93/1.
