SAND2015-1746

## Analysis of Dust Samples Collected from an Unused Spent Nuclear Fuel Interim Storage Container at Hope Creek, Delaware

Charles R. Bryan and David G. Enos

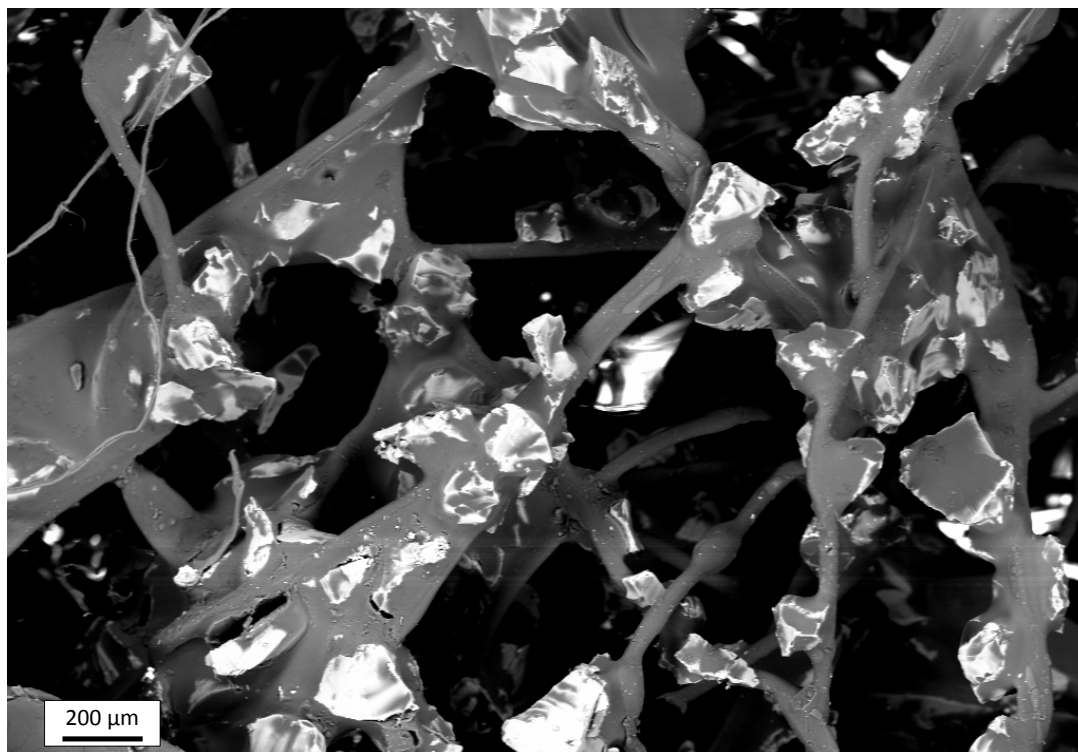
**Figure 1. SEM backscattered electron image of the Scotch-Brite™ pad blank, showing the abrasive particles within the polymeric matrix.**

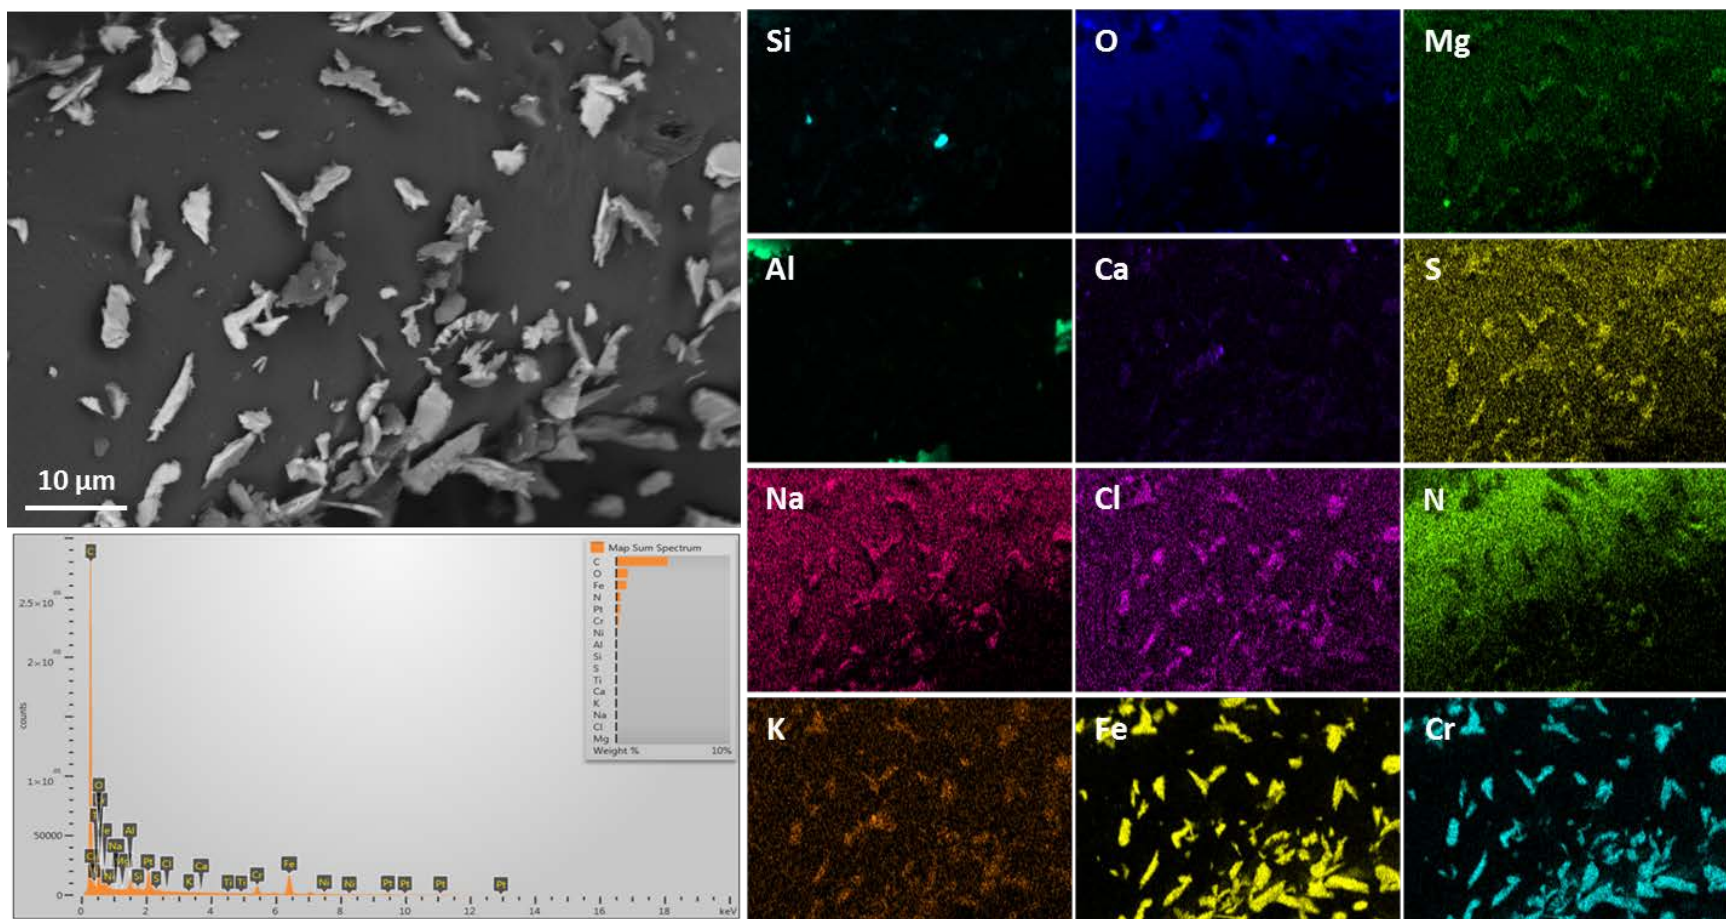
**Figure 3. SEM image/EDS map of Sample 387-003, collected from the canister side, 1 foot above the bottom edge. Almost all particles are stainless steel.**

The dry pad samples 387-001 and 387-003, from the side of the canister, were heavily coated with particulates (Figure 2). Sample 387-009, collected 5 feet above the base of the canister, is more lightly covered, but the mineralogy of the particles is the same. The great majority of the particles on the canister side are stainless steel, probably produced by grinding and finishing during the manufacturing of the canister. Note that in Figure 2 and all other SEM figures, the Ni map is not included to save space, however, as a component of stainless steel, Ni was co-located with Fe and Cr in all maps. A magnified image of the particles from 387-003, with EDS element maps, is shown in Figure 3. Rare aluminosilicate and salt particles are also present. These are

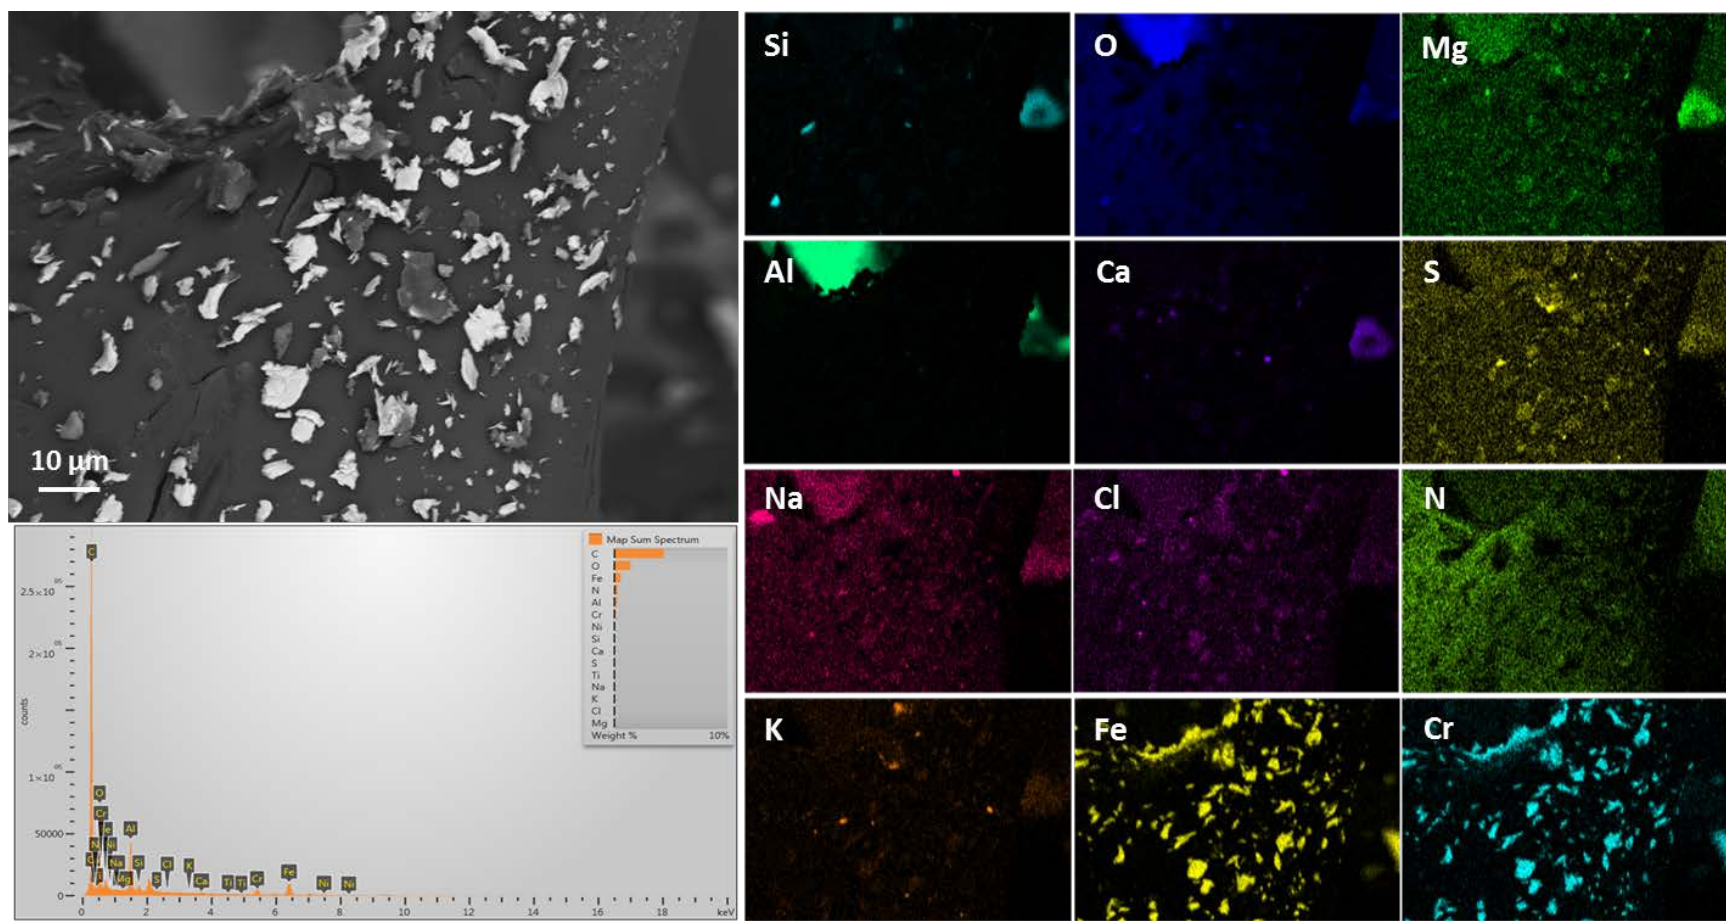
**Figure 4. SEM image/EDS map of Sample 387-001, collected from the canister side, 1 foot above the bottom edge. Almost all particles are stainless steel. Note small grains of a Na-K-SO<sub>4</sub> phase.**

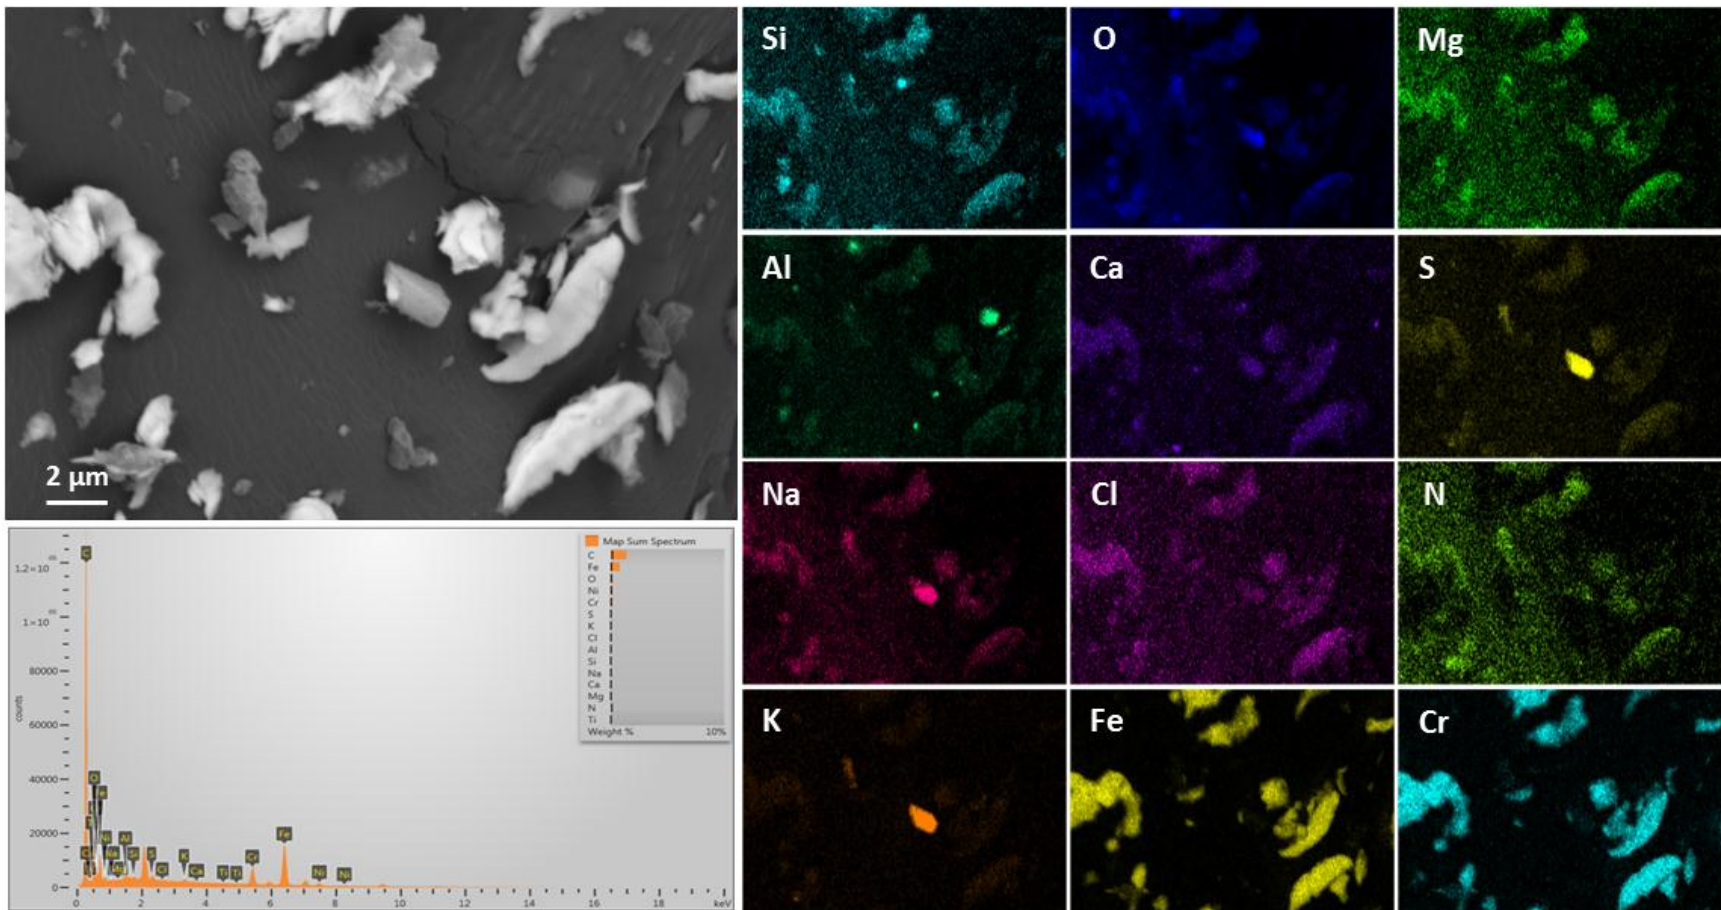
Figure 5. SEM image of sample 387-001, collected from the canister top, showing the heavy dust load. Magnified image of small Na-K-SO<sub>4</sub> grain shown in Figure 4, upper right.

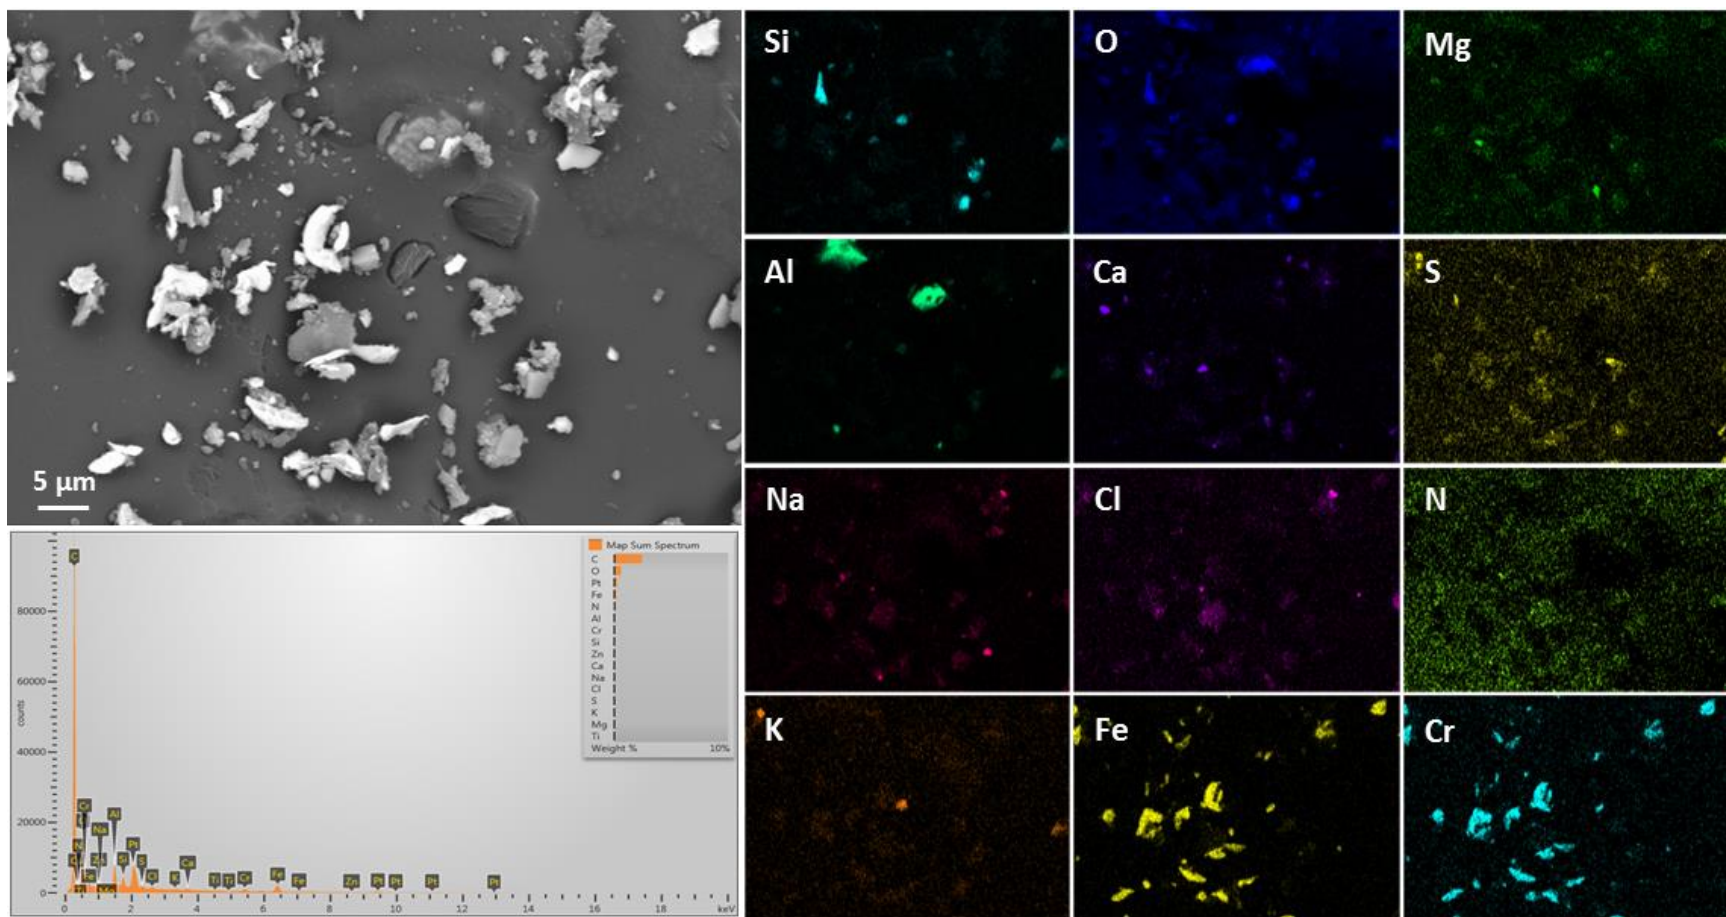
**Figure 7. SEM image/EDS map #1 of Sample 387-005, collected from the canister top, 1 foot from the edge. Most particles are stainless steel. Note Na-Cl grain in upper left, K-SO<sub>4</sub> particle in upper right.**

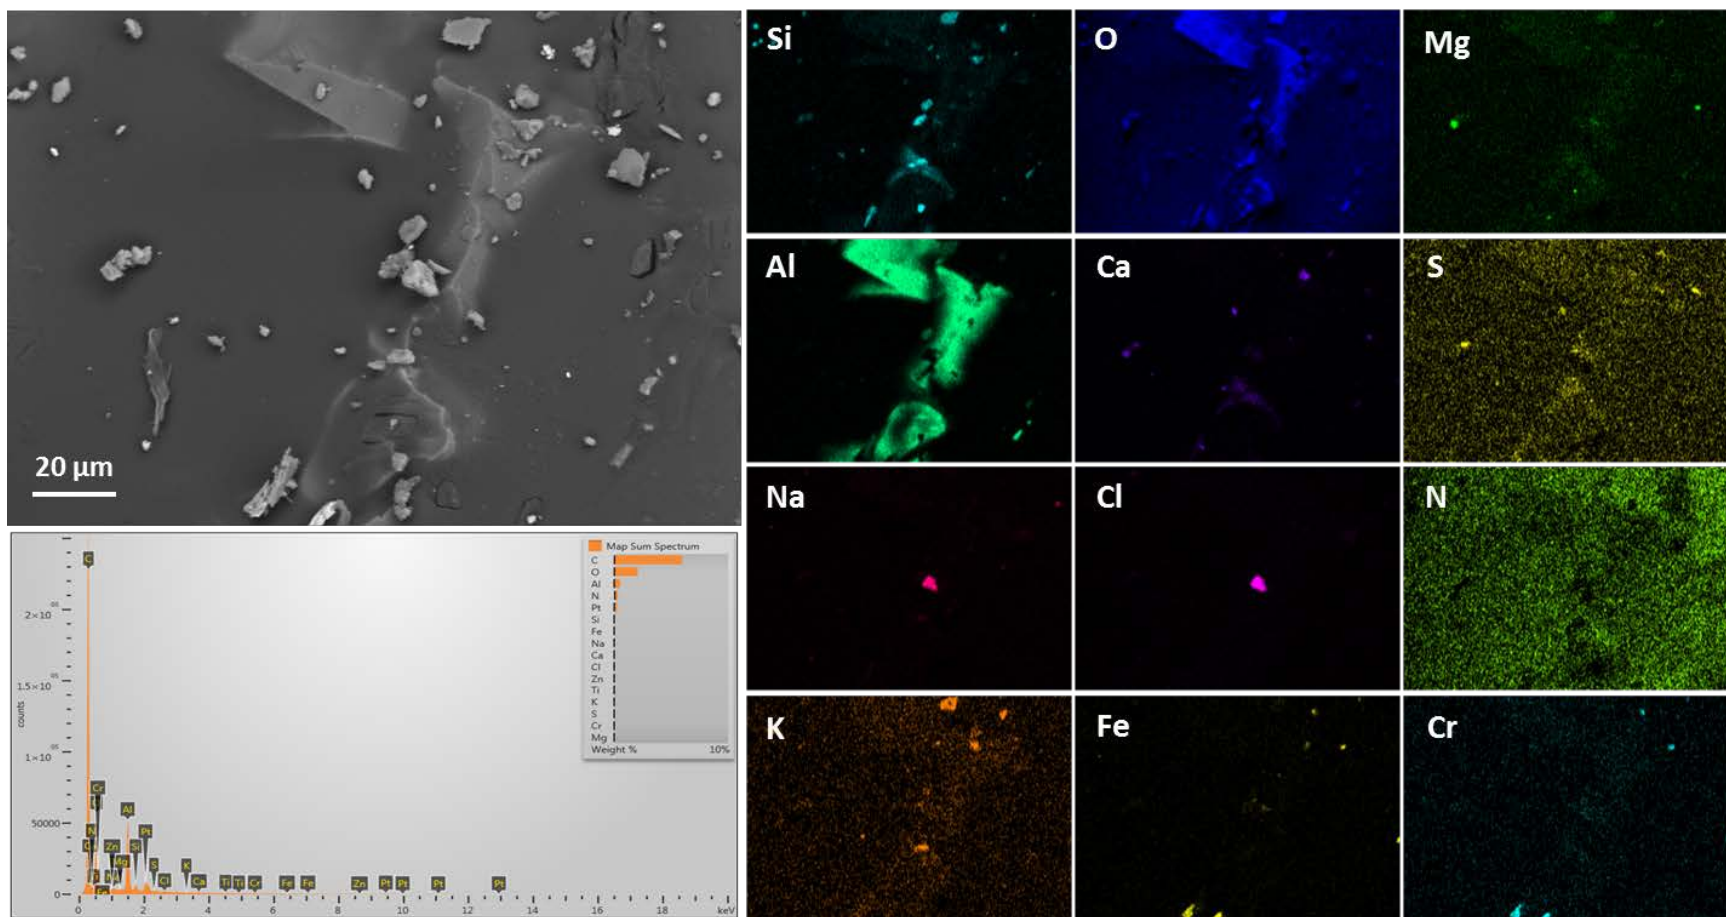
**Figure 8. SEM image/EDS map #2 of Sample 387-005, collected from the canister top, 1 foot from the edge. Note Na-Cl grain in the center of the image.**

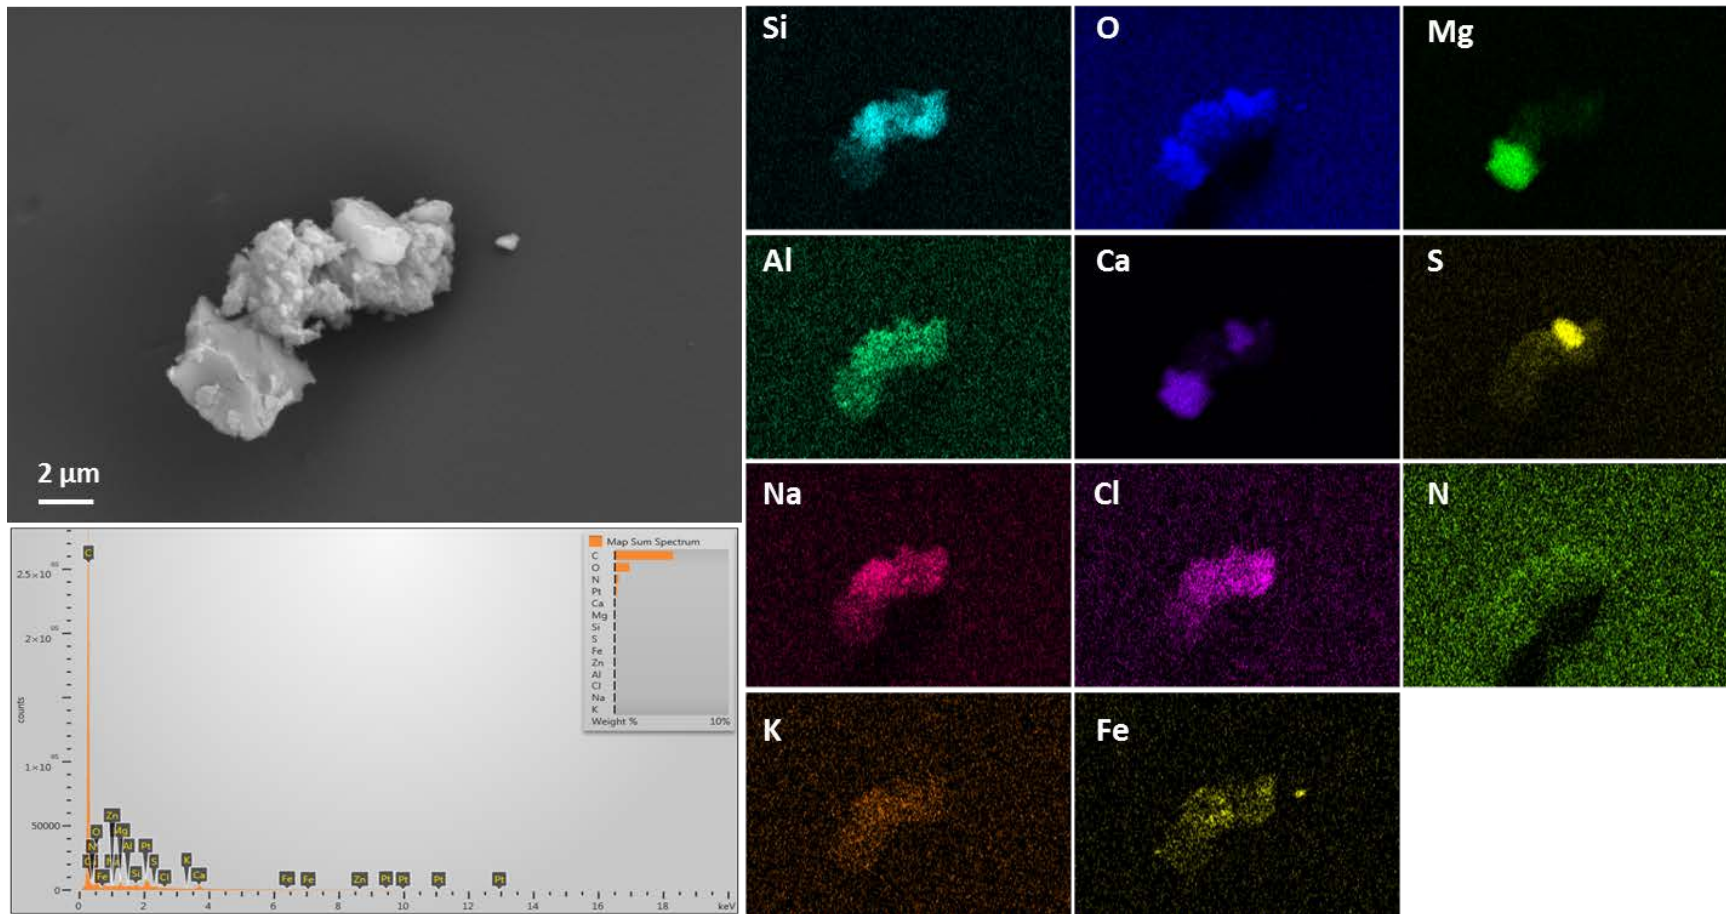
**Figure 9. SEM image/EDS map #3 of Sample 387-005, collected from the canister top, 1 foot from the edge. Magnified image of composite grain in left center of Figure 8. Grain contains Ca-Mg-CO<sub>3</sub> and Ca-SO<sub>4</sub> phases.**

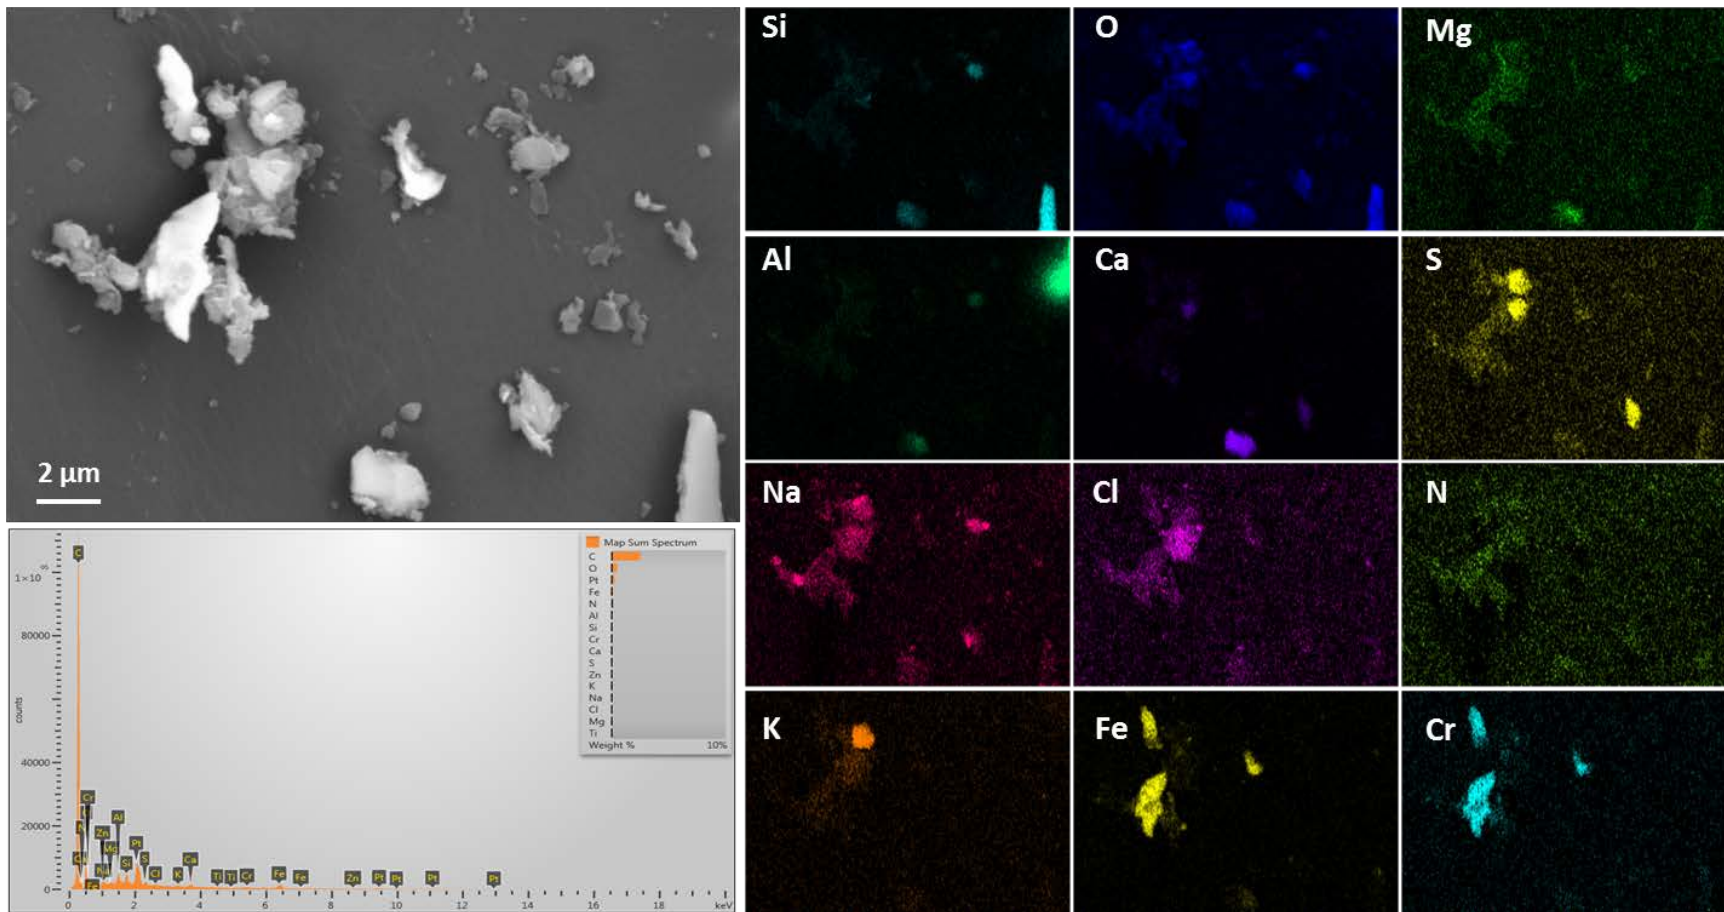
**Figure 10. SEM image/EDS map #4 of Sample 387-005, collected from the canister top, 1 foot from the edge. Note stainless steel particles and SO<sub>4</sub> phases.**

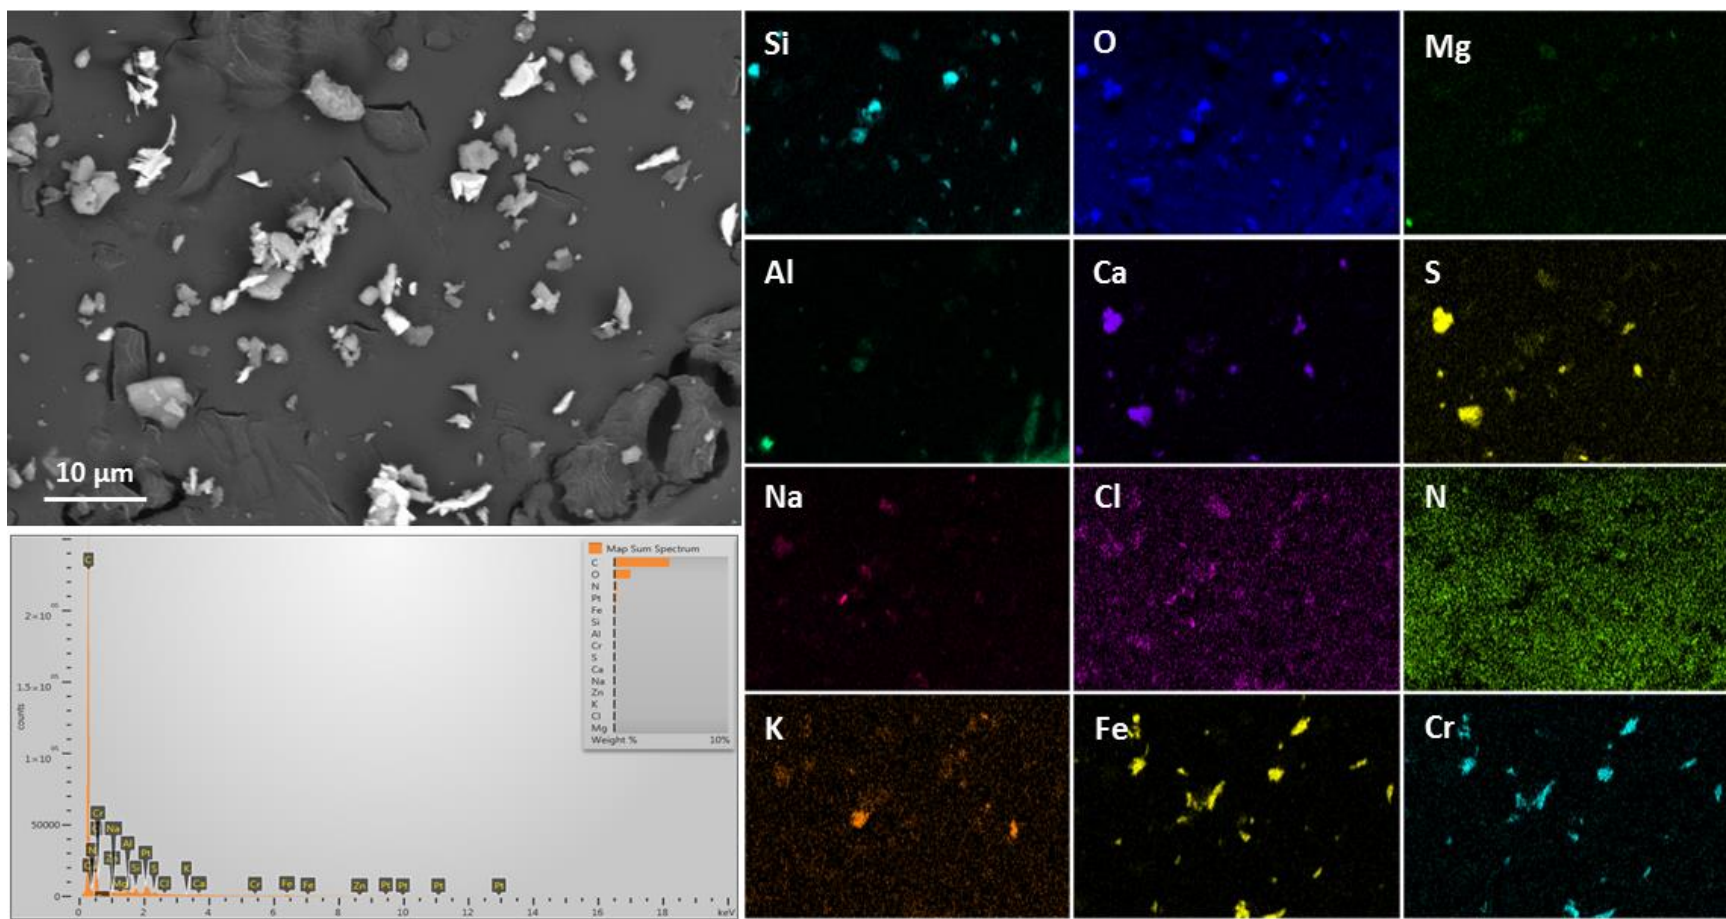
Figure 11. SEM image/EDS map #1 of Sample 387-007, collected from the center of the canister top. Note stainless steel and Ca-SO<sub>4</sub> grains.

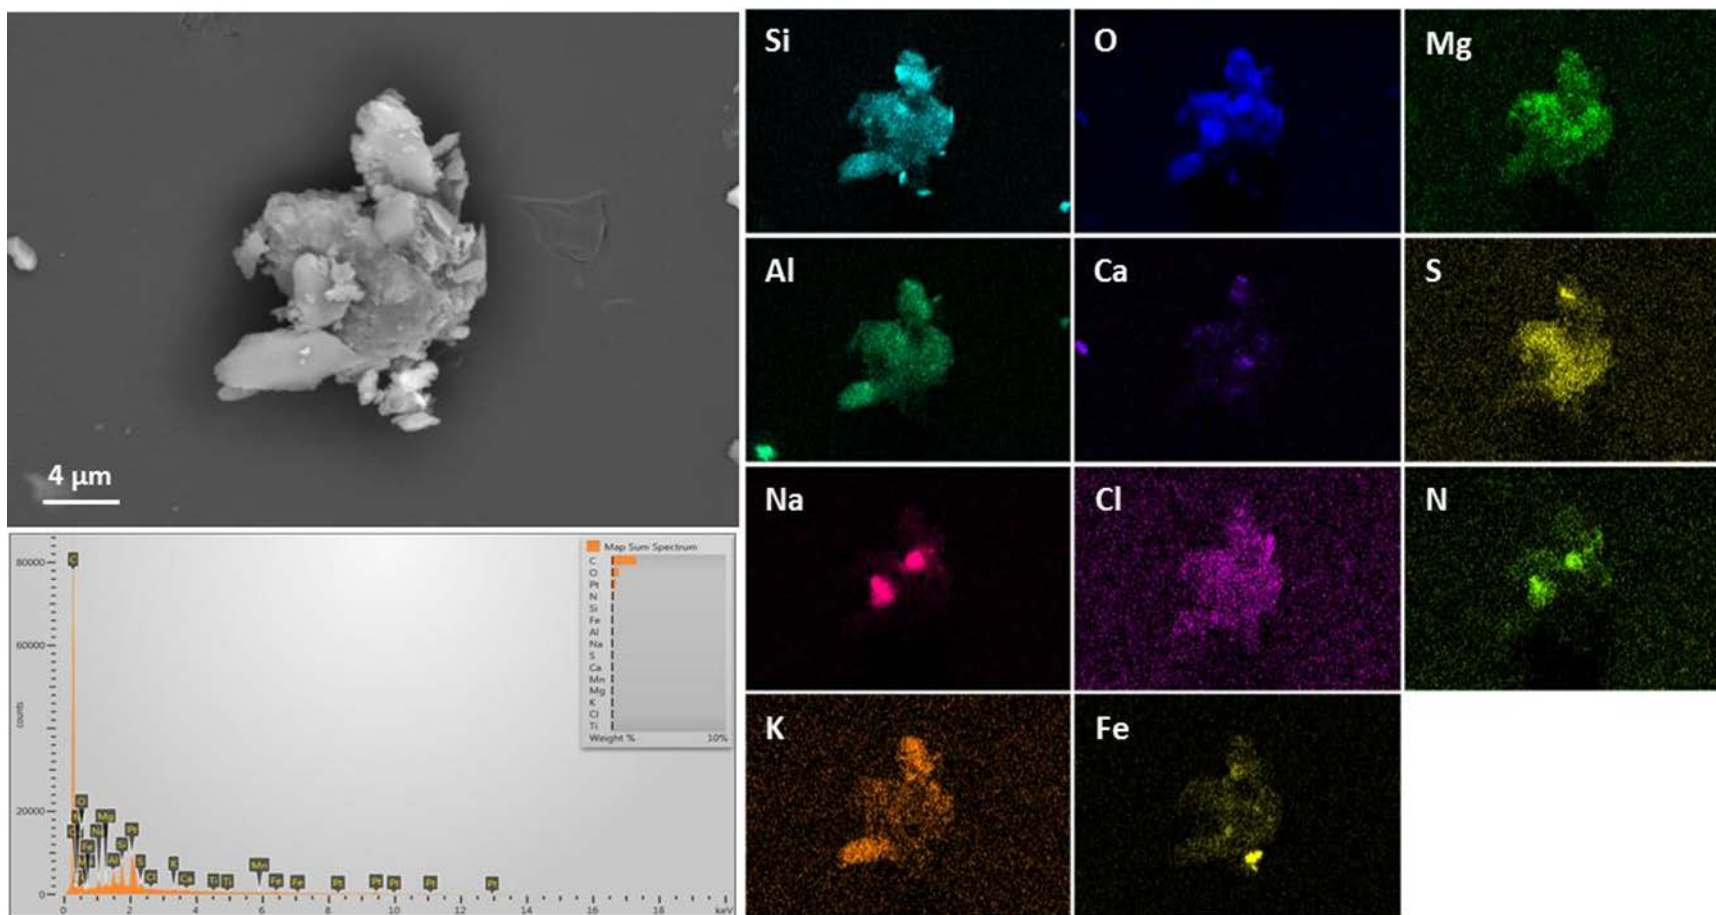
Figure 12. SEM image/EDS map #3 of Sample 387-007, collected from the center of the canister top. Aluminosilicate grain, with associated Na-NO<sub>3</sub>.

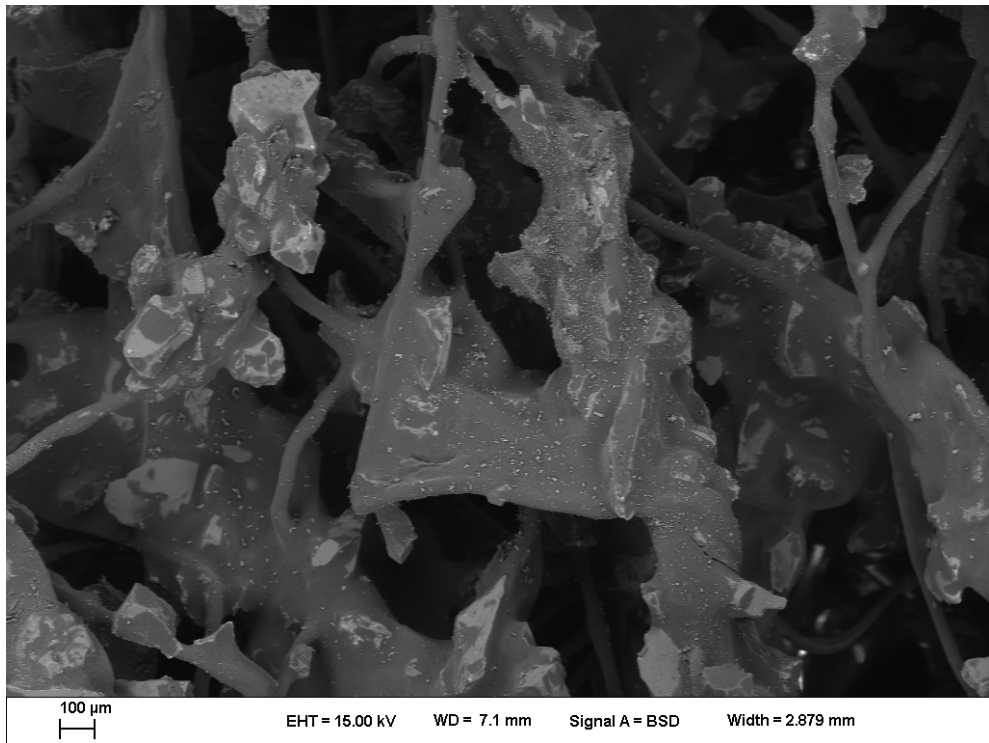
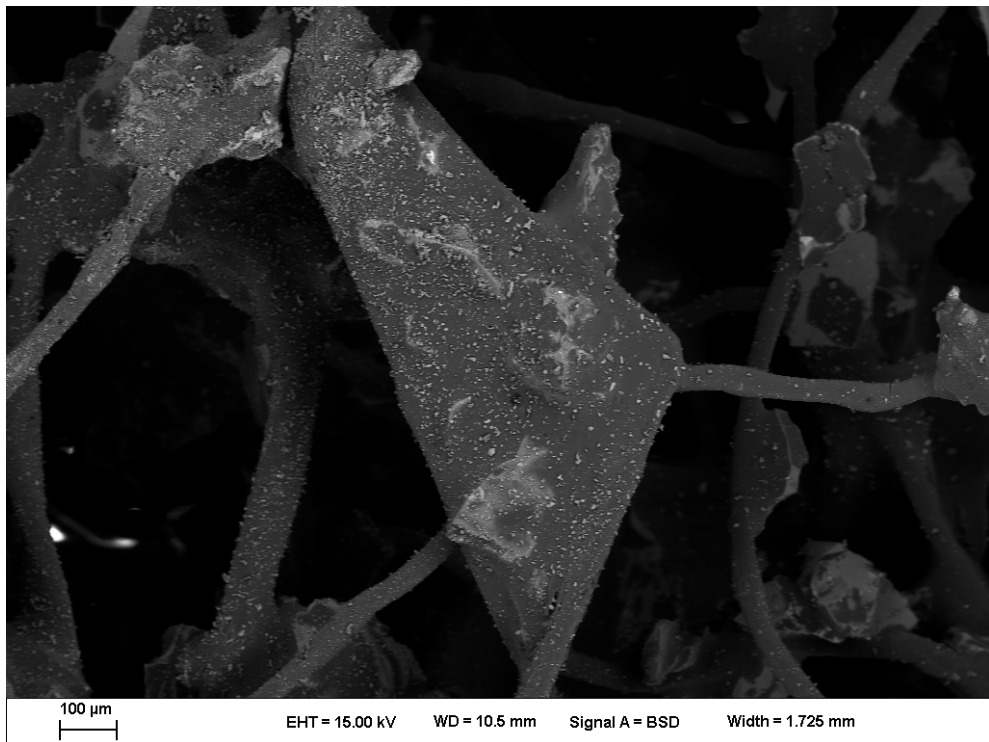
**Figure 13. Upper: SEM image of pad sample 387-011, collected from the FME cover, 1 foot from the edge. Lower: SEM image of pad sample 387-013, collected from the center of the FME cover.**

The dust loads on the dry pad samples were variable. Sample 387-011 was lightly loaded, while the other two were more heavily coated. Typical pad regions for 387-011 and 387-013 are shown in Figure 13 (see Appendix A for an overview image of 389-015). In addition to having generally higher dust loads than the samples from the canister itself, the FME samples have significantly different compositions. While the canister dusts consisted almost entirely of stainless steel particles, the dust on the FME cover seems to be dominantly terrestrially-derived silicate and aluminosilicate particles, and stainless steel particles are rare. Salt phases are common, and consist almost entirely of sulfates, but a few specks of nitrate-rich material were observed. No unequivocal chloride mineral grain was observed.

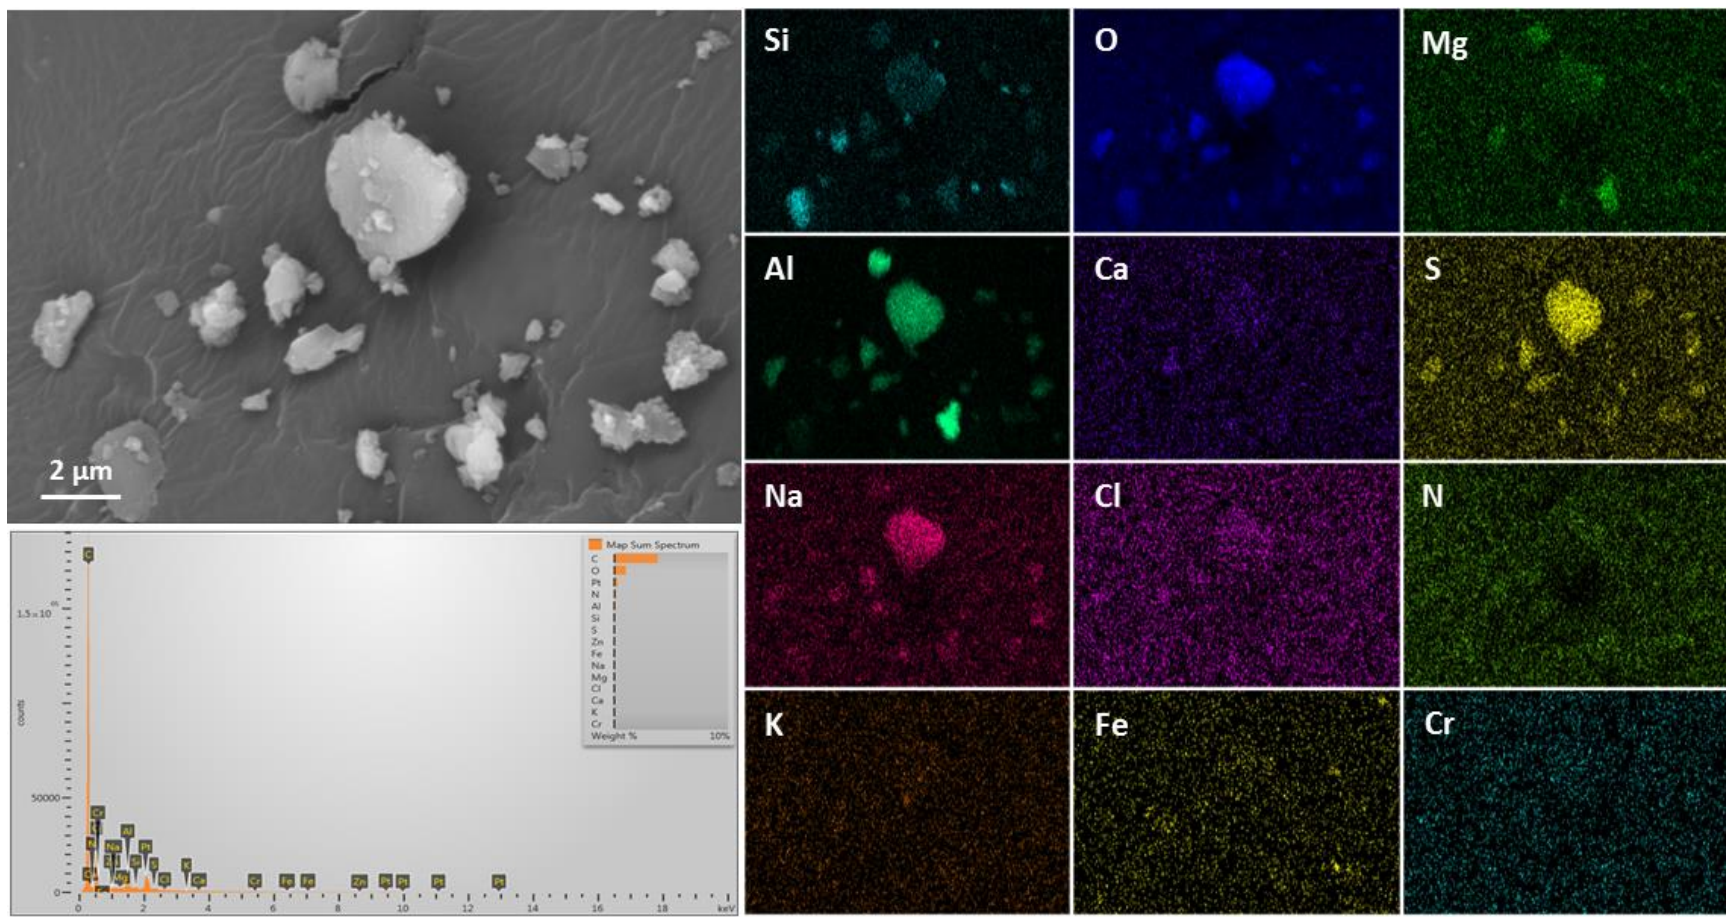
Figure 14. SEM image/EDS map #1 of Sample 387-011, collected 1 foot from the edge of the FME cover. Dust particles are quartz and aluminosilicates, with a large particle consisting of Na-Al-SO<sub>4</sub>.

Some representative SEM images and EDS maps are shown for the FME samples in Figure 14 to Figure 22. The silicate minerals include quartz and various Na, K, Ca, Mg, and Mg-Fe aluminosilicates that are probably a mixture of feldspars and clays. Calcium carbonate is present. Sulfates are the most abundant salts present, occurring as Ca-SO<sub>4</sub> but mostly as a Na-Al-SO<sub>4</sub> phase. While Na-Al-SO<sub>4</sub> minerals occur naturally, in areas of hydrothermal alteration, the natural minerals are unlikely to be present in aerosols at the Hope Creek site. The Na-Al-SO<sub>4</sub> phase probably formed, either prior to or after deposition, by a particle-gas conversion reaction between sodium-and-aluminum-bearing aerosol particles and sulfuric acid captured as SO<sub>2</sub> from the atmosphere. Naturally occurring Na-Al phases are also unlikely to be present as aerosols at the Hope Creek site. However, both a particulate (cryolite, Na<sub>3</sub>AlF<sub>6</sub>) and a gas-phase compound (NaAlF<sub>4</sub>) are found in emissions from aluminum smelting operations that use the Hall-Heroult process for refining aluminum (Kvande and Drabløs, 2014). These could react with atmospheric sulfuric acid (also present in smelter emissions) to form the Na-Al-SO<sub>4</sub> phase observed by SEM. There is a large Al recycling and smelting company in Camden NJ, 40 miles NE of the Hope Creek site. This company, State Metal Industries Inc., uses the Hall-Heroult method (<http://www.statemetalindustries.com/statemetalindustries/>). It seems likely that the Na-Al-SO<sub>4</sub> phase observed in the dusts from the unused canister at Hope Creek can be sourced to reactions between Na-Al phases in the smelter emissions and atmospheric SO<sub>2</sub>/sulfuric acid.

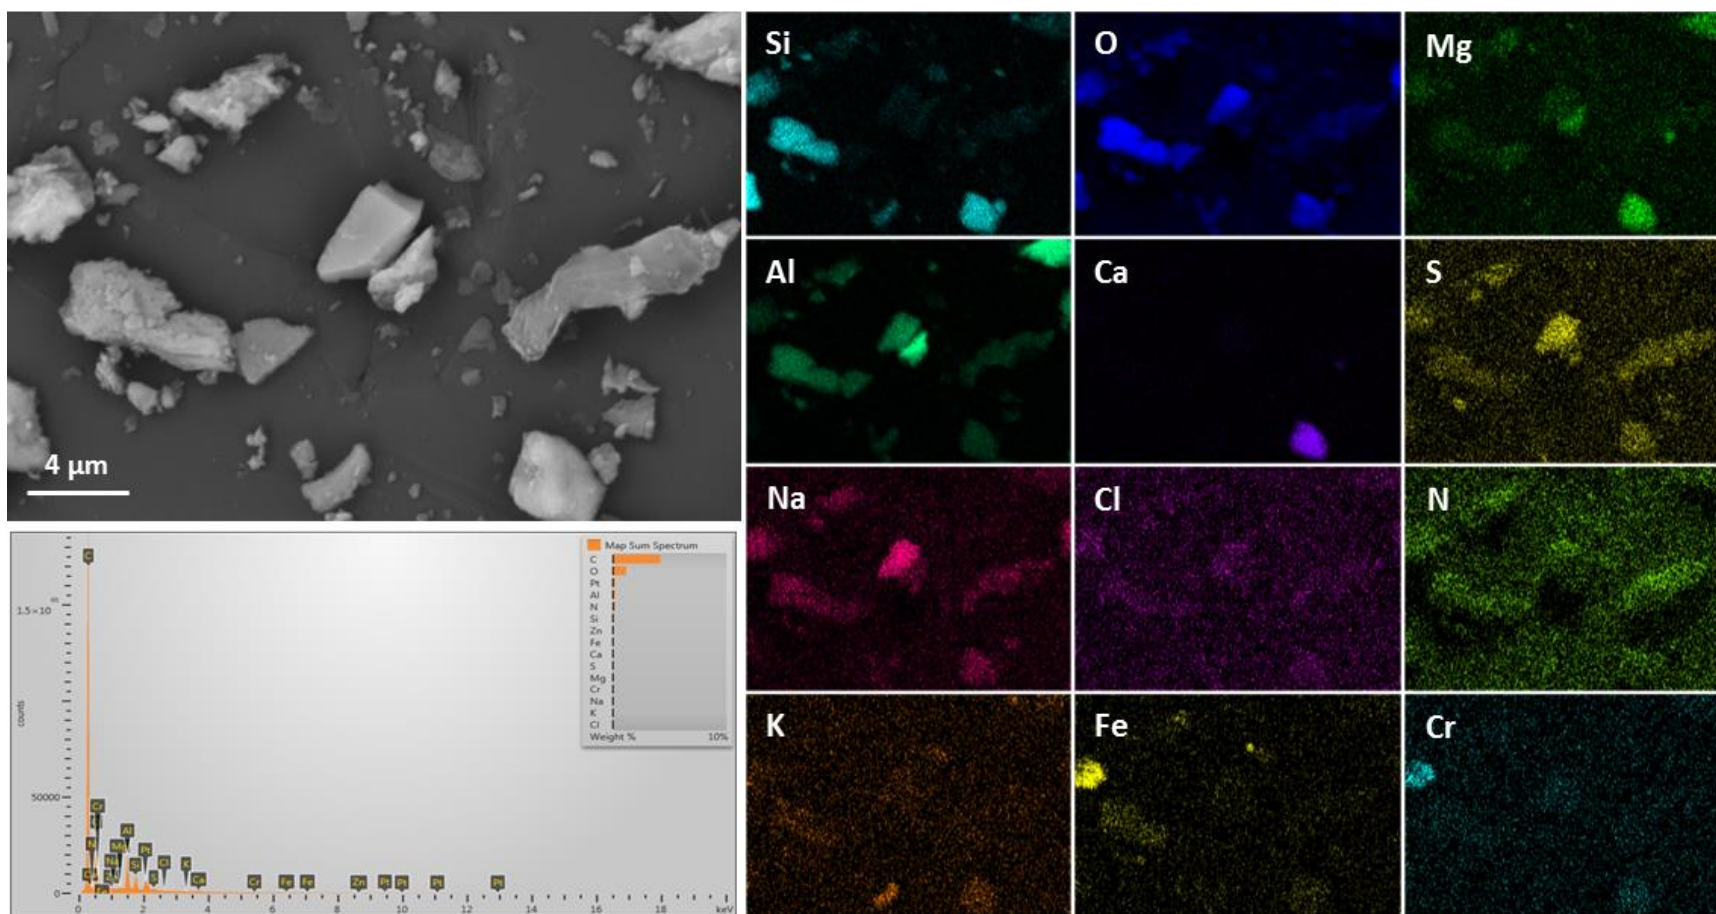
**Figure 15. SEM image/EDS map #1 of Sample 387-011, collected 1 foot from the edge of the FME cover. Particles are mostly aluminosilicates, but note the Na-Al-SO<sub>4</sub> grain in the center of the image.**

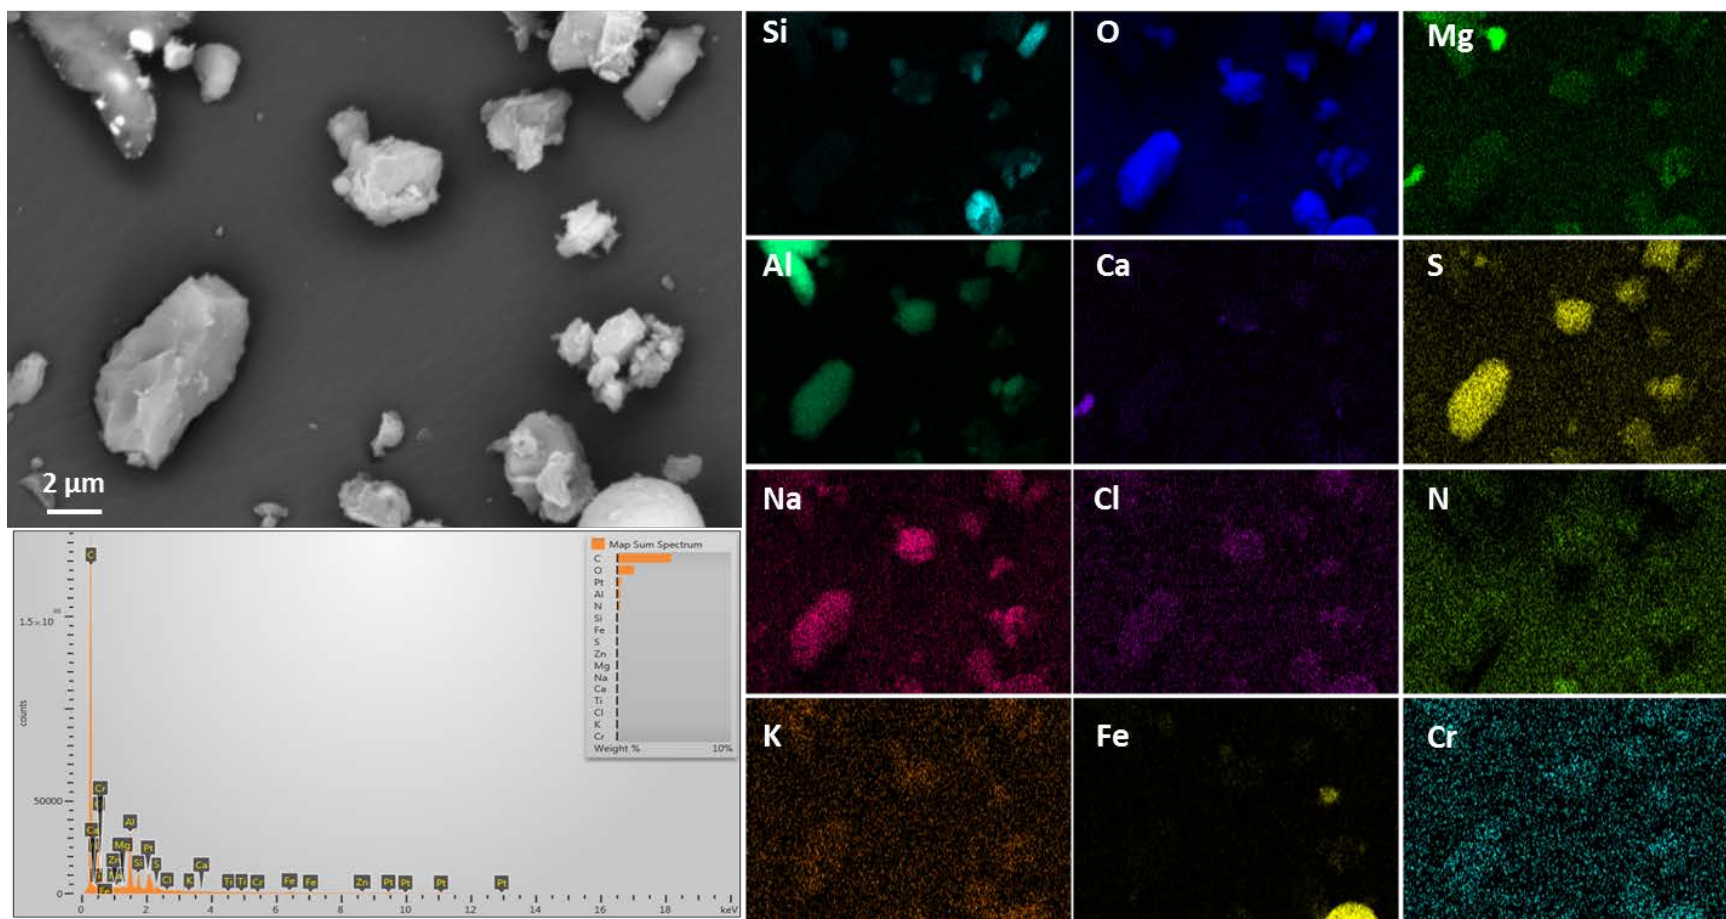
Figure 16. SEM image/EDS map #1 of Sample 387-011, collected 1 foot from the edge of the FME cover. Note multiple grains of Na-Al-SO<sub>4</sub>.
