SAND2015-1746

## Analysis of Dust Samples Collected from an Unused Spent Nuclear Fuel Interim Storage Container at Hope Creek, Delaware

Charles R. Bryan and David G. Enos

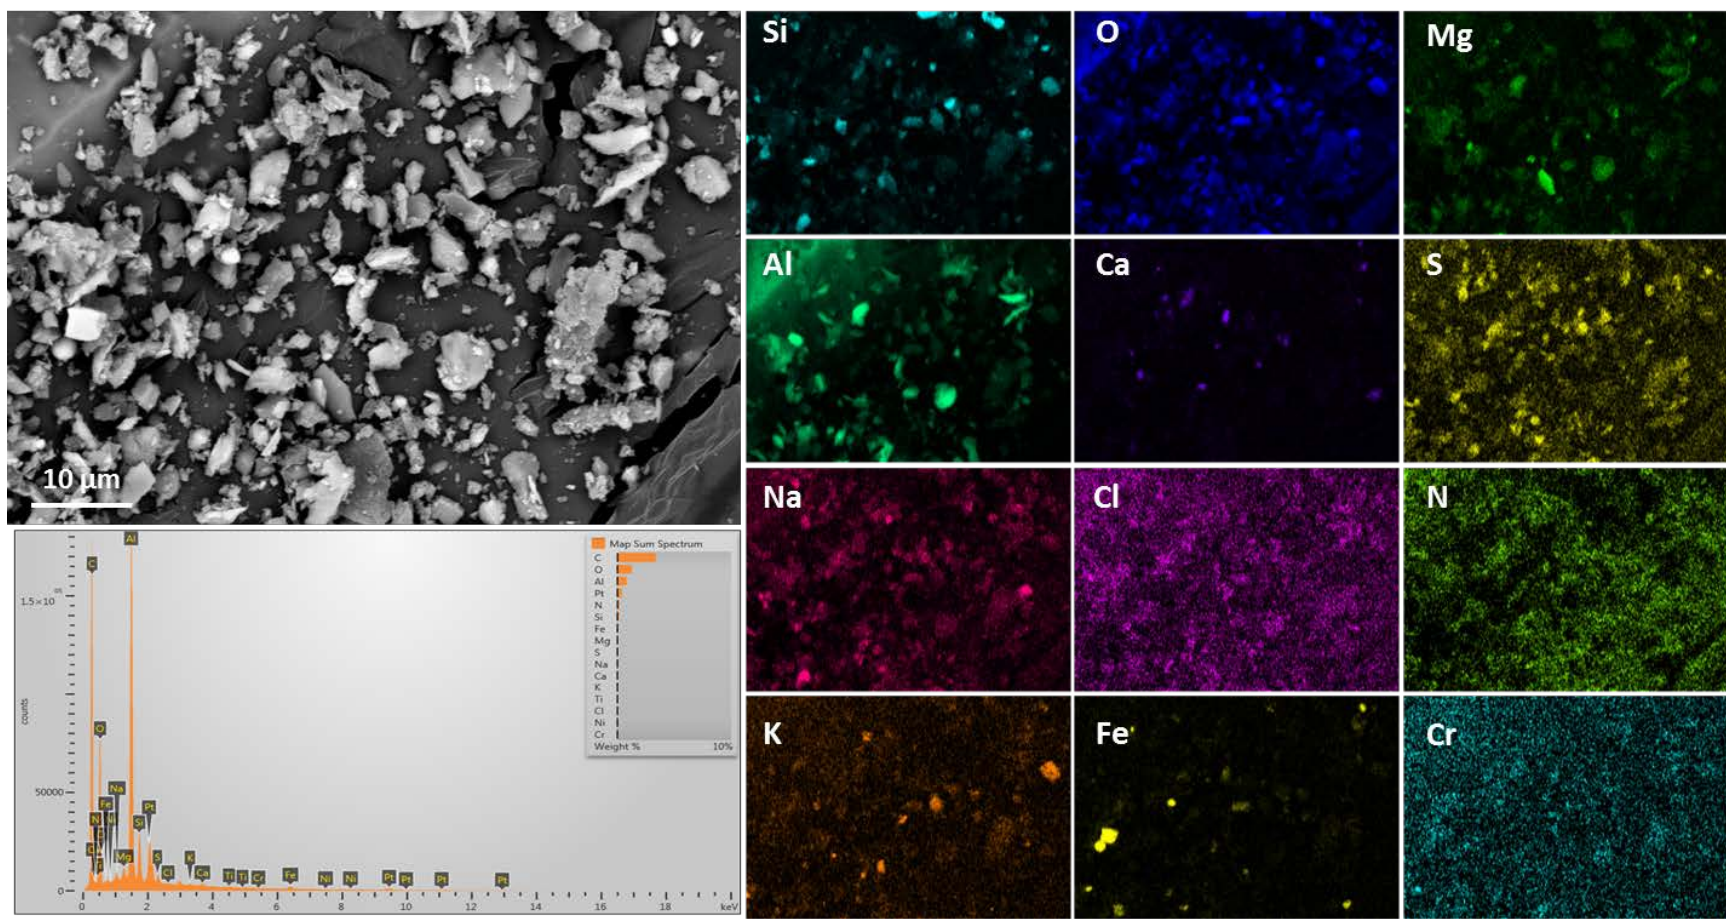
Figure 17. SEM image/EDS map #2 of sample 387-013, collected from the center of the FME cover. Grains are largely aluminosilicates, but note the abundance of  $\text{SO}_4$  phases.

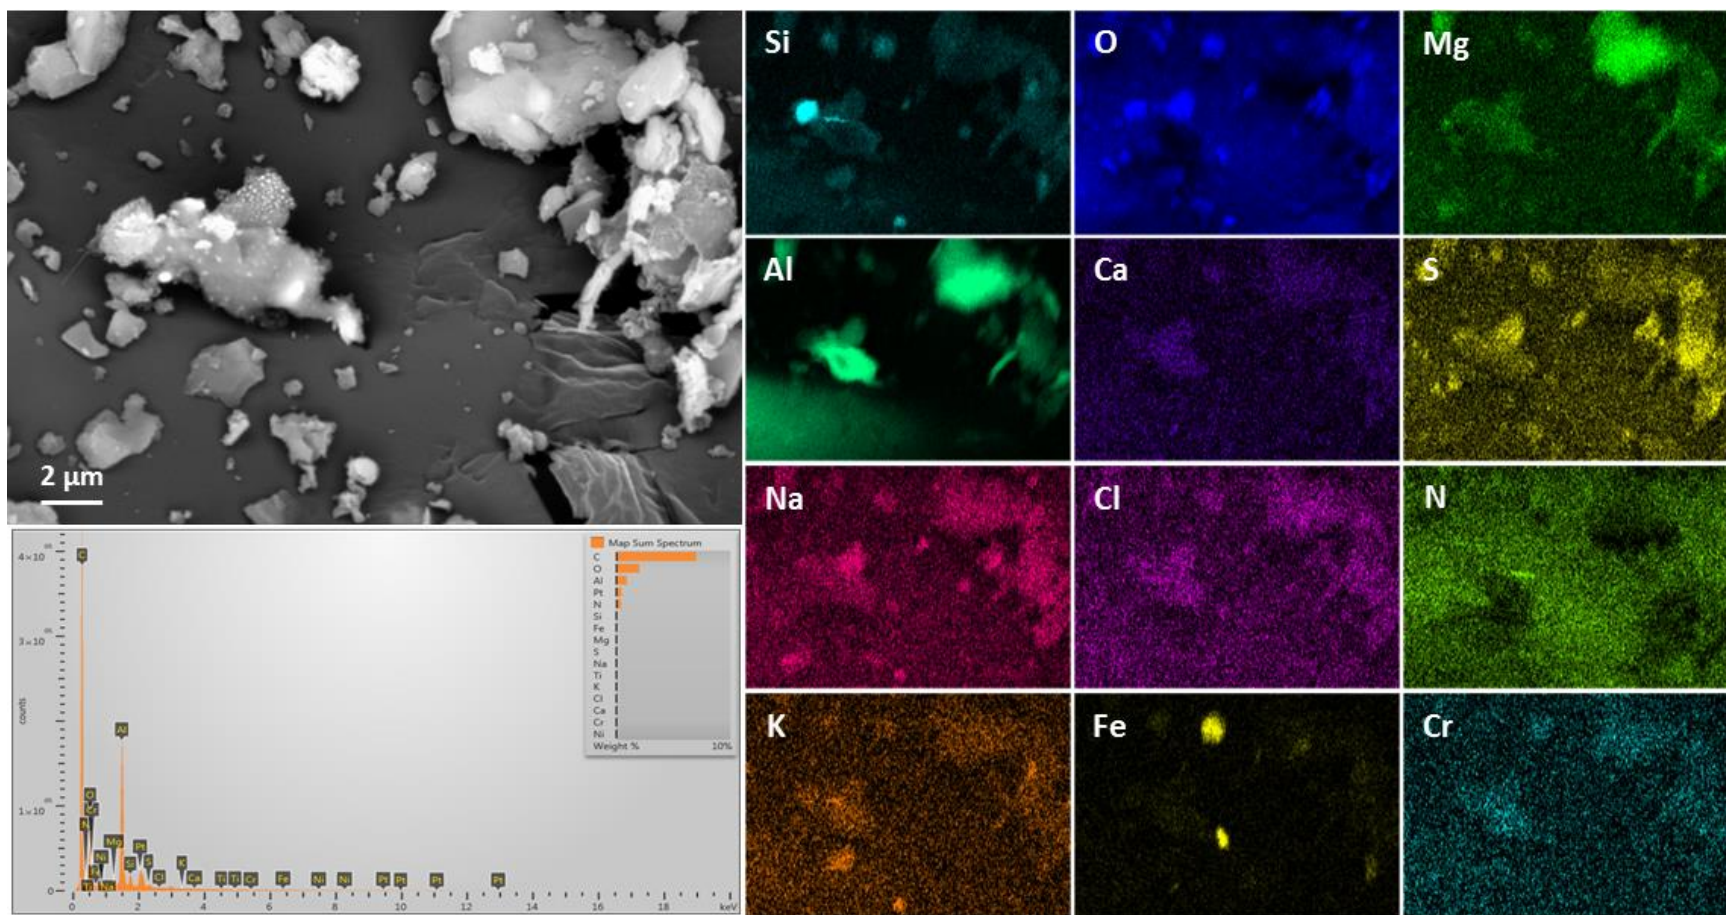
Figure 18. SEM image/EDS map #2 of sample 387-013, collected from the center of the FME cover. Grains are mostly aluminosilicates, but note the Na-SO<sub>4</sub> grain in left center that decomposed in the electron beam.

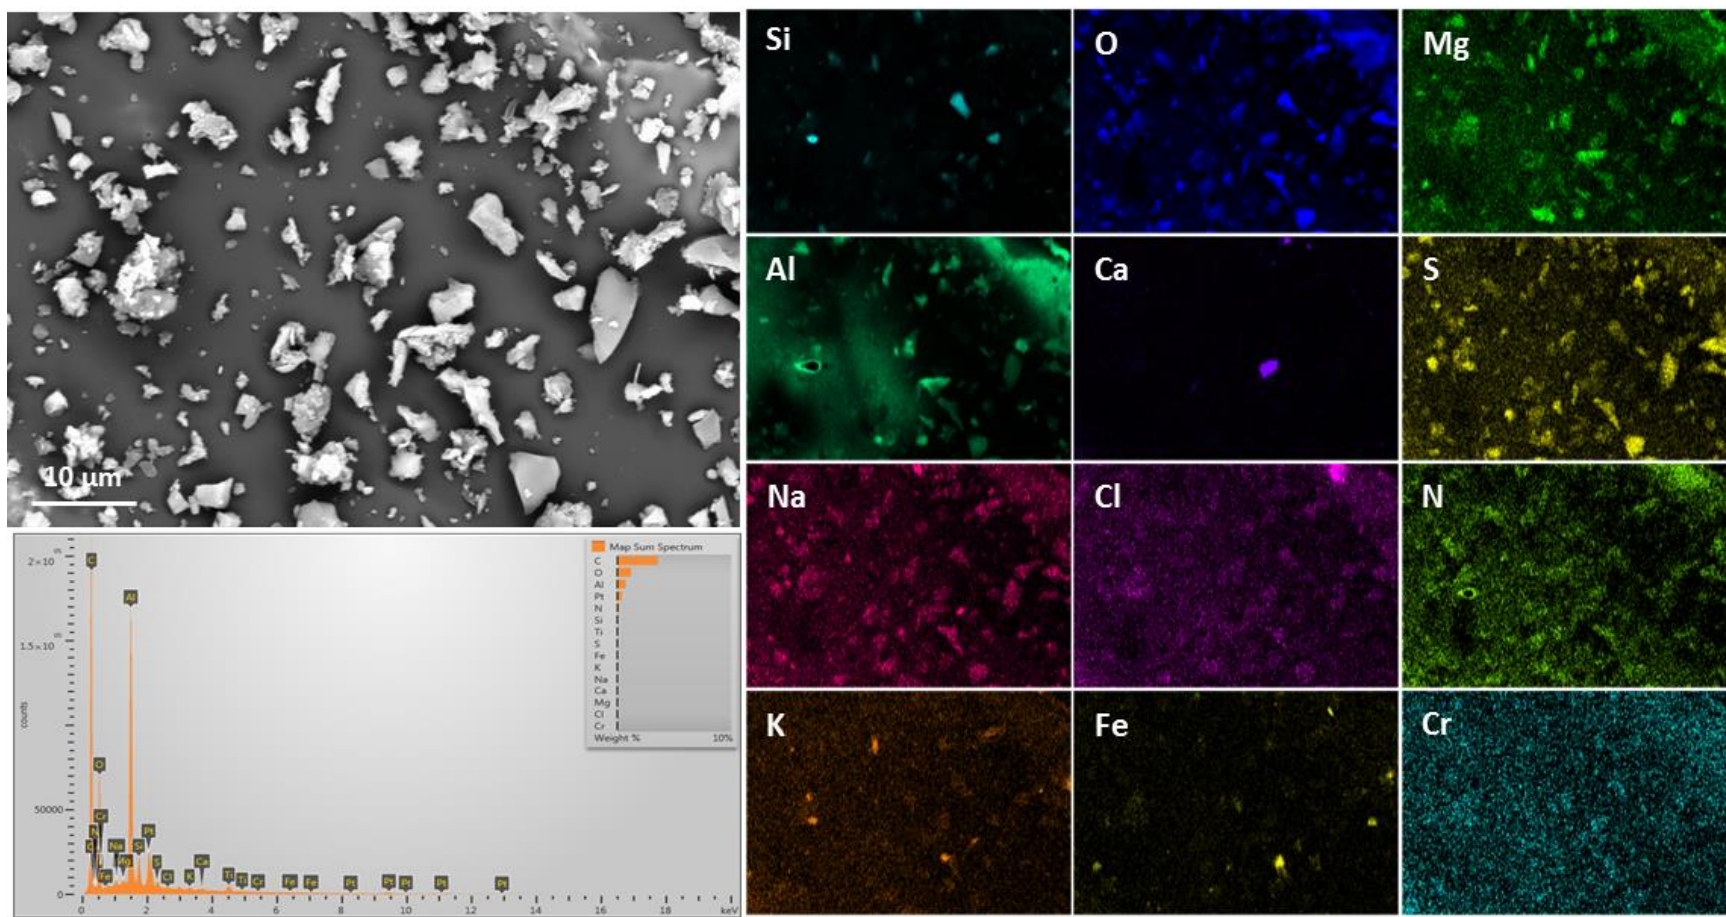
Figure 19. SEM image/EDS map #2 of sample 387-013, collected from the center of the FME cover. Note abundance of  $\text{SO}_4$  phases.

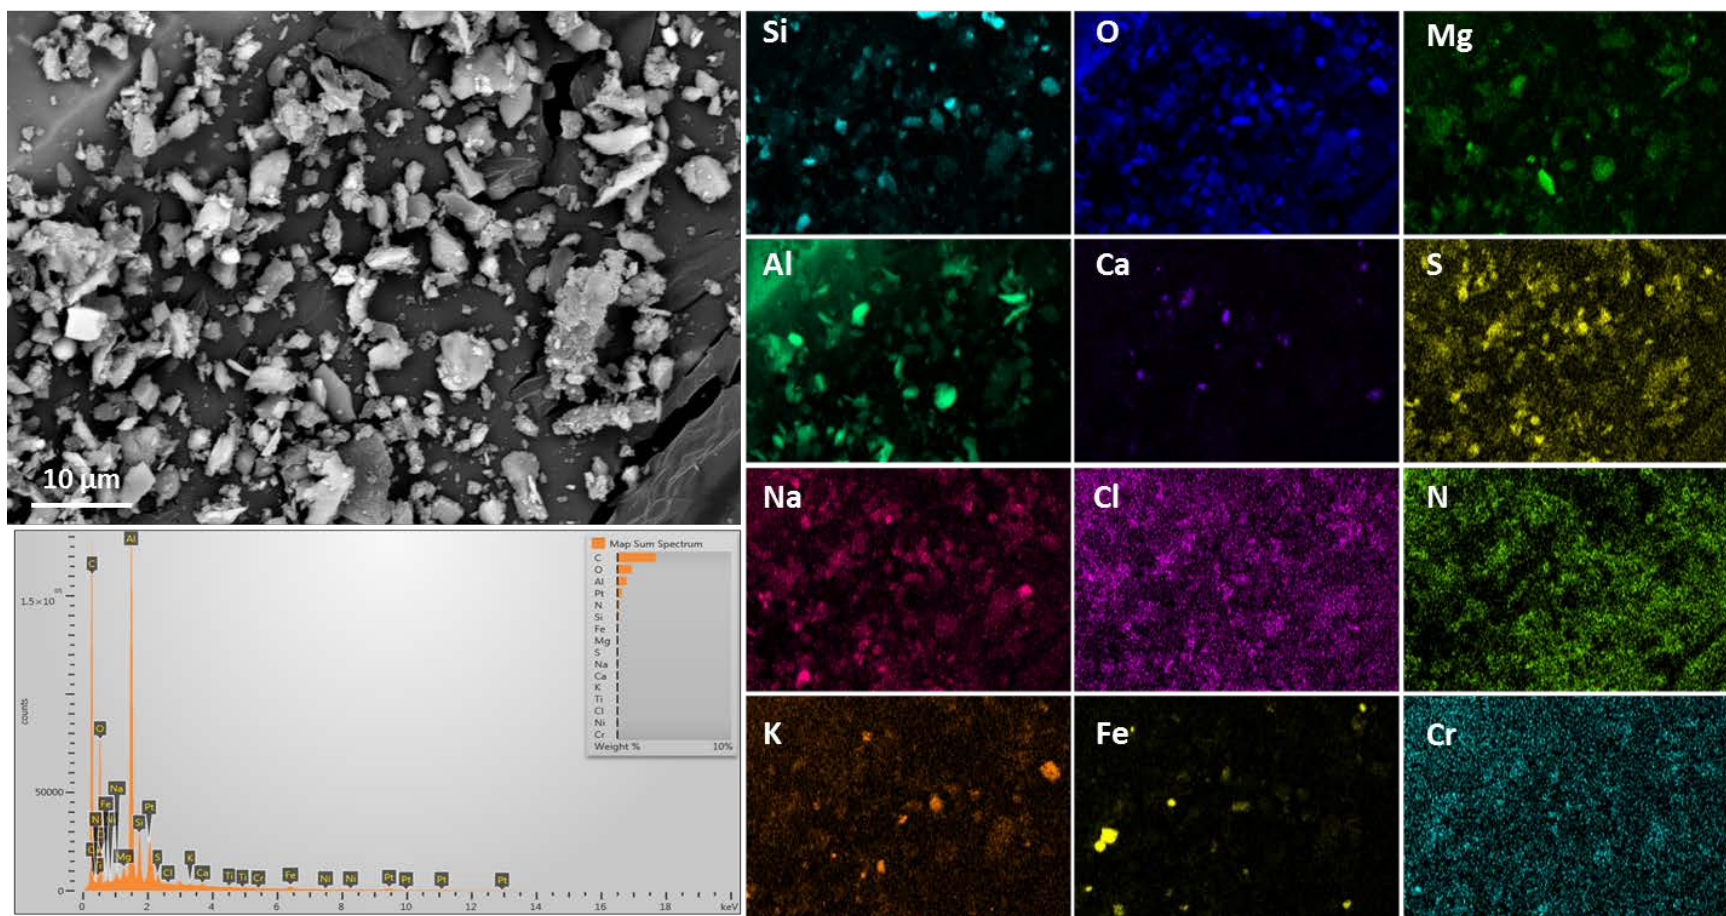
**Figure 20. SEM image/EDS map #2 of sample 387-013, collected from the center of the FME cover. Most grains are aluminosilicates, but SO<sub>4</sub> phases are abundant.**

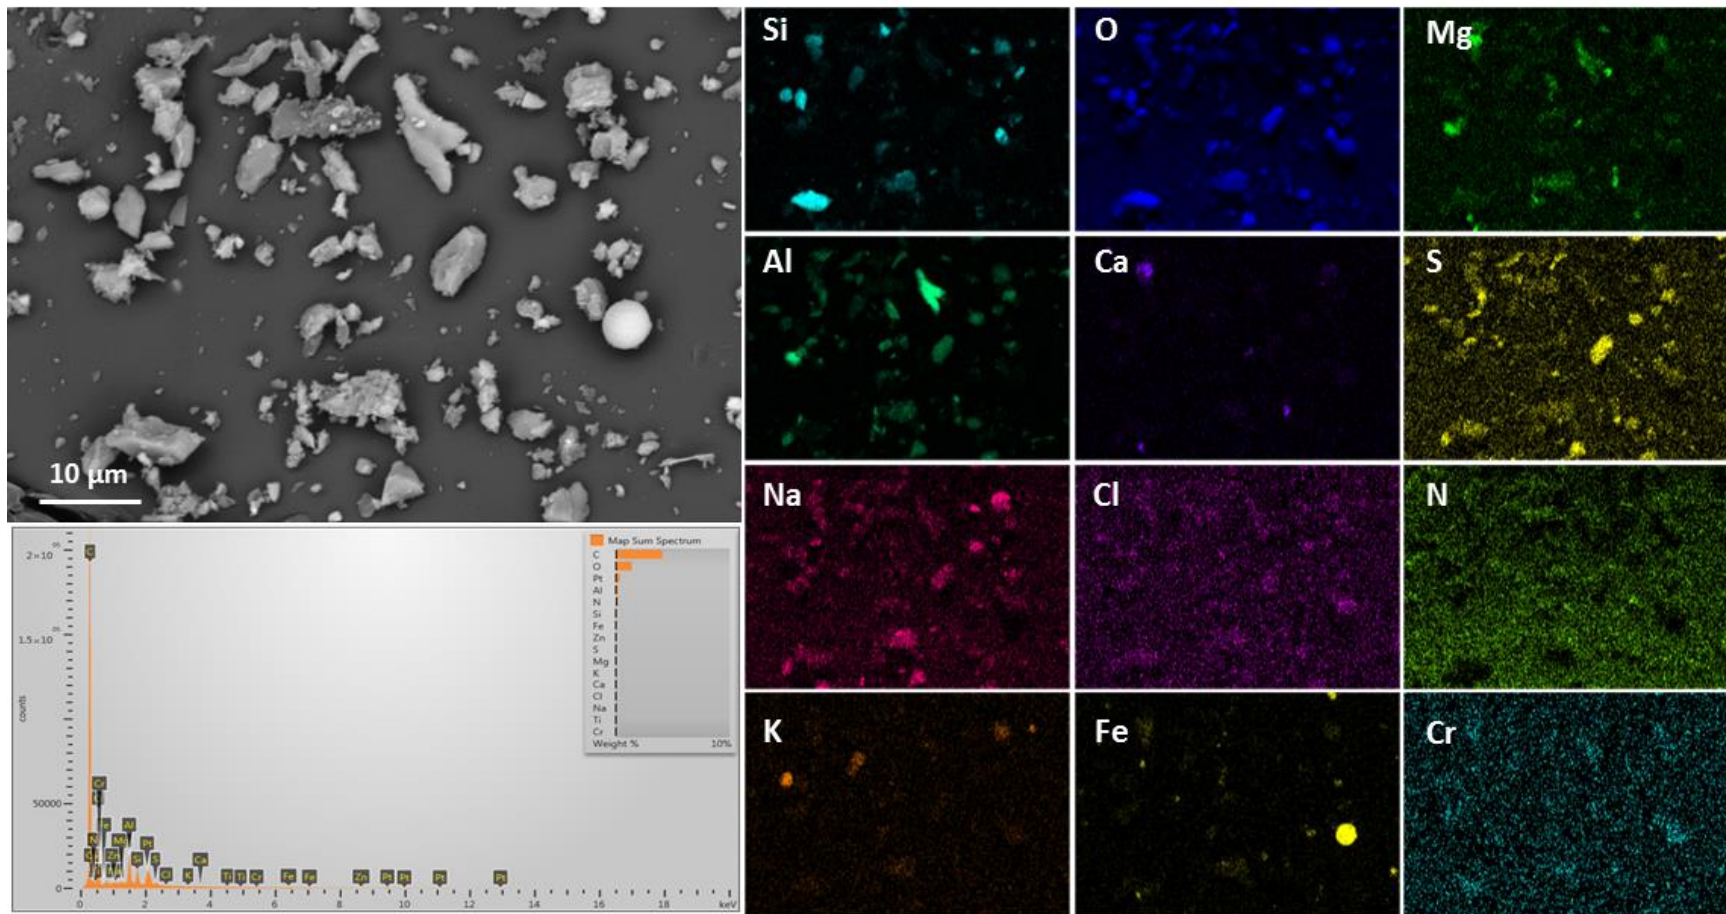
**Figure 21. SEM image/EDS map #2 of sample 389-015, collected 1 foot from the edge of the FME cover. Most grains are silicates/aluminosilicates, but note abundance of Na-Al-SO<sub>4</sub> grains, and single sphere of iron oxide.**

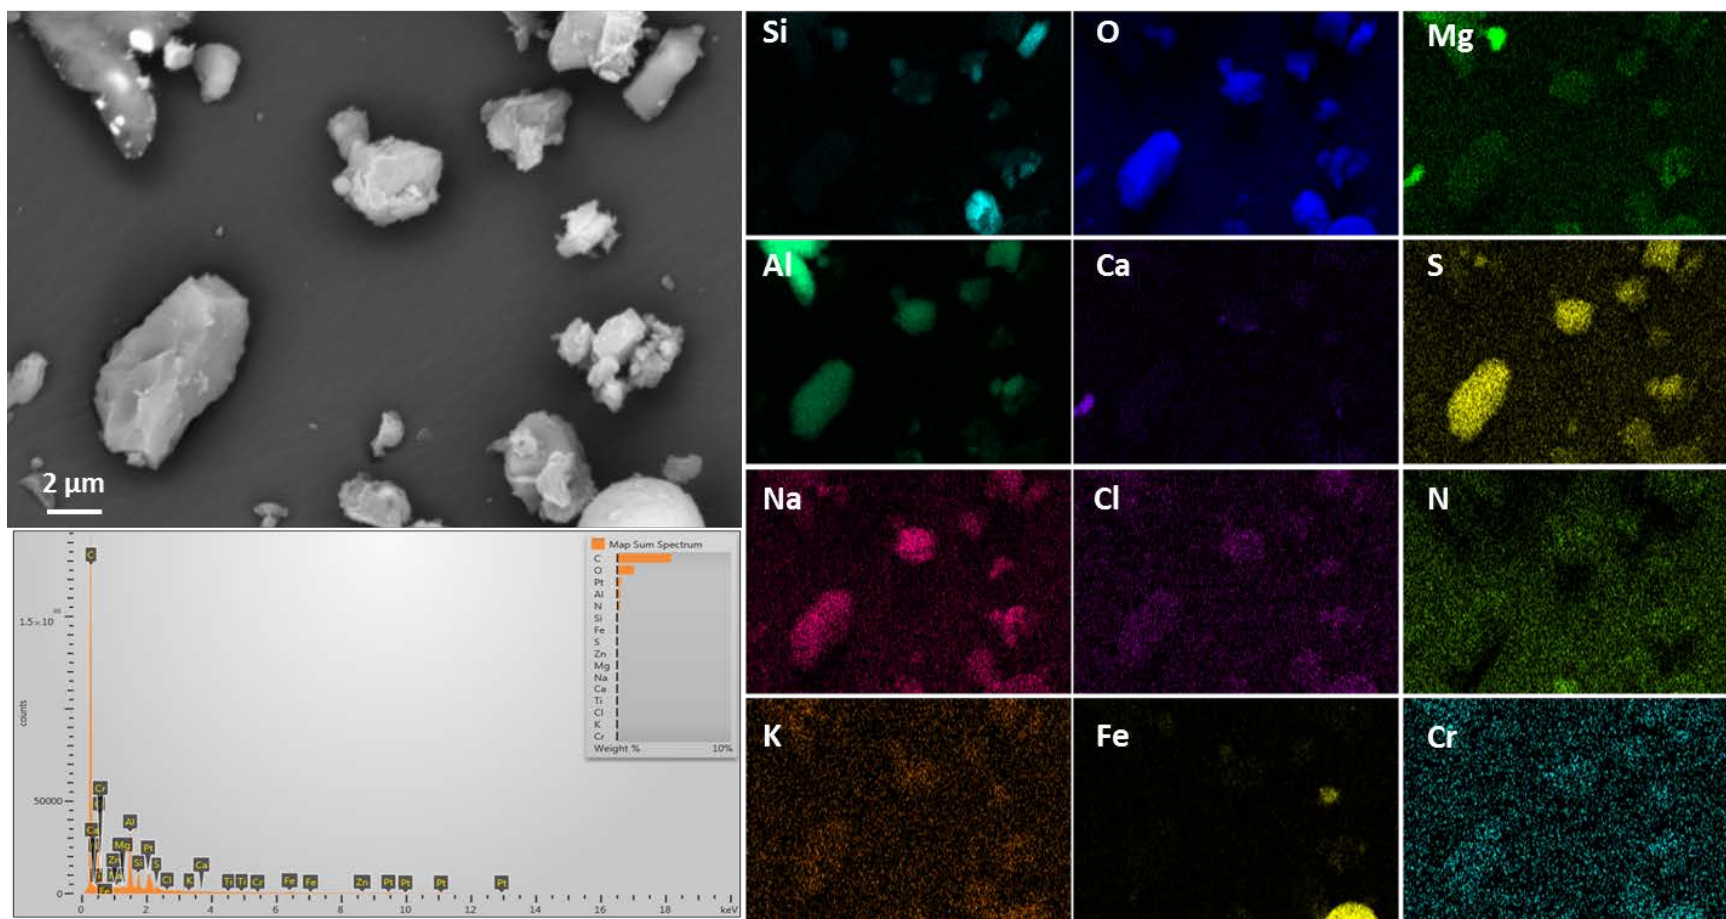
Figure 22. SEM image/EDS map #2 of sample 389-015, collected 1 foot from the edge of the FME cover. Magnified image of Na-Al-SO<sub>4</sub> phases in the upper right hand corner of Figure 21.

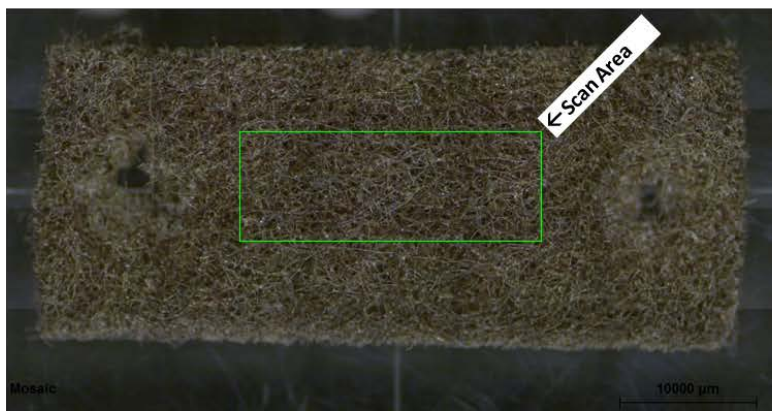
Figure 23. XRF pattern and XRF qualitative analysis results for pad 387-001.

Samples 387-001, 387-003, and 387-005 from the canister side had very similar patterns (Appendix B). The pattern for 387-001 is shown in Figure 23, and a blank-subtracted pattern in Figure 24. For each of these three samples, the pads are enriched in Fe, Cr, and Ni; this is consistent with the SEM observations that particles of stainless steel are the dominant contaminant on the side of the canister. Sample 387-009, also from the side of the canister, has a similar pattern, but with the addition of Ti and Zn (Appendix B). For this sample, white stenciled lettering was visible on Scotch-Brite™ pad surface; this paint has previously been shown to be TiO<sub>2</sub>, and explains the elevated Ti in the X-ray spectrum. The paint on the canister overpacks contains Zn, and flakes of paint may be the source of the zinc on this sample. Zinc-rich particles were also observed on the pad samples from the in-service canisters from Hope Creek (Bryan and Enos, 2014).

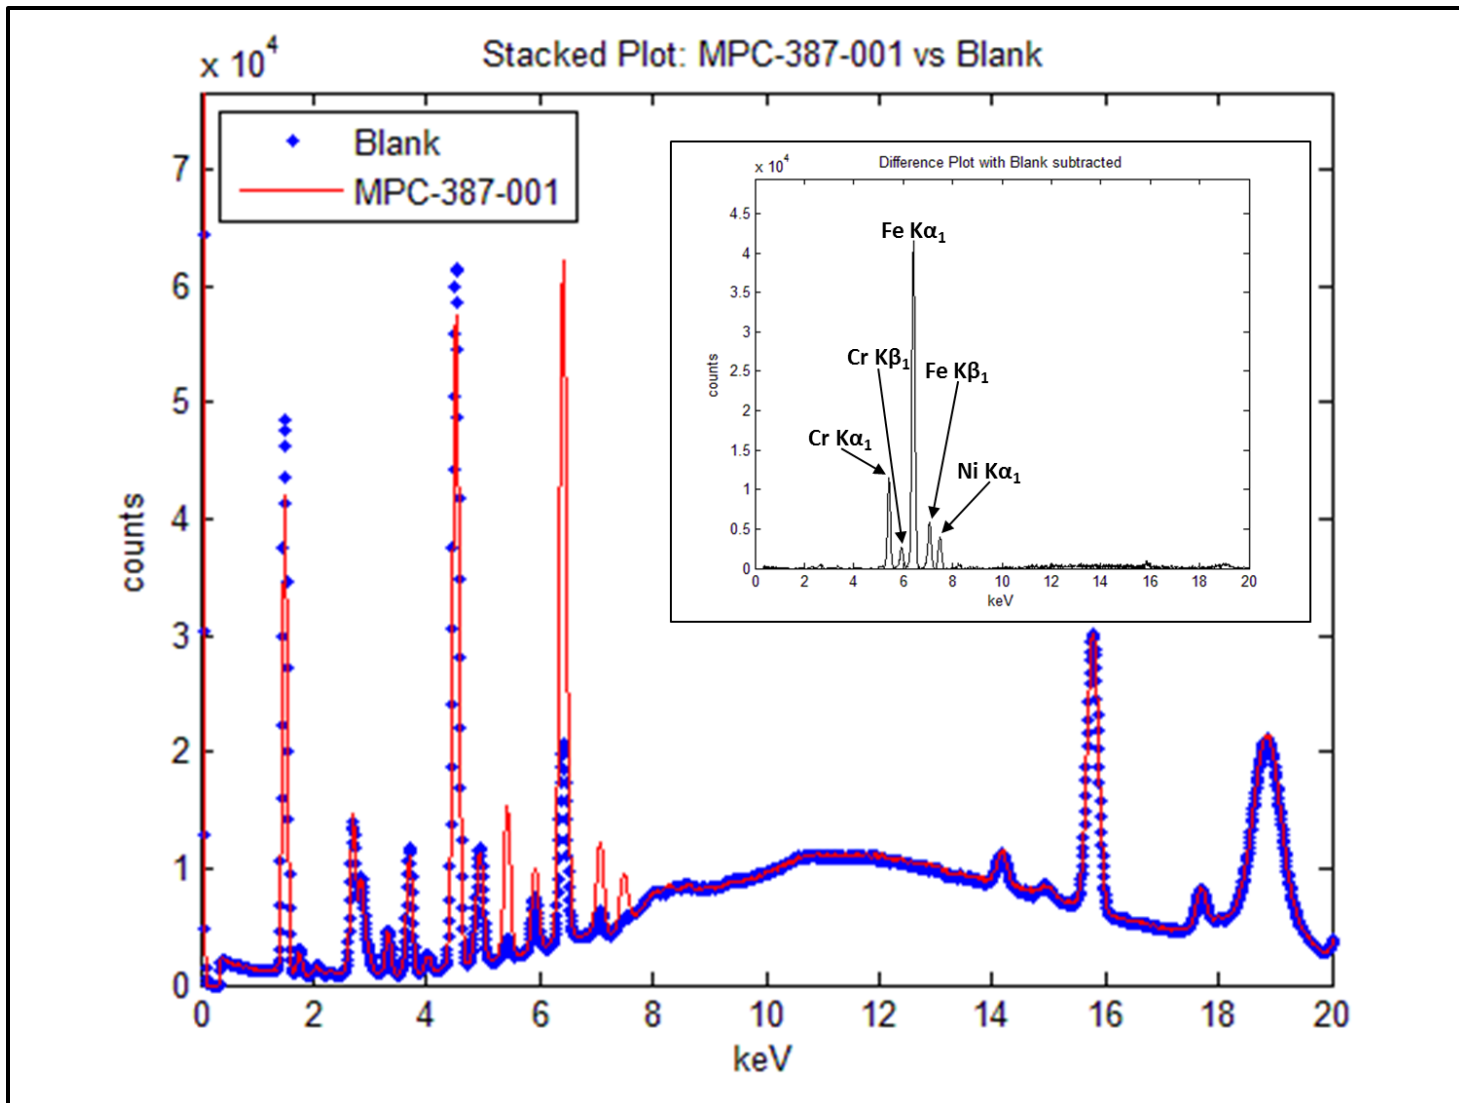
Figure 24. XRF pattern for 387-001 and the Blank pad. The inset shows the blank-subtracted pattern. Stainless steel components are enriched in the dust on the pad.

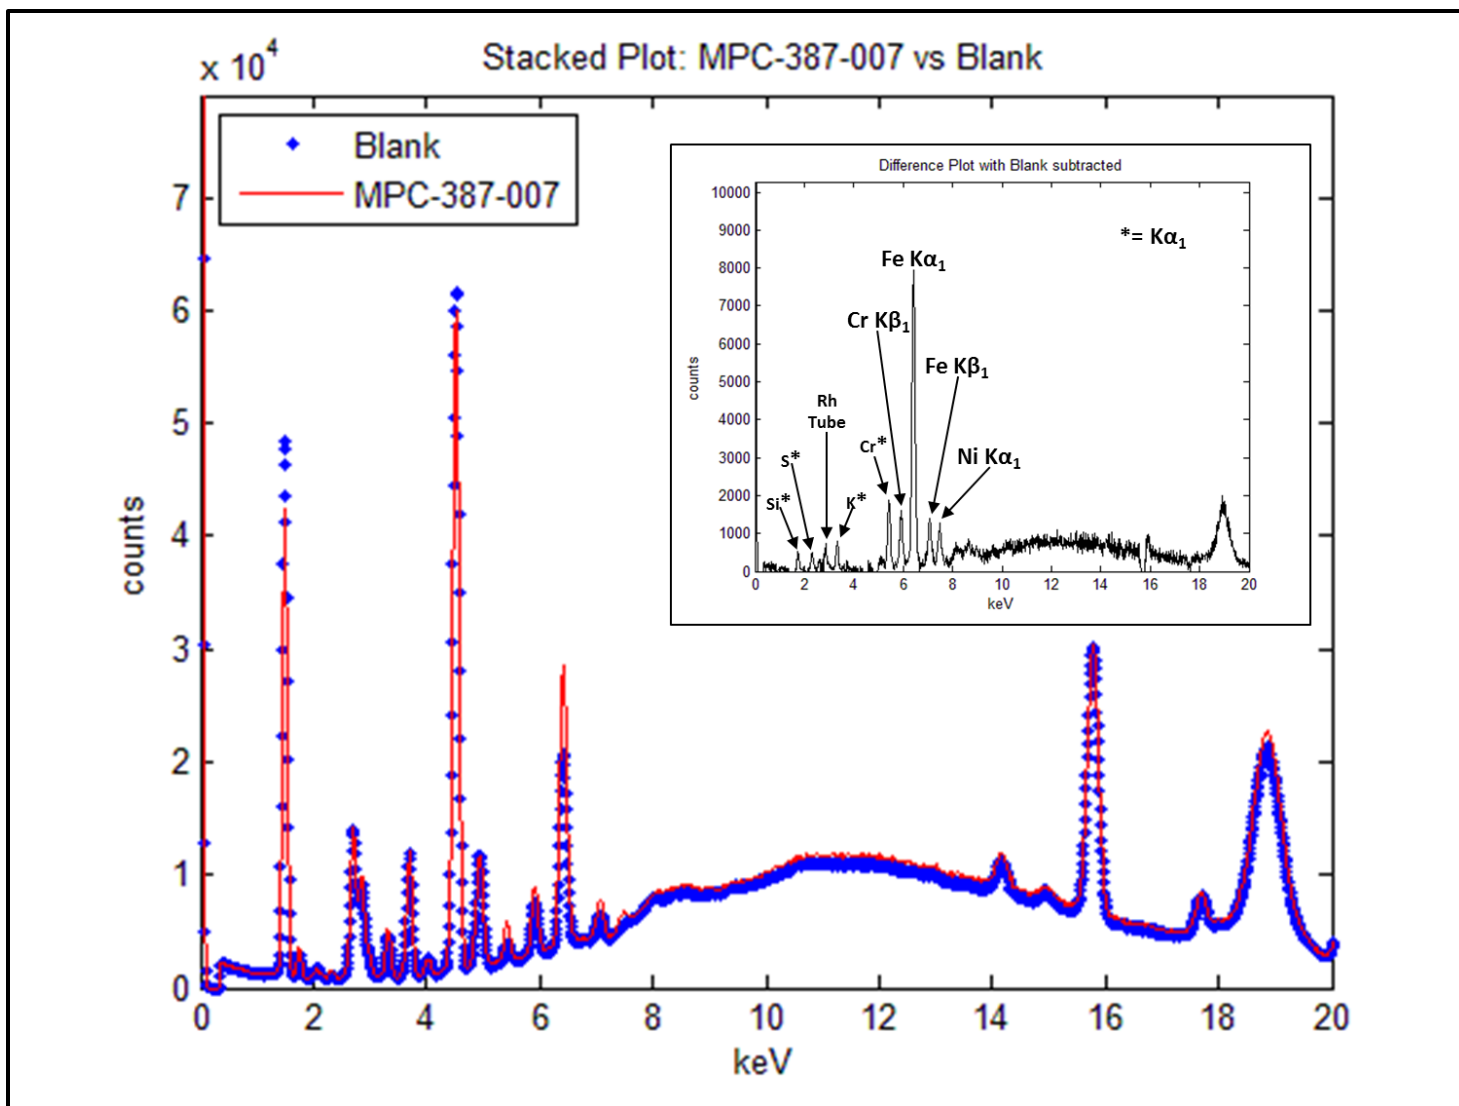
Figure 25. XRF pattern and XRF qualitative analysis results for Hope Creek sample 387-007, from the top of the canister. Relative to the blank, the pad is enriched in stainless steel components, with minor enrichments in S, K, and Si.

Sample 387-007, from the canister lid, displays a slightly different pattern. The sample is enriched in stainless steel components, but is also somewhat enriched in Si, S, and K (Figure 25). This suggests that environmentally-derived dusts, silicates and sulfates, are slightly enriched on the top of the canister relative to the sides, even though the FME cover was in place.

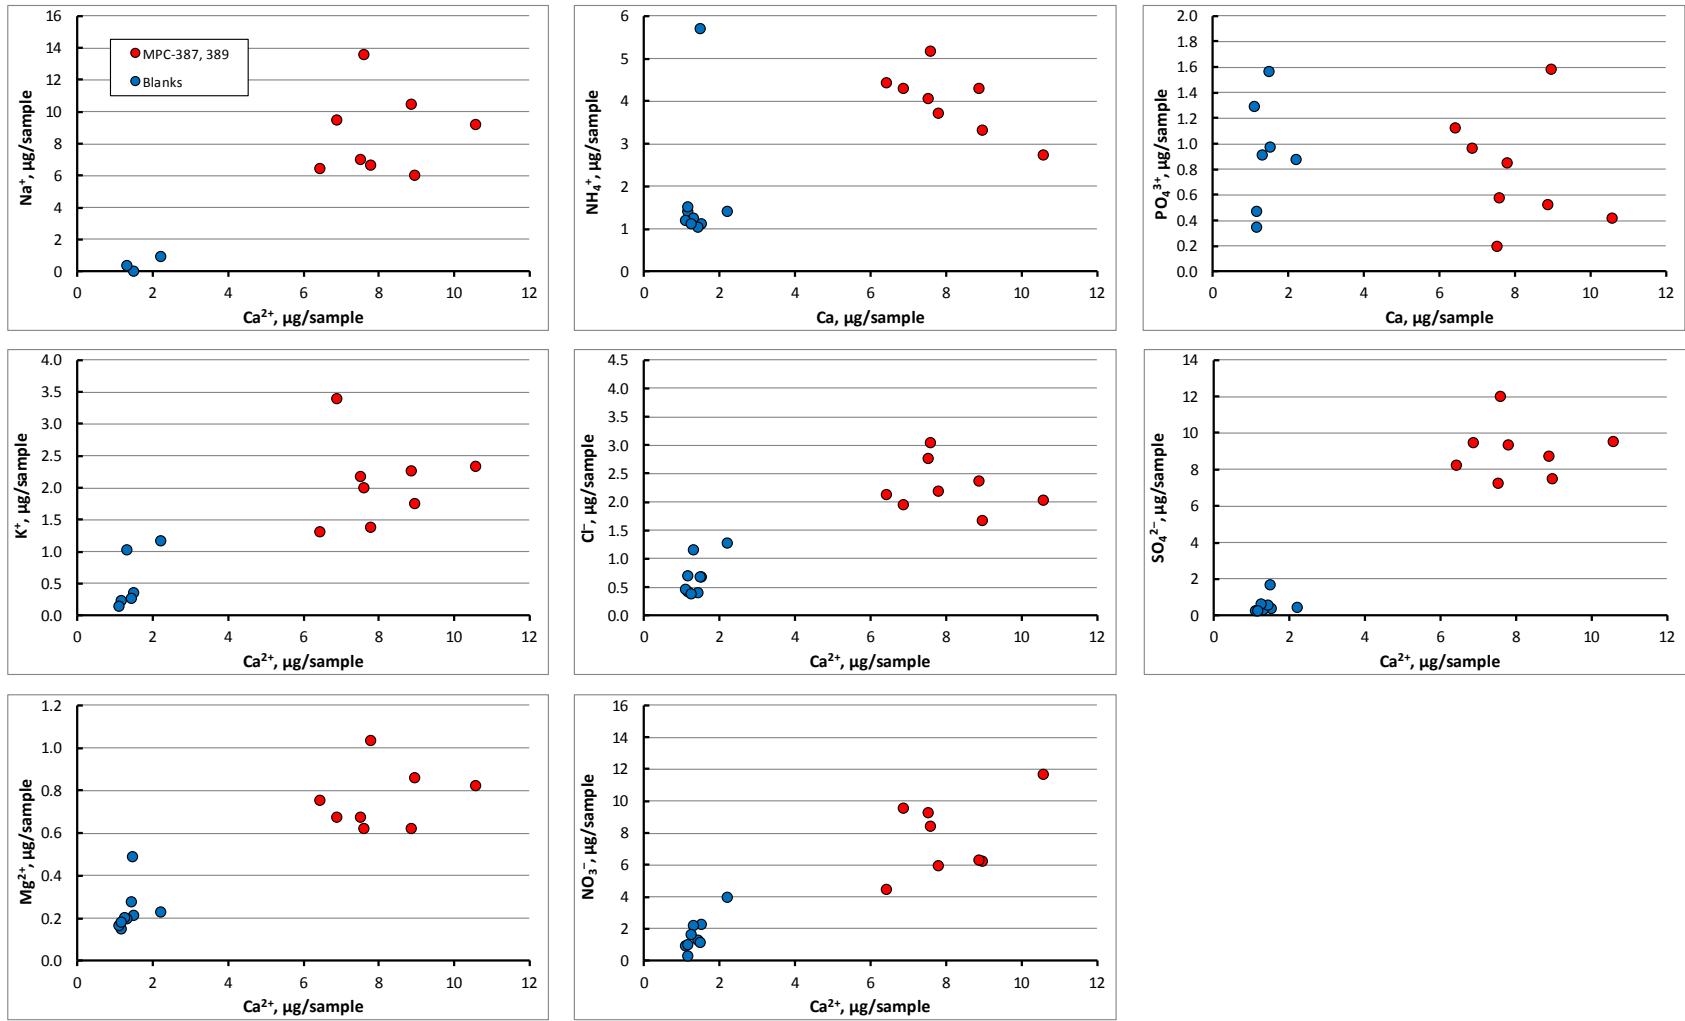
Figure 26. Plots of  $\text{Ca}^{2+}$  vs. other species in the unused canister and FME cover samples (MPC-387 and MPC-389) and the blanks.

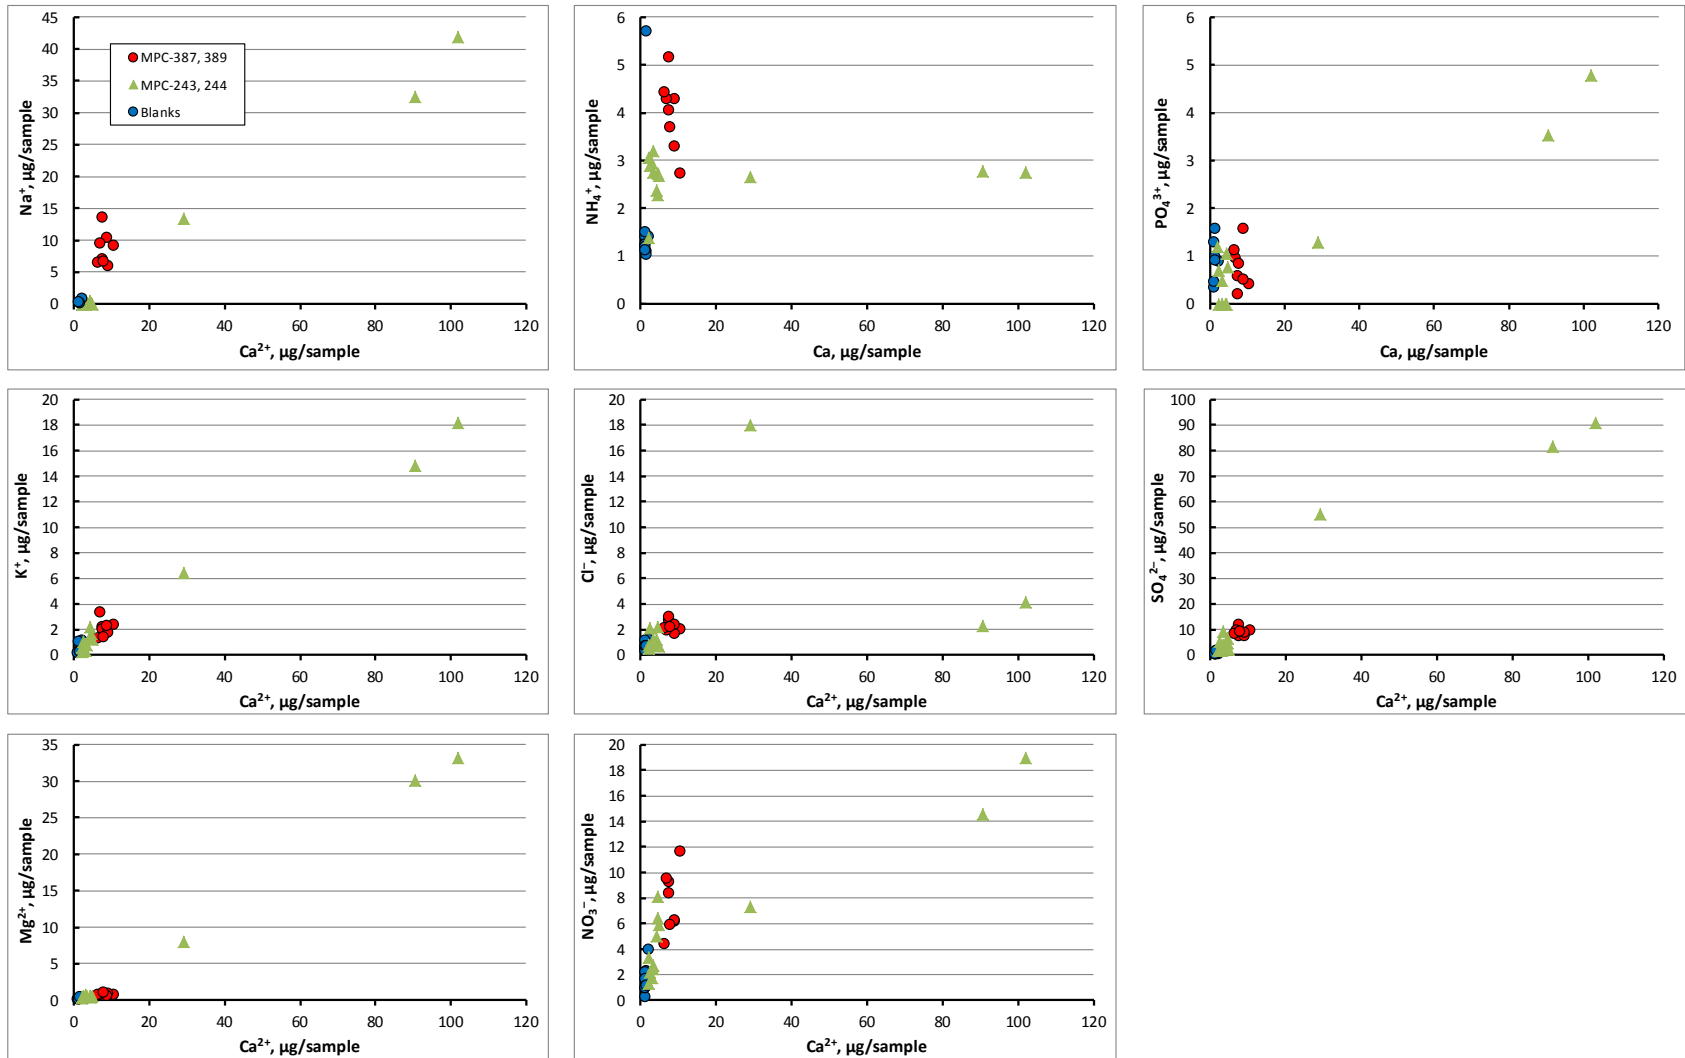
Figure 27. Plots of  $\text{Ca}^{2+}$  vs. other species in the unused canister and FME samples (MPC-387 and MPC-389), in-service canister samples (MPC-143 and MPC-144), and blanks. See Figure 30 for a blow-up of the lower range of the graphs.

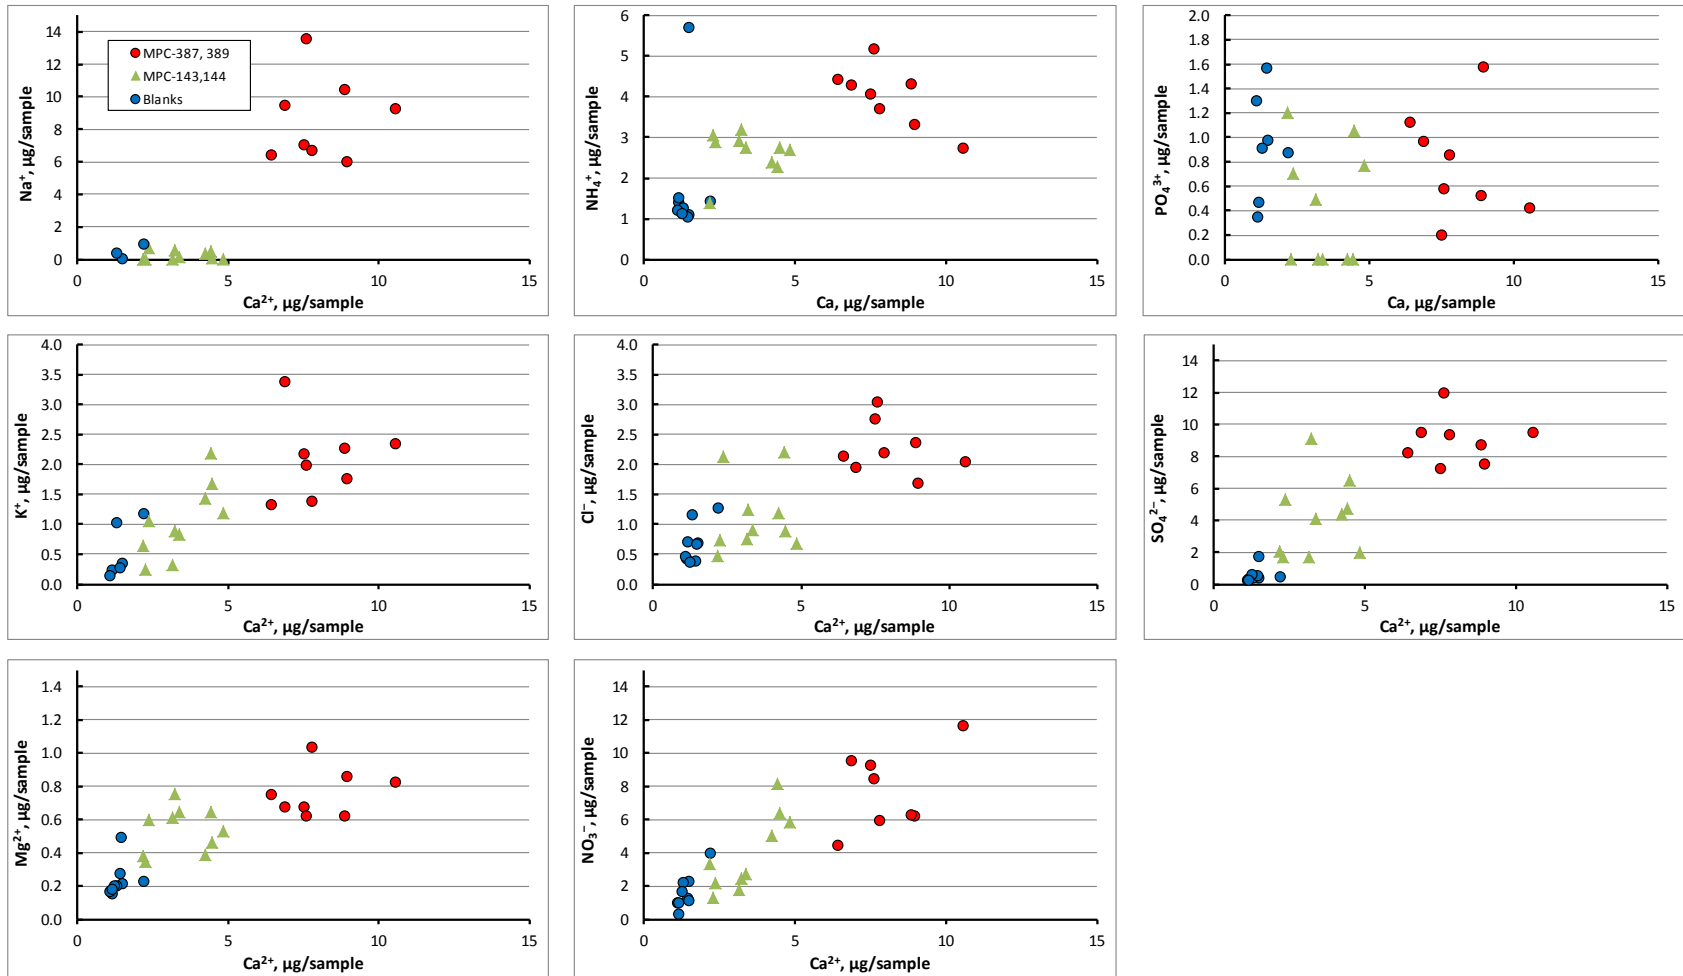
Figure 28. Plots of  $\text{Ca}^{2+}$  vs. other species in the unused canister and FME samples (MPC-387 and MPC-389), in-service canister samples (MPC-143 and MPC-144), and blanks. Graphs are expanded plots of the lower corners of graphs shown in Figure 27.

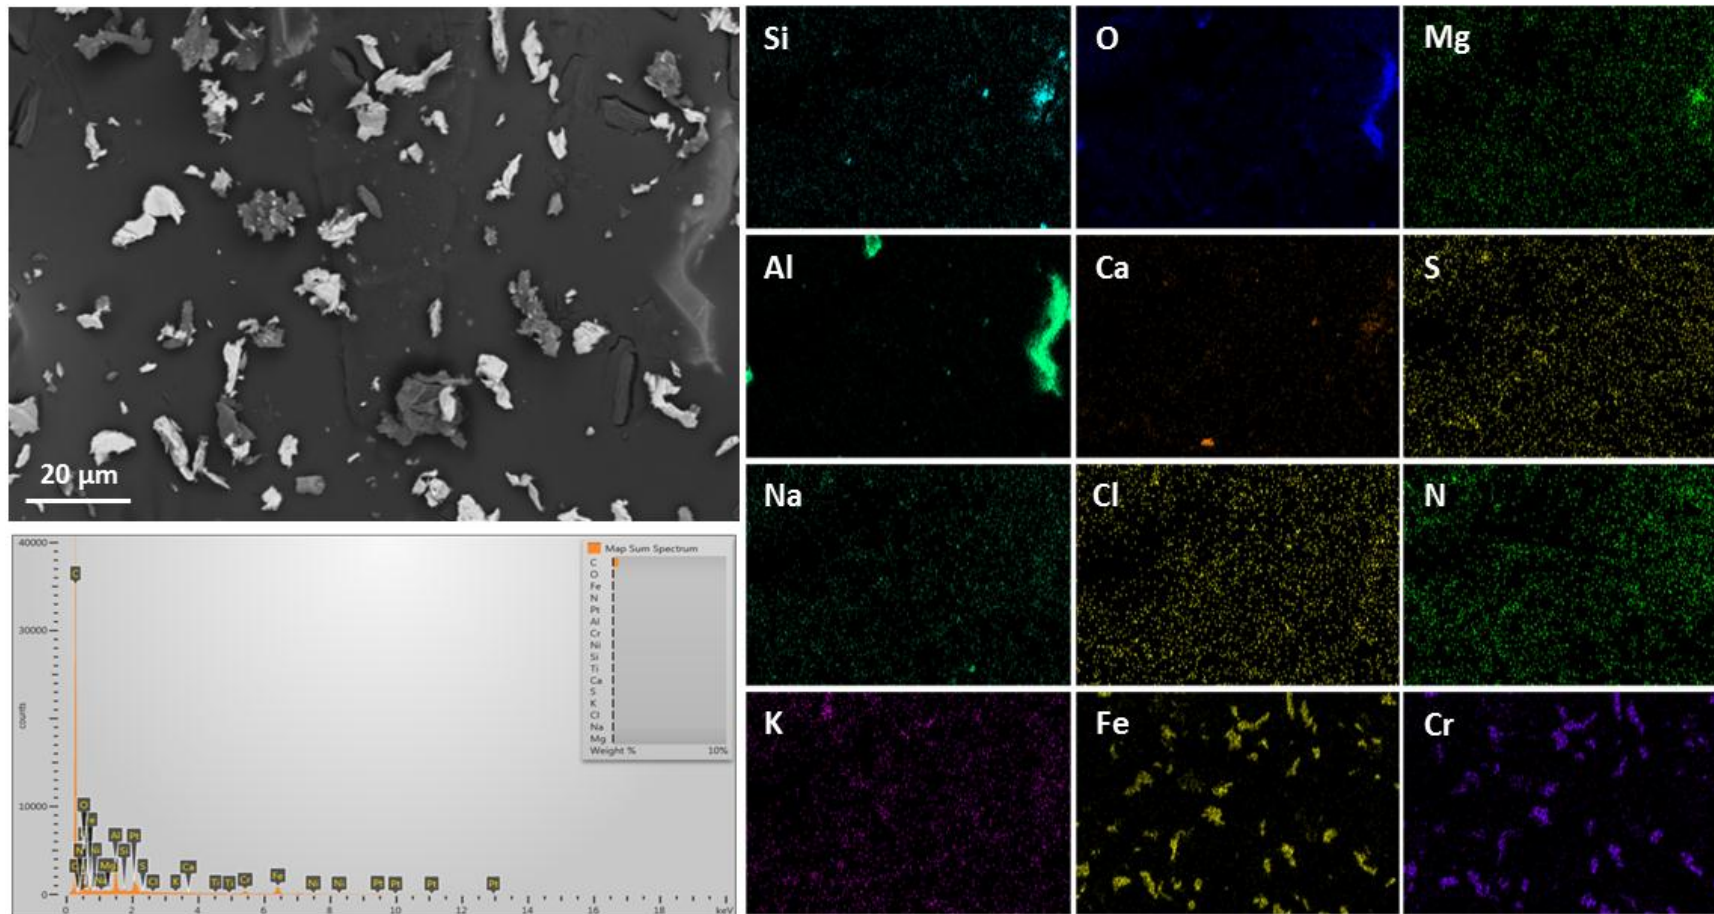
**Sample 387-001, collected from the canister side, 1 foot above the bottom edge**  
**Map B**

Notes: Almost all particles are stainless steel; a Ca-Mg-aluminosilicate grain is in the center of the image.

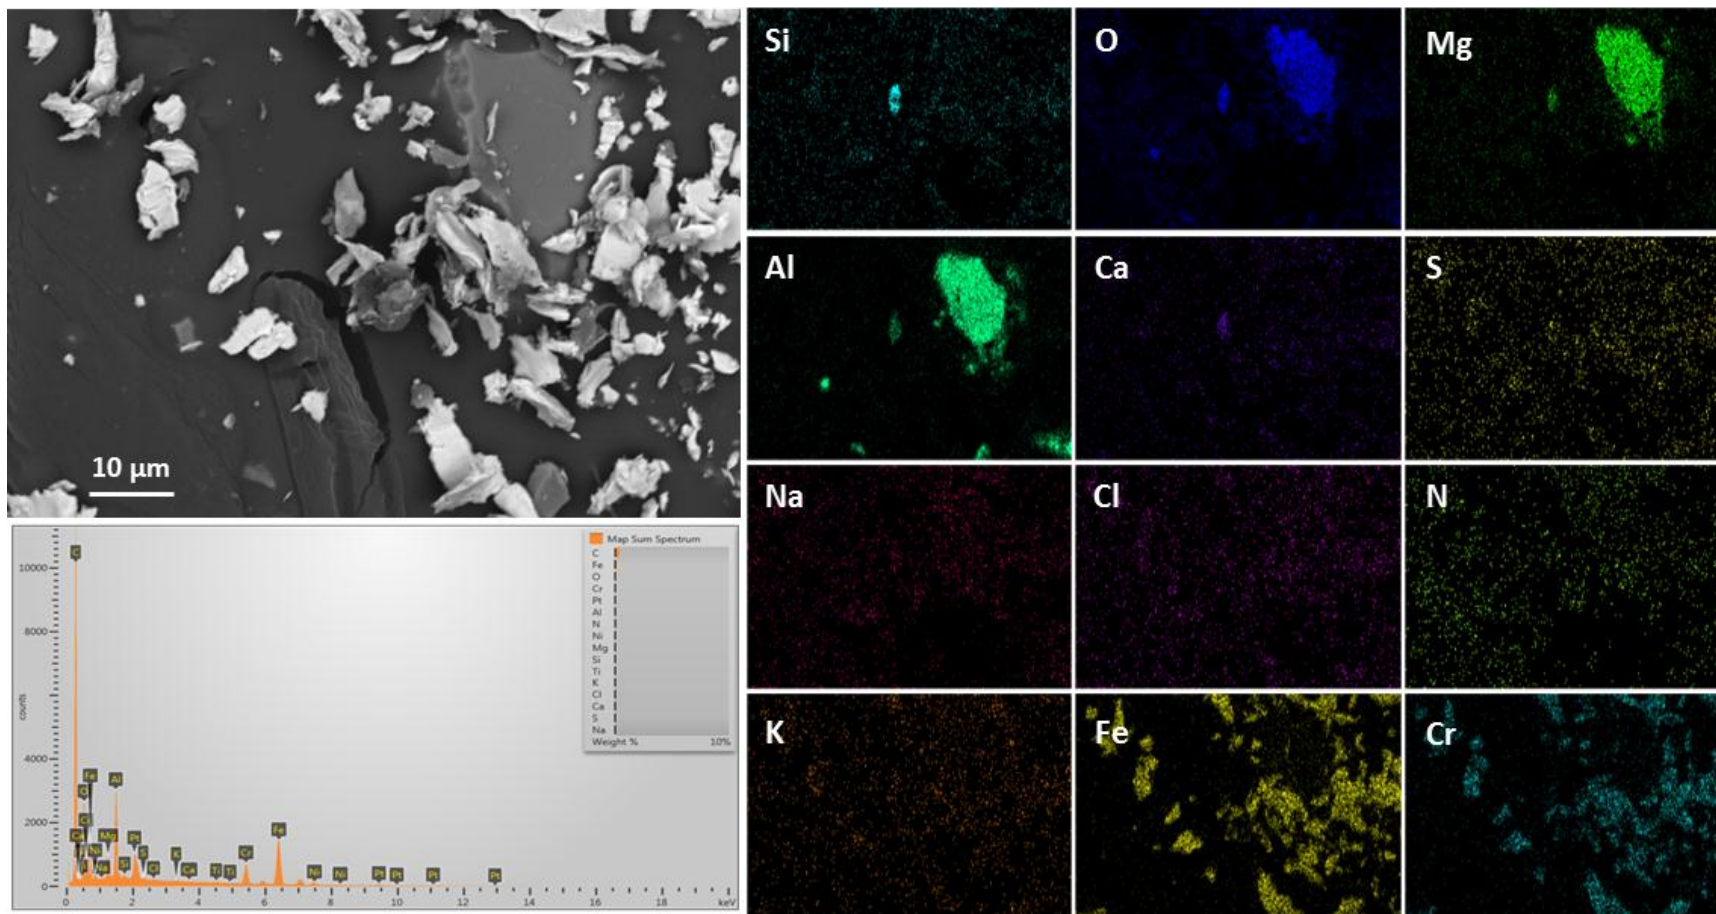
**Sample 387-001, collected from the canister side, 1 foot above the bottom edge**  
**Map C**

Notes: Most grains are stainless steel.
