SAND2015-1746

## Analysis of Dust Samples Collected from an Unused Spent Nuclear Fuel Interim Storage Container at Hope Creek, Delaware

Charles R. Bryan and David G. Enos

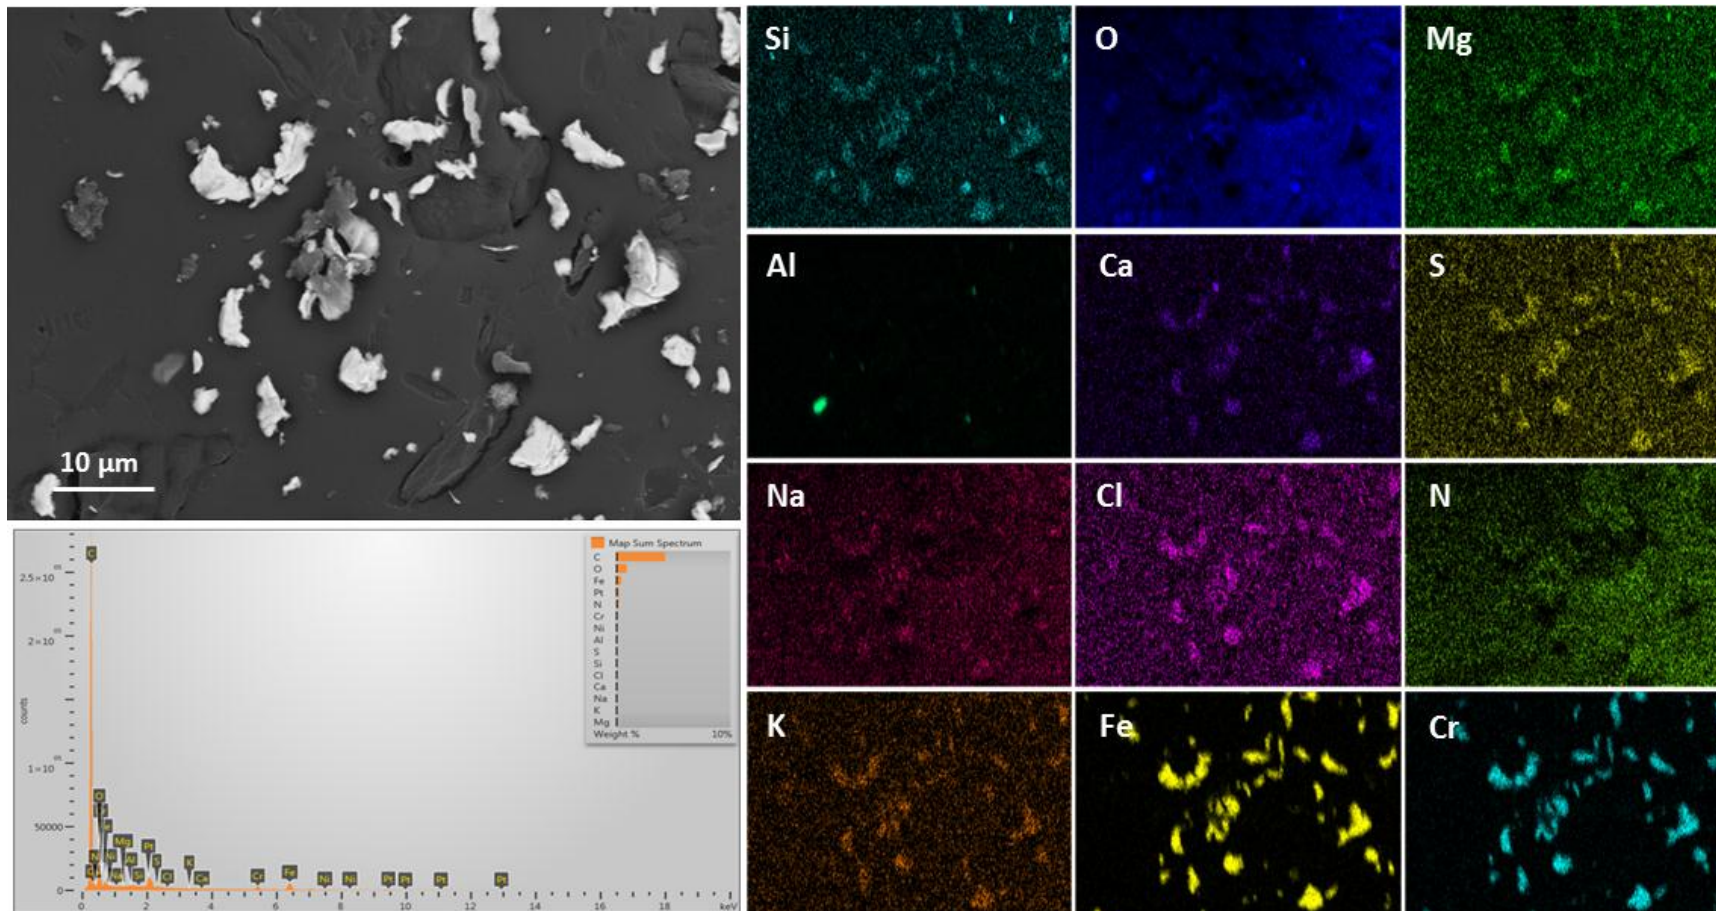
**Sample 387-001, collected from the canister side, 1 foot above the bottom edge**  
**Map D**

Notes: Most grains are stainless steel; a few small grains of K-Na-SO<sub>4</sub> are present.

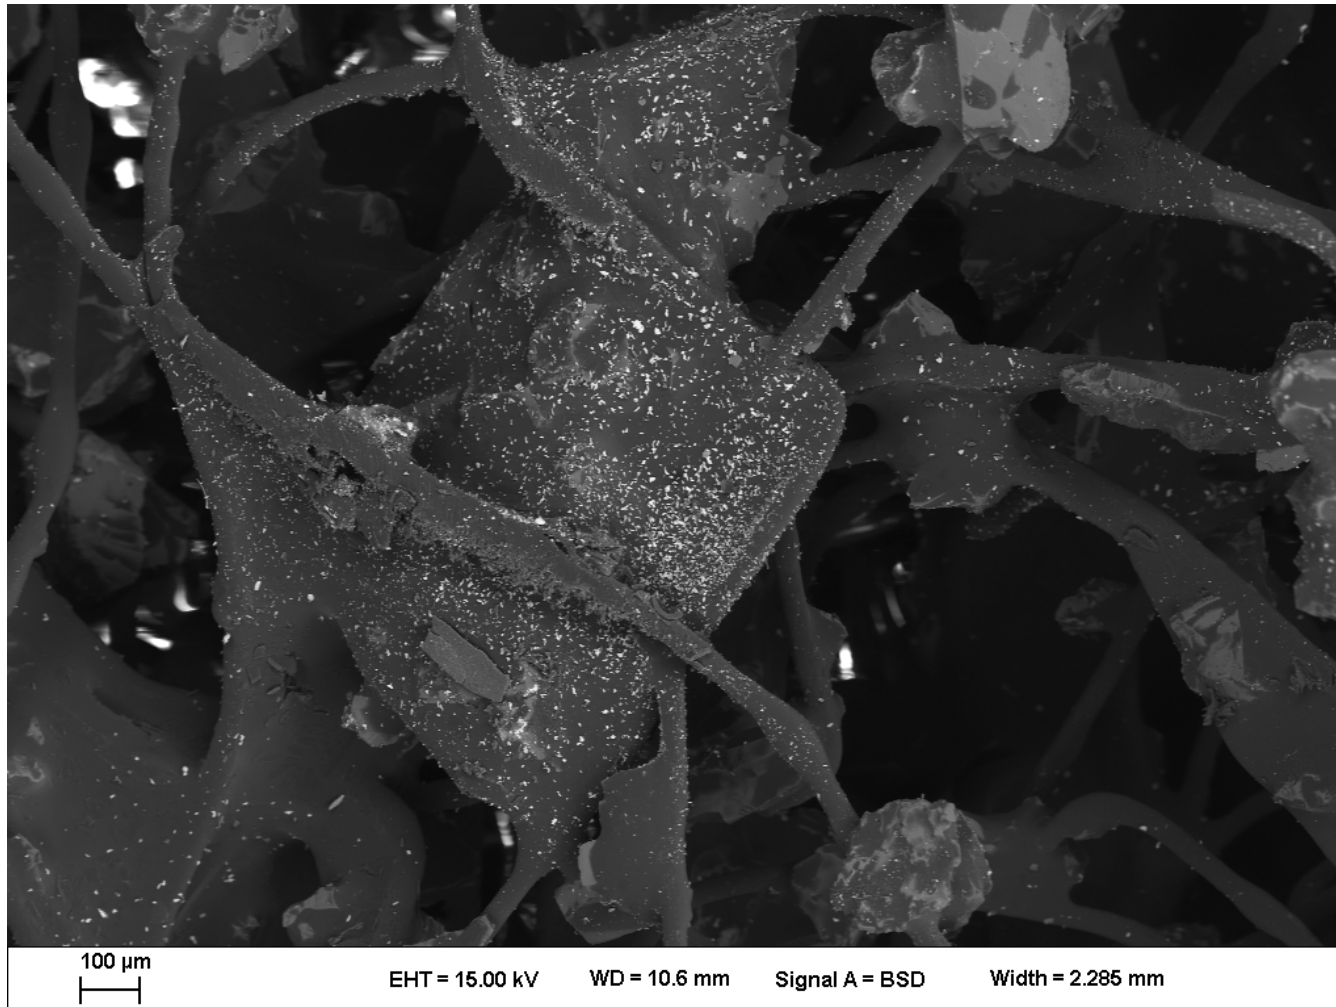
**Sample 387-003, collected from the canister side, 1 foot below the upper edge**  
**Map A**

Notes: Most particles are stainless steel. Note large Ca-Mg-CO<sub>3</sub> grain in the center of the image.

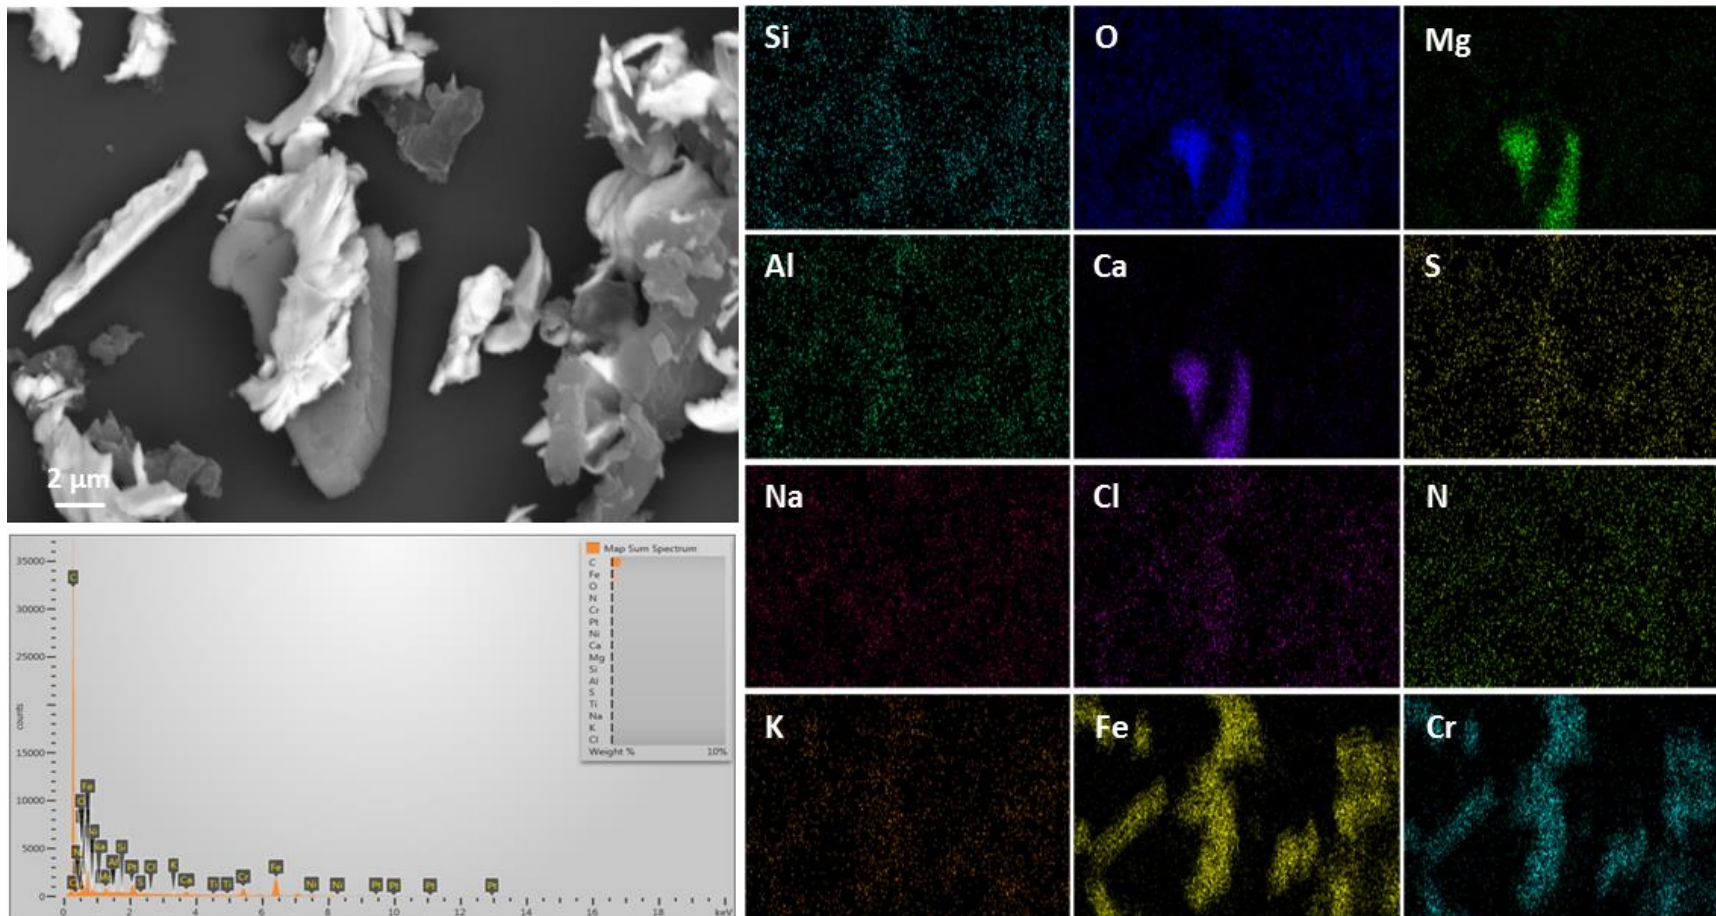
**Sample 387-003, collected from the canister side, 1 foot below the upper edge**  
**Map B**

Notes: Almost all grains are stainless steel.

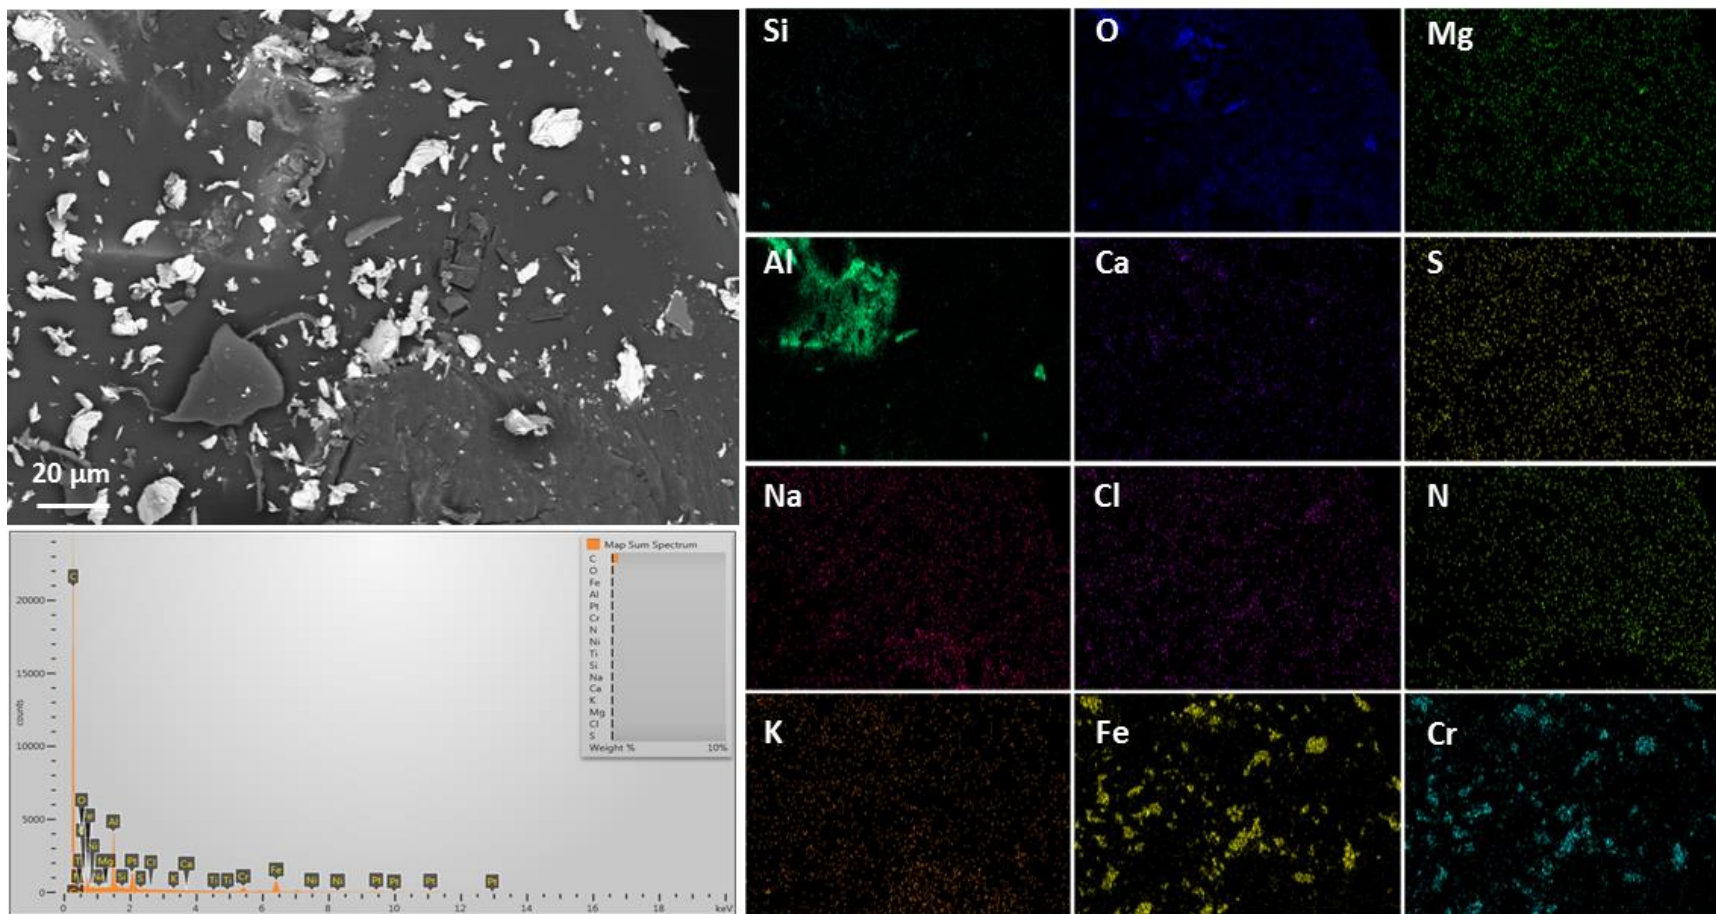
**Sample 387-003, collected from the canister side, 1 foot below the upper edge**  
**Map C**

Notes: Almost all grains are stainless steel. Note grain of silica (quartz) in the center of the image.

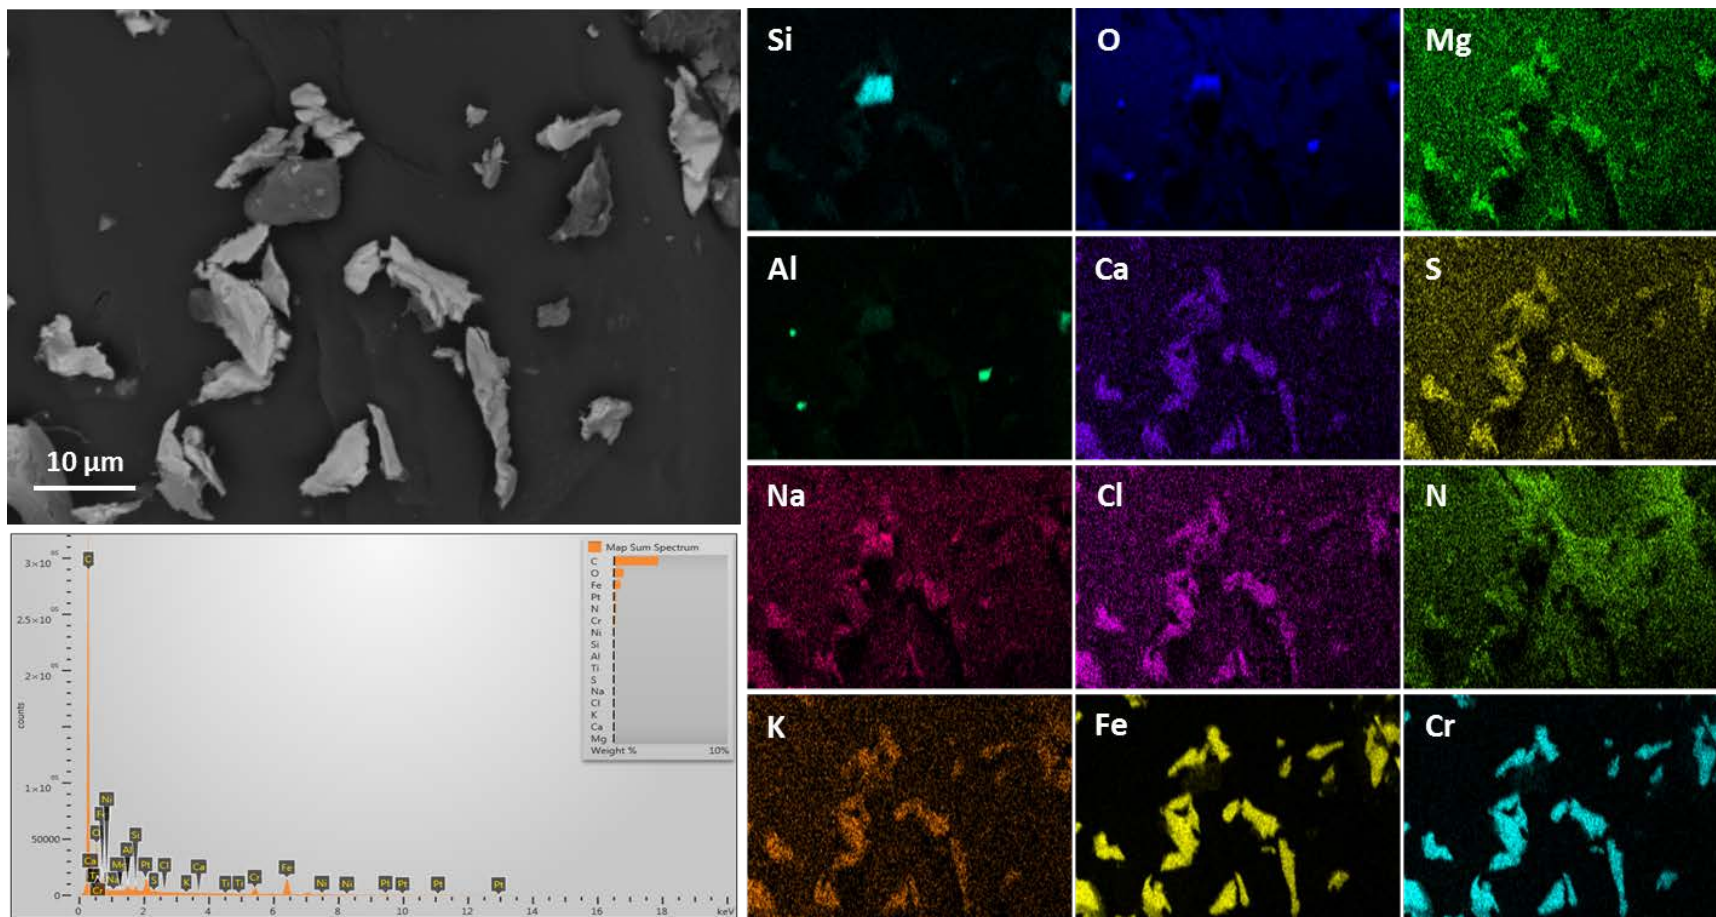
**Sample 387-003, collected from the canister side, 1 foot below the upper edge**  
**Map D**

Notes: Almost all grains are stainless steel. Note grain of silica (quartz) in the center of the image.

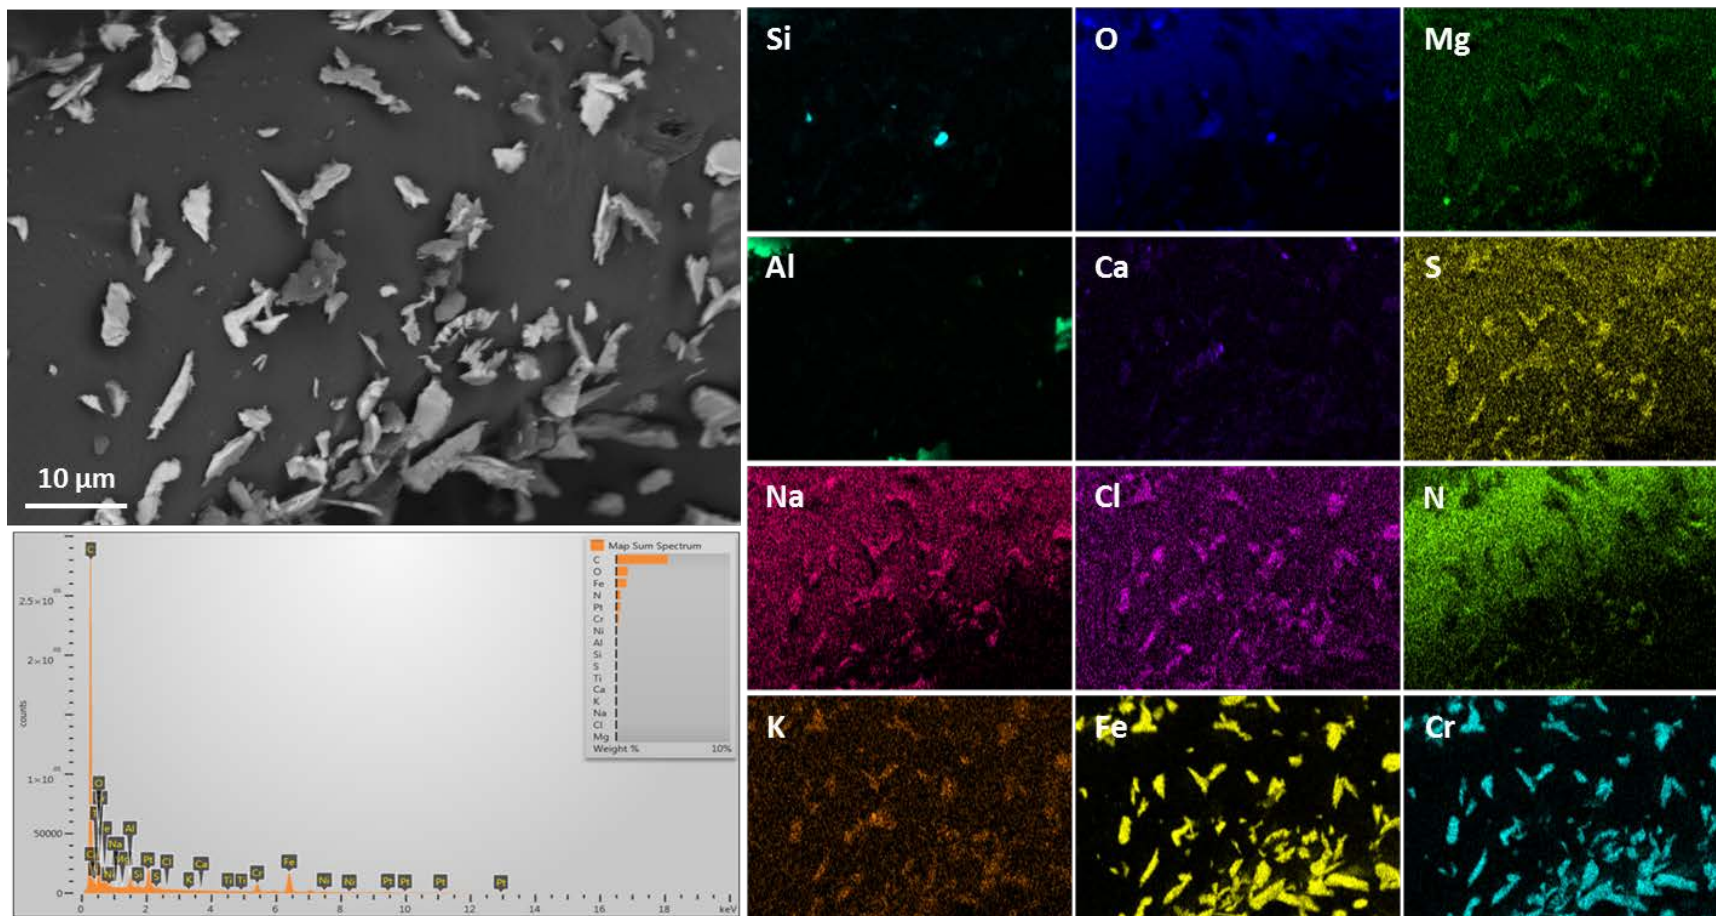
**Sample 387-003, collected from the canister side, 1 foot below the upper edge**  
**Map E**

Notes: Almost all grains are stainless steel. A few grains of Si-O (quartz) are present, and a single grain of Ca-Mg-CO<sub>3</sub>.

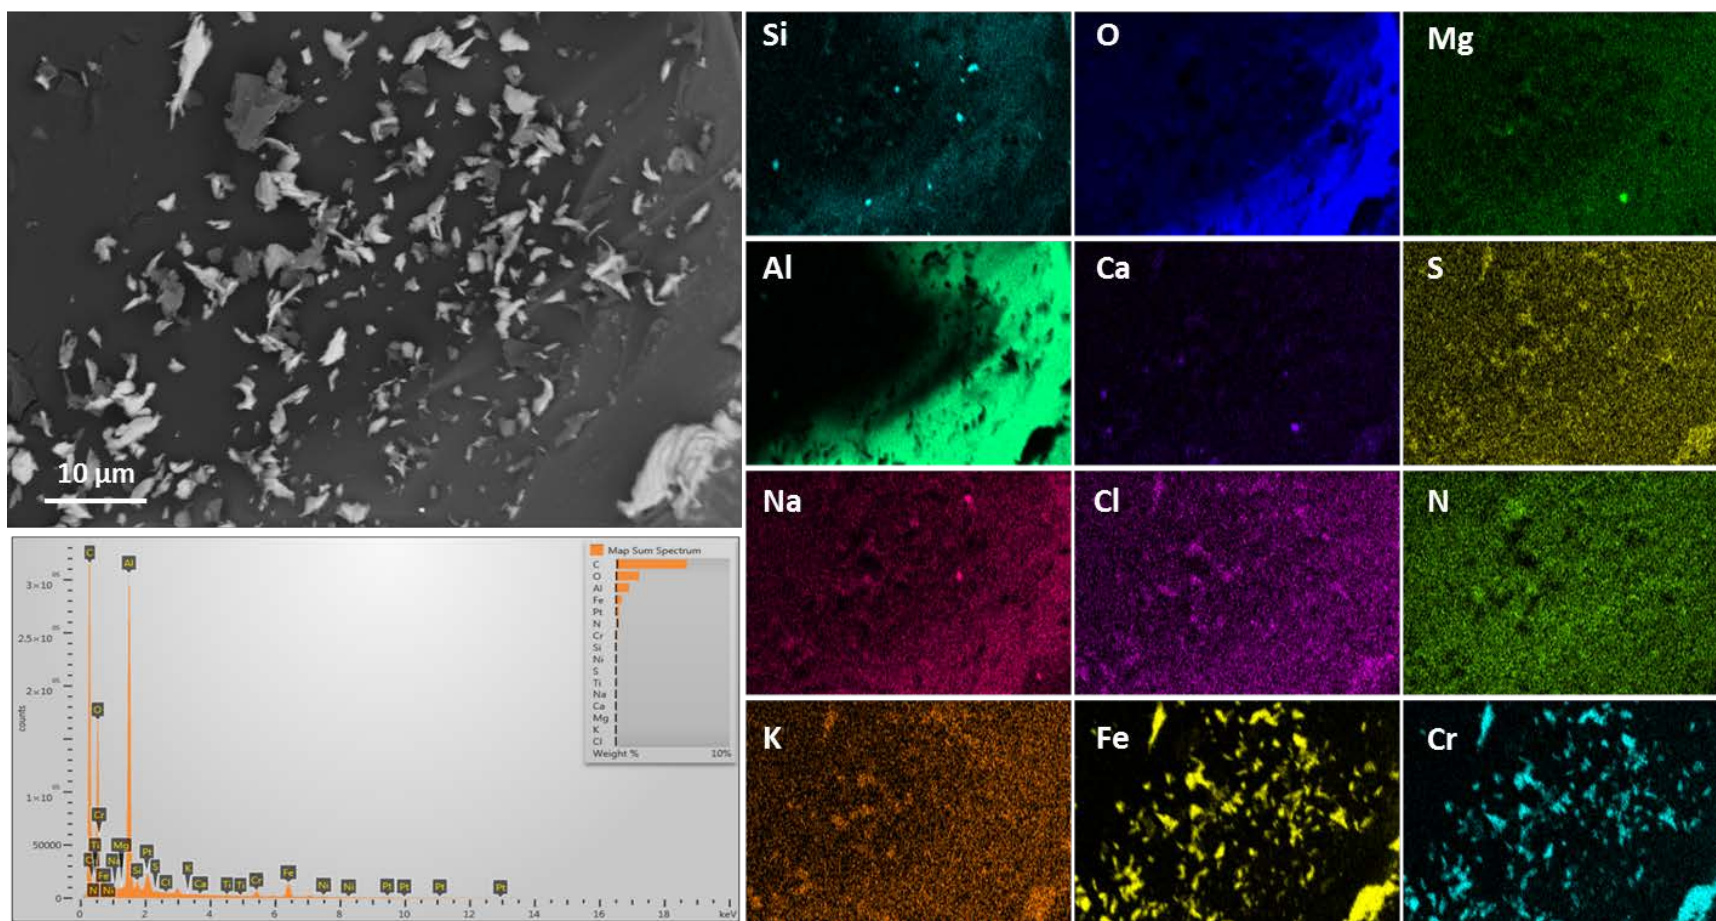
**Sample 387-003, collected from the canister side, 1 foot below the upper edge**  
**Map F**

Notes: Magnified view of Ca-Mg-CO<sub>3</sub> grain and stainless steel grains in Map E.

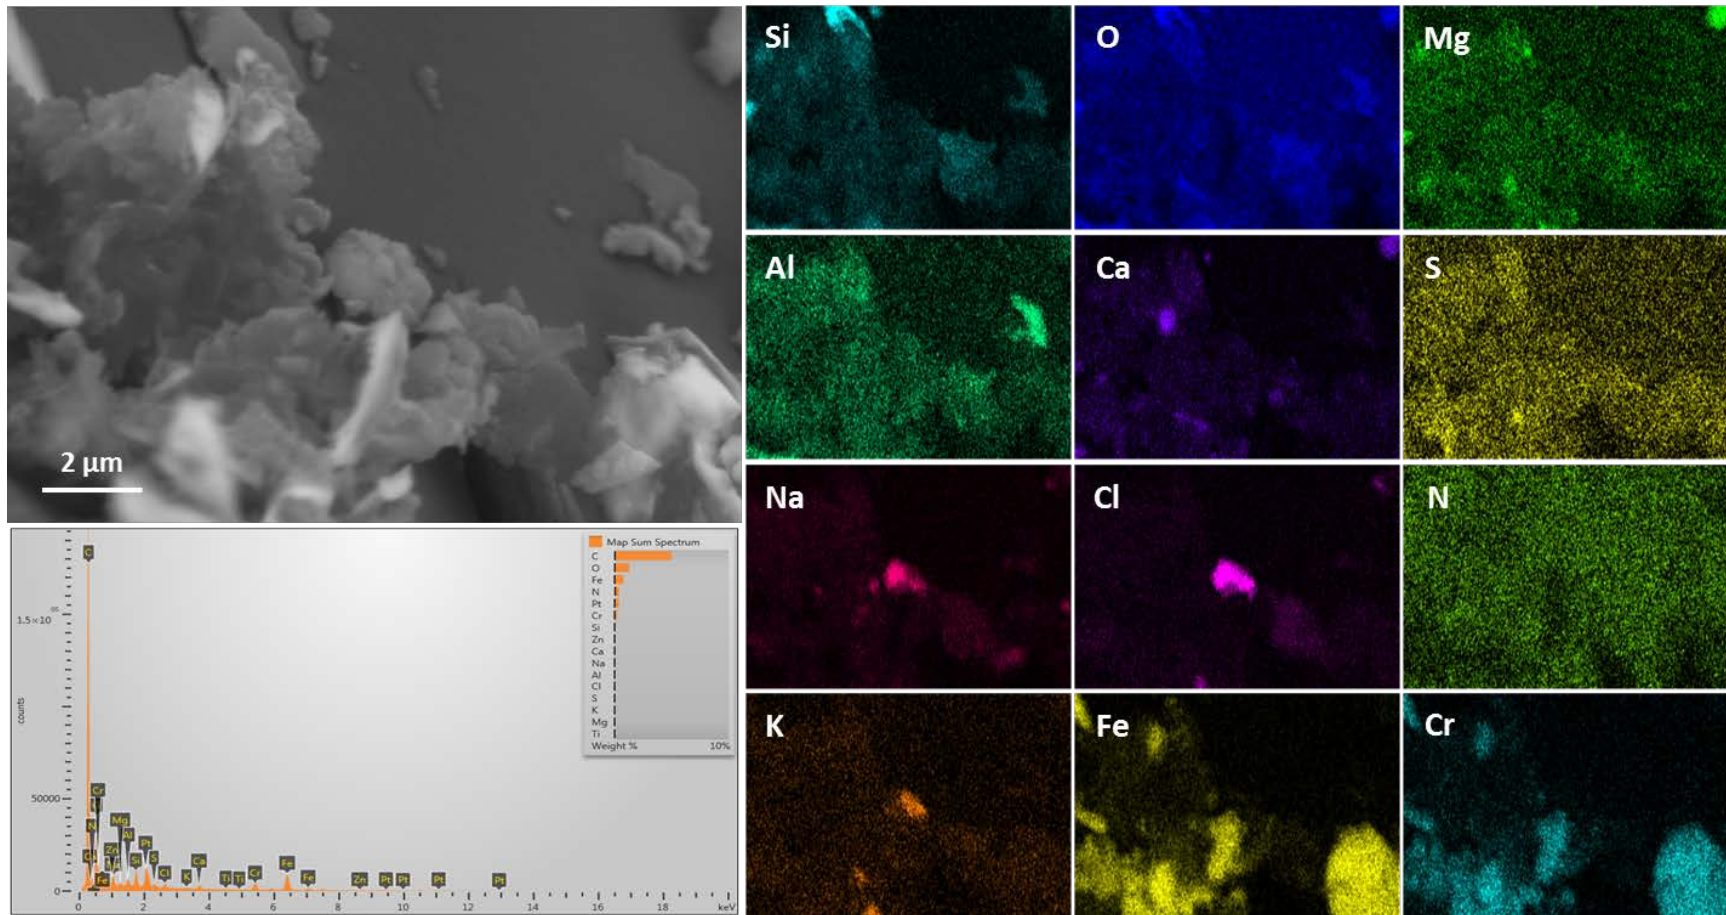
**Sample 387-005, collected from the canister top, 1 foot from the edge**  
**Map B**

Notes: Particles of stainless steel, Ca-Mg-CO<sub>3</sub>, and Ca silicate.

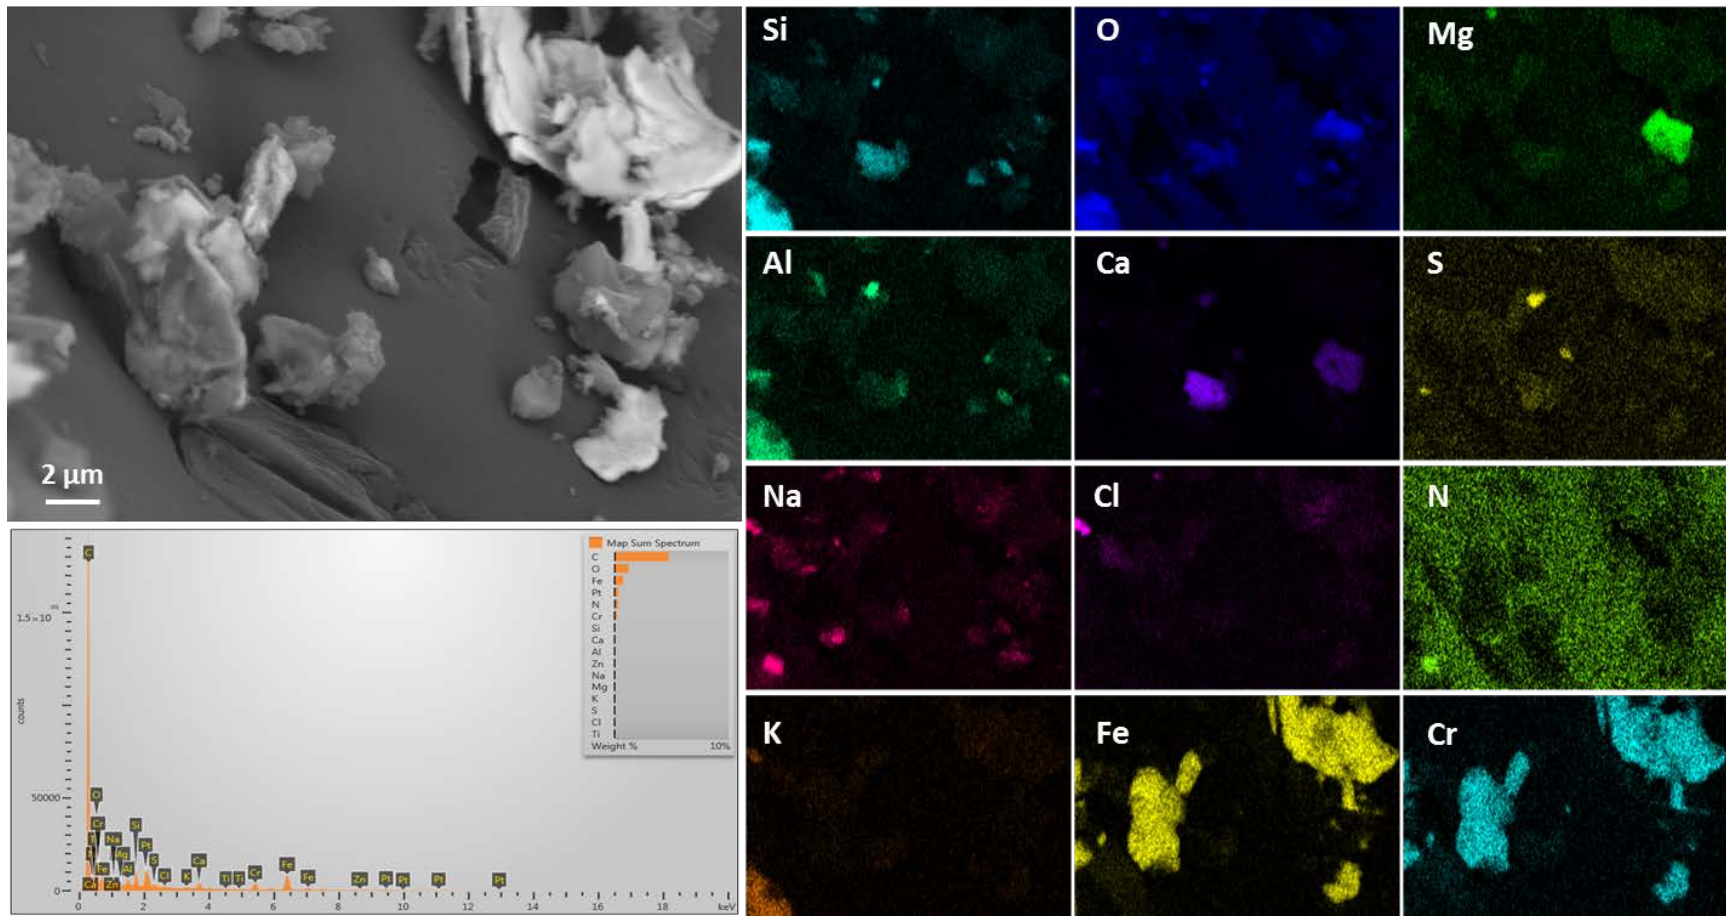
**Sample 387-005, collected from the canister top, 1 foot from the edge**  
**Map C**

Notes: Sparse dust on the pad. Note NaCl grain in the center of the image.

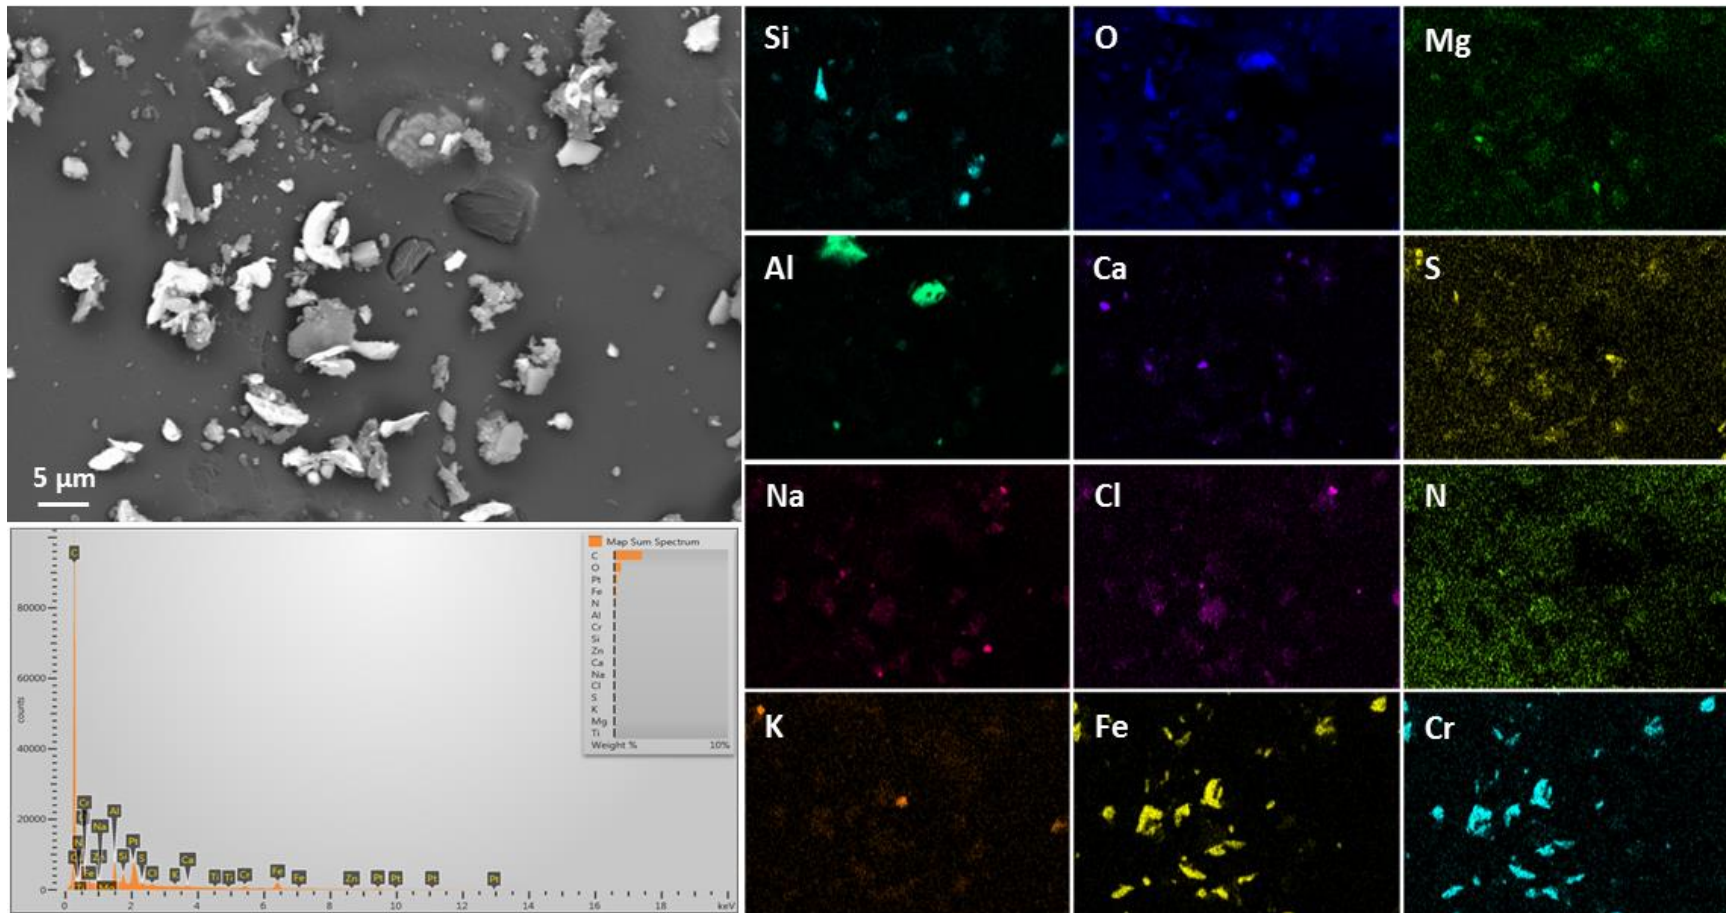
**Sample 387-005, collected from the canister top, 1 foot from the edge**  
**Map F**

Notes: Dust particles are stainless steel, quartz (Si-O), Ca-CO<sub>3</sub>, K-SO<sub>4</sub>, Ca-SO<sub>4</sub>.

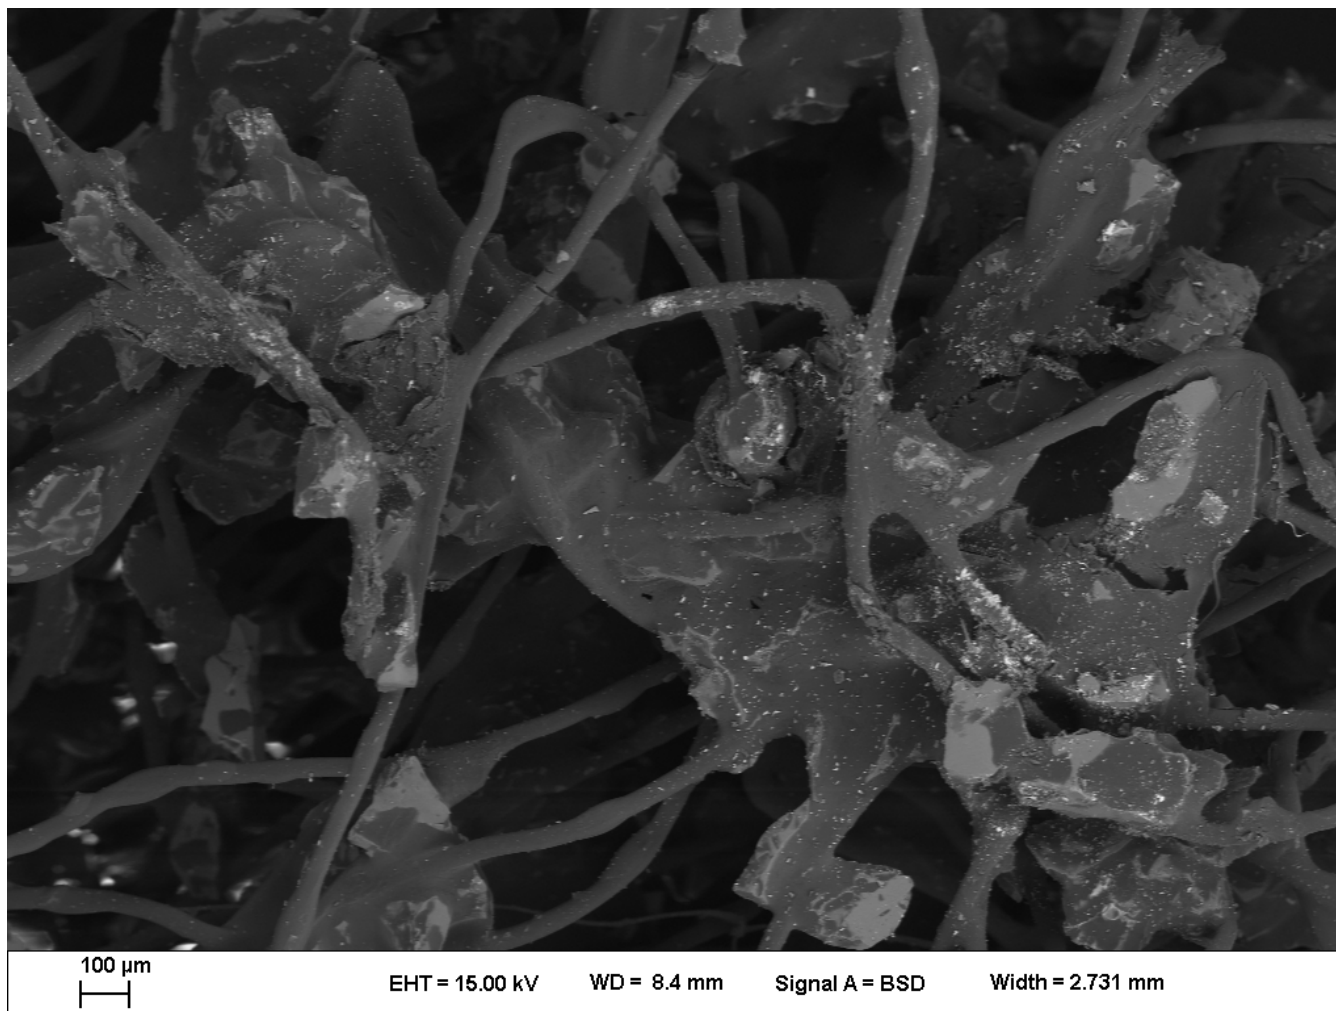
**Sample 387-007, collected from the center of the canister top**  
**Map A**

Notes: Sparse dust particles are stainless steel and a large composite grain of aluminosilicates and salts.

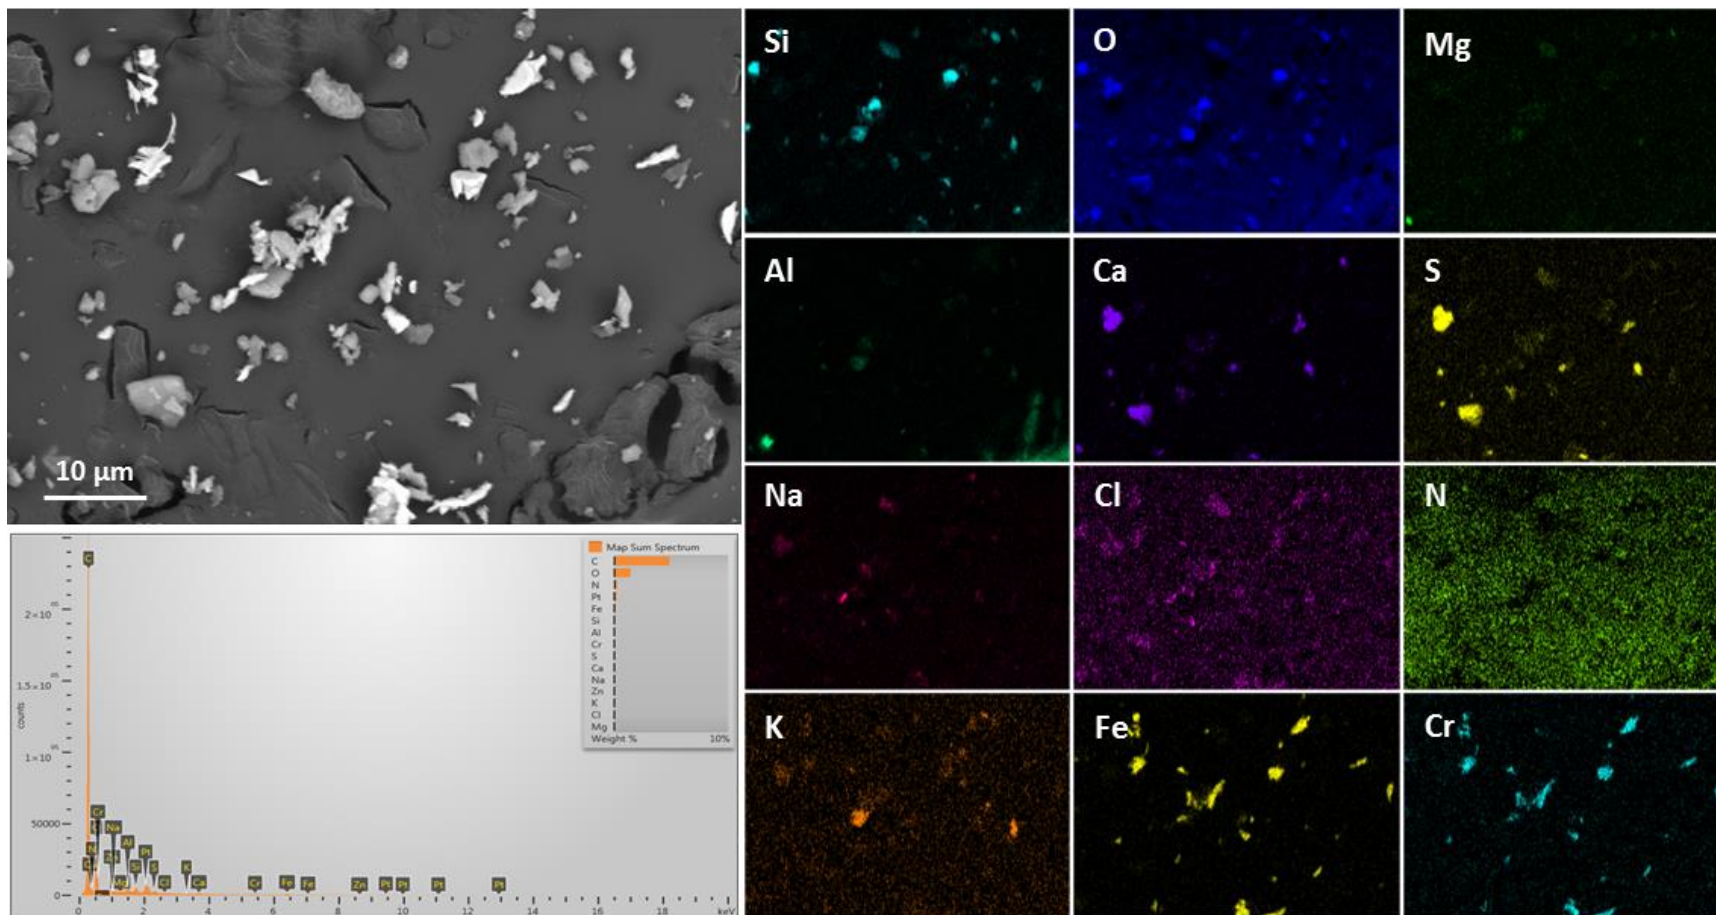
**Sample 387-007, collected from the center of the canister top**  
**Map D**

Notes: Most dust particles are stainless steel, but large composite grains of silicates/aluminosilicates and salts are also present.

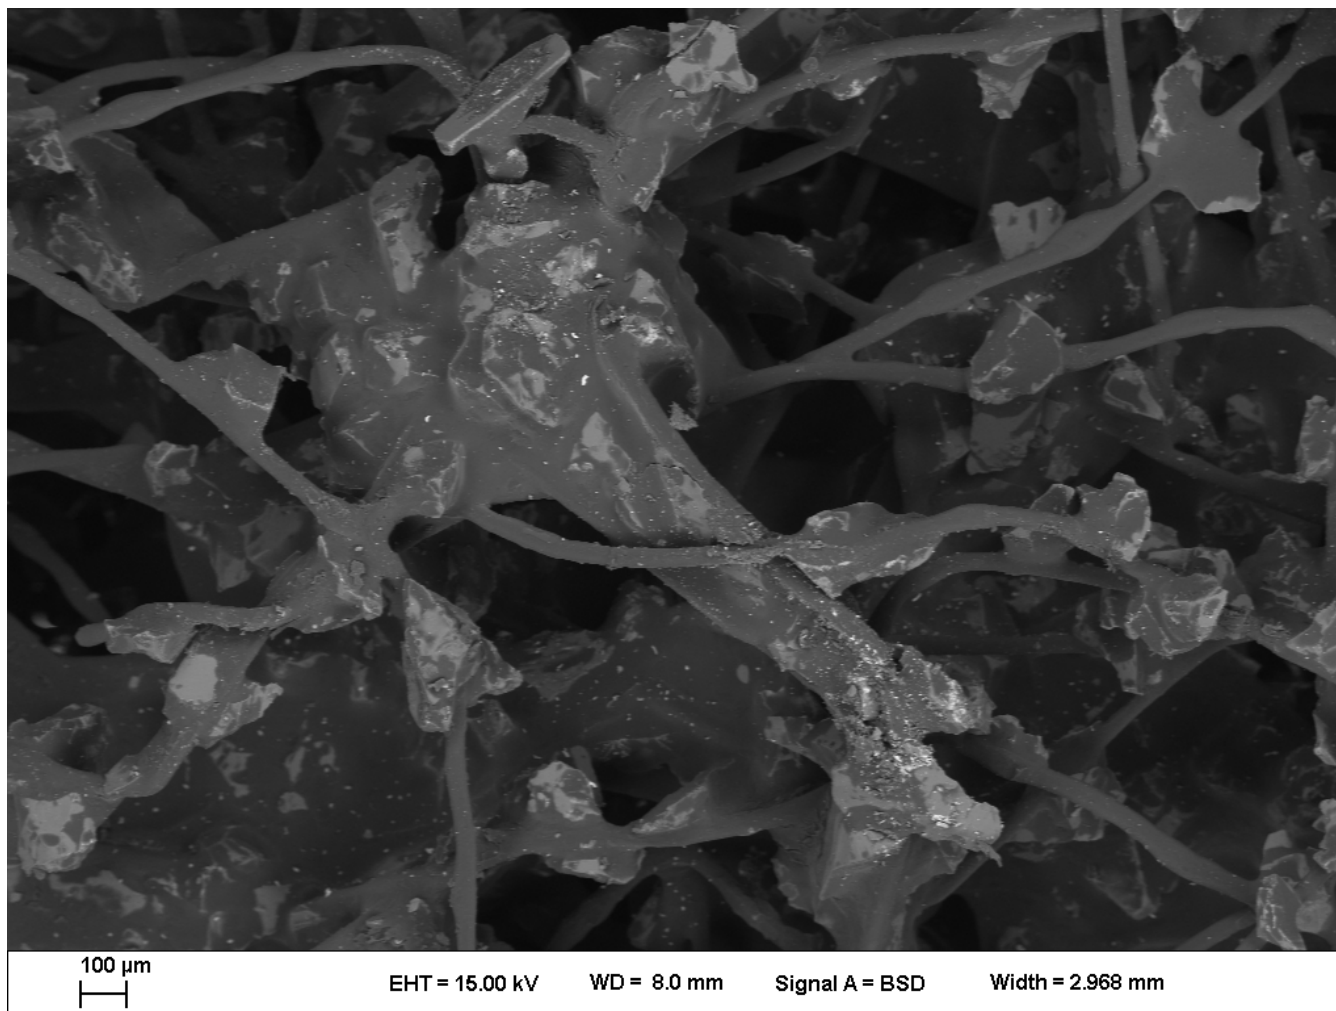
**Sample 387-009, collected from the canister side, 5 feet from the base**  
**Map A**

Notes: Dust grains are almost entirely stainless steel. A single Ca-SO<sub>4</sub> grain is present in the upper left of the image.

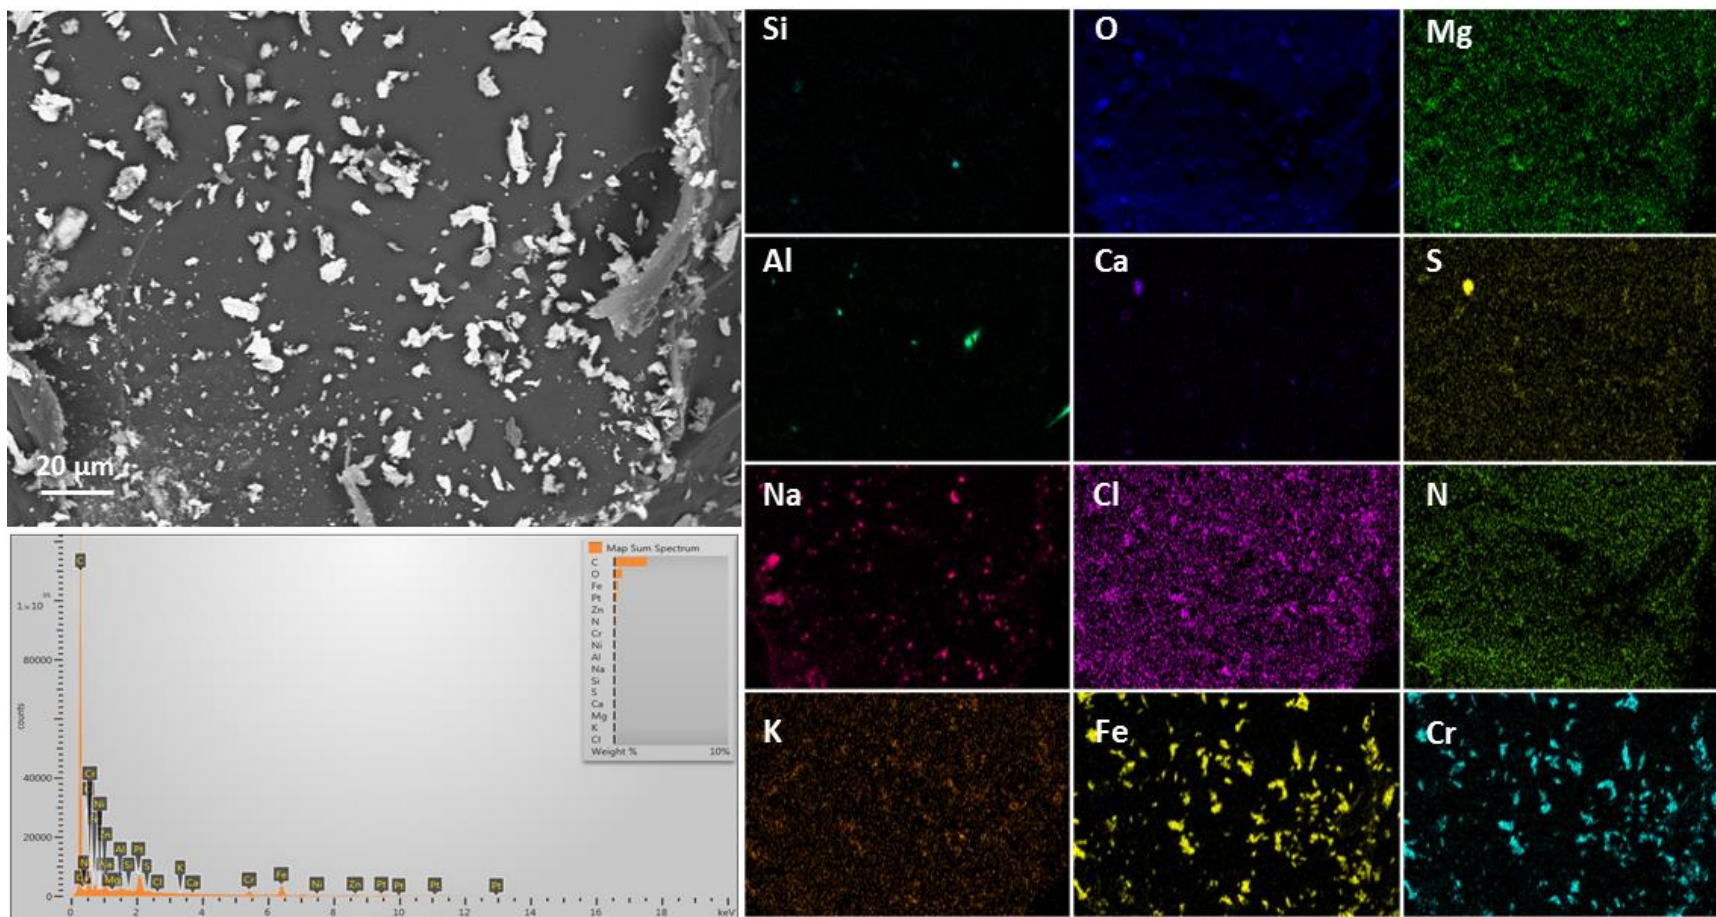
**Sample 387-009, collected from the canister side, 5 feet from the base**  
**Map B**

Notes: Grains are mostly stainless steel.
