Sister Rod Destructive Examinations (FY20)

Spent Fuel and Waste Disposition

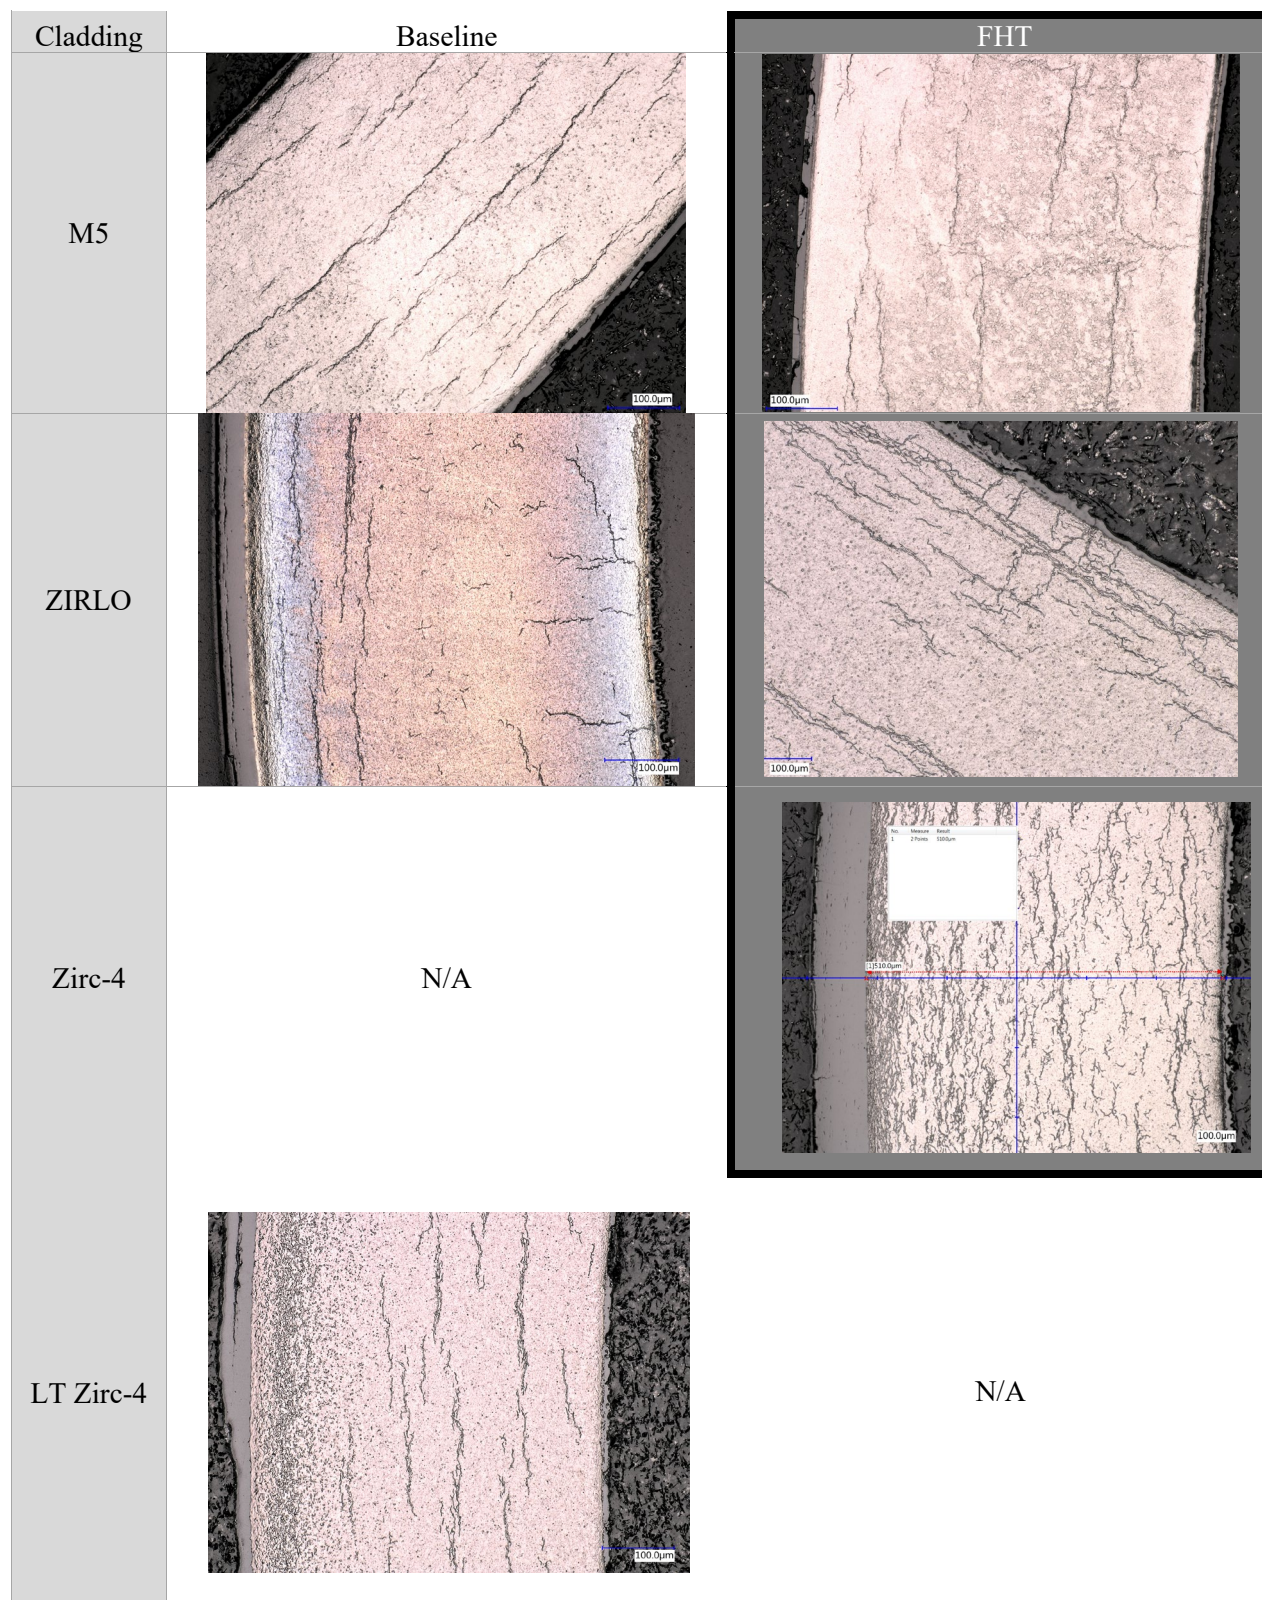
o For the FHT M5-clad rod (30AE14), many radial hydrides are visible, particularly at the ID of the cladding. They preferentially precipitated at locations in which a pellet crack exists at the cladding ID.

o Baseline rod 3A1F05 is heavily spalled, and there is a high density of circumferential hydrides near the waterside surface of the cladding. There is a lower density of circumferential hydrides through the remainder of the wall section. A few short radial hydrides are visible near the cladding ID.

Figure 3. Selected METs illustrating primary hydride content and orientations for baseline and FHT sister rods.

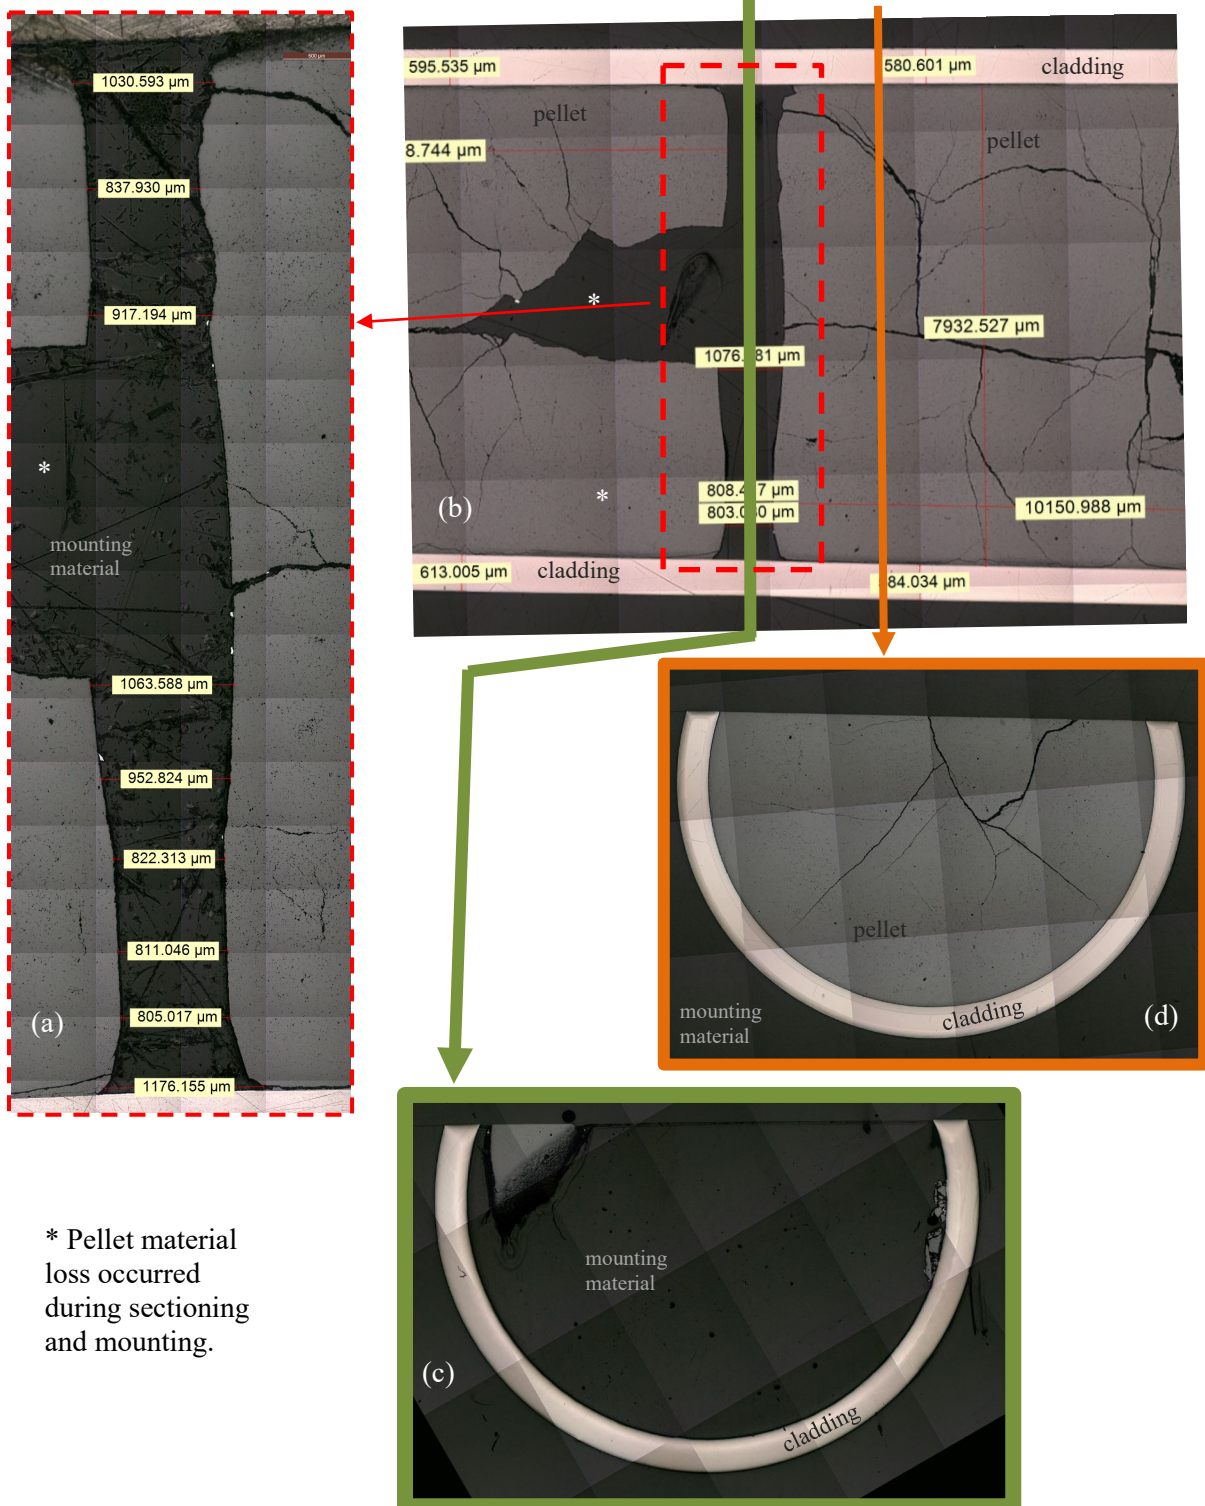
The NDE identified several pellet-pellet gaps among the sister rods. One gap, which was measured at 3 mm long and located at an elevation of 1,403 mm on baseline rod 3D8E14, was sectioned axially to allow for additional examination of the pellet and cladding. MET measurements revealed that the gap is actually less than 1 mm and was overestimated by the gamma scan likely due to the chamfers and dishes in the pellets. The axial view, shown in Figure 4 (also provided in Appendix B), allows axial and radial pellet cracks that occurred during reactor operation to be inspected. The pellet HBU rim is easily discernable and is enhanced at the pellet chamfer locations. The lower pellet has a small chip that relocated within the dish region, and at least one chamfer has loose chips. The axial section was then sectioned radially to view the hydride distribution through the cladding wall. Figure 5 (also provided in Appendix B) provides examples of the hydride distribution in the cladding in the gap and below the gap in the pellet body. There is not a visual difference in the hydride distribution in the gap compared with the cladding in the pellet body below the gap. Total cladding hydrogen measurements will be performed to better quantify any additional hydrogen (in solution or precipitated) in the pellet-pellet gap region. Additional detail is provided on the axial gap METs in Appendix B.

Figure 4. 3D8E14 at 1,403 mm elevation; pellet-pellet (a) gap measurements, (b) cropped axial section view and cross-sectional view locations, (c) cross-sectional view in the gap, and (d) cross-sectional view of the pellet above the gap .

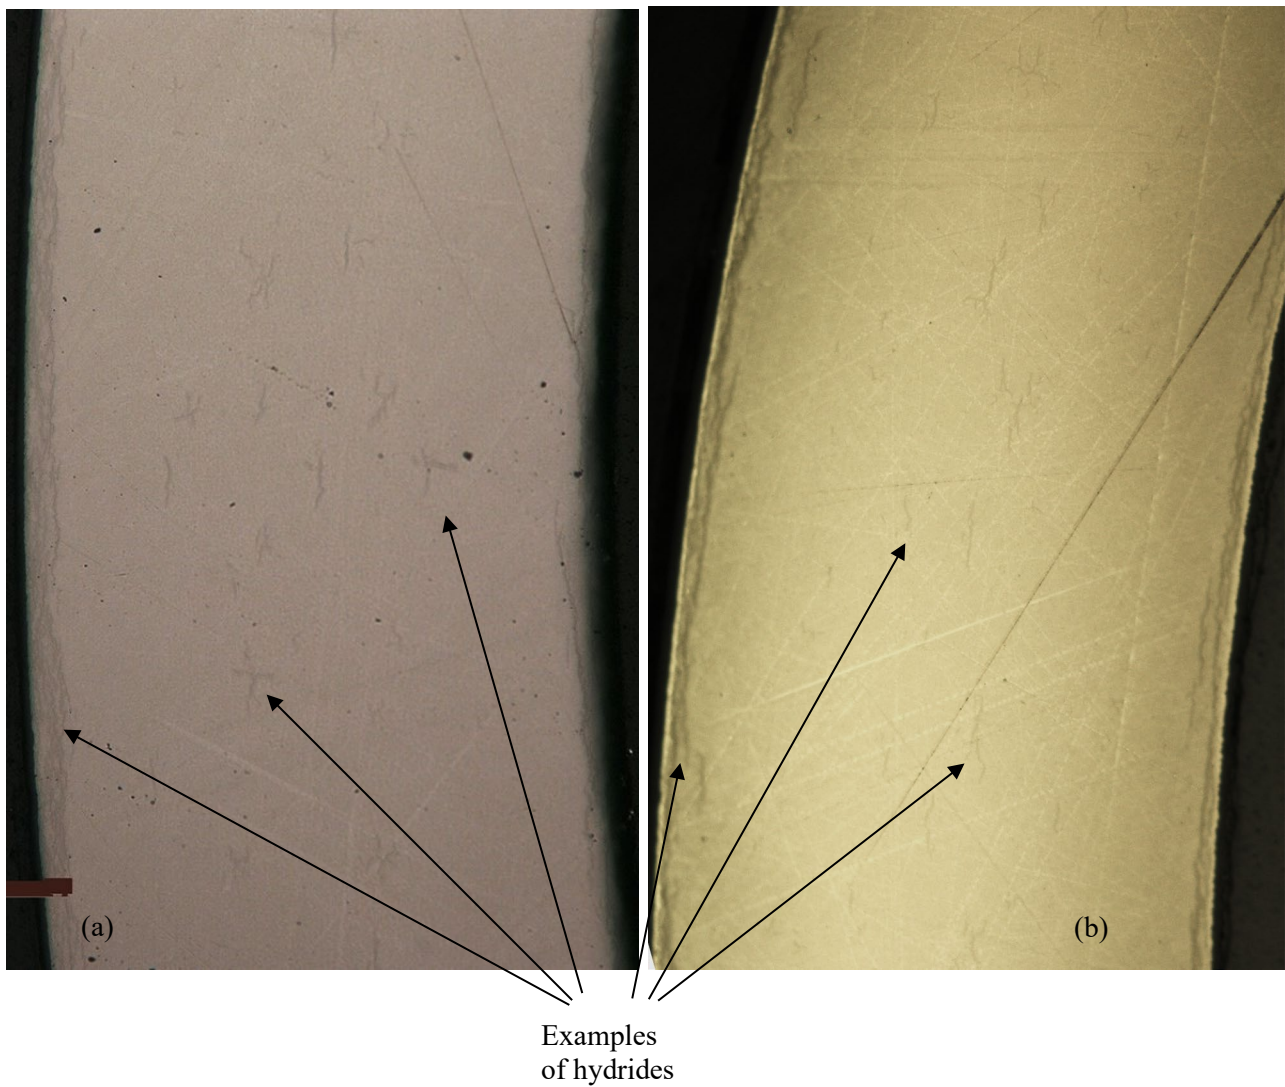
**Figure 5. 3D8E14 centered at 1,403 mm elevation; cladding hydride distribution (a) above the gap
in the pellet body, (b) in the gap, (c) below the gap in the pellet body.**

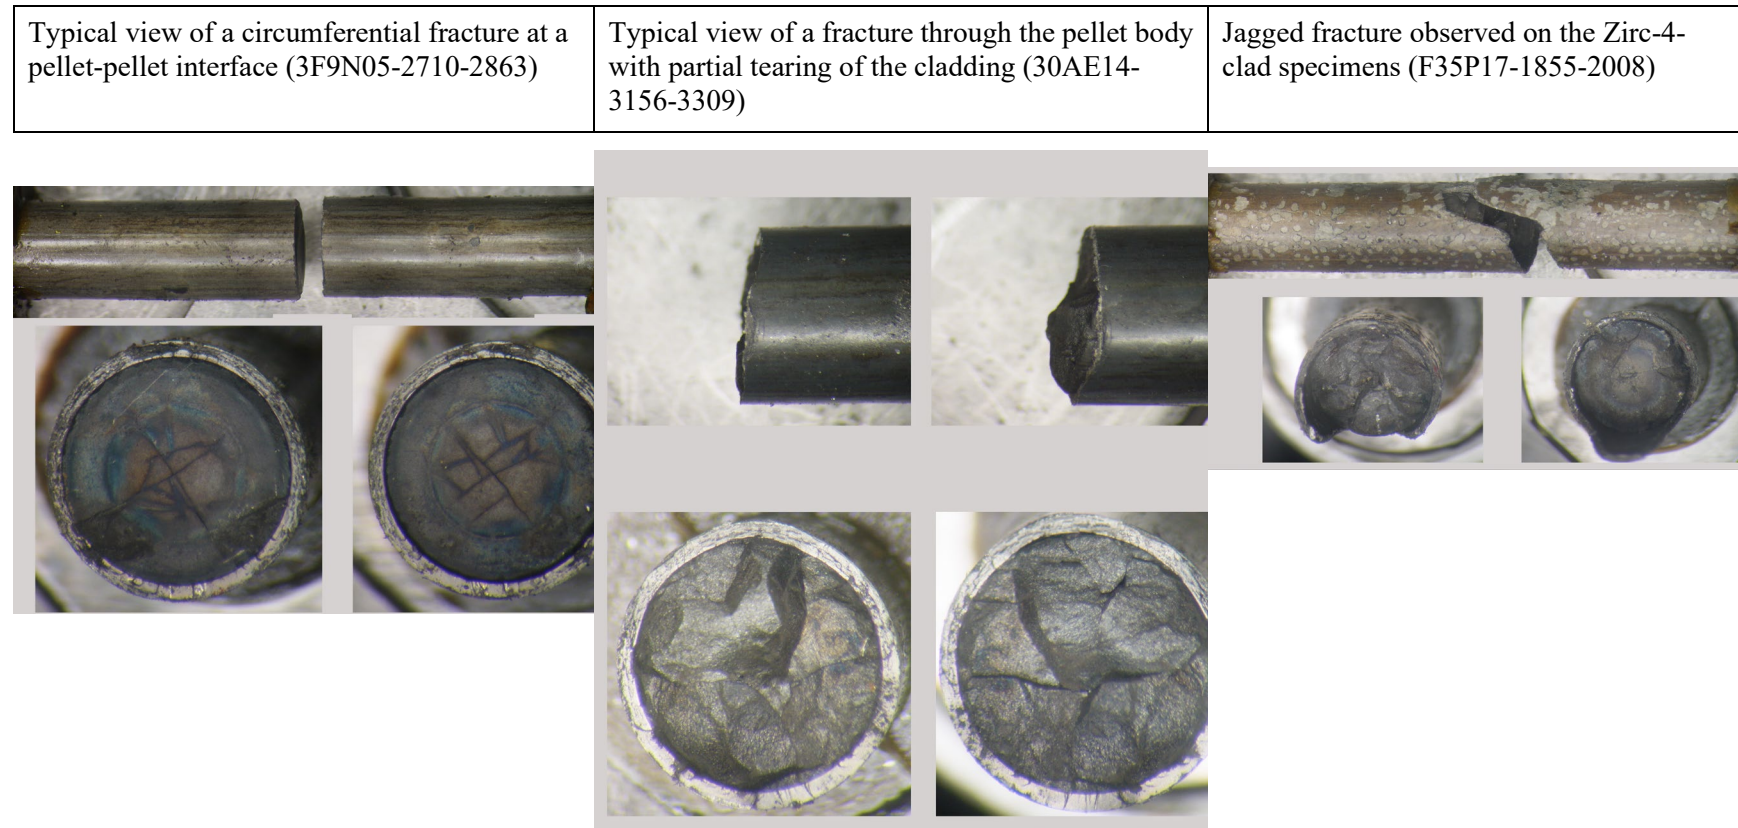
The fractured CIRFT specimens were imaged, and all photos are provided in Appendix F. Typical views of the different fracture observations are provided in Figure 14. There is no visible difference in the fracture mode from baseline to FHT rods. The specimens with fatigue lifetimes lower than other data did not fracture in an anomalous manner. The F35P17 Zirc-4-clad rods seemed to fracture in a more brittle mode than the other specimens with deeper tearing of the cladding across the pellet body.

| Typical view of a circumferential fracture at a pellet-pellet interface (3F9N05-2710-2863)	Typical view of a fracture through the pellet body with partial tearing of the cladding (30AE14-3156-3309)	Jagged fracture observed on the Zirc-4-clad specimens (F35P17-1855-2008)

Figure 14. Typical appearance of post-fatigue test specimens.

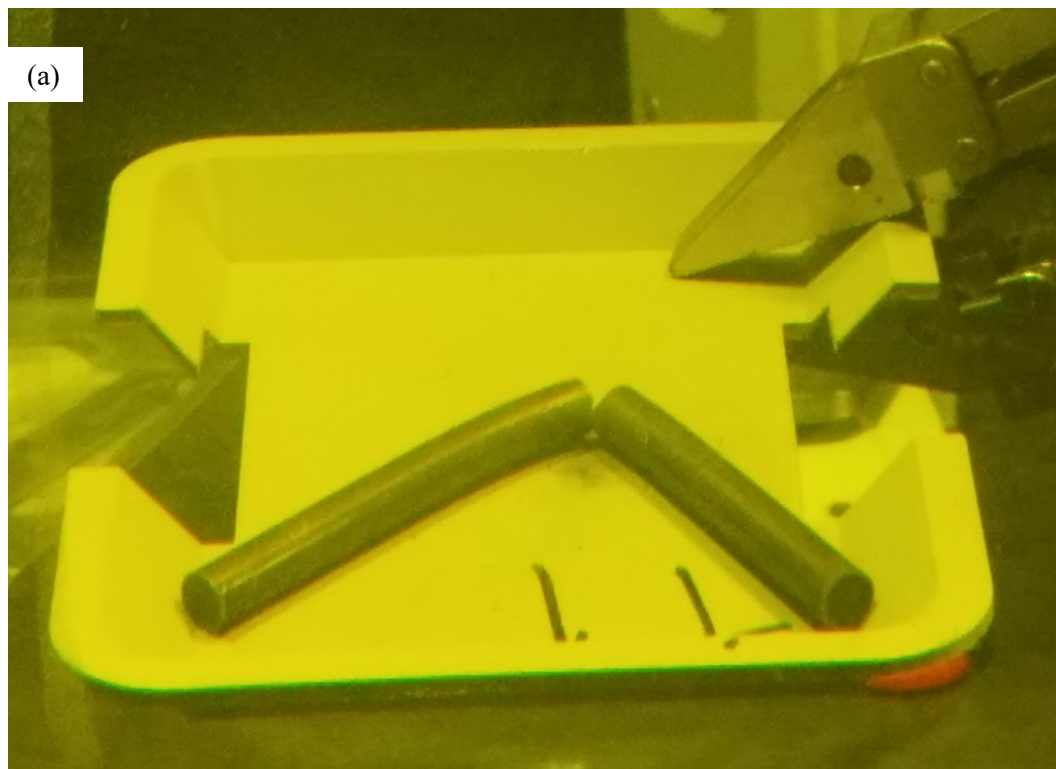
The amount of fuel released during fracture was monitored by weighing each specimen before and after the test and weighing the debris collected. The largest difference from pretest to posttest weight was 1.7 ± 0.1 g for F35P17-1472-1625 (RT test). There is not a trend of mass loss with test temperature or burnup. There is a tendency for the RT tests to have more mass loss, likely because the cladding fracture is more energetic at RT than at 200°C. The maximum mass lost represents about one-quarter of a pellet, whereas the more typical mass loss is less than one-tenth of a full pellet. Often, the released material was composed of small particulate, as shown in Figure 17. Several 4PB tests will be completed with the aerosol collection system to better quantify the size distribution and quantity of aerosol particles released during fracture. The aerosol tests have not yet been completed (see Section 13).

Figure 17. (a) Posttest debris was captured by a catch tray located below the specimen with (b) the typical RT debris field composed of small particles.

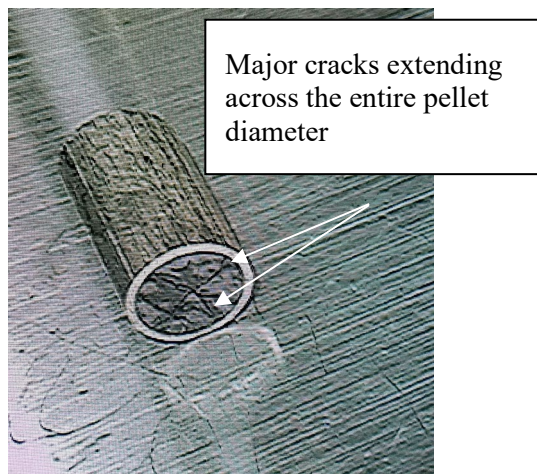
The RCT specimens are ~25 mm long for RCTs, as shown in Figure 19, and each specimen should contain two full pellets. Five tests were completed at 200°C and 12 tests were completed at RT, and the results, which have not been corrected for machine compliance, are summarized in Table 13. The specimens typically carried load until at least one cladding fracture developed. Frequently, as shown in Figure 18, the specimen broke into two equal halves.

Figure 18. Typical post-RCT appearance.

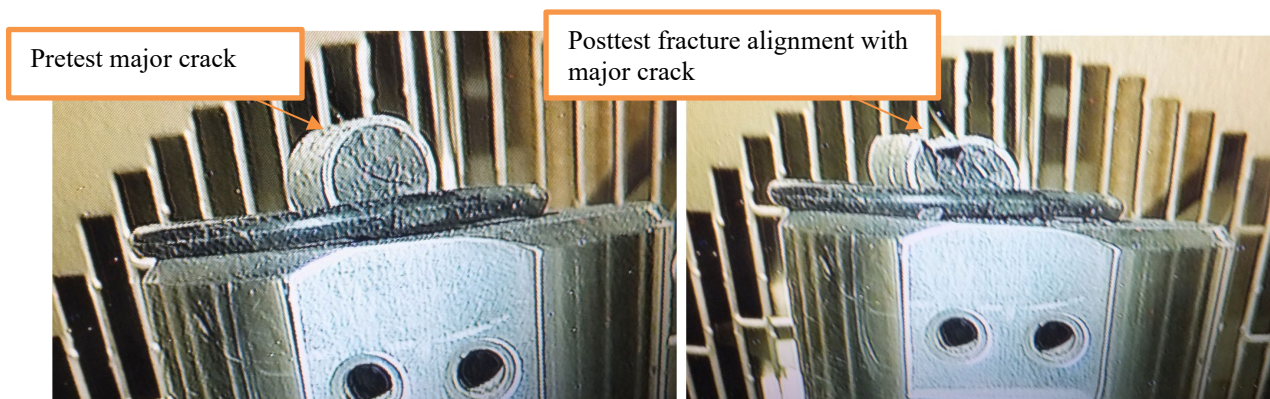
Pretest major crack

Posttest fracture alignment with major crack

Figure 20. RCT fracture path along major pellet crack.
