SANDIA REPORT

SAND2014-16383
Unlimited Release
Printed July 2014

Analysis of Dust Samples Collected from Spent Nuclear Fuel Interim Storage Containers at Hope Creek, Delaware, and Diablo Canyon, California

Charles R. Bryan and David G. Enos

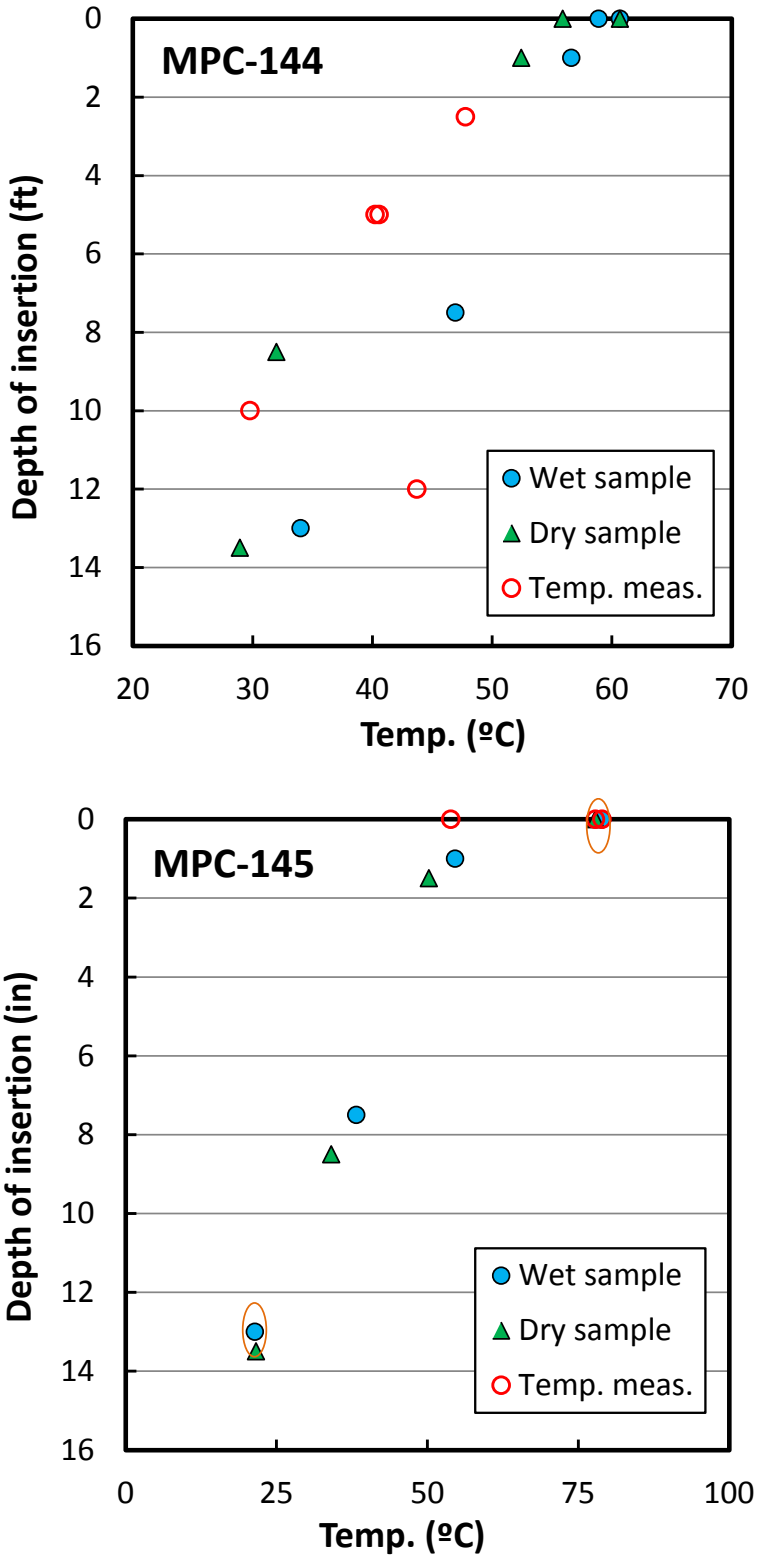
Figure 11. Hope Creek sample locations and temperatures. Orange ovals mark SaltSmart™ samples with heat-damaged wicks or unsaturated reservoir pads.

The surface temperatures at each sampling location are provided in Table 1 and Table 2, and are plotted versus sample location in Figure 11 and Figure 12 for the Hope Creek and Diablo Canyon canisters, respectively. It should be noted that in the case of Hope Creek MPC-144 and Diablo Canyon MPC-170, temperatures were not consistent over the course of the sampling effort, with measured temperatures for the wet and dry sampling forming two different trends as a function of depth. The observed temperature differences are too large to be due to variations in the external air temperature, and it is assumed that readings from one or more of the thermocouples are inaccurate; possibly, poor contact was achieved with the canister surface.

Testing by the manufacturer indicated that the maximum operating temperature for the SaltSmart™ sensors was 90ºC. The dry pads had a much higher maximum operating temperature. For this reason, thermocouple readings or dry pad samples were taken first, and the recorded temperatures used to determine what parts of the canisters could be sampled using the SaltSmart™ sensors. The Hope Creek canisters were sufficiently cool that the entire surface of each canister could be sampled, but the Diablo Canyon canisters were much hotter, and only the lower portion of the canister sides was sampled with the SaltSmart™ devices. The SaltSmart™ sensors actually began to operate poorly at temperatures ≥~80ºC; the wick would adhere to the silicone pressure pad backing it, and the reservoir pad would not be fully wetted, suggesting that water flow through the sensor may have been limited, and salt recovery may not have been complete. SaltSmart™ samples where the wick adhered to the pressure pad, or which did not have fully wetted reservoir pads, are also shown in Figure 11 and Figure 12.

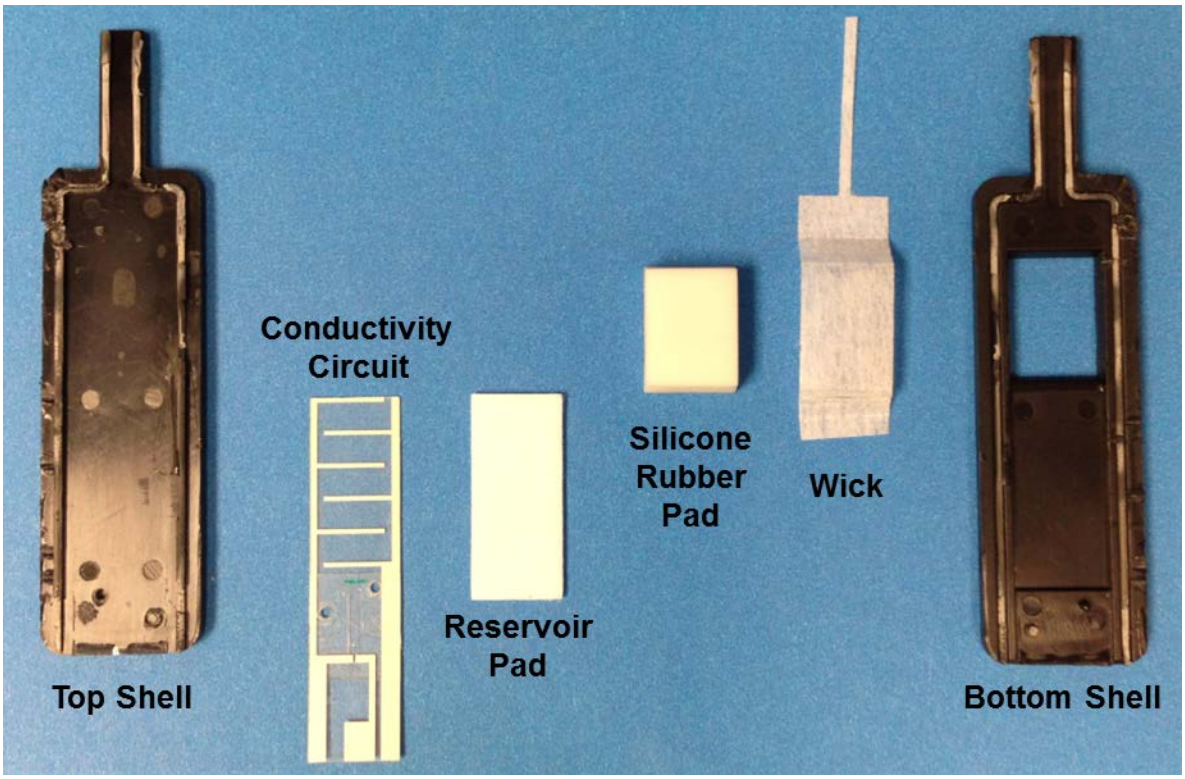
Figure 13. Disassembled SaltSmart™ Device.

Also during disassembly, the condition of the wick and the saturation state of the reservoir pad were recorded. During normal operation of the sensor, the reservoir pads inside the sensors are completely saturated after use, indicating that water flow was adequate through the sensor. This was confirmed by ambient-temperature testing of SaltSmart™ sensors at Sandia. Testing at Sandia using metal coupons with known deposited salt loadings showed that SaltSmart™ sensors are efficient at removing soluble salts from metal surfaces, and that the disassembly and leaching procedure used on the Hope Creek and Diablo Canyon samples is effective (Memo from C. Bryan to L. Zsidai dated Nov. 13, 2013; SAND#2013-9948P); experimental salt recoveries were in the 80-100% range.

Although testing by the SaltSmart™ company suggested that the sensors performed adequately to ~90ºC, the condition of the Hope Creek and Diablo Canyon samples indicated that the operational limit for SaltSmart™ sensors is lower. During sample disassembly, it was observed that the reservoir pad was saturated in most of the relatively low-temperature Hope Creek samples, but that that the wicks adhered strongly to the silicon pressure pad for samples collected at temperatures of ~80ºC and above; in nearly all of those cases, the reservoir pad was not saturated. Wick adherence and/or poor reservoir pad saturation was observed for three of the Hope Creek samples and for most of the Diablo Canyon samples (See Figure 11 and Figure 12). In only one instance was poor wetting associated with a lower-temperature sample (sample 145-006); in this case, it appears to be associated with poor contact between the wick and canister surface. It is possible, perhaps likely, that salt removal was incomplete for SaltSmart™ samples that were poorly wetted, as the adherence of the wick to the silicone pressure pad and the incomplete saturation of the reservoir pad suggest that water transport through the wick was limited.

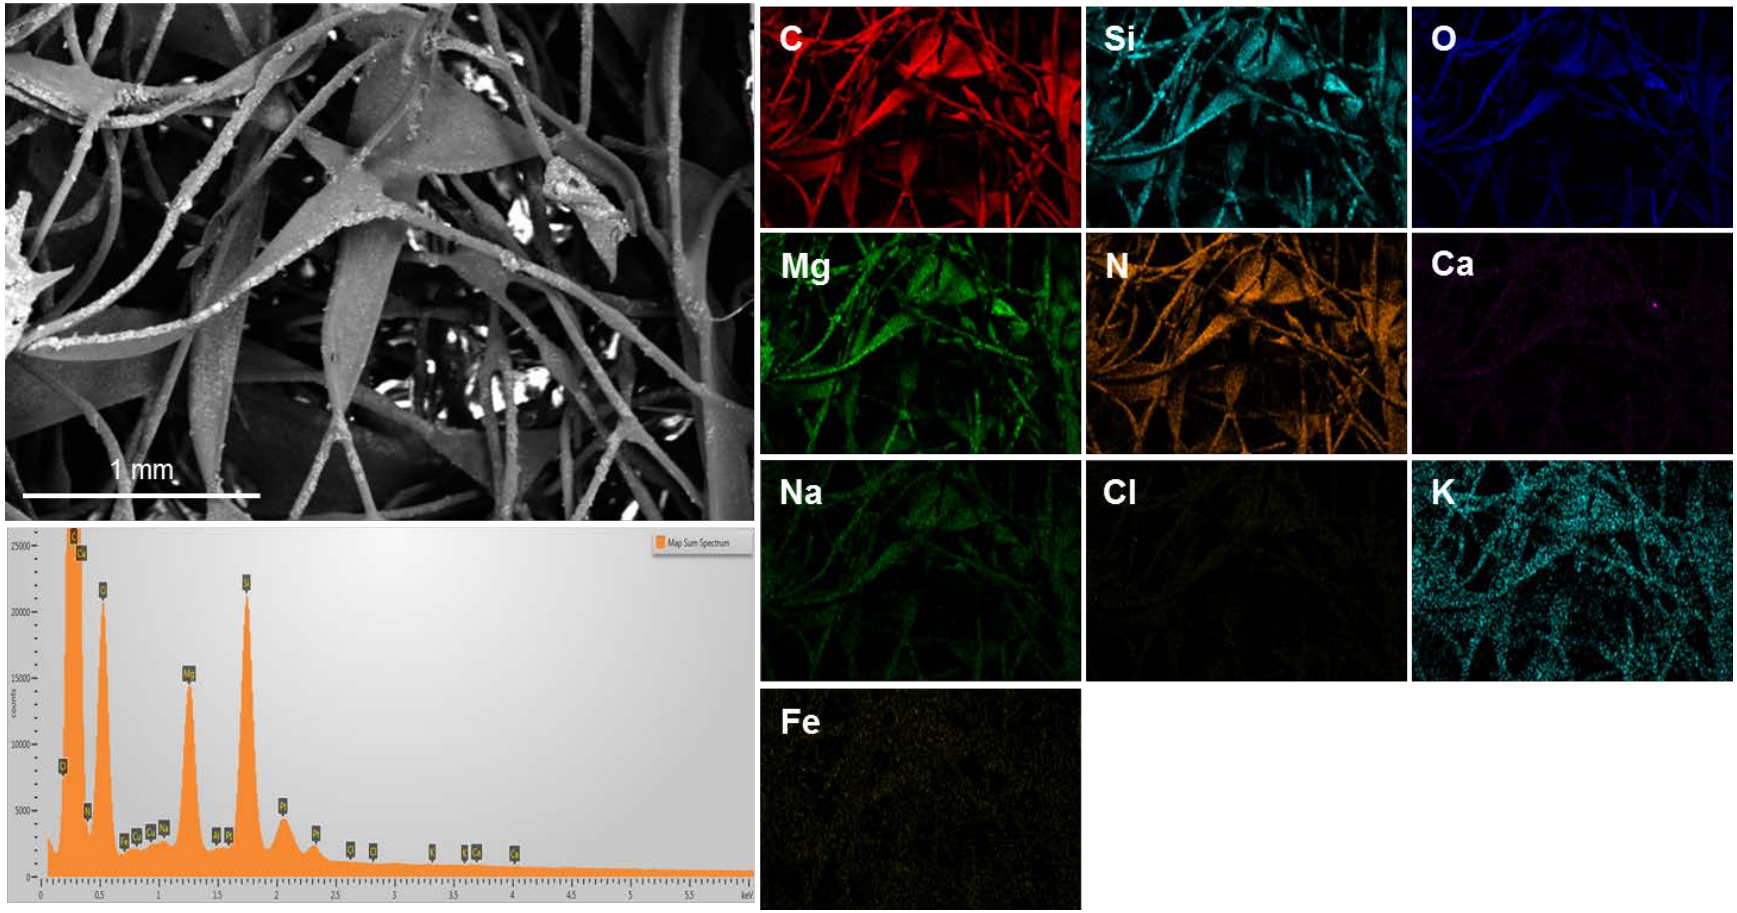
Figure 14. Low magnification SEM image/EDS map of Scotch-Brite™ pad blank.

Figure 14 is a low-magnification image of the blank pad. The fibers form a network, and the resin-filler binds the mass together, forming broad bridges at fiber intersections. The talc is generally embedded within the resin, and does not penetrate the exposed surface, except where the resin has been abraded. The bridges are ideal locations for analysis of adhering dust, because the talc is embedded within the resin, particulate talc contamination is commonly minimal, and the broad flat surface is ideal for SEM analysis. However, in cases where the sampled dust load is light, the adhering dust may be mostly on the exposed uppermost surfaces of the pads, where abrasion has revealed the talc. In these cases, much of the particulate matter on the pads may be talc flakes. In addition to Mg, Si, and O in the talc, the nylon is an amide, containing carbon (C), nitrogen (N), and oxygen (O), and these species are reflected in the EDS spectrum and the element maps. The dominant chemical components in the pad, as identified by EDS, are C, Si, and Mg; N is obscured by proximity to the C peak, but shows up in the element maps. Other chemical components that leach from the pad during chemical analysis include sodium (Na), phosphate (containing phosphorous, P), and sulfate (containing sulfur, S); however, these contribute too little to the bulk composition to be identified by SEM/EDS analysis.

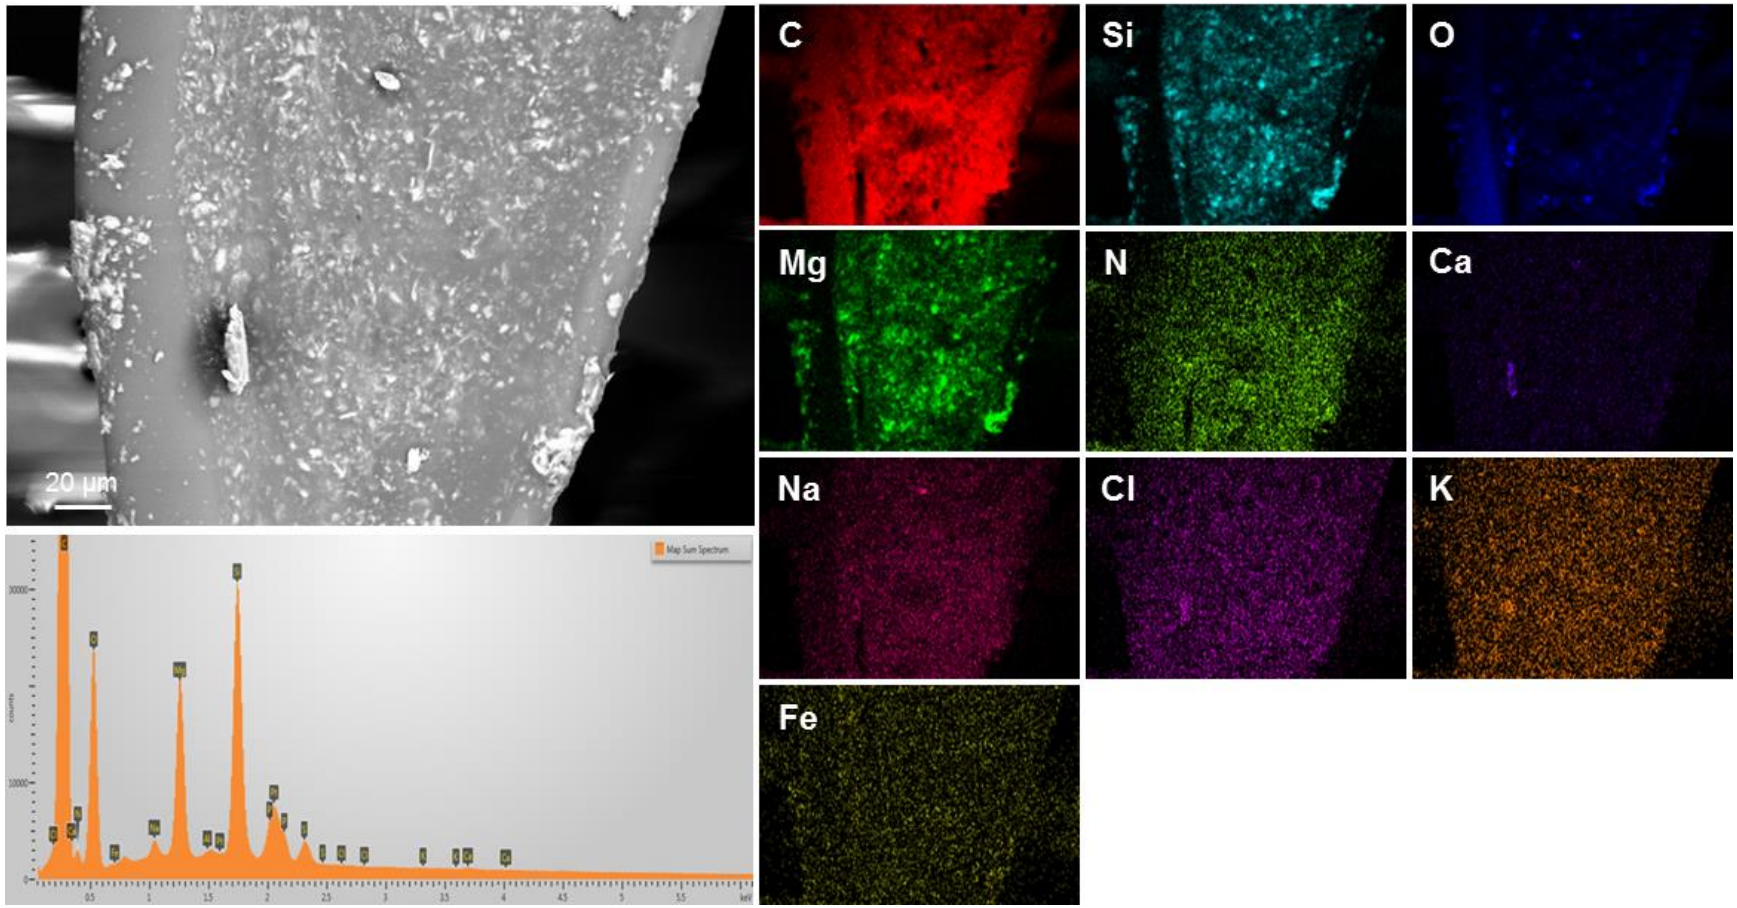
Figure 15. High magnification SEM image/EDS map of Scotch-Brite™ pad blank.

Figure 15 is a higher resolution image of the bad blank, showing the texture of the pad and the embedded talc. In general, the blank pad had little adhering particulate matter, other than talc particles freed by abrasion during cutting and handling of the pad for SEM analysis.

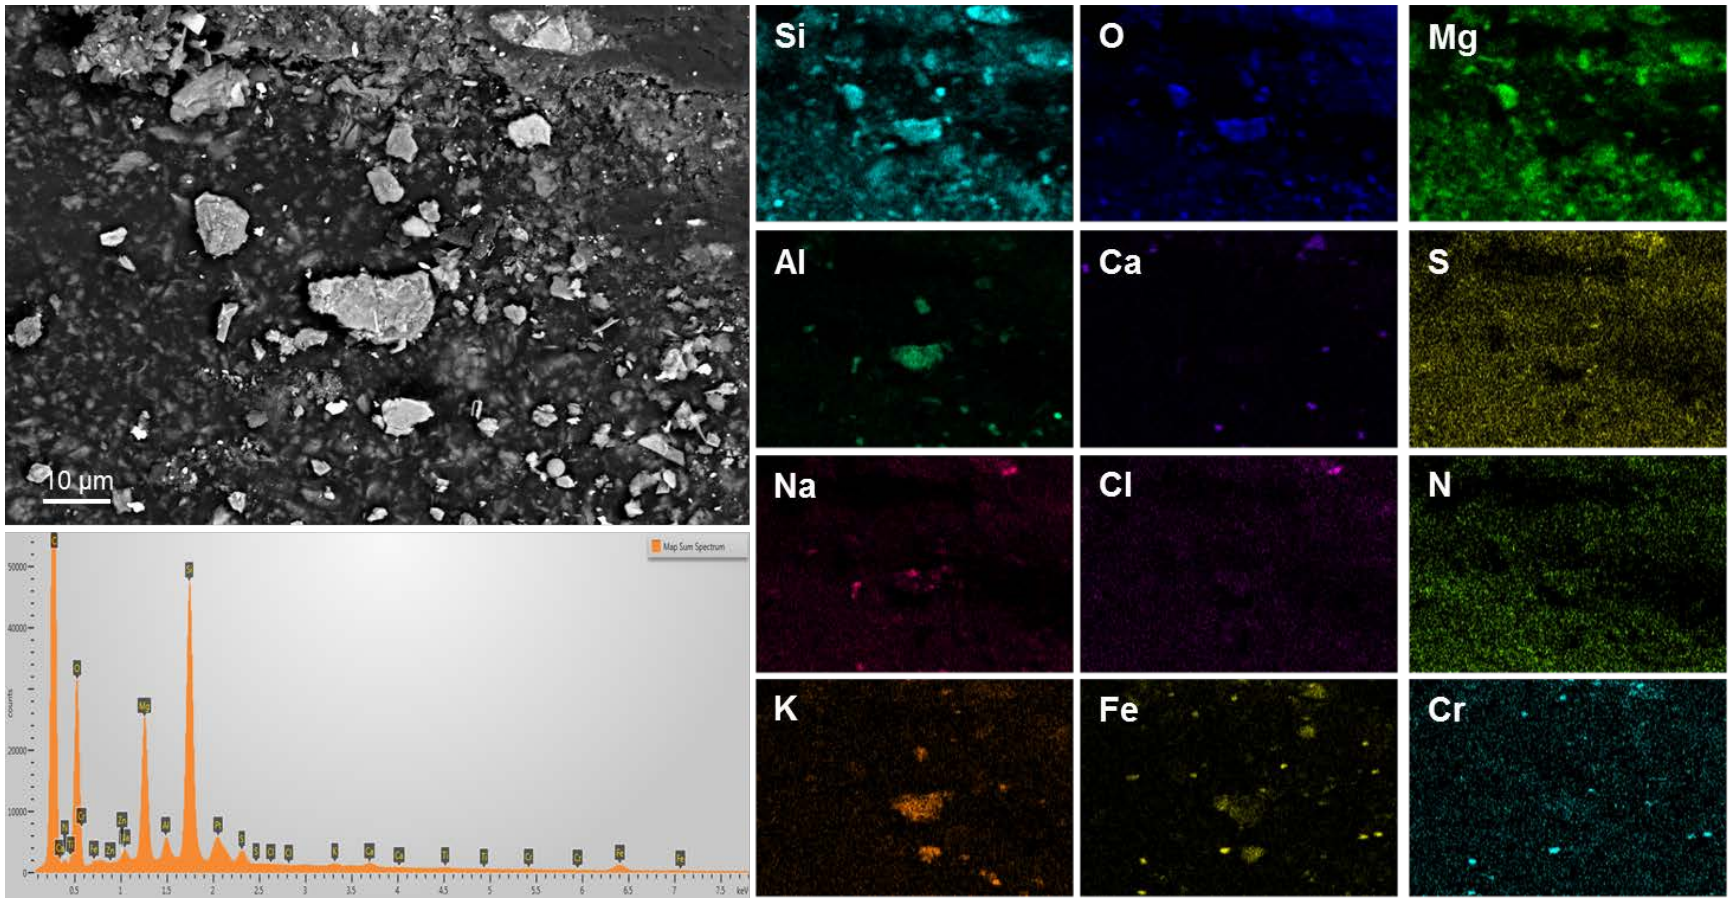
Figure 16. SEM image/EDS map (#2) of Sample 145-003, collected from the canister side, 13.5 feet below the upper edge.

SEM/EDS data for Sample 145-003, collected at a distance of 13.5 feet below the upper edge of the canister, are shown in Figure 16. Figure 16 shows an accumulation of dust, mostly aluminosilicates and Fe-Cr particles, near an abraded edge—note that many of the particles in the image are talc released from the pad by abrasion. On very lightly loaded pads, dust is commonly only present on or near abraded areas. Also, on lightly loaded pads, Fe-Cr particles form a larger proportion of the total, because the amount of environmentally-derived dust (as opposed to manufacturing-derived), is low.

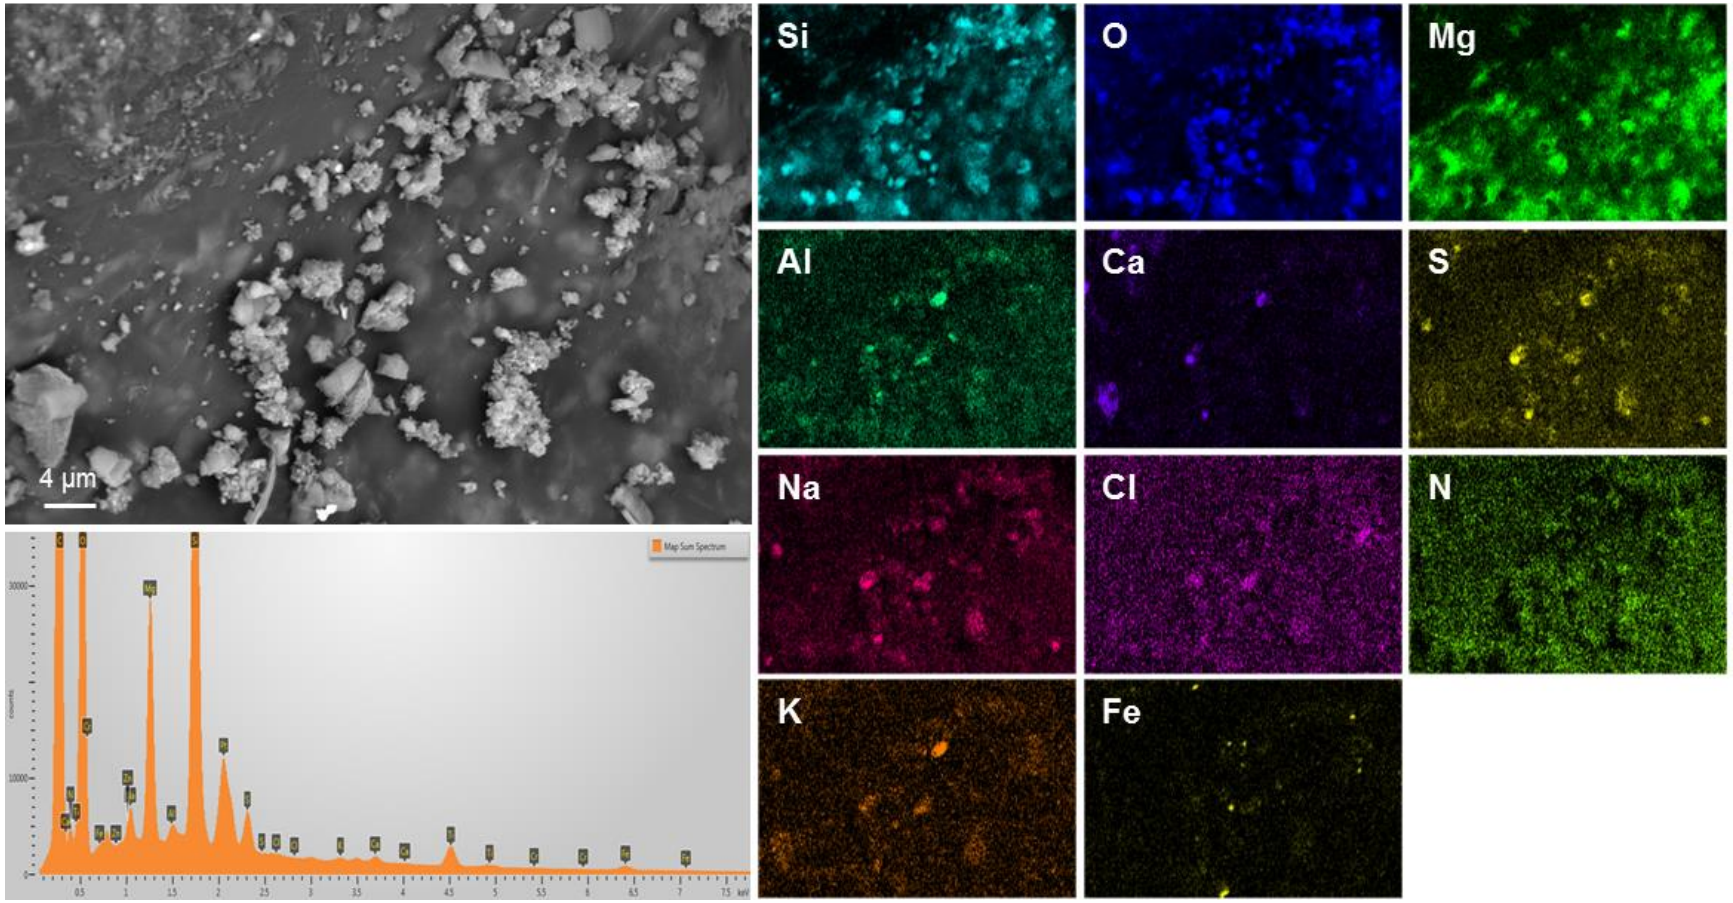
Figure 17. SEM image/EDS map of Sample 145-004, collected from the canister side, 8.5 feet below the upper edge.

Sample #145-004 (Figure 17) was collected 8.5 feet below the top of the canister. Most of the particles visible in Figure 17 are talc, freed by abrasion of the pad. Adhering particles are sparse, and are generally small, less than 5 microns in diameter. The dominant dust phases include quartz, aluminosilicates, 304SS particles, and Ca-sulfate.

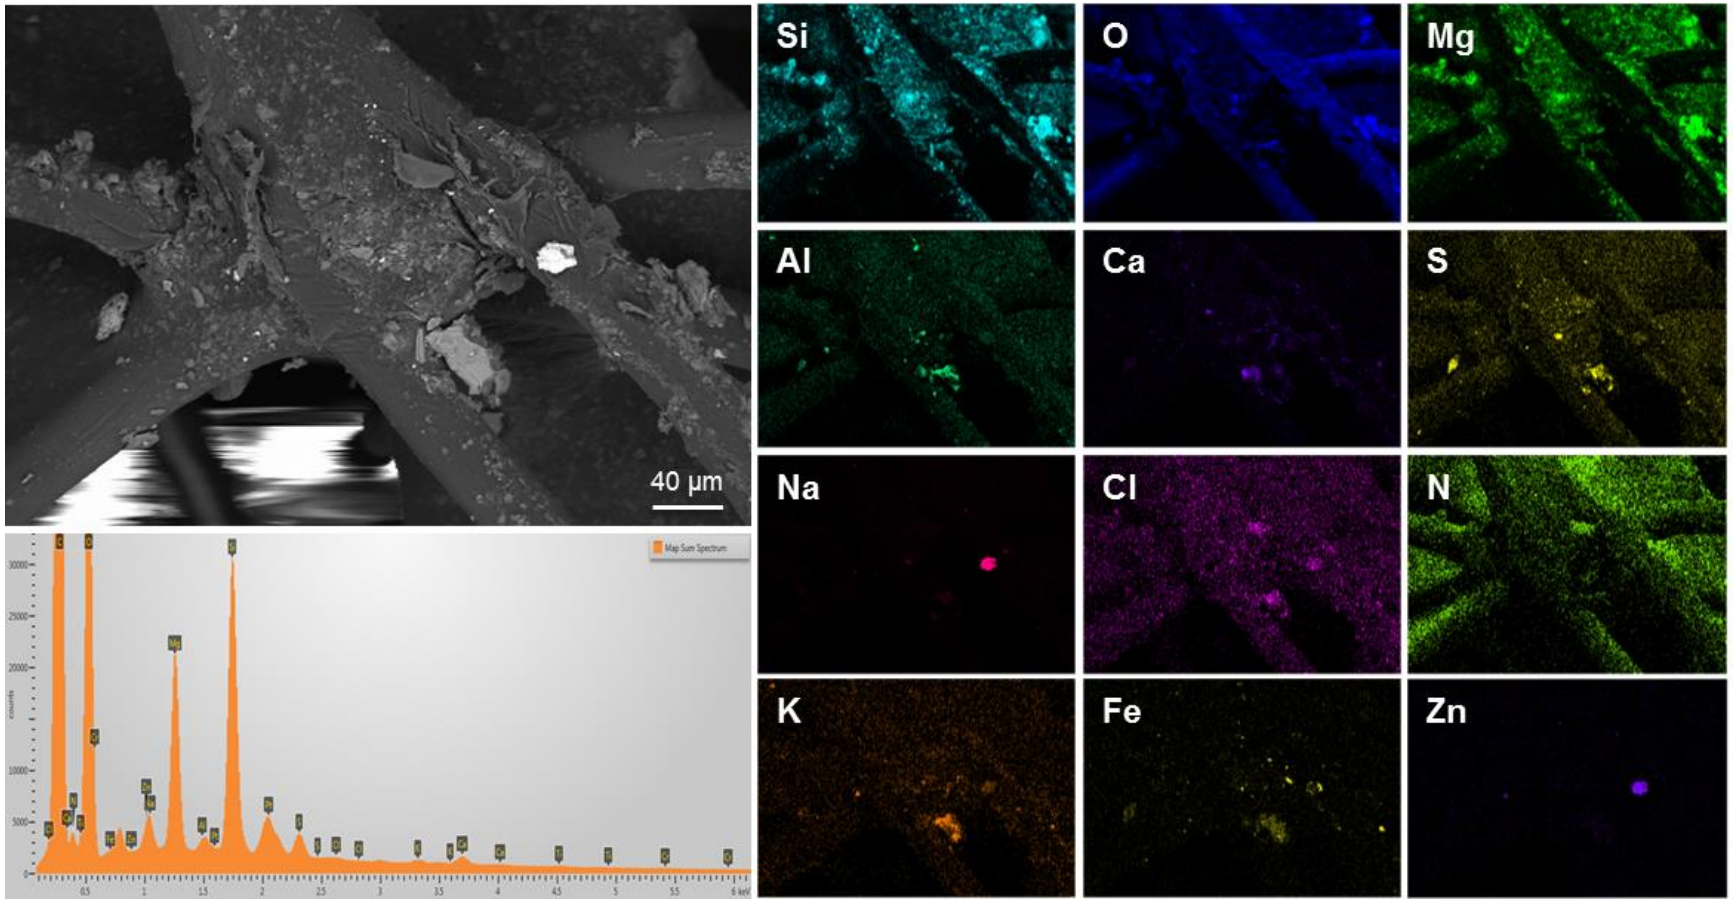
Figure 18. SEM image/EDS map of Sample 145-005, collected from the canister side, 1.5 feet below the upper edge.

Sample 145-005 was collected 1.5 feet below the upper edge of the canister, and once again, the pad was very lightly loaded; adhering dust was largely restricted to topographically high regions on the pad, which had been abraded by contact with the canister surface. Figure 18 shows the only region of the pad with identifiable dust. Fine particles of stainless steel are embedded in the resin, and two large dust grains are present. The two larger grains are biotite, and a Na-Zn phase,

apparently from the corrosion-inhibiting Zn-rich paint on the outer surface of the canister overpack. Similar Zn-Na rich grains were seen on the other cask from Hope Creek, and on a canister at Diablo Canyon.

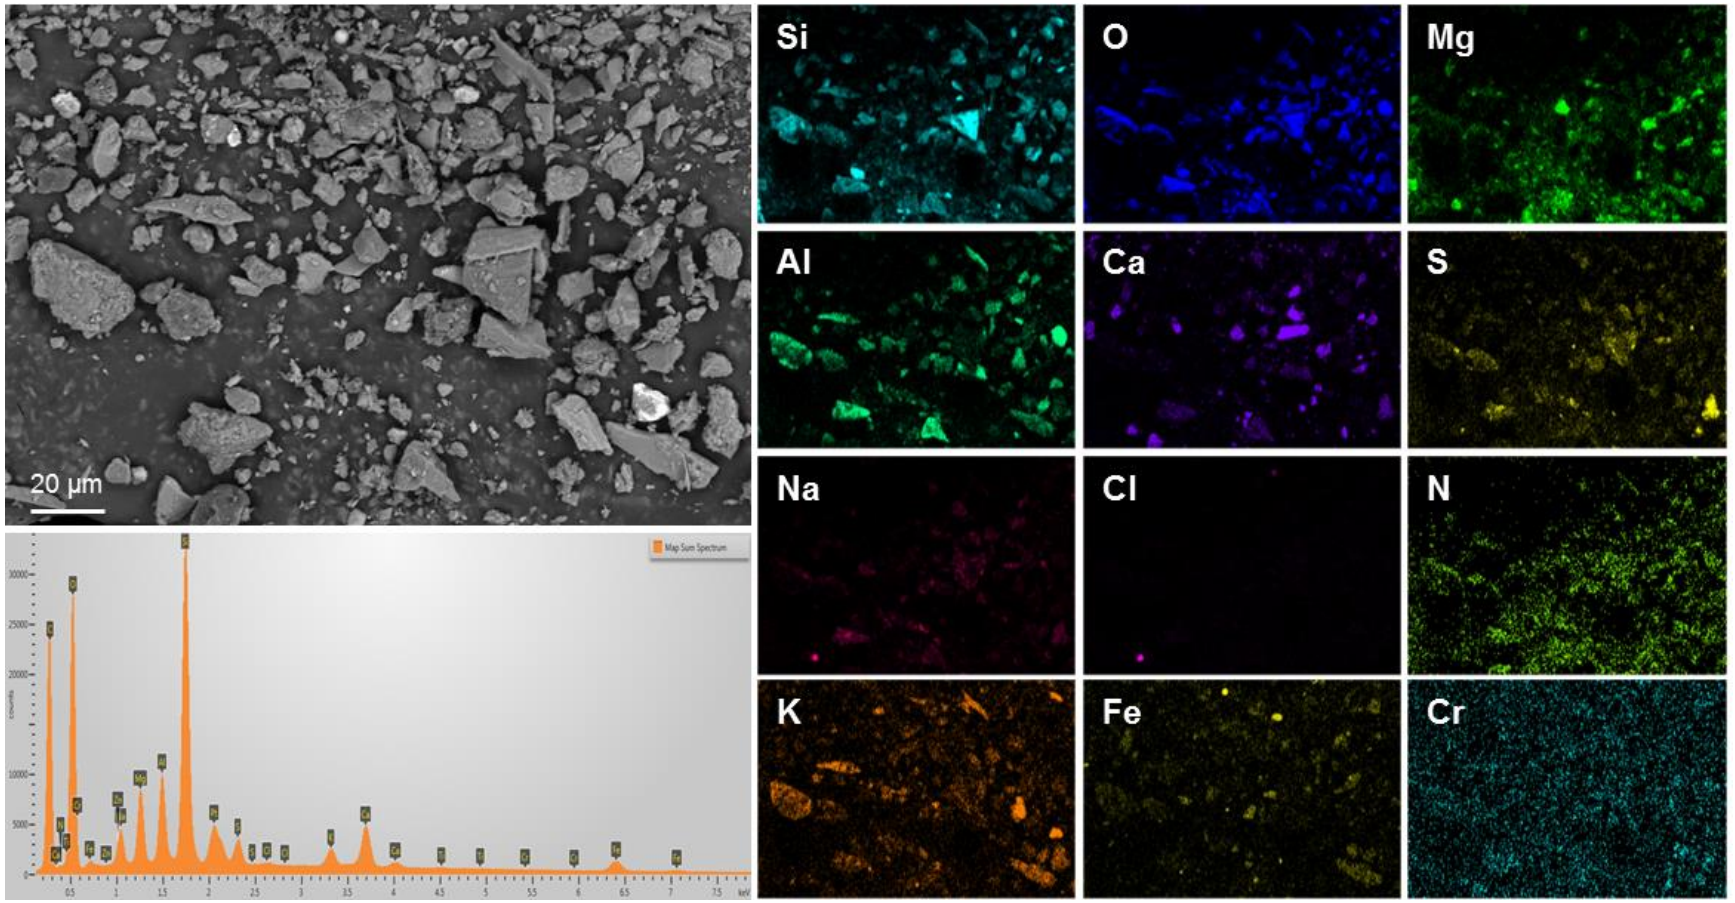
Figure 20. SEM image/EDS map of sample 145-012, collected from the canister top.

A typical SEM/EDS map for sample 145-012 is shown in Figure 20. In this map, and in other SEM/EDS maps in Appendix A, quartz and aluminosilicates are the dominant phases in this sample. The aluminosilicates are mostly blocky mineral fragments that are probably feldspars, and biotite. Ca and Ca-Mg carbonates are also common. Soluble salts include sparse NaCl and Ca-SO_4.

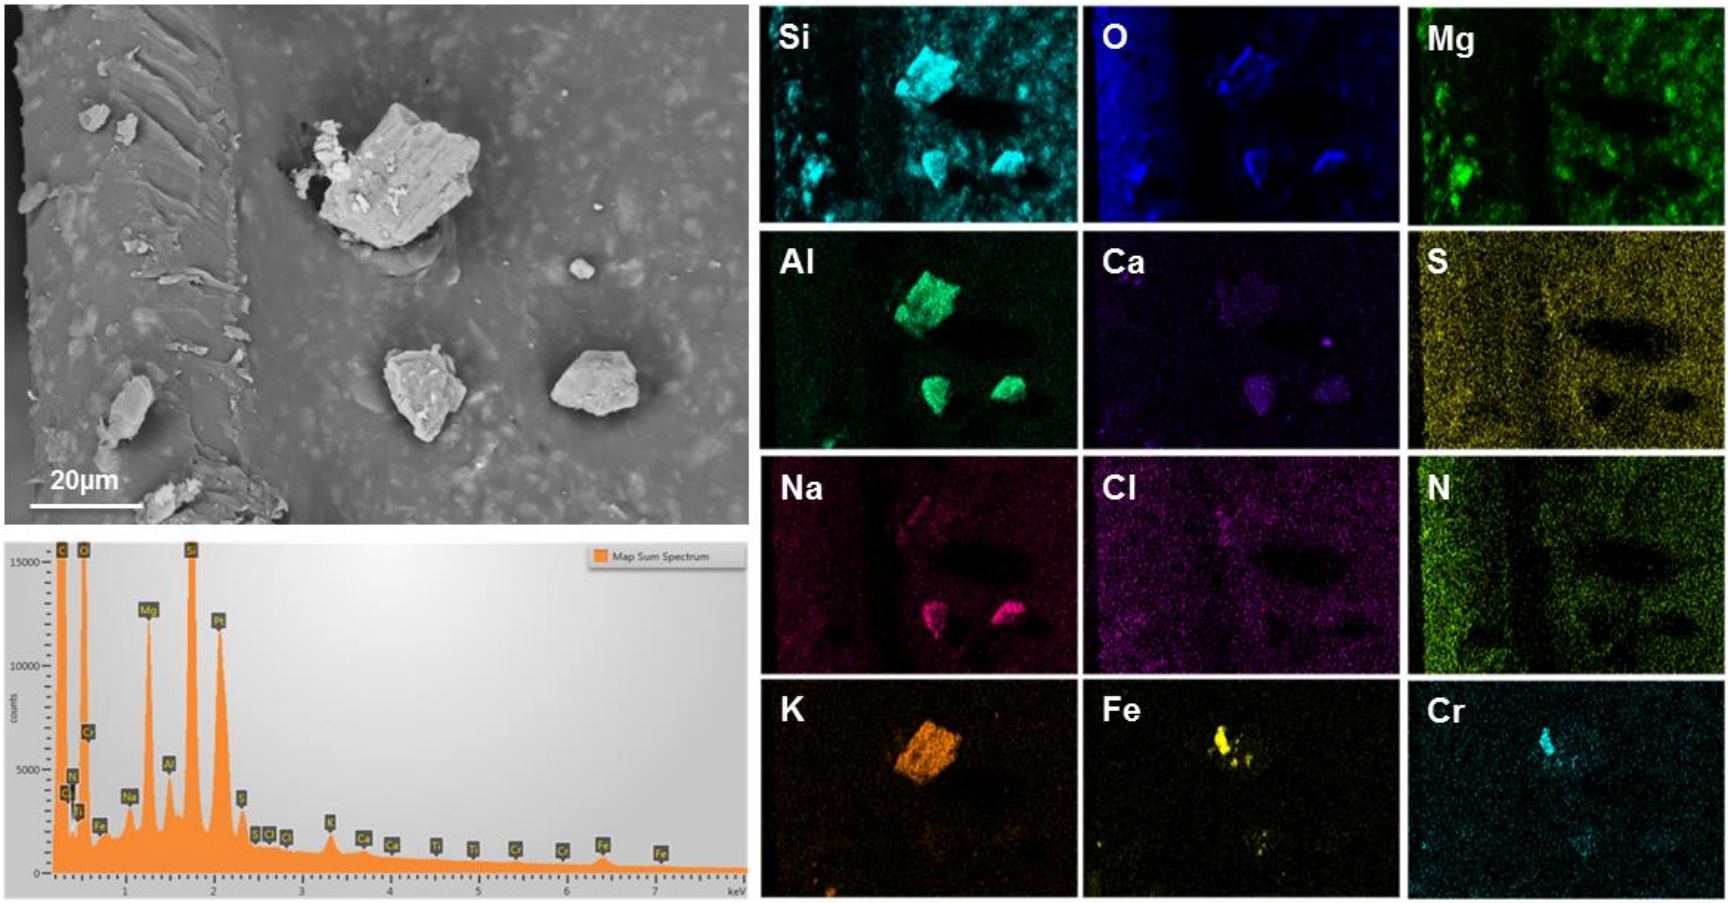
Figure 21. SEM image/EDS map (#1) of sample 144-005, collected from the canister side, 13.5 feet below the upper edge.

MPC-144. Results for MPC-144 were very similar to those for MPC-143. Phases observed during SEM analysis of samples from MPC-144 are listed in Table 4. Sample 144-005 was collected near the base of the canister, at a depth of 13.5 feet from the upper edge. The dust load on the pad was very light, and dust was largely restricted to areas where clear abrasion of the pad was present. SEM/EDS data for Sample 144-005 are shown in Figure 21 and Figure 22. Observed phases in sample 144-005 include coarse blocky grains K and Na feldspars, quartz grains, particles of 304SS; and sparse NaCl particles (note that a shadow partially obscures the element maps in Figure 22, strongly affecting the maps the lighter elements such as Na). Ca-carbonate was also commonly observed. Sample 144-011 was collected from the canister top, and copious amounts of dust adhered to the pad. An SEM/EDS map is shown in Figure 23. The dominant dust phases are identical to those in 144-005. In other images of this sample (Appendix A), pollen grains were common, and rare salt particles of NaCl and Ca-SO4 were observed. A single Zn-Na grain was present; again, this is attributed to the Zn-rich anticorrosive paint on the exterior of the overpack.

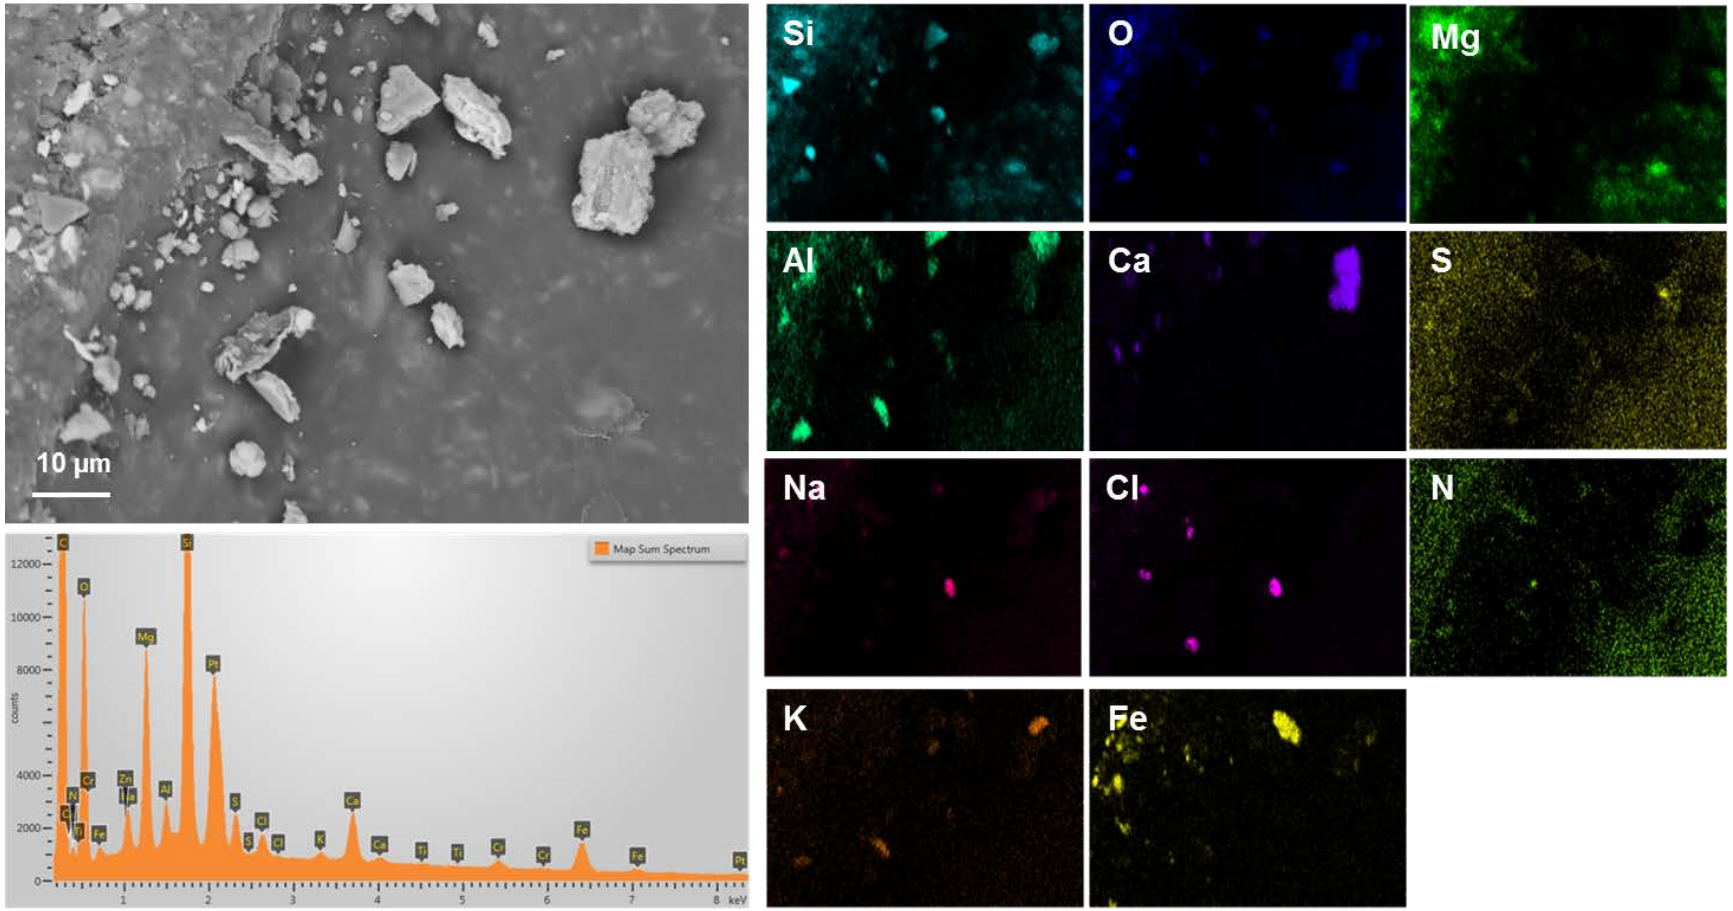
Figure 22. SEM image/EDS map (#2) of sample 144-005, collected from the canister side, 13.5 feet below the upper edge.

The salts in the Hope Creek samples occur as heavily etched individual grains of NaCl, often only a few microns across, although a single spherical aggregate was seen in one image (see lower left center, Figure 22). It is not clear that the NaCl grains observed at Hope Creek are sea-salts in origin. The NaCl grains observed at Hope Creek may source to mist and fog being emitted from the nearby onsite cooling tower, which uses brackish river water. These do not resemble the sea-salt aerosols on the Diablo Canyon canisters, described below.

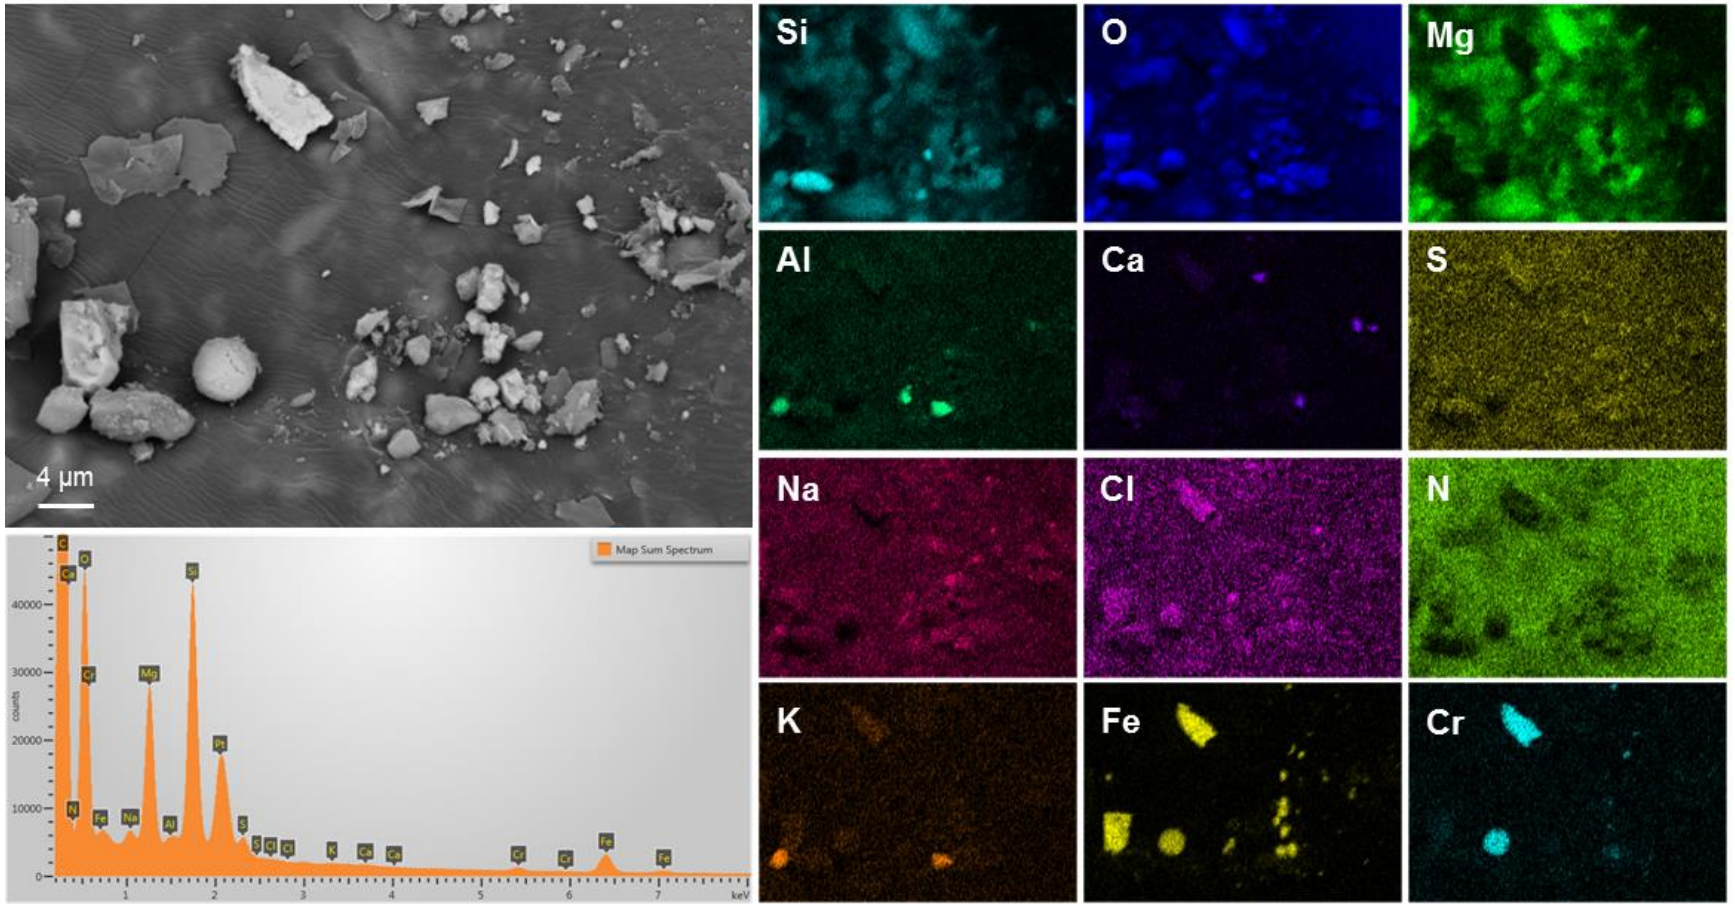
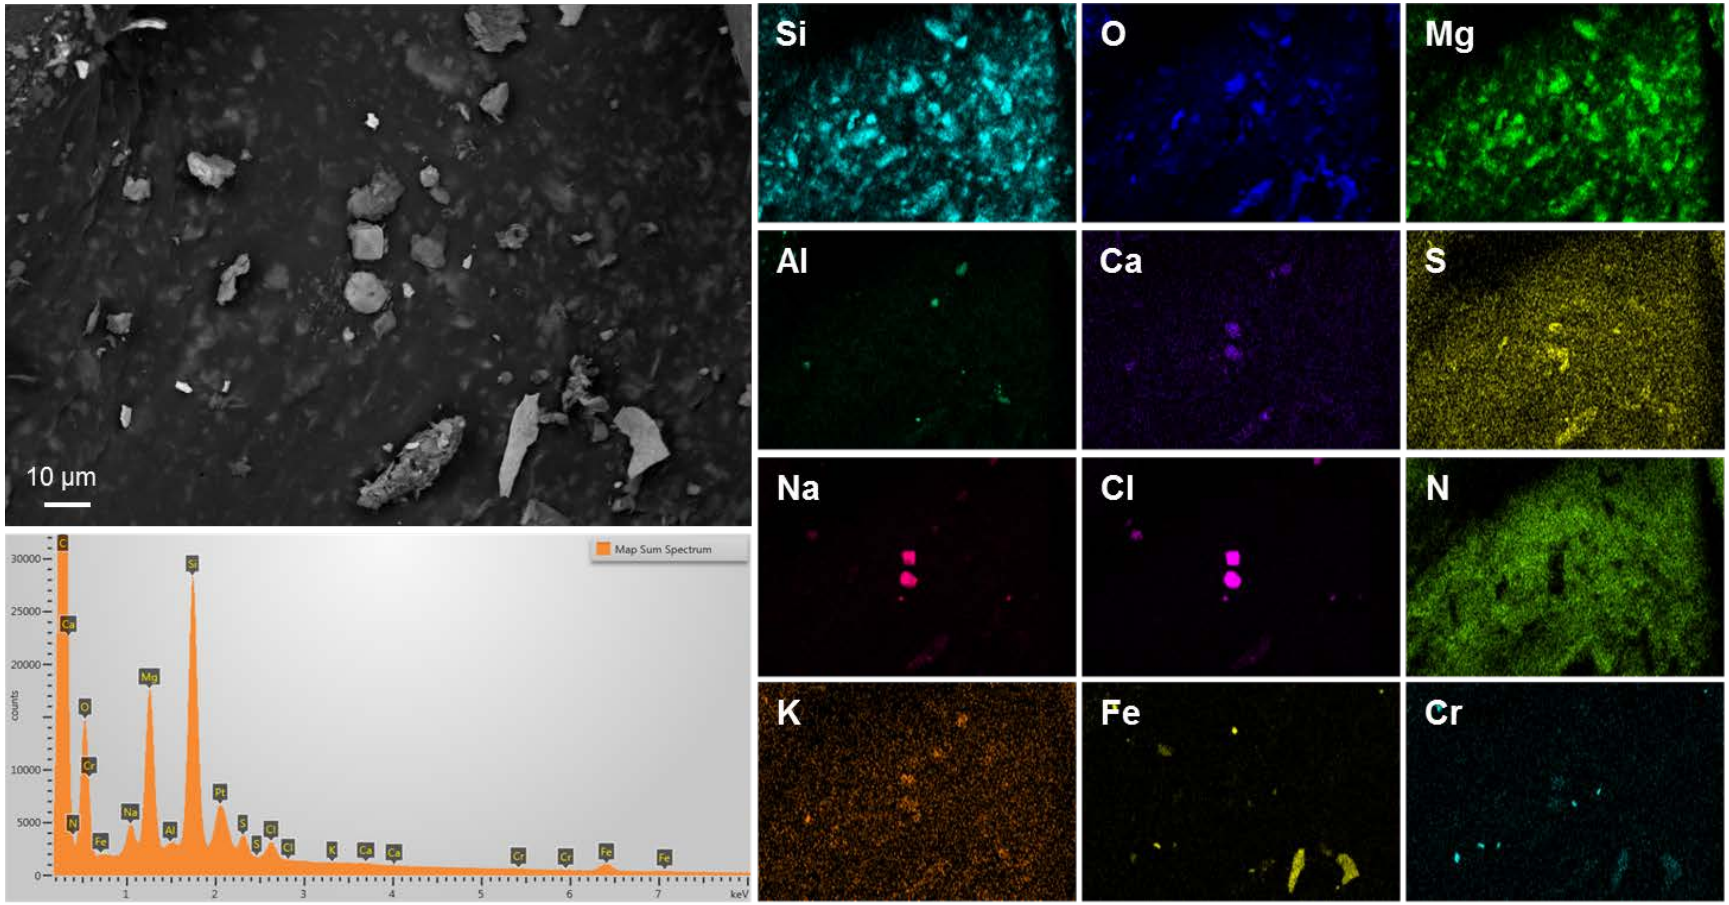
SEM/EDS data for sample 123-006 collected 11.0 feet below the upper edge of the canister, are shown in Figure 24 and Figure 25. Dust was sparse on this sample, but in Figure 24, several

phases can be recognized, including quartz, K-feldspar, and a Ca-O phase which is probably calcium carbonate. This image also illustrates the variability in the Fe-bearing phases present in the dust. In addition to Fe-oxides, there is a large particle of Fe-Cr (stainless steel) and a sphere of Fe-Cr oxide, apparently an oxidized melt droplet formed by welding or cutting stainless steel. Figure 25 shows a few grains of NaCl; interestingly, the associated sulfate appears to be Ca-SO_4 rather than Mg-SO_4.

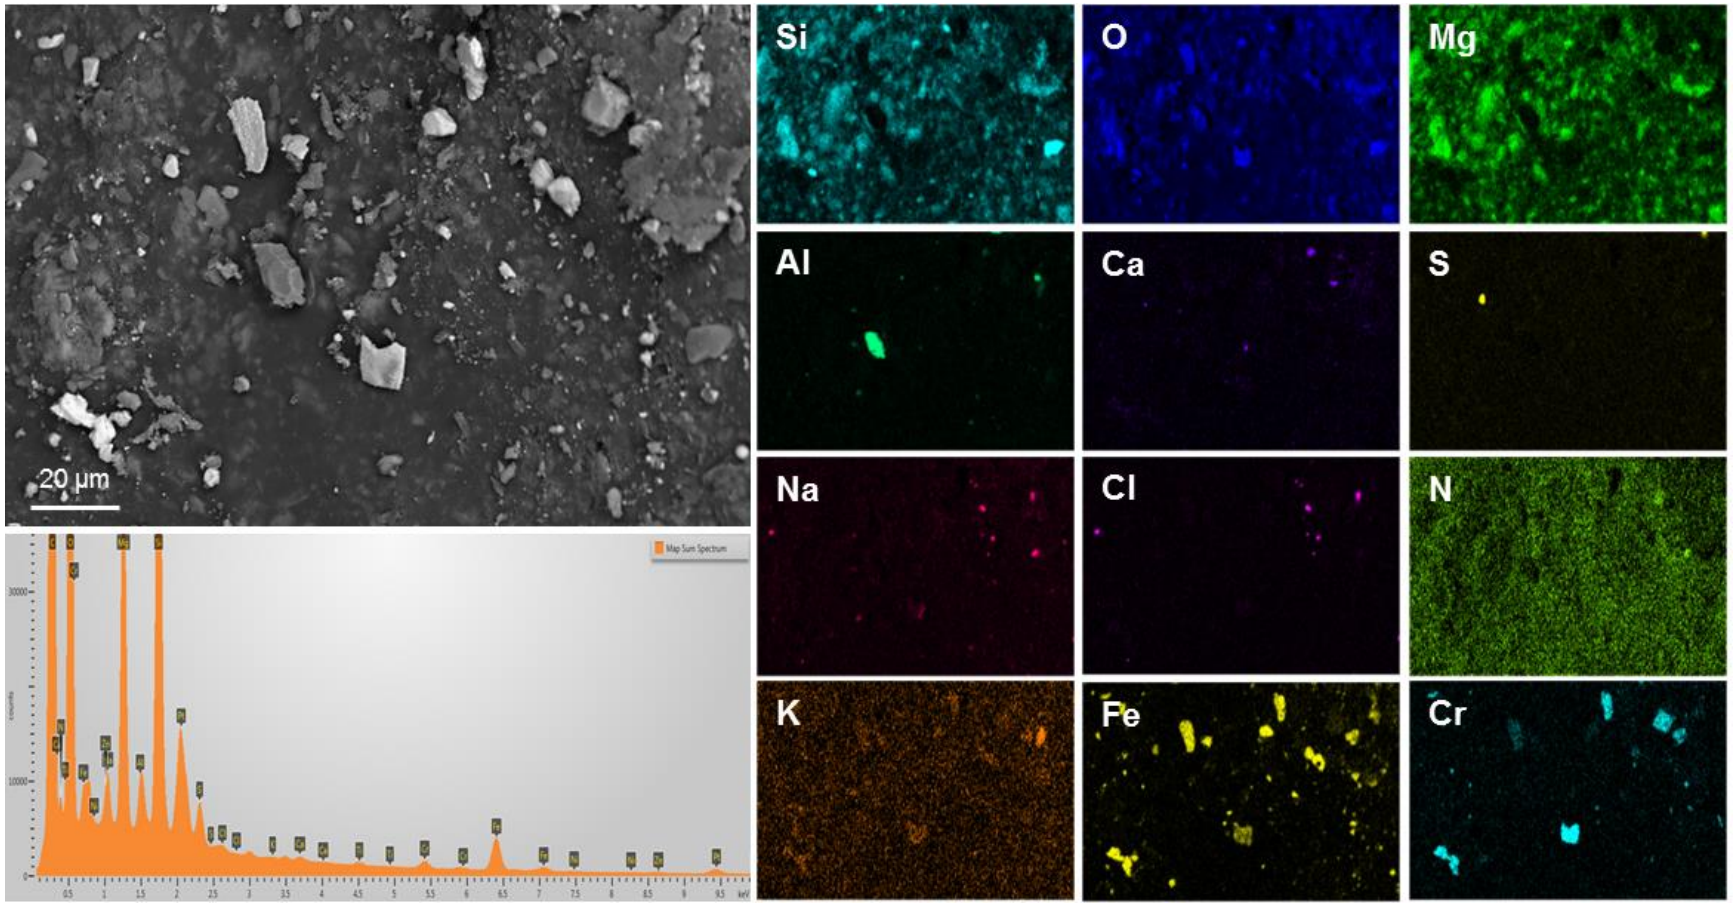
Figure 26. SEM image/EDS map (#1) of sample 123-008, collected from the canister side, 7.5 feet below the upper edge.

Dust on sample 123-008, somewhat higher on the package, has a similar mineralogy (Figure 26) in that Fe-bearing phases seem to dominate. Steel particles of varying degrees of oxidation, including Fe-Cr (stainless steel), Fe-Cr oxide, Fe metal and Fe oxide are common. Also present is a single grain of pyrite (Fe-S), and a grain of an Al-O-(H?) phase. A few tiny grains of NaCl are present, but also a particle of $NaNO_3$; a third grain appears to be mixture of the two salts.
