SANDIA REPORT

SAND2014-16383
Unlimited Release
Printed July 2014

Analysis of Dust Samples Collected from Spent Nuclear Fuel Interim Storage Containers at Hope Creek, Delaware, and Diablo Canyon, California

Charles R. Bryan and David G. Enos

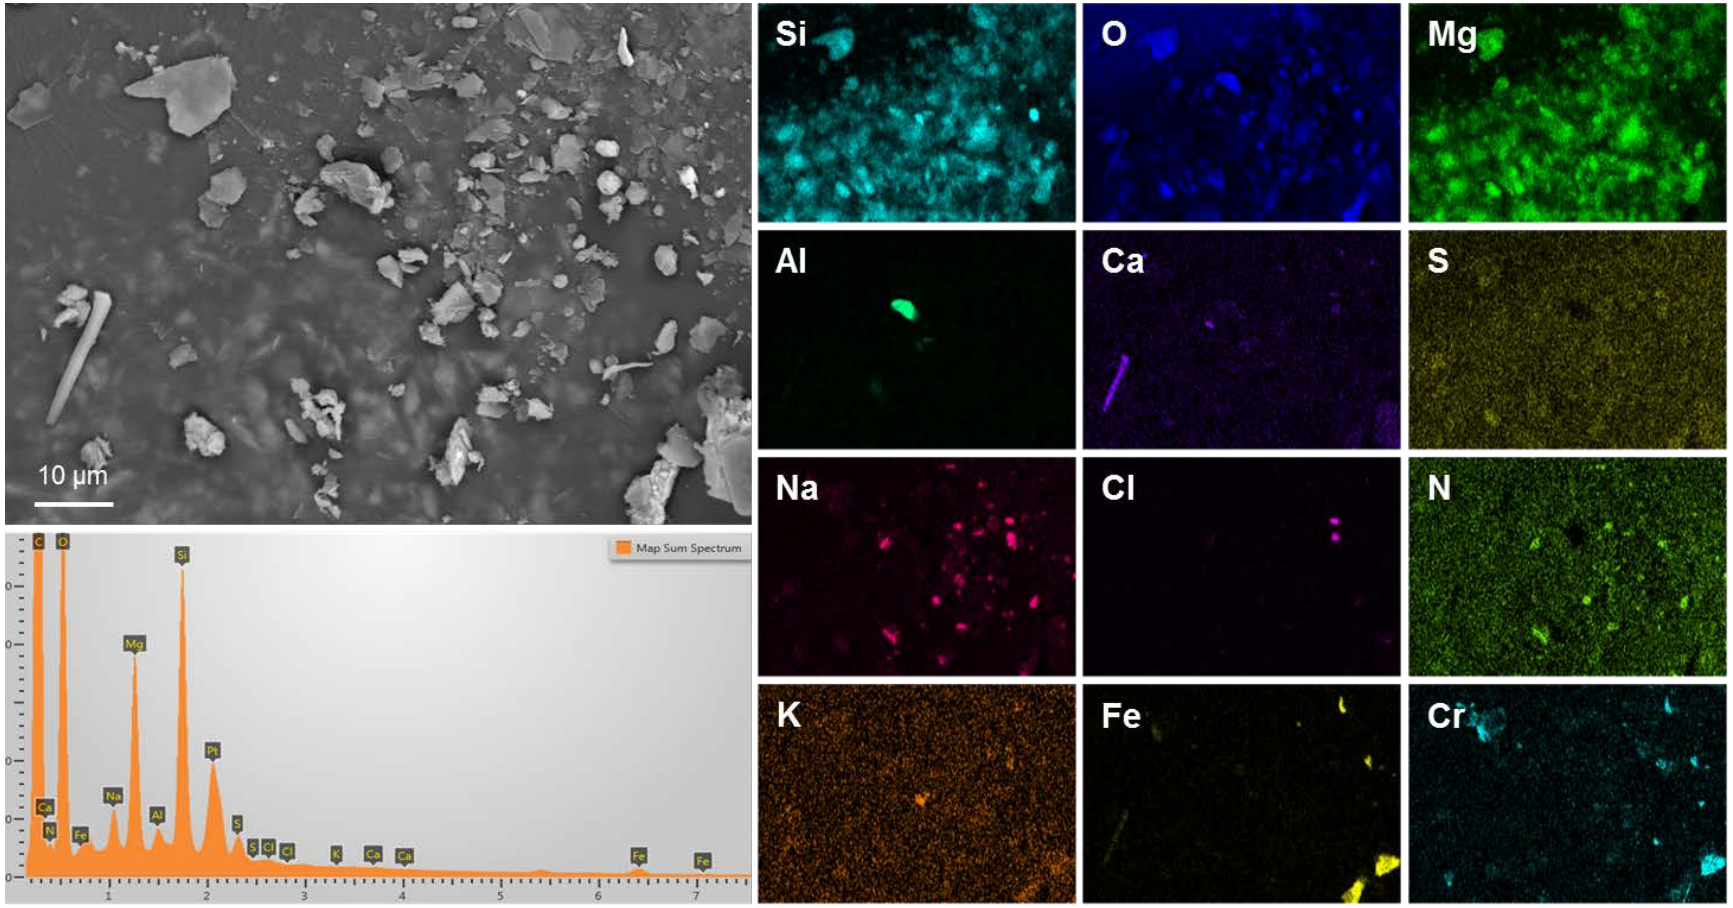
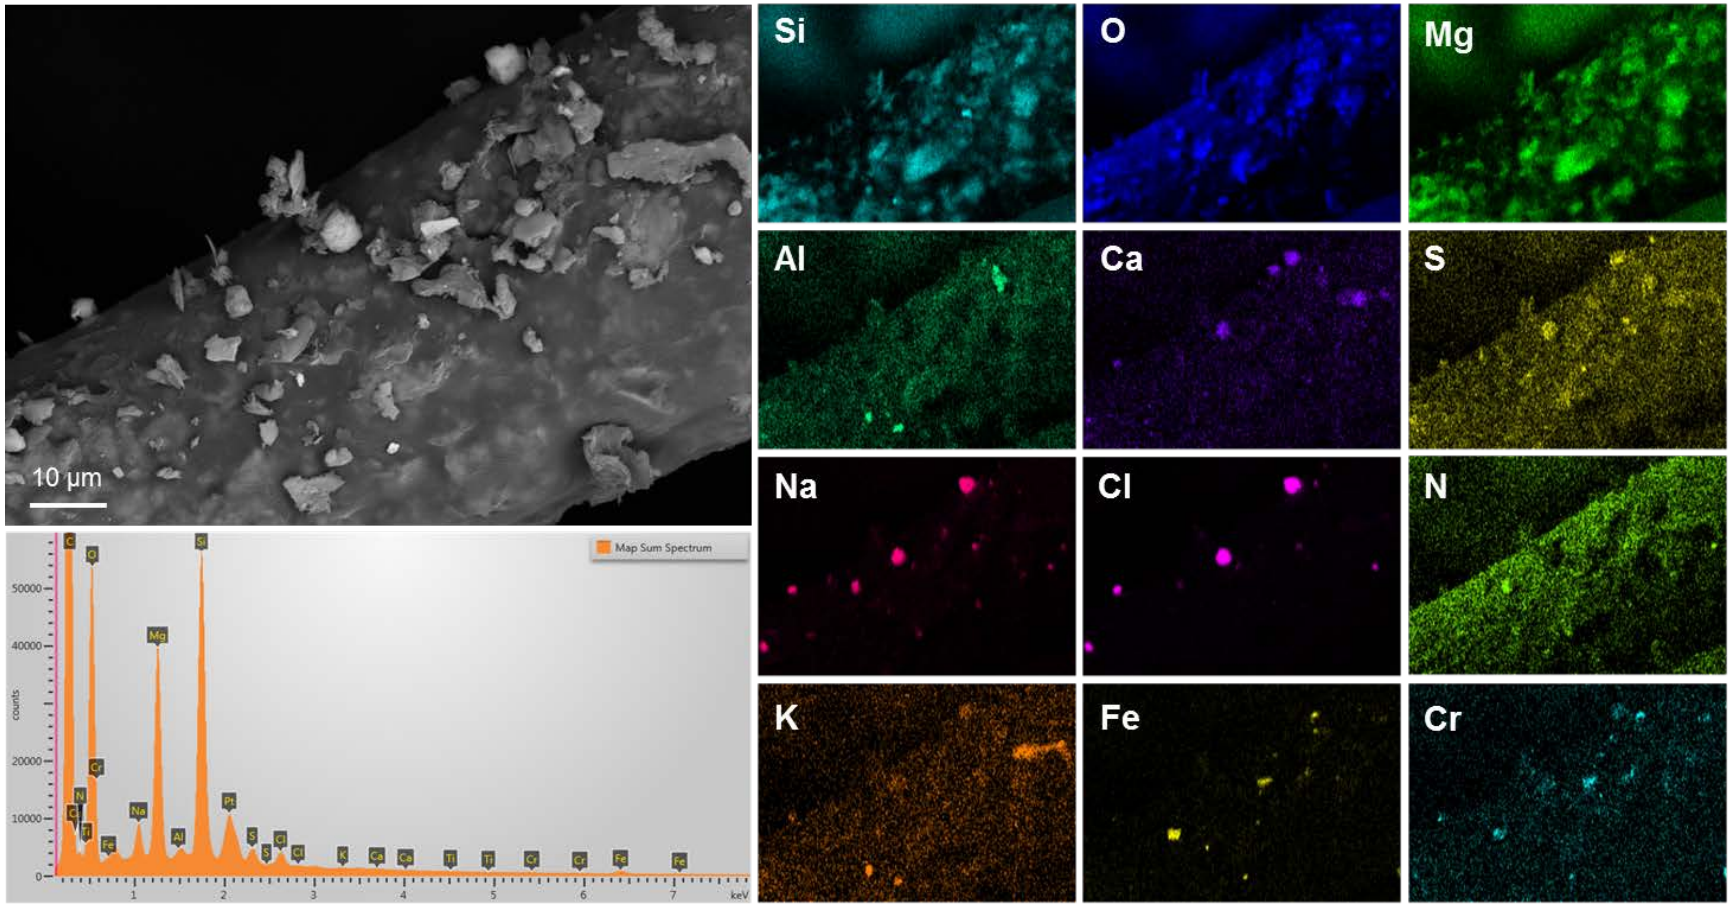
SEM/EDS data for 123-009 are shown in Figure 27 and Figure 28. This sample represents the canister side just below the upper edge, and it was the hottest sample collected. As with the other canister side samples, dust was very sparse. Figure 27 shows little but Fe-Cr particles and salts. The salts are mostly $NaNO_3$ particles, with only a few NaCl grains. Other maps from sample 123-009 in Appendix A show composite NaCl-$NaNO_3$ particles. For these composite grains; it was observed that the X-ray beam caused the grains to shrink. The relative amount of nitrogen present decreased the longer the grain was in the beam. For these composite grains, it appears that the nitrate is mostly present on the surface of the NaCl grains. A 20 µm Ca-carbonate rod of probable biogenic origin is also present in Figure 27. Figure 28 shows another part of the pad. In this area, NaCl is more common, although$NaNO_3$ is still present. The NaCl grains are co-located and apparently intergrown with a Ca-S-O phase (calcium sulfate).

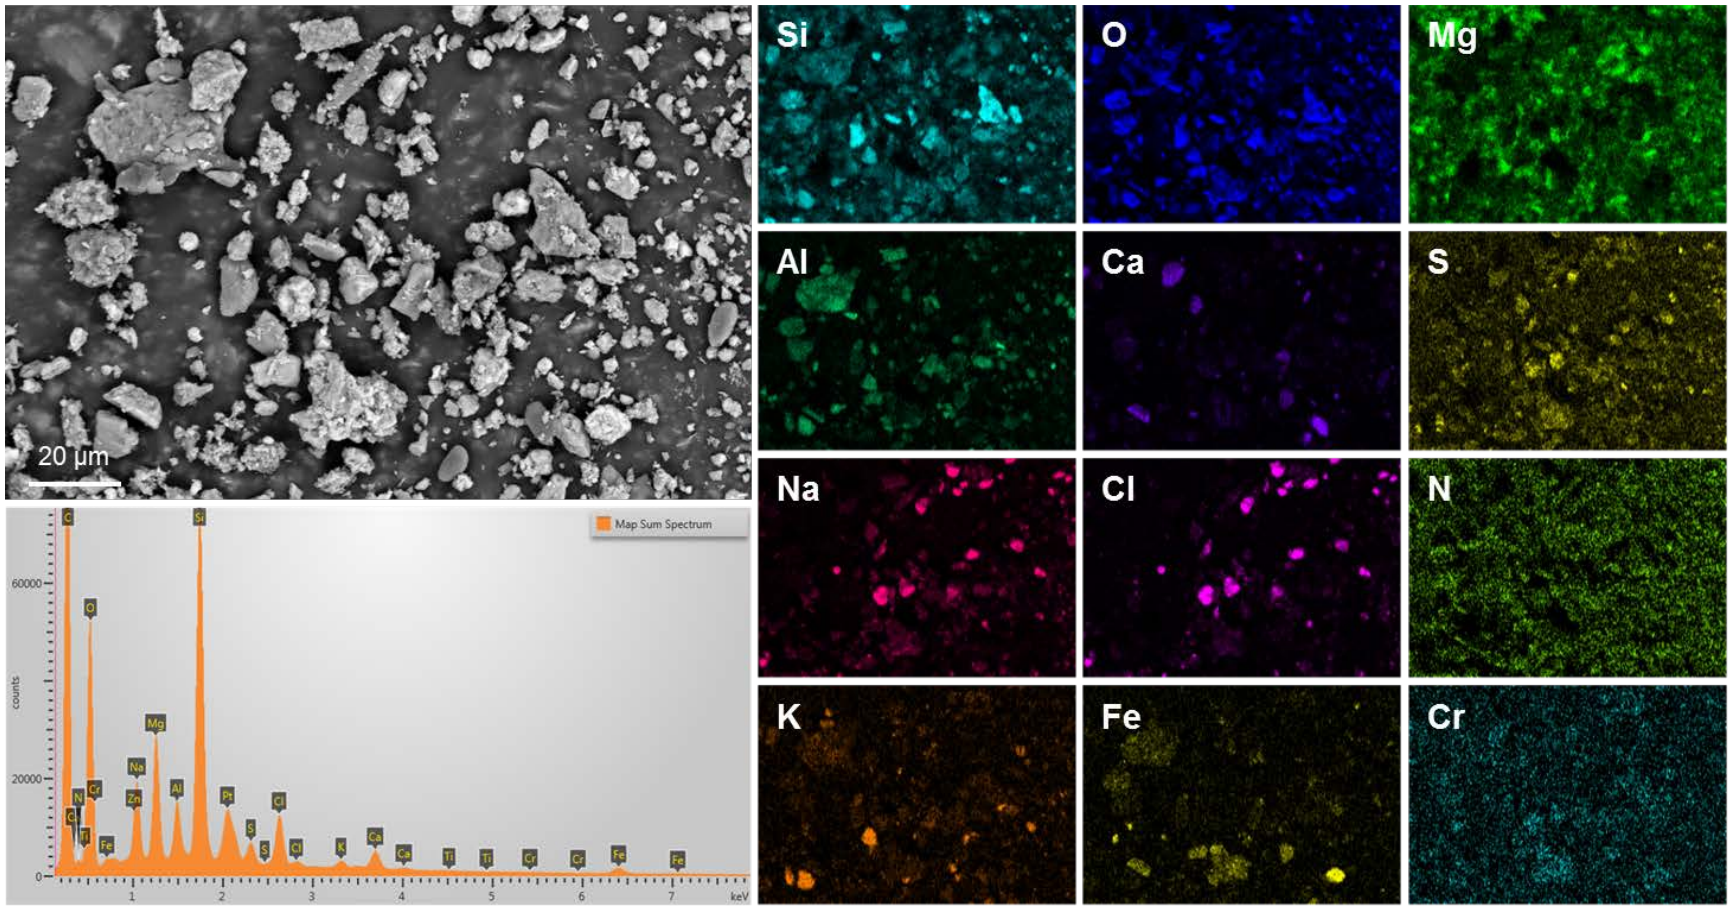
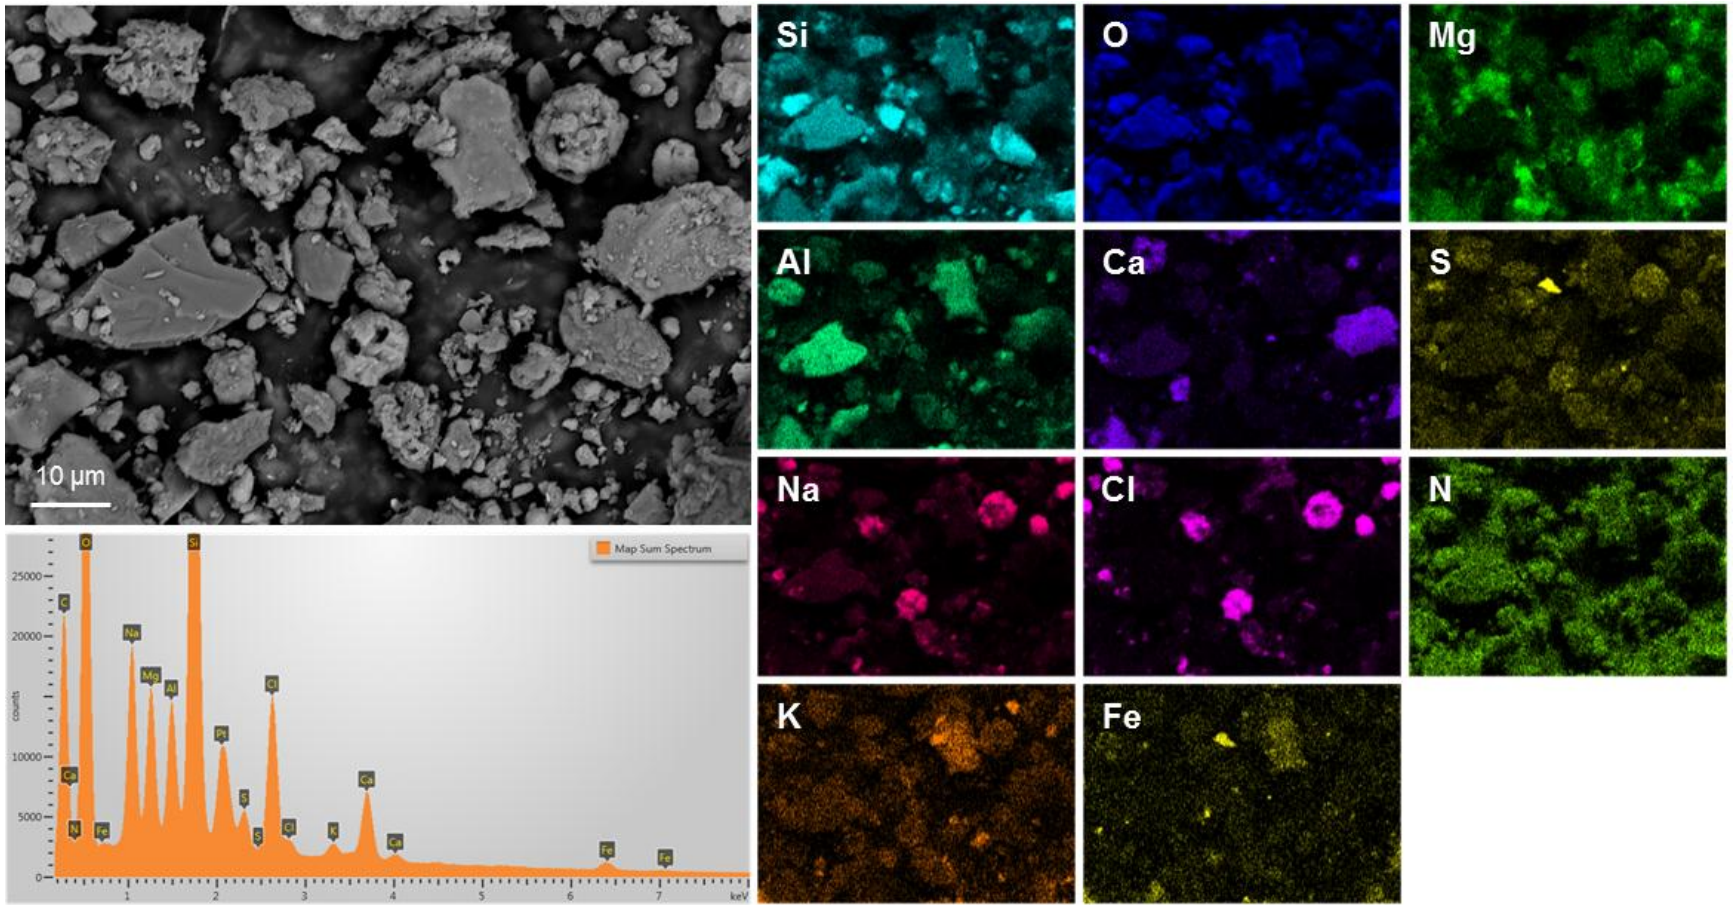
Sample 123-012 is from the top of the canister, and is heavily loaded with dust. Moreover, the dust compositions vary significantly from the samples collected from the sides of the canister. Figure 29 and Figure 30 show SEM/EDS maps of the sample. The mineralogy is similar in both cases. Salt aggregates, consisting of NaCl + Mg-SO_4 (referred to as Mg-SO_4 rather than $MgSO_4$, because the hydration state is unknown), with minor associated Ca and K, are abundant in the dust. These aggregates are commonly hollow spherical aggregates of halite crystals with intergrown Mg-sulfate, but euhedral halite crystals with associated Mg-sulfate also occur. As Na, Cl, Mg, and SO_4 are the most abundant ionic species in seawater, these are certainly sea-salt aggregates. The hollow spheres formed when droplets of seawater, suspended in the air by breaking waves, evaporated from the outside inwards. They commonly have an aperture, apparently where the last fluid escaped. As morning fogs are common at Diablo Canyon, it is likely that this evaporation occurred, in many cases, within the overpack as the deliquesced sea-salt droplets were drawn in and moved upwards through the heated annulus. Figure 29 illustrates the abundance of salts in the dust, and Figure 30 is a close-up of three salt aggregates, showing the size and morphology. Figure 31 magnifies a single sea-salt aggregate, showing the structure of the aggregate, and the relationship between the NaCl crystals and the interstitial Mg-SO_4. Several examples of the sea-salt aggregates from sample 123-012 are shown in Figure 32. While salt particles of all sizes are present on the canister surfaces, the aggregates are commonly quite coarse, in the 5-20 µm size range, and it is likely that these large grains account for most of the chloride deposited on the canister surfaces.

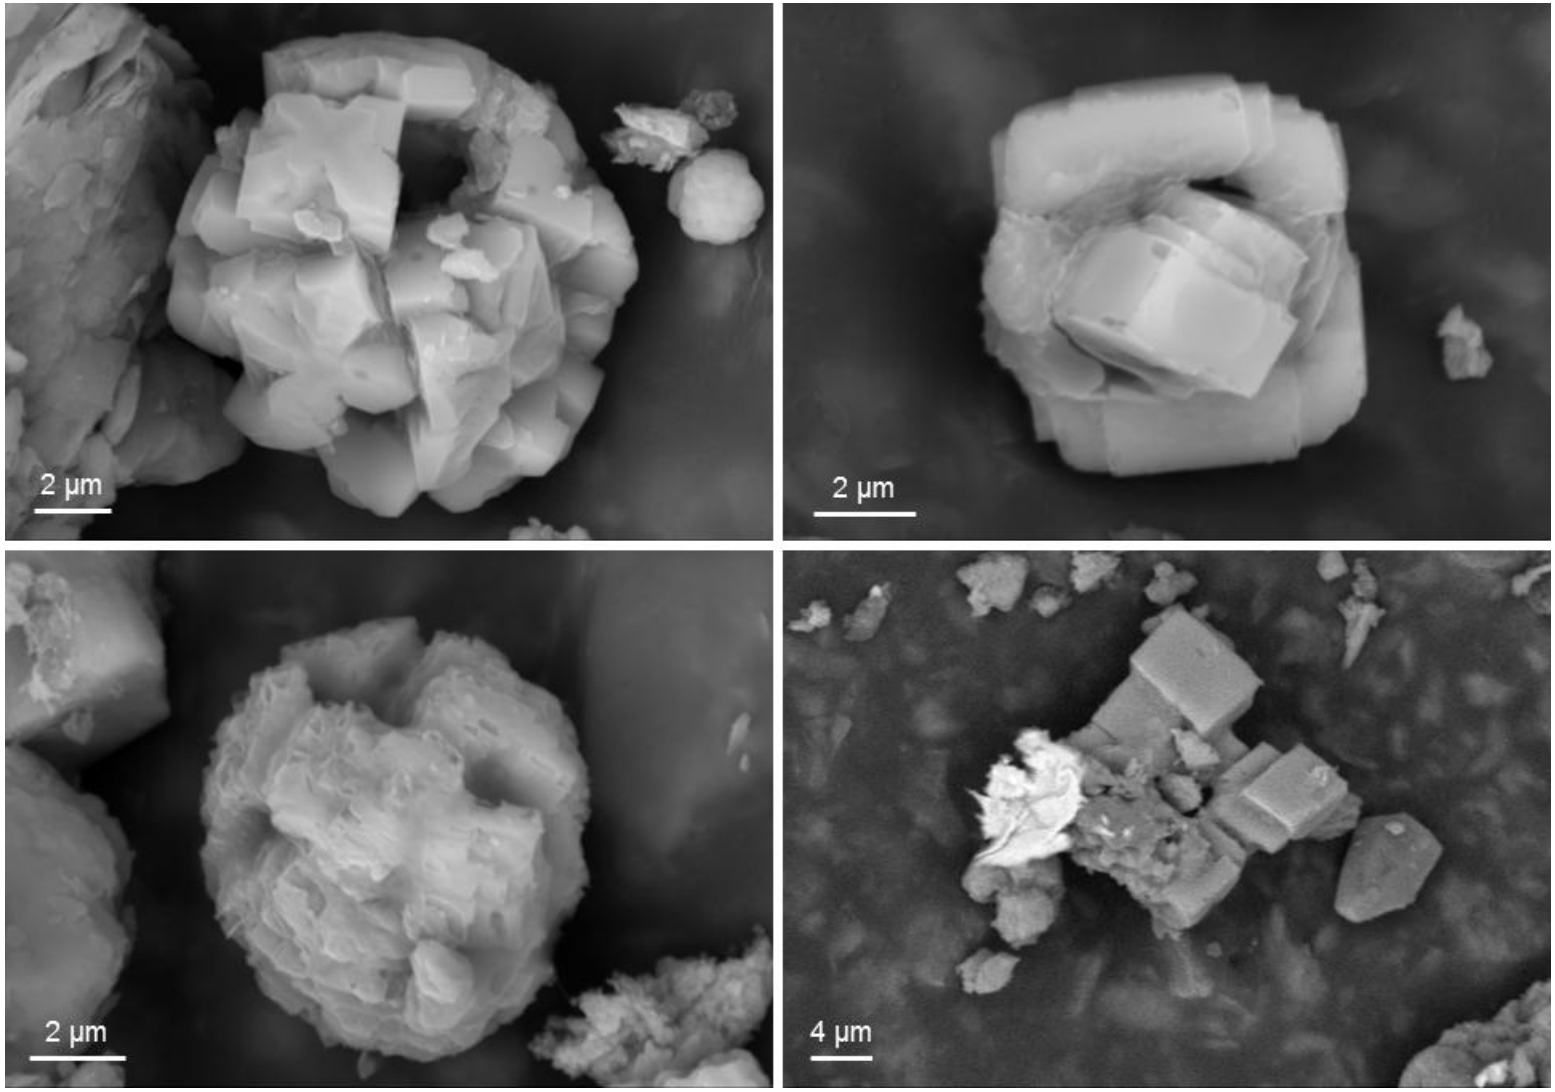
Figure 32. SEM images of sea-salt (intergrown NaCl cubes with interstitial Mg-SO_4) aggregates in sample 123-012, collected from the canister top.

on the top, and not on MPC-170. Salt particles on the sides of the canister are generally smaller than those on the top—perhaps the compositional difference is a function of particle size. Temperature may also play a role—the greatest abundance of nitrate-containing particles is on the sample from the hottest location (sample # 123-009) on the package. We speculate that the nitrate represents particle-gas conversion reactions that occurred prior to the salts entering the overpack—reactions with HNO_3 in the air that convert chloride particles to nitrates. This process is more efficient for small particles, and results in a NaCl mineral partially converted to $NaNO_3$. At high canister surface temperatures, nitrate and mixed chloride-nitrate particles were preserved on the canister surface, because deliquescence and acid degassing could not occur. At lower temperatures, deliquescence occurred and both HCl and HNO_3 degassed; however, chloride was replenished by dissolution of the abundant chloride minerals. Replenishment of nitrate did not occur, so the nitrate was eventually depleted. This also explains the corroded surface of many of the NaCl crystals on the canister surfaces (see, for instance, Figure 32).

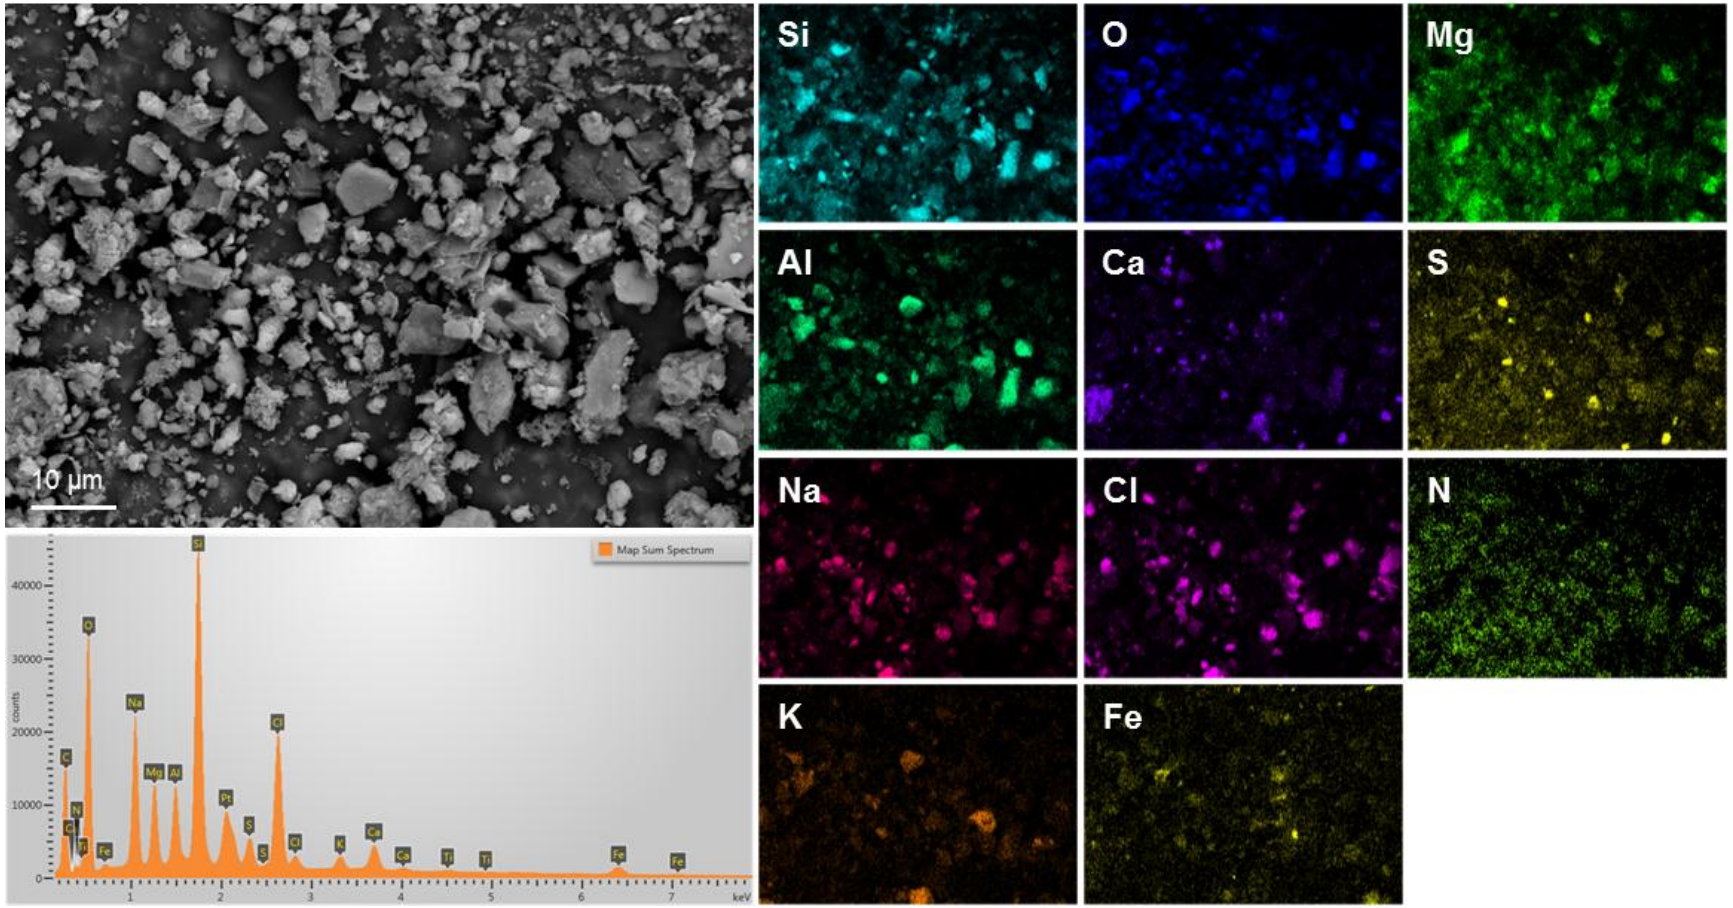
Sample 170-003 was collected from the flat top of the canister, and the pad was heavily loaded with dust. Figure 38 shows a typical region on the pad. The dust consists largely of aluminosilicate minerals, with common sea-salt aggregates of intergrown NaCl and Mg-SO_4; Ca-SO_4 is also common as a separate phase. Figure 39 shows a similar region, with similar mineralogy, but somewhat coarser dust and sea-salt particles. A magnified view on one of the sea-salt particles is shown in Figure 40; this particular grain consists of intergrown halite and Mg-sulfate, and does not appear to be hollow.

Figure 38. SEM image/EDS map (#1) of sample 170-003, collected from the canister top.

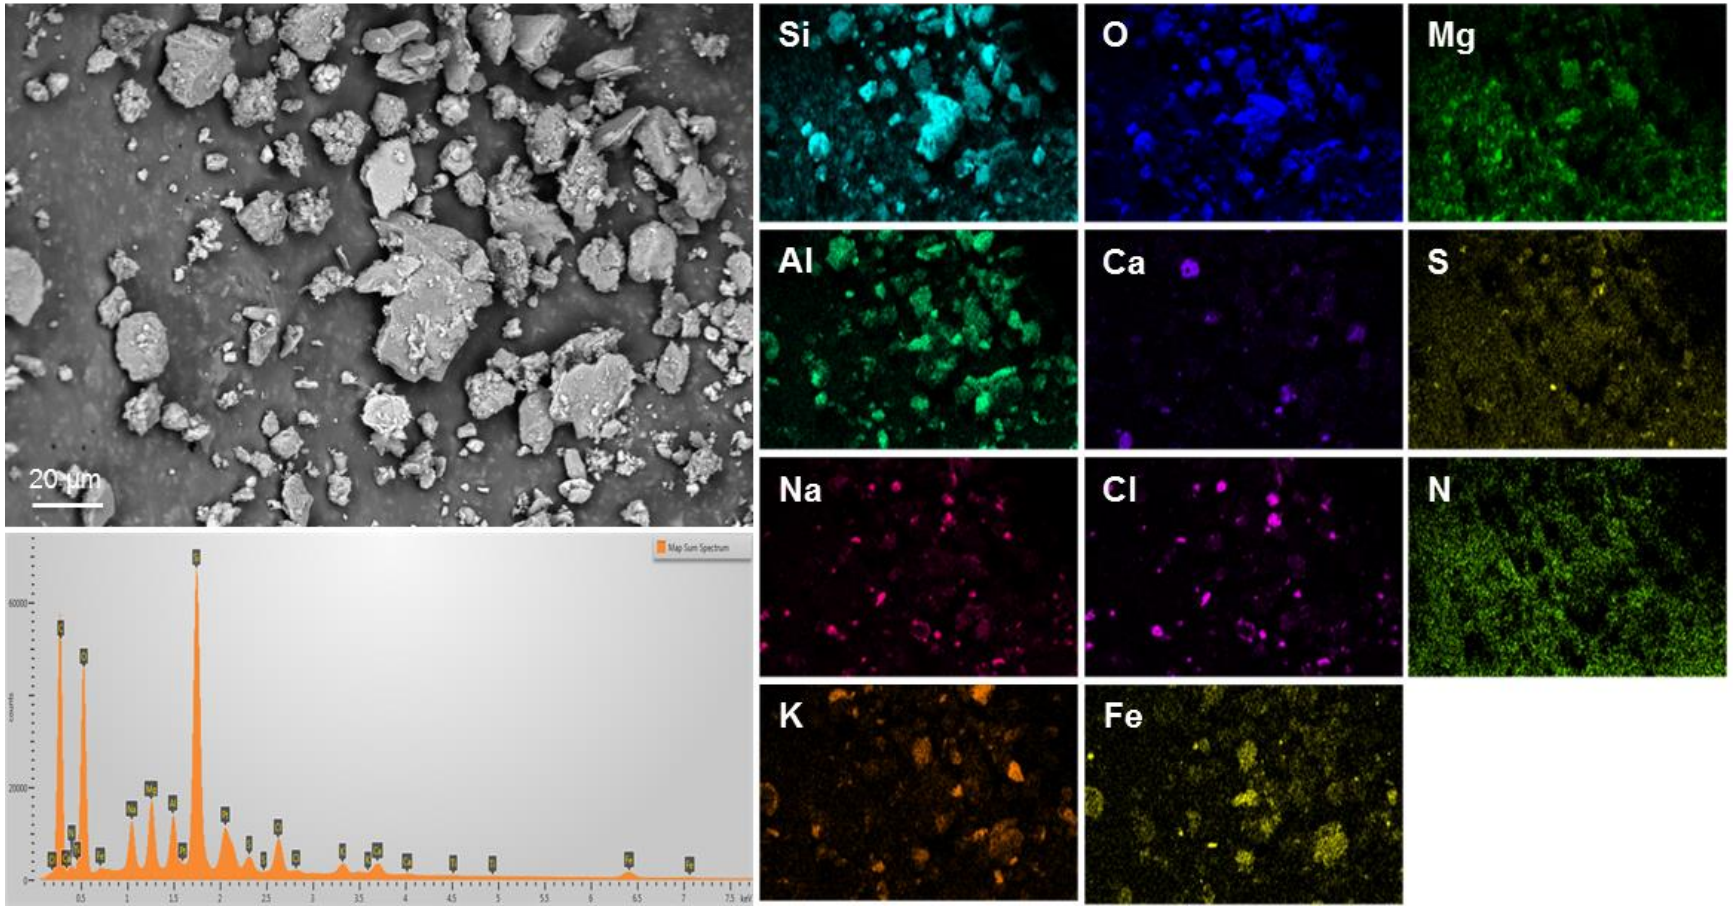
Figure 39. SEM image/EDS map (#2) of sample 170-003, collected from the canister top.

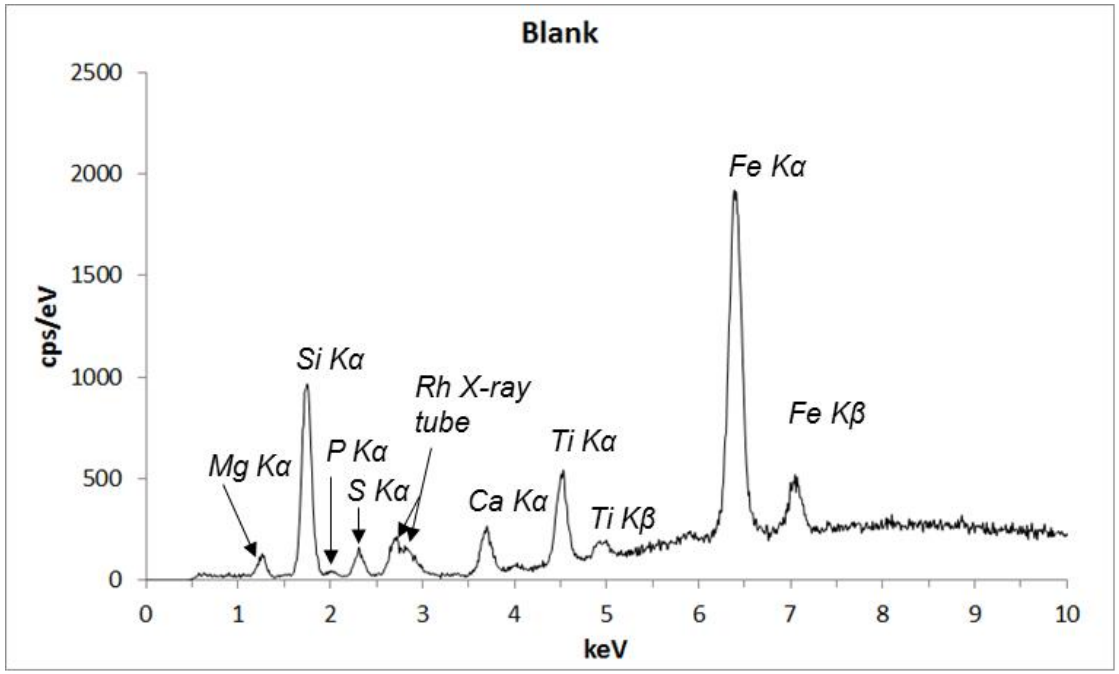
Blanks. The XRF pattern and qualitative analysis results for the pad blank are shown in Figure 42. Although the pad was intended to be mineral-free, it actually contained talc ($Mg_3Si_4O_{10}(OH)_2$ as a filler material. This resulted in large Mg and Si peaks in the blank, and large estimated concentrations of Mg and Si in the blank pad (red boxes in Figure 42). Other compounds present in the pad include Ti, which is probably present in the oxide form as a white pigment, Ca, P, and S. All of these elements contribute to the measured XRD signal, but not all can be leached from the pad. The Mg, Si, Fe, Ti, and Ca appear to be sequestered in insoluble compounds in the pad. However, PO_4, SO_4, and Na leach from the pad in large concentrations and interfere with measurement of these elements in the dust soluble fractions leached from the pads. Note that Na does not appear in the X-ray spectrum because of the low sensitivity of the method for this element.

Figure 42. XRF pattern and XRF qualitative analysis results for the pad blank.

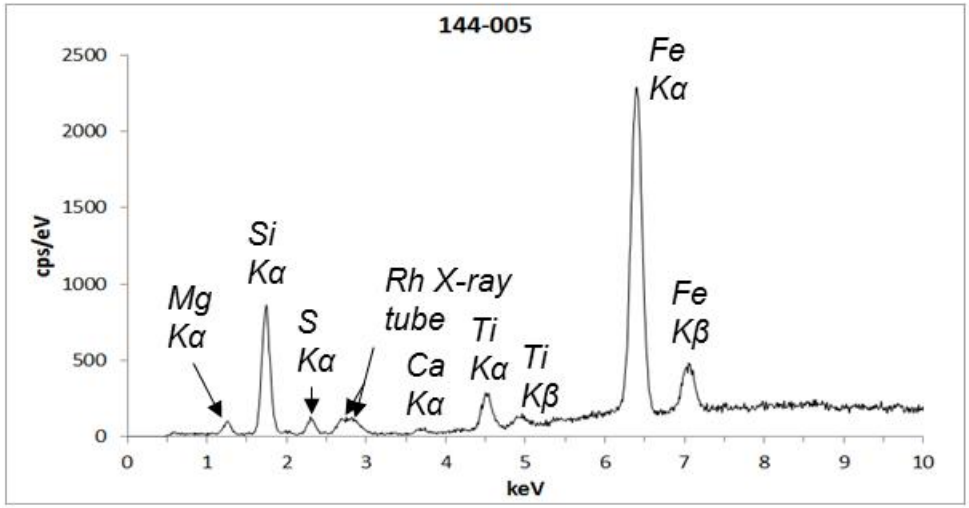
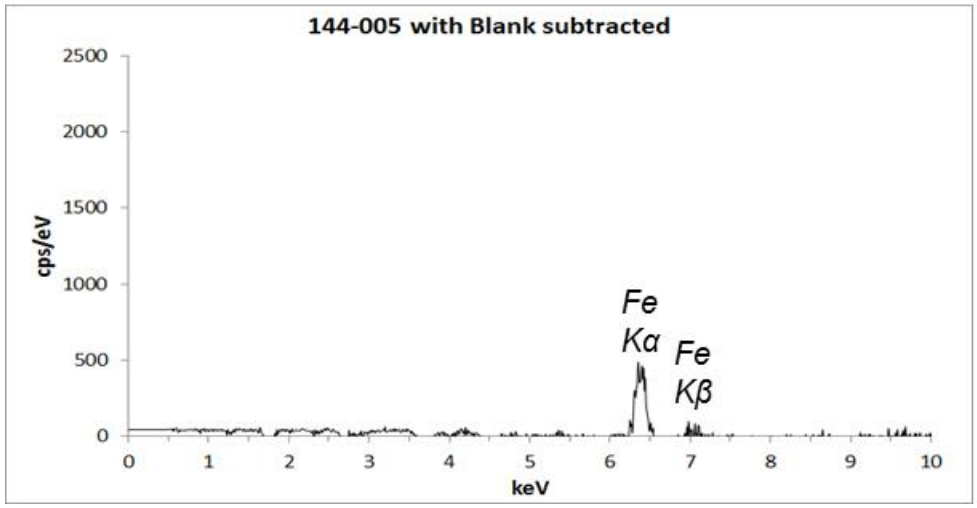
Canister side samples. For both Hope Creek and Diablo Canyon, the dust loads on samples from the sides of the canisters were very light, and the XRF patterns and analyses varied little from the blank (see Appendix B). Typically only Fe and Si were enriched relative to the blank. An example pattern for the lightly-coated canister side samples is represented by Hope Creek sample 144-005 (collected 13.5 feet below the upper edge of the canister) in Figure 43. The initial X-ray

Figure 43. XRF pattern and XRF qualitative analysis results for Hope Creek sample 144-005, from the side of the canister.

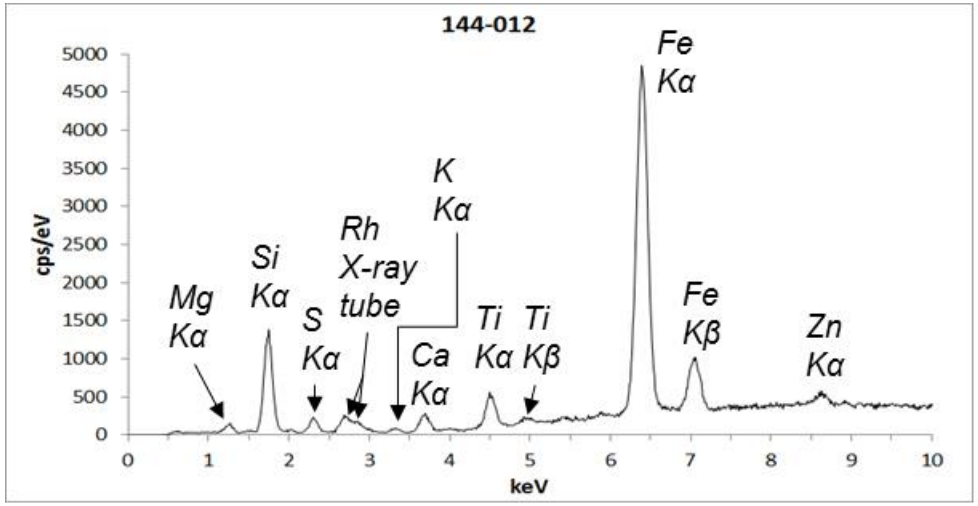
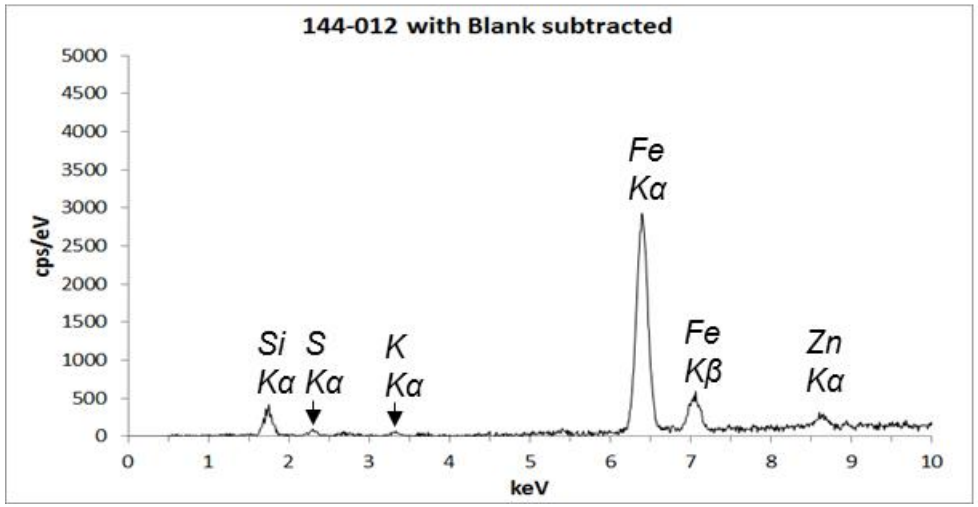
Canister top samples. For samples from the tops of the canisters, where the salt loads are higher, there is a clear X-ray contribution from the dust on the filters. Results for Hope Creek sample 144-011 are shown in Figure 44. Relative to the blank, several elements are significantly enriched, including Fe, Si, Zn, Ca, K, and S. The enrichment in Fe is consistent with the SEM observations of abundant stainless steel particles and Fe-oxides in the dust; and that of Si is consistent with the observations of abundant quartz and aluminosilicate minerals. Although Zn-rich particles, apparently from the paint on the outside of the overpacks, were only rarely observed, they are apparently the source of the Zn X-ray peak shown here. Minerals containing Ca, K, and S (as sulfate) were observed by SEM, and these elements comprise a large fraction of the soluble salts extracted from the pads (Section 3.3). These results are typical for the Hope Creek canister top samples.

Figure 44. XRF pattern and XRF qualitative analysis results for Hope Creek sample 144-011, from the top of the canister.

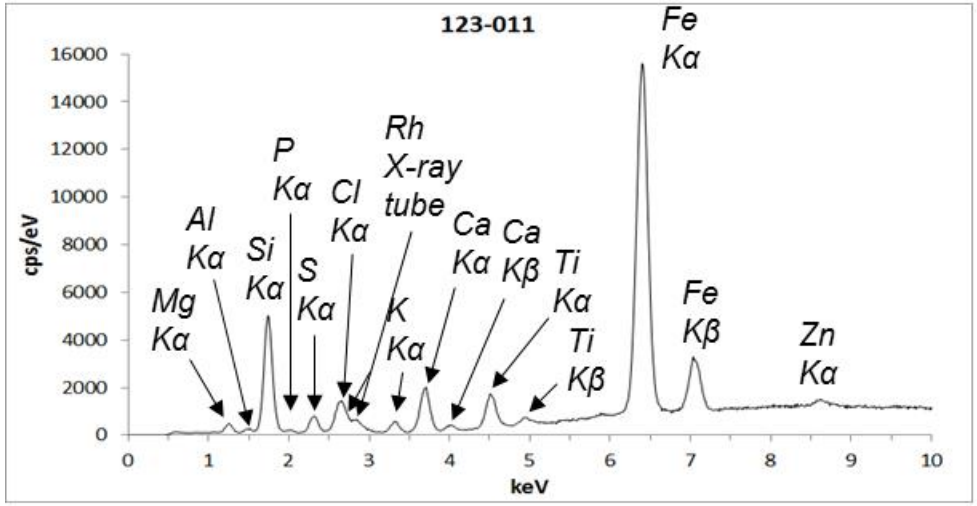
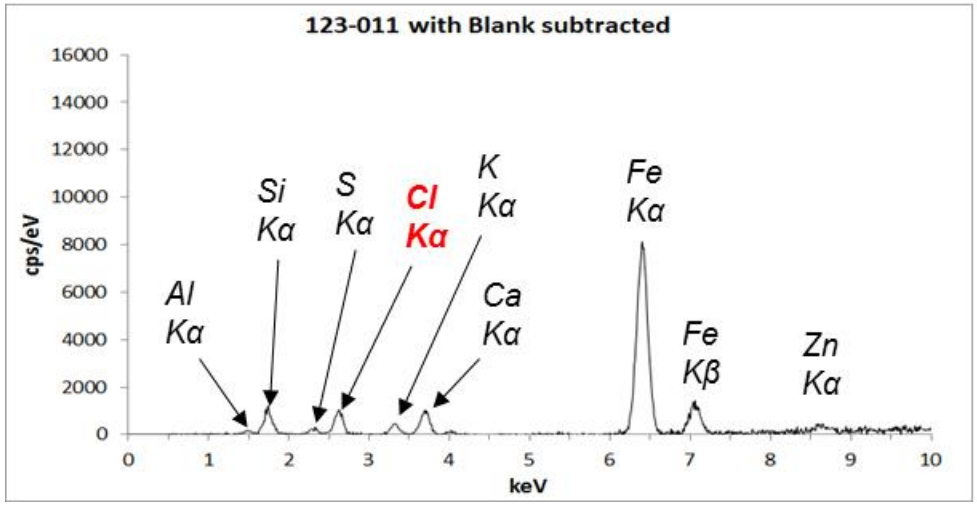
XRF analysis results for sample #123-011, a representative canister top sample from Diablo Canyon, are shown in Figure 45. Relative to the blank, the Diablo Canyon sample is enriched in Fe, Si, Zn, Ca, K, S, and Cl. In some other Diablo Canyon samples, peaks for Cr were also present. As with the Hope Creek samples, this is largely consistent with the phases identified in the dust by SEM. Given the prevalence of sea-salt aggregates, one might expect to see peaks for Mg and Na as well; however, the method sensitivity for Mg is low, and for Na, very low. The detection of Cl and Zn, and of Cr in some other samples from Diablo Canyon (Appendix B), is convincing, because these elements do not occur in the blank.

Figure 45. XRF pattern and XRF qualitative analysis results for Diablo Canyon sample 123-011, from the top of the canister.

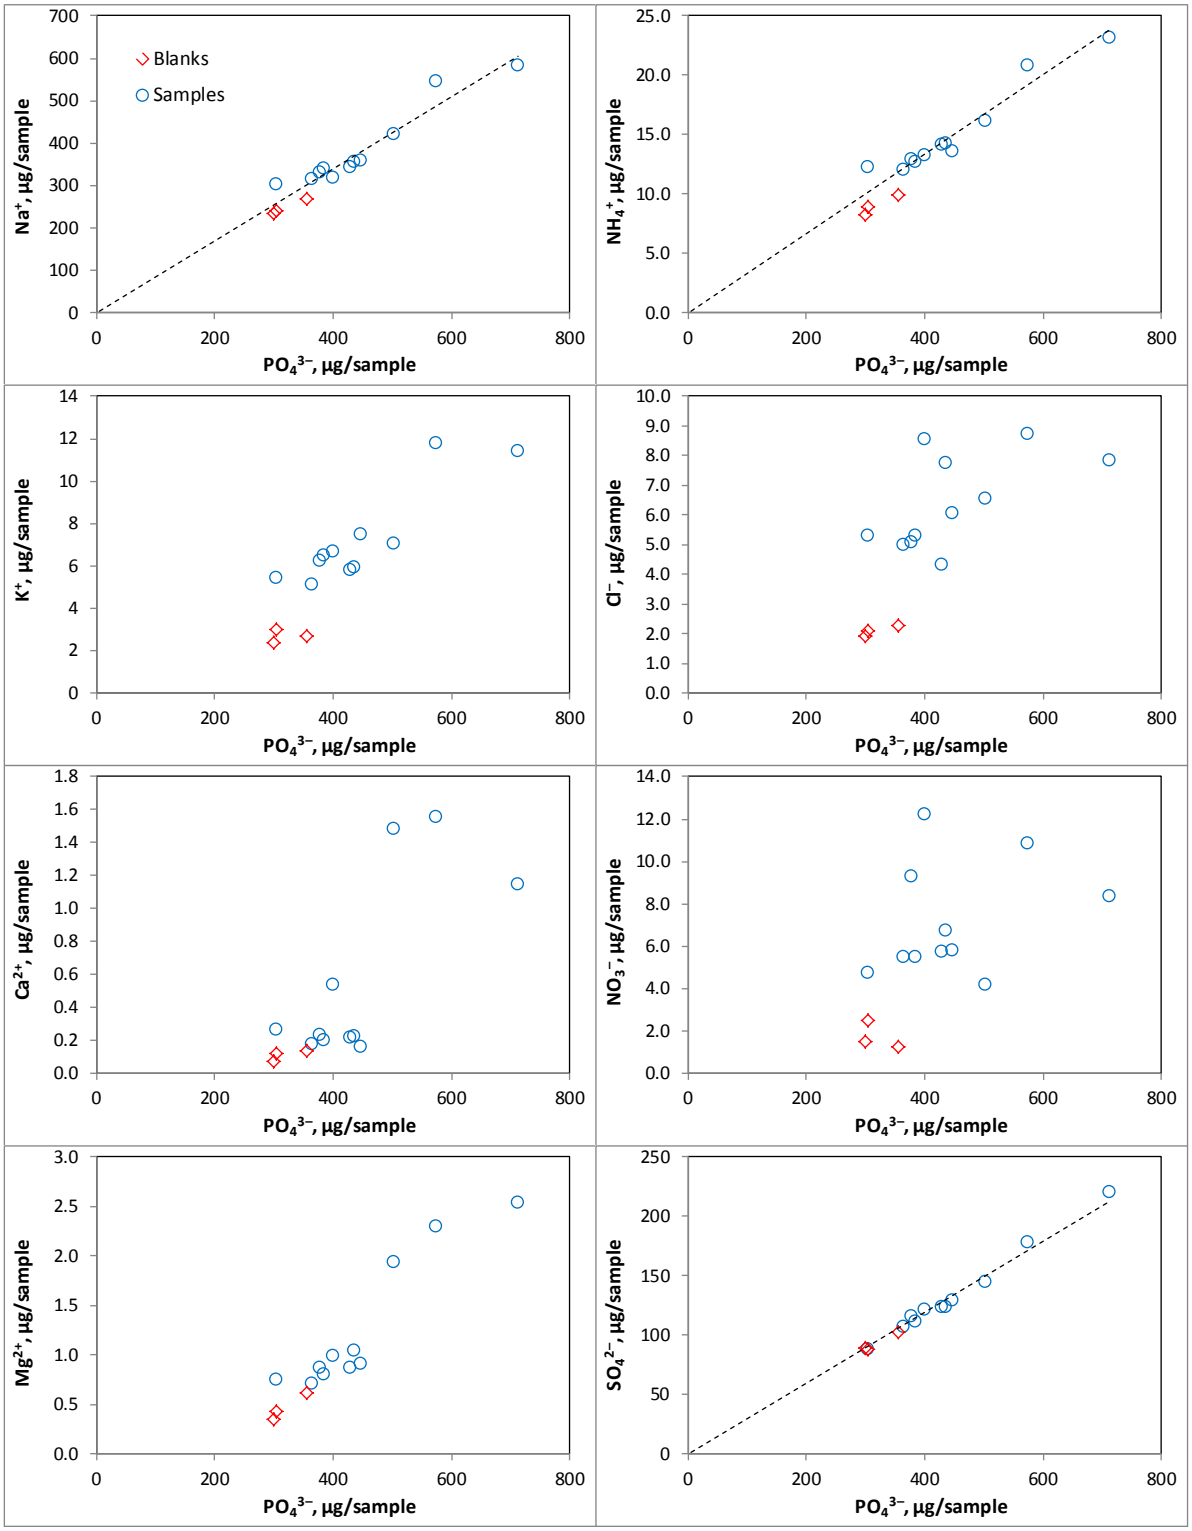
As shown in Table 12, large quantities of Na^+, SO_4^{2-}, and PO_4^{3-} leach from the pad matrix, making quantification of these elements in any adhering dust impossible. Leachable amounts of each of these species are in the hundreds of micrograms per sample. If the concentrations of these species are entirely due to leaching from the pads, then the concentration of each should vary with the mass of the pad sample. While each of these species shows a strong trend with pad mass, there is significant scatter. The scatter could be due to contributions from dust, but is more likely due to variations in the pad matrix as discussed in Section 3.2. To address this, rather than plotting species concentrations against mass, it is more useful to plot them against PO_4^{3-}, a species that is unlikely to be present in the dust in any significant quantities (unlike Na^+ and SO_4^{2-}). These plots are shown in Figure 46. If the species is dominantly from the pad, then the blanks and samples should form a linear trend versus PO_4^{3-}, intersecting the origin of the plot. If the species is in the dust, or has a significant contribution from the dust, then it will not show a clear linear trend. There will still be a general increase in species concentration with PO_4^{3-}, however, because the larger sample pads were used on the canister tops and were more heavily loaded with dust. Examining the graphs, it is clear that, in addition to Na^+, SO_4^{2-}, and PO_4^{3-}, NH_4^+ is also leaching from the pads, and for all four of these, any contribution from the dust is negligible. K^+ and Mg^{2+} display weak trends, and may be partially derived from the pad. Other species such as Ca^{2+}, Cl^-, and NO_3^-, show no trend; these must be largely sourced to the dust.

Figure 46. Plots of soluble species concentration versus PO_4^{3-} concentration for the Hope Creek dry pad samples.

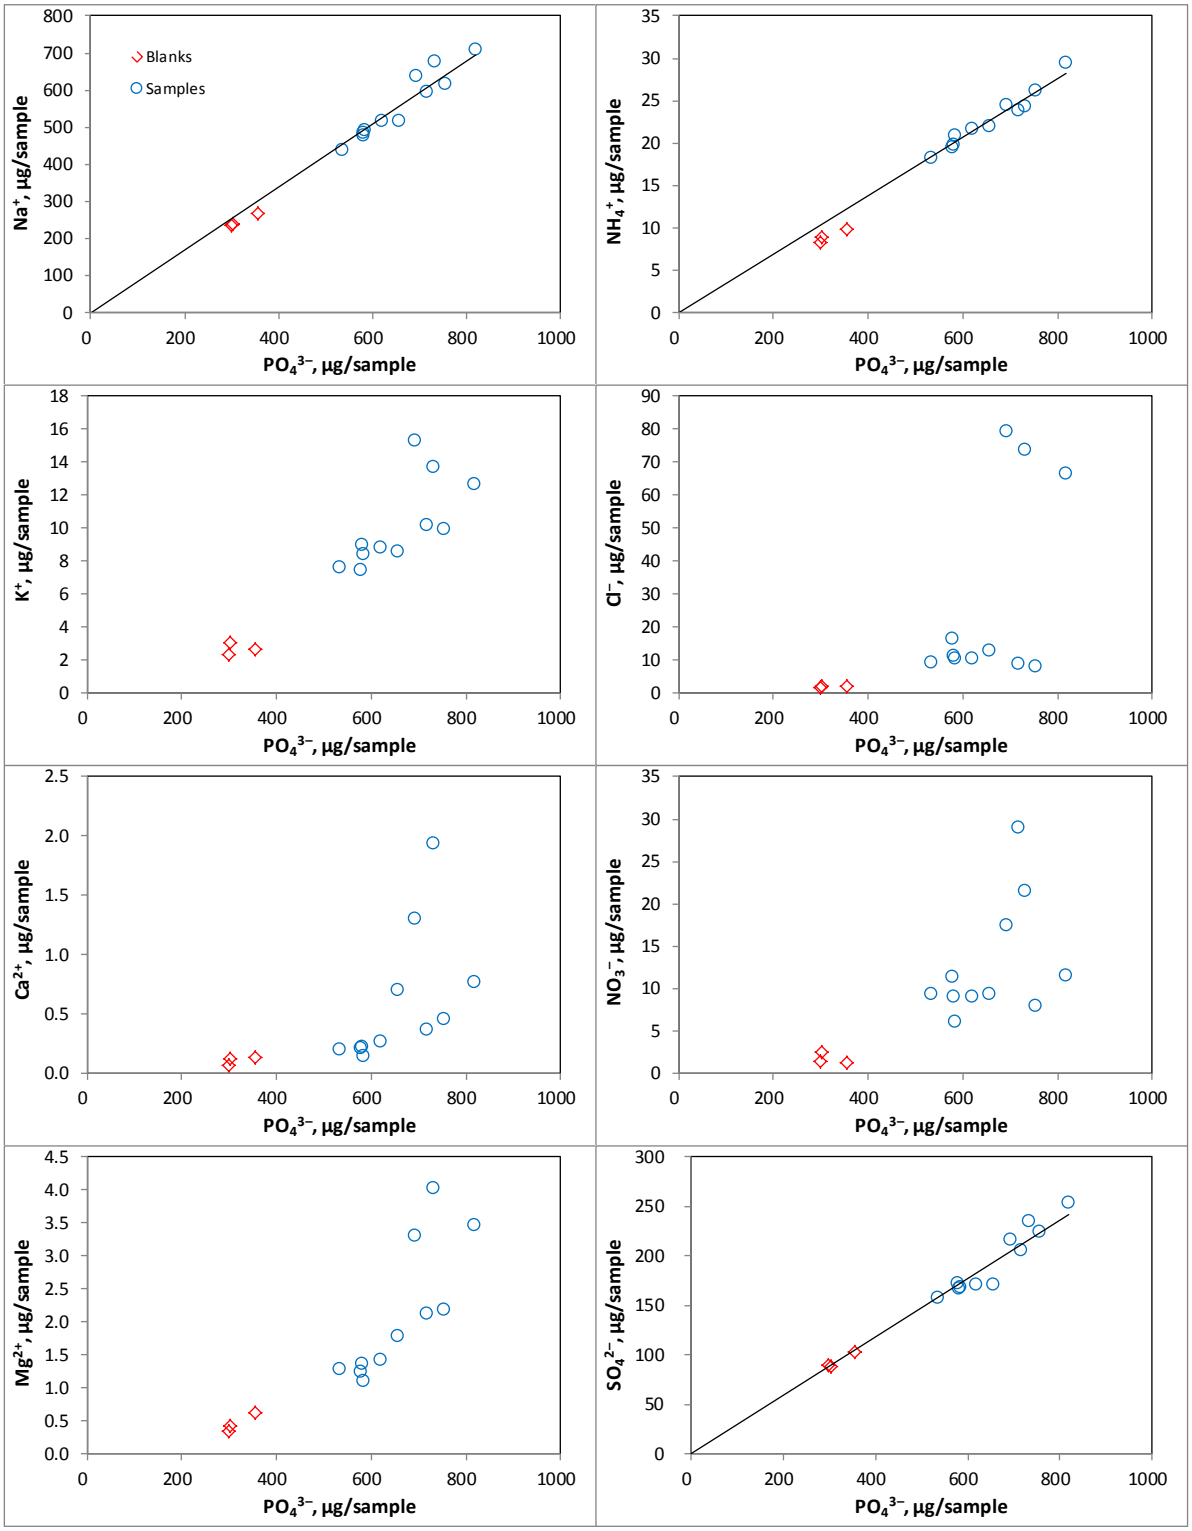
As with the Hope Creek samples, the Diablo Canyon dry pad samples were affected by large quantities of Na^+, SO_4^{2-}, and PO_4^{3-} leaching from the pad matrix, making quantification of these elements in any adhering dust impossible. Once again, we can plot each species against the concentration of PO_4^{3-} to assess whether there is any significant contribution from the dust (Figure 47). The species Na^+, SO_4^{2-}, and PO_4^{3-}, and NH_4^+ are clearly derived from the pad matrix, while K^+ and Mg^{2+} appear to be partially derived from the pad, but also to have a dust

Although the soluble salts are strongly affected by the effect of leaching from the pads, it is clear that both Cl and NO_3^- are enriched in all the samples relative to the blanks, and must be present in significant amounts in the dust. Moreover, samples from the tops of the canisters (the three points falling well above the trends in Figure 47) show the greatest enrichment in these species, reflecting the higher dust load on these samples. Ca, Mg, and K are also significantly enriched in the canister top samples, falling above the trends in Figure 47. Because sea-salts were commonly observed in the SEM analyses, we can infer that some fraction of the Na and SO_4 concentrations is also from the dust; however, any dust contribution to these species is insignificant relative to that of the pads, and these samples do not deviate significantly from the trend defined by the pad releases.

Figure 47. Plots of soluble species concentration versus PO_4^{3-} concentration for the Diablo Canyon dry pad samples.
