SANDIA REPORT

SAND2014-16383
Unlimited Release
Printed July 2014

Analysis of Dust Samples Collected from Spent Nuclear Fuel Interim Storage Containers at Hope Creek, Delaware, and Diablo Canyon, California

Charles R. Bryan and David G. Enos

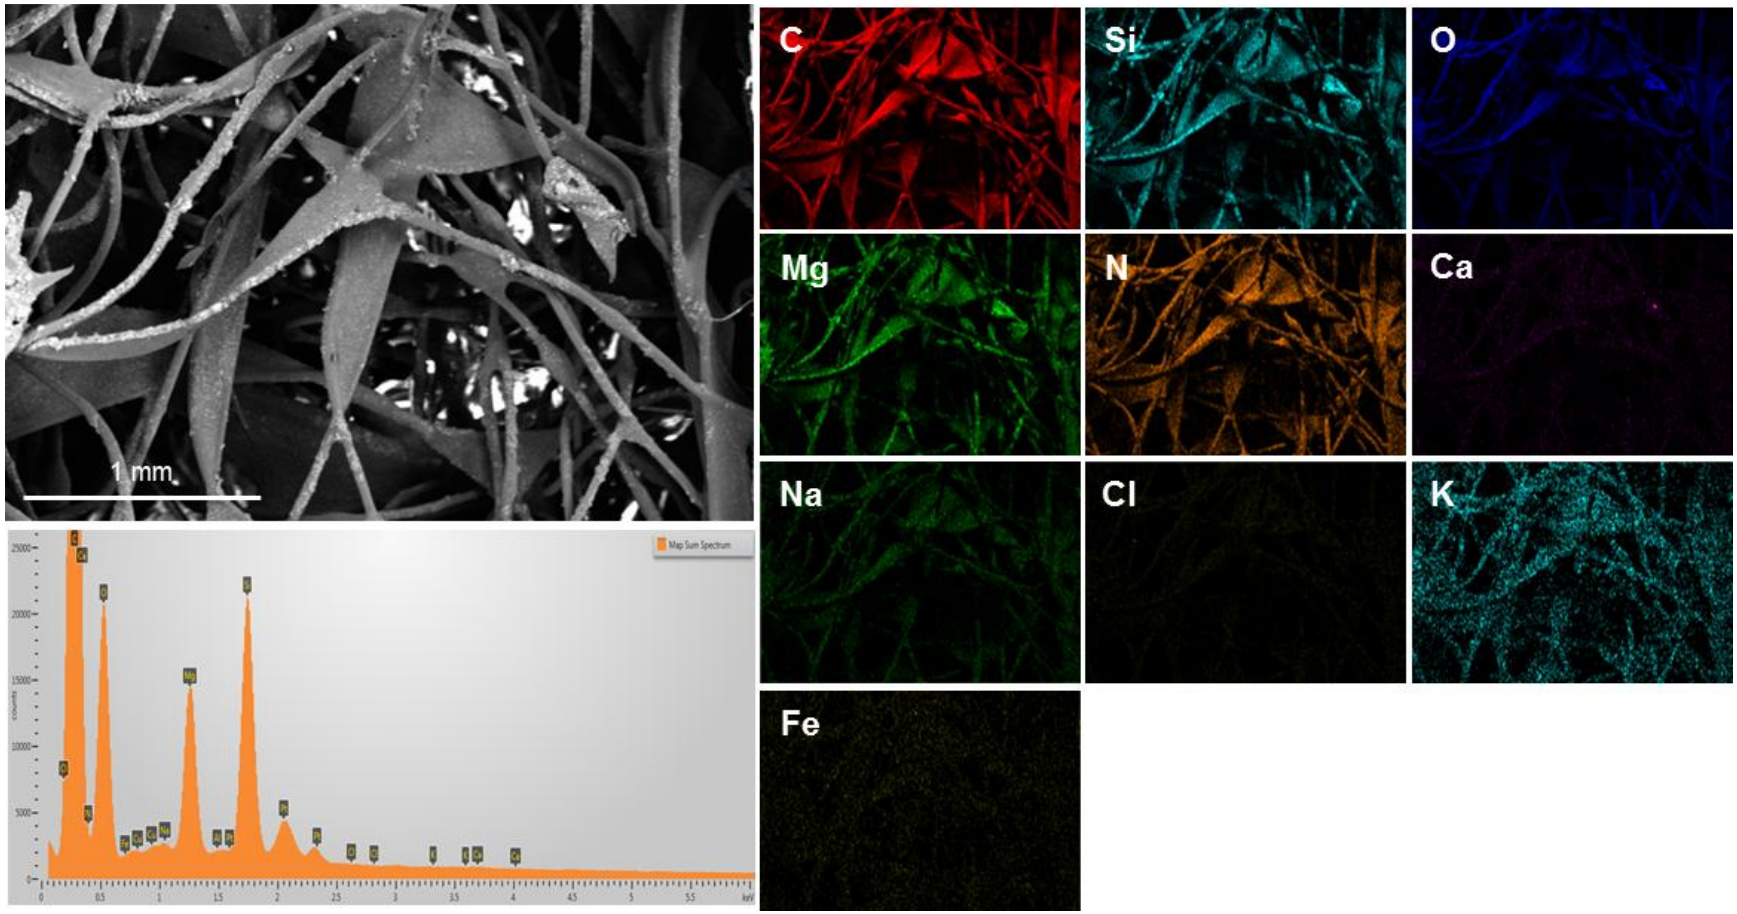
Map A

Notes: Low magnification SEM image/EDS map of the dry pad blank.

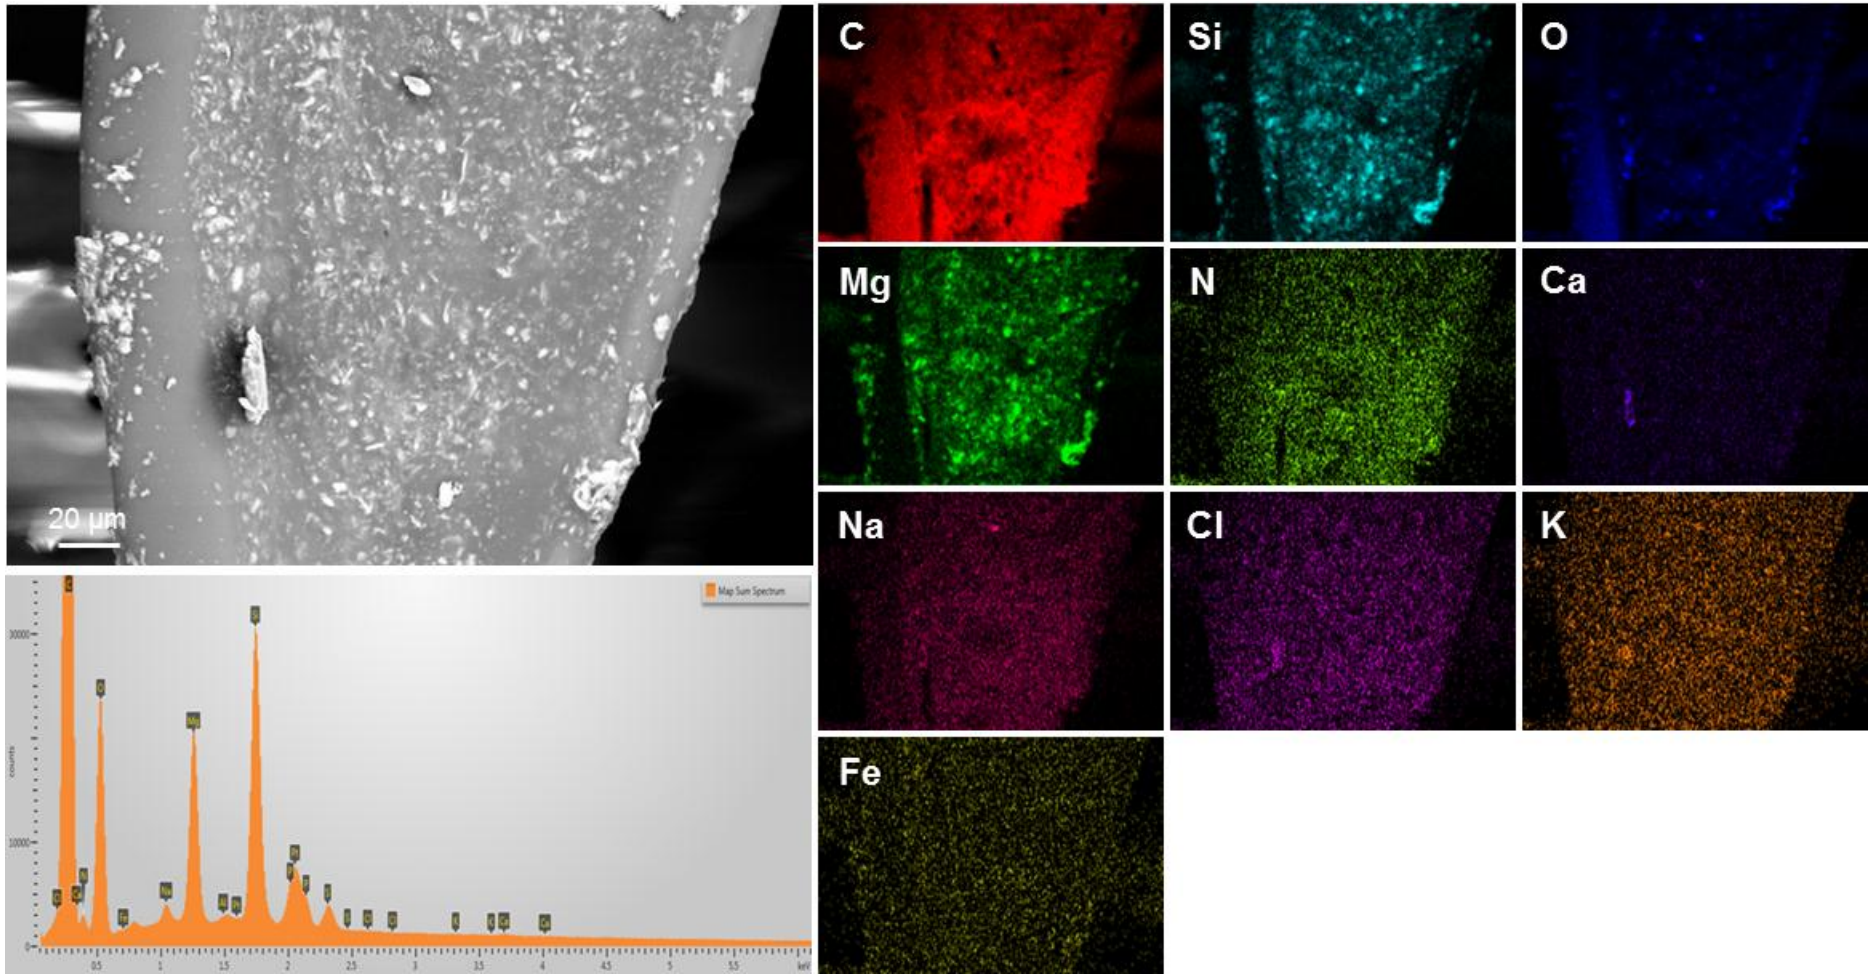
Map B

Notes: Magnified view of the blank pad, showing the matrix and the talc (magnesium silicate) filler.

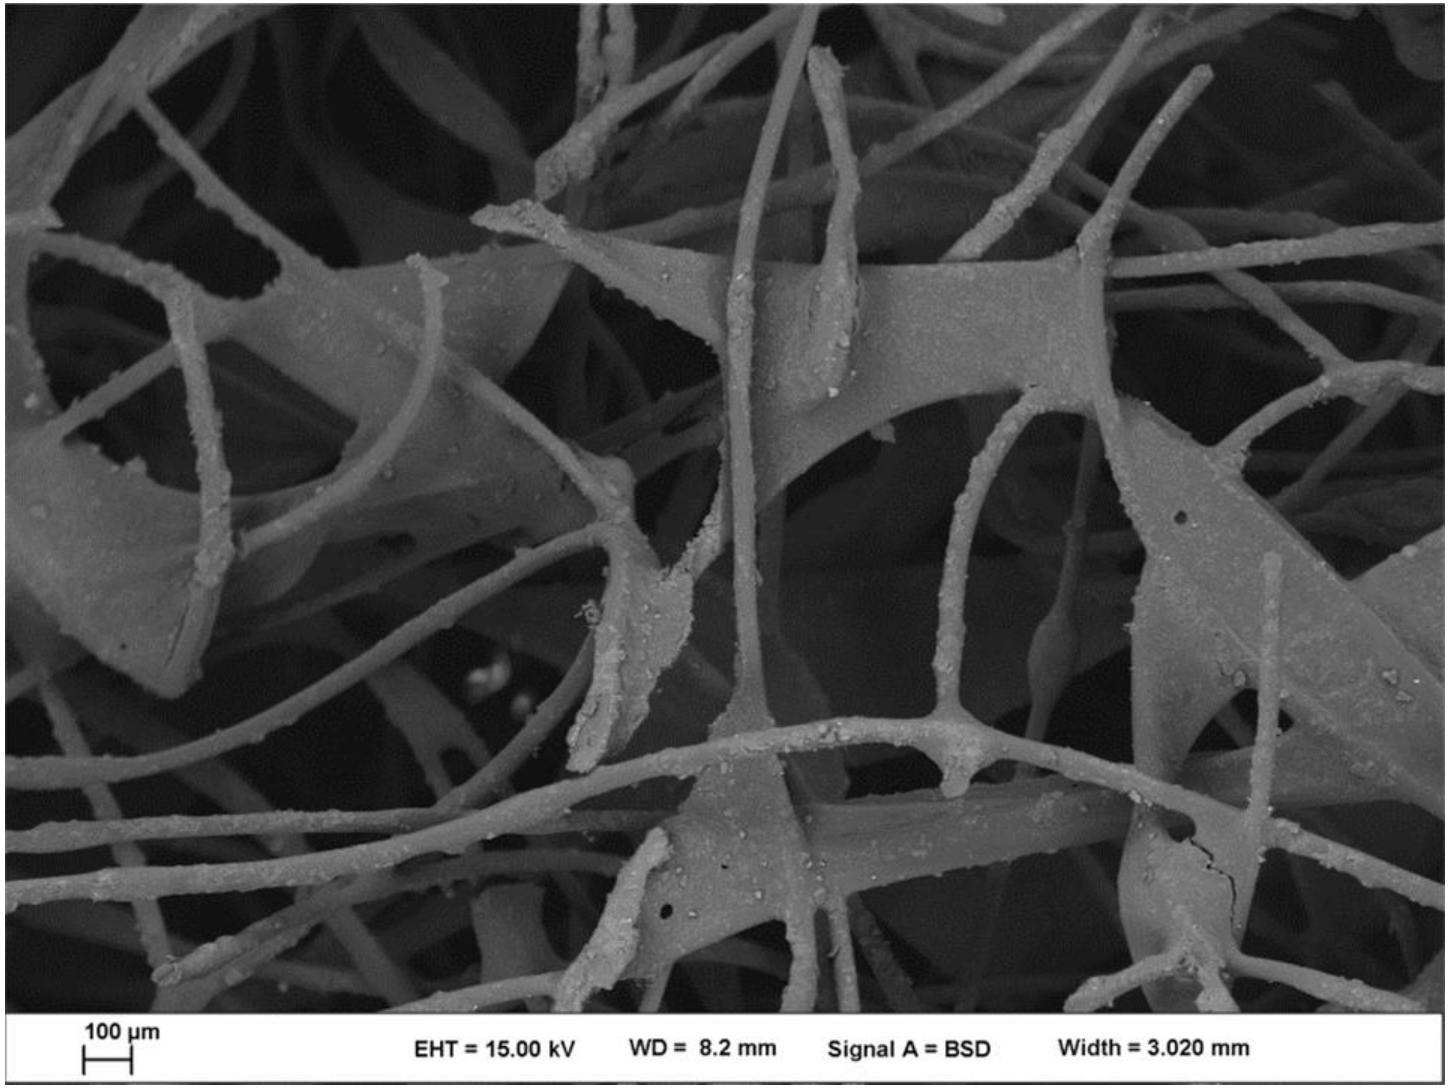
Sample: 144-005

Notes: Overview image of dry pad sample 144-005, showing the very light dust load.

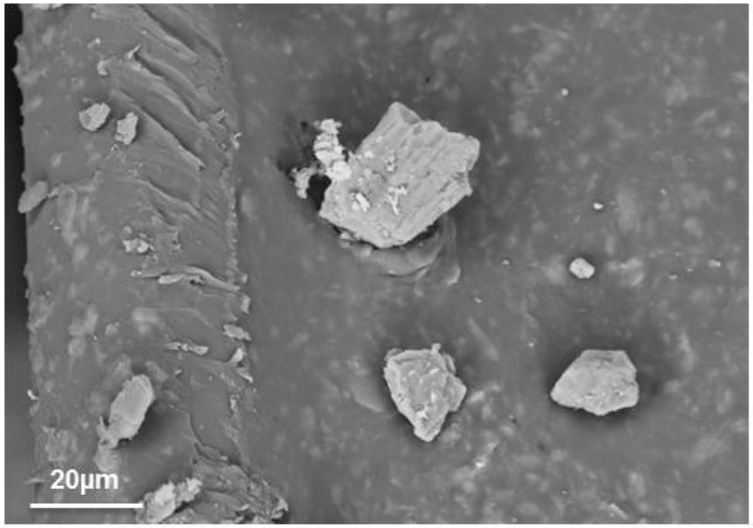
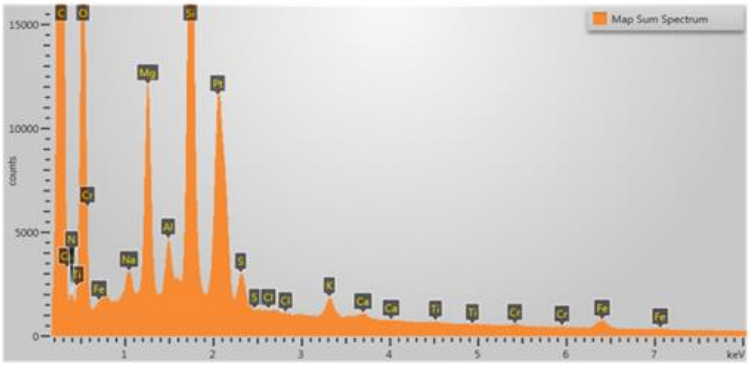
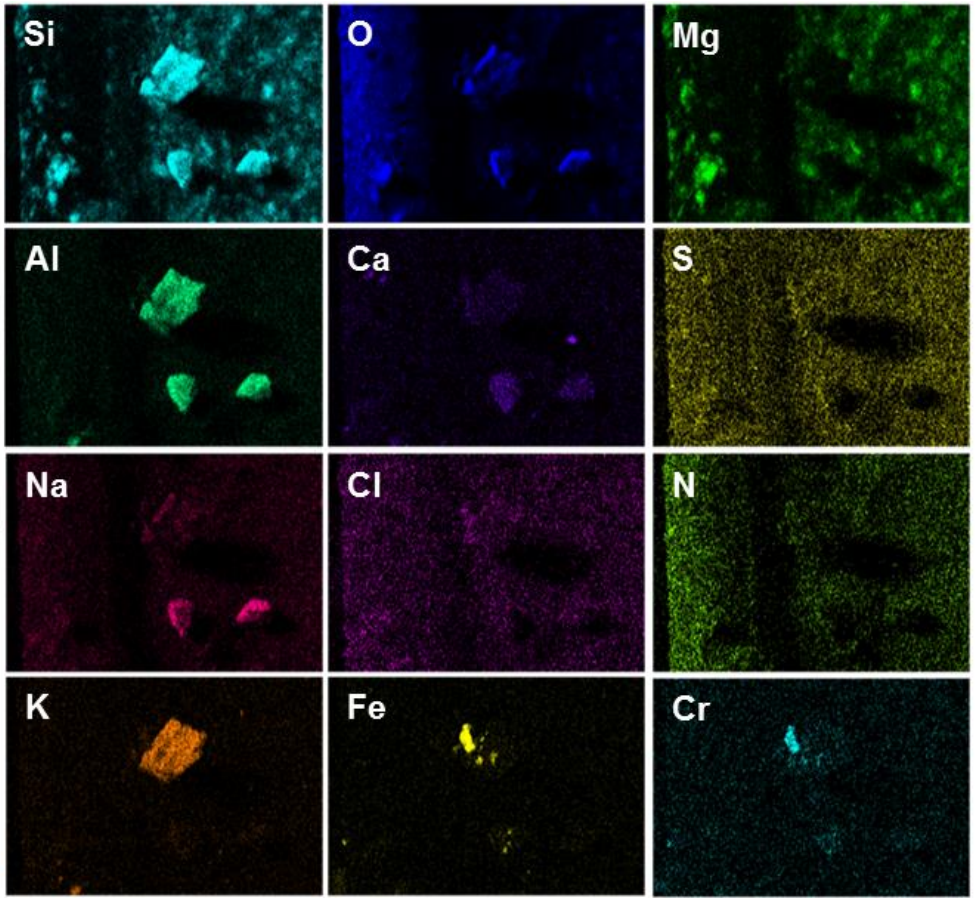
Sample: 144-005
Map A

Notes: Large aluminosilicate mineral grains.

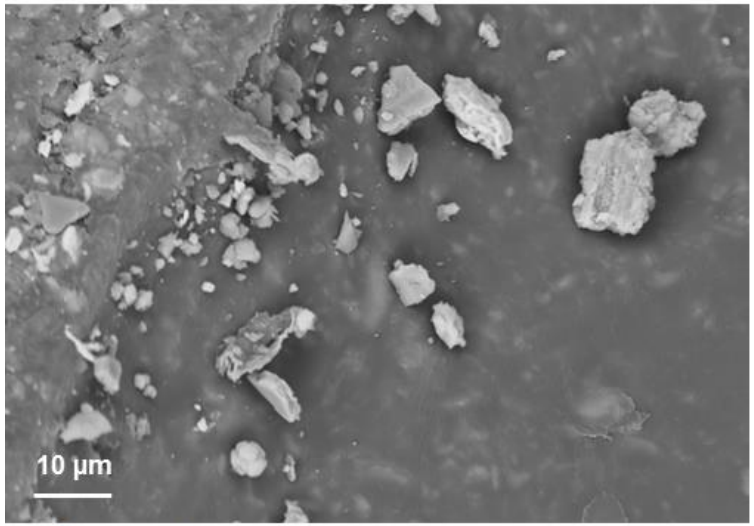
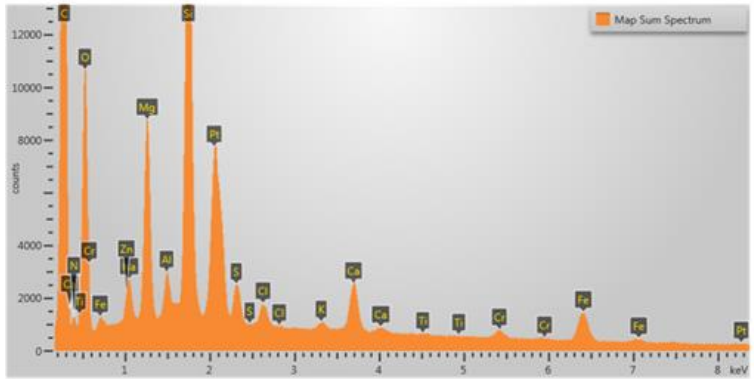
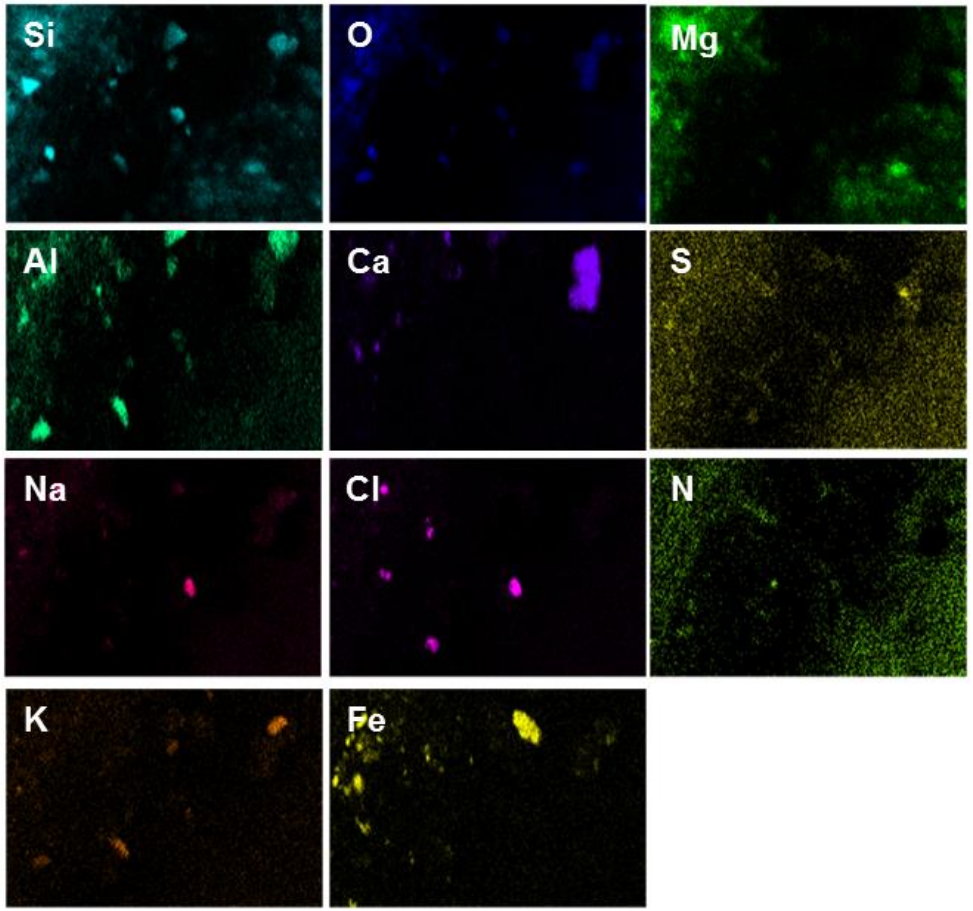
Sample: 144-005
Map B

Notes: This sample has a shadow across the middle of the image; light elements do not show up in this area. Despite this, it was used here because several chloride grains are visible in this image. Most fall within the shadow and do not appear on the Na map, but they appear to be NaCl. The lowermost chloride grain appears to be a spherical cluster of NaCl crystals.

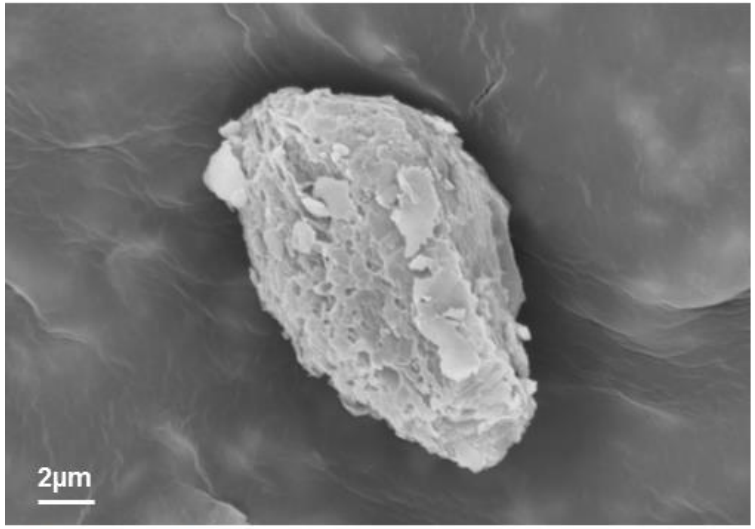
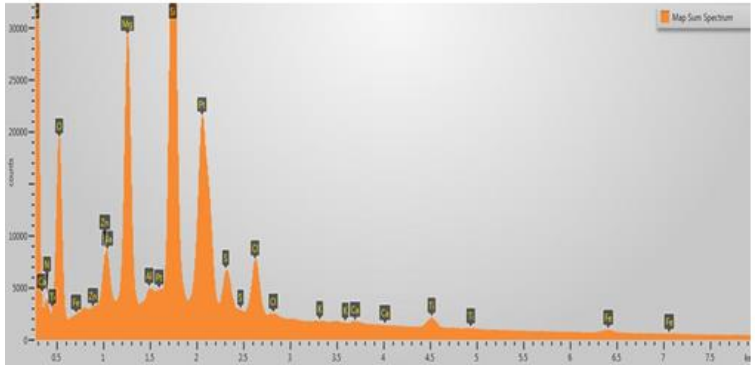
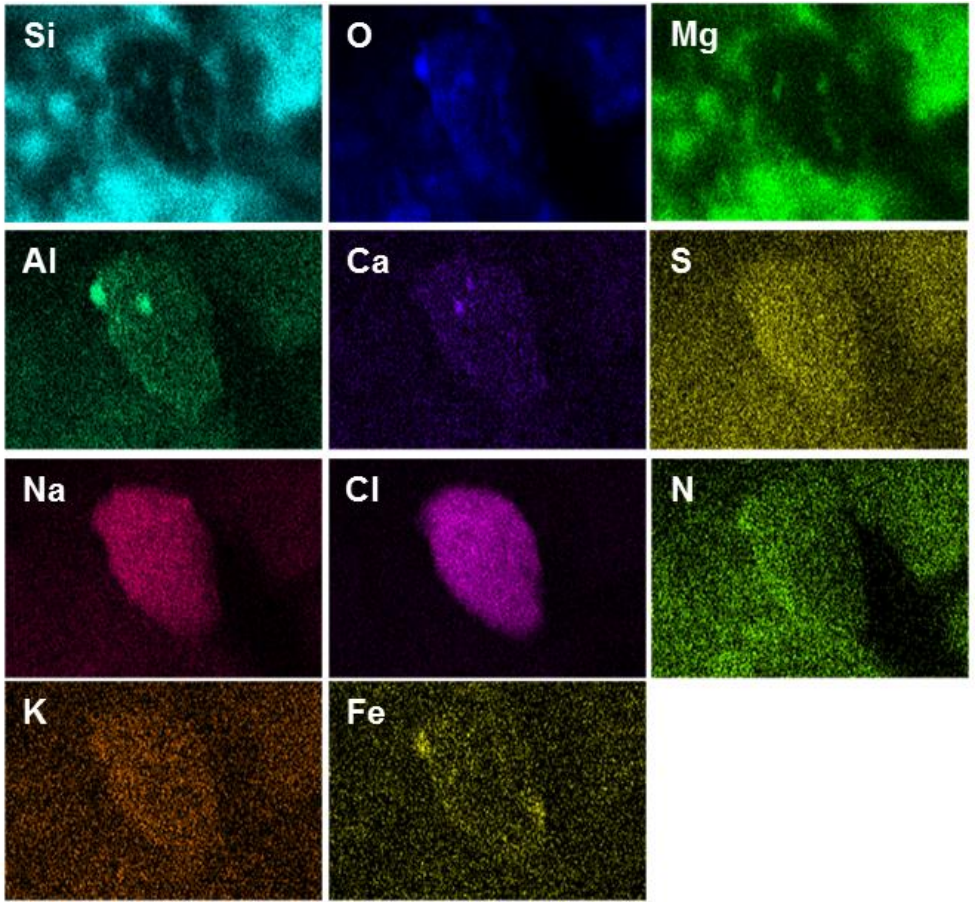
Sample: 144-005
Map C

Notes: Close-up of NaCl grain. The surface of the grain is heavily etched.

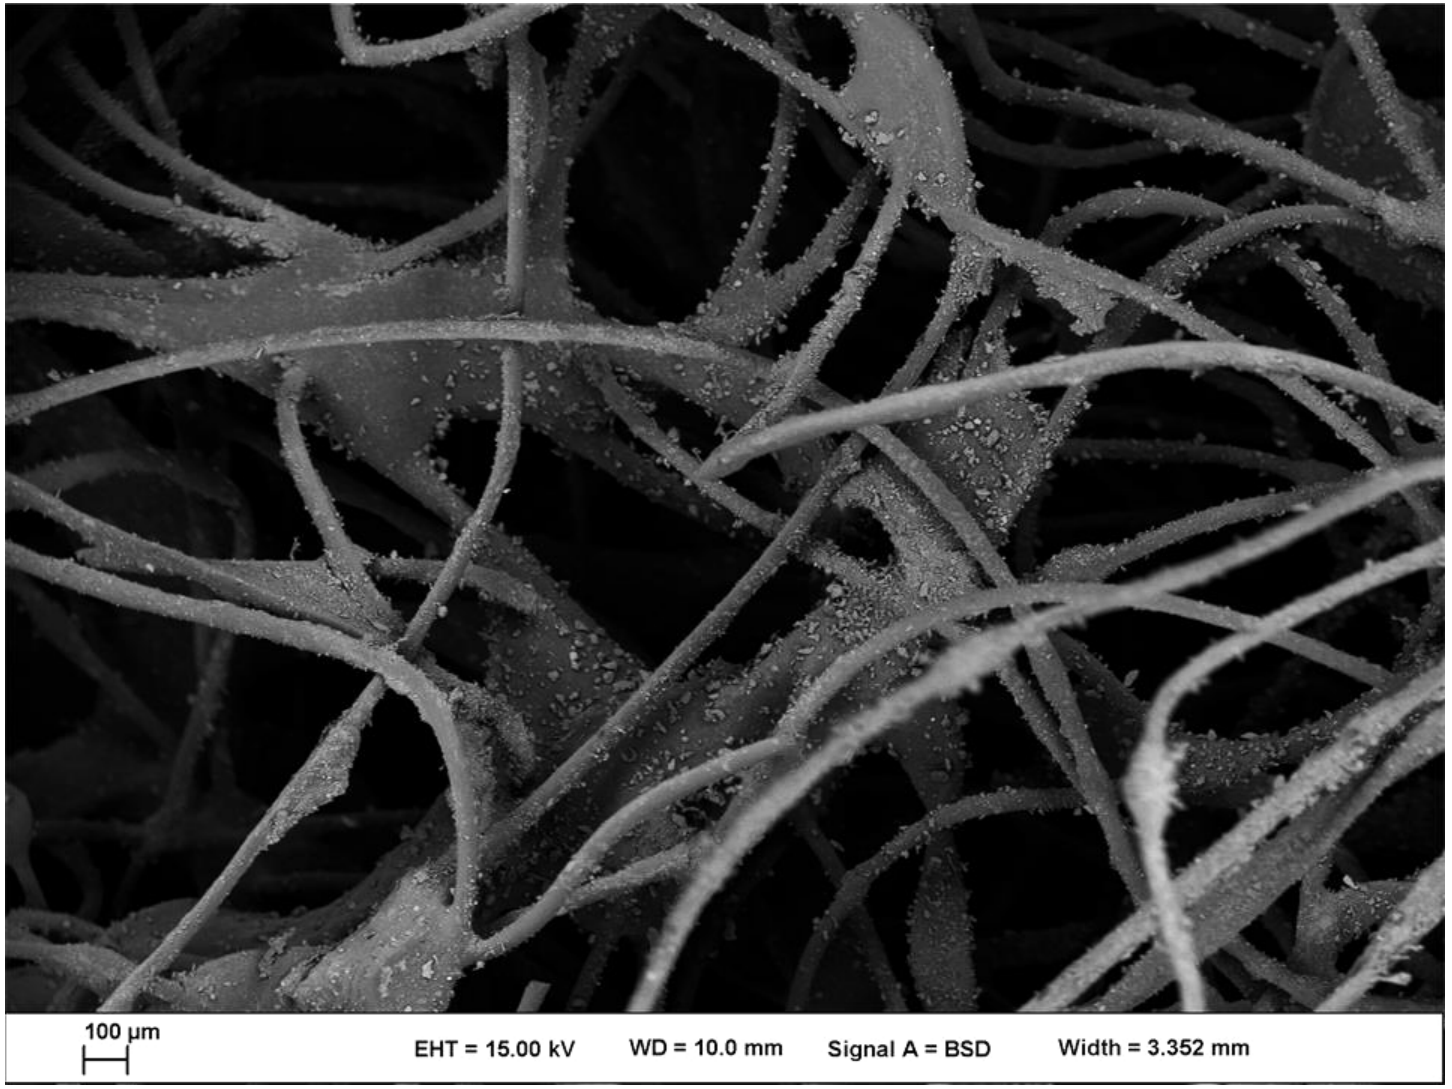
Sample: 144-011

Notes: Overview image of pad sample 144-011, showing the heavy dust load.

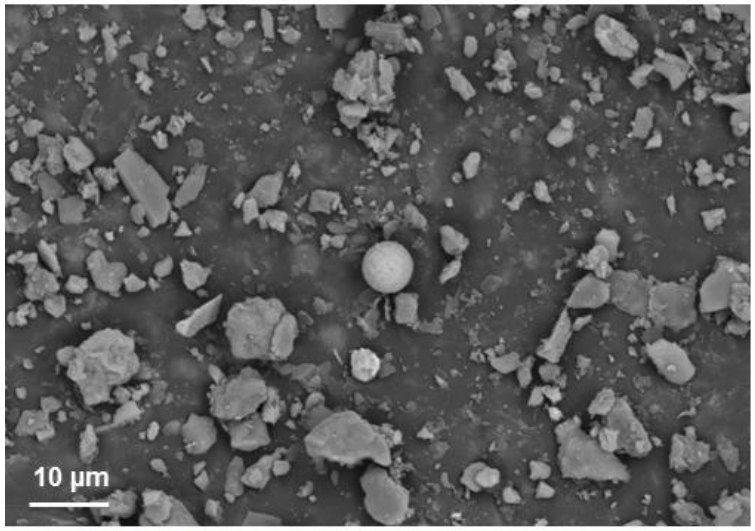
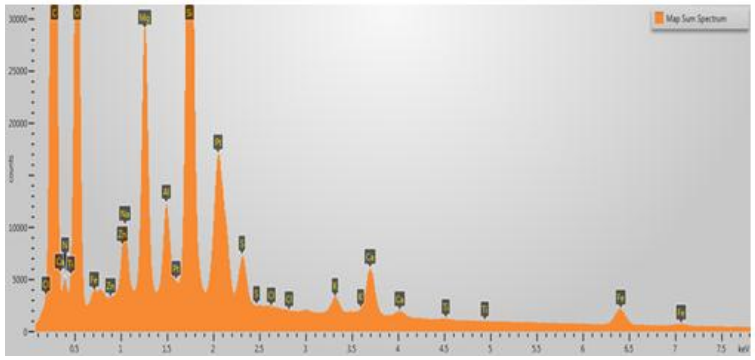
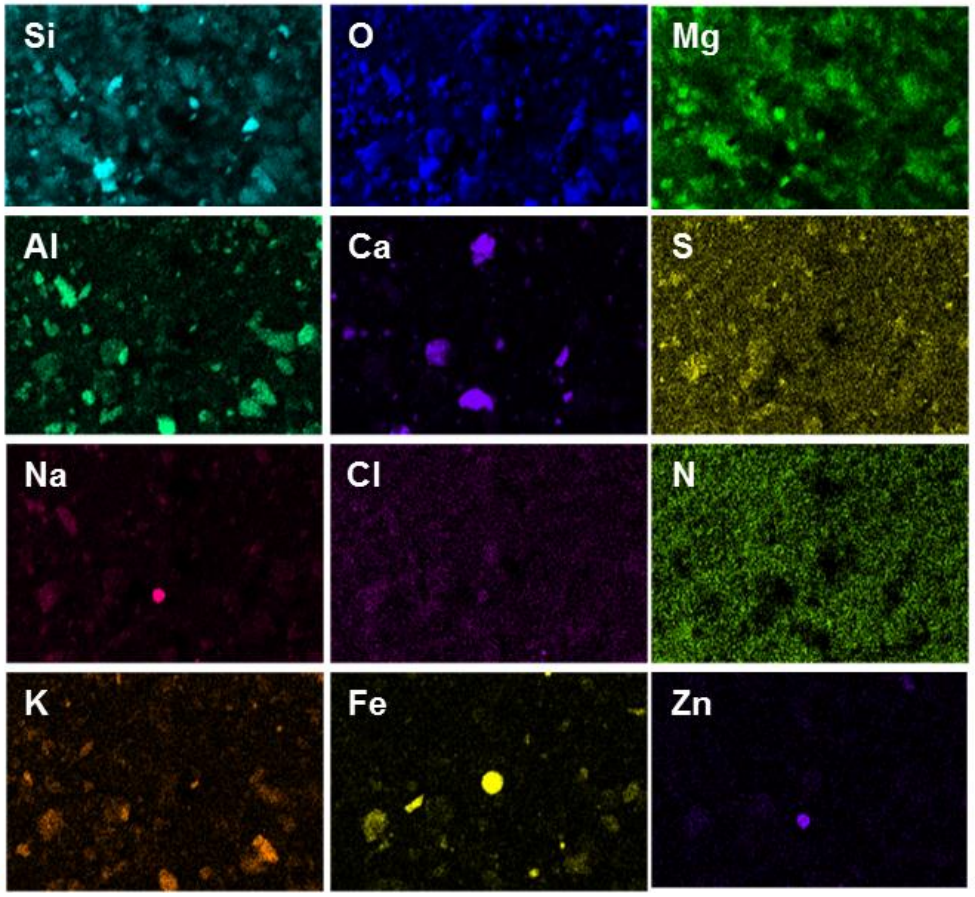
Sample: 144-011
Map A

Notes: Minerals are dominantly aluminosilicates, but note the Fe-oxide sphere in the center of the image, and the Na-Zn rich phase (carbonate?) in the lower center.

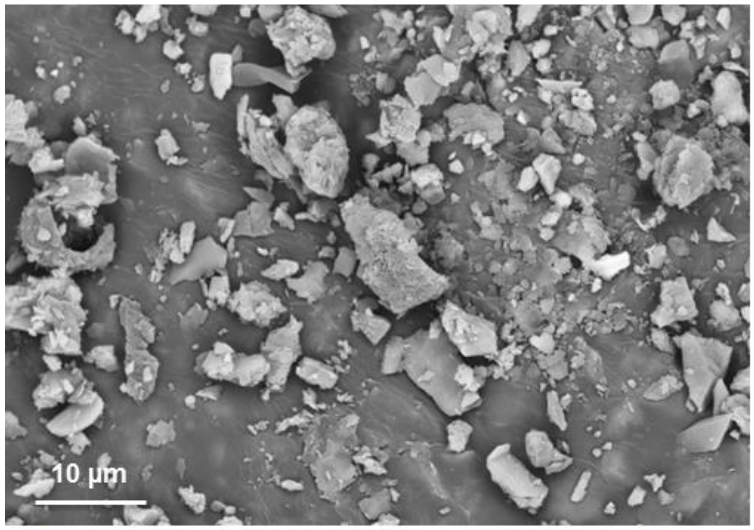
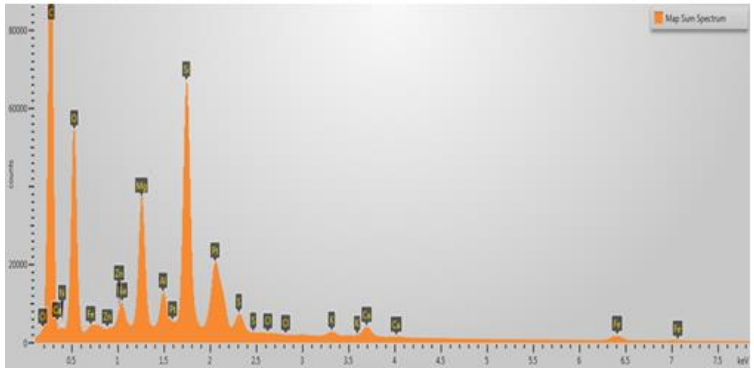
Sample: 144-011
Map B

Notes: Minerals are largely aluminosilicates.

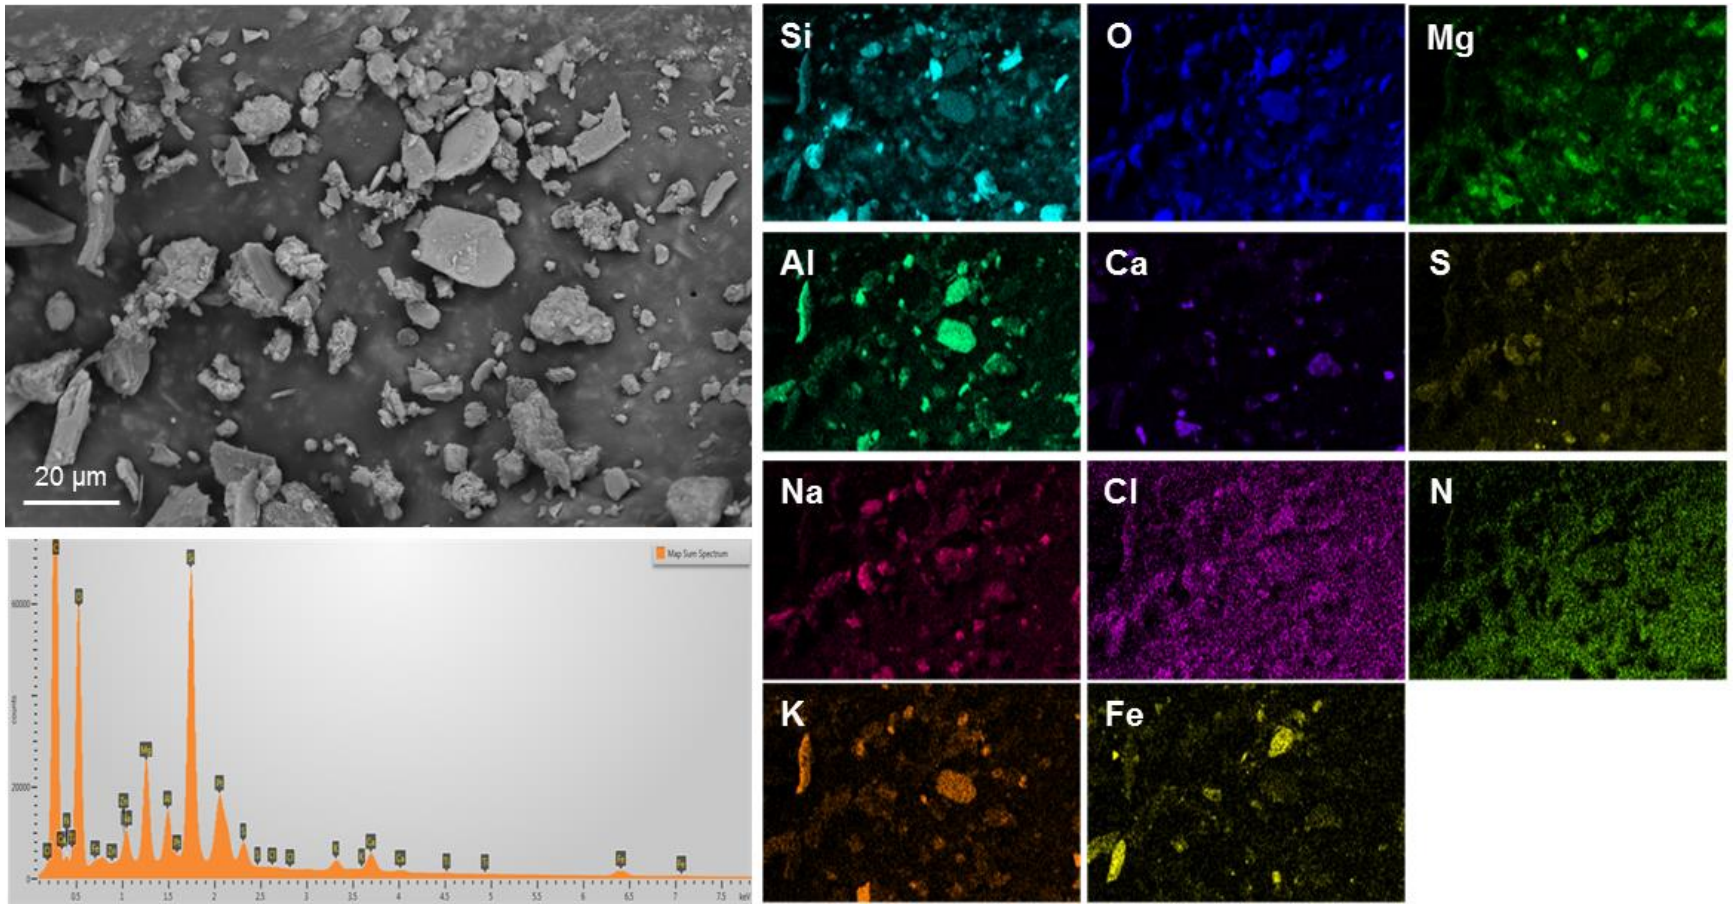
Sample: 144-011
Map C

Notes: Minerals are largely aluminosilicates.

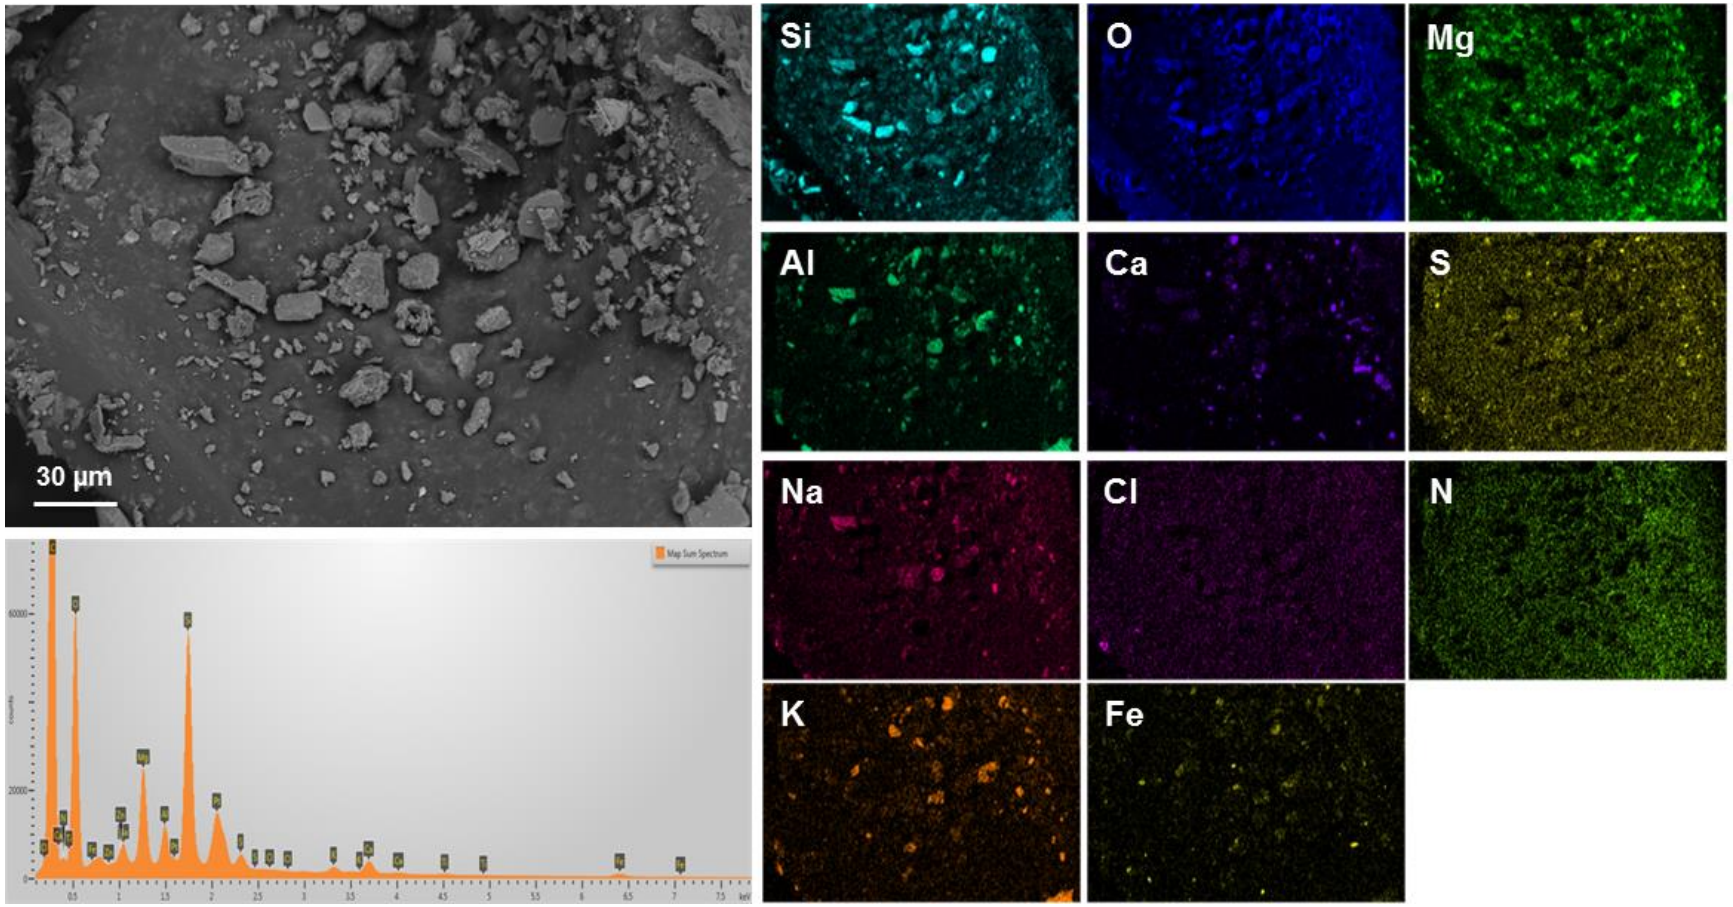
Sample: 144-011
Map D

Notes: Minerals are largely aluminosilicates.

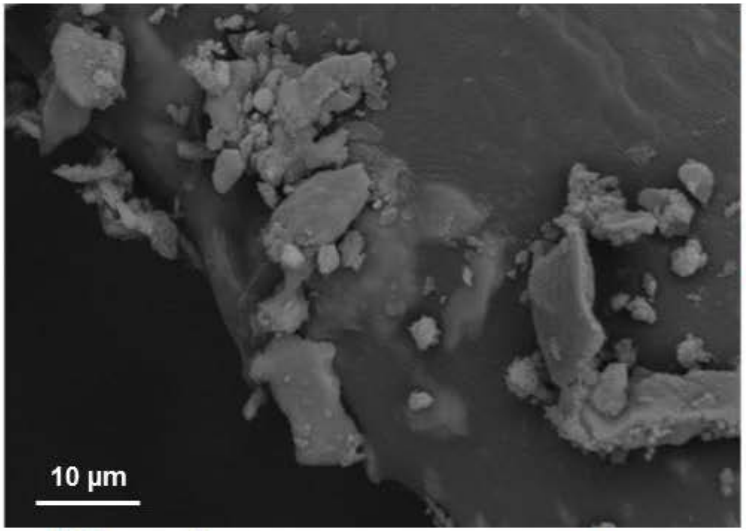
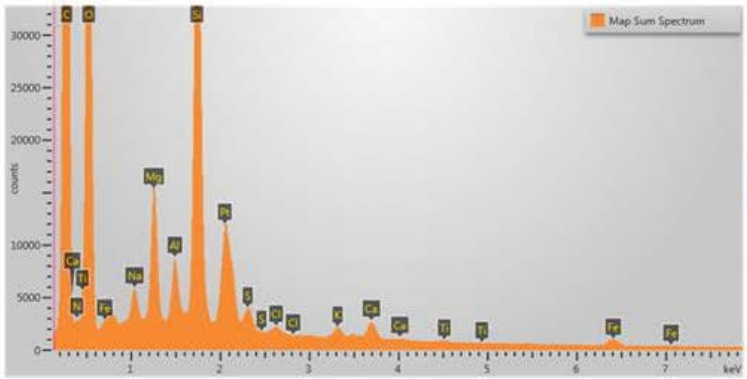
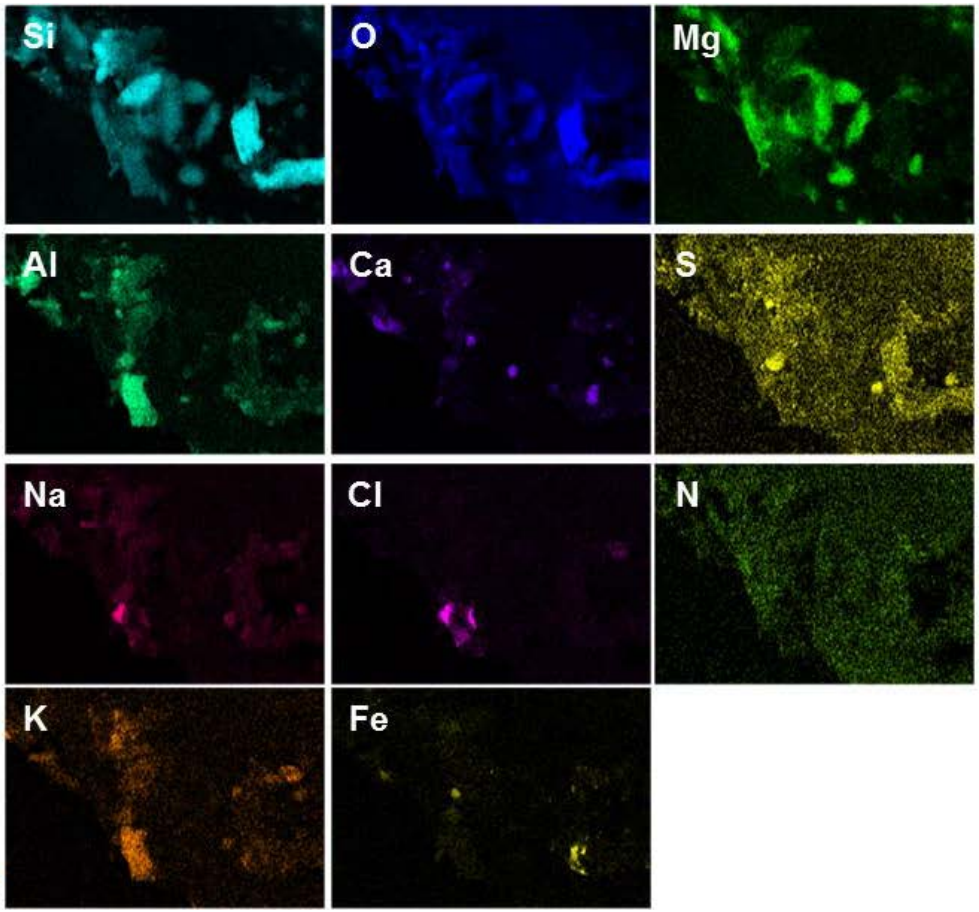
Sample: 144-011
Map E

Notes: Close-up of the lower left corner of Map D, showing the chloride-rich phase.

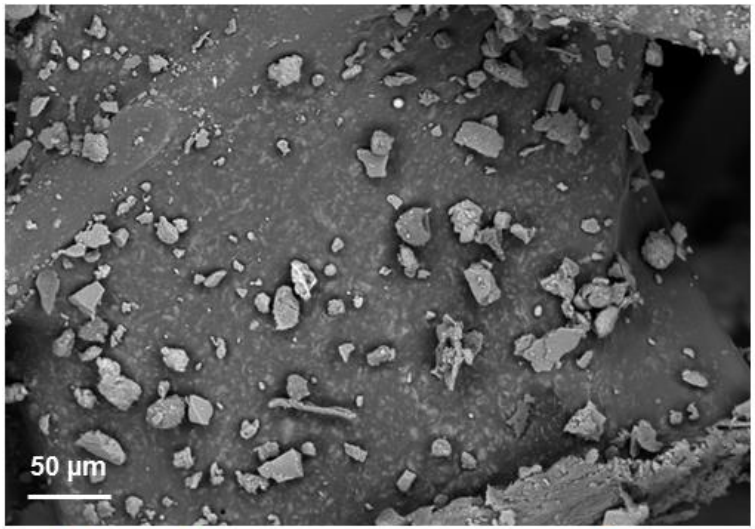
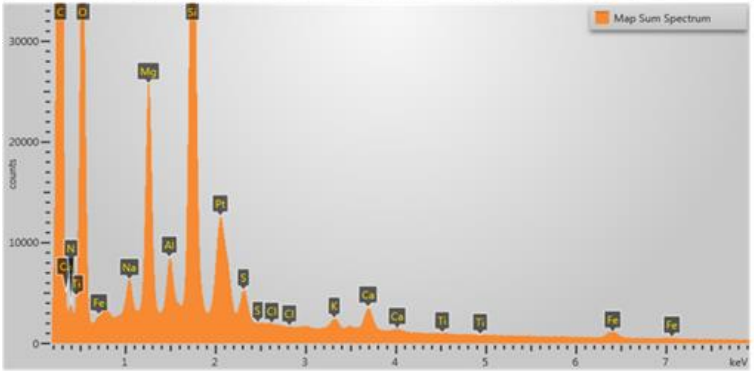
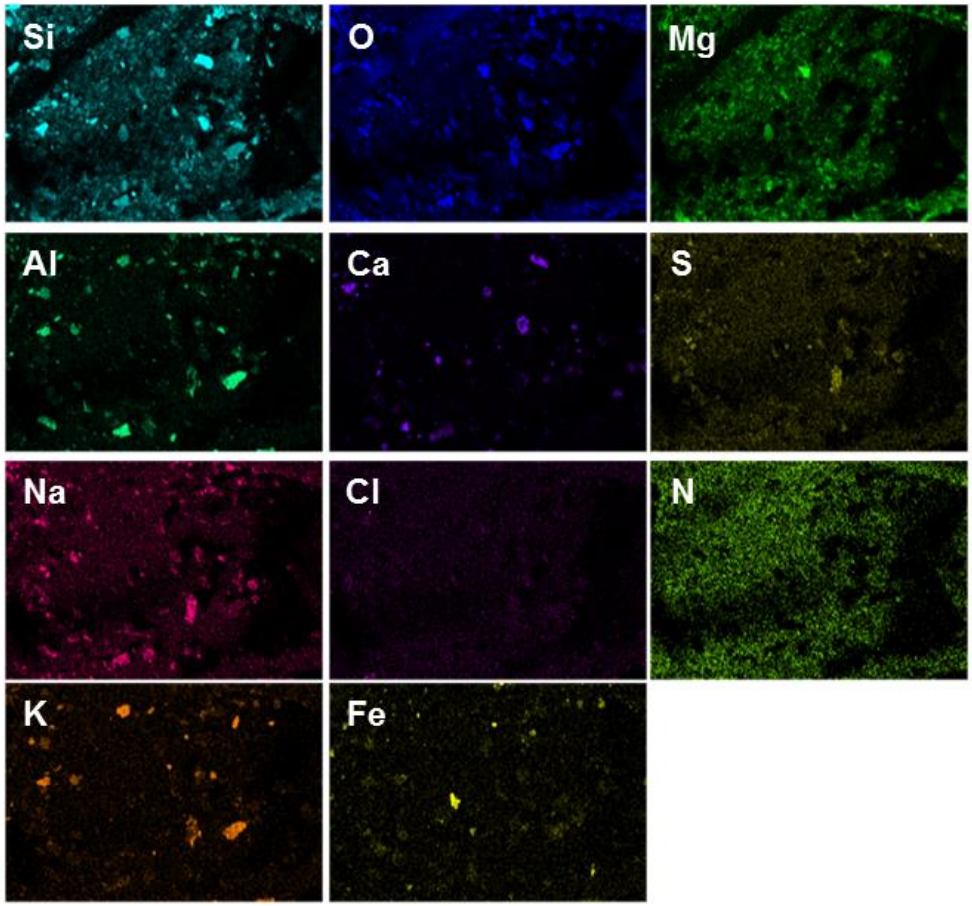
Sample: 144-011
Map F

Notes: Minerals are largely aluminosilicates.

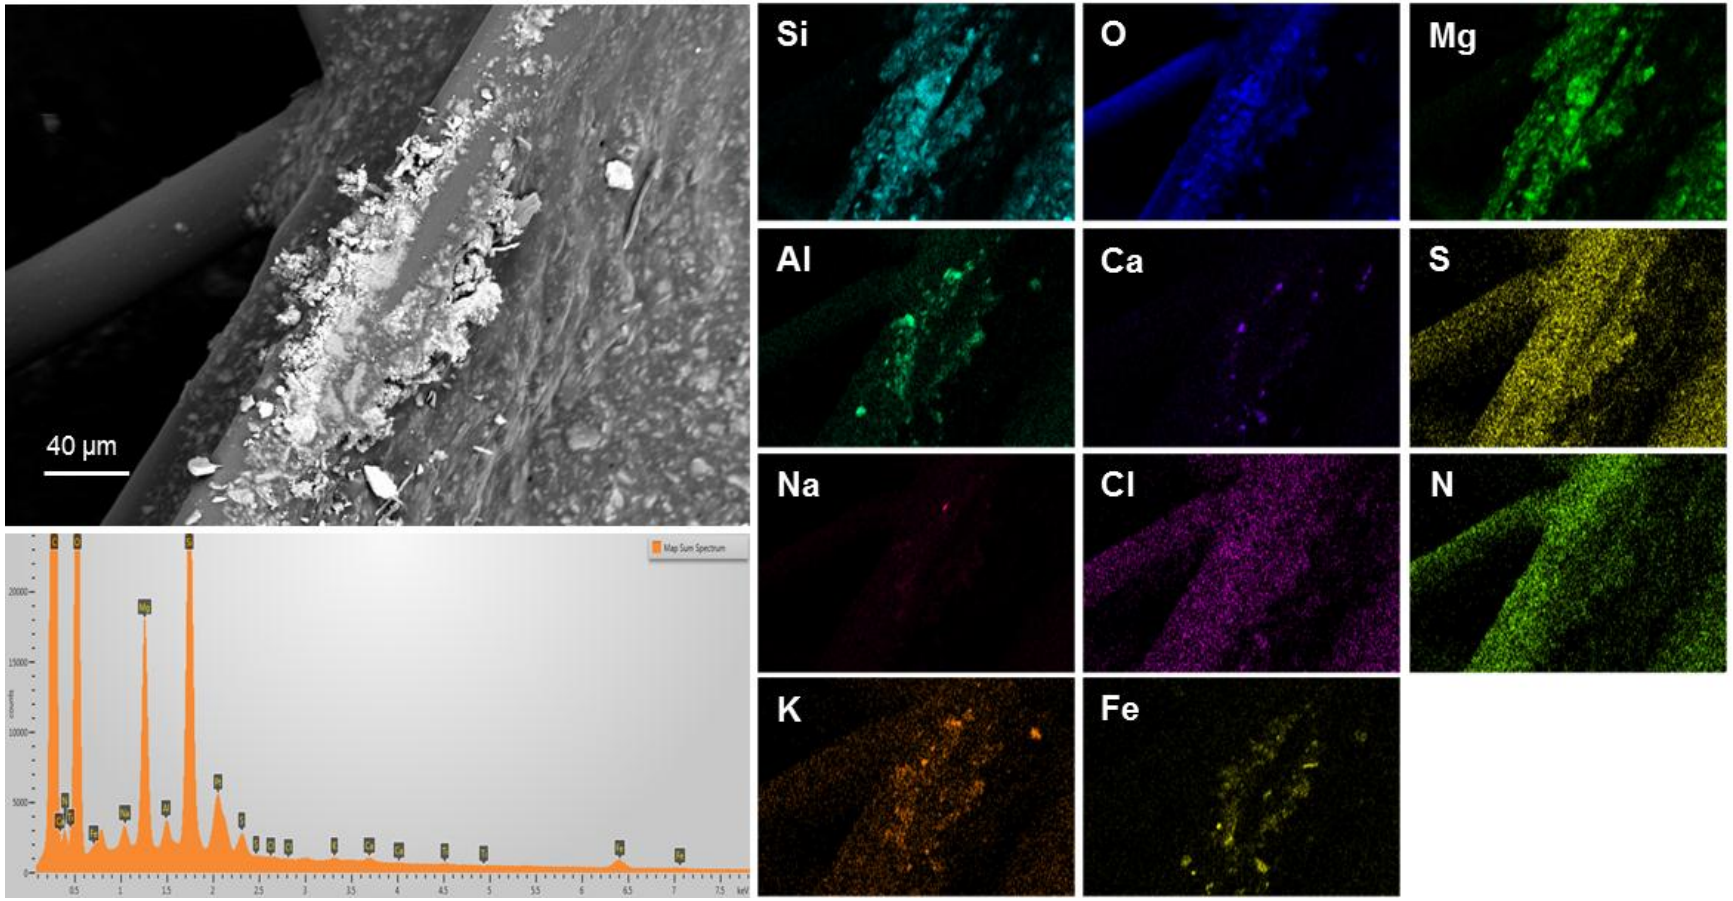
Sample: 145-001
Map A

Notes: Dust accumulation at an abraded edge. Dust phases are largely aluminosilicates and stainless steel particles.
