SANDIA REPORT

SAND2014-16383
Unlimited Release
Printed July 2014

Analysis of Dust Samples Collected from Spent Nuclear Fuel Interim Storage Containers at Hope Creek, Delaware, and Diablo Canyon, California

Charles R. Bryan and David G. Enos

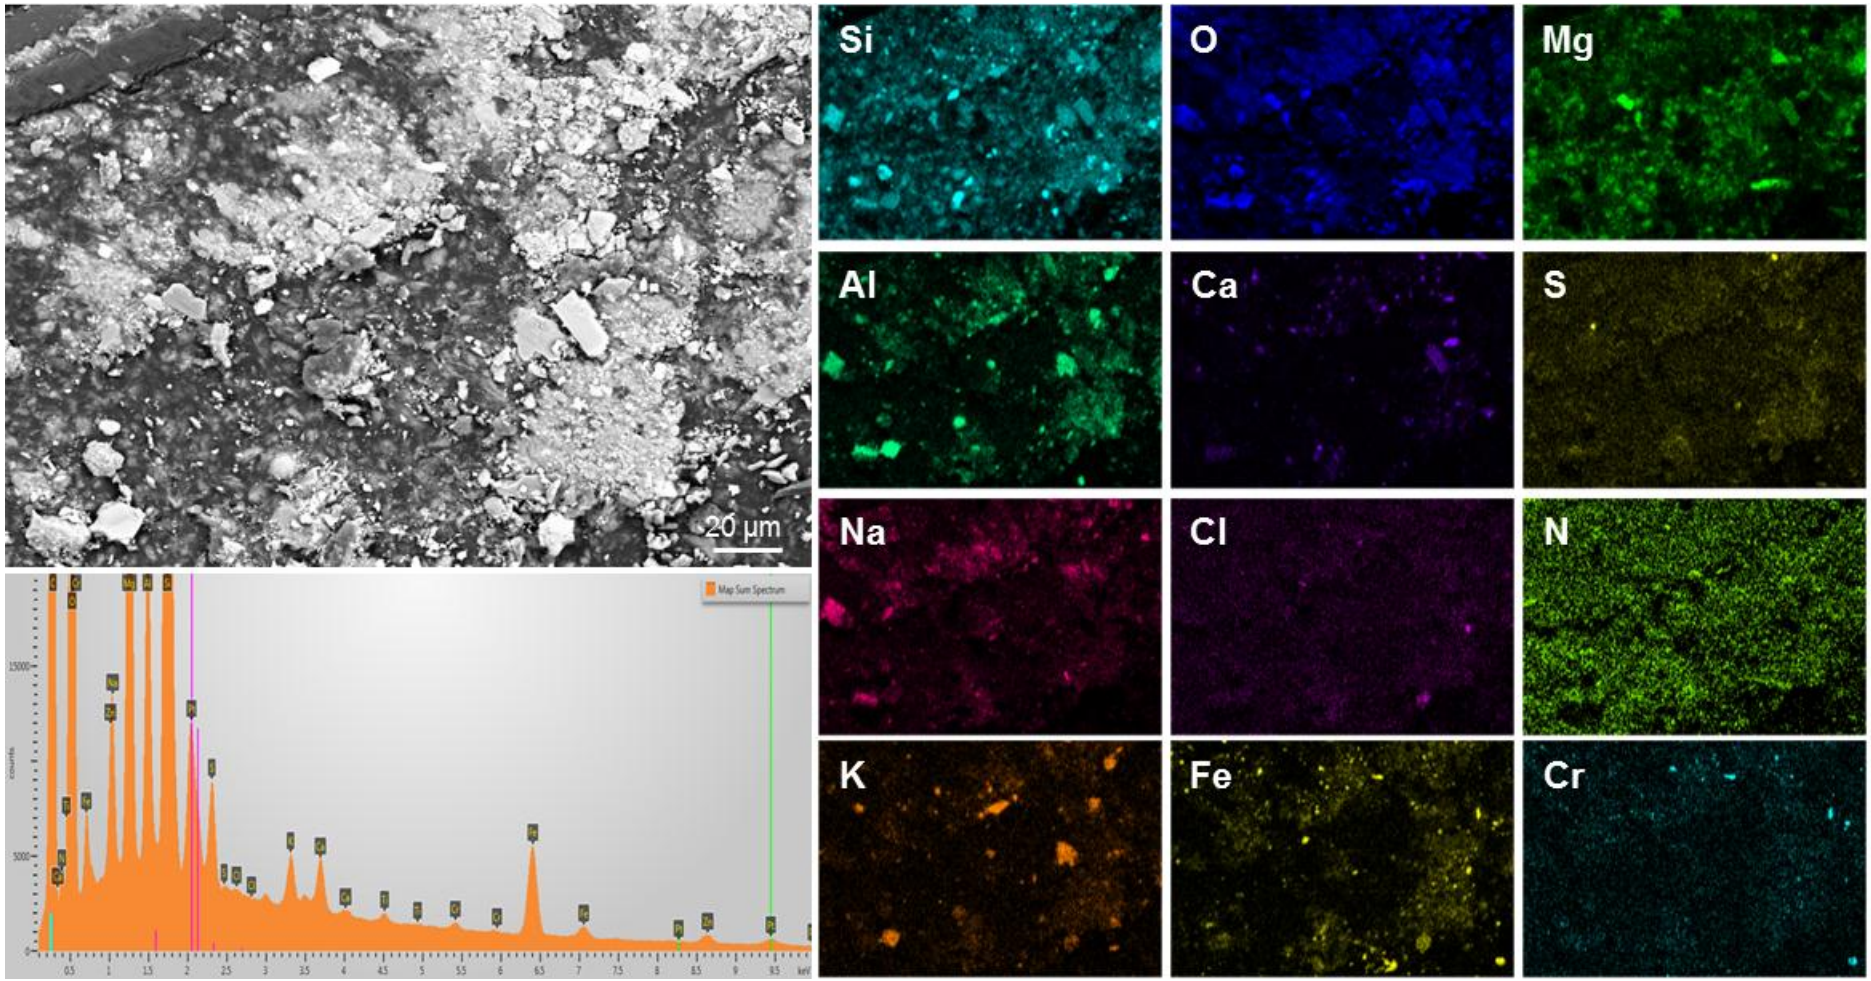
Sample: 145-001
Map B

Notes: Dust accumulation on an abraded edge. Minerals are largely aluminosilicates, with some stainless steel particles.

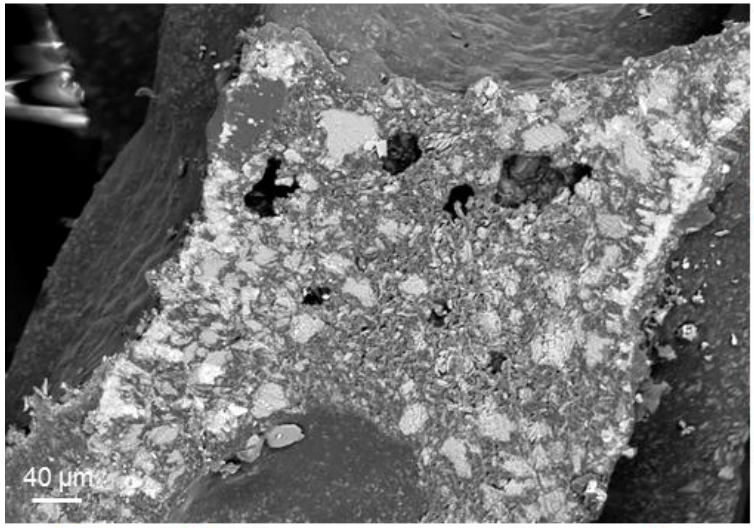
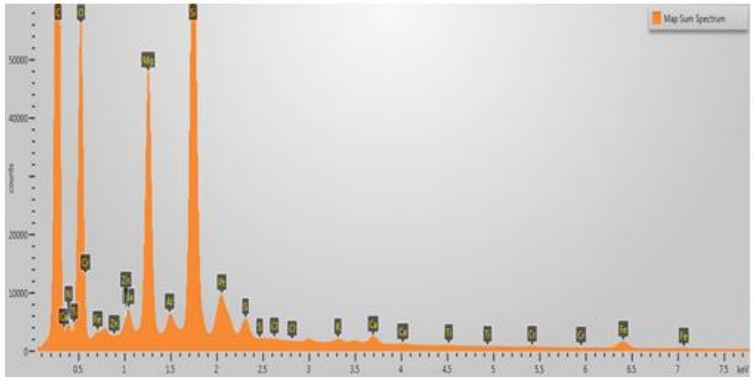
Sample: 145-001
Map C

Notes: Dust particles on an abraded surface. Particles are mostly stainless steel.

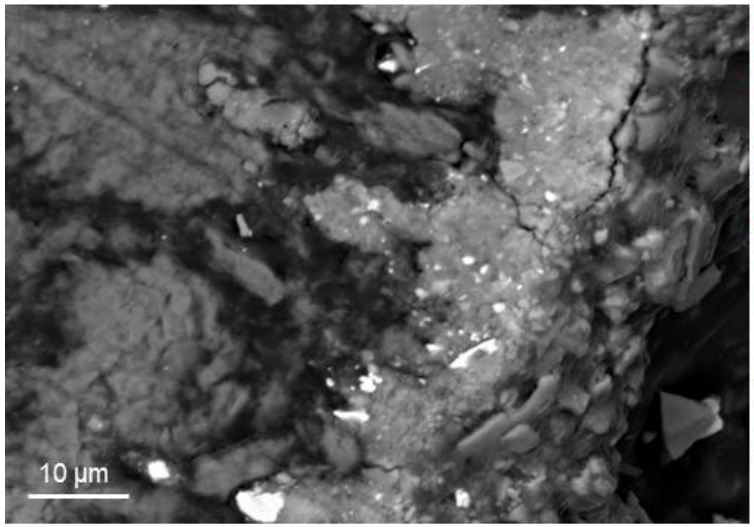
Sample: 145-001
Map D

Notes: Dust accumulation on an abraded edge. Embedded particles are mostly aluminosilicates and stainless steel.

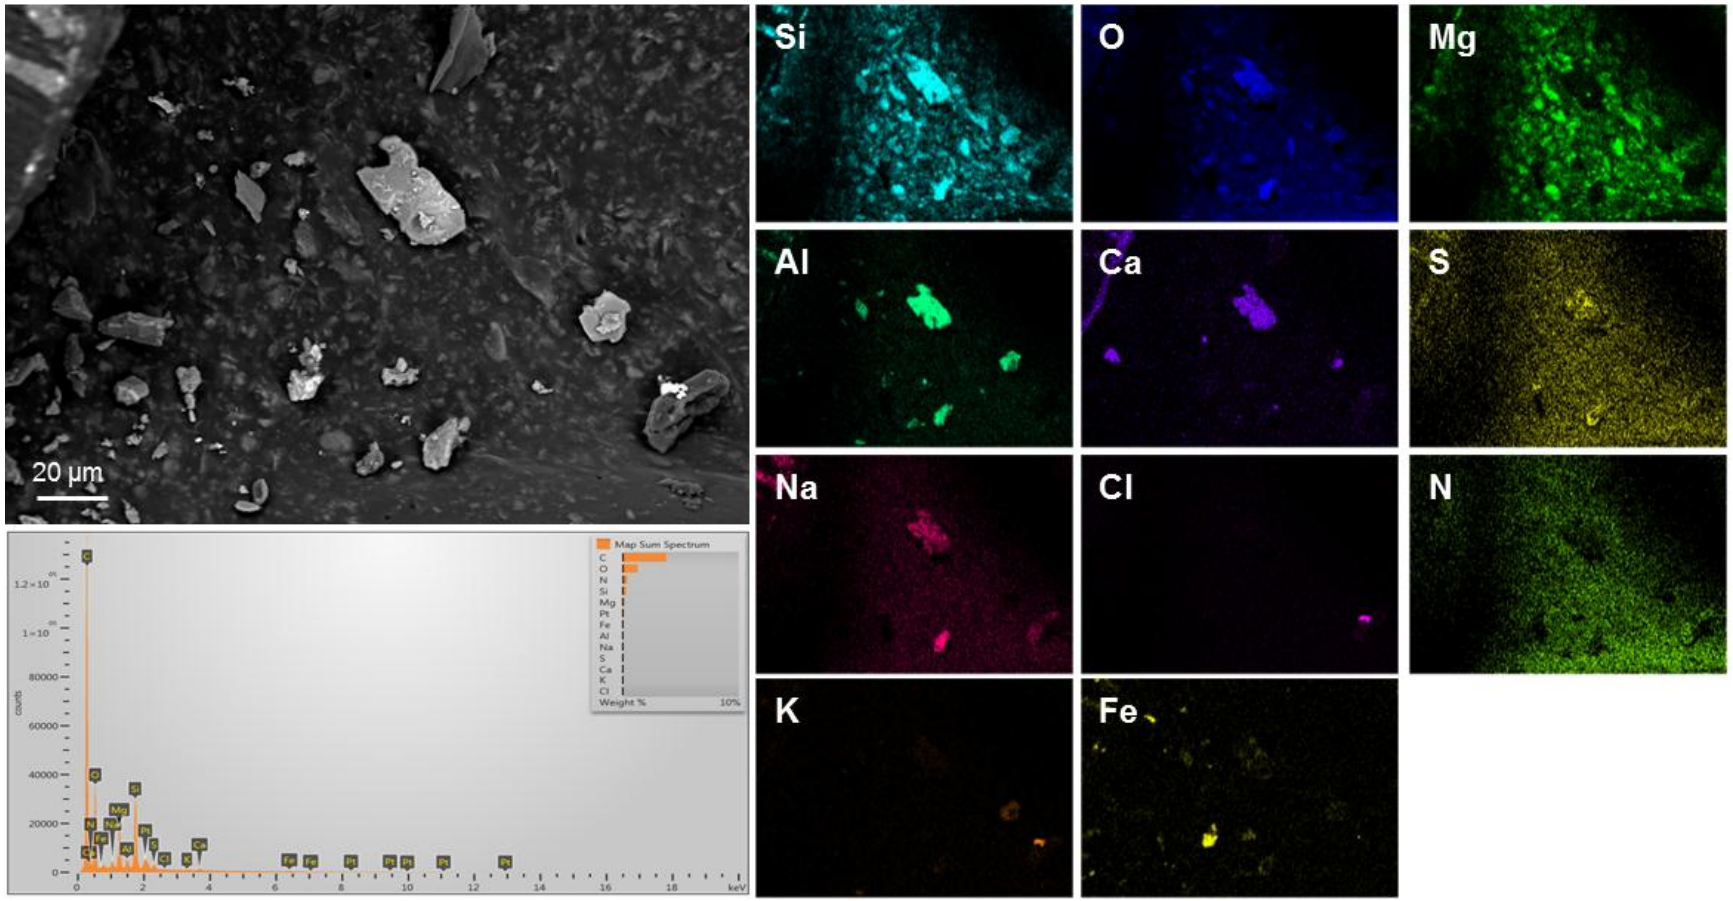
Sample: 145-001
Map F

Notes: Dust particles on an abraded edge of sample 145-001. Particles are mostly aluminosilicates and stainless steel particles. A Zn-Na-rich particle is in the lower center.

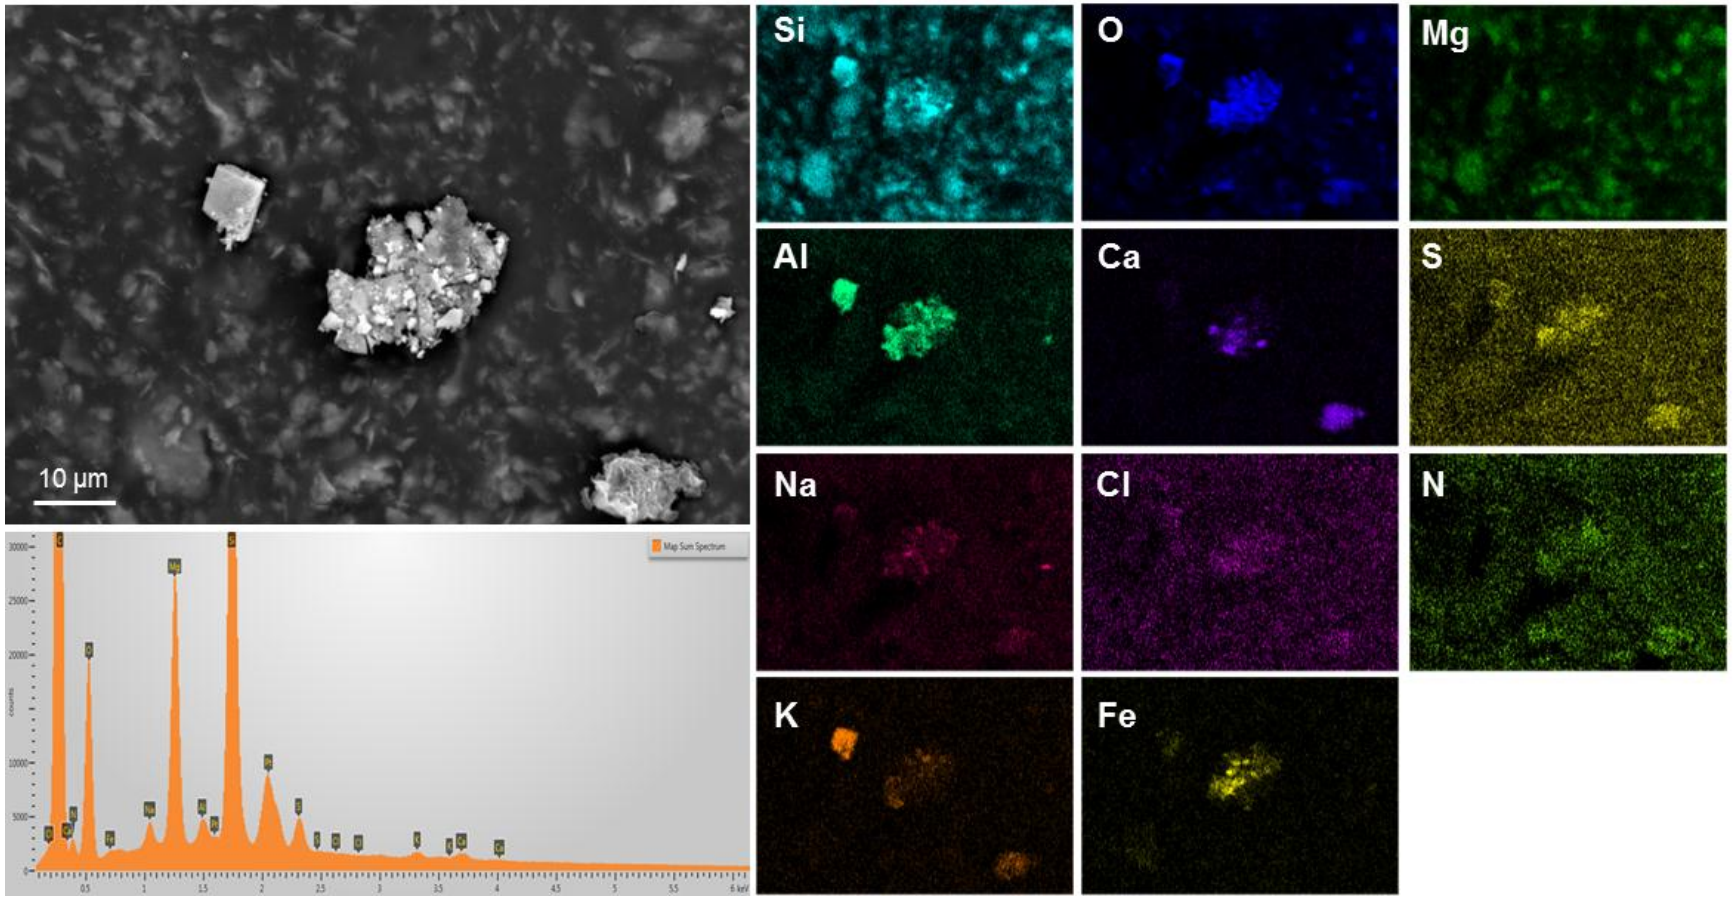
Sample: 145-001
Map H

Notes: Dominantly aluminosilicates, with some Ca-carbonate. A pollen grain is visible in the upper left corner of the image.

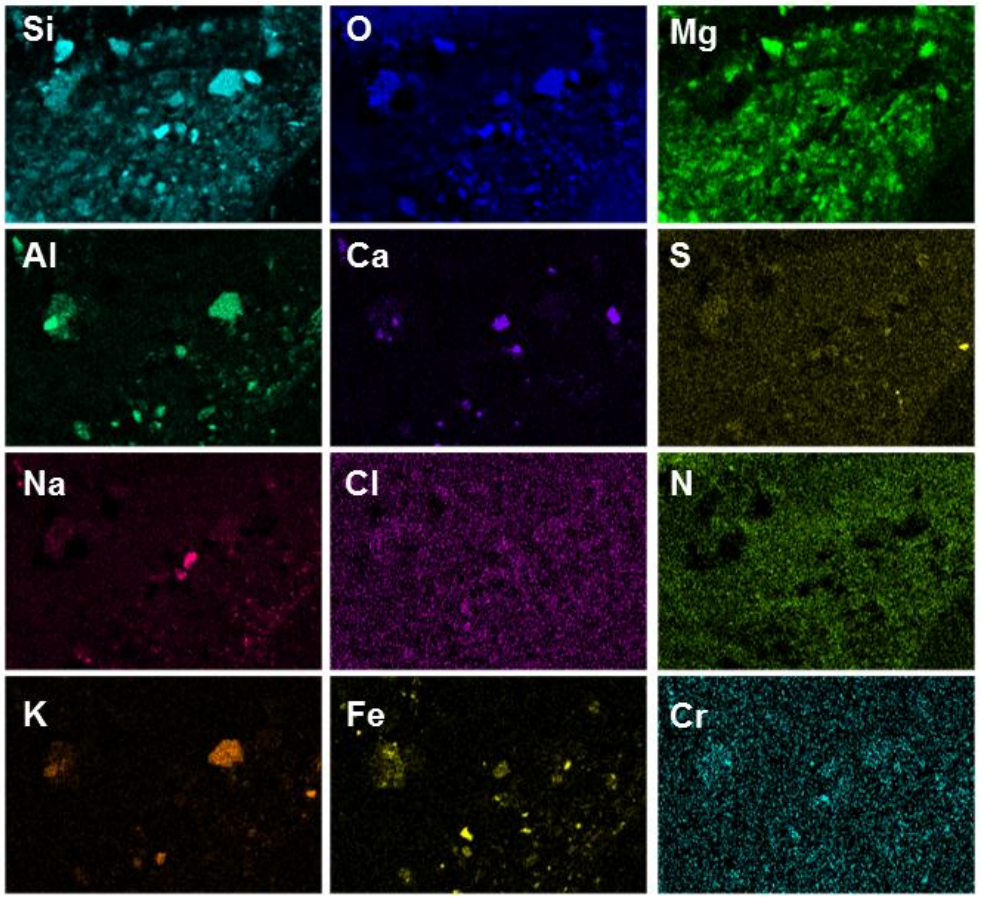
Sample: 145-003

Notes: An abraded edge on the pad. Embedded dust grains are mostly stainless steel particles.

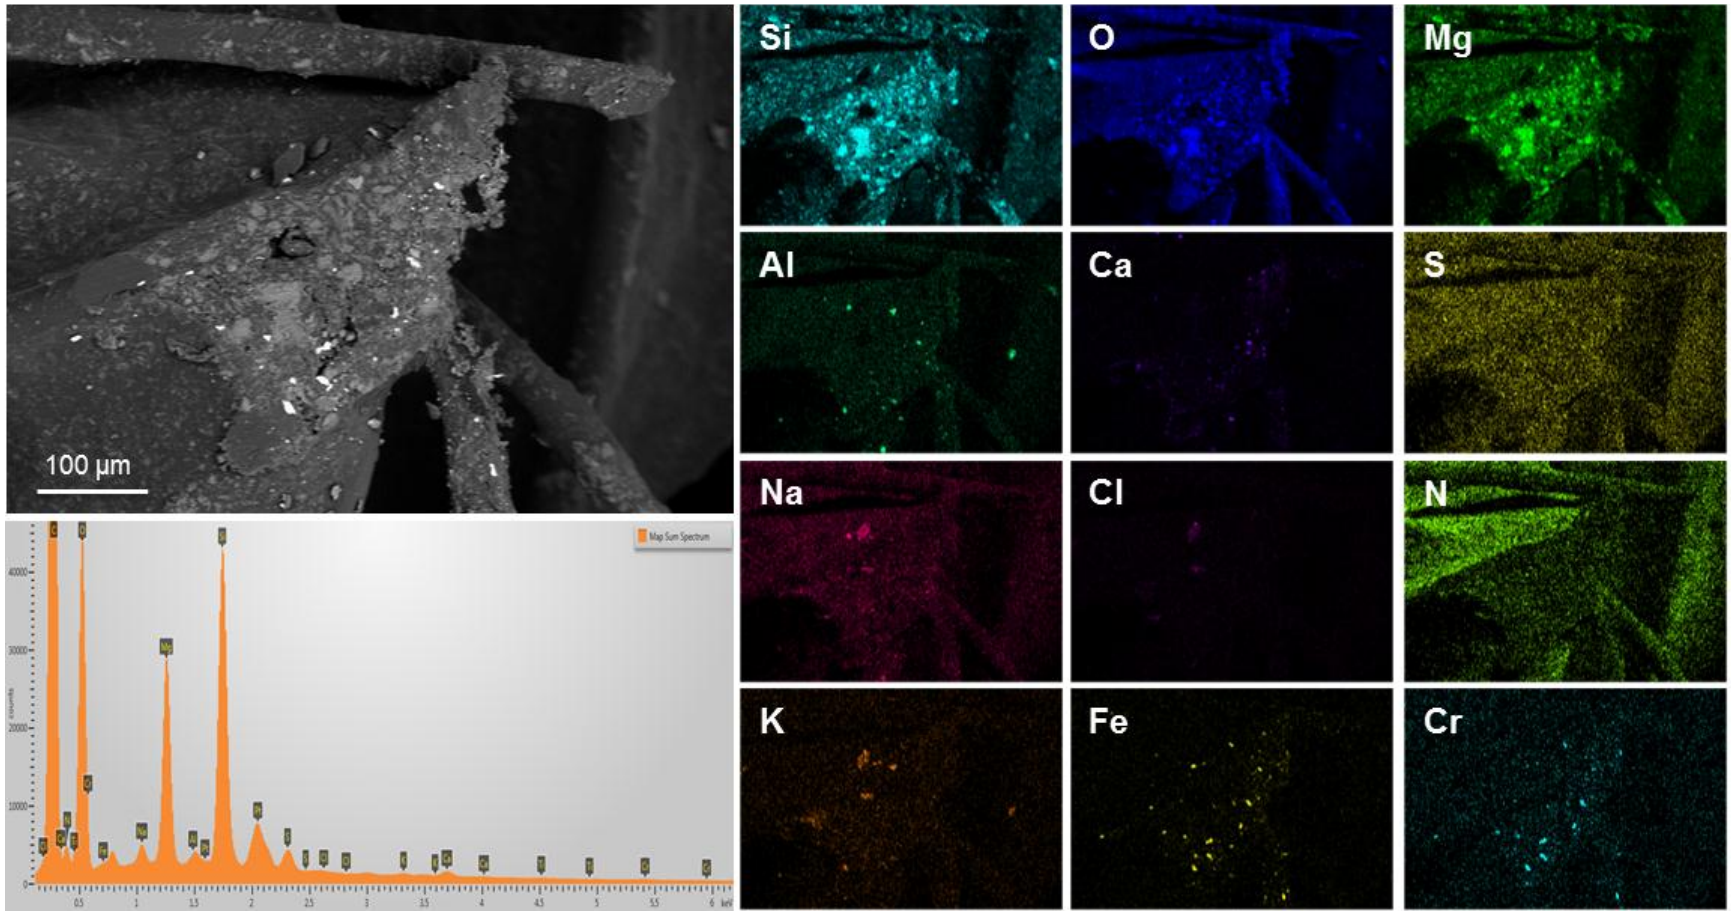
Sample: 145-003

Notes: Dust particles are mostly aluminosilicates and stainless steel particles.

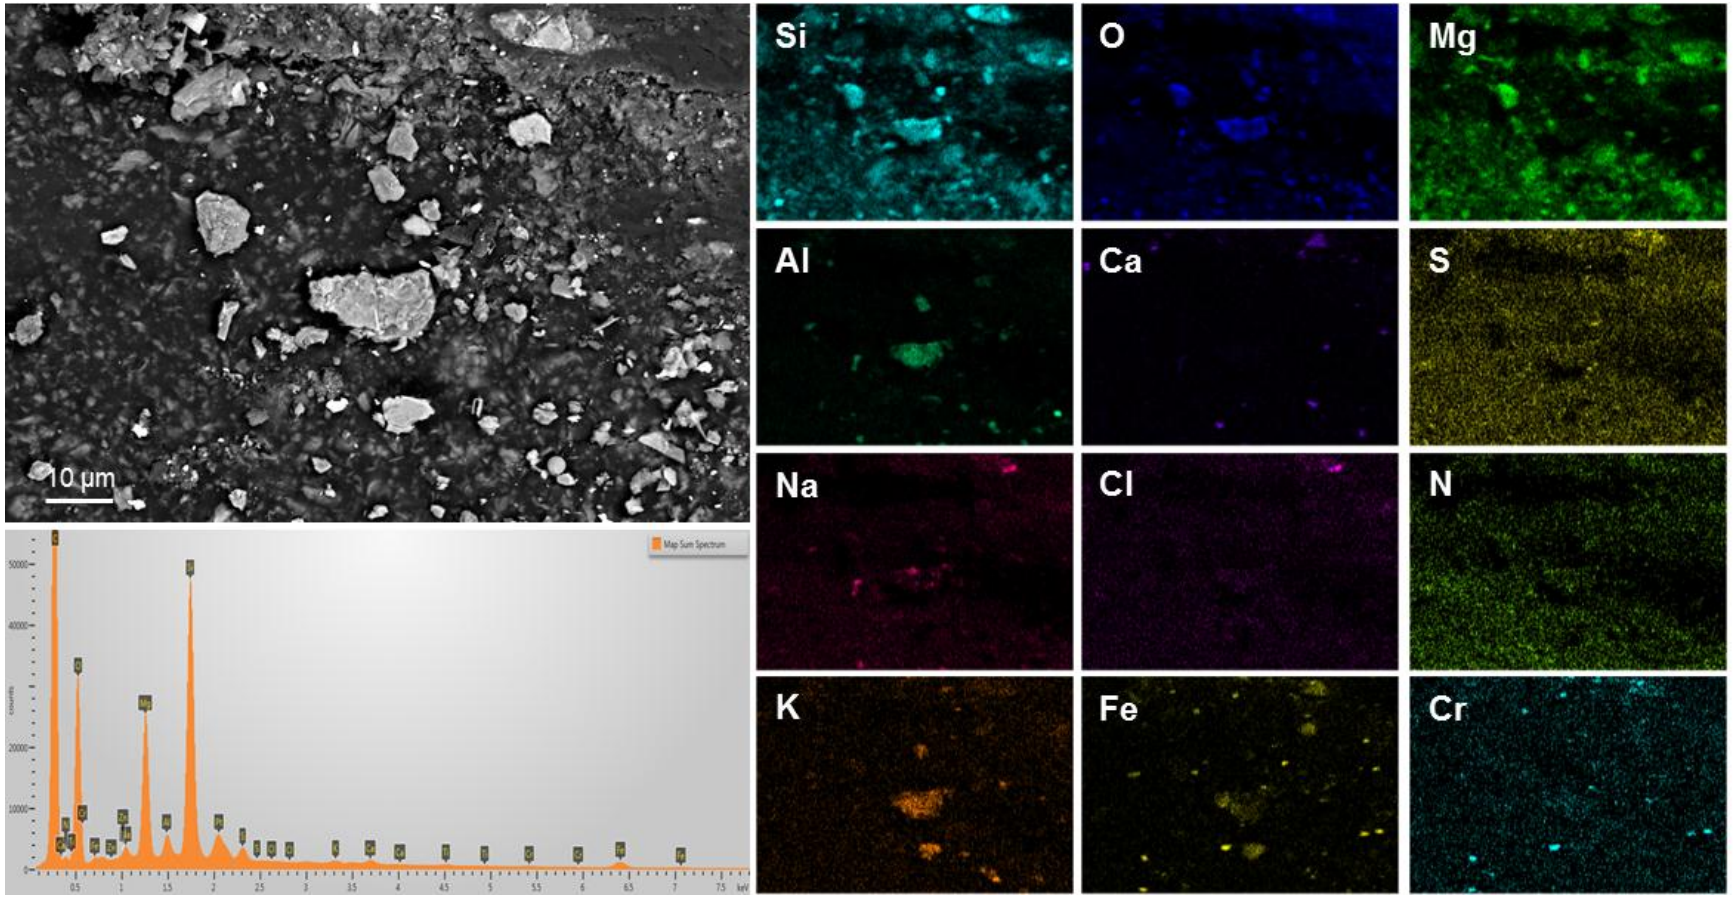
Sample: 145-003

Notes: Particles mostly talc, liberated by abrasion of the pad. Calcium carbonate is also present, and particles of stainless steel.

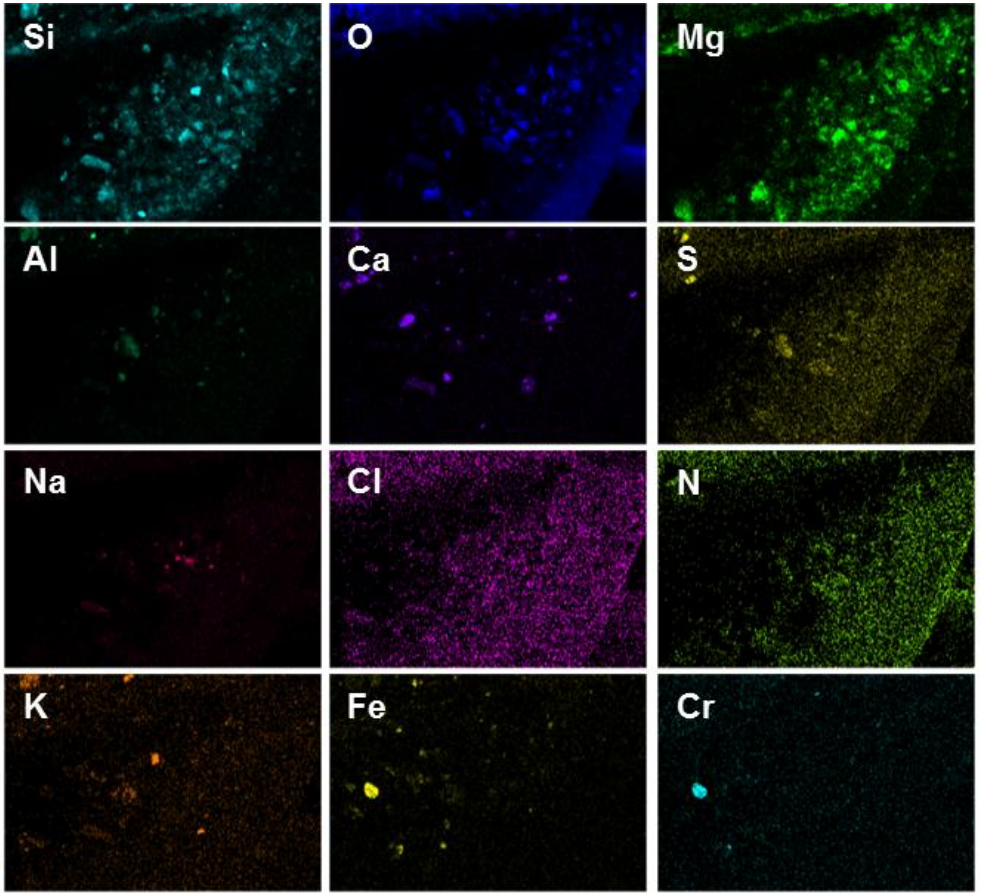
Sample: 145-004
Map A

Notes: Particles mostly talc, liberated by abrasion of the pad. Several grains of Ca-SO_4 are also present.

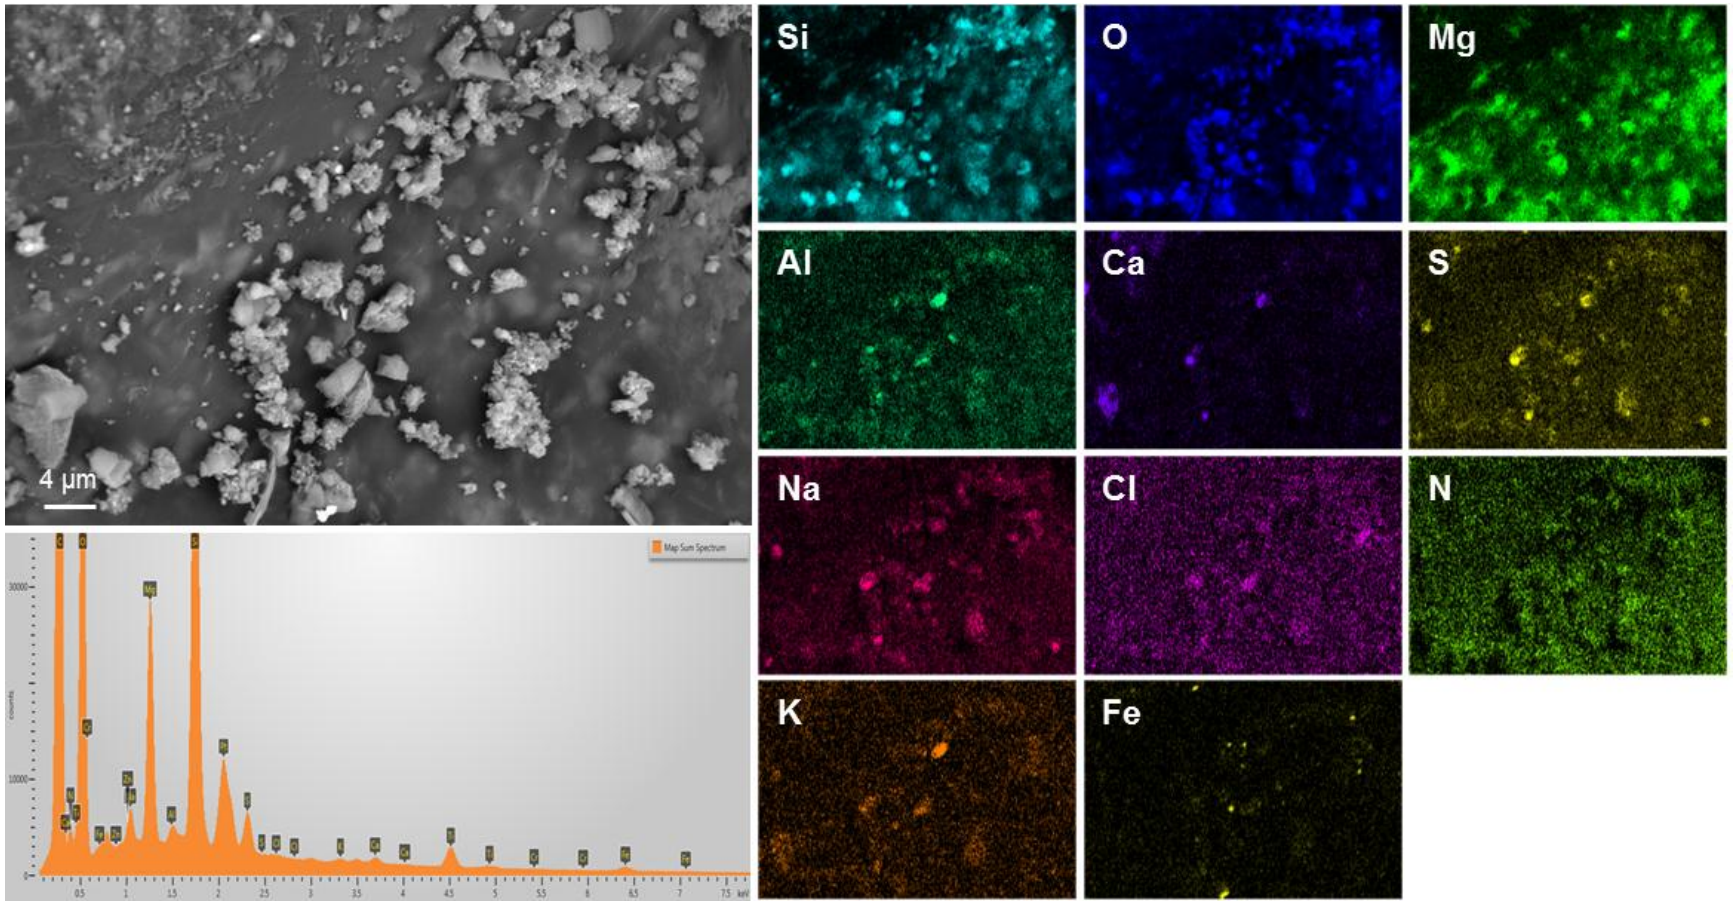
Sample: 145-004

Notes: Accumulated dust on an abraded edge. Embedded grains are dominantly stainless steel.

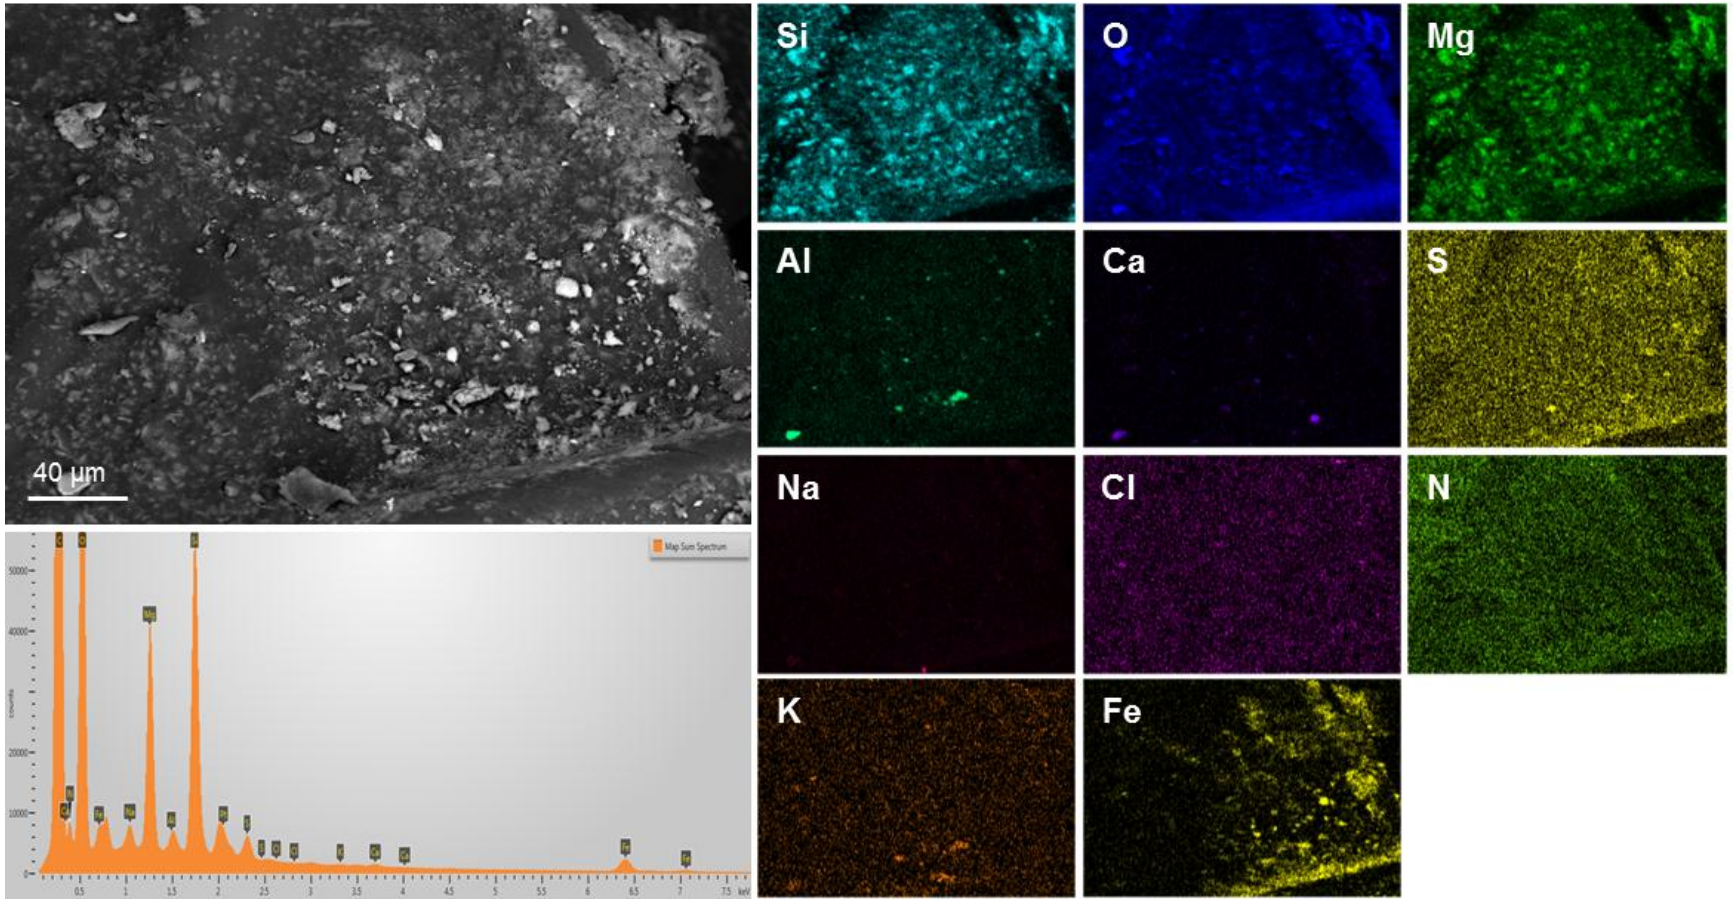
Sample: 145-005
Map A

Notes: Accumulation of trace dust on an abraded edge.

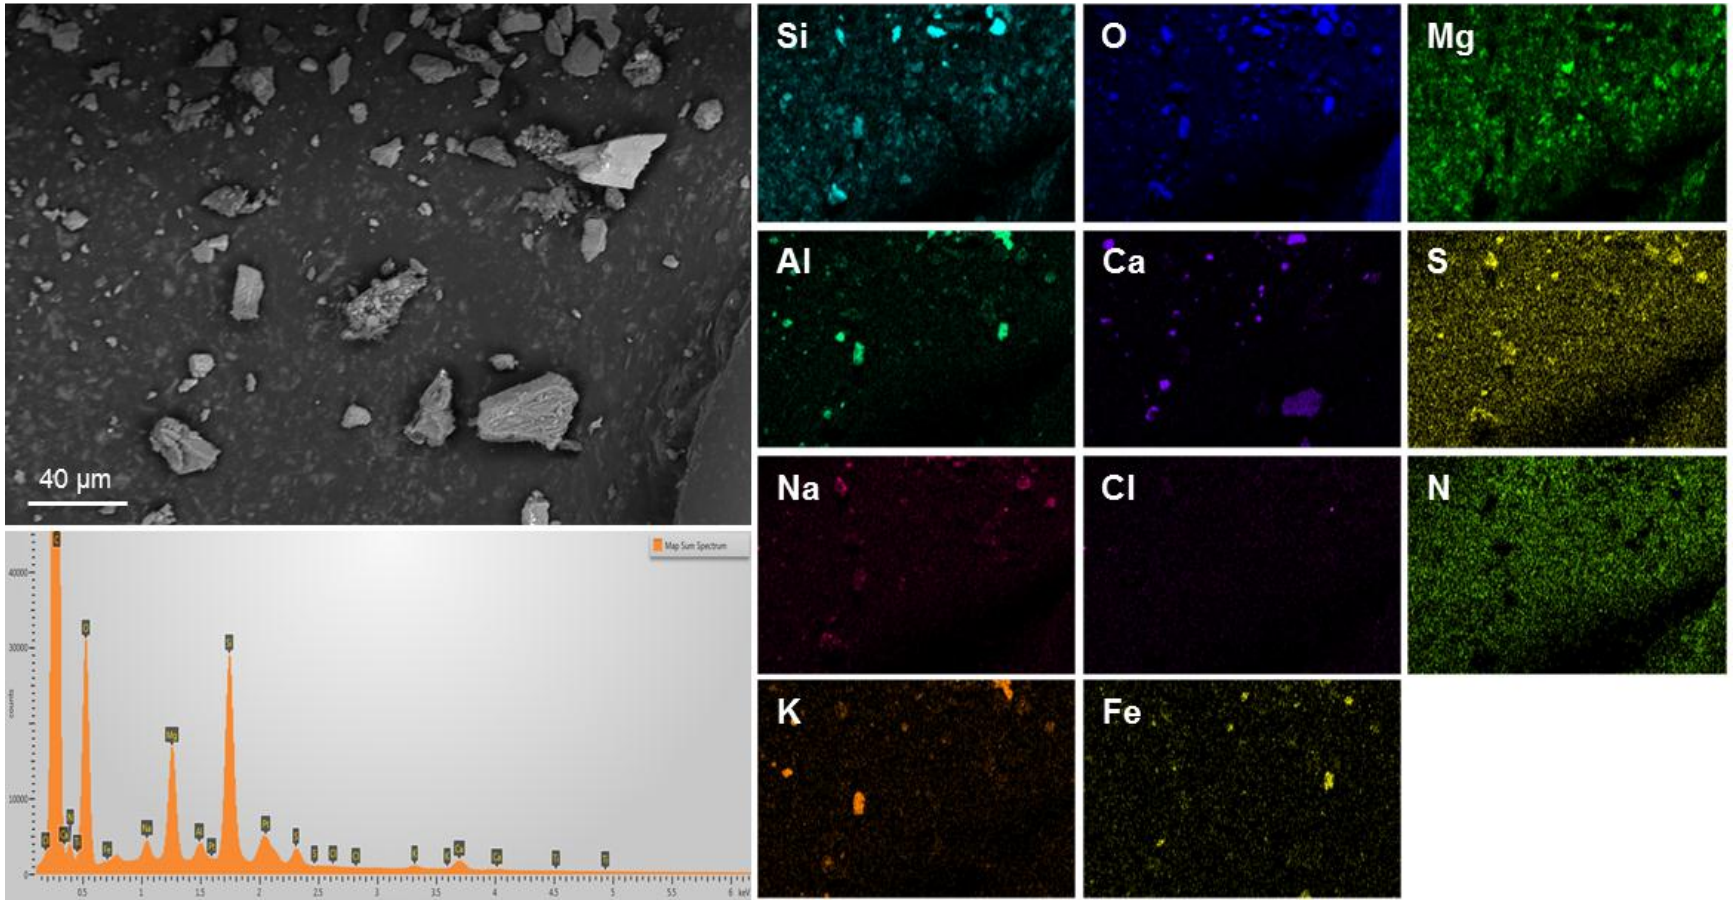
Sample: 145-012
Map B

Notes: Rare NaCl particle.

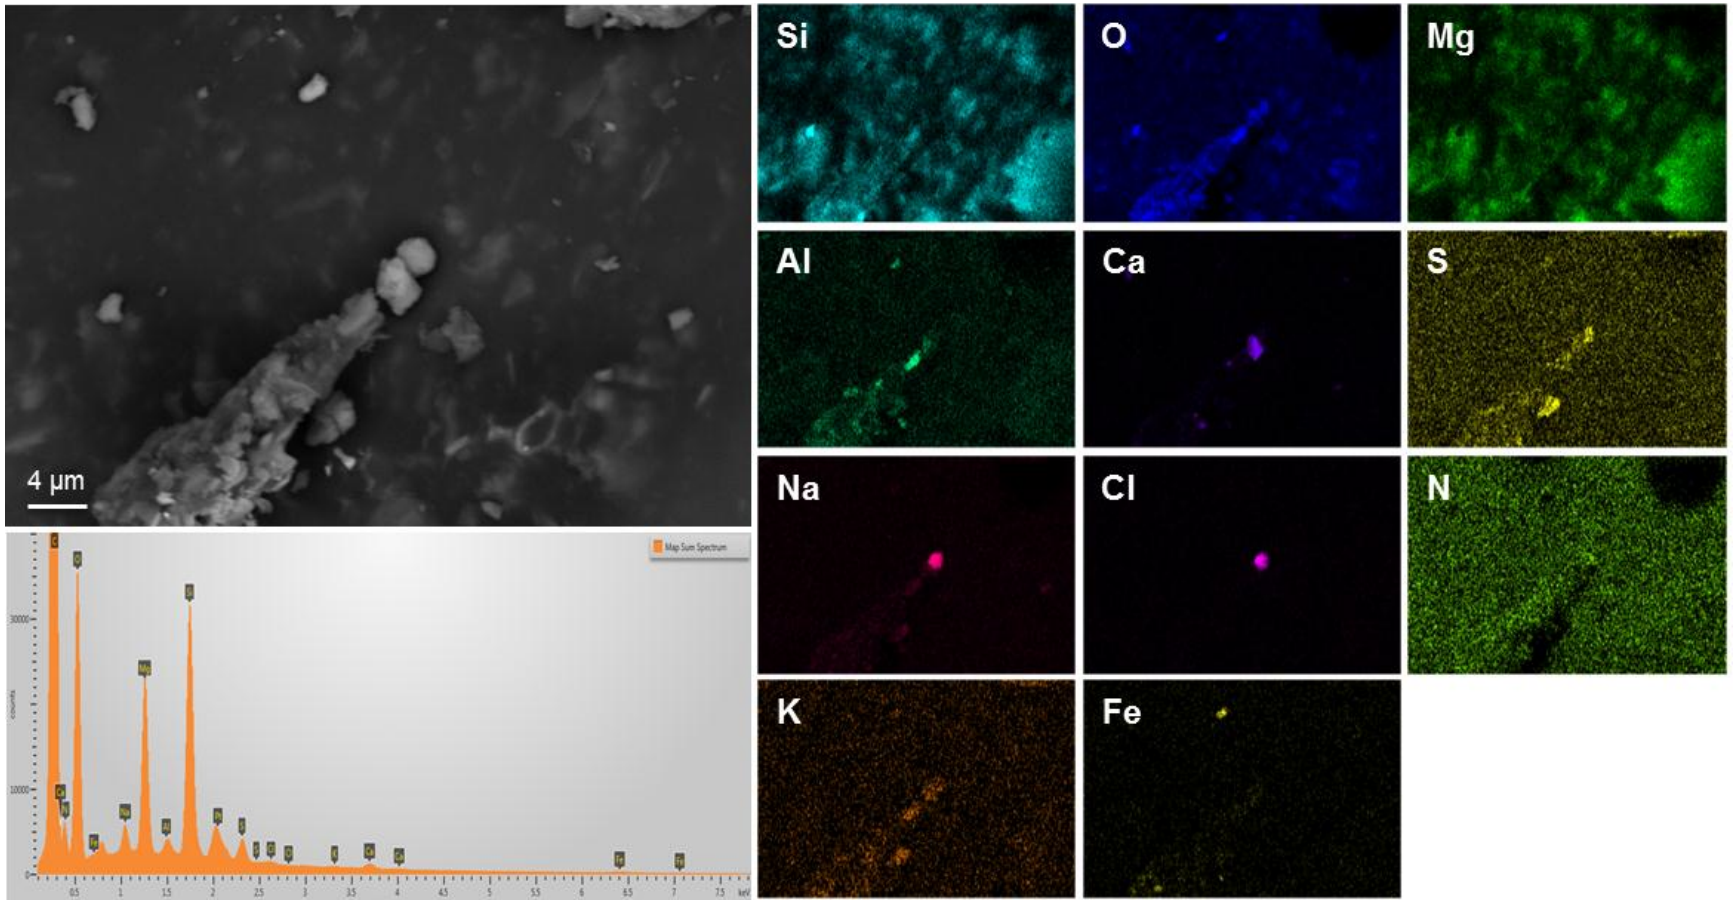
Sample: 145-012
Map C

Notes: Aluminosilicate grains and stainless steel particles.

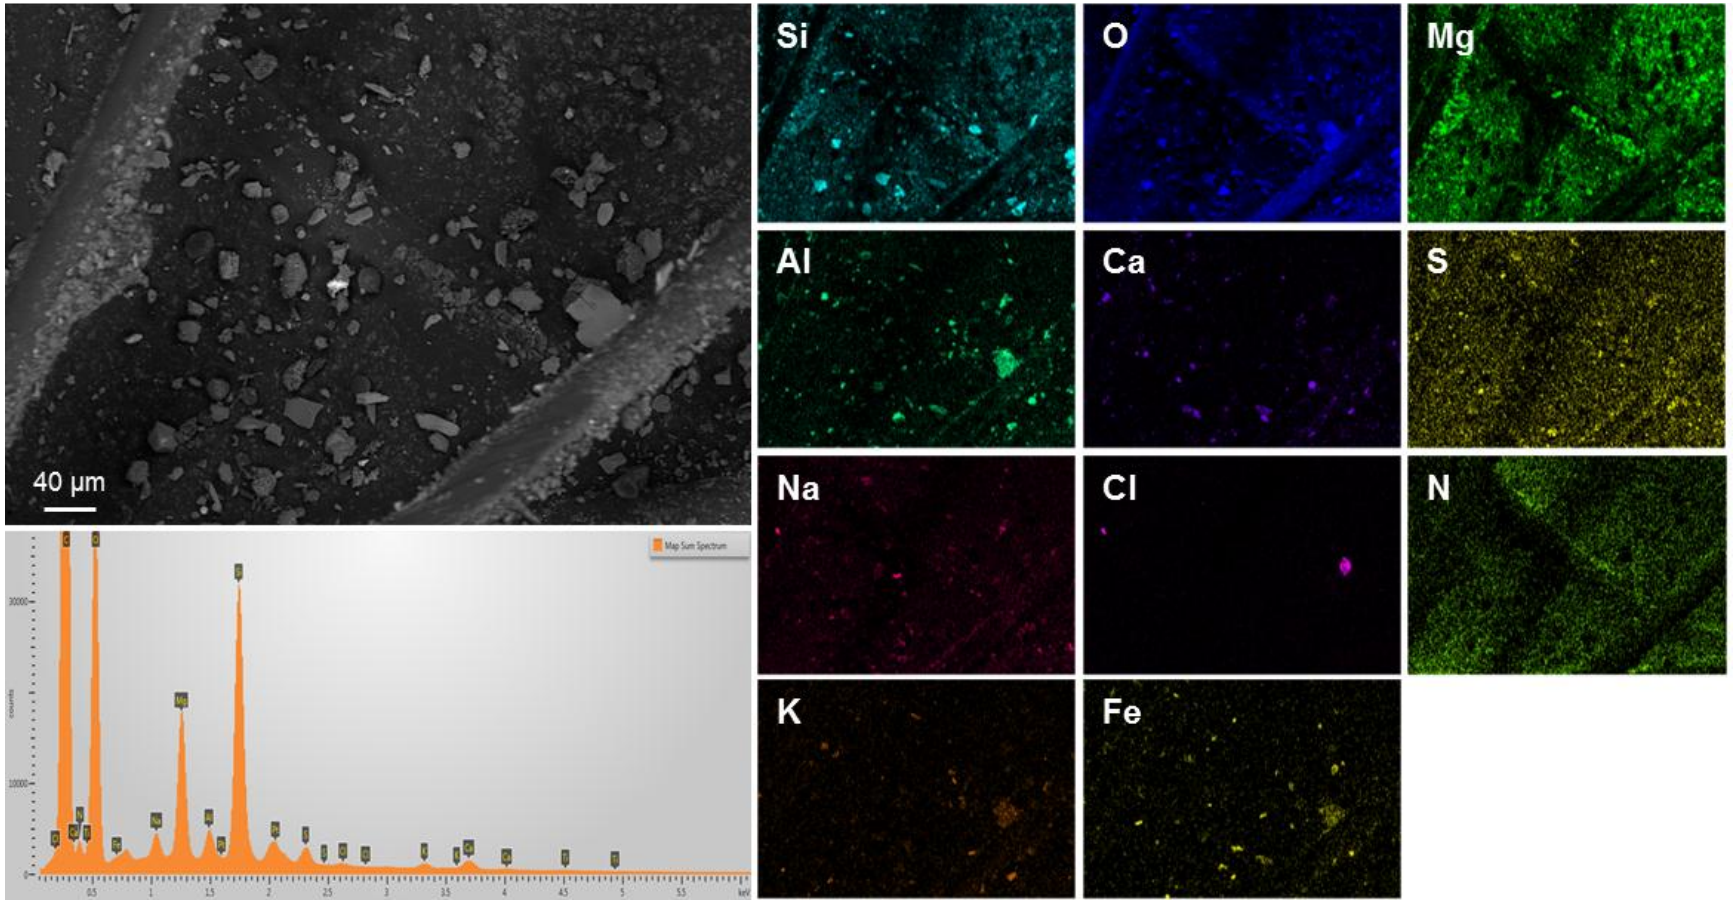
Sample: 145-012
Map D

Notes: Chloride-rich organic particle.

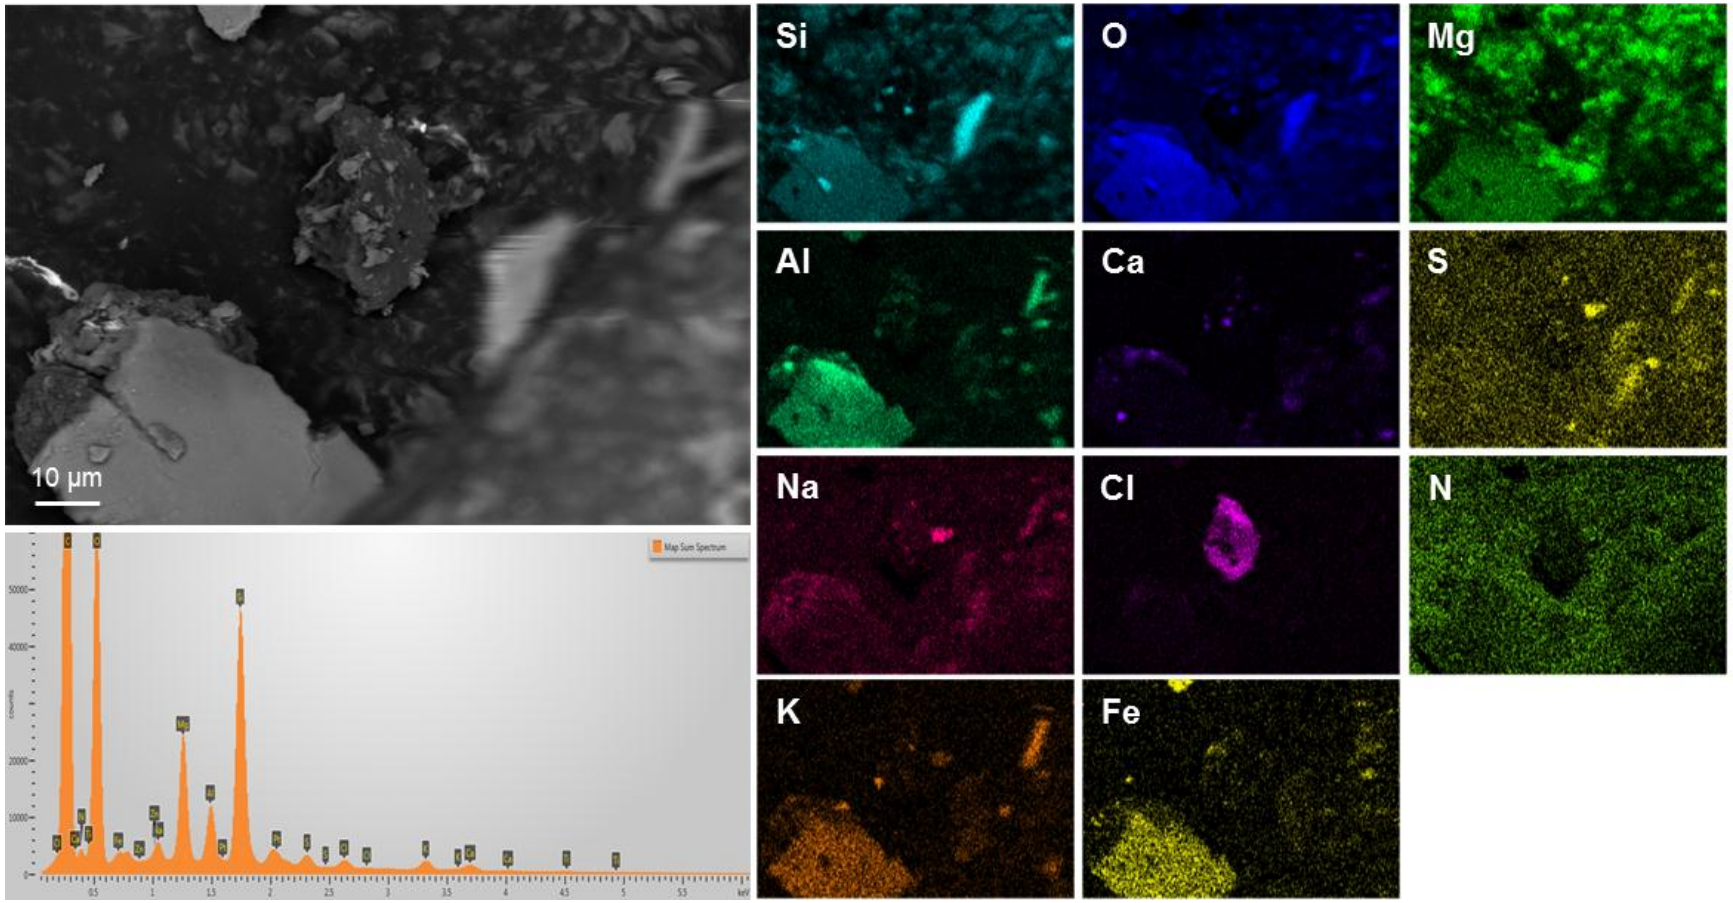
Sample: 145-012
Map E

Notes: Heavy dust load, dominantly aluminosilicates.

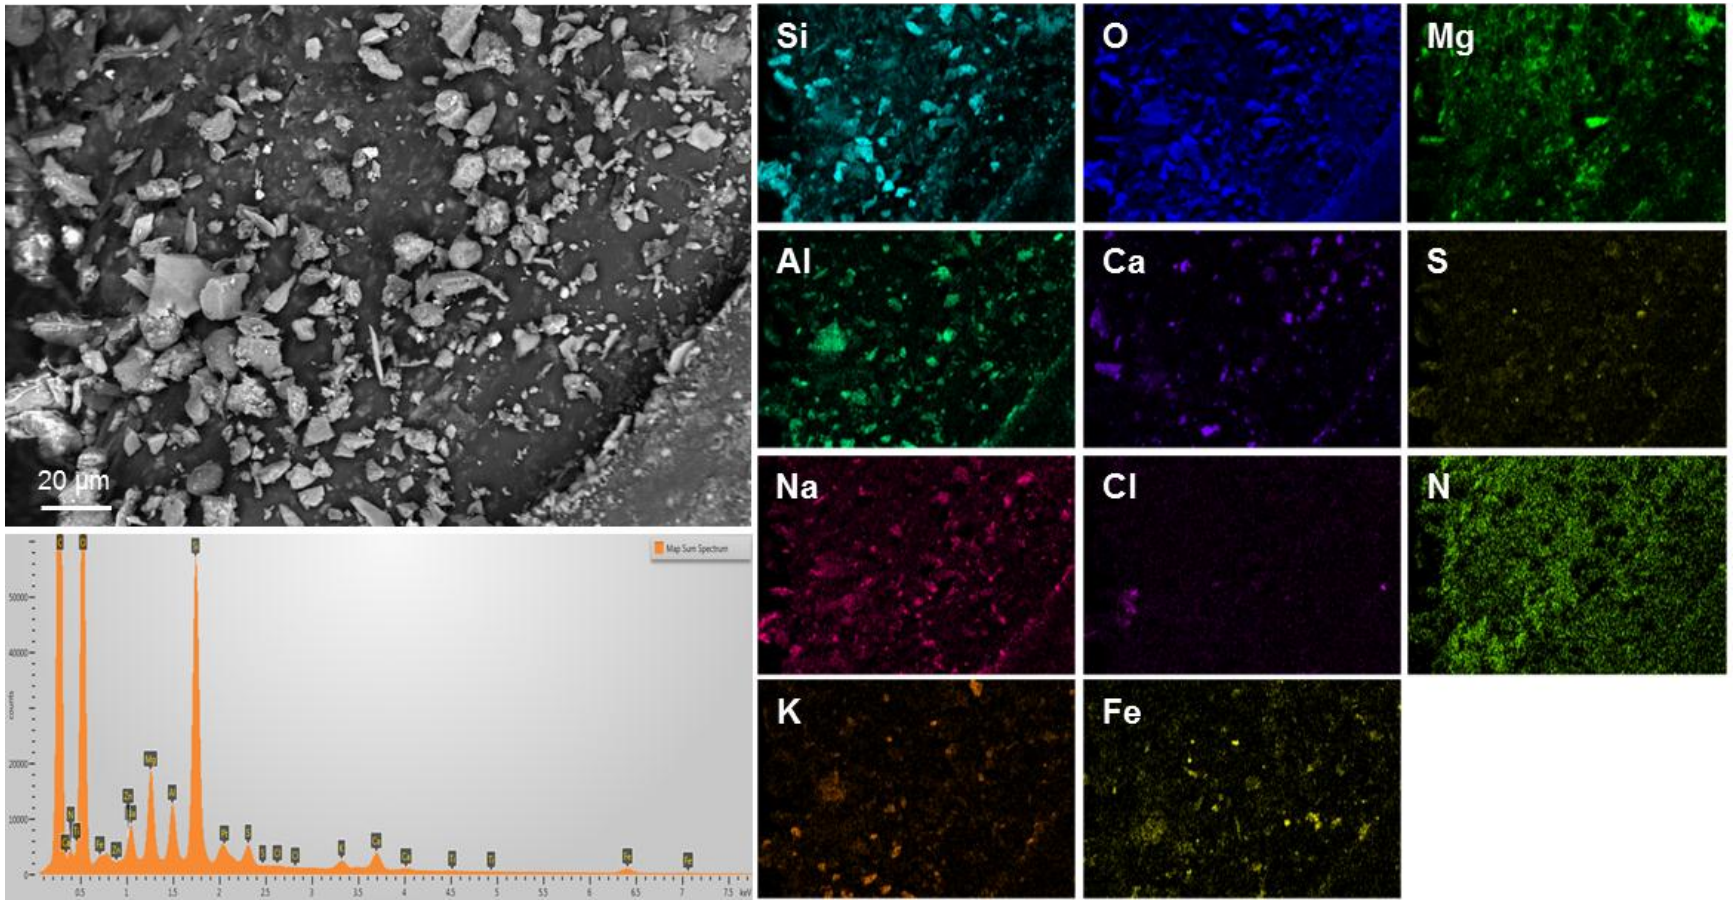
Sample: 145-012
Map F

Notes: heavy dust load, dominantly aluminosilicates, calcium carbonate, and Fe-oxides.
