SANDIA REPORT

SAND2014-16383
Unlimited Release
Printed July 2014

Analysis of Dust Samples Collected from Spent Nuclear Fuel Interim Storage Containers at Hope Creek, Delaware, and Diablo Canyon, California

Charles R. Bryan and David G. Enos

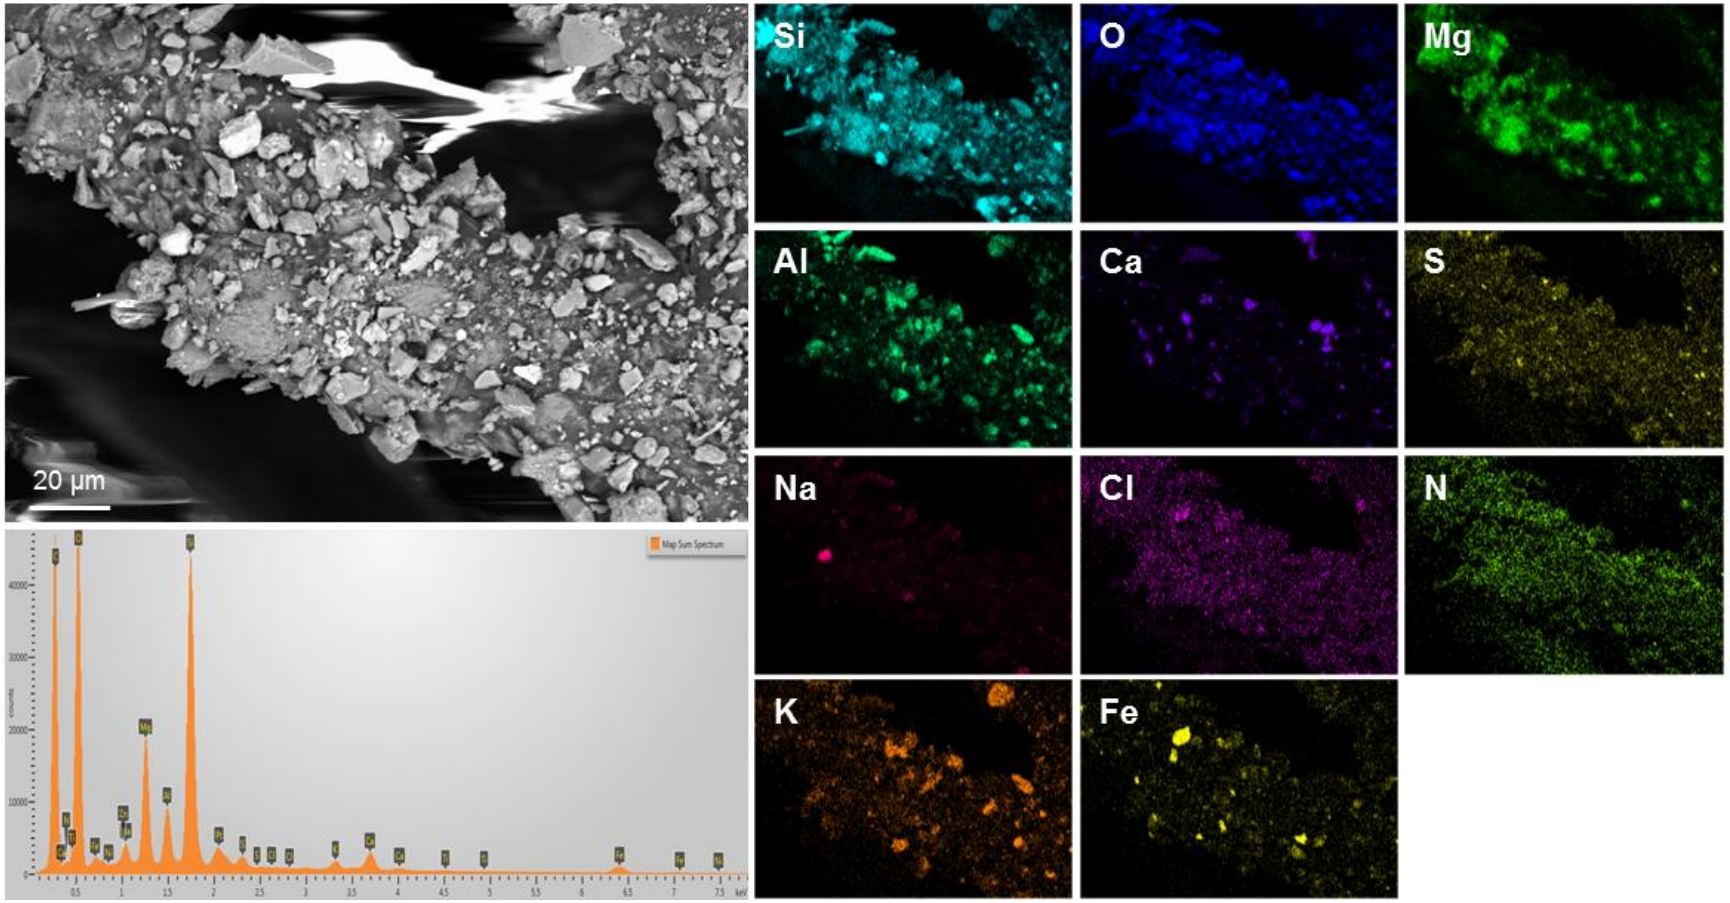
Sample: 145-012
Map G

Notes: Heavy dust load, dominantly aluminosilicates and calcium carbonate.

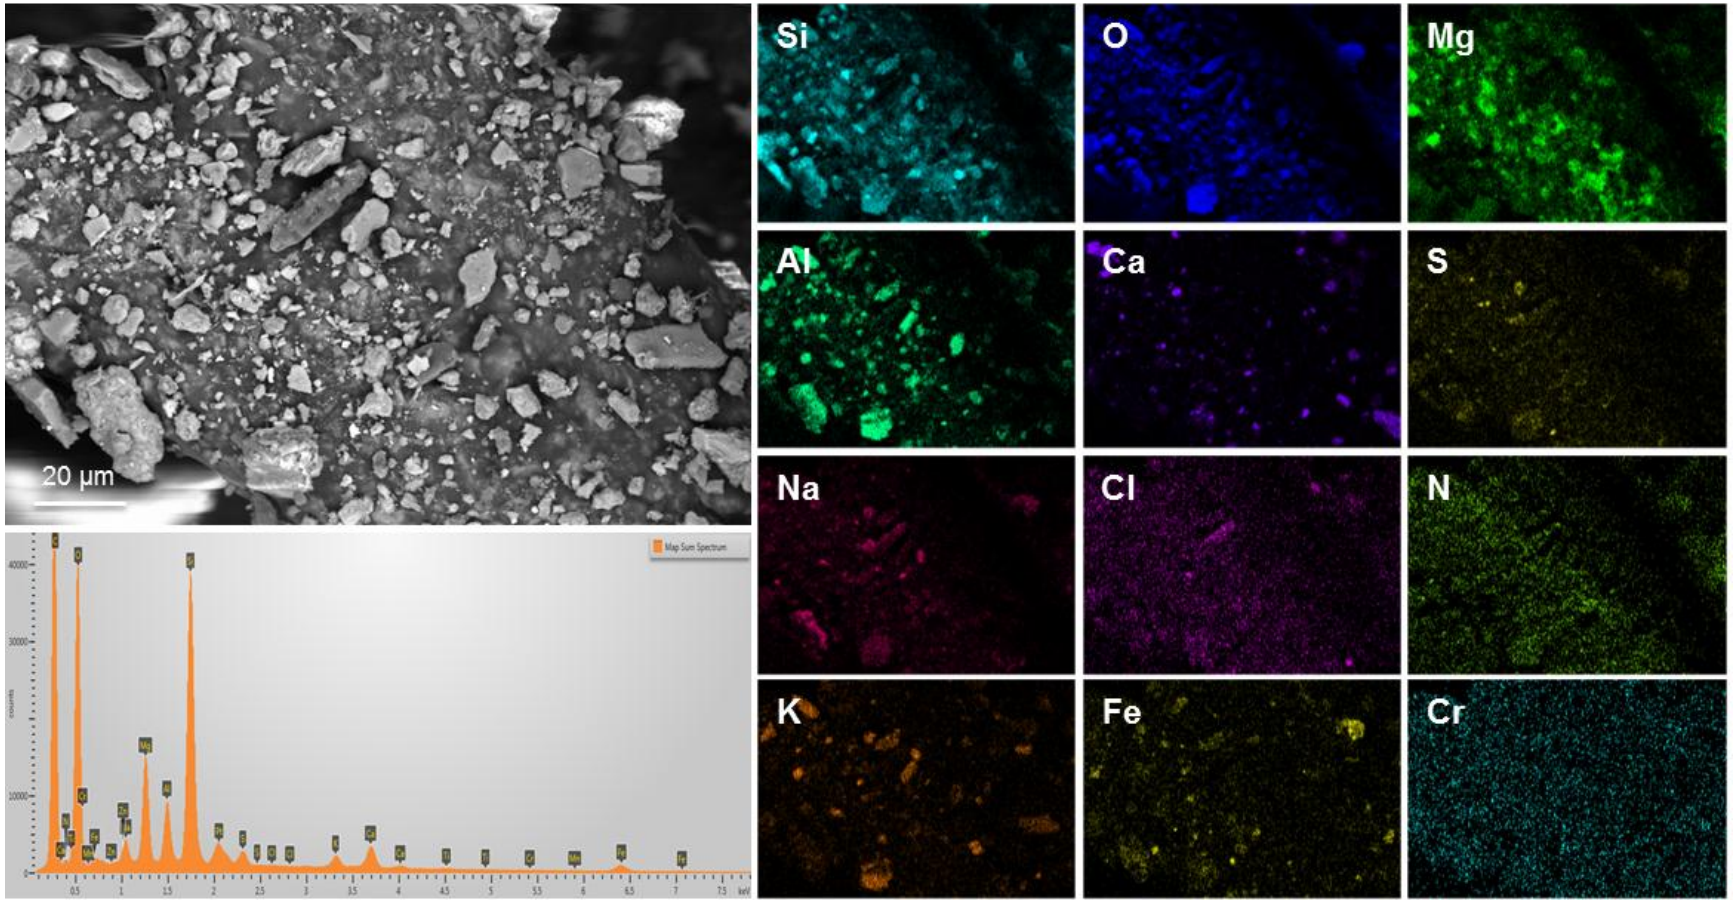
Sample: 145-012
Map H

Notes: Heavy dust load, dominantly aluminosilicates and calcium carbonate.

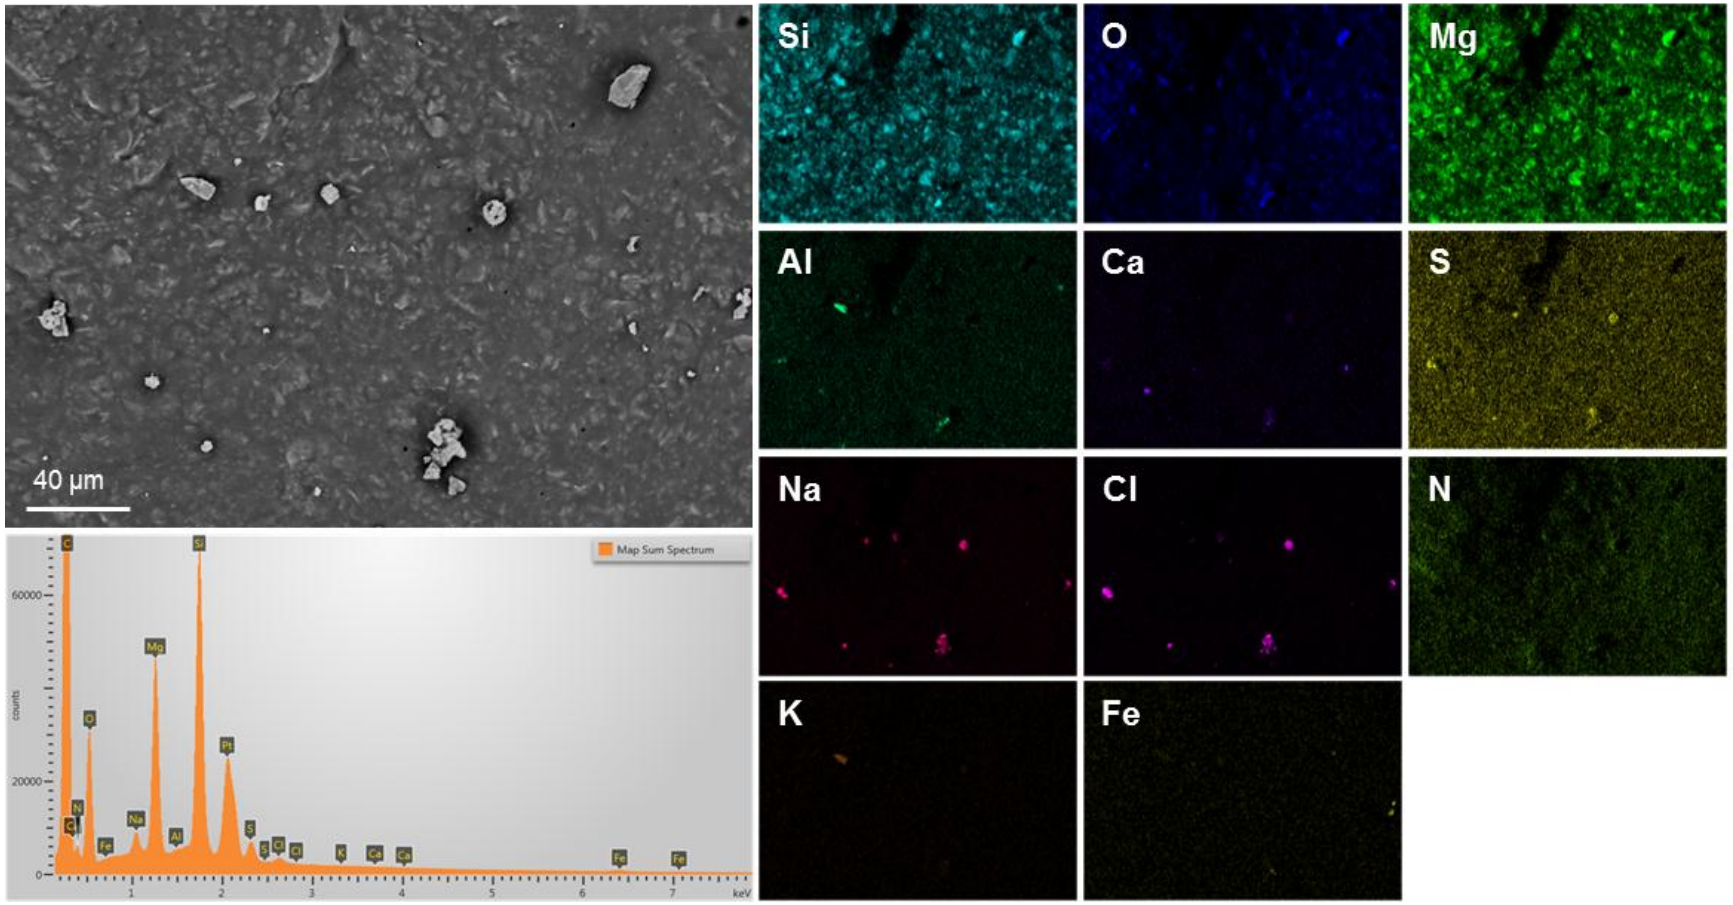
Sample: 123-001

Composite mineral grain, with NaCl and aluminosilicates.

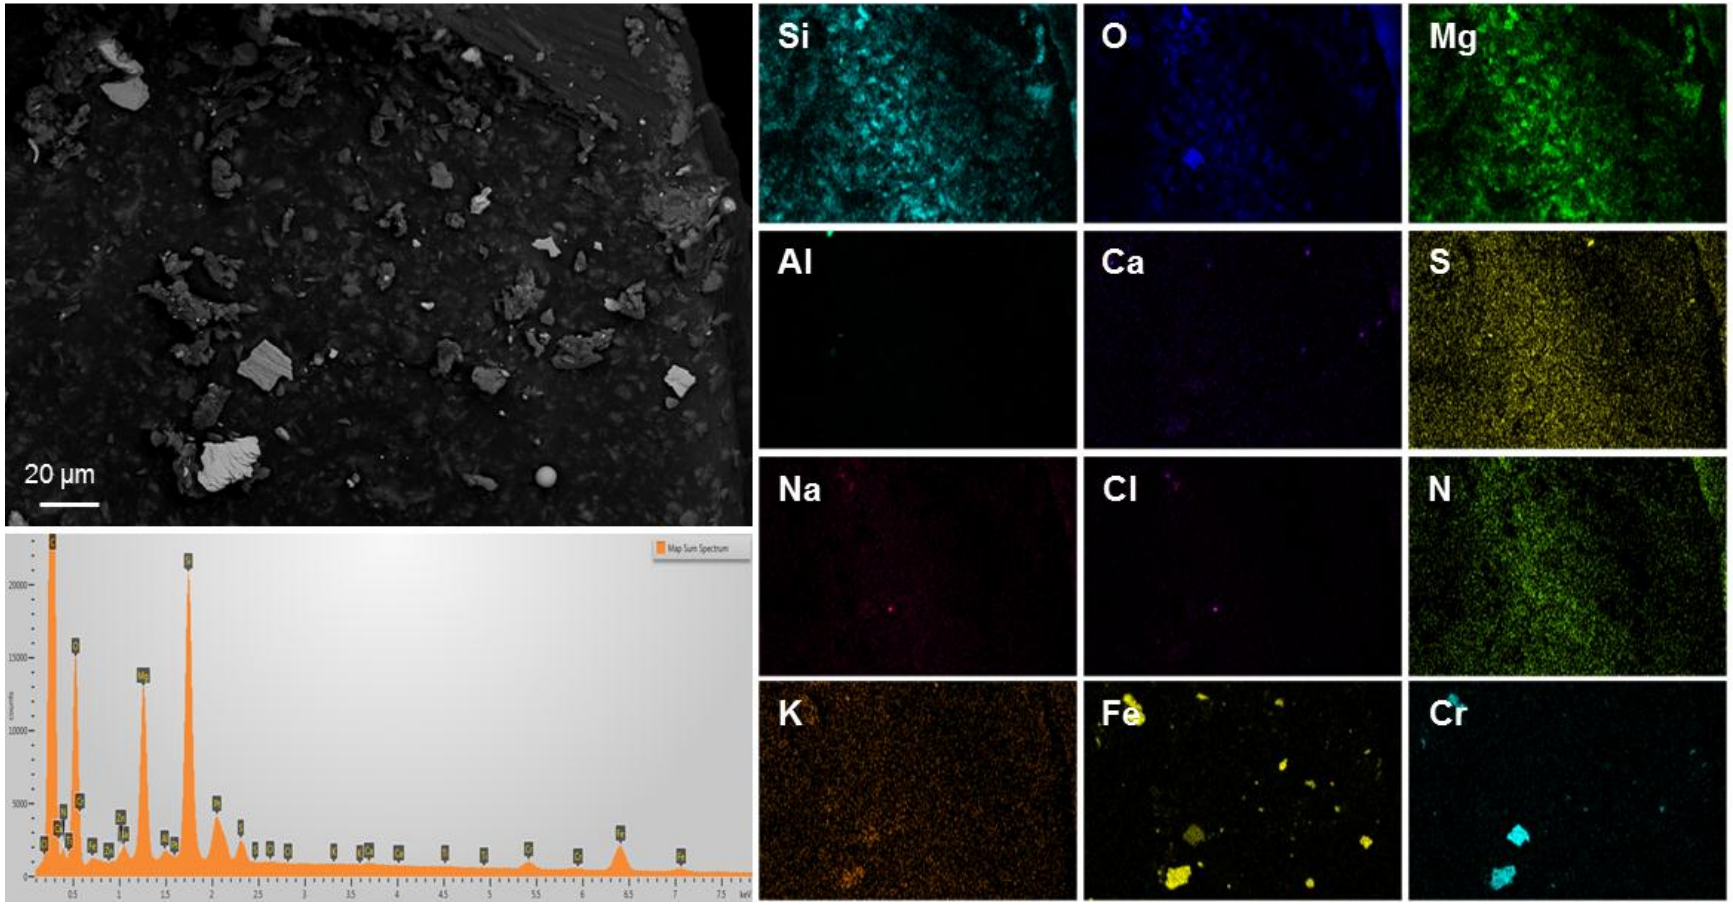
Sample: 123-006
Map C

Notes: Large NaCl grains. Stainless steel and Fe-oxide particles are also present.

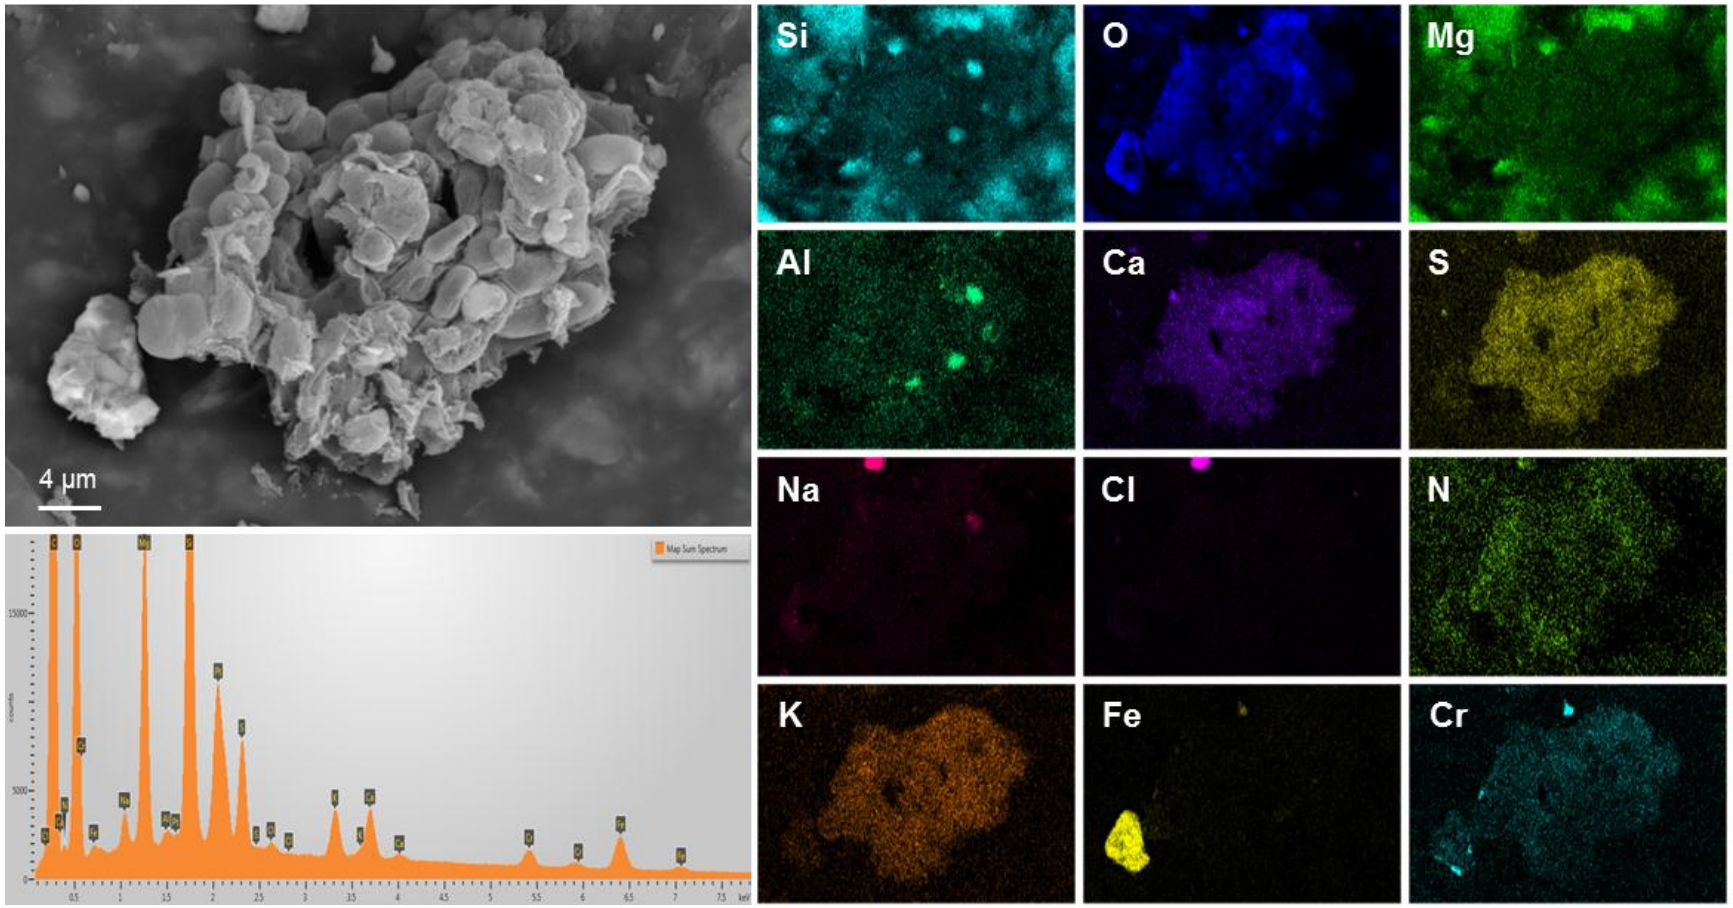
Sample: 123-009
Map C

Notes: $NaNO_3$ and NaCl salt particles. Stainless steel particles common. Ca-carbonate rod of biological origin in lower left.

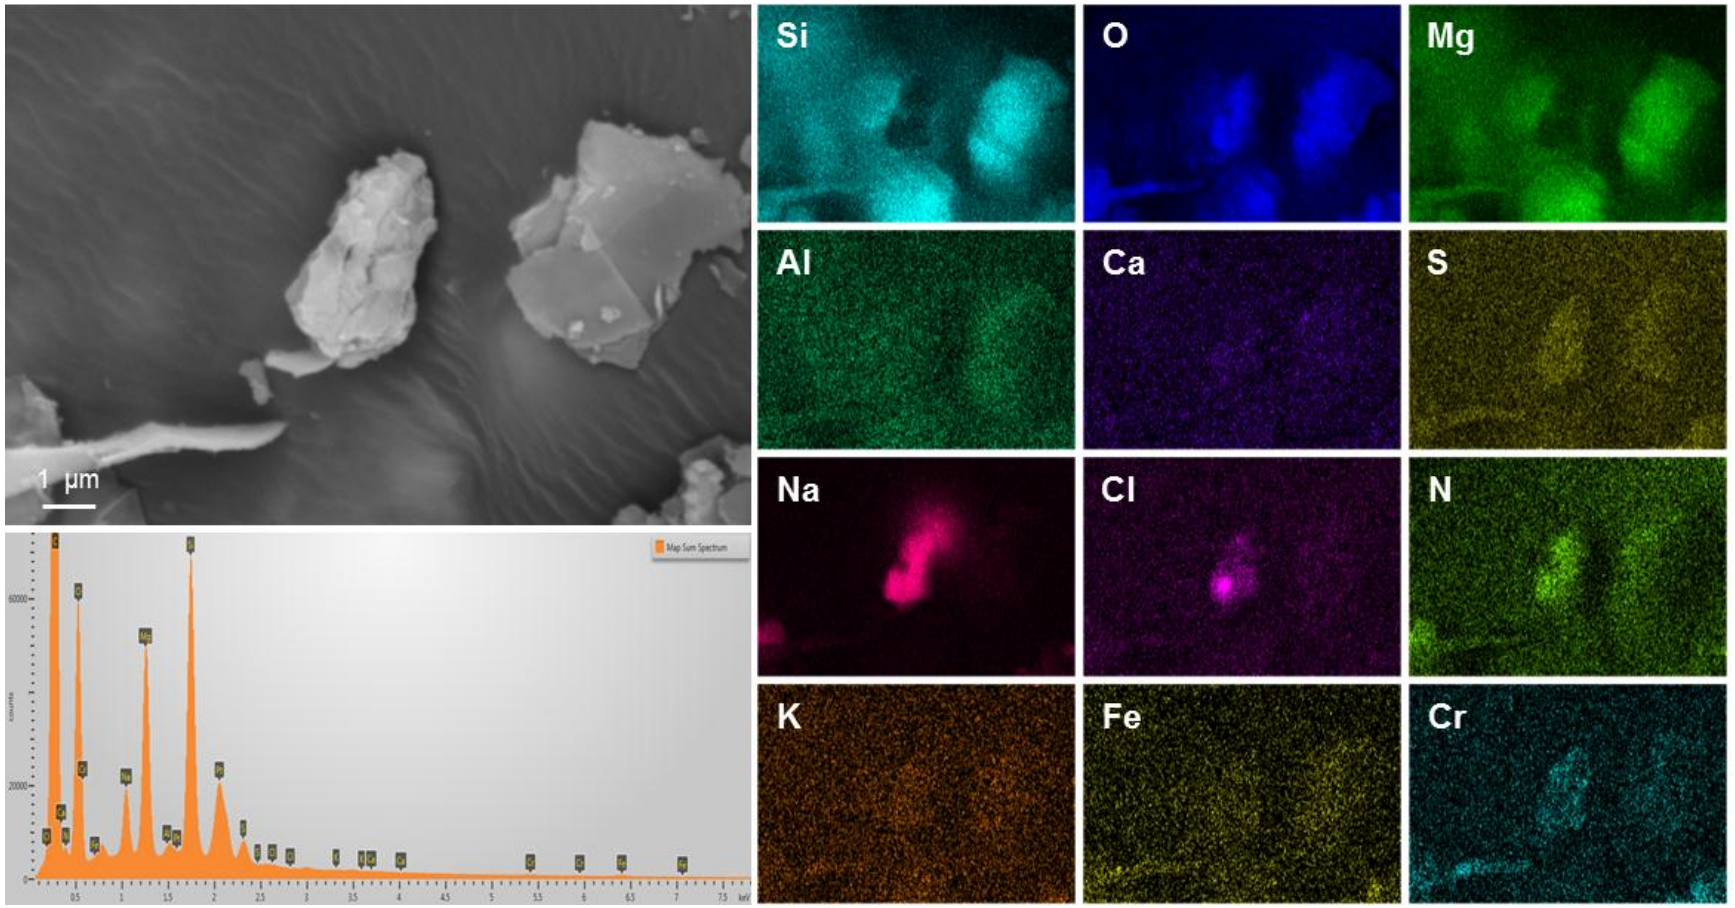
Sample: 123-009
Map E

Notes: Composite grain of NaCl and $NaNO_3$ salts.

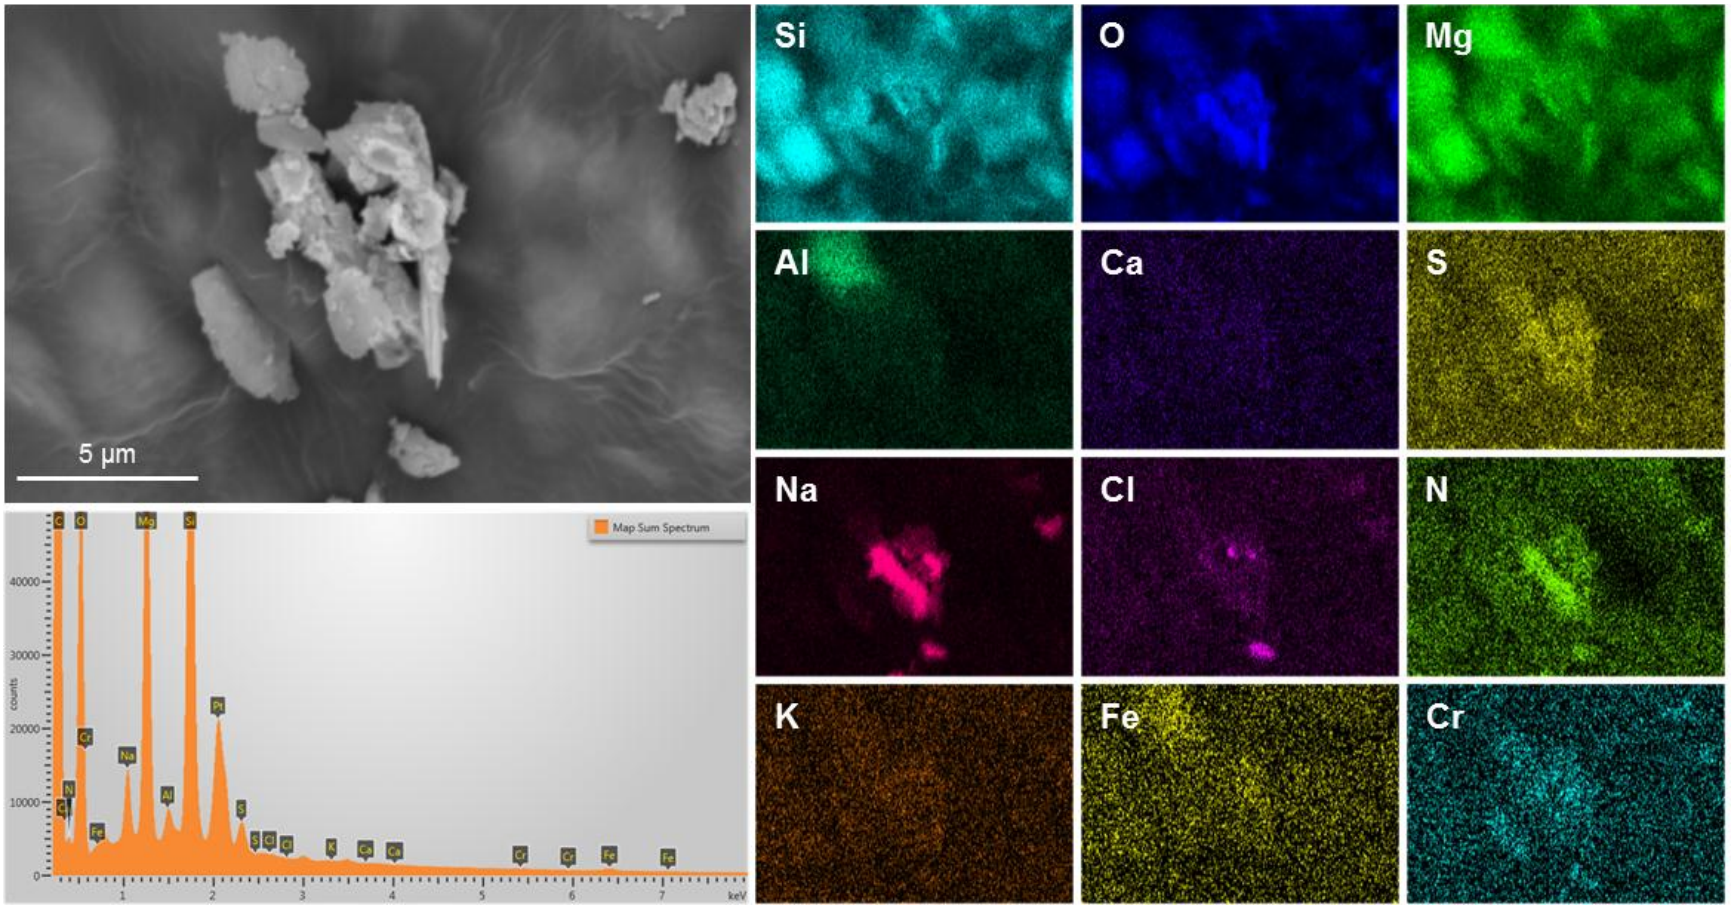
Sample: 123-009
Map F

Notes: Most particles are talc, liberated by abrasion of the pad. Sparse dust, including $NaNO_3$ and stainless steel particles.

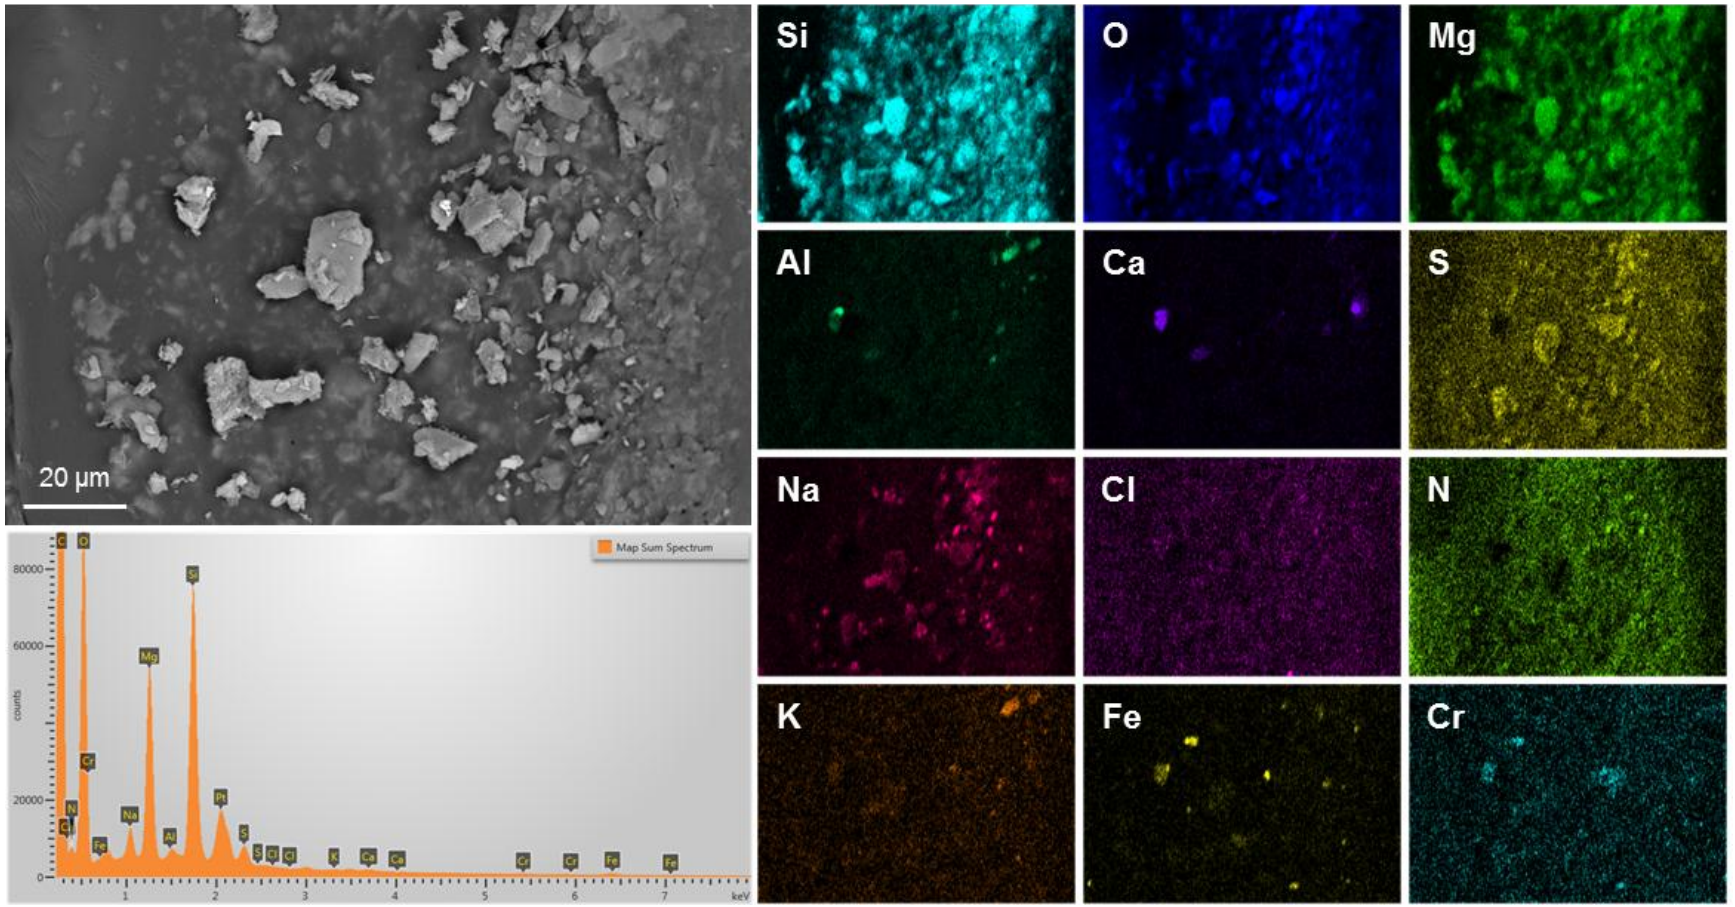
Sample: 123-009
Map G

Notes: Most particles are talc, liberated by abrasion of the pad. Sparse dust, including $NaNO_3$.

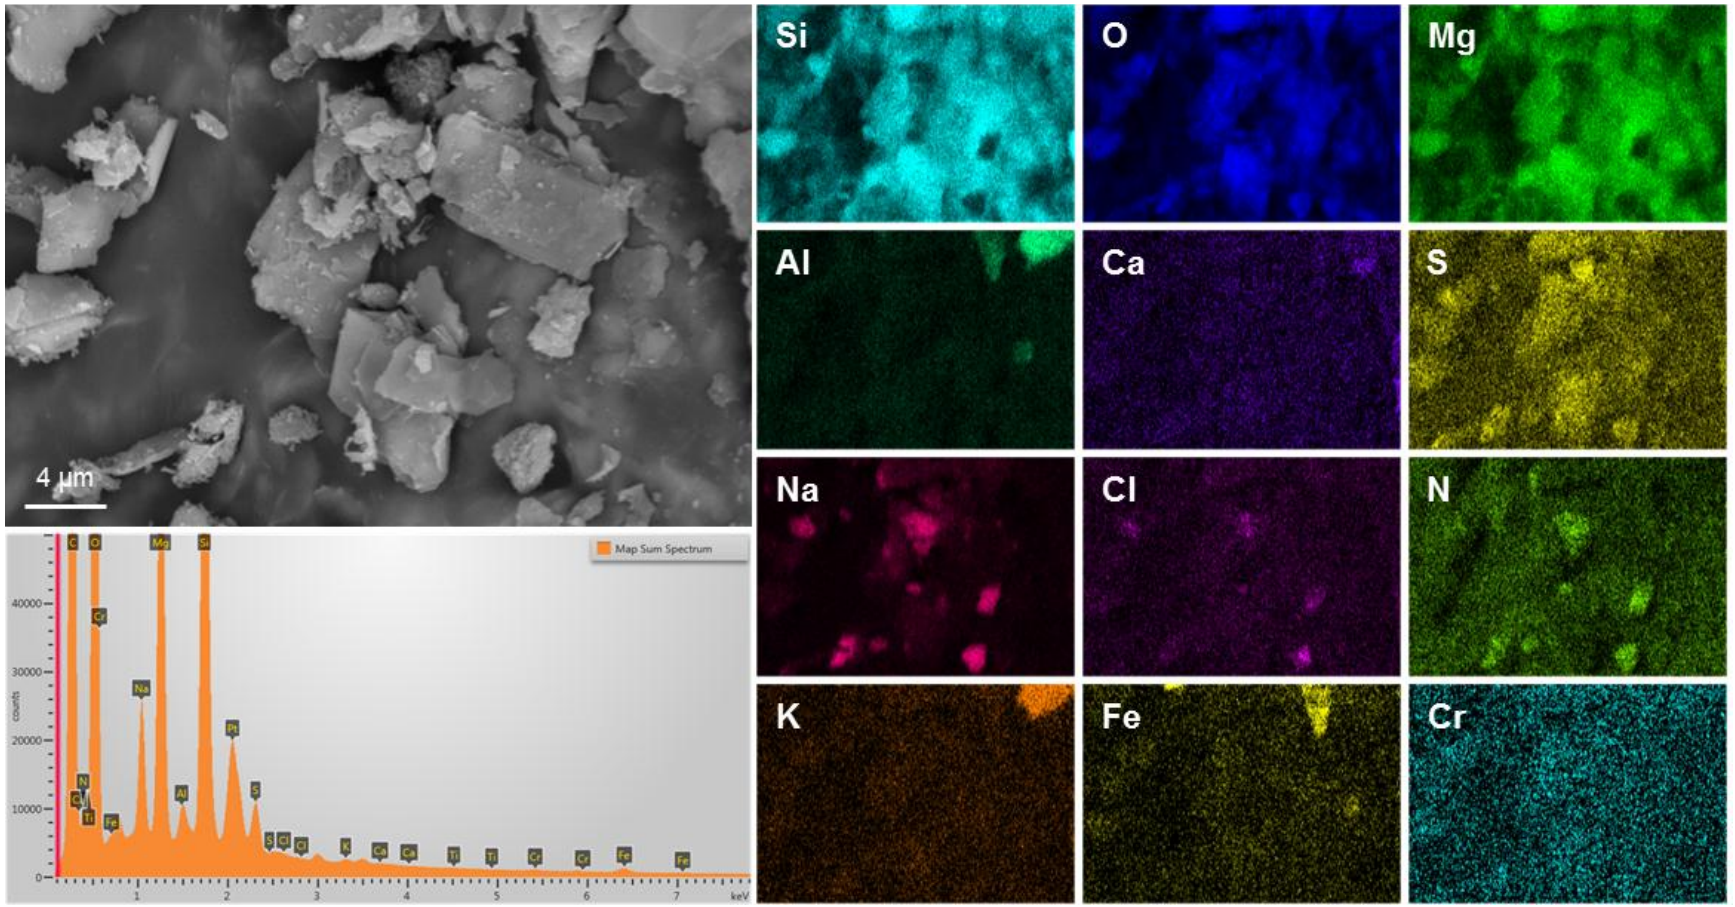
Sample: 123-009
Map H

Notes: Most particles are talc, liberated by abrasion of the pad. Sparse dust, including NaCl and $NaNO_3$, and stainless steel particles. Note association of Ca-SO_4 with NaCl.

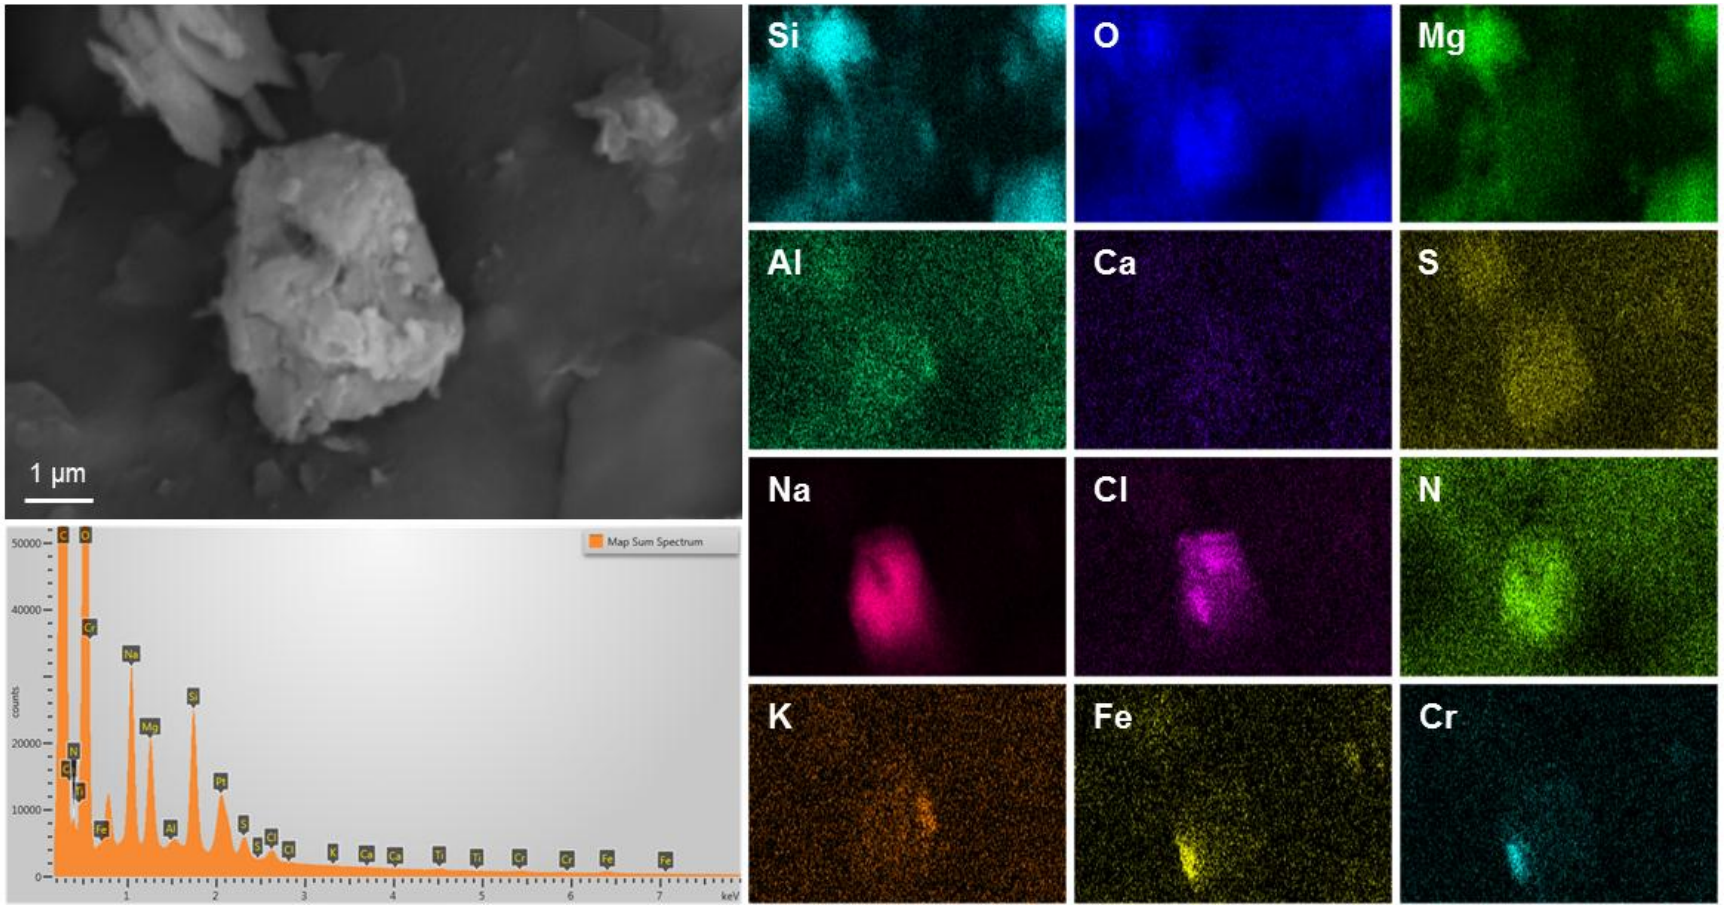
Sample: 123-009
Image of grain in Map I, before and after element mapping

Notes: Grain was originally Na-NO_3 rich, but decomposed due to heating during element mapping; nitrogen signal decreased, while the Chlorine signal increased. Interpreted as loss of $NaNO_3$ from the grain surface, revealing a NaCl core.

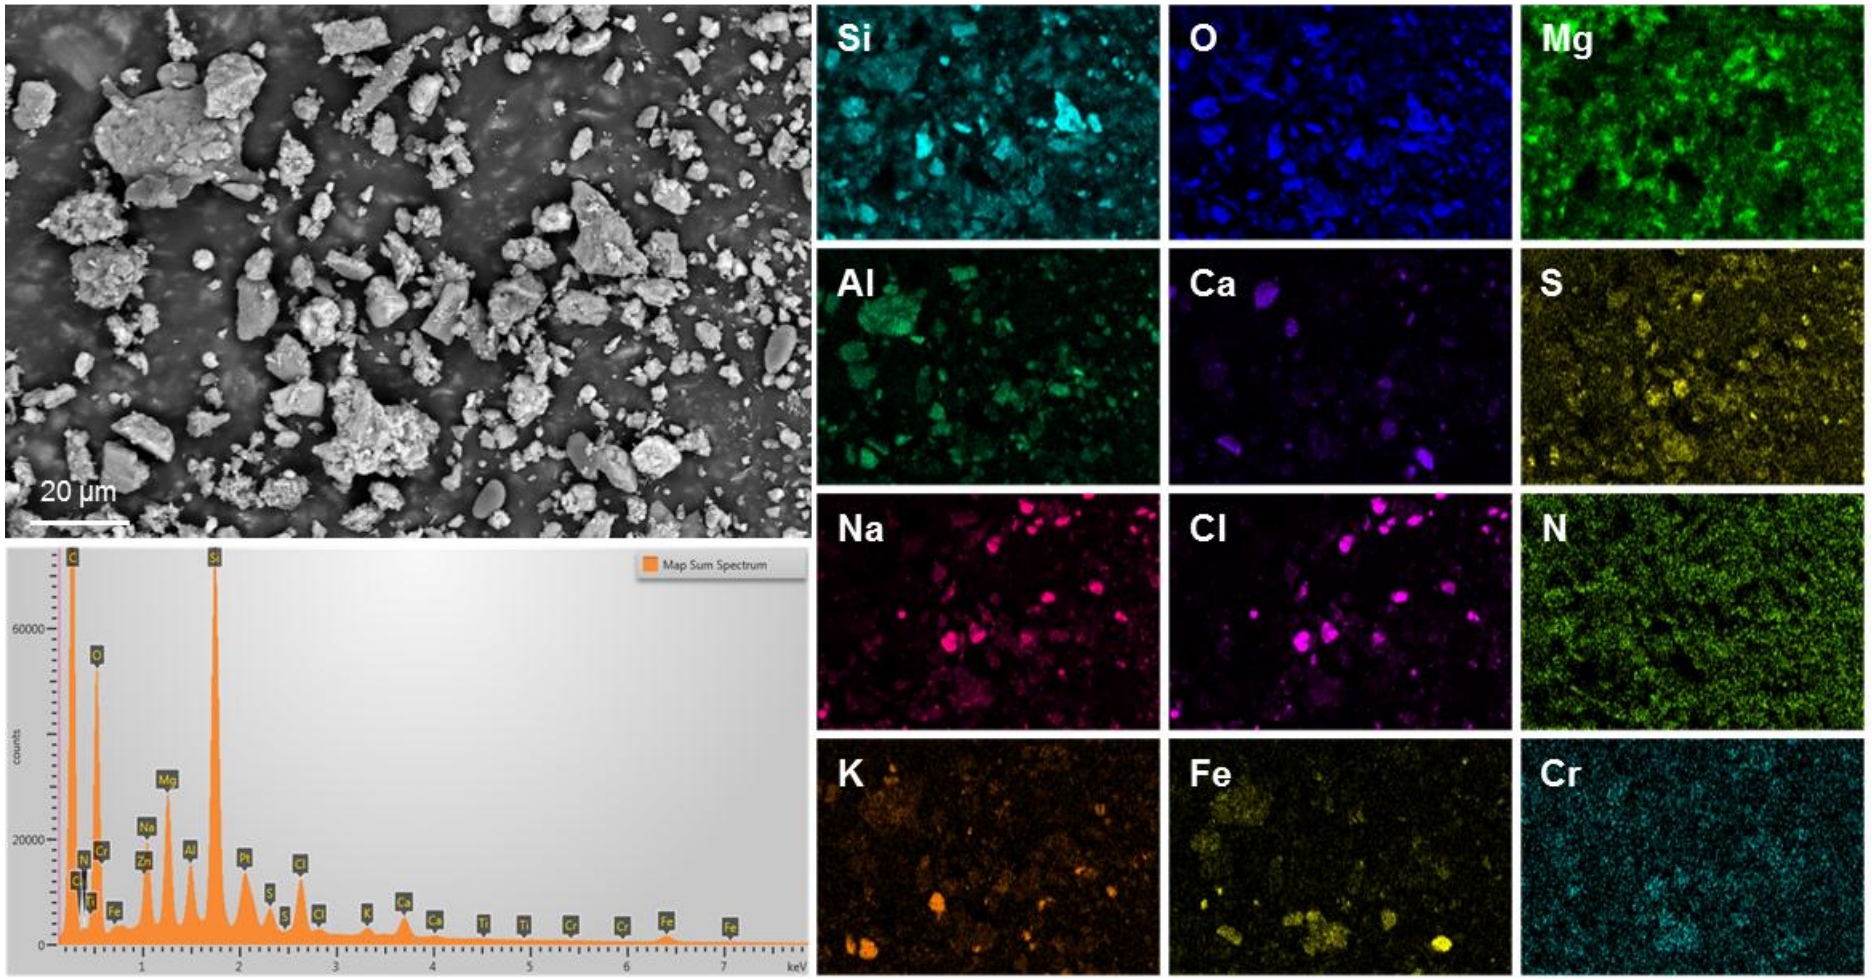
Sample: 123-012
Map A

Notes: Heavy dust load, dominantly aluminosilicates and Sea-salts (aggregates of NaCl and Mg-SO_4).

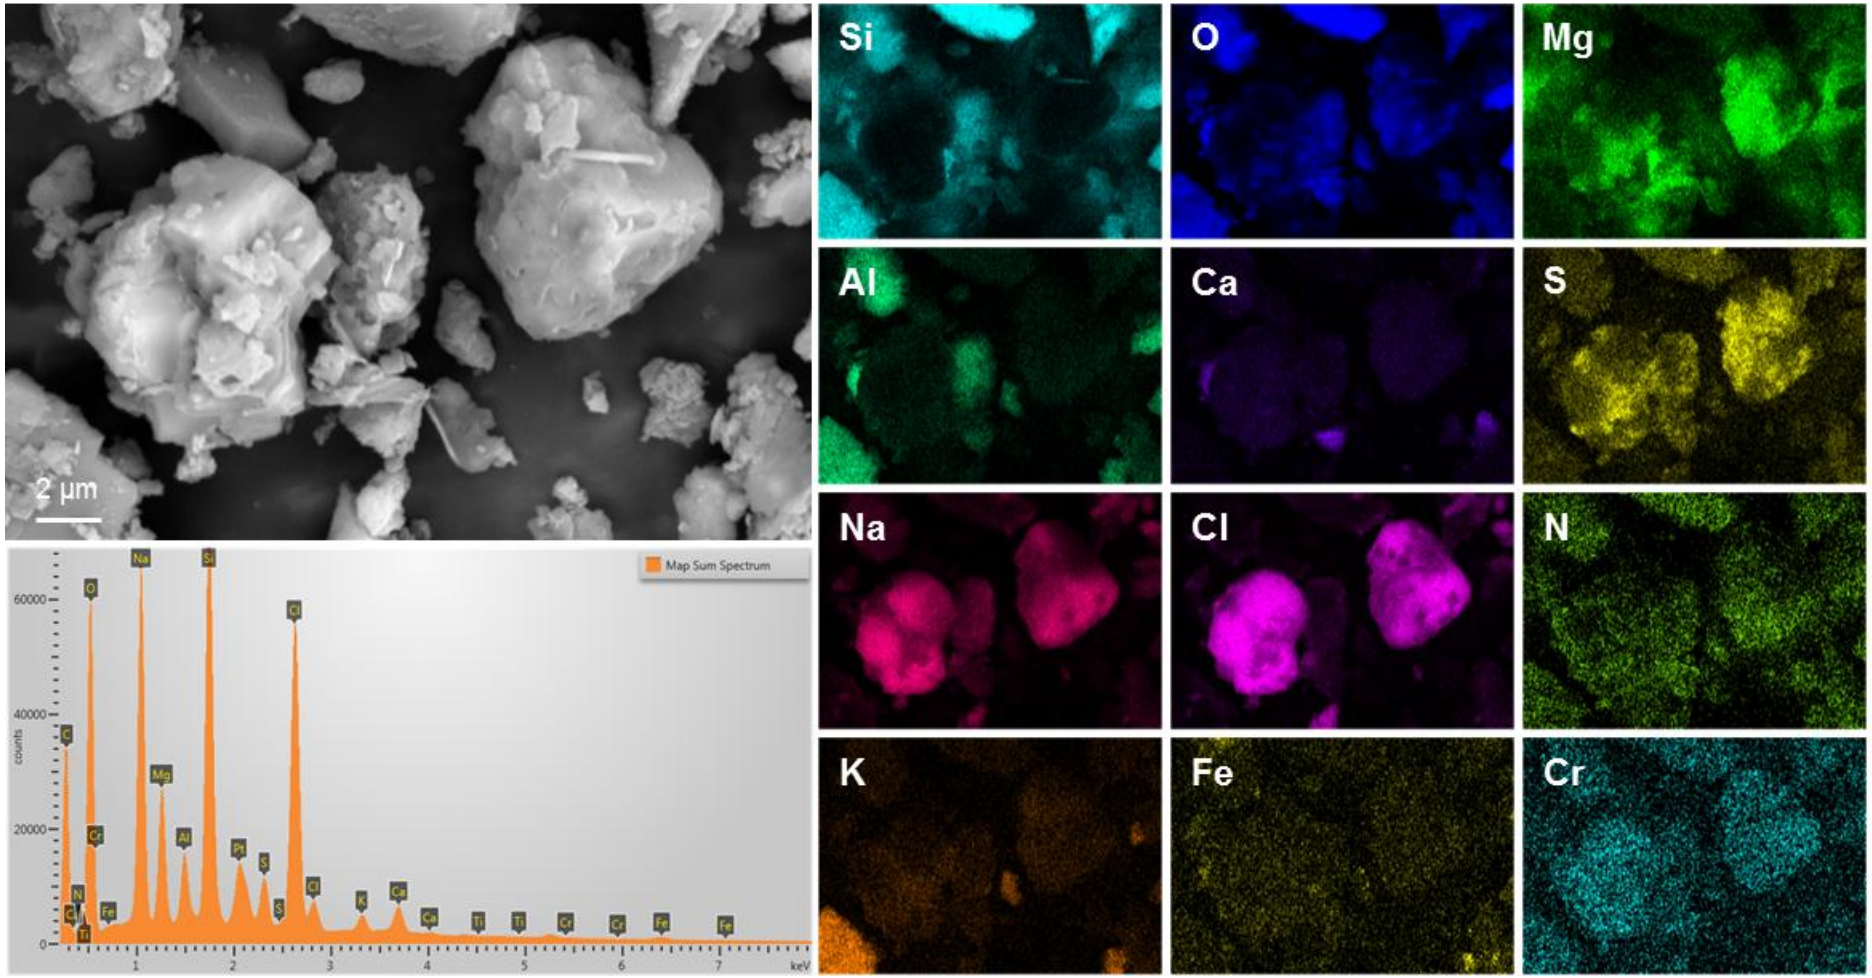
Sample: 123-012
Map B

Notes: Close-up of two large sea-salt aggregates near the center of Map A.

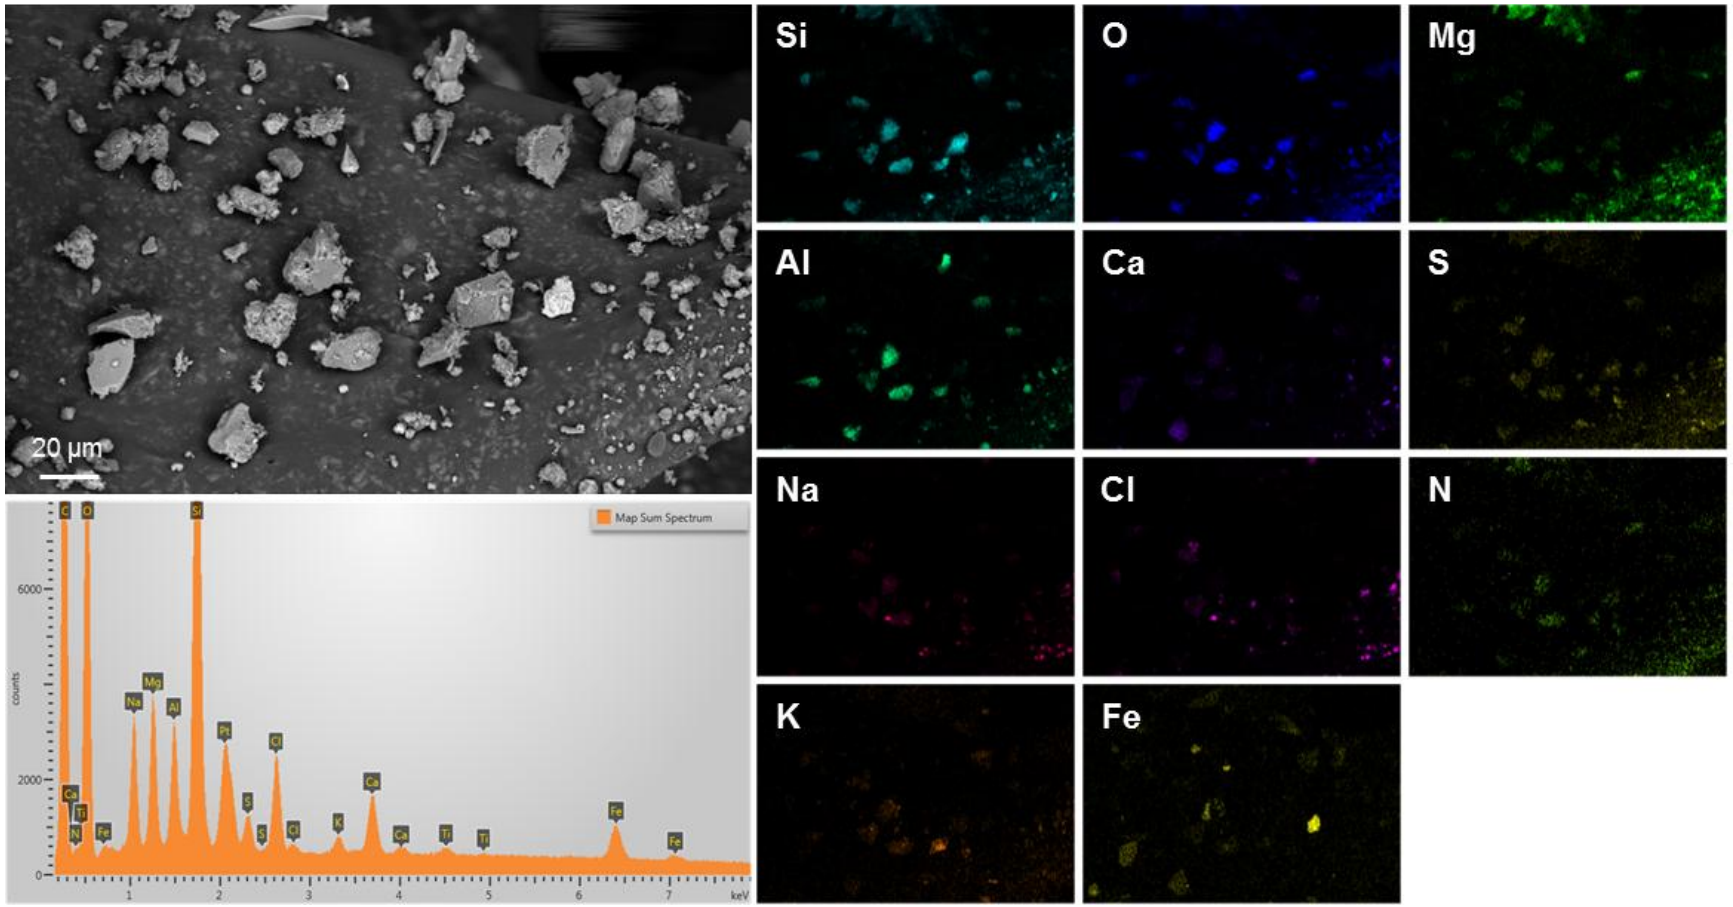
Sample: 123-012
Map D

Notes: Coarse dust grains are dominantly aluminosilicates and sea-salts.

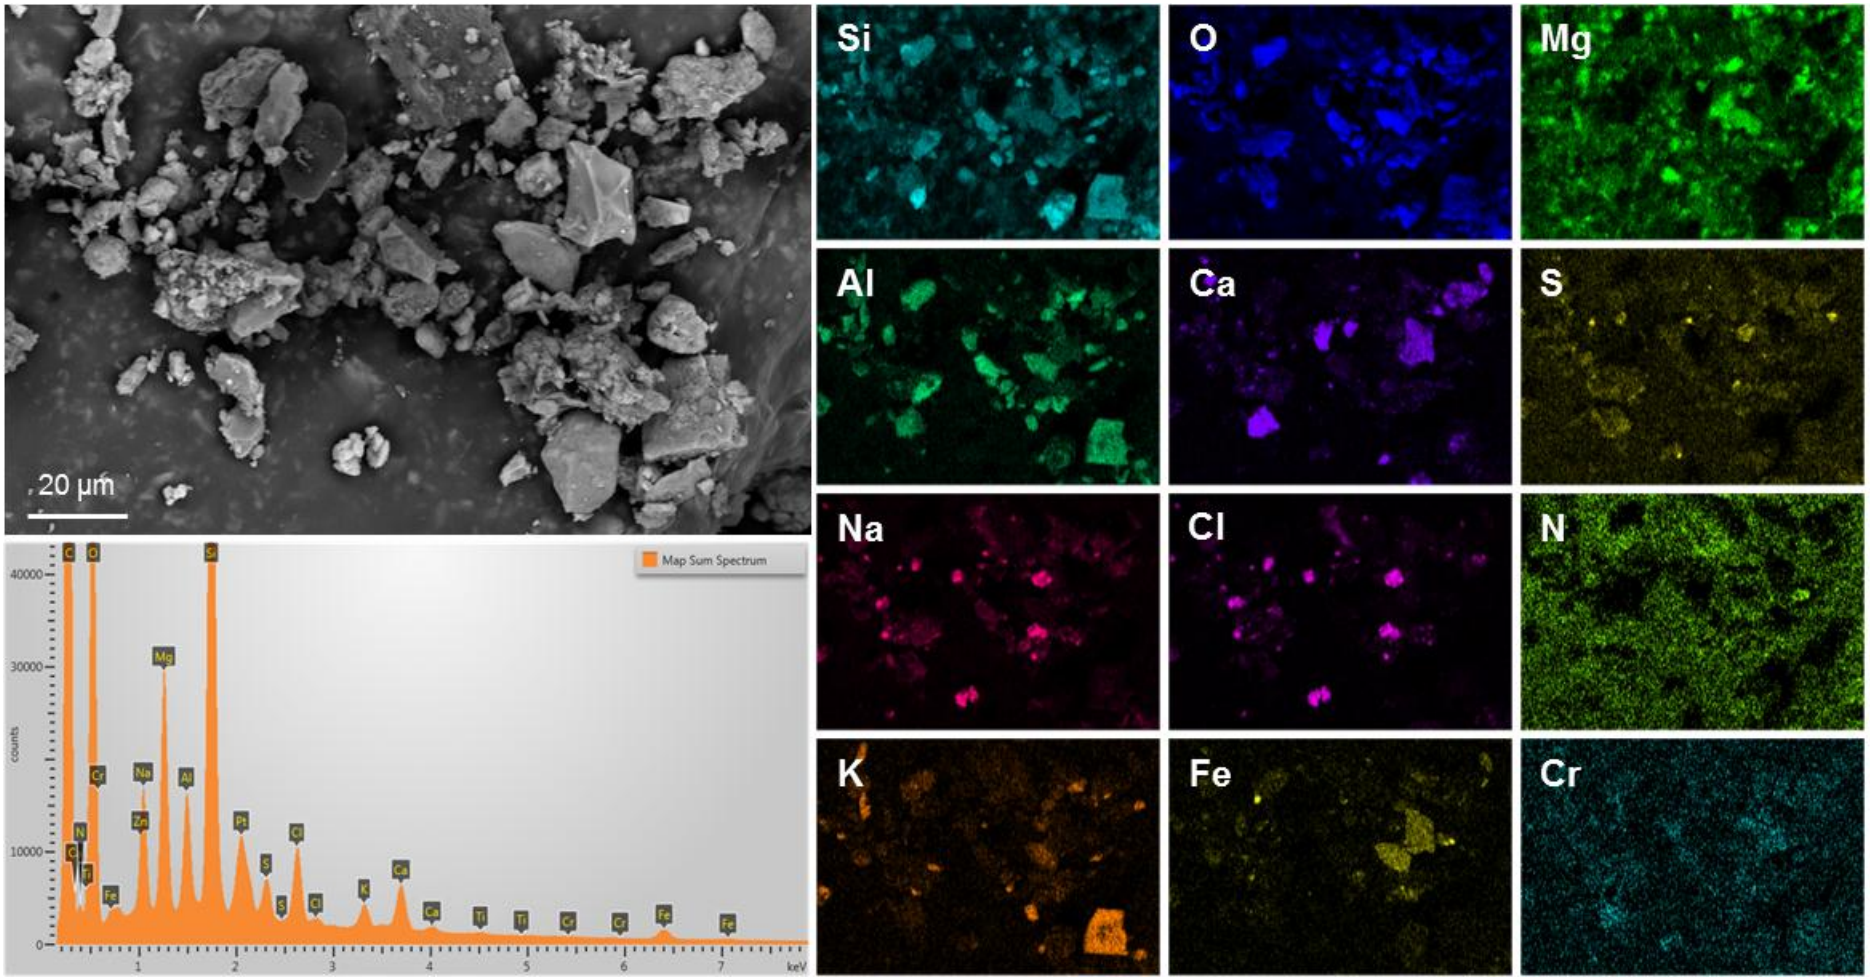
Sample: 123-012
Map E

Notes: Coarse dust grains are dominantly aluminosilicates and sea-salts.
