SANDIA REPORT

SAND2014-16383
Unlimited Release
Printed July 2014

Analysis of Dust Samples Collected from Spent Nuclear Fuel Interim Storage Containers at Hope Creek, Delaware, and Diablo Canyon, California

Charles R. Bryan and David G. Enos

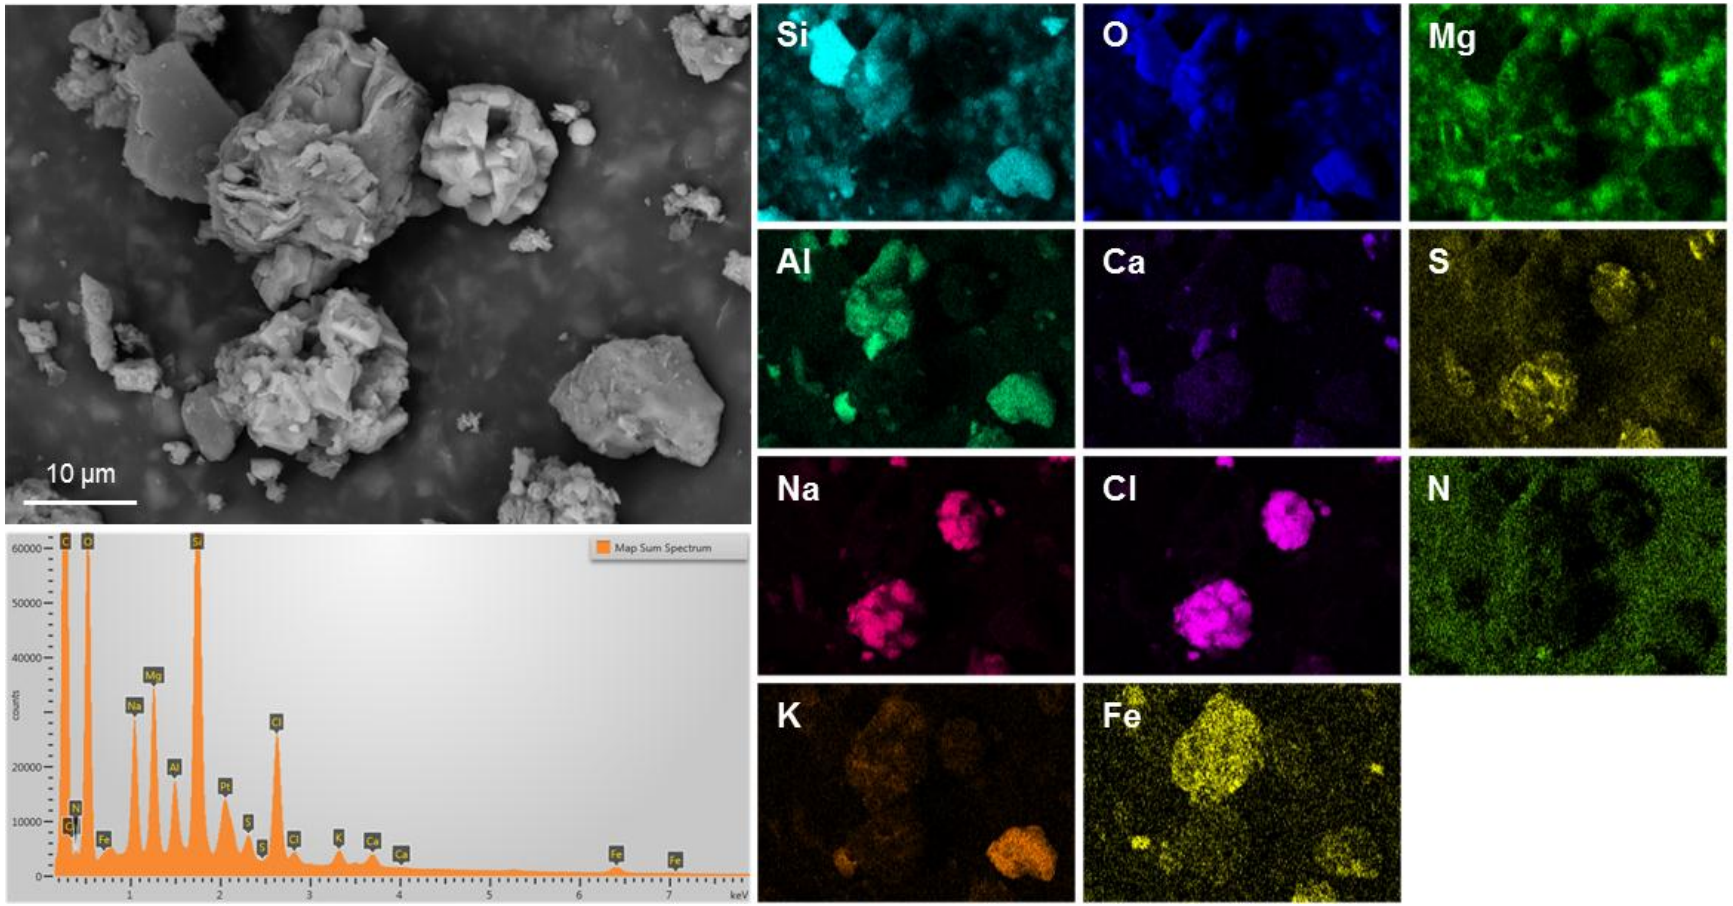
Sample: 123-012
Map I

Notes: Close-up of spherical sea-salt aggregate consisting of etched NaCl cubes and interstitial Mg-SO_4.

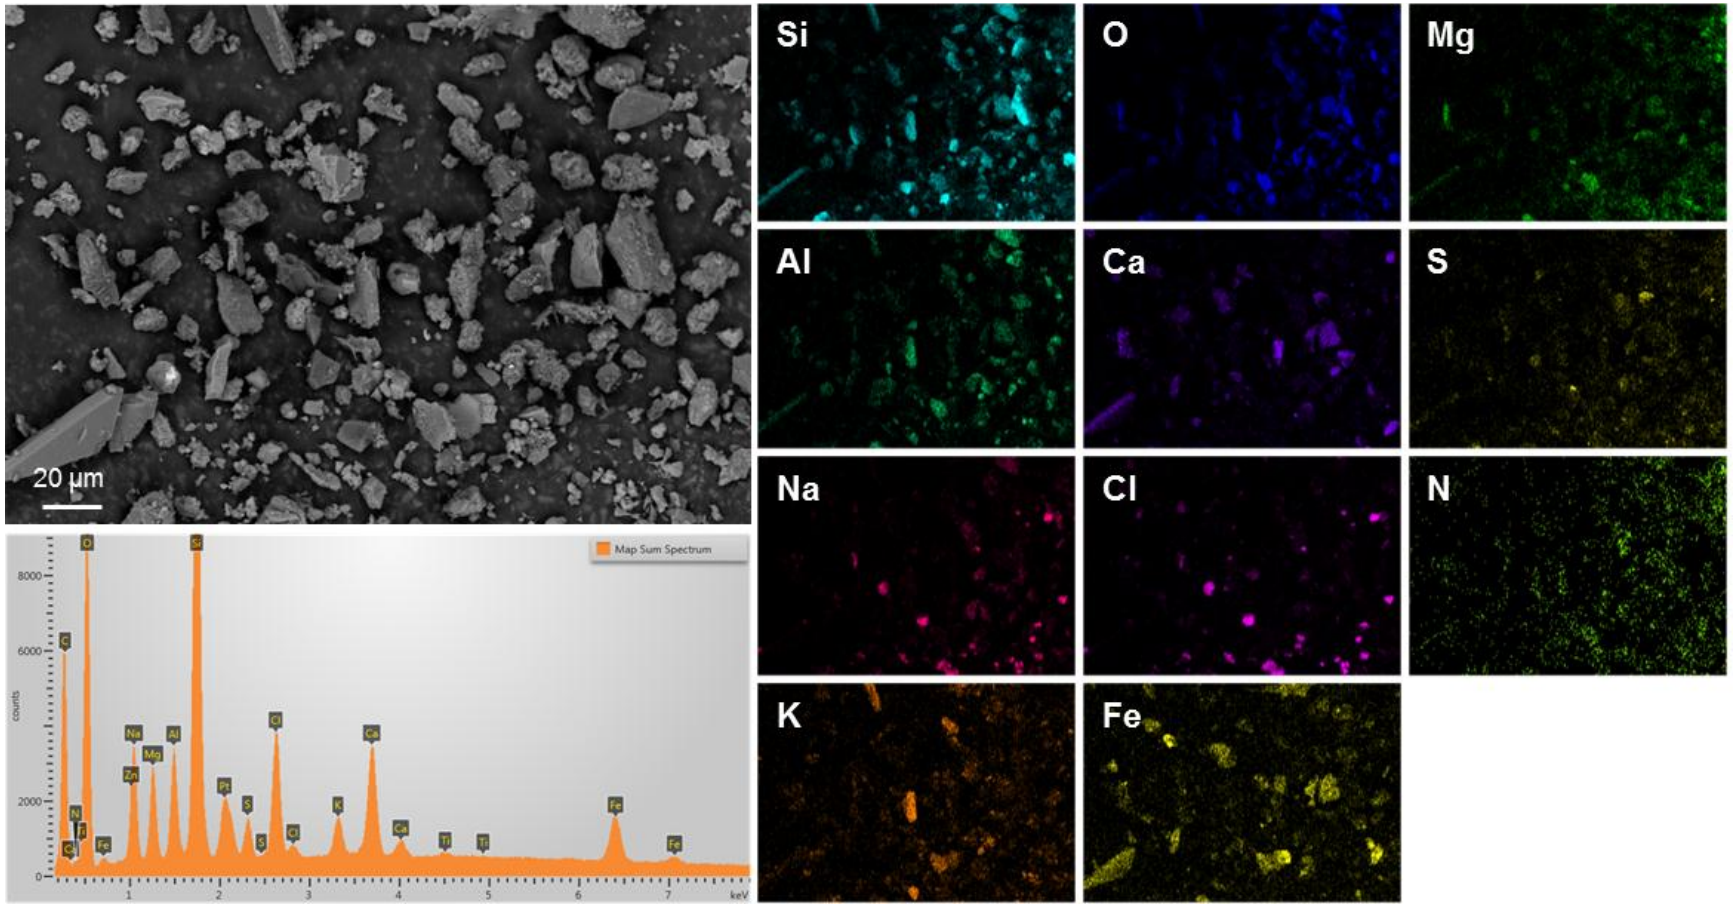
Sample: 123-012
Map K

Notes: Heavy dust load, dominantly aluminosilicates and sea-salts.

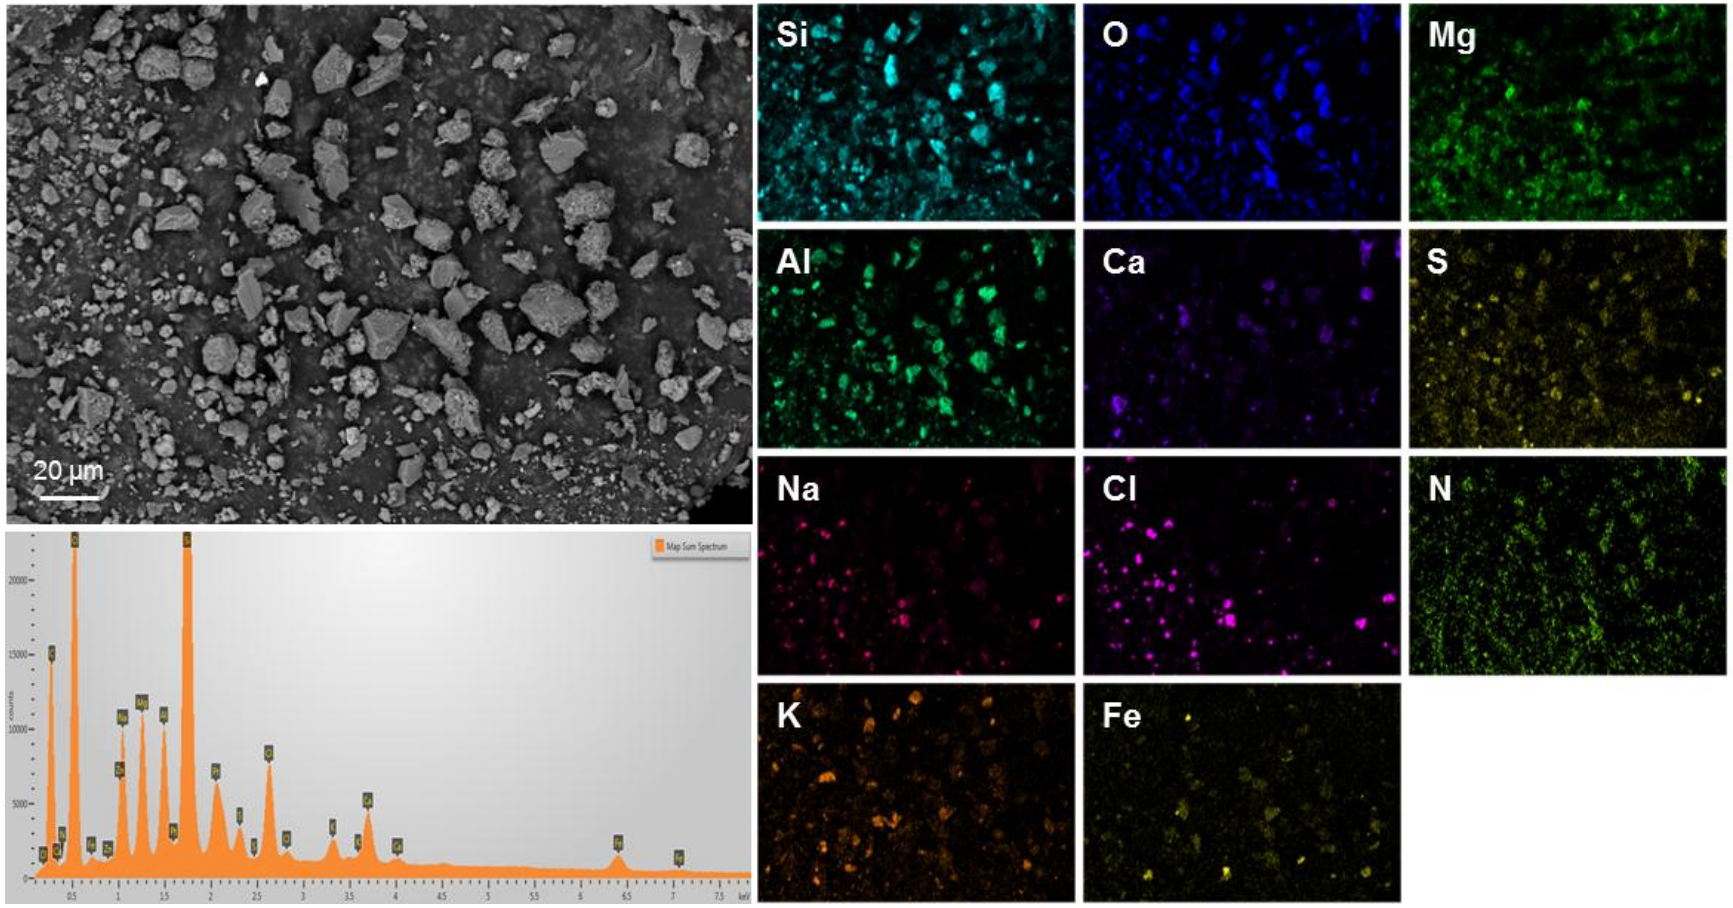
Sample: 123-012
Map L

Notes: Heavy dust load, dominantly aluminosilicates and sea-salts, commonly occurring as spherical aggregates.

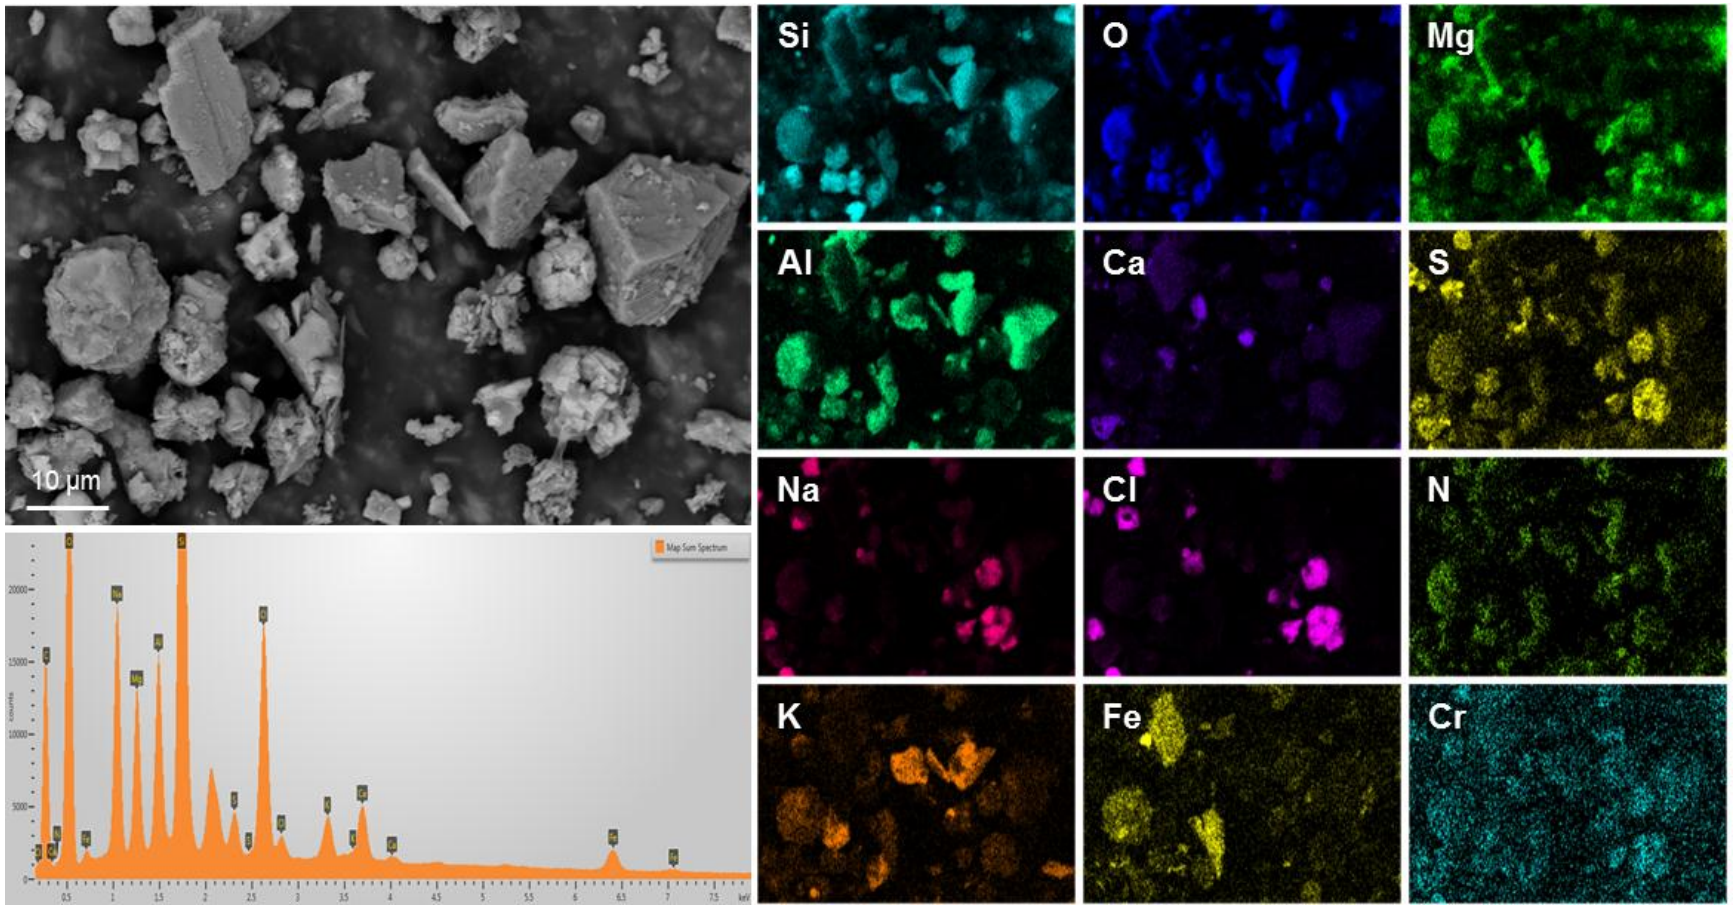
Sample: 123-012
Map M

Notes: Heavy dust load, dominantly aluminosilicates and sea-salts, commonly occurring as spherical aggregates.

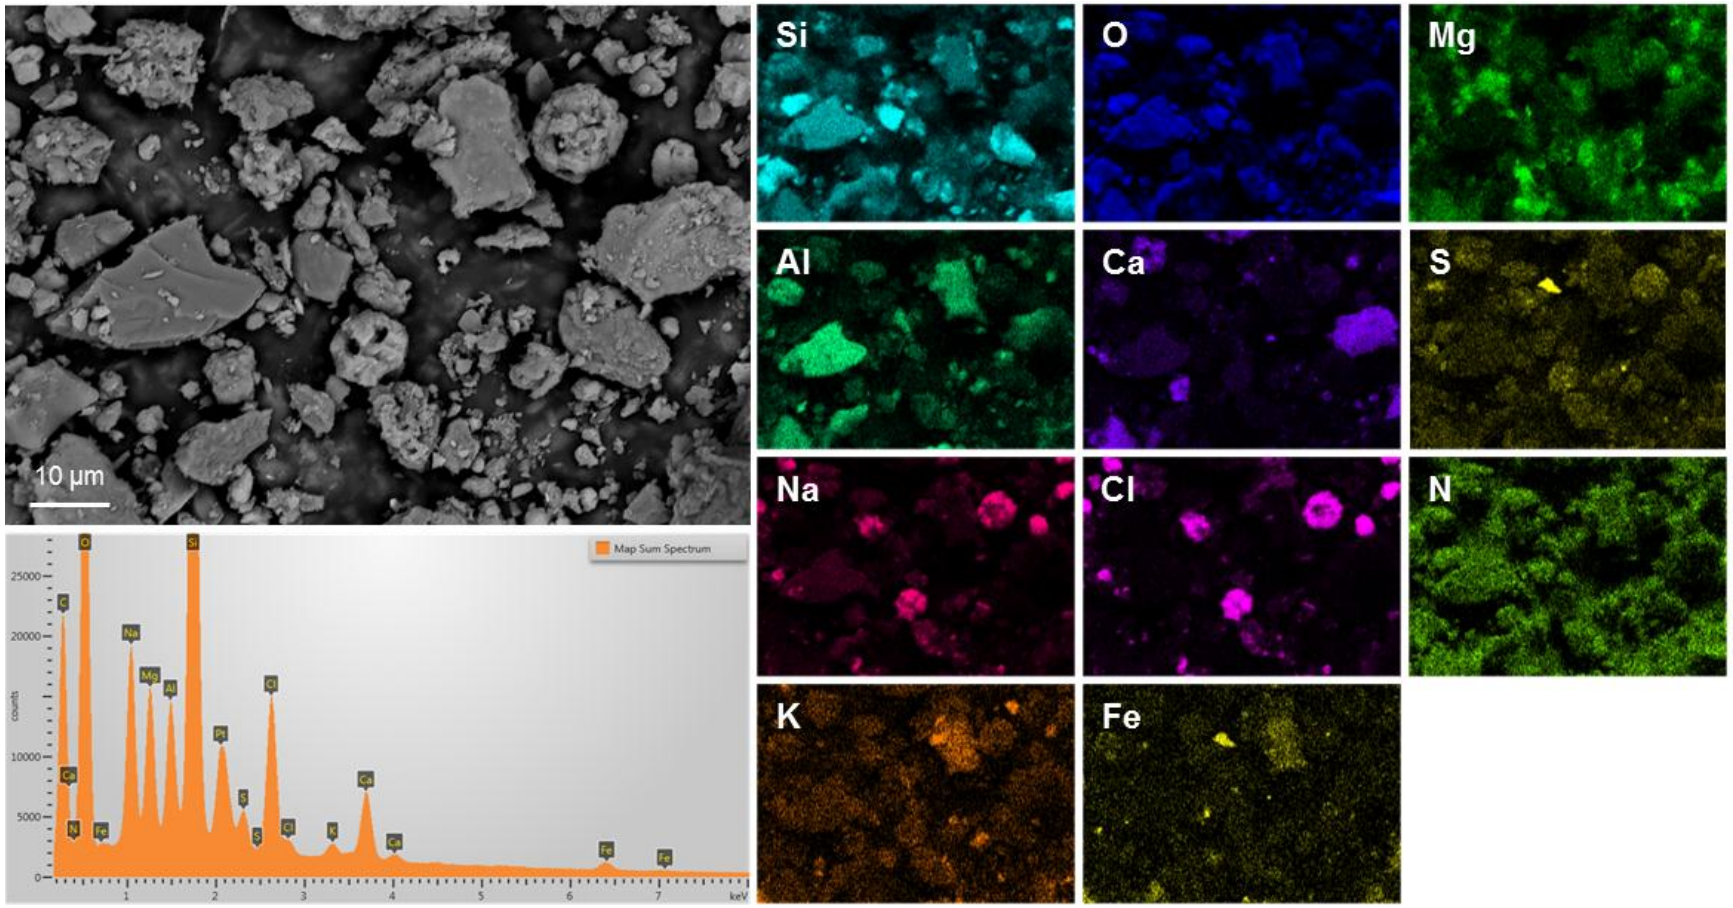
Sample: 123-012
Map N

Notes: Heavy dust load, dominantly aluminosilicates and aggregates of sea-salts.

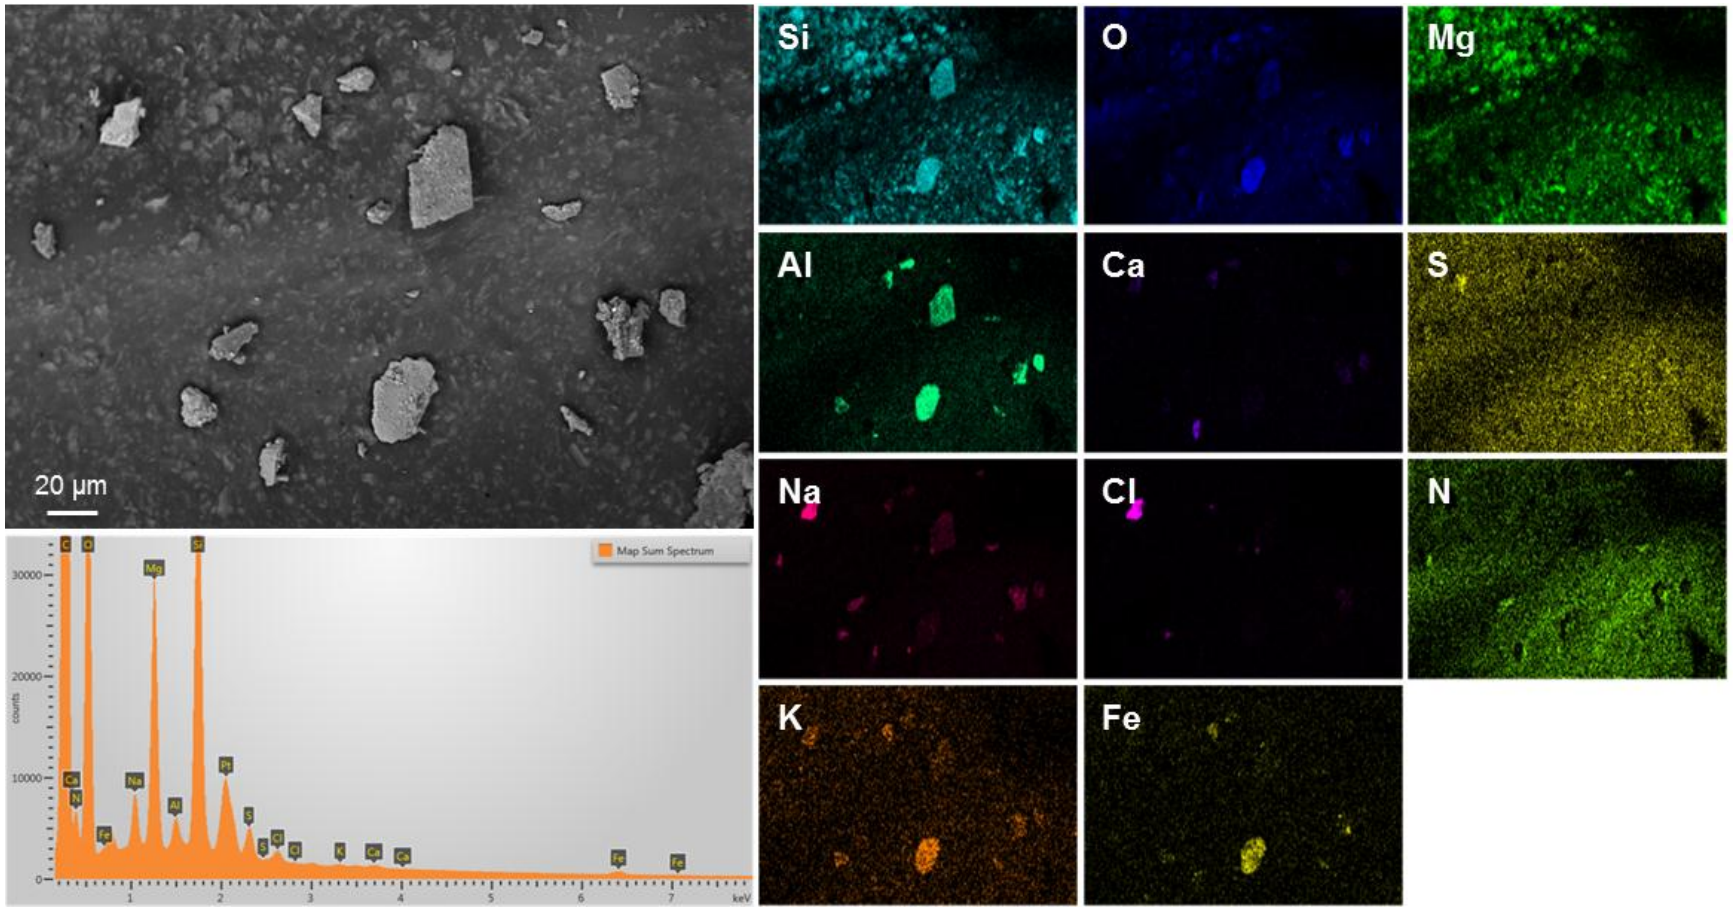
Sample: 170-001
Map B

Notes: Abundant fine dust particles along an abraded edge. Dominantly aluminosilicates and sea-salts; some Ca-sulfate.

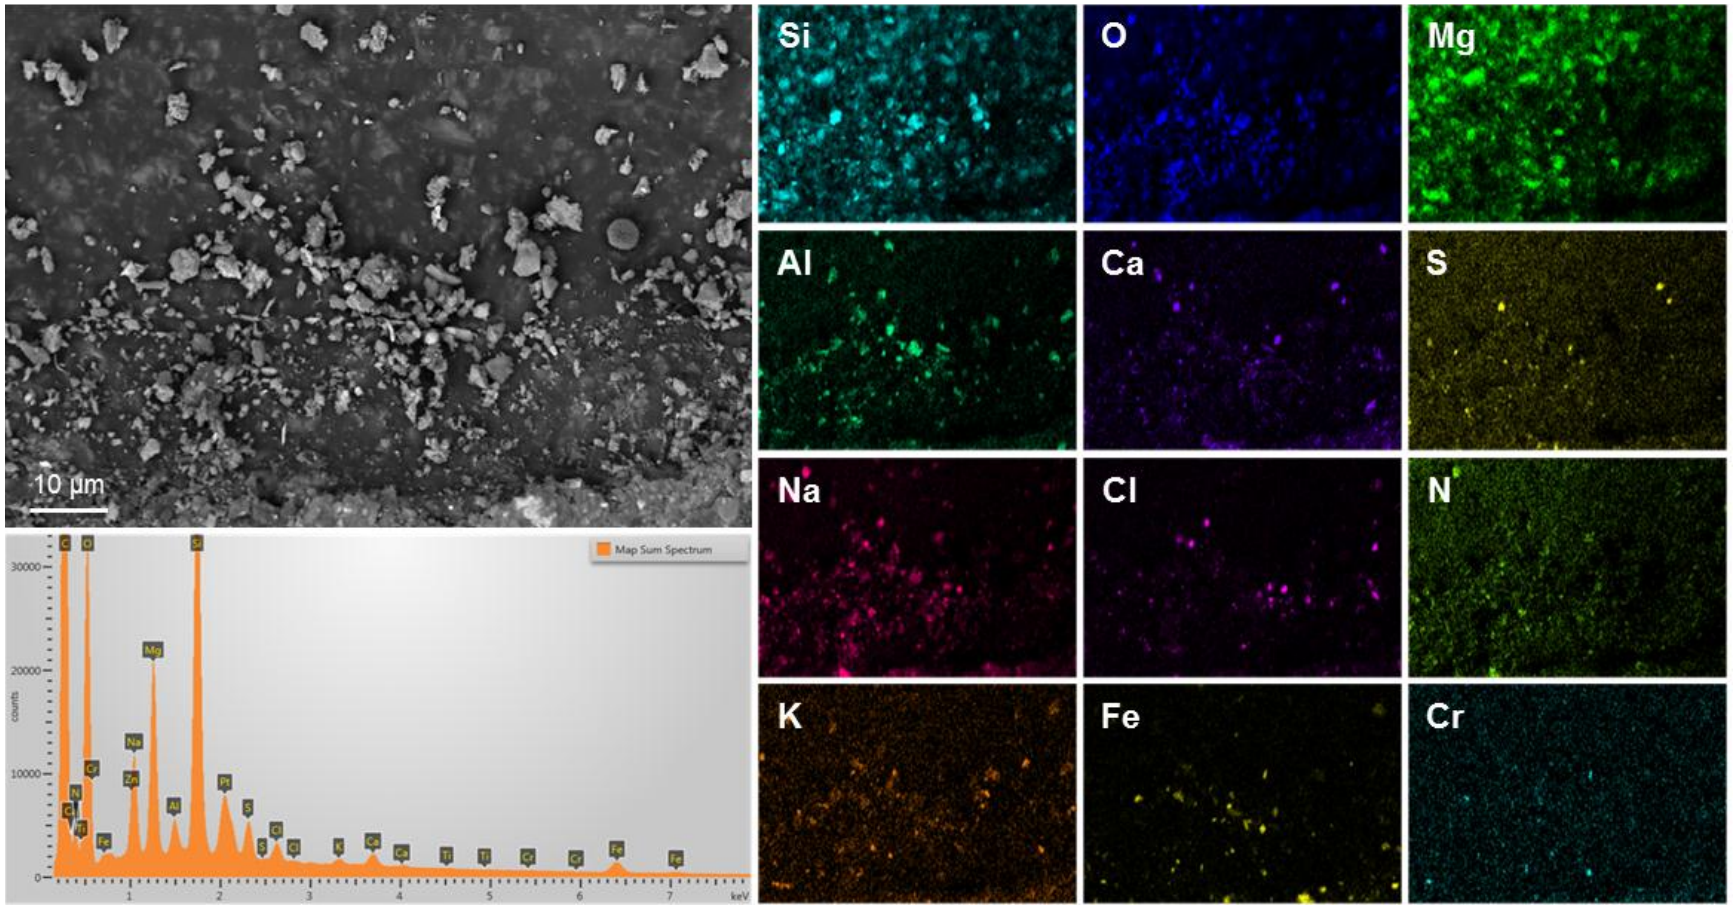
Sample: 170-001
Map C

Notes: Dust particles along an abraded edge. Dominantly aluminosilicates.

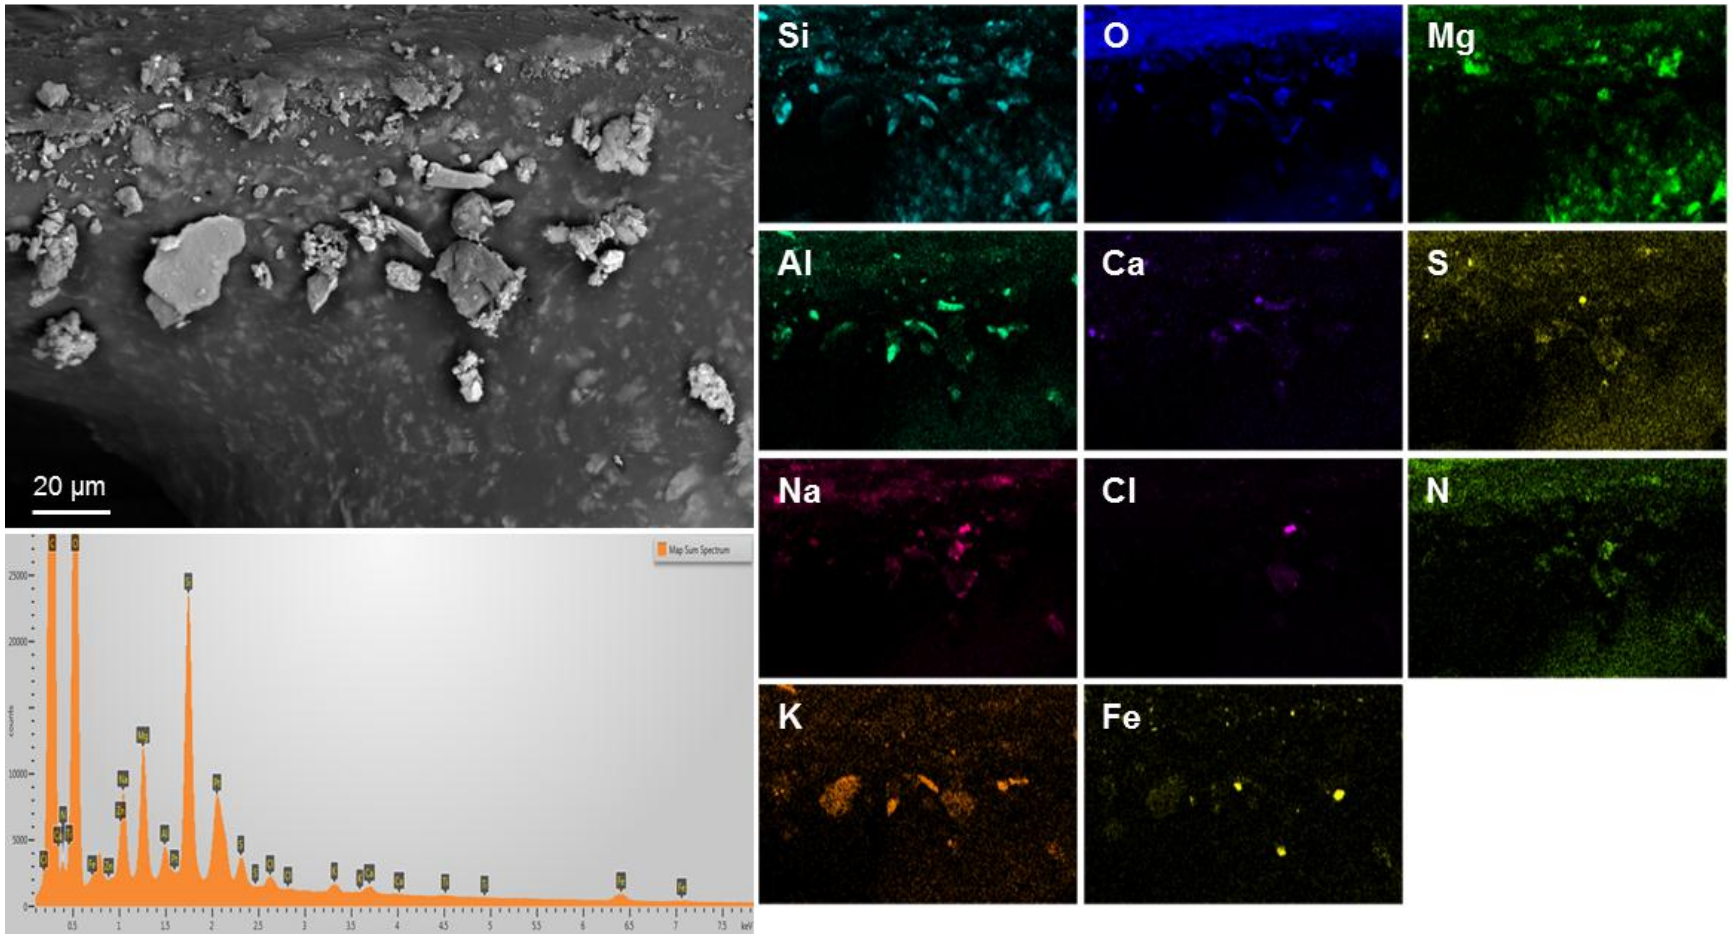
Sample: 170-001
Map D

Notes: Sparse dust particles, dominantly aluminosilicates.

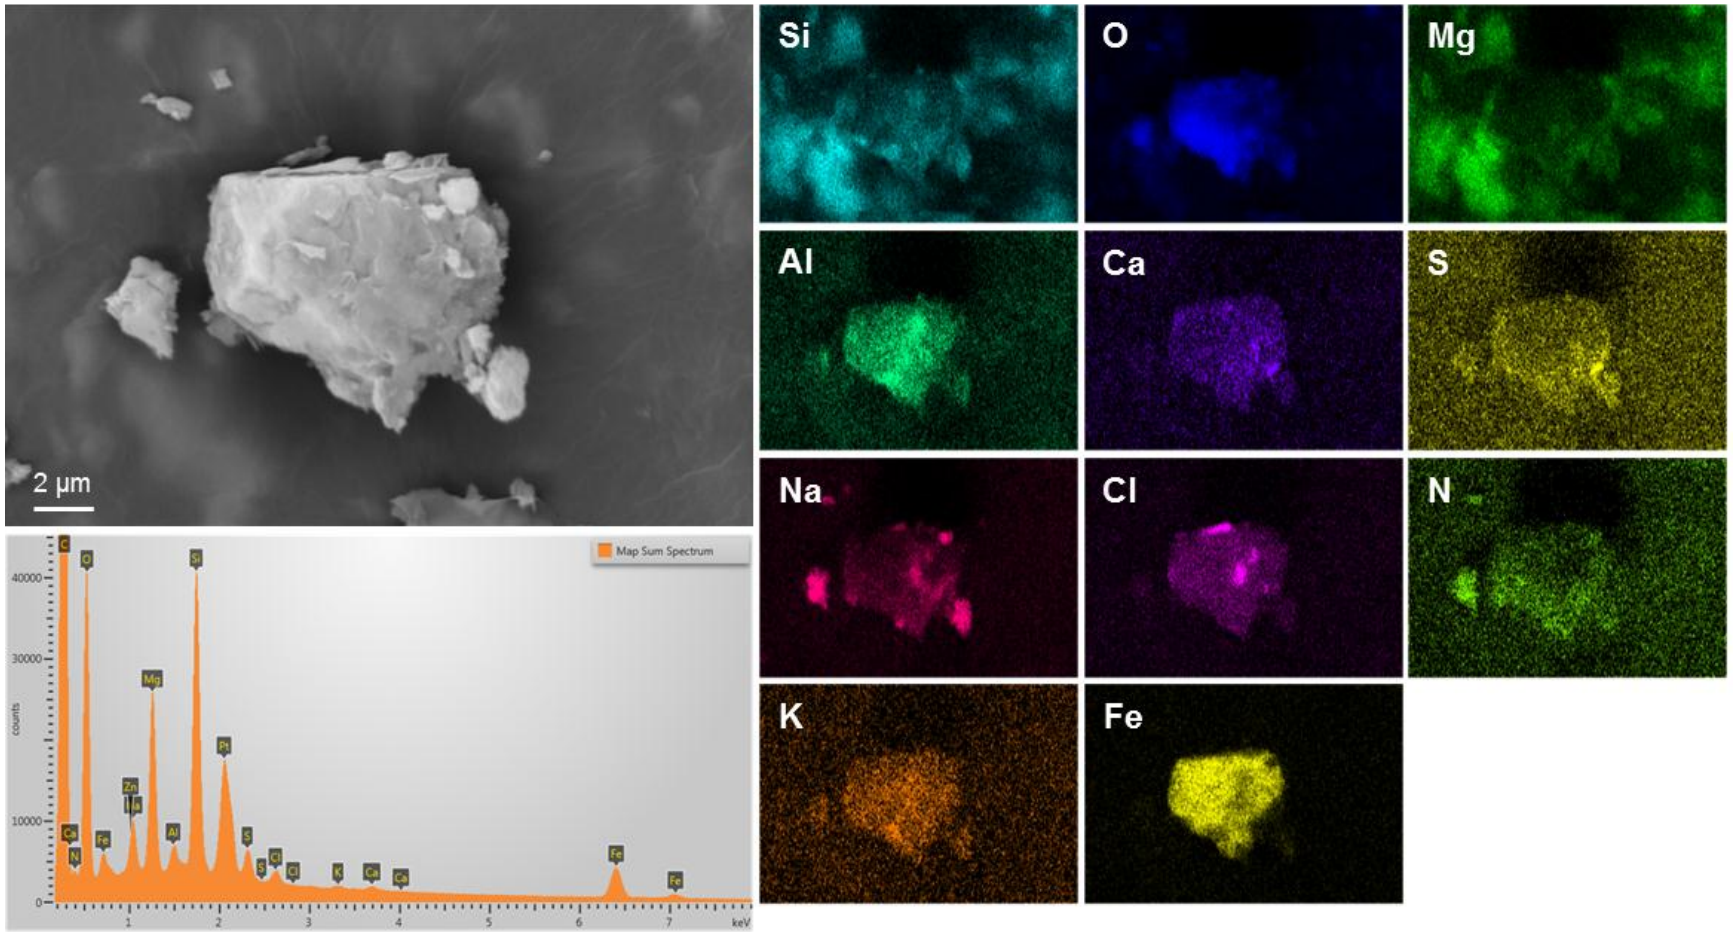
Sample: 170-001
Map F

Notes: Particles along an abraded edge. Most particles are talc, liberated by abrasion of the pad. Dust is dominantly aluminosilicates, Ca-sulfate.

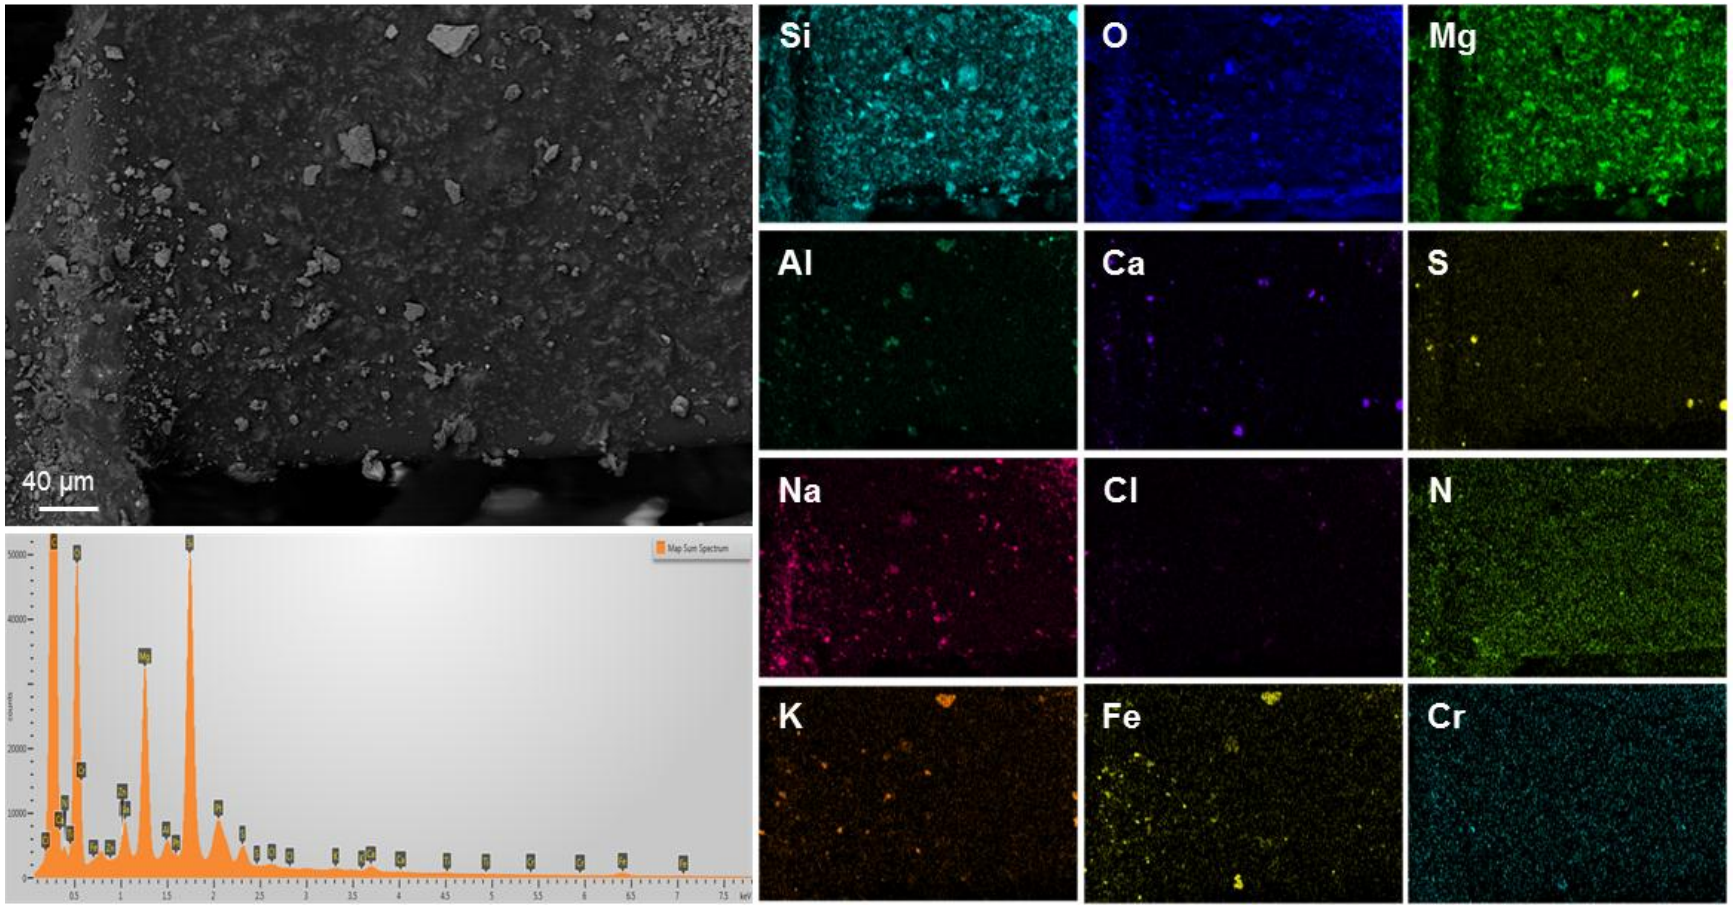
Sample: 170-003

Notes: Overview image of pad sample 170-003, showing the heavy dust load.

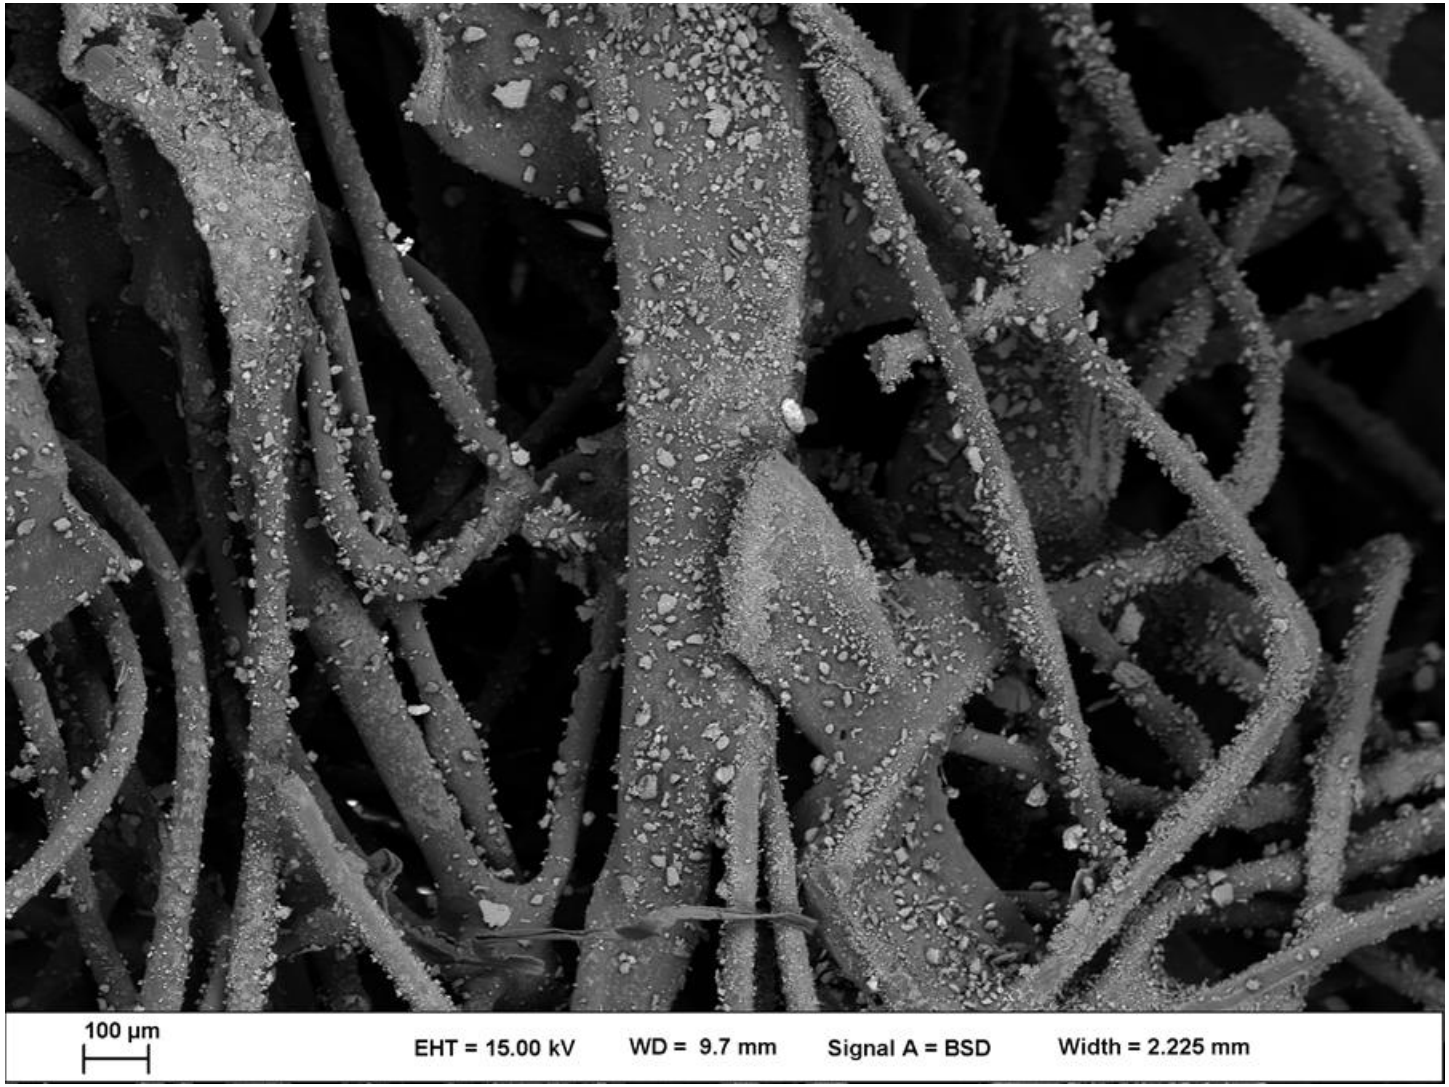
Sample: 170-003
Map A

Notes: Heavy dust load, dominantly aluminosilicates and sea-salt aggregates.

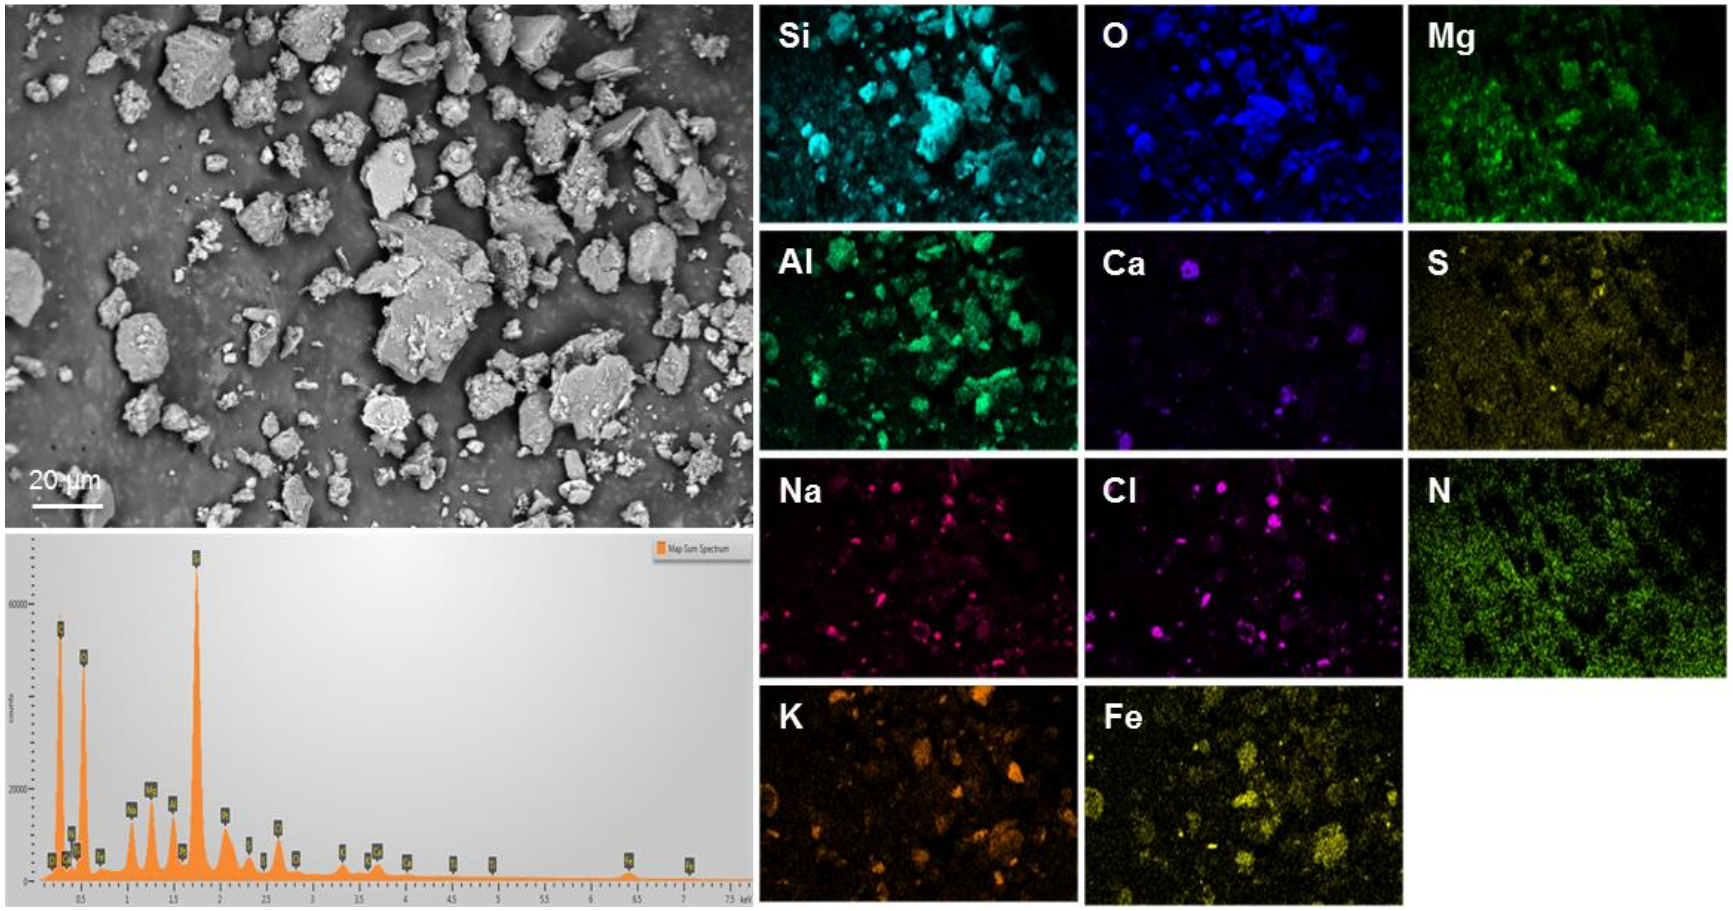
Map B

Notes: Close-up of area in upper center of Map A. Area contains three large sea-salt aggregates among aluminosilicates grains.

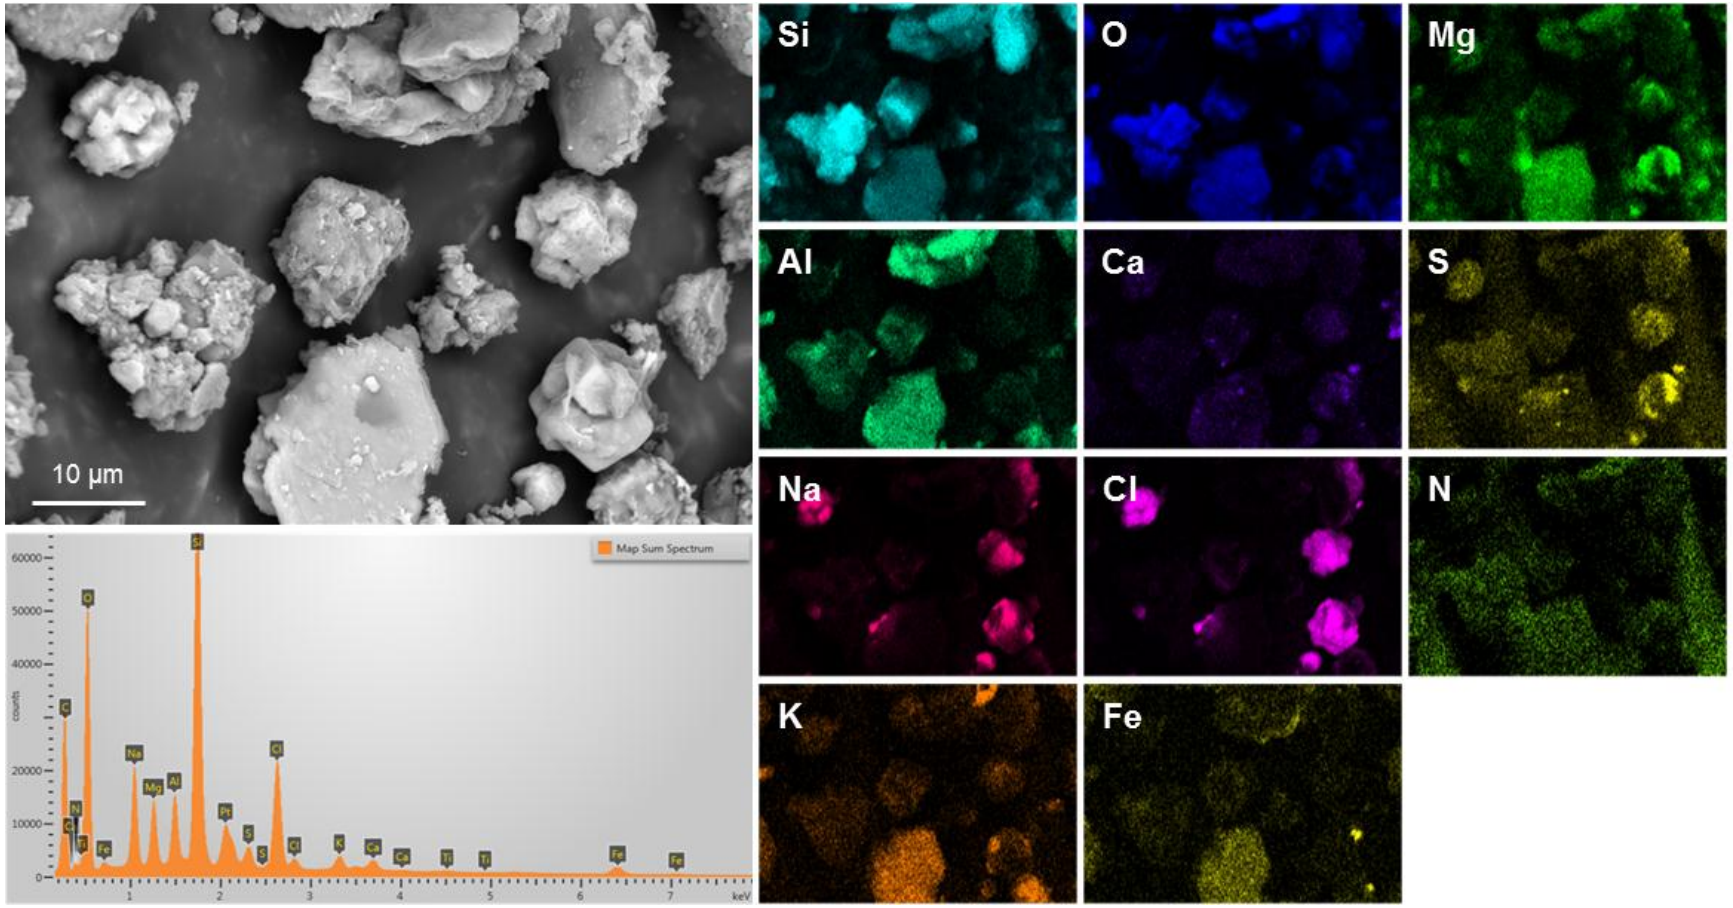
Sample: 170-003
Map C

Notes: Close-up of sea-salt aggregate in upper left corner of Map B, showing intergrown NaCl cubes with interstitial Mg-SO_4, and trace Ca, K.

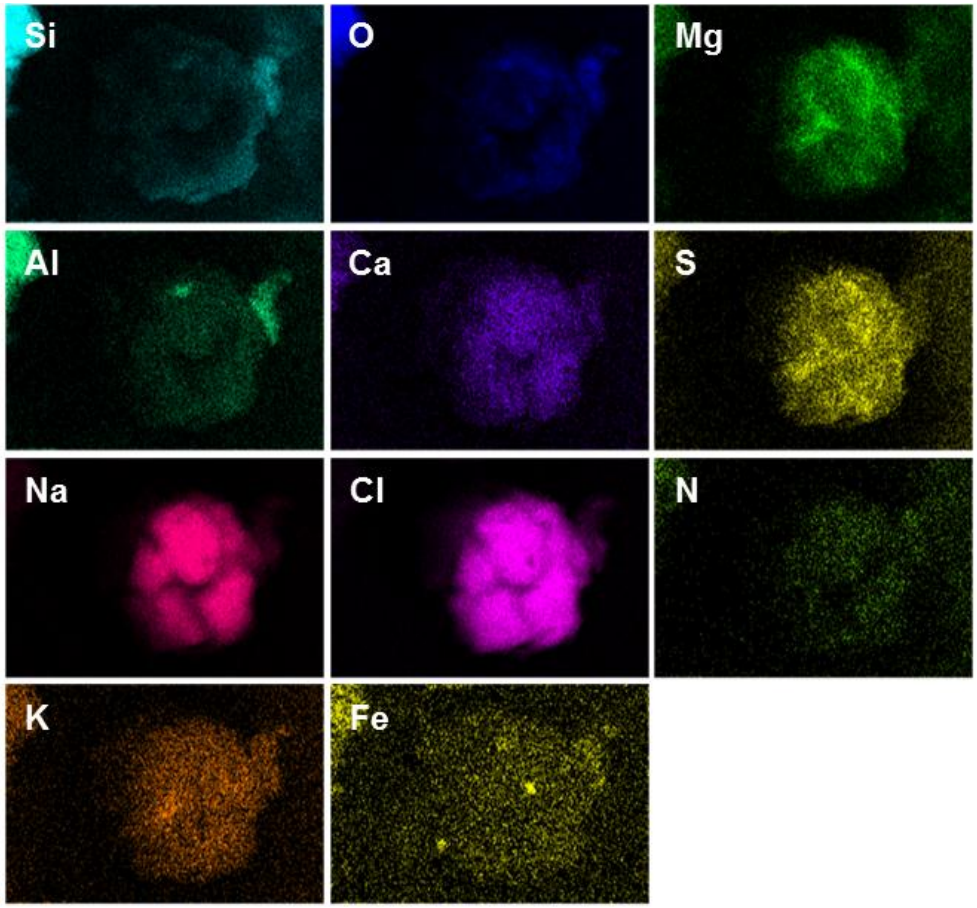
Sample: 170-003
Map D

Notes: Close-up of sea-salt aggregate in lower right corner of Map B, showing intergrown NaCl cubes with interstitial Mg-SO_4, and trace Ca, K.
