SANDIA REPORT

SAND2014-16383
Unlimited Release
Printed July 2014

Analysis of Dust Samples Collected from Spent Nuclear Fuel Interim Storage Containers at Hope Creek, Delaware, and Diablo Canyon, California

Charles R. Bryan and David G. Enos

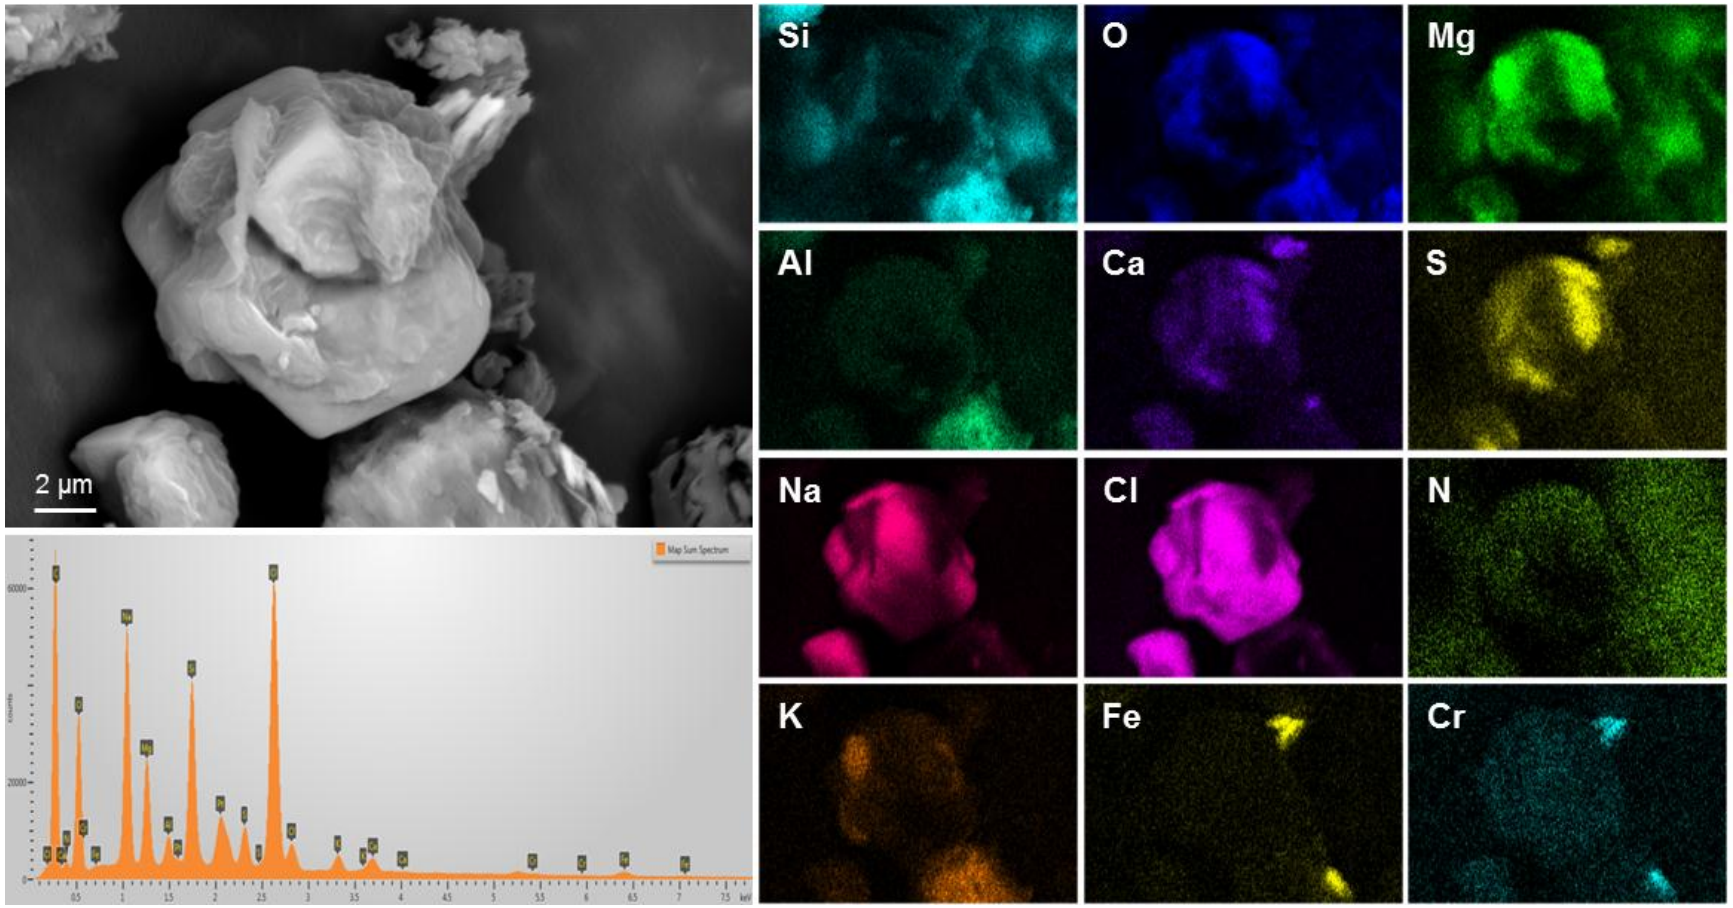
Sample: 170-003
Map E

Notes: Close-up of sea-salt aggregate in upper right corner of Map B, showing intergrown NaCl cubes with interstitial Mg-SO_4, and trace Ca, K.

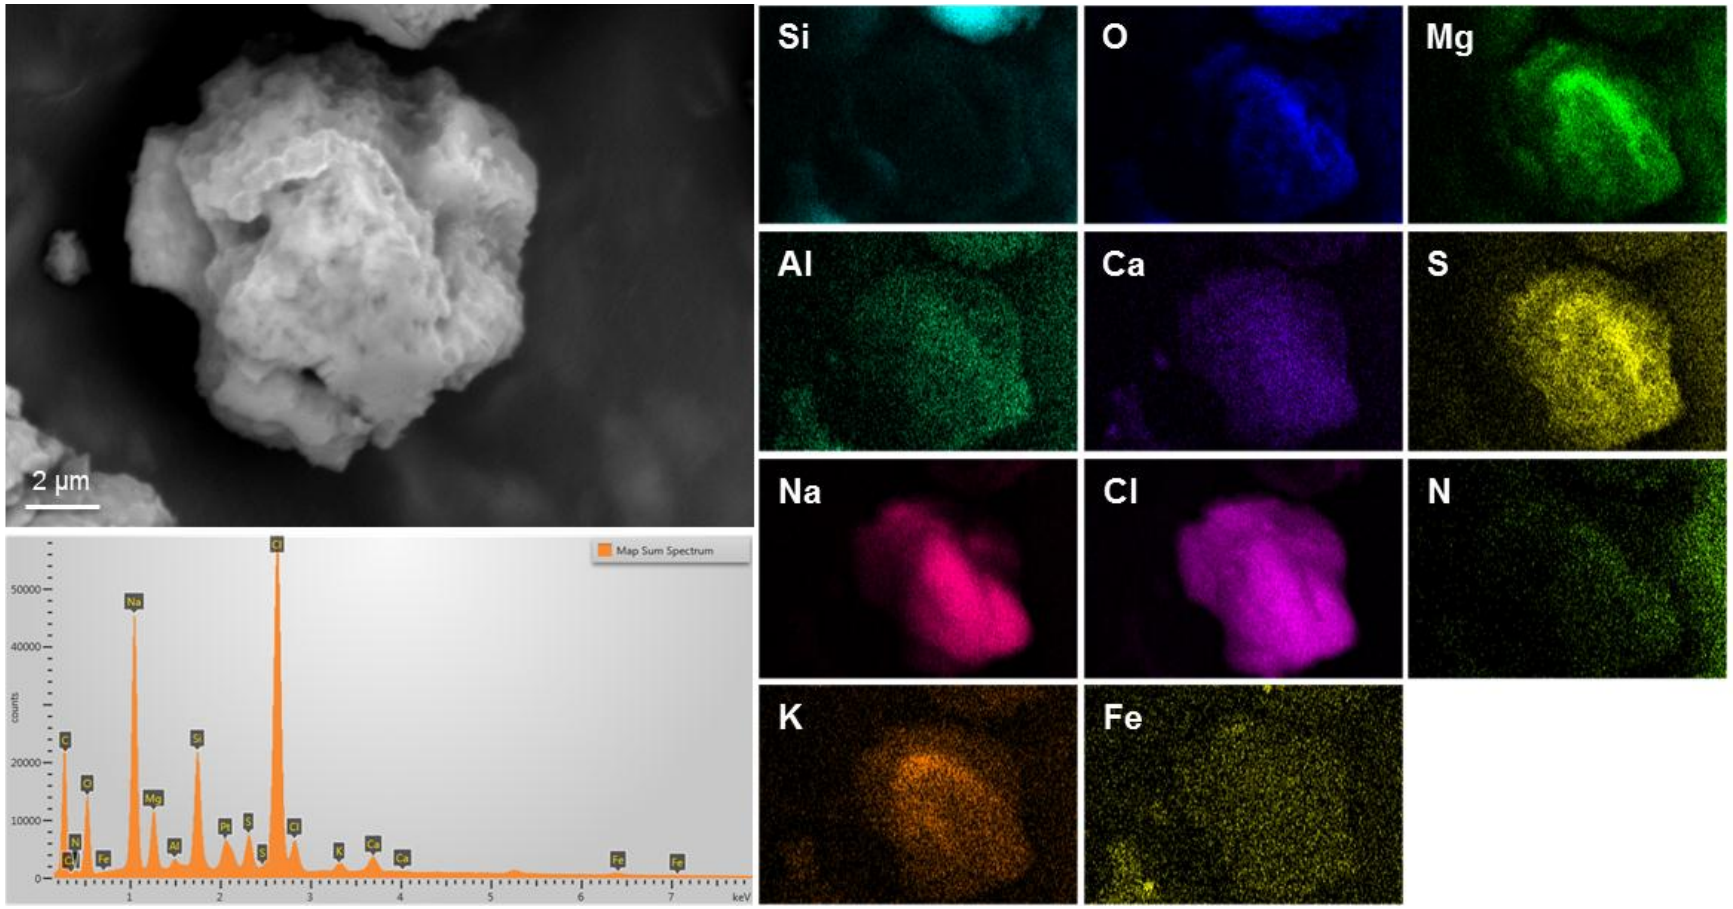
Sample: 170-003
Map F

Notes: This Map is largely in a shadow, making the element maps nearly useless. But the image does show a degraded pollen grain.

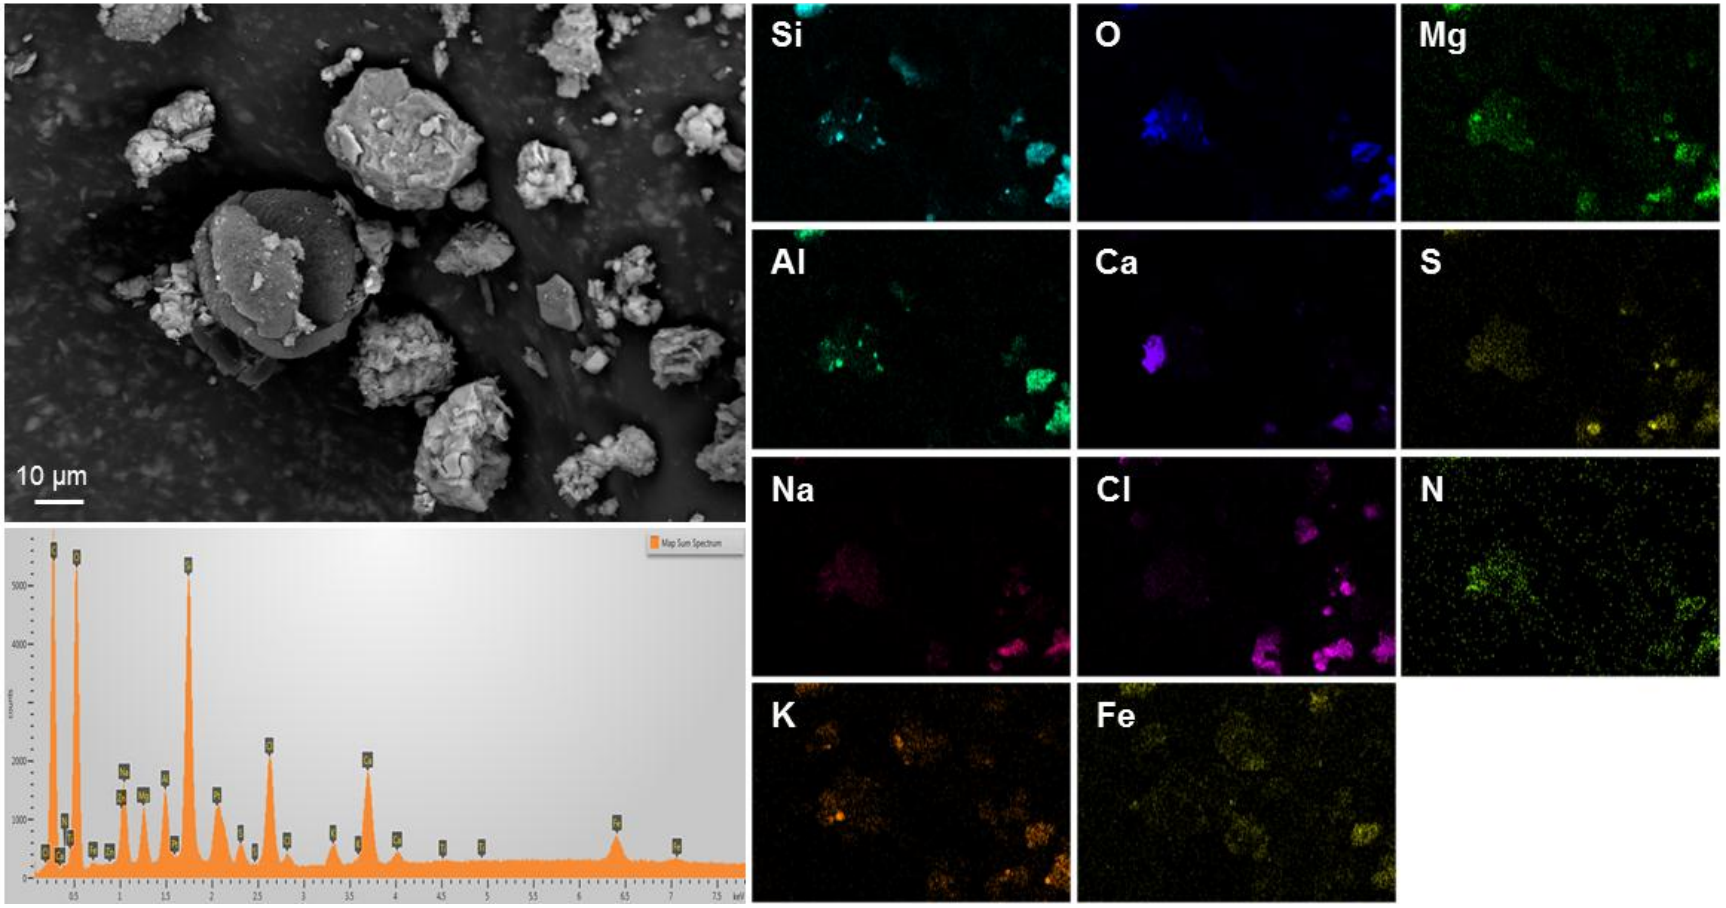
Sample: 170-003
Map G

Notes: Abundant dust on an abraded edge, consisting dominantly of aluminosilicates and sea-salt aggregates.

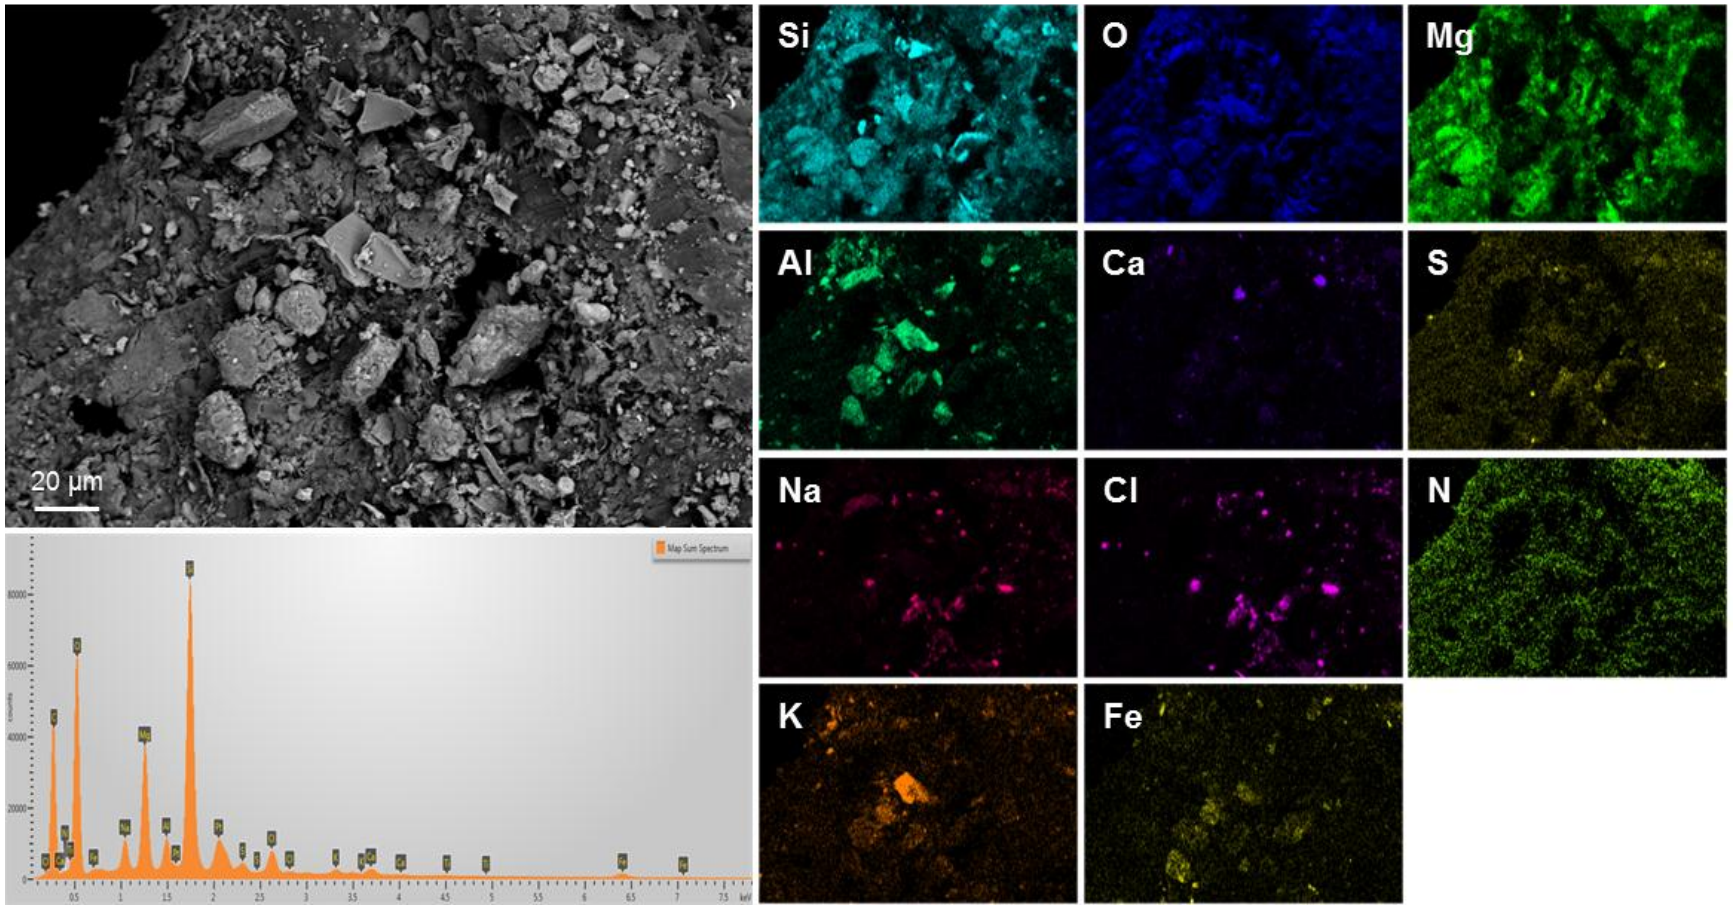
Sample: 170-003
Map H

Notes: Dust consisting dominantly of aluminosilicates and sea-salt aggregates.

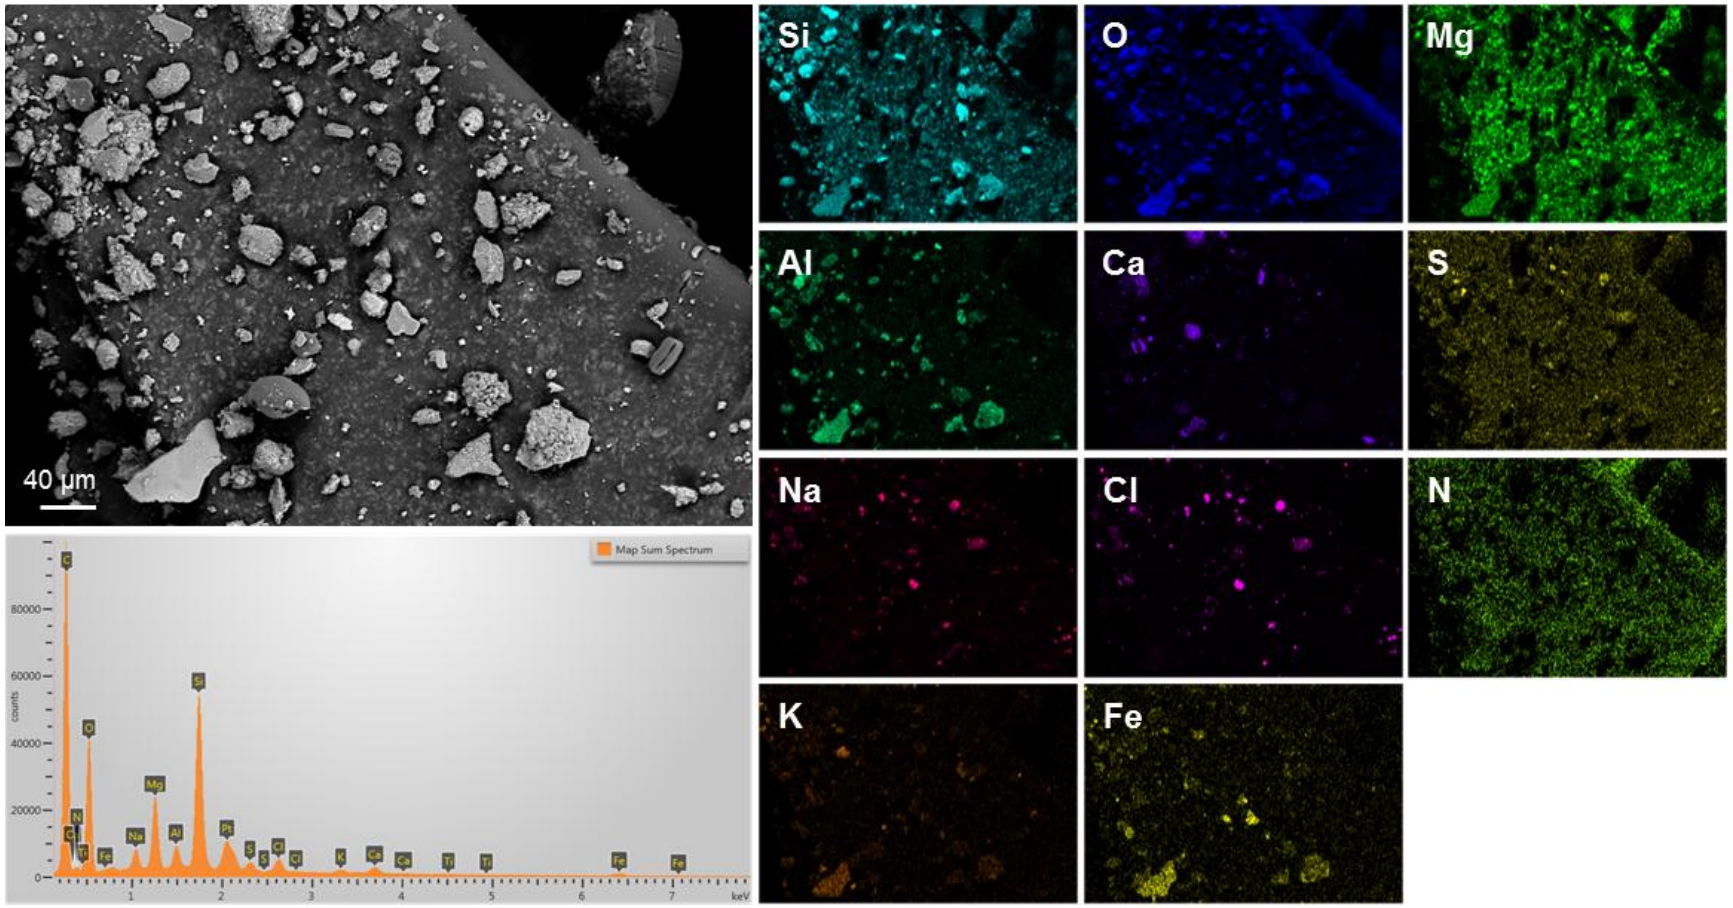
Sample: 170-003
Map K

Notes: Dust consisting dominantly of aluminosilicates and sea-salt aggregates (NaCl and Mg-SO_4). Ca-carbonate is also present.

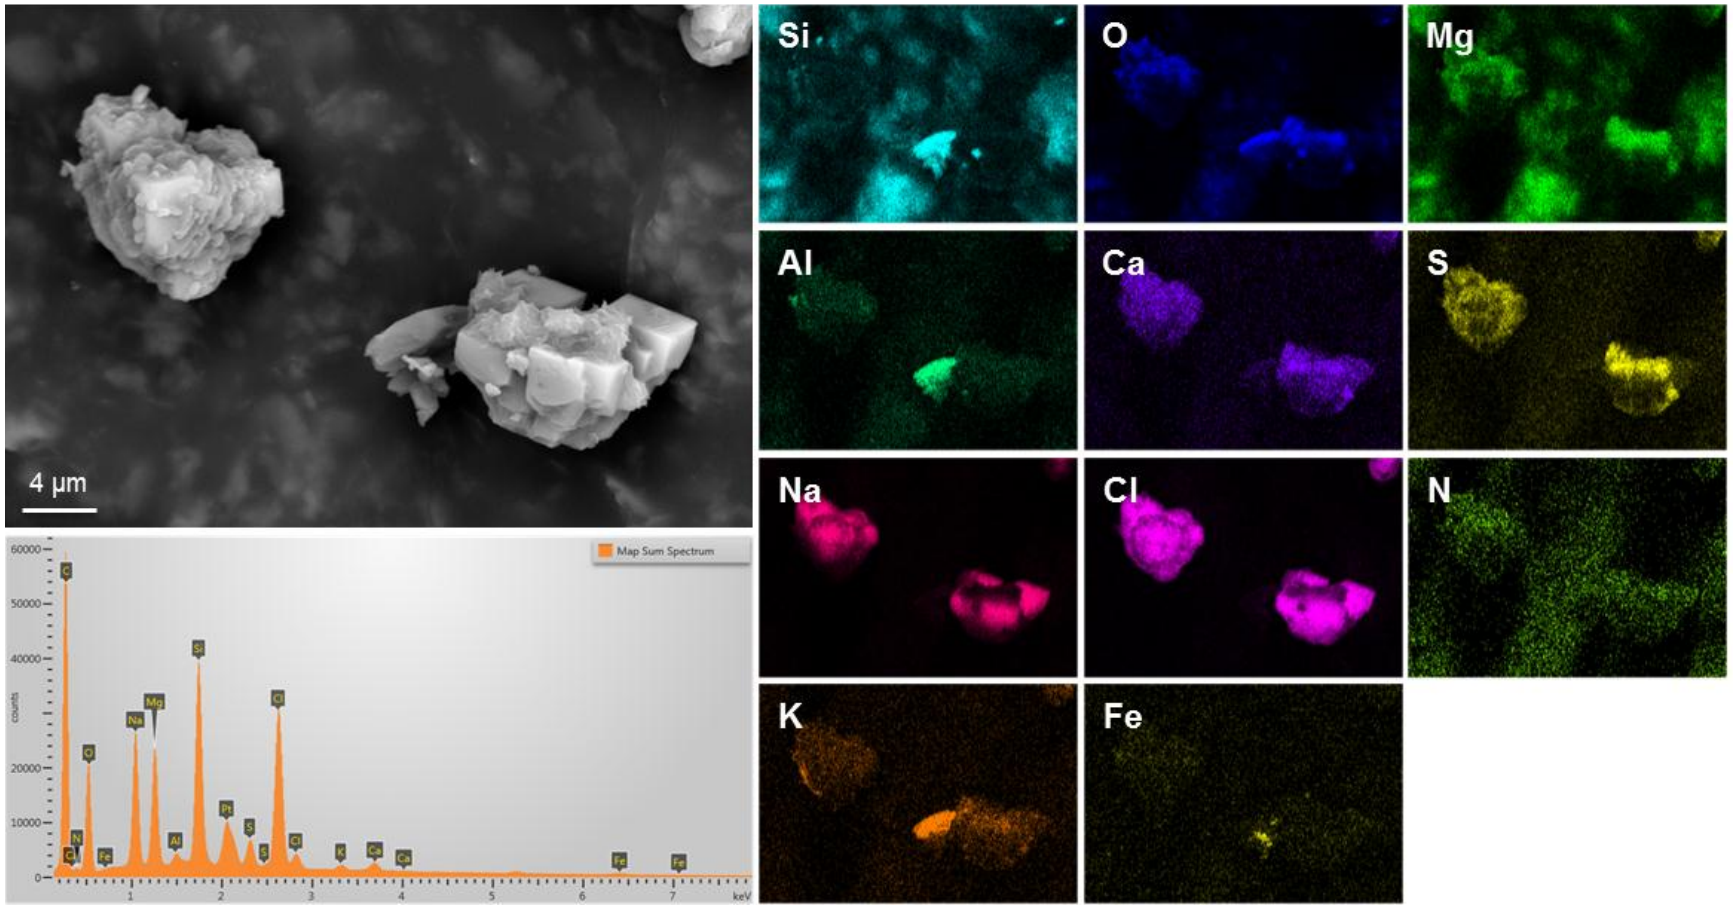
Sample: 170-003
Map L

Notes: Close-up of two sea-salt aggregates, consisting of skeletal NaCl crystals and interstitial Mg-SO_4, with trace Ca and K.

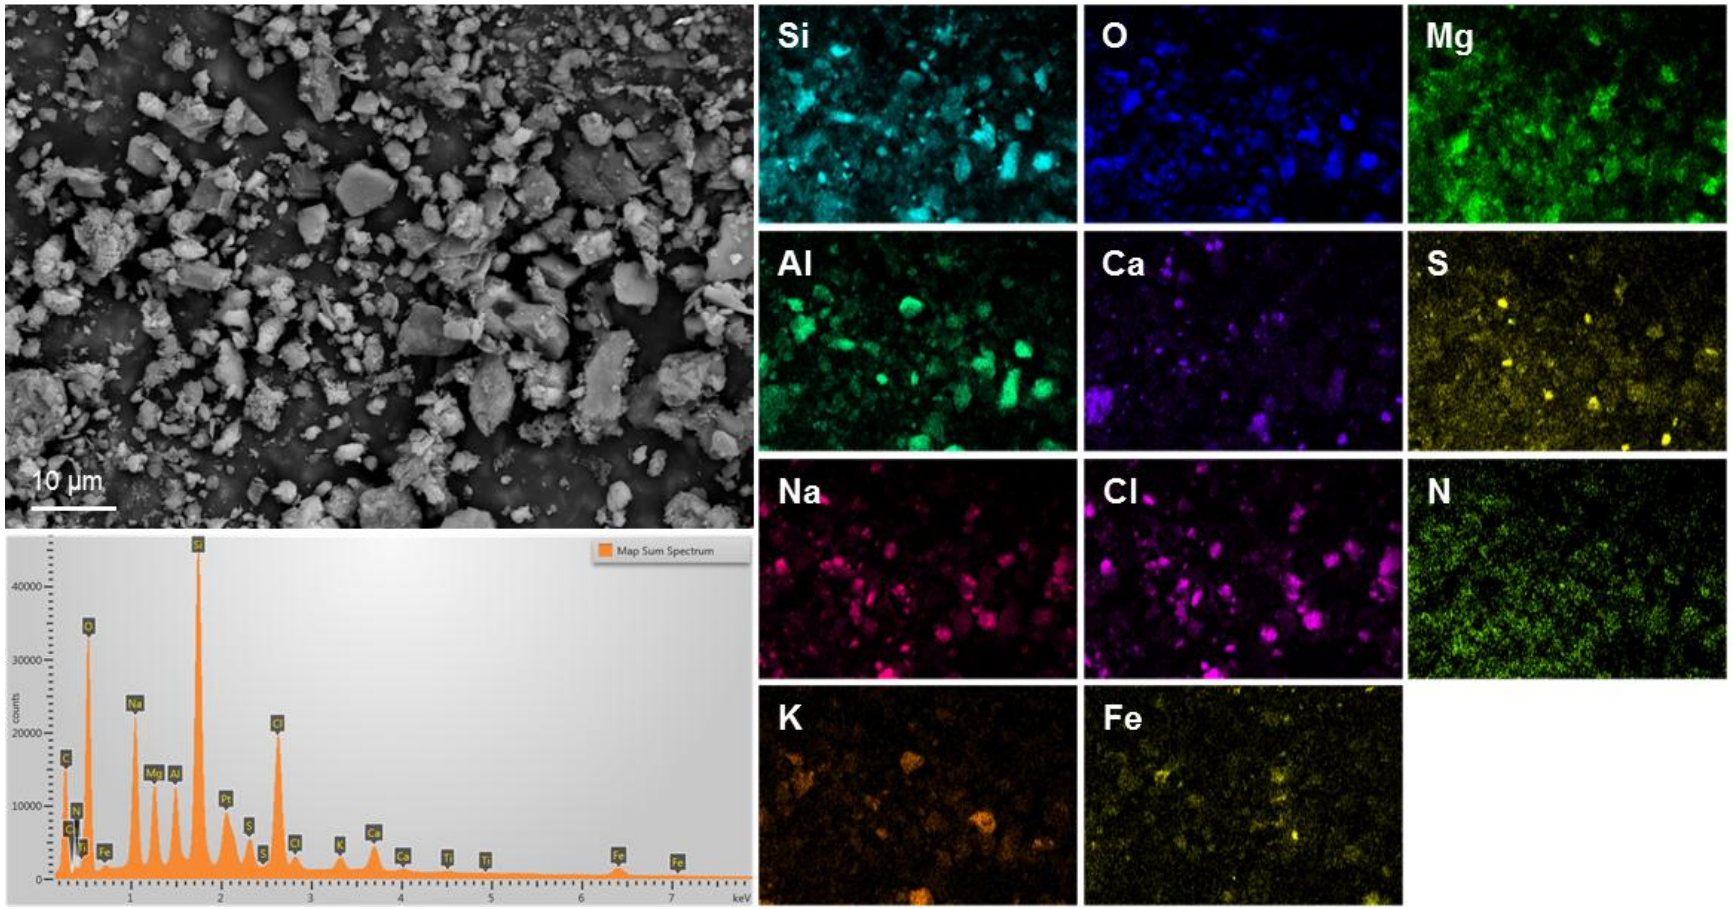
Sample: 170-003
Map M

Notes: Dust consisting dominantly of aluminosilicates and sea-salt aggregates (NaCl and Mg-SO_4).

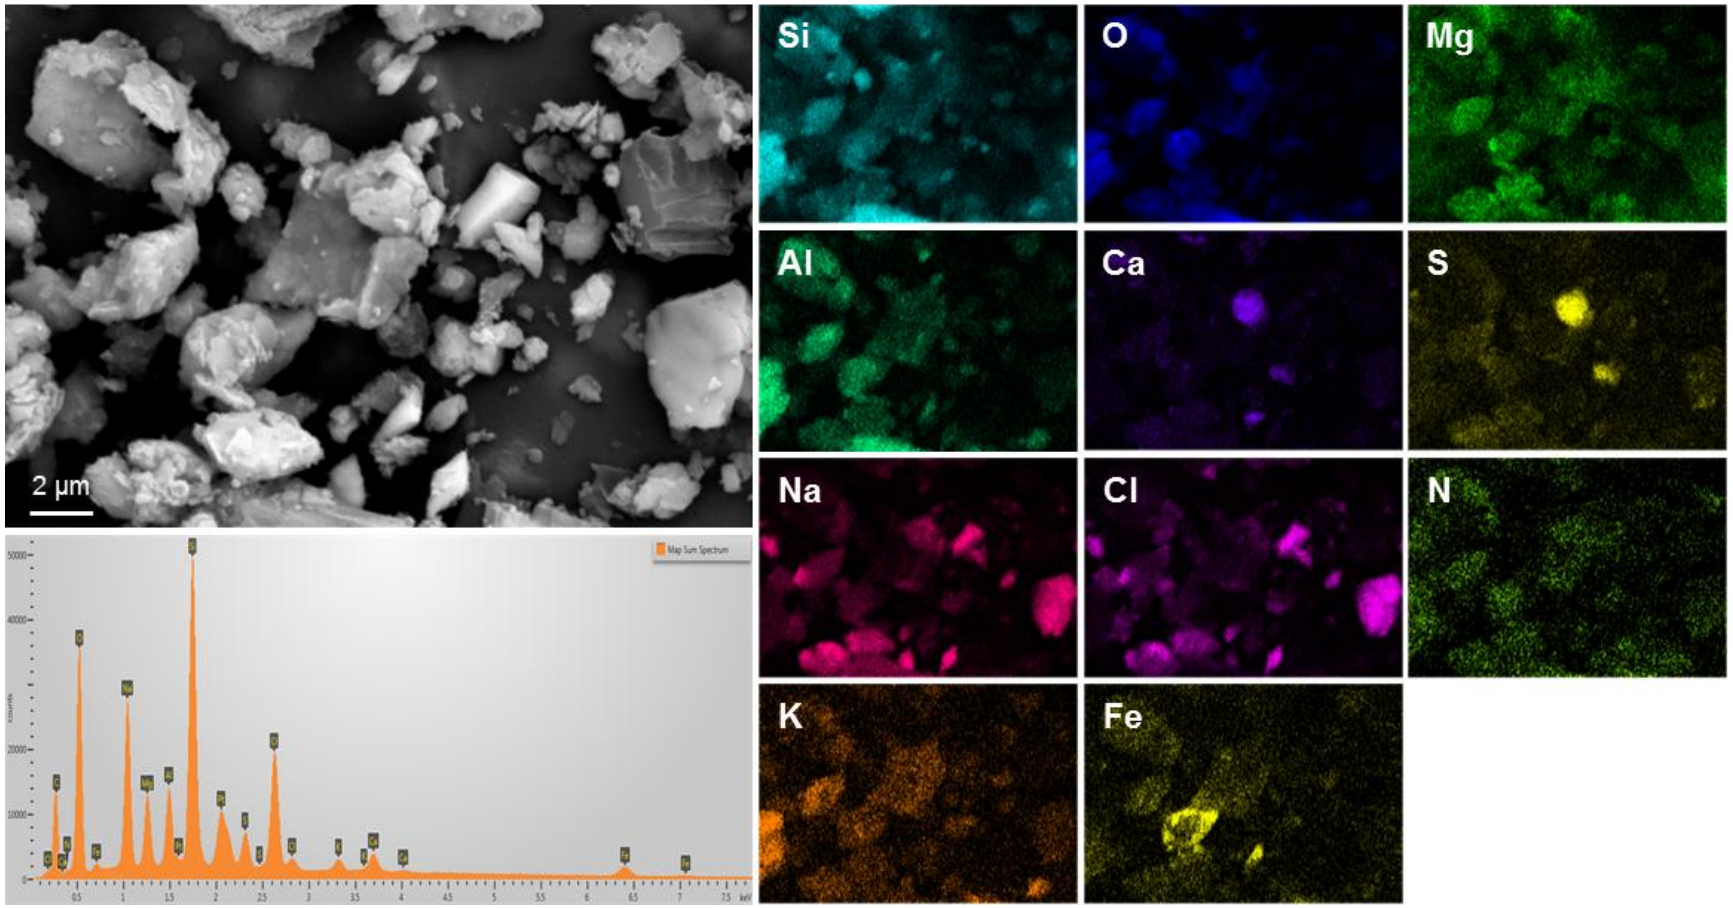
Sample: 170-003
Map N

Notes: Dust consisting dominantly of aluminosilicates and sea-salt aggregates (NaCl and Mg-SO_4). Ca-sulfate is also present.

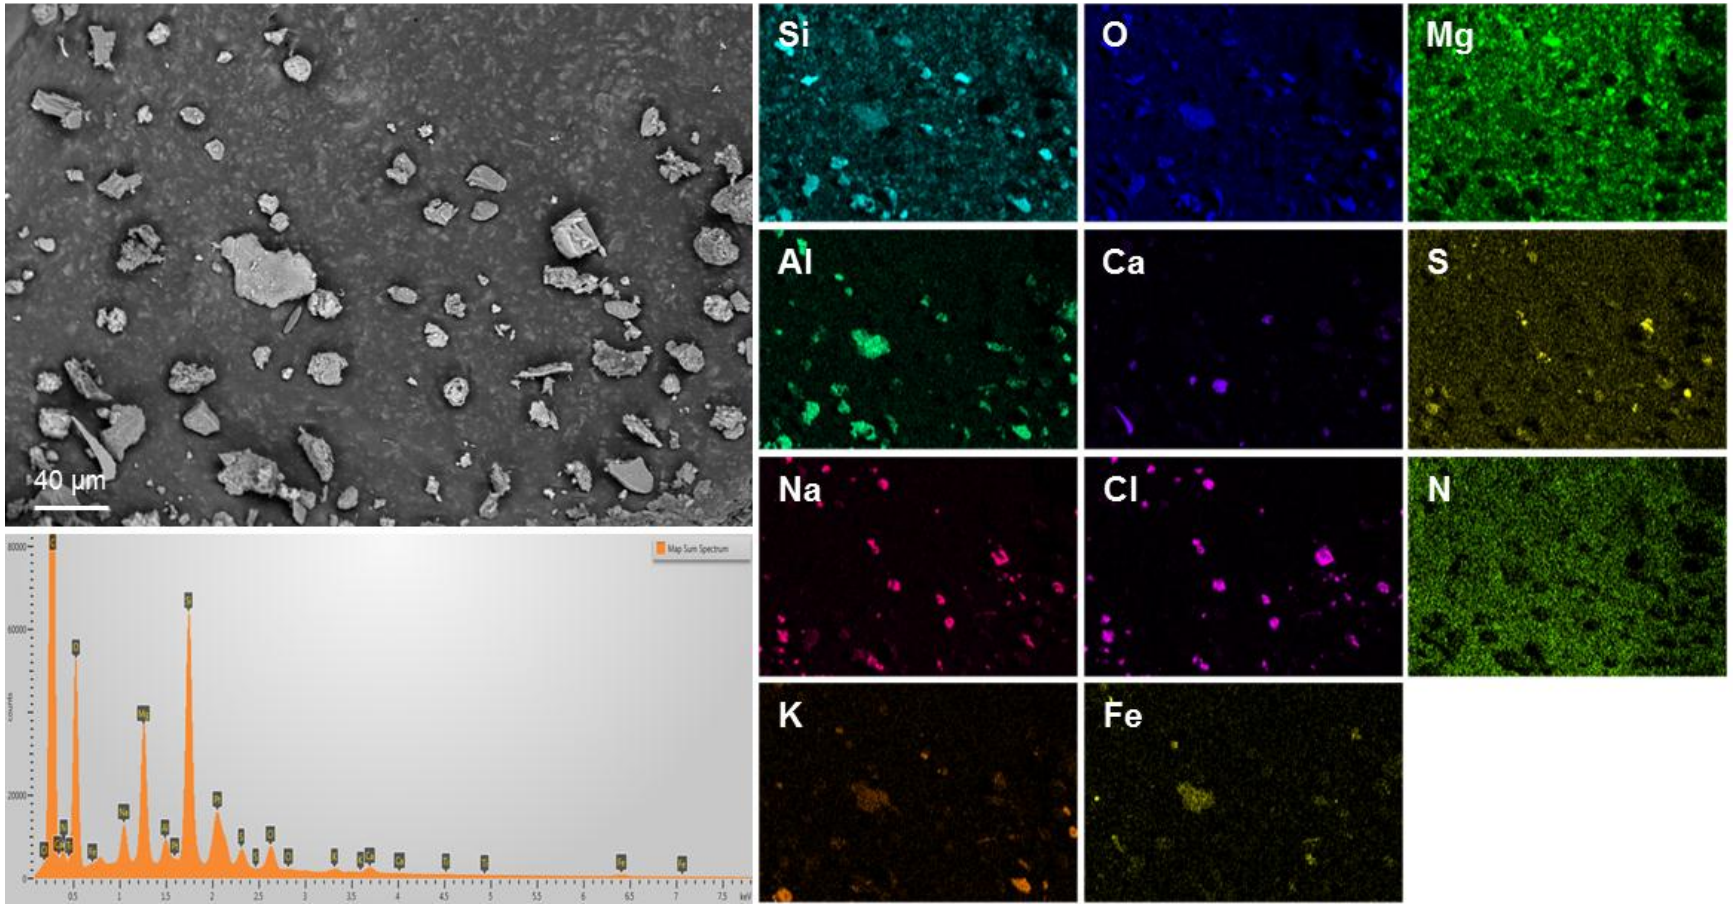
Sample: 170-003
Map O

Notes: Dust consisting dominantly of aluminosilicates and sea-salt aggregates (NaCl and Mg-SO_4).

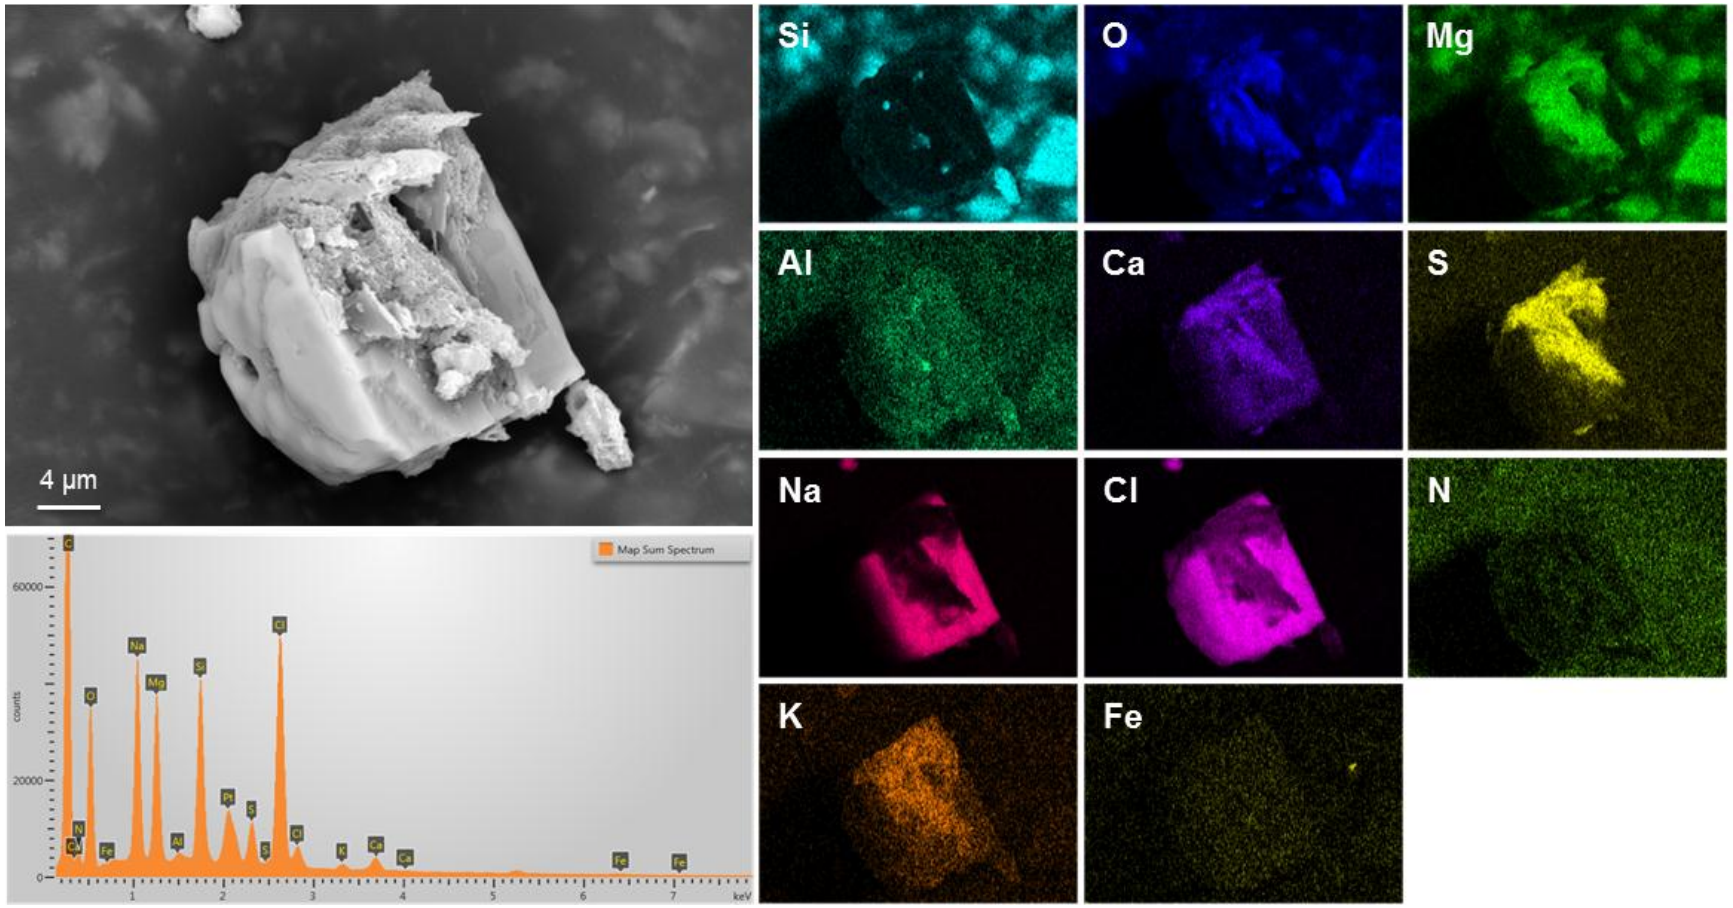
Sample: 170-003
Map P

Notes: Close-up of sea-salt aggregate in left center of Map O, showing intergrown NaCl cubes and sheaf-like Mg-SO_4, and trace Ca and K, both mostly associated with the sulfate.

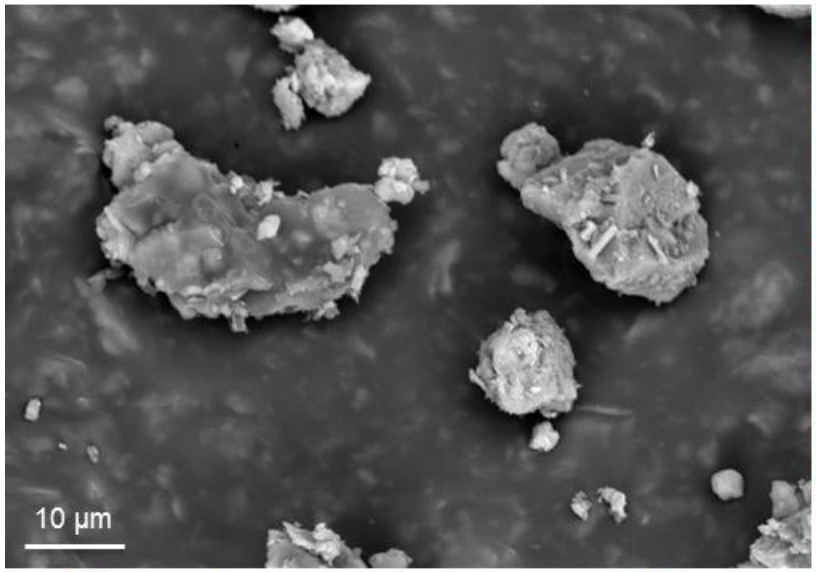
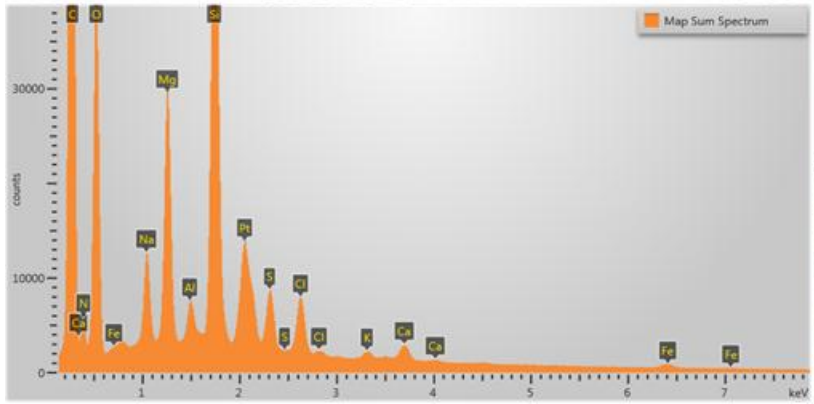
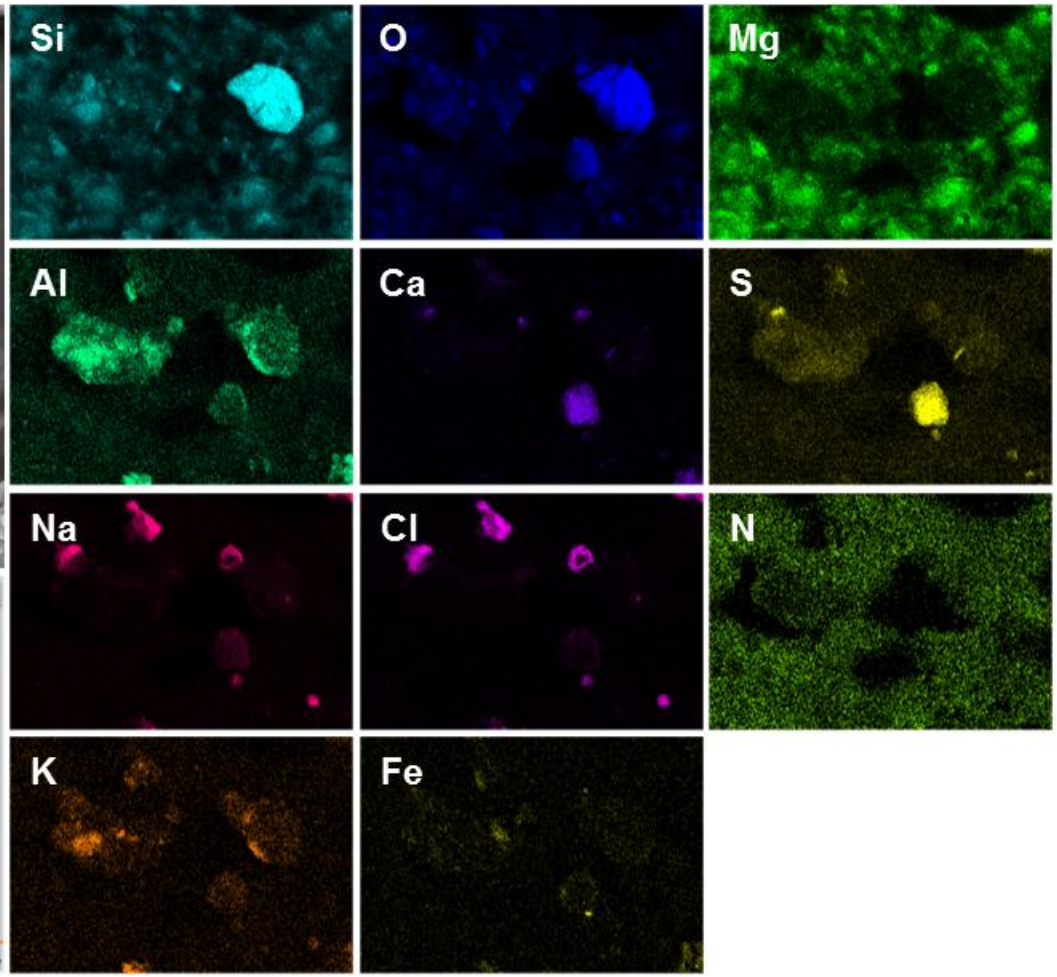
Sample: 170-003
Map Q

Notes: Dust consisting dominantly of aluminosilicates and sea-salt aggregates (NaCl and Mg-SO_4). A large grain of Ca-sulfate is present.

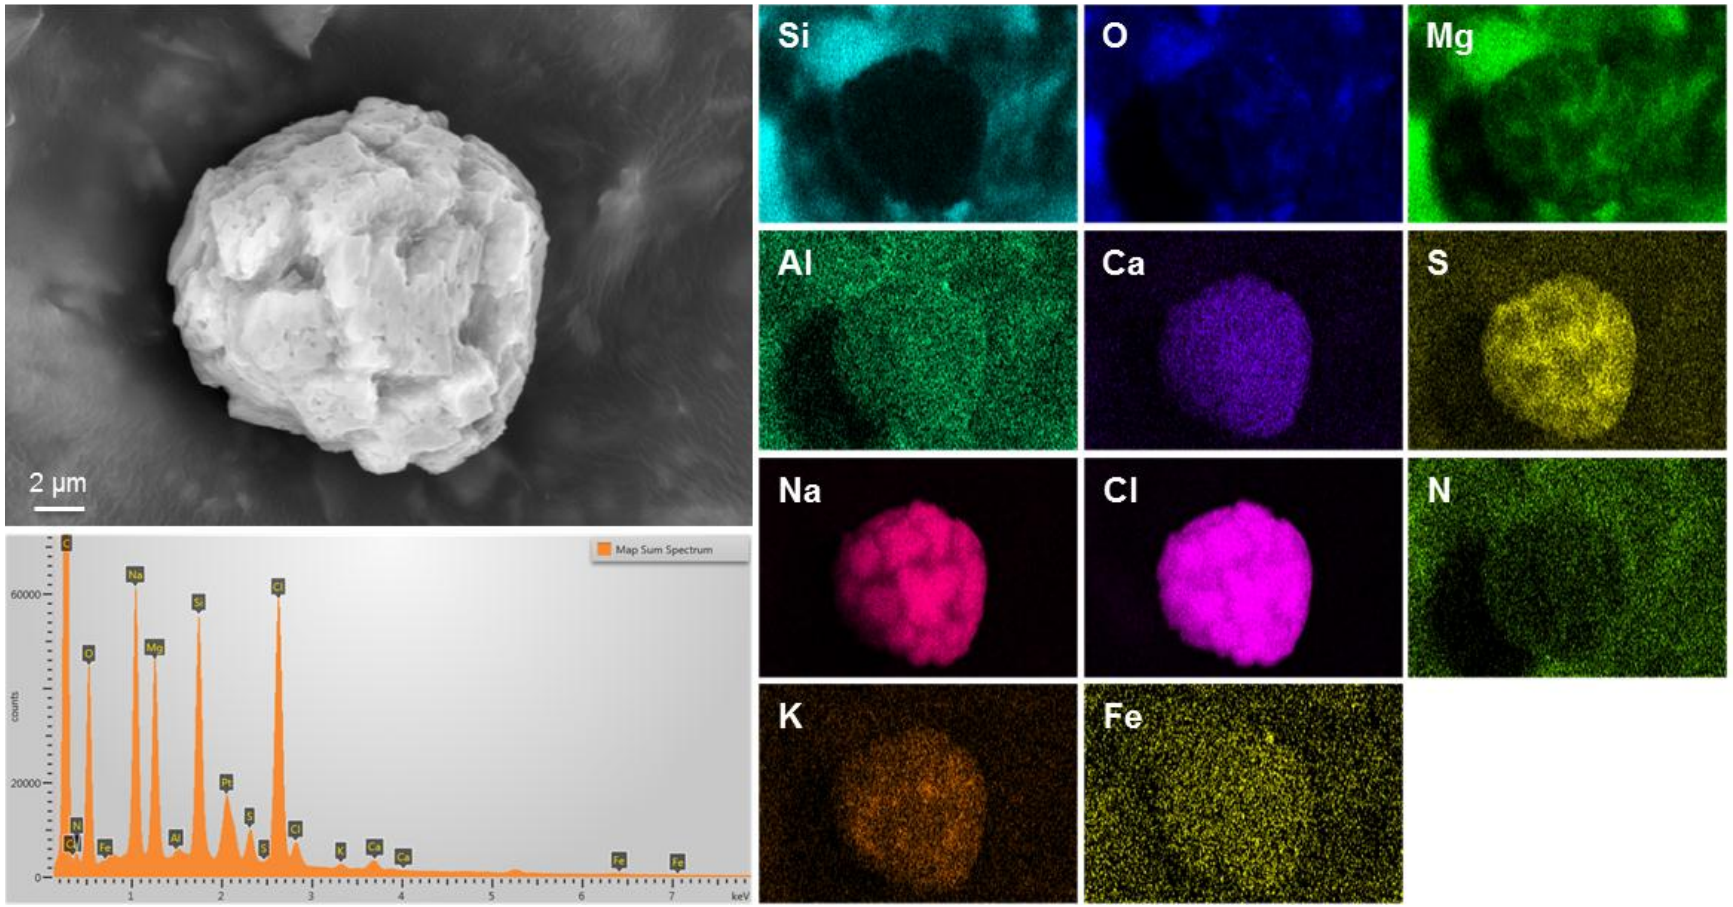
Sample: 170-003
Map R

Notes: Close-up of sea-salt aggregate, showing intergrown NaCl cubes and interstitial Mg-SO_4, and trace Ca and K.

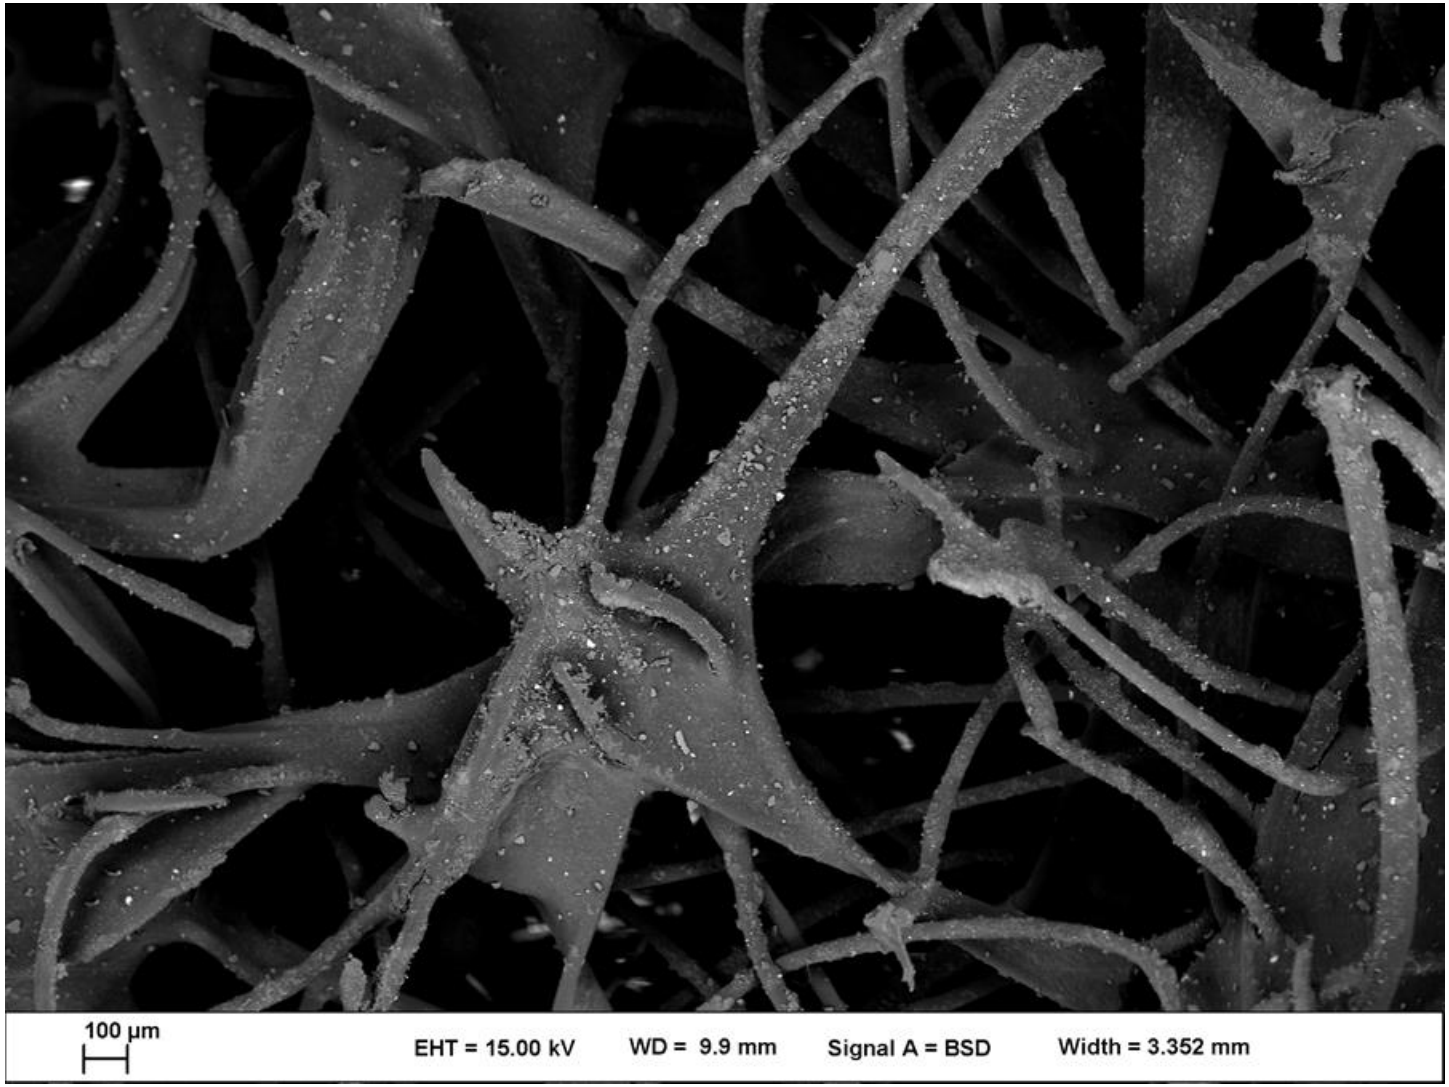
Sample: 170-004

Notes: Overview image of pad sample 170-004, showing the light dust load.

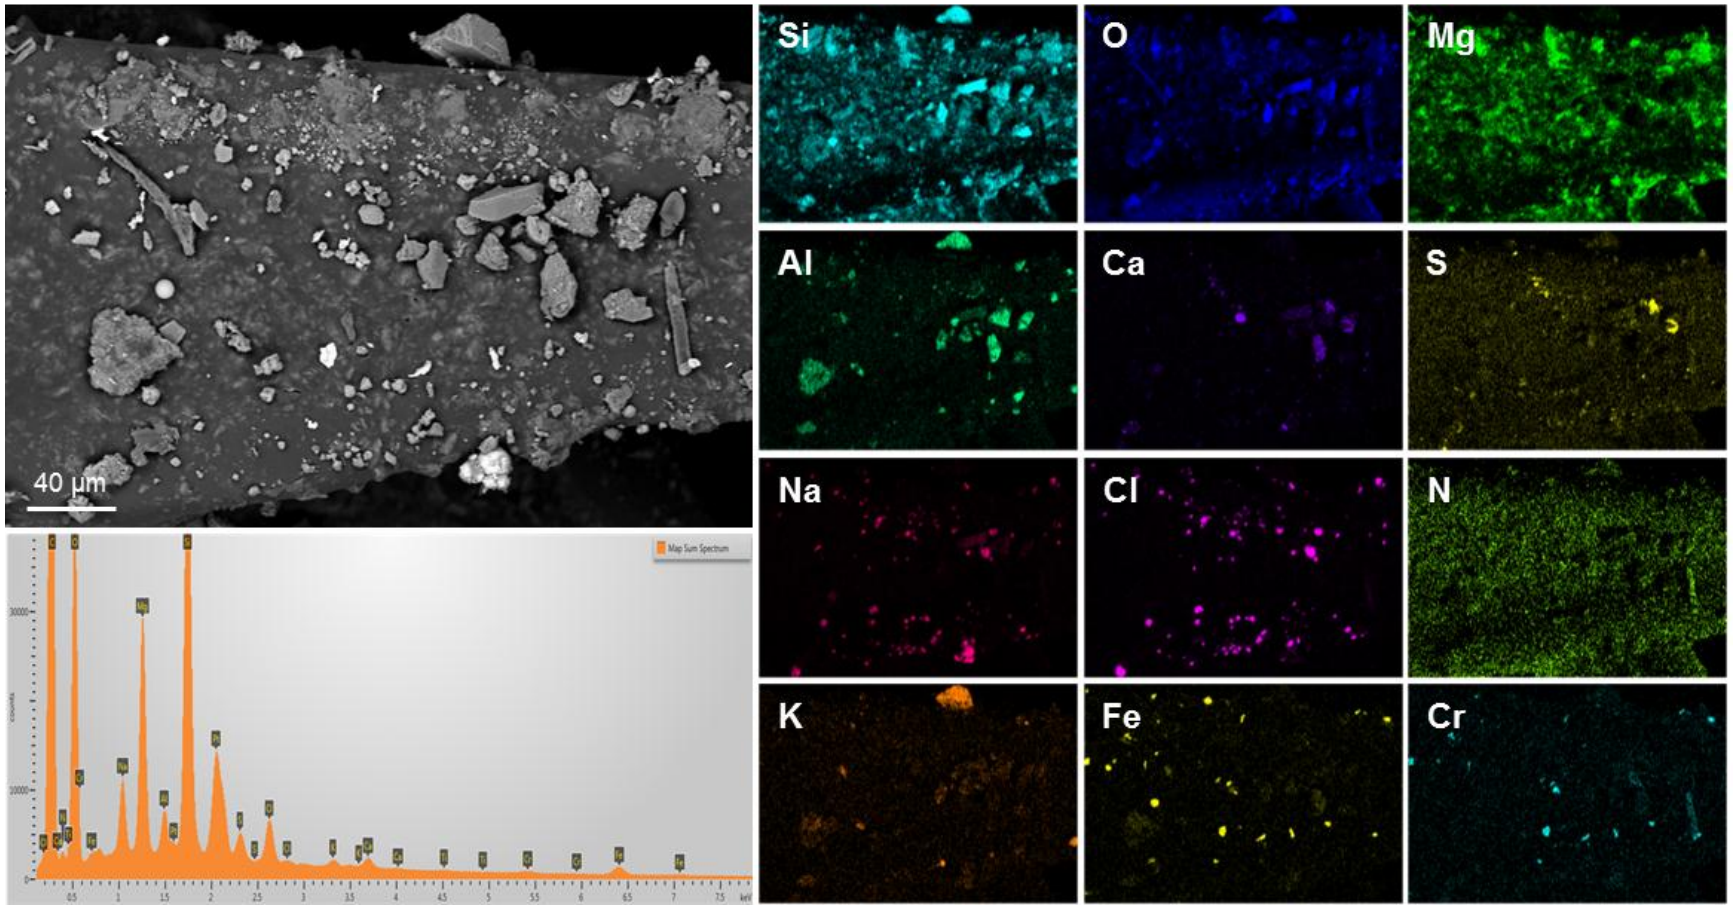
Sample: 170-004
Map A

Notes: Dust consisting of aluminosilicates, sea-salt particles, and stainless steel particles.
