SANDIA REPORT

SAND2014-16383
Unlimited Release
Printed July 2014

Analysis of Dust Samples Collected from Spent Nuclear Fuel Interim Storage Containers at Hope Creek, Delaware, and Diablo Canyon, California

Charles R. Bryan and David G. Enos

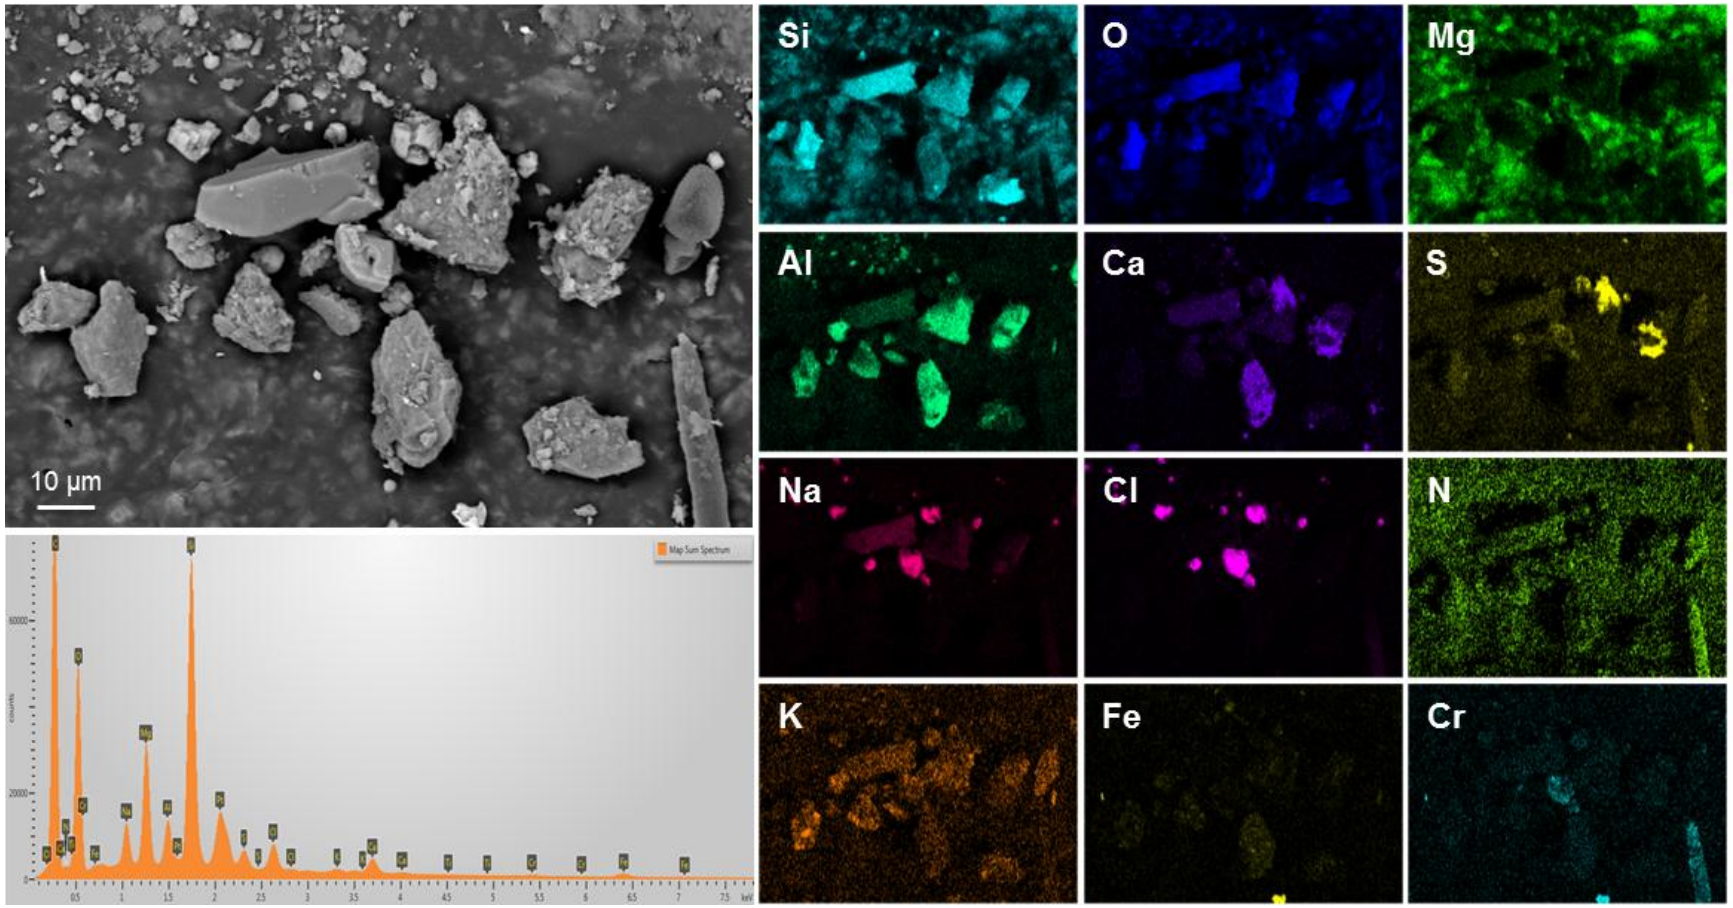
Sample: 170-004
Map B

Notes: Close-up of upper left quadrant of Map A, showing aluminosilicates, sea-salt aggregates, and Ca-sulfate. A pollen grain is present on the far right side of the image.

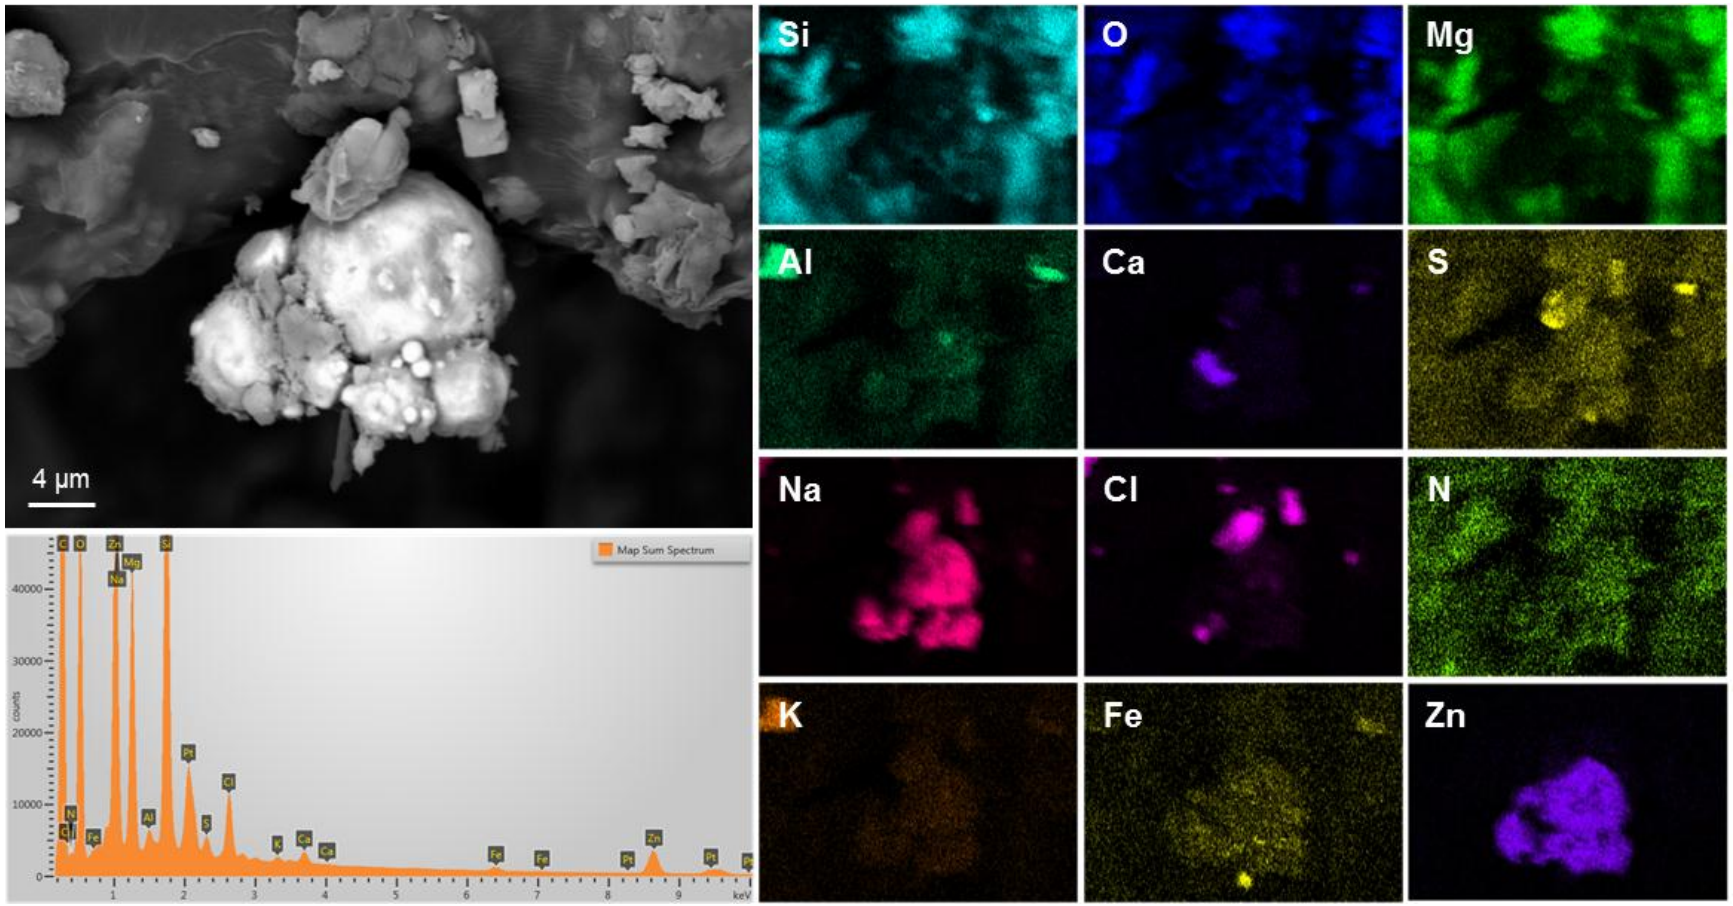
Sample: 170-004
Map C

Notes: Close-up of bright Na- and Zn-rich feature along the bottom edge of Map A.

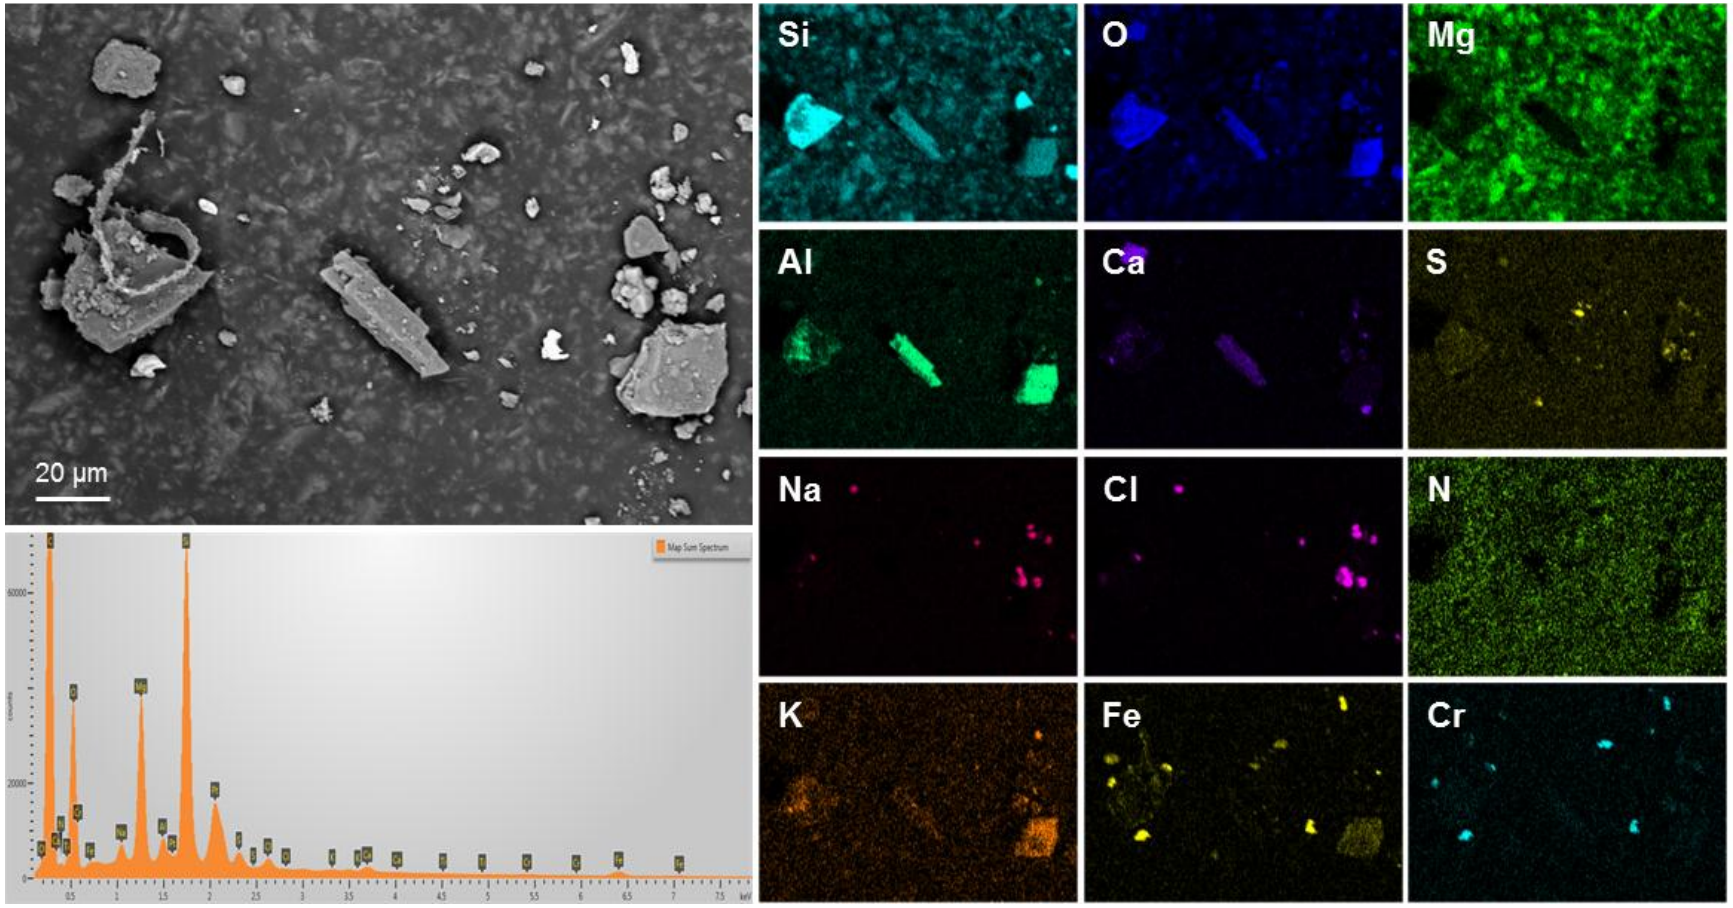
Sample: 170-004
Map D

Notes: Dust containing aluminosilicates, sea-salt aggregates, and stainless steel particles.

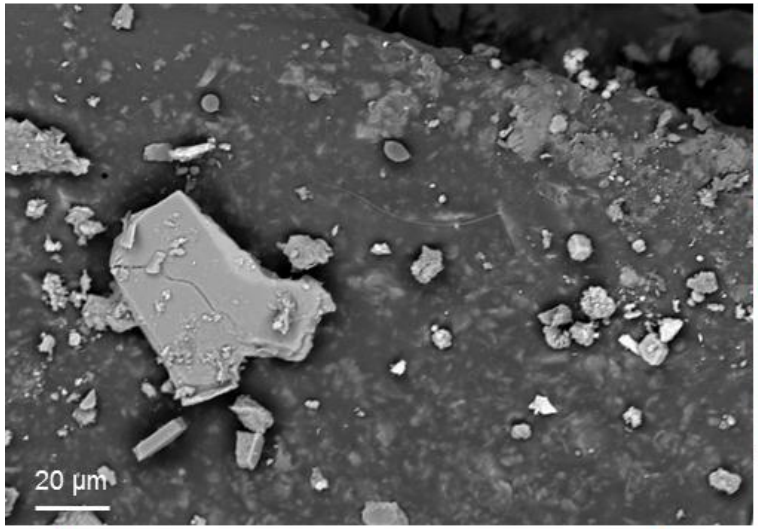
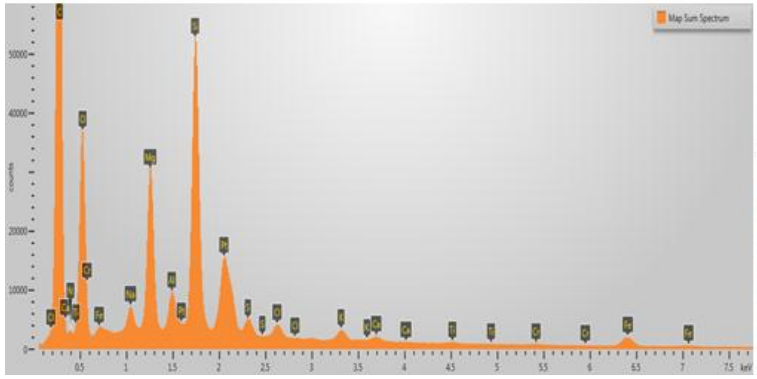
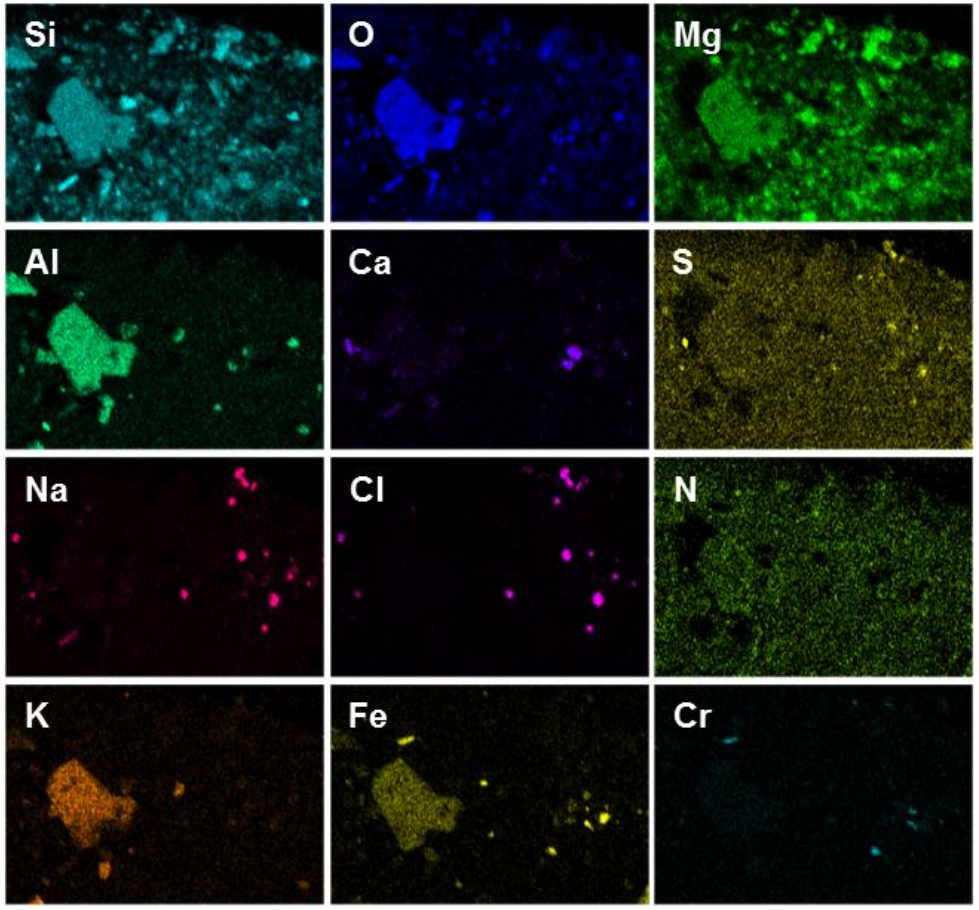
Sample: 170-004
Map E

Notes: Dust consisting mostly of aluminosilicates and sea-salt aggregates. The large platy grain is probably biotite.

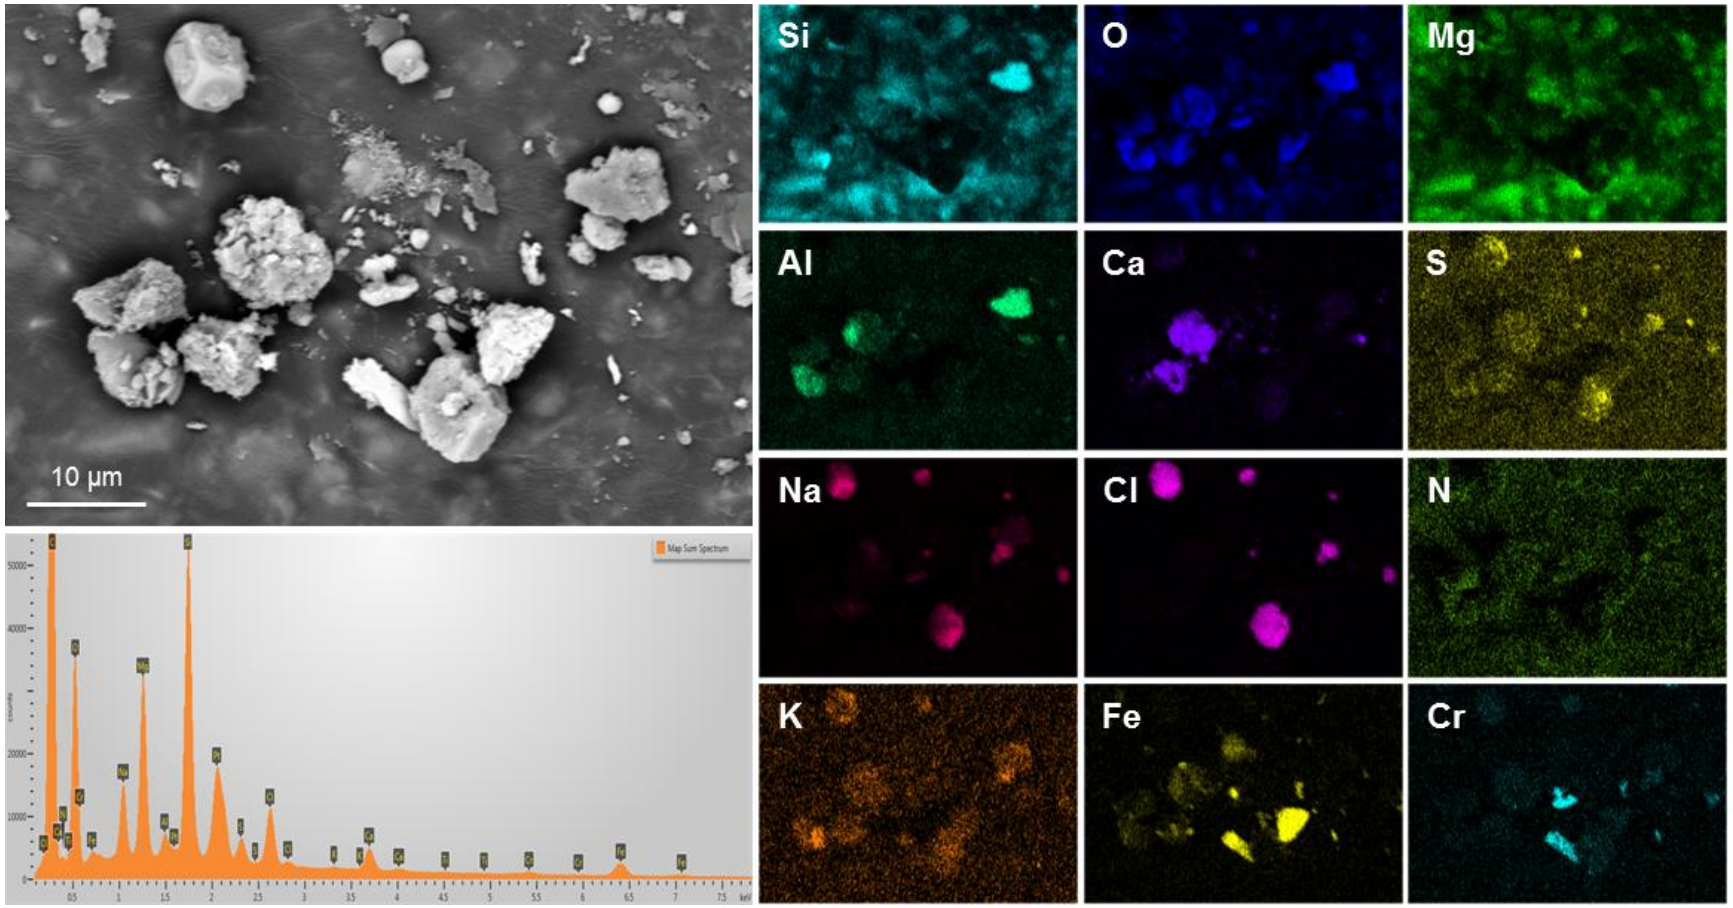
Sample: 170-004
Map F

Notes: Dust containing aluminosilicates, sea-salt aggregates, and Ca-carbonate.

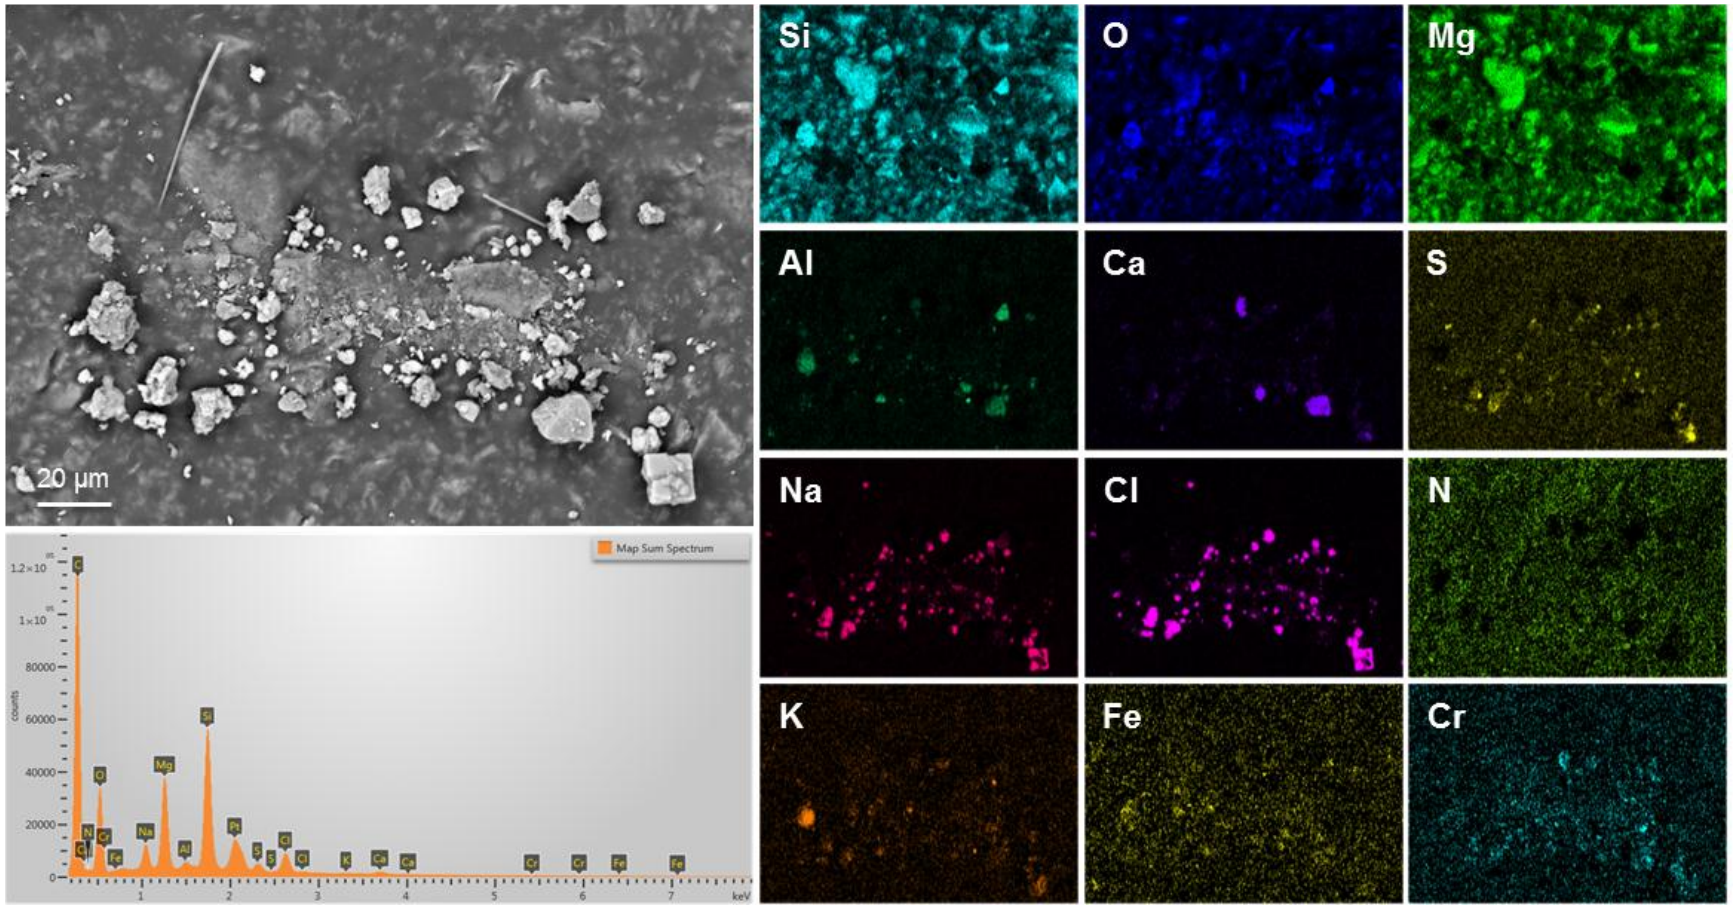
Sample: 170-004
Map G

Notes: Dust adhering to an abraded edge. Possibly comminuted during collection. Consists mostly of sea-salts.

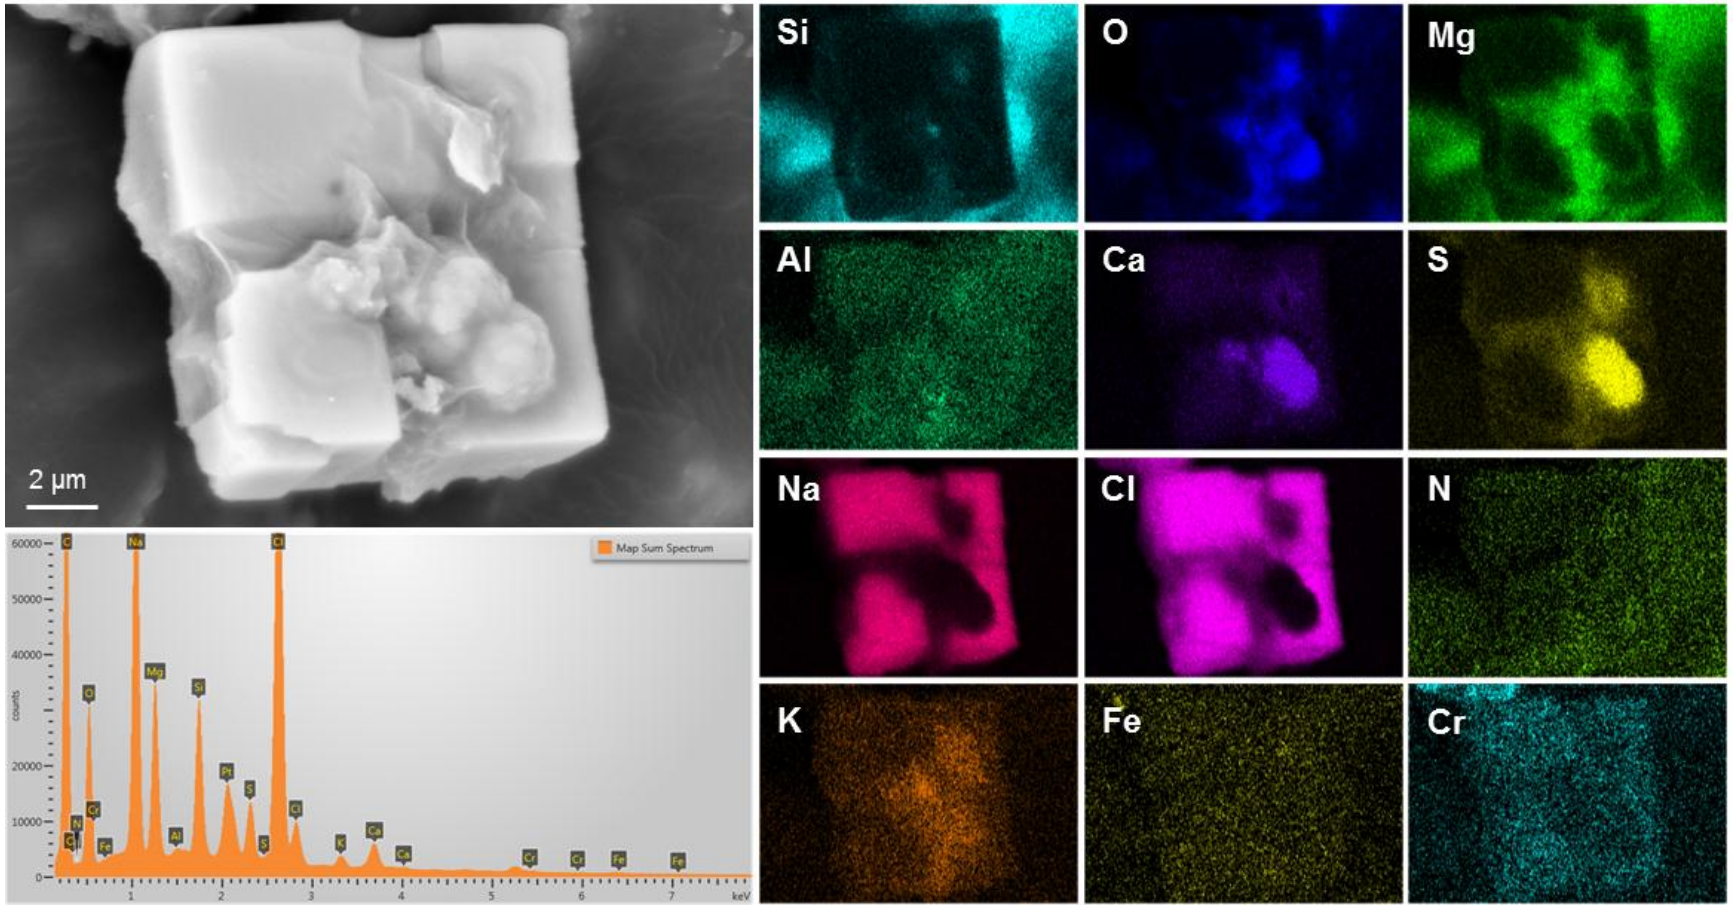
Sample: 170-004
Map H

Notes: Close-up of sea-salt aggregate in lower right corner of Map G, consisting of skeletal or intergrown NaCl cubes, and Mg-SO_4, and trace Ca and K.

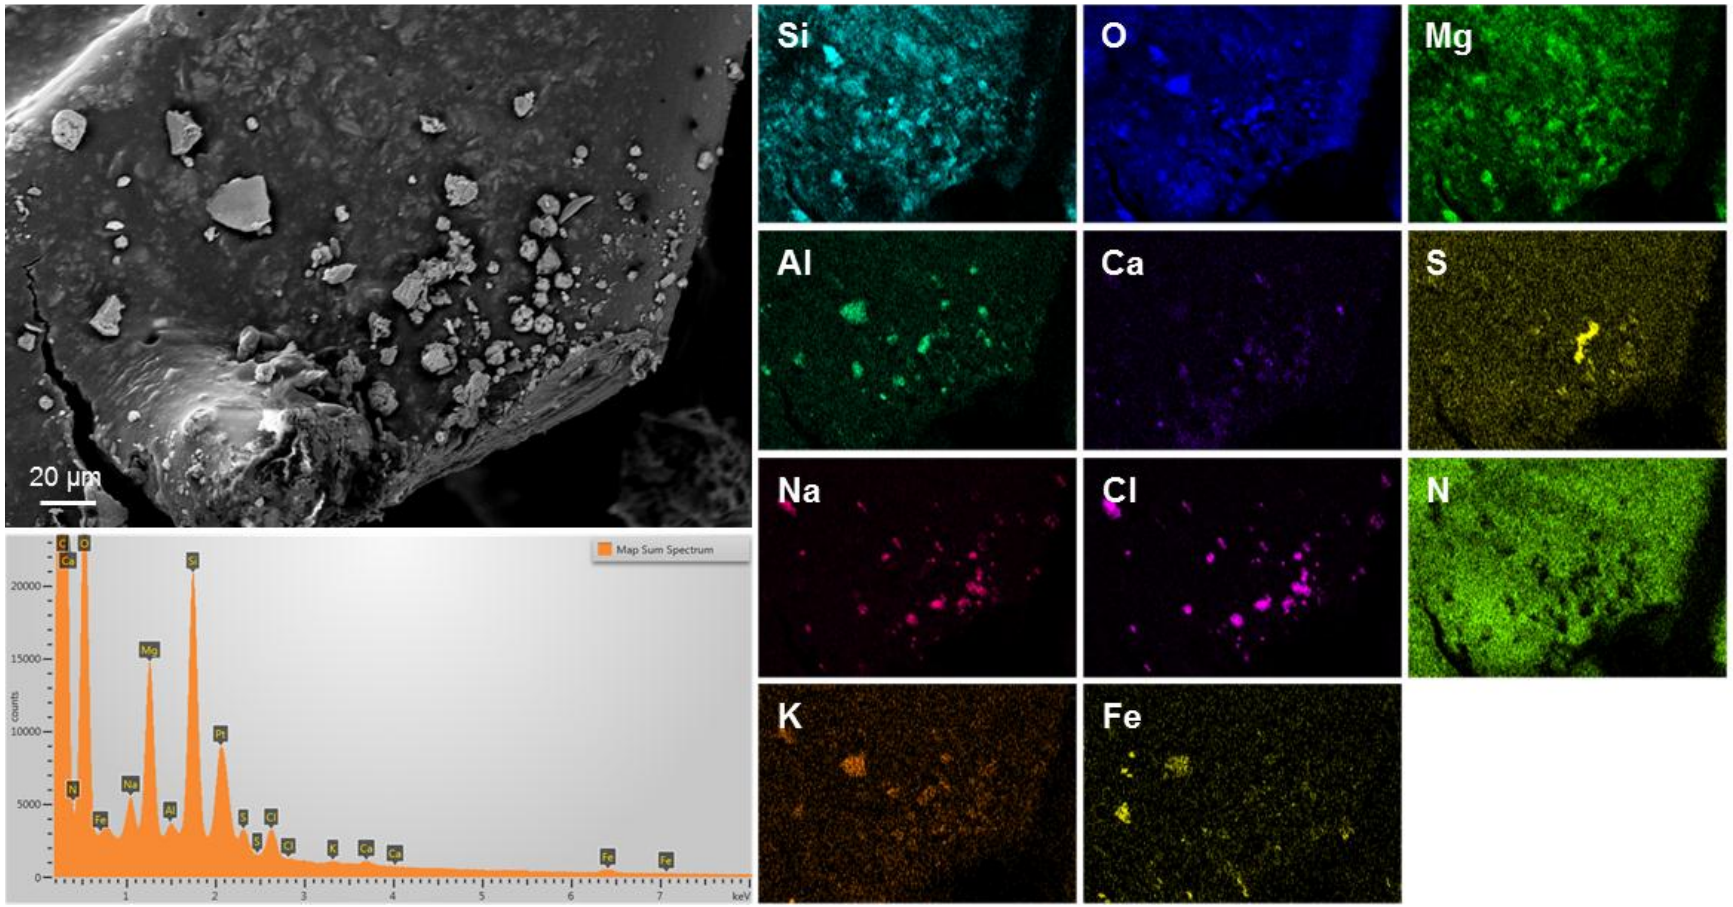
Sample: 170-004
Map I

Notes: Abundant dust on an abraded edge, consisting dominantly of aluminosilicates and sea-salt aggregates.

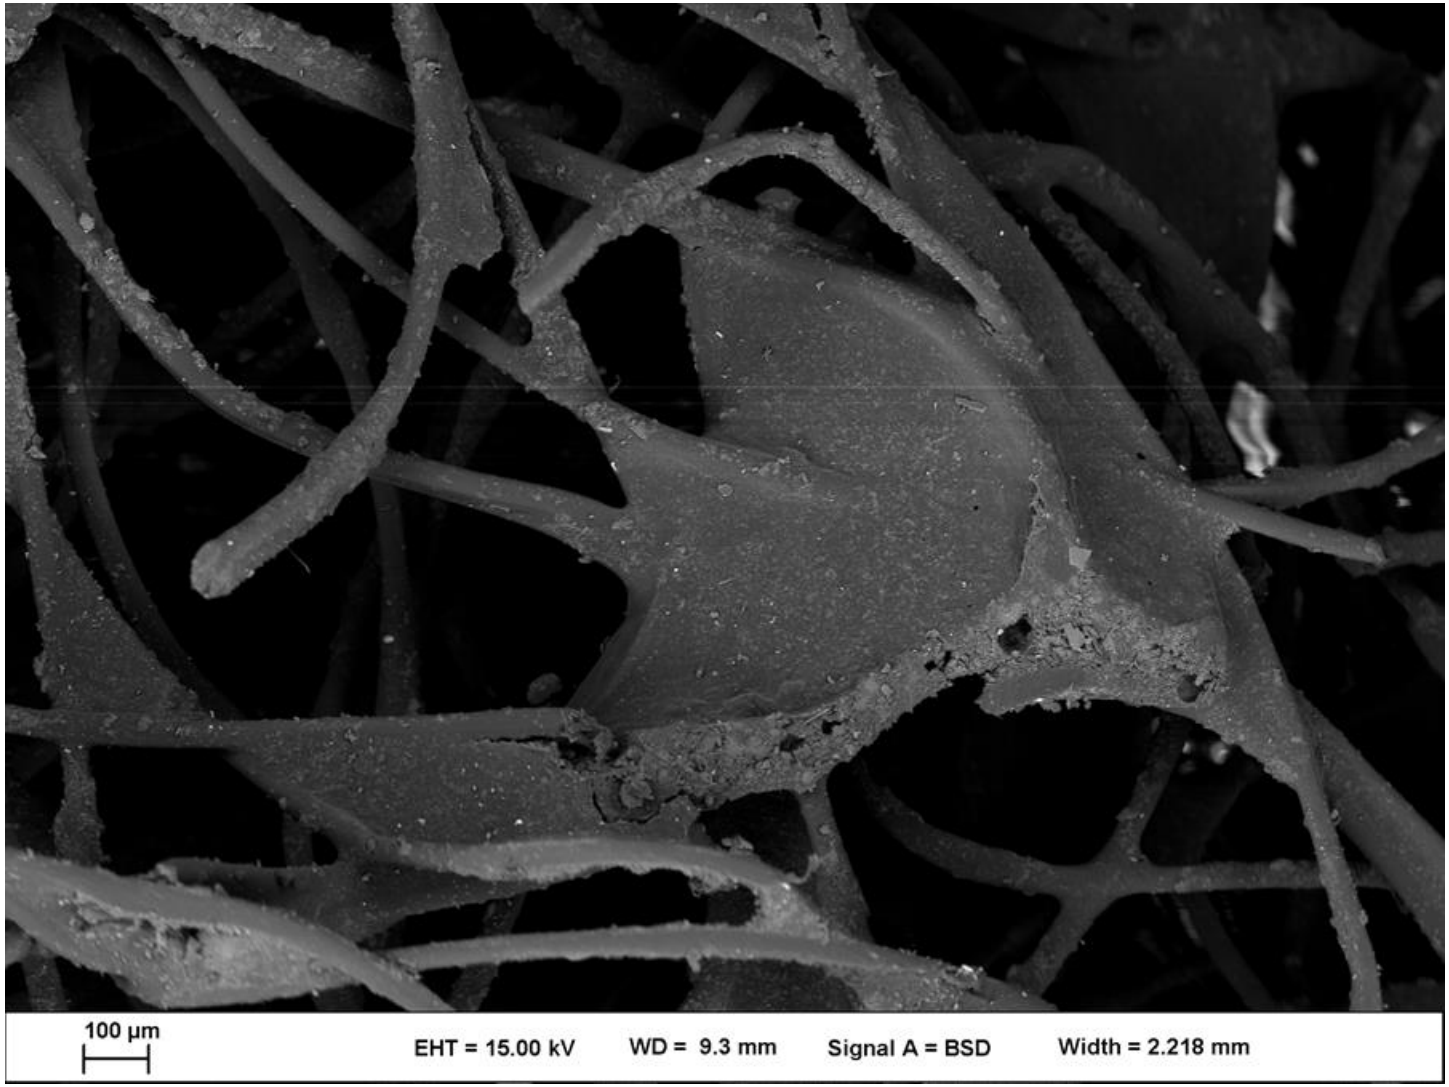
Sample: 170-005

Notes: Overview image of pad sample 170-005, showing the very light dust load.

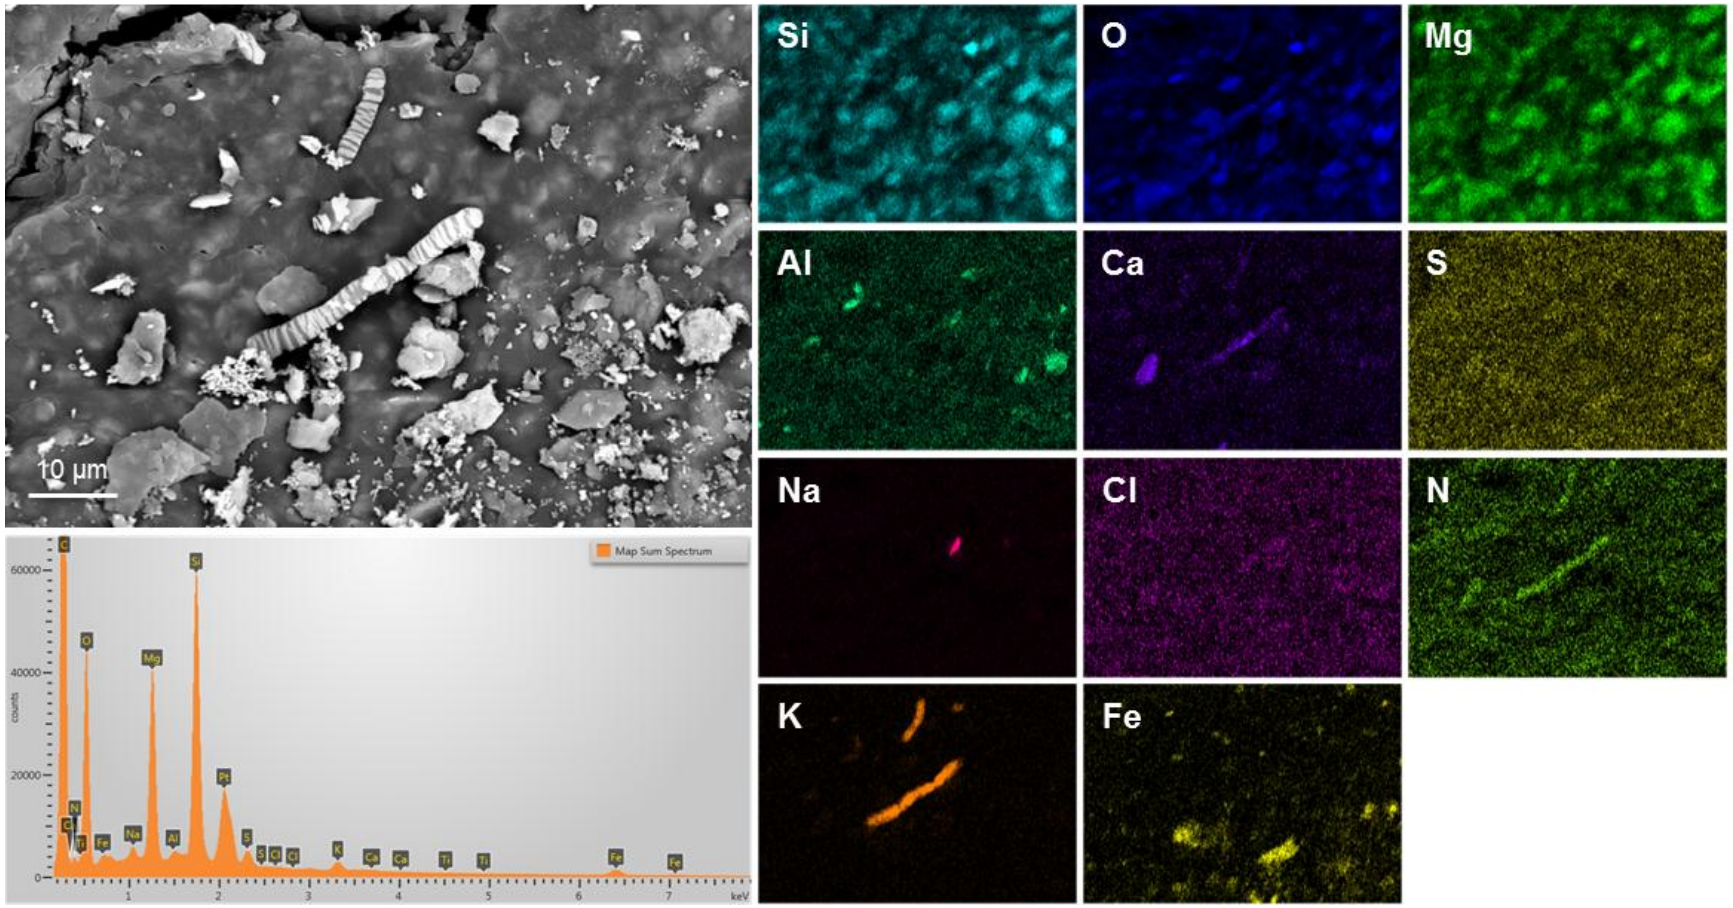
Sample: 170-005
Map A

Notes. The two elongated features are unidentified. They appeared as blade-like crystals initially, but rapidly changed in the electron beam, elongating by a factor of 3 or more. Compositionally, they contain K, O, N, C (not shown), and Ca.

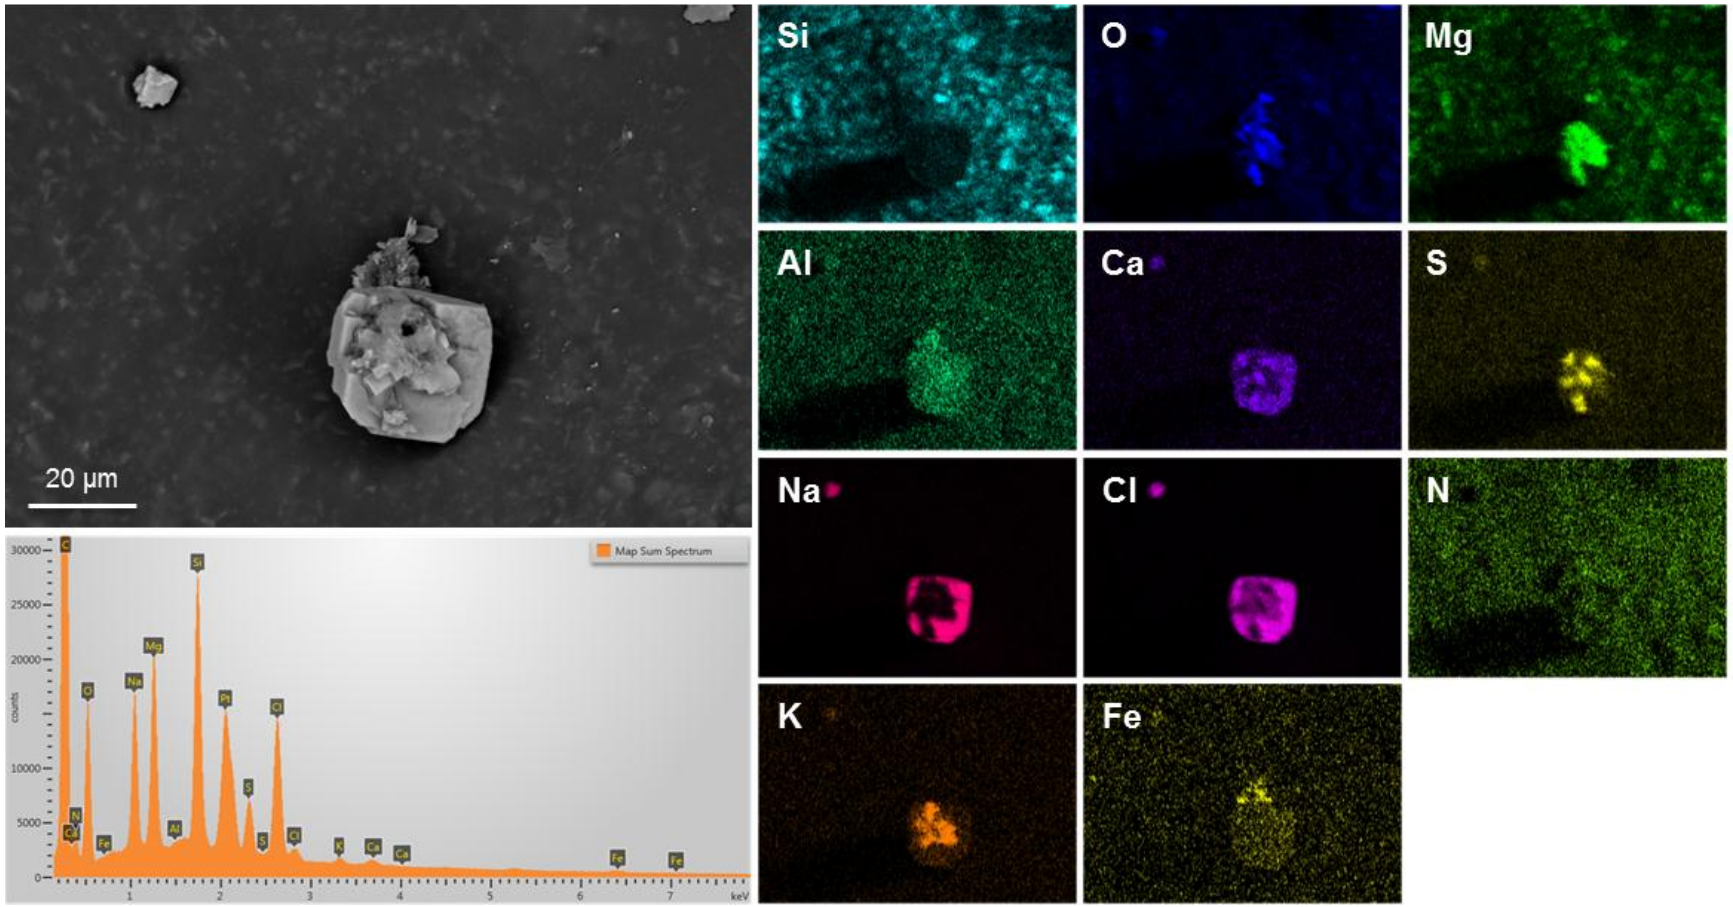
Sample: 170-005
Map B

Notes: Close-up of sea-salt aggregate consisting of NaCl cubes with Mg-SO_4 and minor Ca and K.

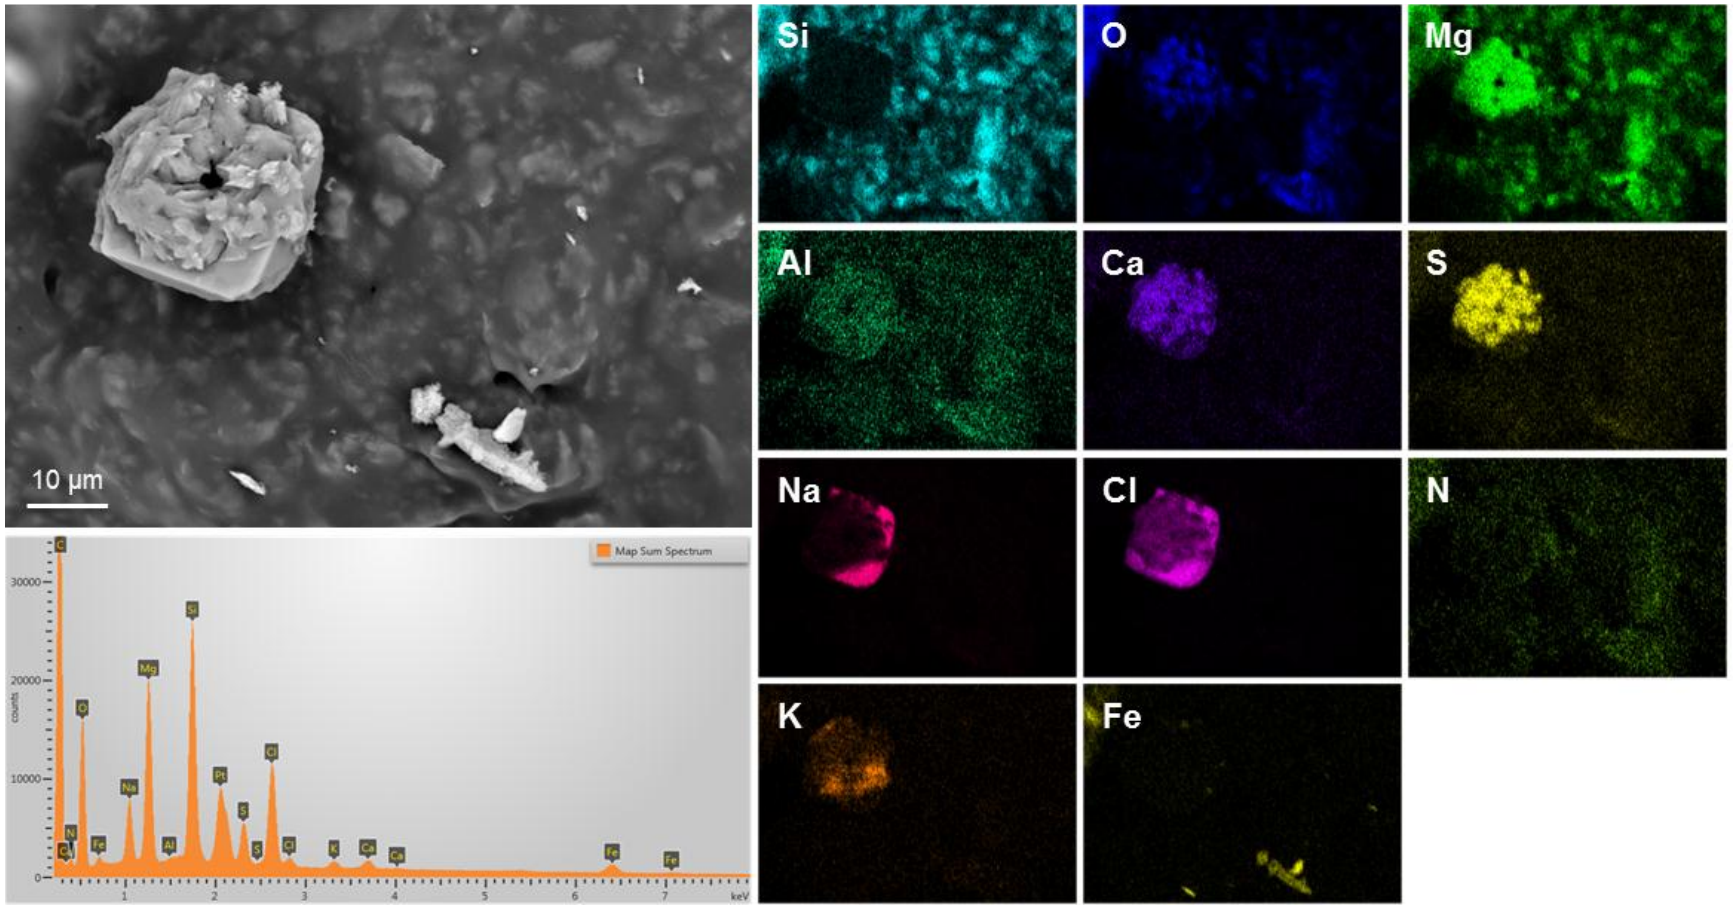
Sample: 170-005
Map C

Notes: Close-up of sea-salt aggregate consisting of a NaCl cube with sheaf-like Mg-SO_4 and minor Ca and K.

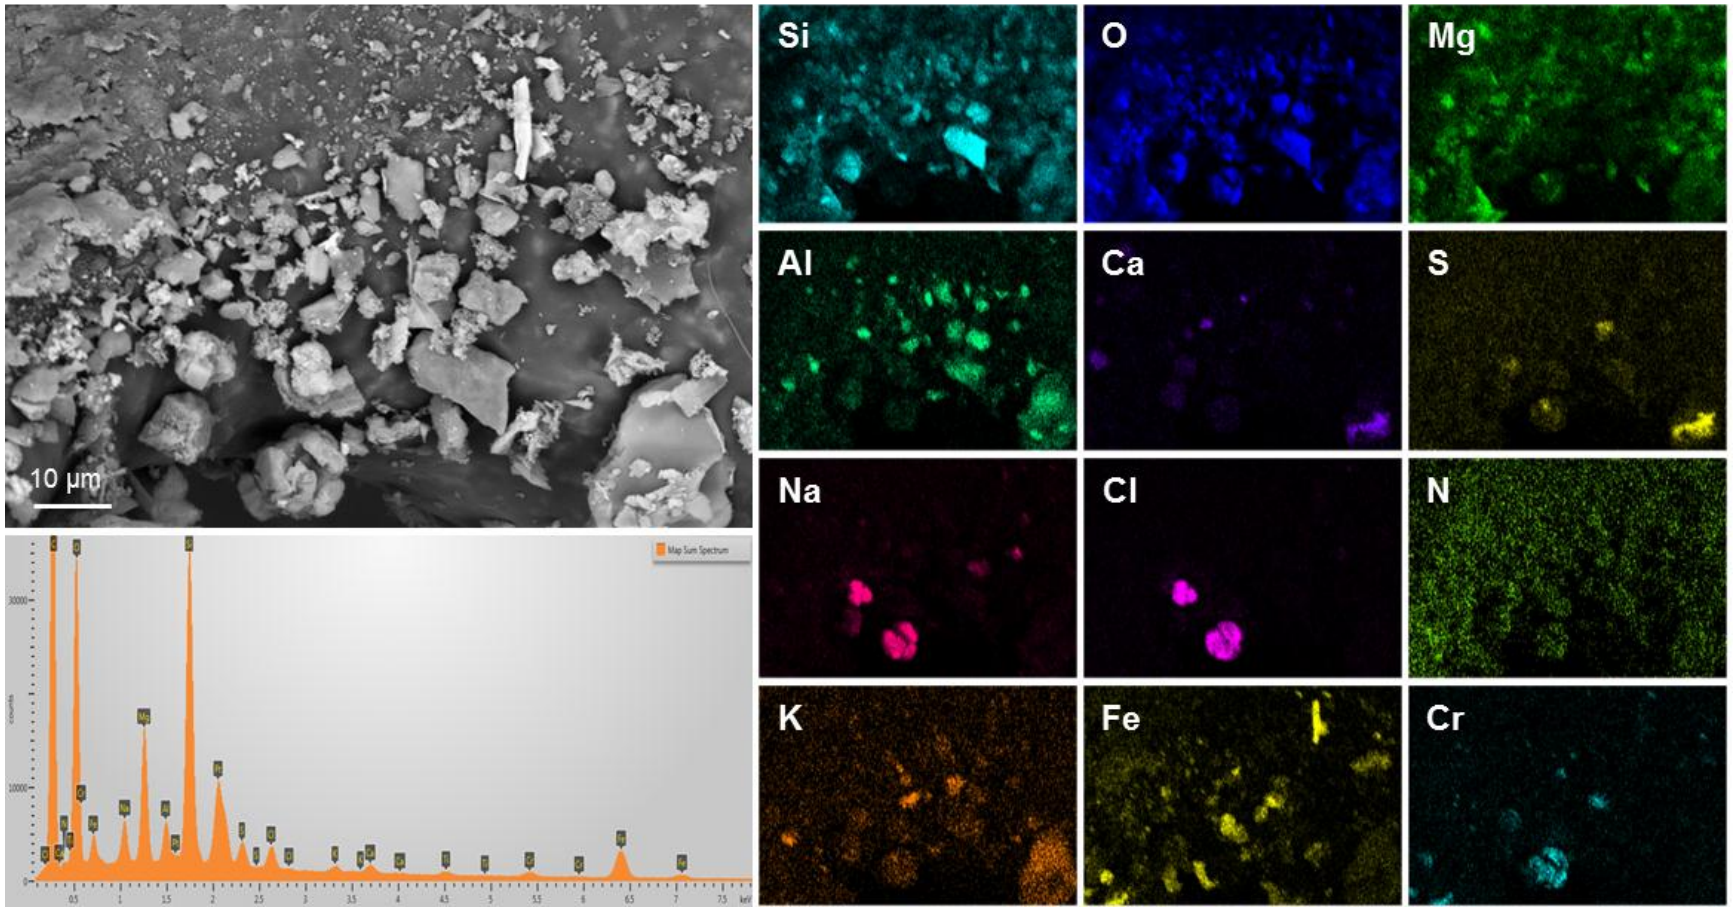
Sample: 170-005
Map D

Notes: Dust on an abraded edge, consisting dominantly of aluminosilicates and two large sea-salt aggregates.

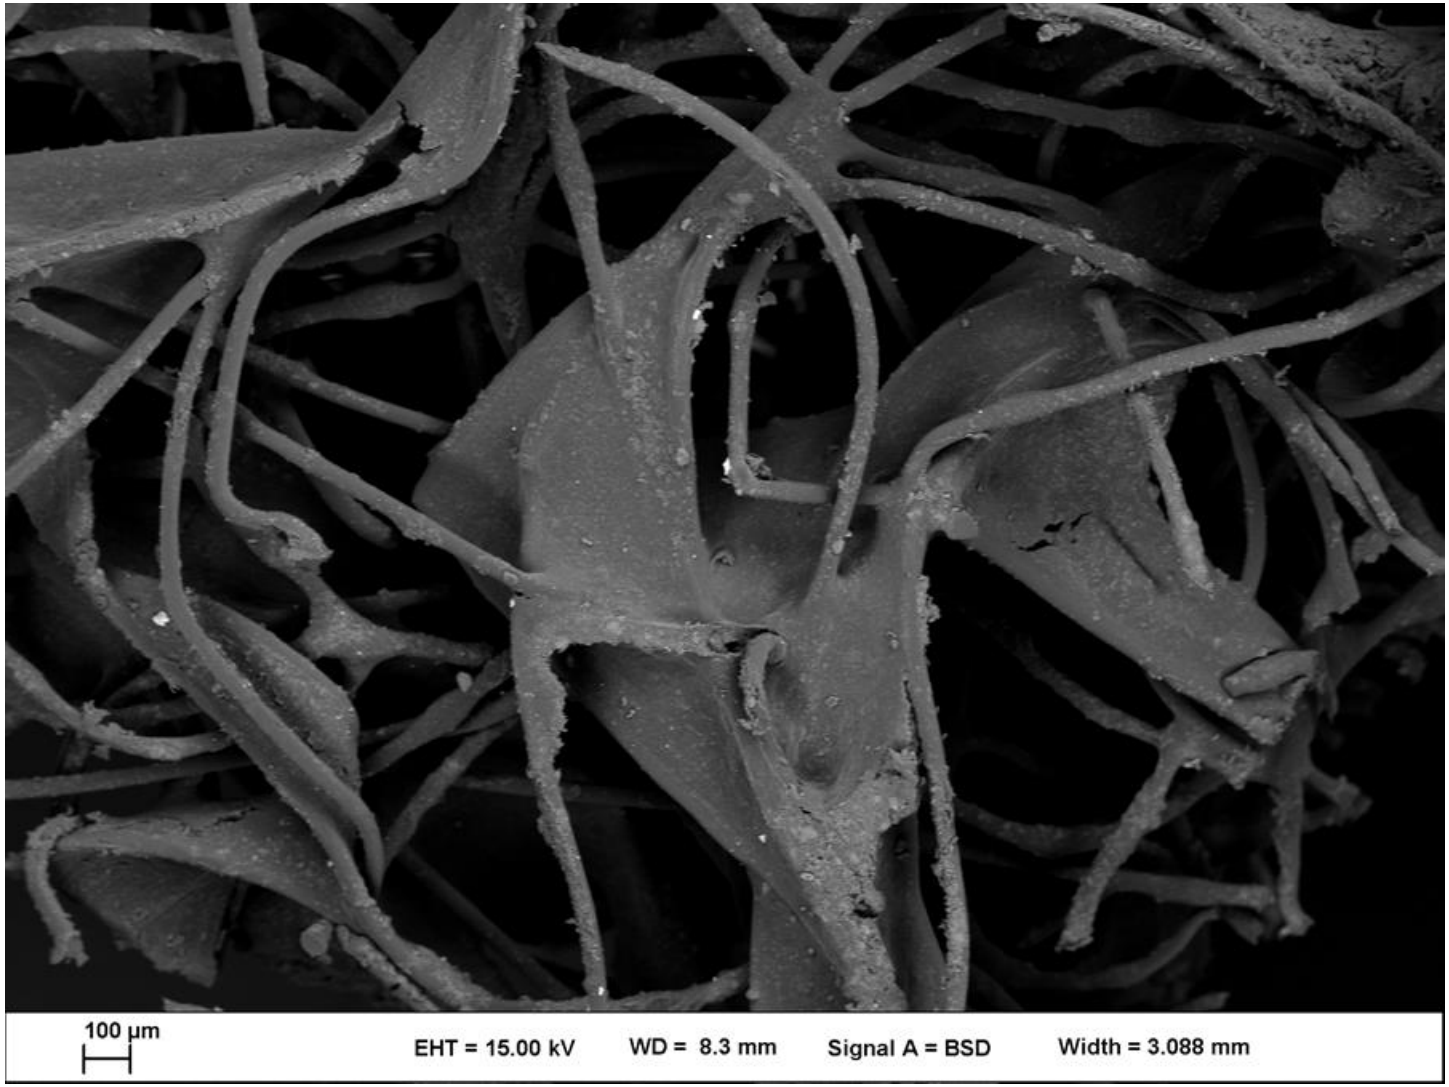
Sample: 170-006

Notes: Overview image of pad sample 170-006, showing the very light dust load.
