SANDIA REPORT

SAND2014-16383
Unlimited Release
Printed July 2014

Analysis of Dust Samples Collected from Spent Nuclear Fuel Interim Storage Containers at Hope Creek, Delaware, and Diablo Canyon, California

Charles R. Bryan and David G. Enos

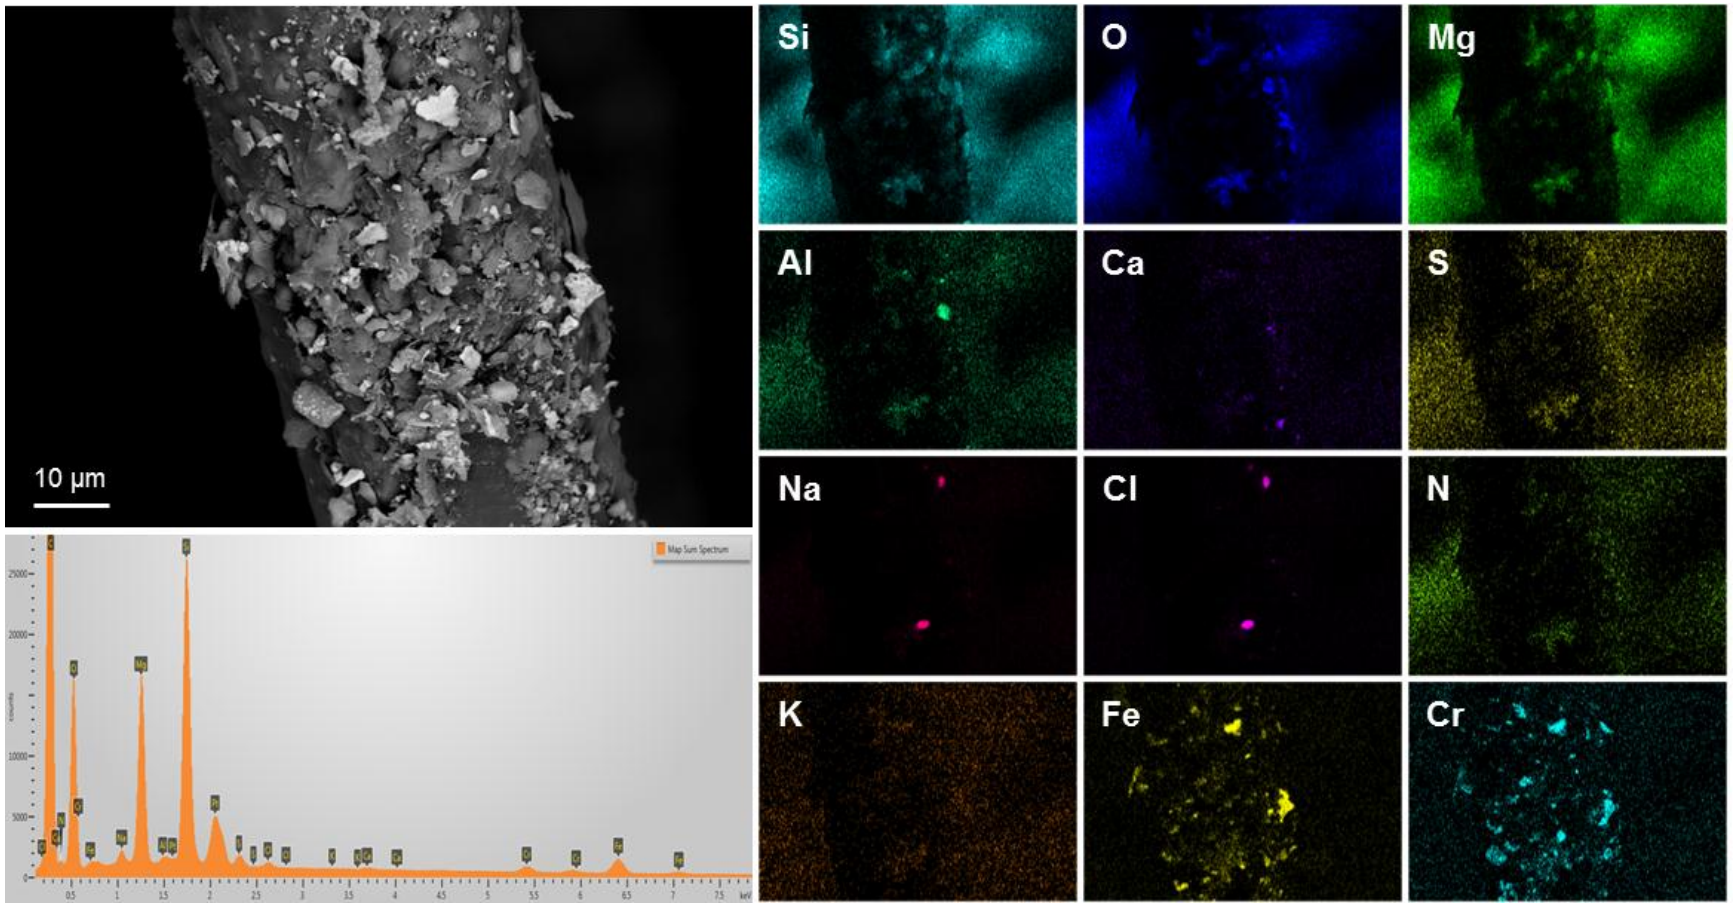
Sample: 170-006
Map A

Notes: Most particles are talc, liberated by abrasion of the pad. Sparse dust is dominantly stainless steel particles. A few grains of NaCl are present.

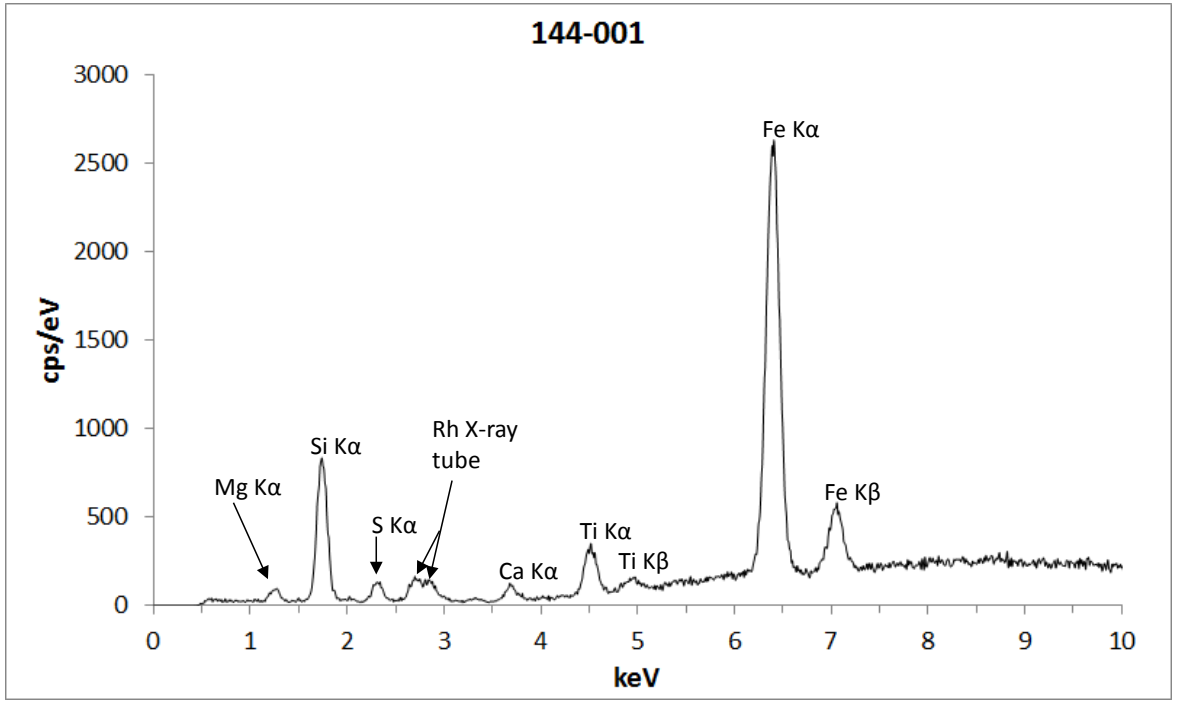
Sample: Hope Creek 144-001

This shows higher concentrations of Fe compared to **Blank** (right-side table).

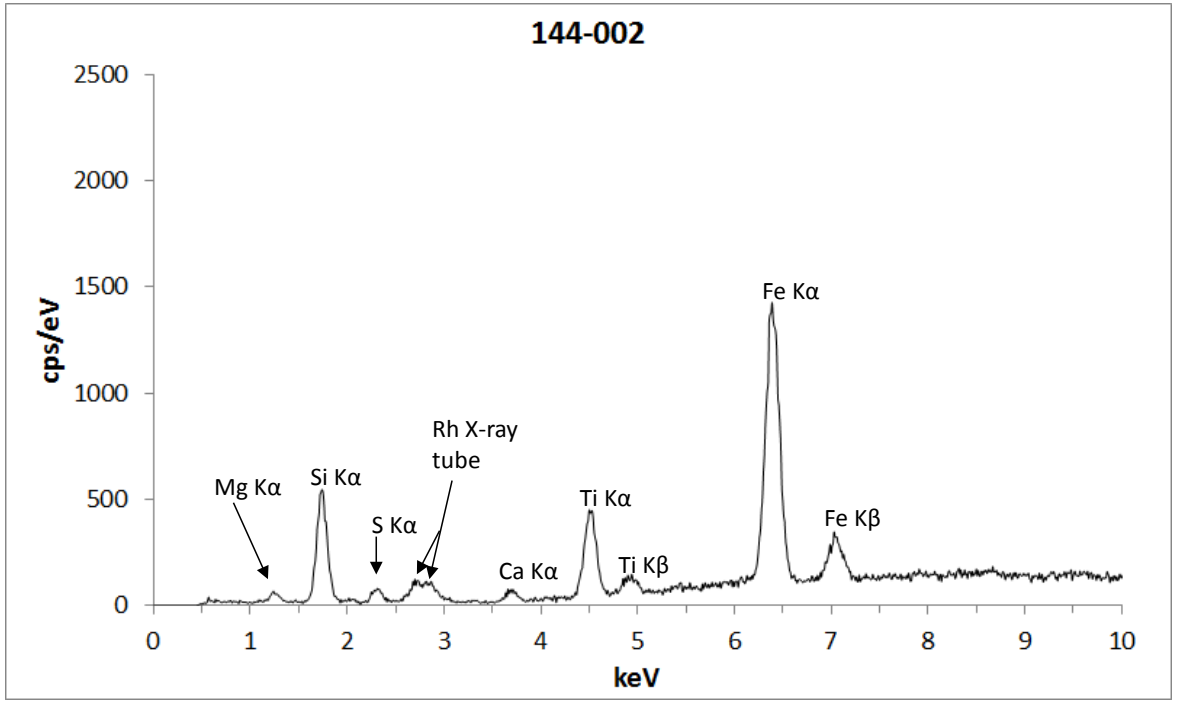
Sample: Hope Creek 144-002

This shows higher concentrations of Fe compared to **Blank** (right-side table).

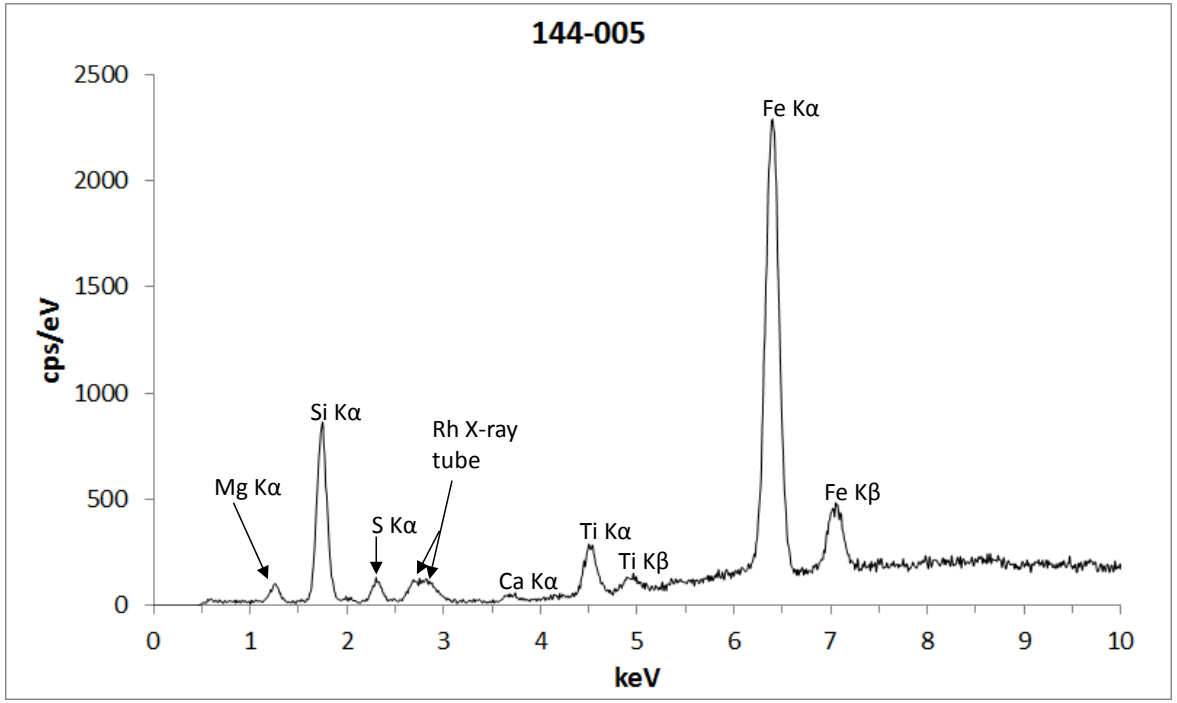
Sample: Hope Creek 144-005

This shows higher concentrations of Fe compared to **Blank** (right-side table).

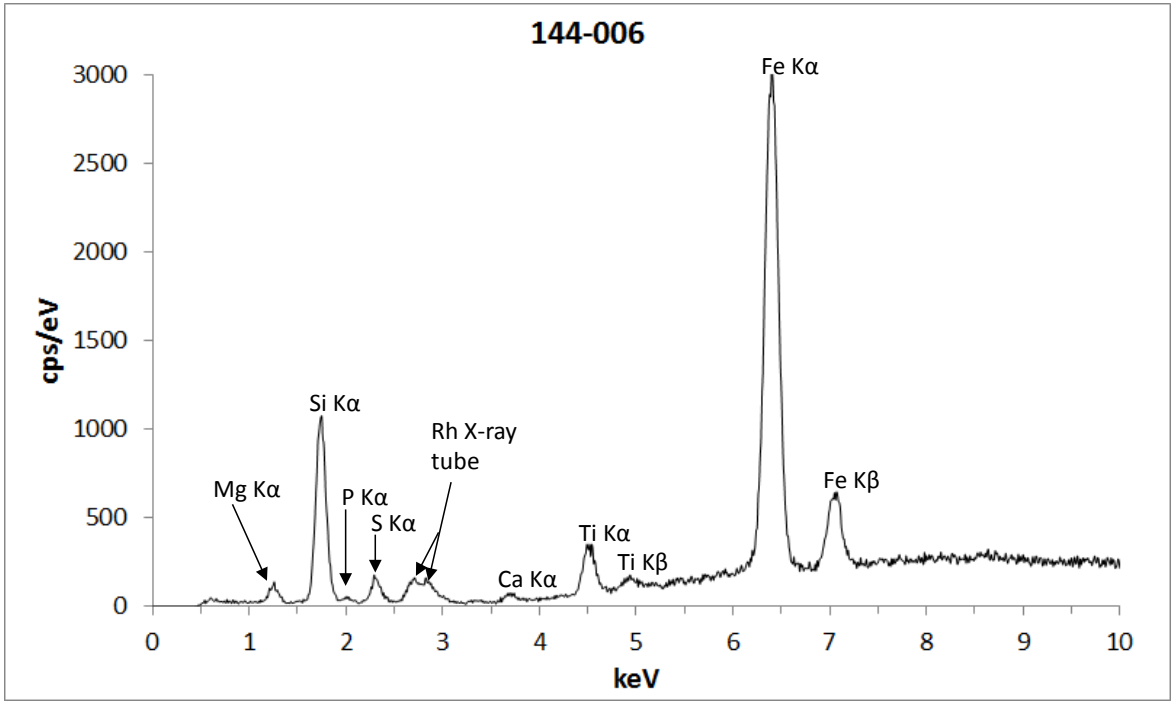
Sample: Hope Creek 144-006

This shows higher concentrations of Fe compared to **Blank** (right-side table).

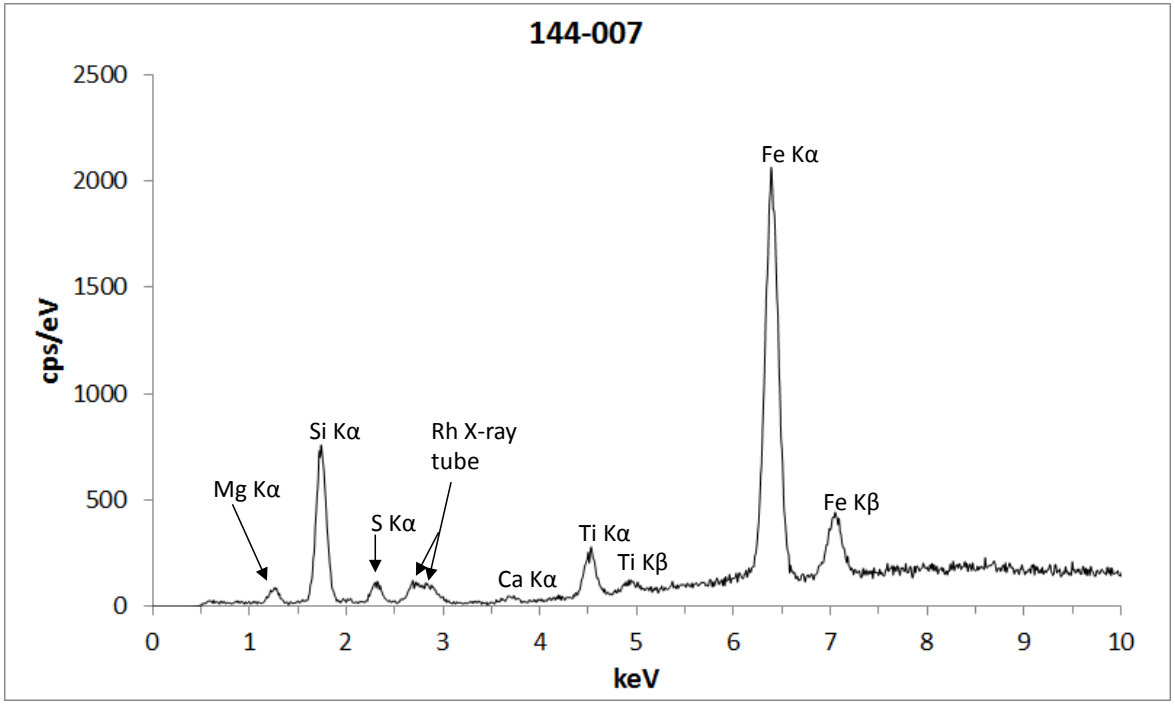
Sample: Hope Creek 144-007

This shows higher concentrations of Fe compared to **Blank** (right-side table).

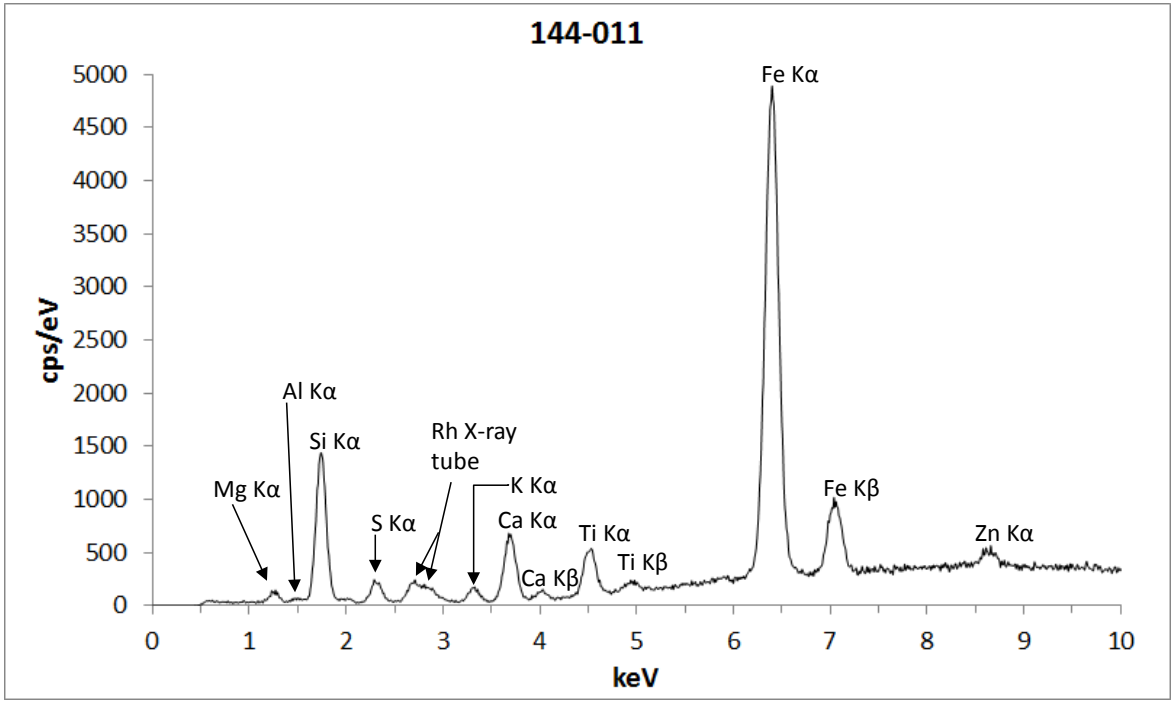
Sample: Hope Creek 144-011

Canister top samples. For samples from the tops of the canisters, where the salt loads are higher, there is a clear X-ray contribution from the dust on the filters. Results for Hope Creek sample 144-011 are shown in Figure 44. Relative to the blank, several elements are significantly enriched, including Fe, Si, Zn, Ca, K, and S. The enrichment in Fe is consistent with the SEM observations of abundant stainless steel particles and Fe-oxides in the dust; and that of Si is consistent with the observations of abundant quartz and aluminosilicate minerals. Although Zn-rich particles, apparently from the paint on the outside of the overpacks, were only rarely observed, they are apparently the source of the Zn X-ray peak shown here. Minerals containing Ca, K, and S (as sulfate) were observed by SEM, and these elements comprise a large fraction of the soluble salts extracted from the pads (Section 3.3). These results are typical for the Hope Creek canister top samples.

This shows higher concentrations of Fe compared to **Blank** (right-side table).

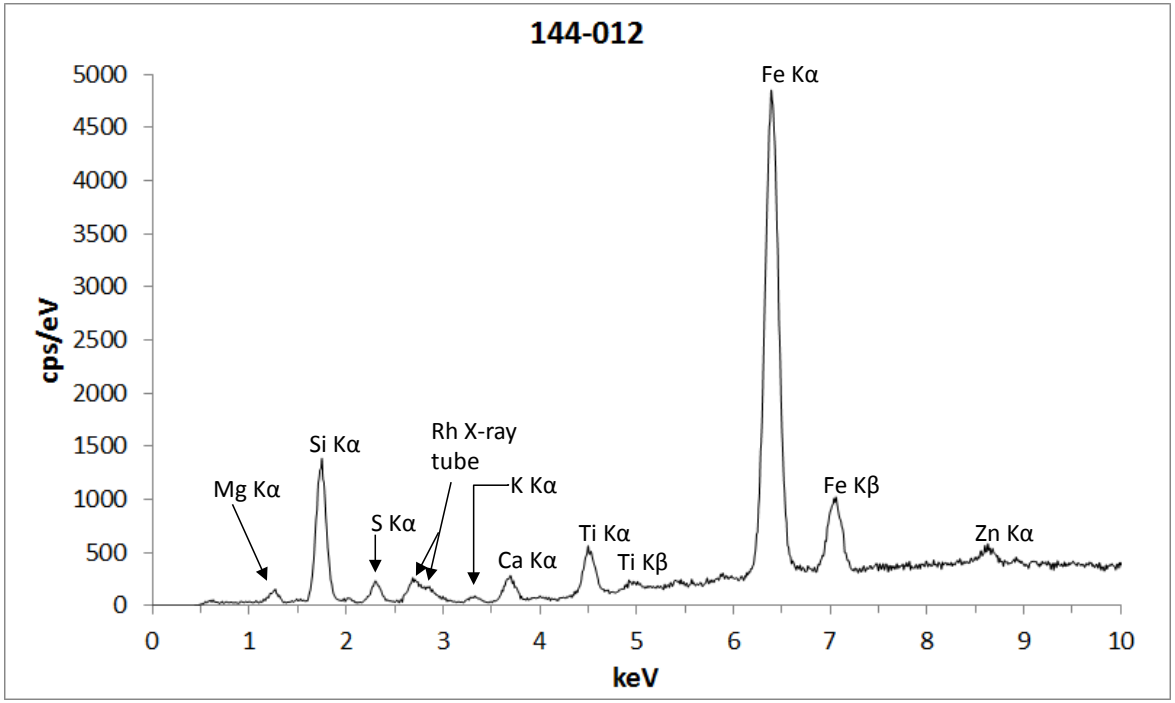
Sample: Hope Creek 144-012

This shows higher concentrations of Fe compared to **Blank** (right-side table).

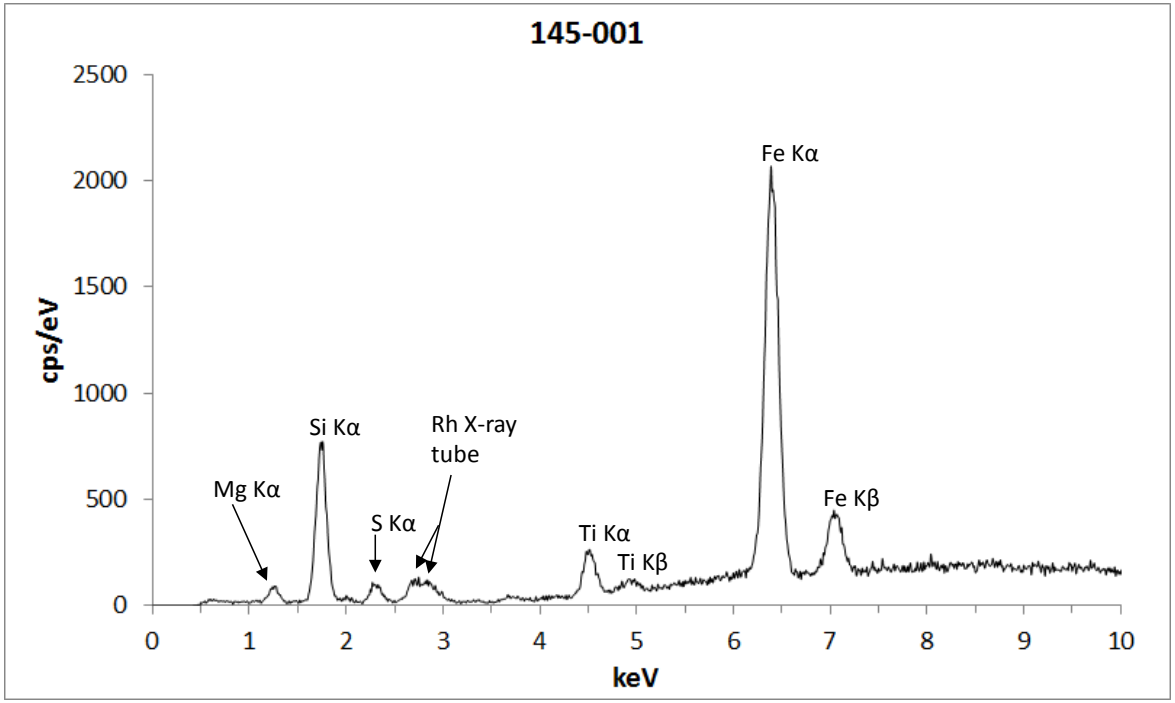
Sample: Hope Creek 145-001

This shows higher concentrations of Fe compared to **Blank** (right-side table).

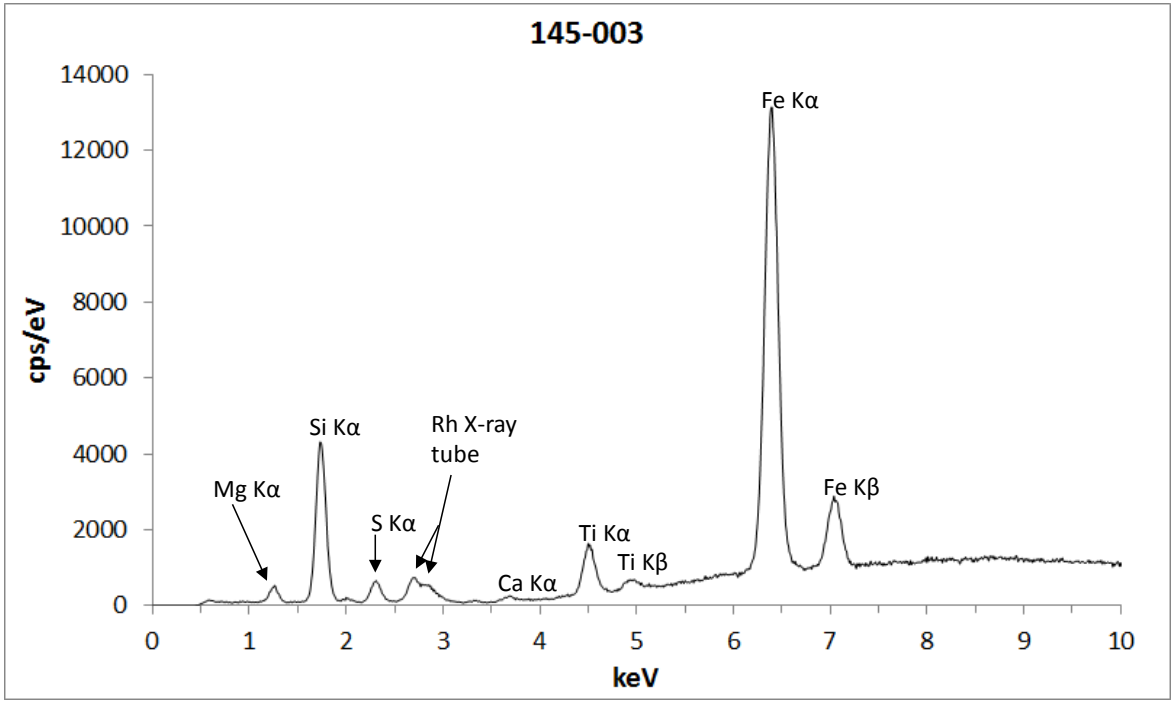
Sample: Hope Creek 145-003

This shows higher concentrations of Fe compared to **Blank** (right-side table).

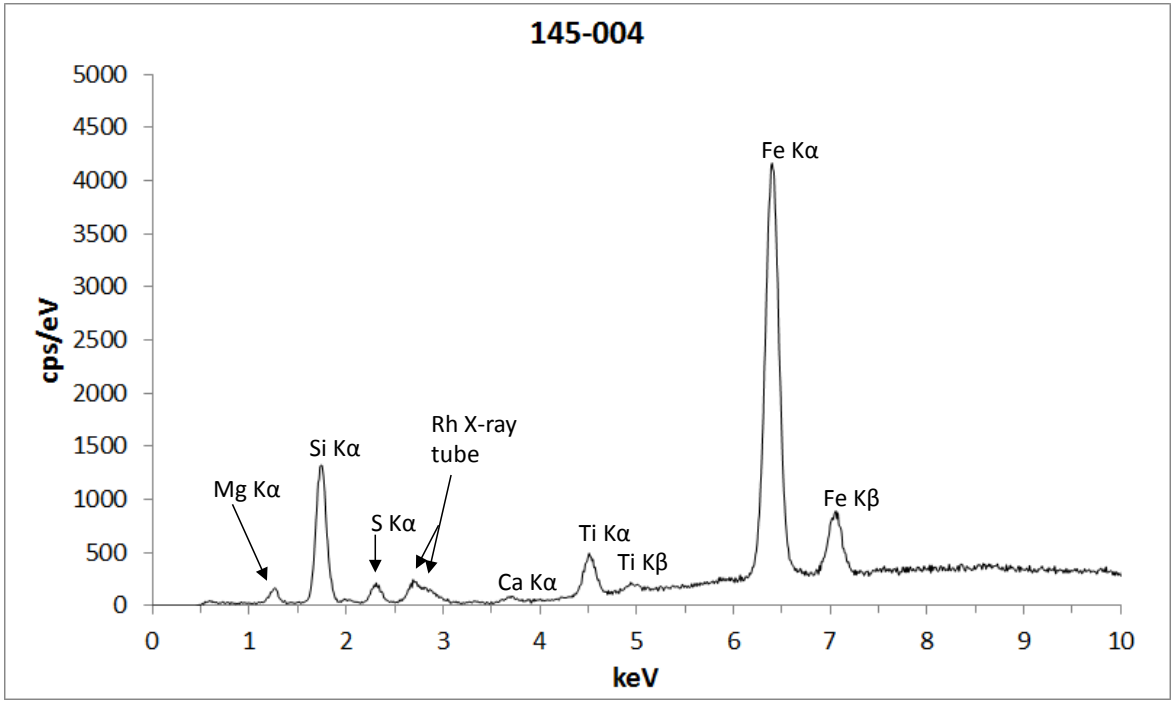
Sample: Hope Creek 145-004

This shows higher concentrations of Fe compared to **Blank** (right-side table).

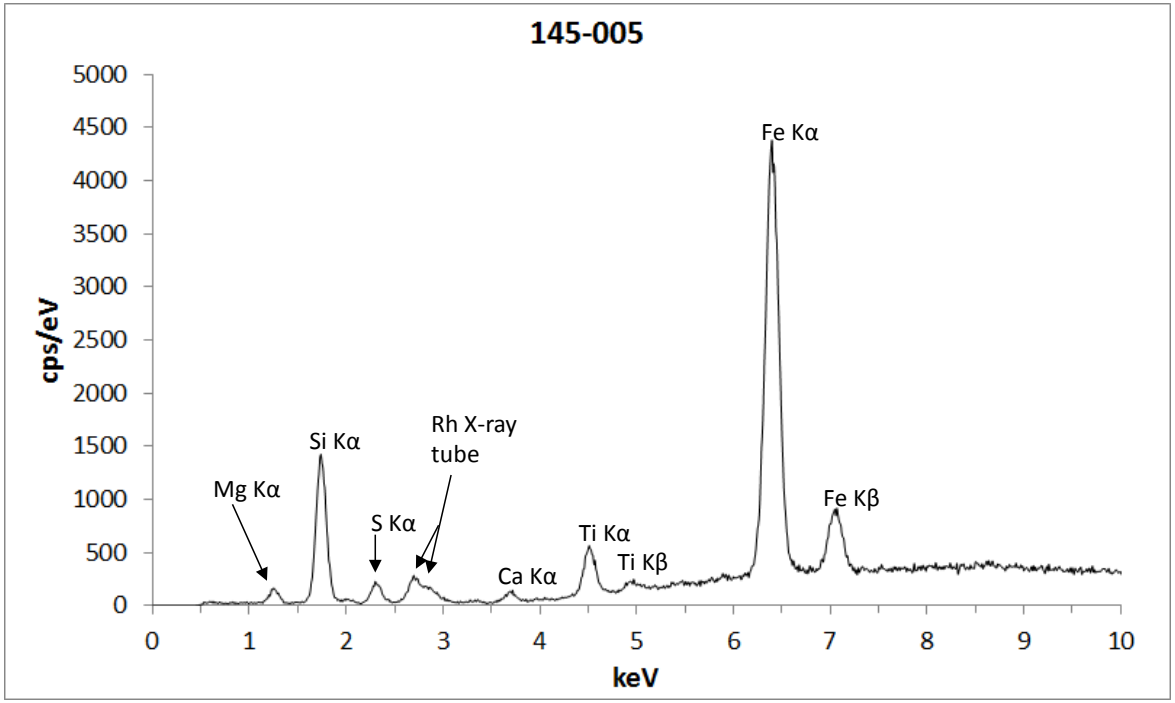
Sample: Hope Creek 145-005

This shows higher concentrations of Fe compared to **Blank** (right-side table).

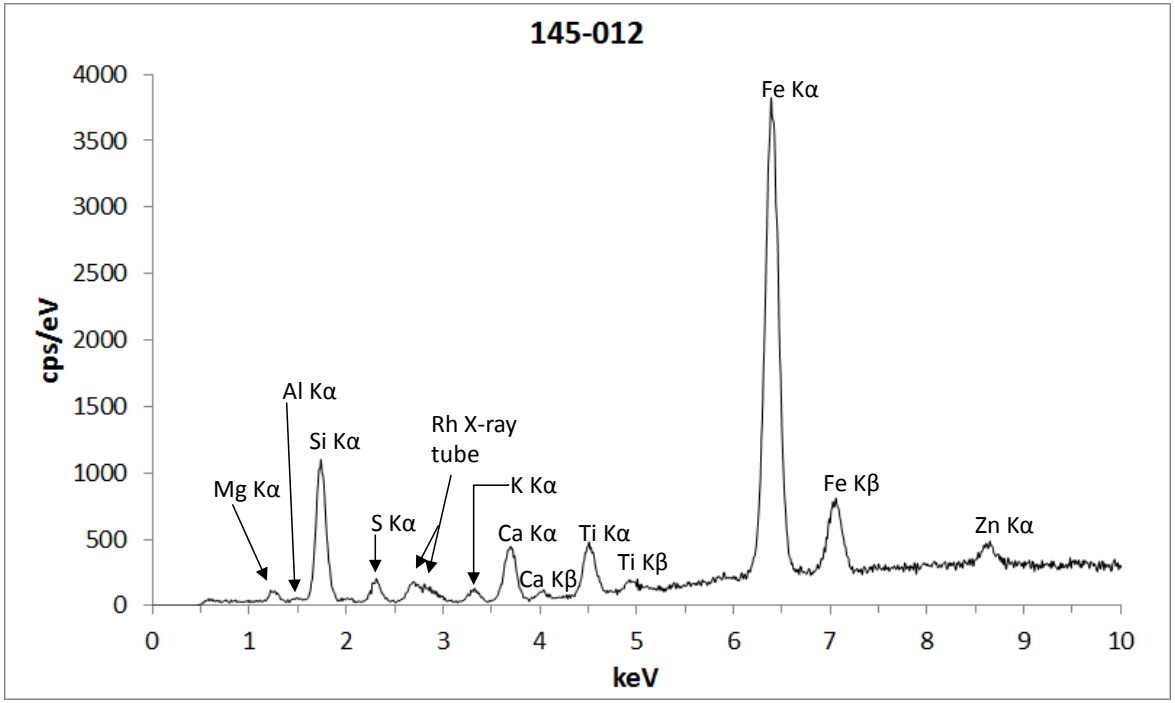
Sample: Hope Creek 145-012

This shows higher concentrations of Fe compared to **Blank** (right-side table).

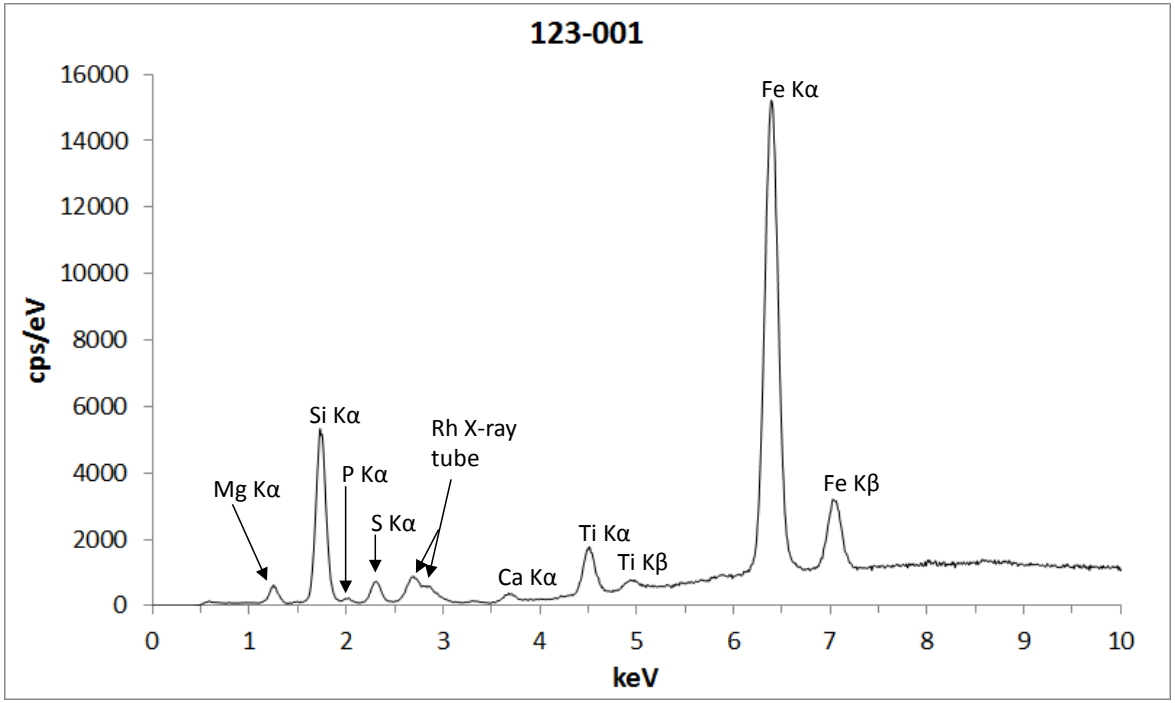
Sample: Diablo Canyon 123-001

This shows higher concentrations of Fe compared to **Blank** (right-side table).

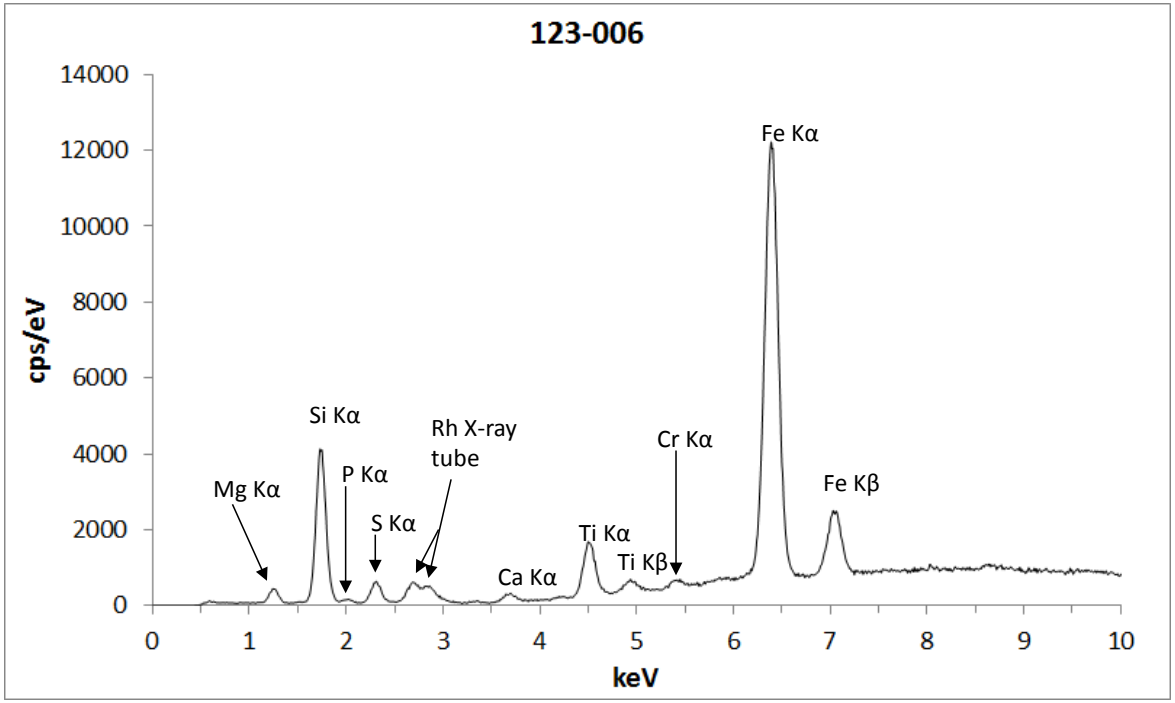
Sample: Diablo Canyon 123-006

This shows higher concentrations of Fe compared to **Blank** (right-side table).

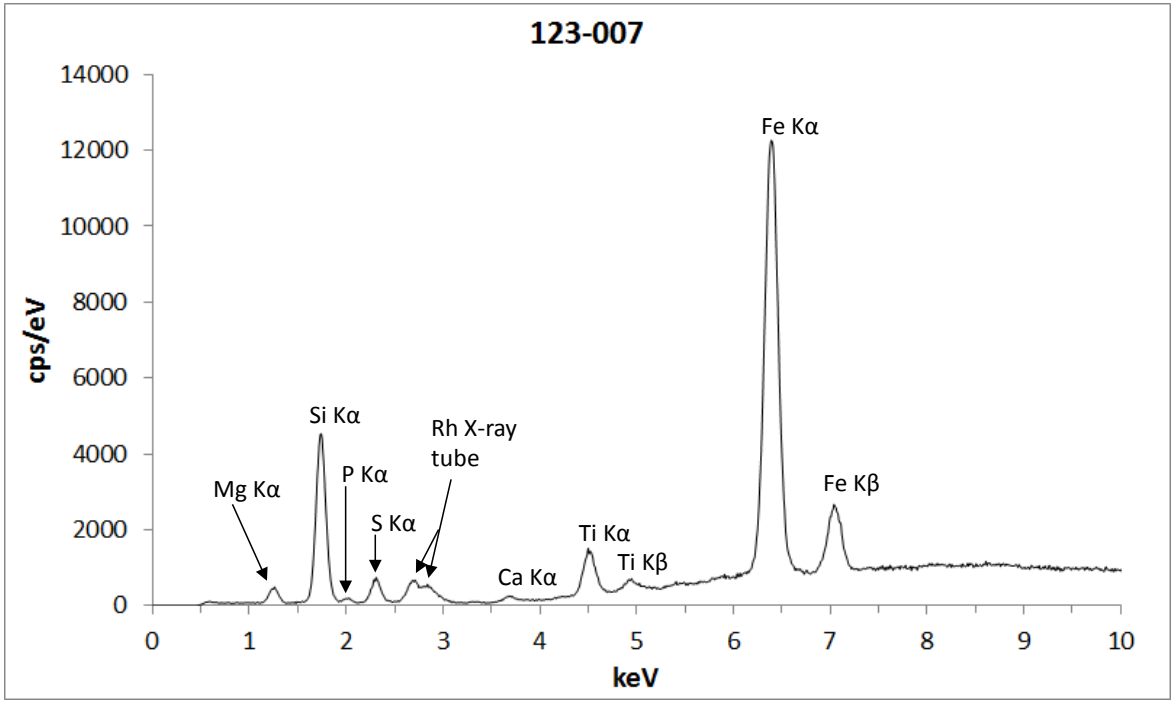
Sample: Diablo Canyon 123-007

This shows higher concentrations of Fe compared to **Blank** (right-side table).

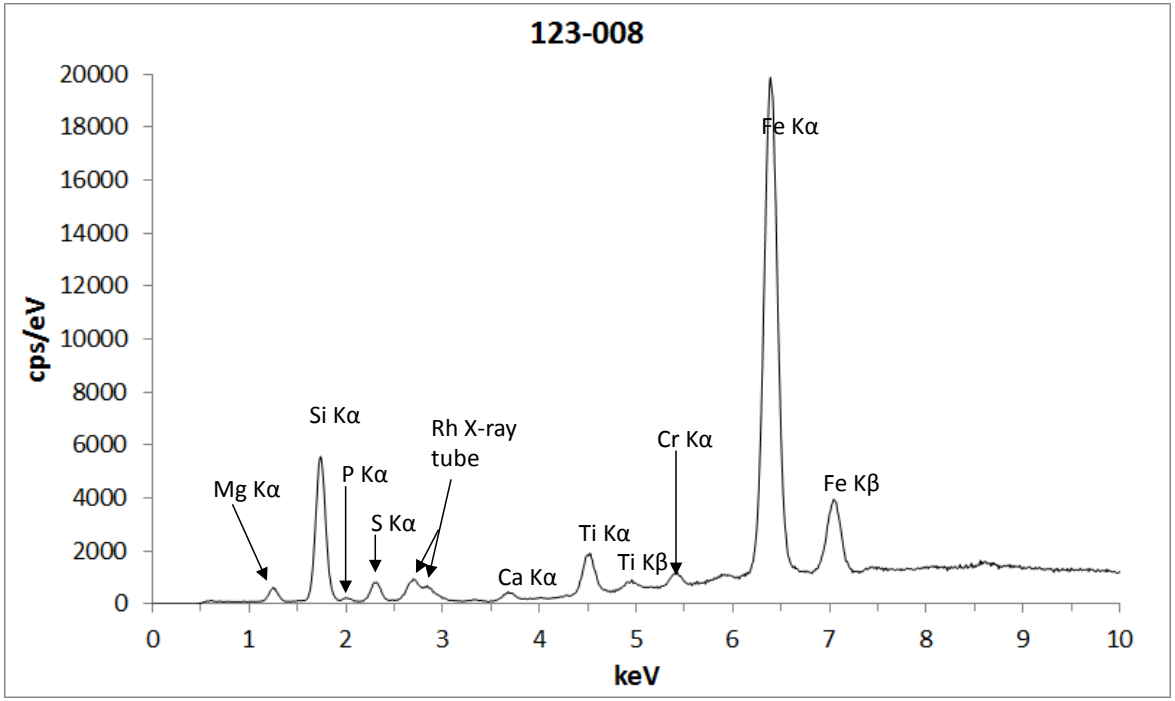
Sample: Diablo Canyon 123-008

This shows higher concentrations of Fe compared to **Blank** (right-side table).

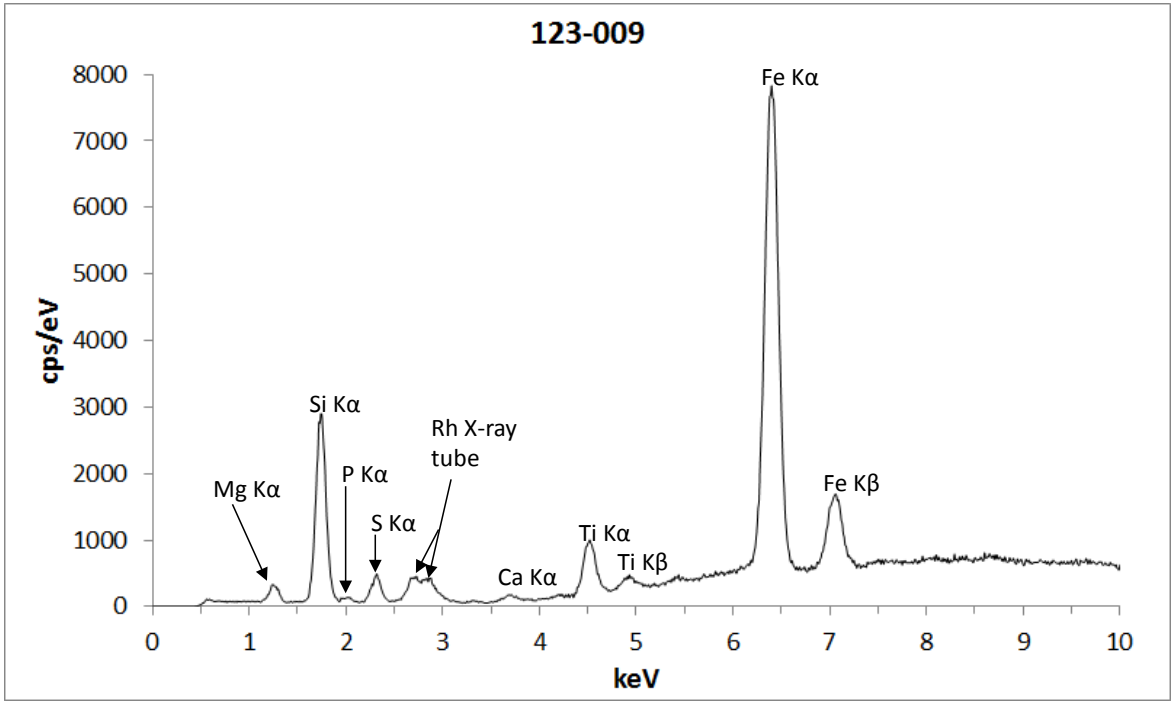
Sample: Diablo Canyon 123-009

This shows higher concentrations of Fe compared to **Blank** (right-side table).

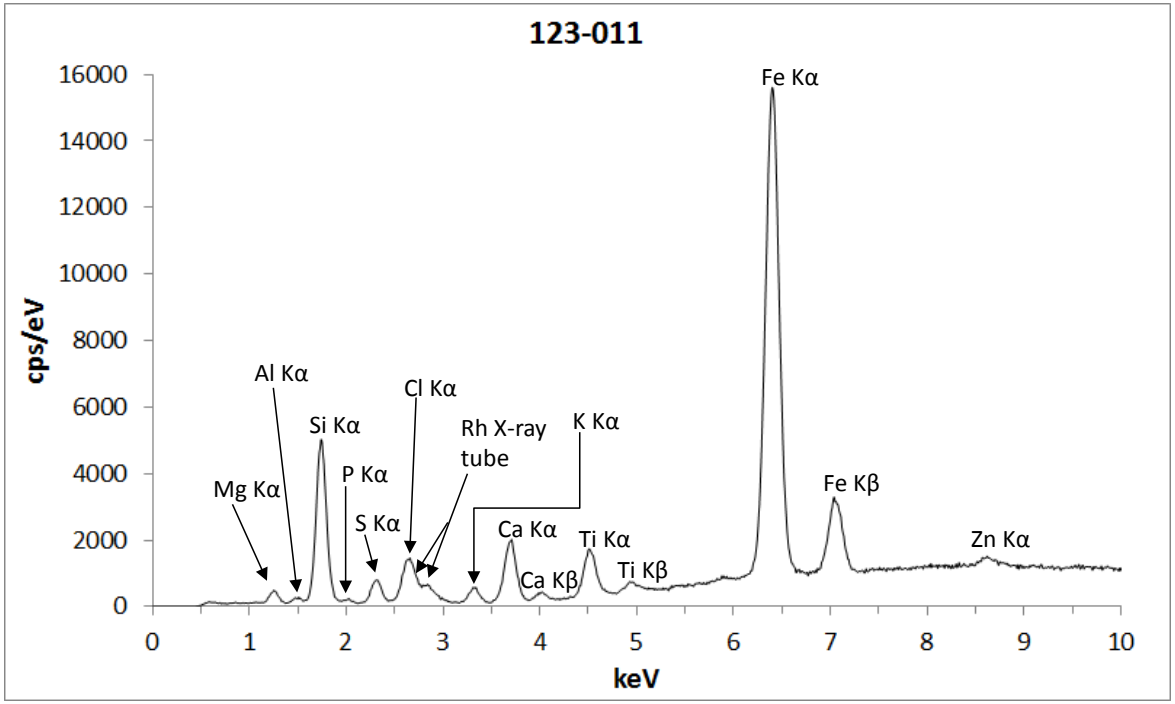
Sample: Diablo Canyon 123-011

This shows higher concentrations of Fe compared to **Blank** (right-side table).

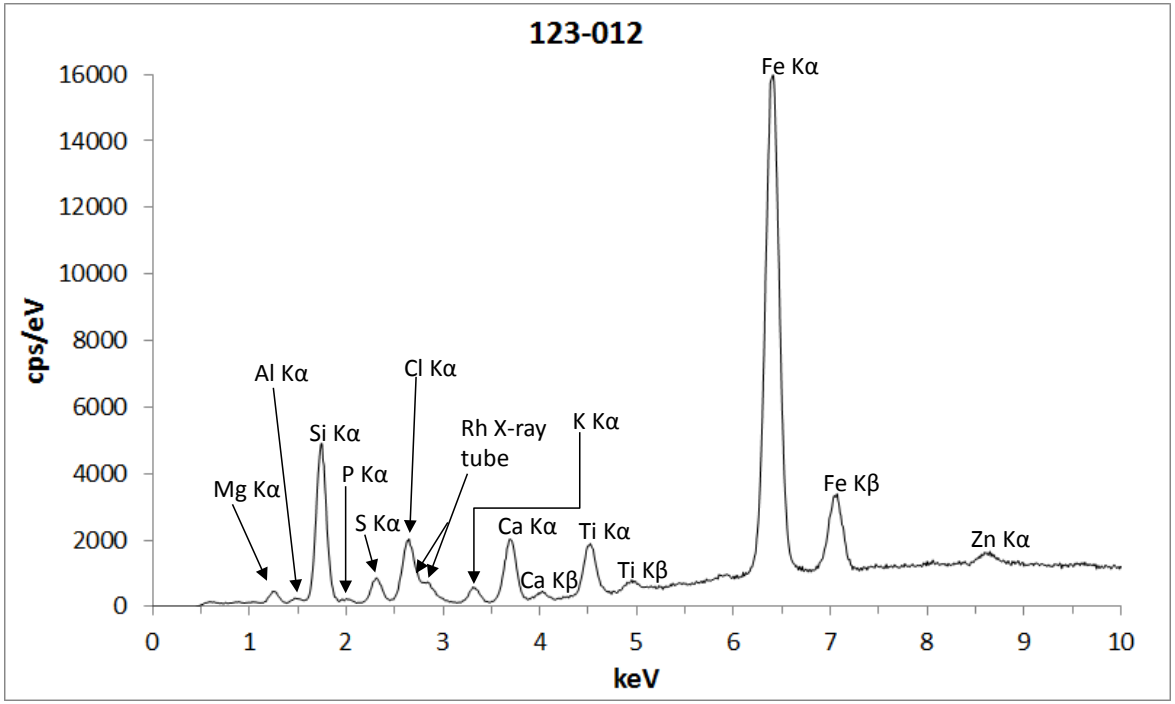
Sample: Diablo Canyon 123-012

This shows higher concentrations of Fe compared to **Blank** (right-side table).

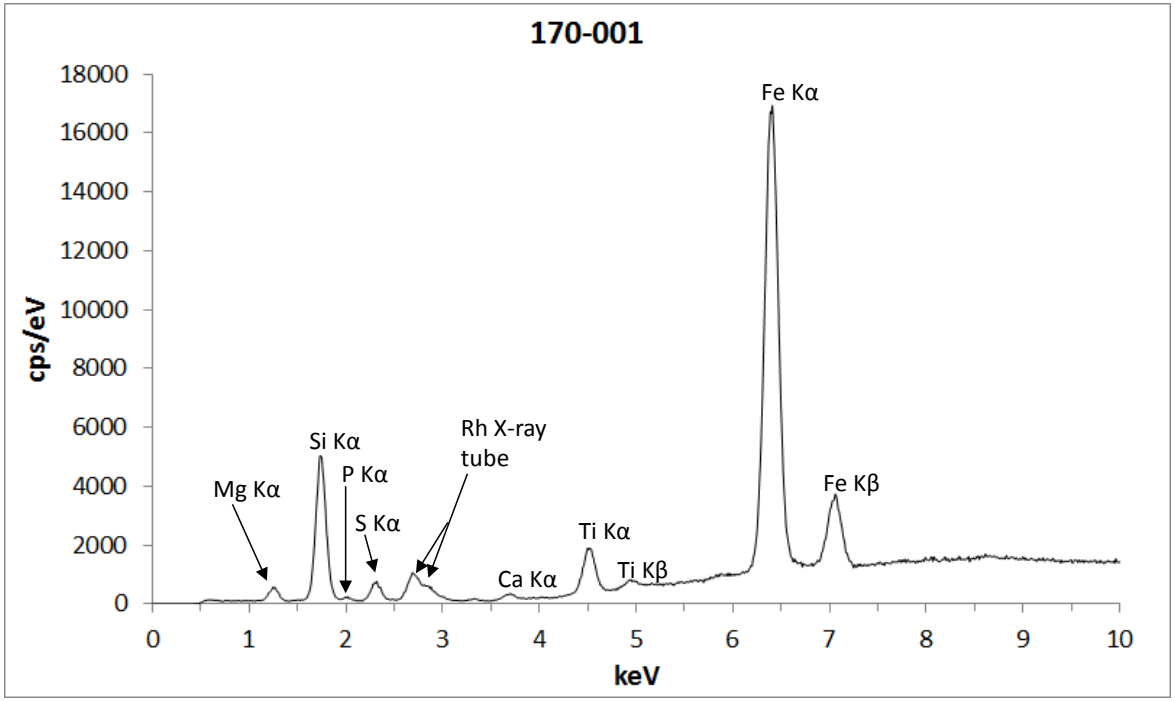
Sample: Diablo Canyon 170-001

This shows higher concentrations of Fe compared to **Blank** (right-side table).

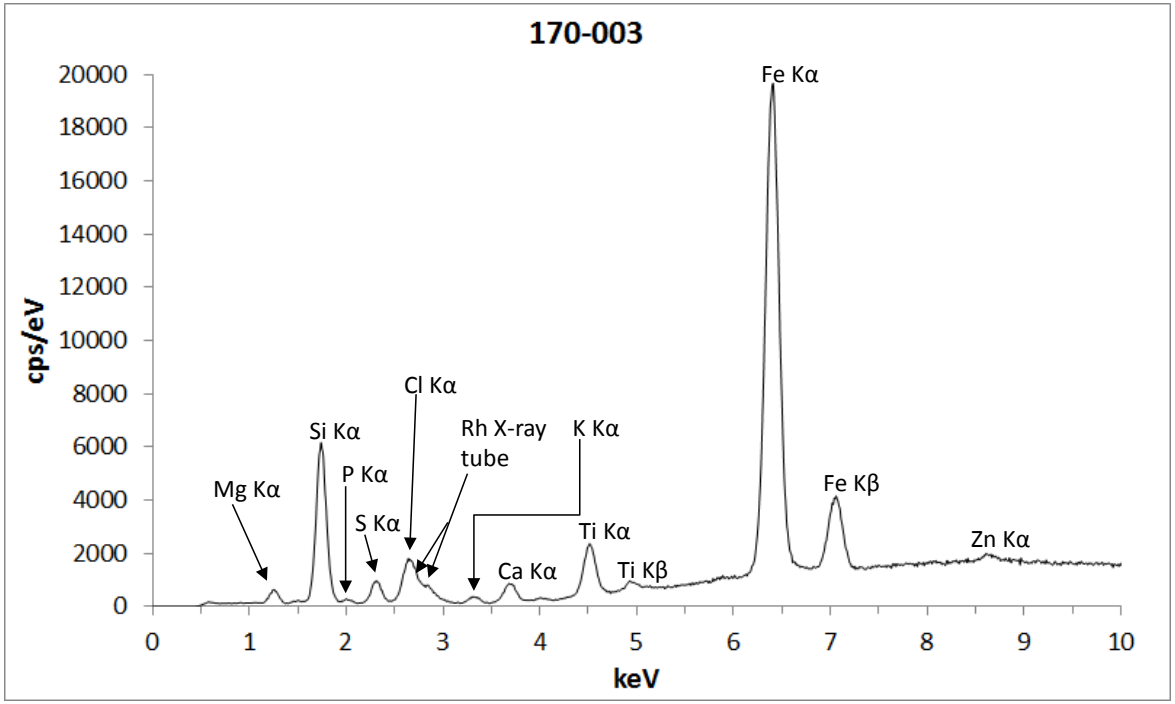
Sample: Diablo Canyon 170-003

This shows higher concentrations of Fe compared to **Blank** (right-side table).

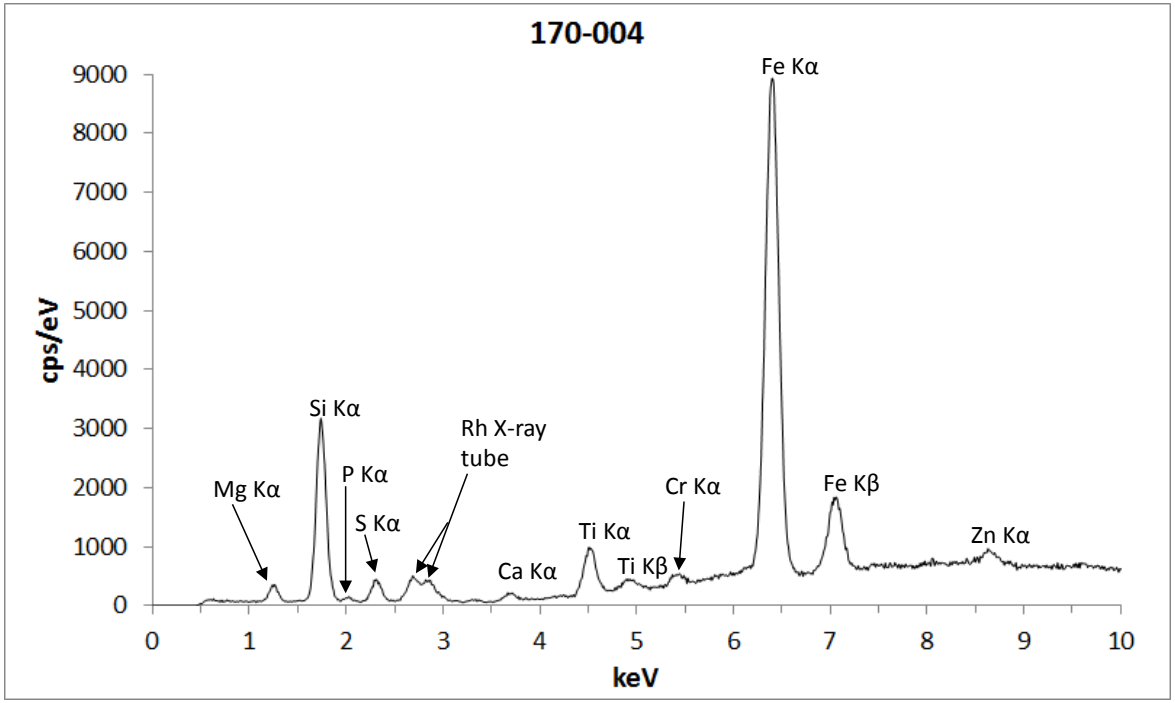
Sample: Diablo Canyon 170-004

This shows higher concentrations of Fe compared to **Blank** (right-side table).

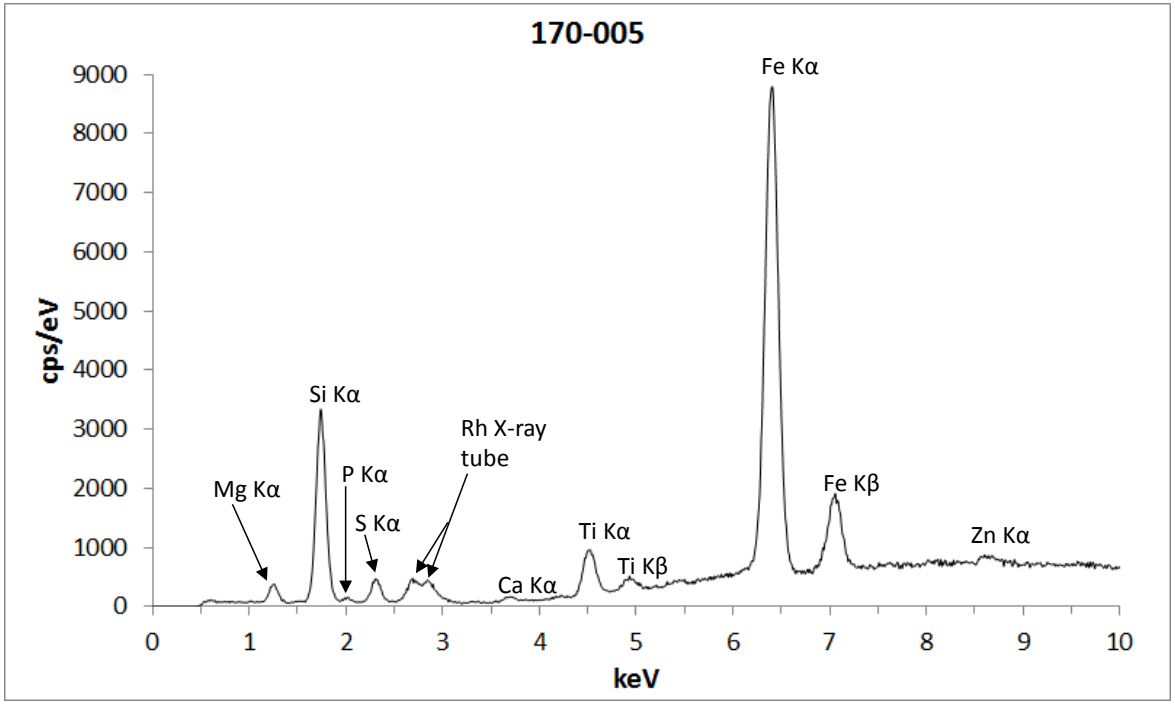
Sample: Diablo Canyon 170-005

This shows higher concentrations of Fe compared to **Blank** (right-side table).

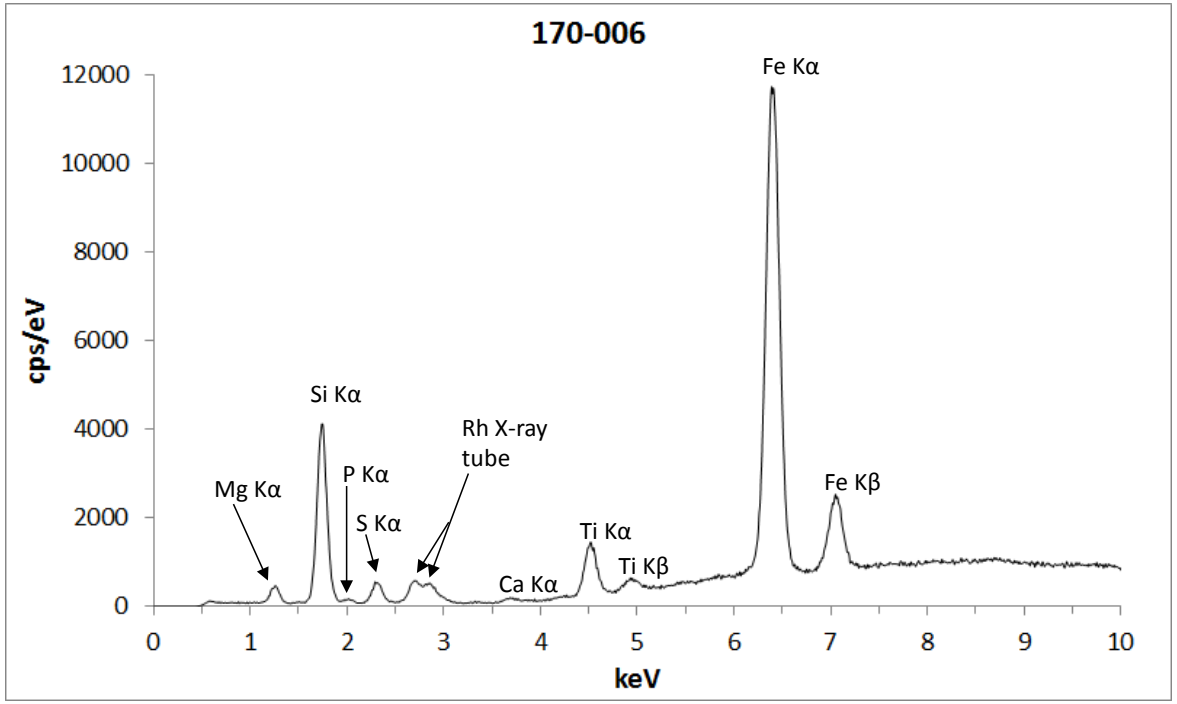
Sample: Diablo Canyon 170-006

This shows higher concentrations of Fe compared to **Blank** (right-side table).
