***Sister Rod
Nondestructive
Examination
Annual Report FY2017***

***Prepared for
US Department of Energy
Spent Fuel and Waste Science and
Technology***

***September 15, 2017
SFWD-SFWST-2017-000003
ORNL/SPR-2017/484***

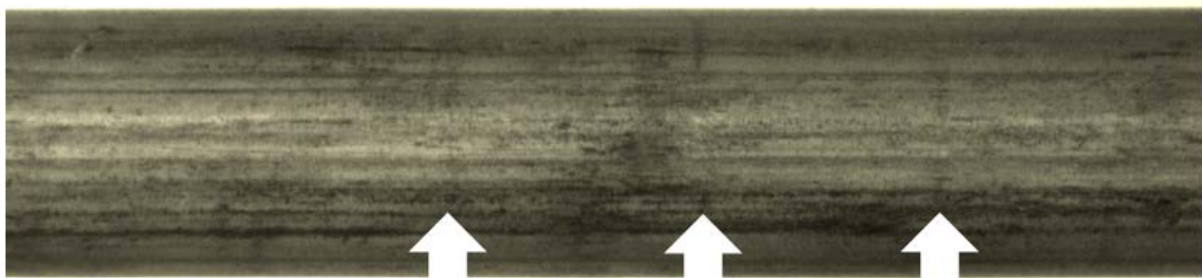
For the Zircaloy-4 (Zirc-4), low tin (LT) Zirc-4, and ZIRLO fuel rods, when the parent fuel assembly was fabricated, the fuel rods were pulled or pushed through the spacer grids with the springs/dimples engaged. Interaction with the spacer grid springs and dimples during rod insertion can produce long, shallow axial scratches along much of the rod's length at the azimuthal locations of the grid springs/dimples. These are visible on the rod as oxidized scratches, as shown in Figure 3. Likewise, in many cases, interaction with the spacer grid springs and dimples during rod removal created long axial scratches along much of the rod length at orthogonal locations (consistent with the location of the grid springs/dimples), removing surface CRUD and perhaps some oxide. In contrast, the M5 fuel rods were inserted into the assembly using a method called "keying" in which the springs and dimples are depressed to prevent scratching of the cladding during assembly fabrication. Therefore, it is likely that any axial scratches observed on the M5 rods occurred during rod removal.

Figure 3. Typical Appearance of Orthogonal Longitudinal Scratches Consistent with Spacer Grid Spring/Dimple Interaction during Rod Insertion and Withdrawal from the Fuel Assembly.

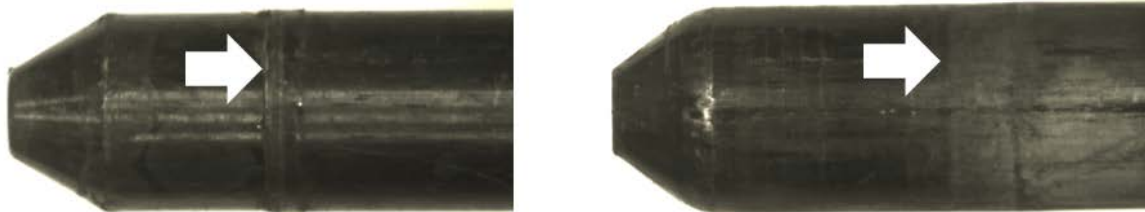
The pellet-pellet interfaces are frequently visible in the images as circumferential dark stripes, as illustrated in Figure 4. During in-reactor operation, the cladding at the pellet-pellet interface is slightly cooler, and hydrogen is known to migrate to these cooler regions. Also, oxidation is slightly lower at the cooler pellet-pellet interfaces. The combination of these two effects creates a band of deeper coloration at the pellet-pellet interfaces. End cap welds are also clearly visible, as illustrated in Figure 5.

Figure 4. Example of Circumferential Striping at Pellet-Pellet Interfaces (6U3P16).

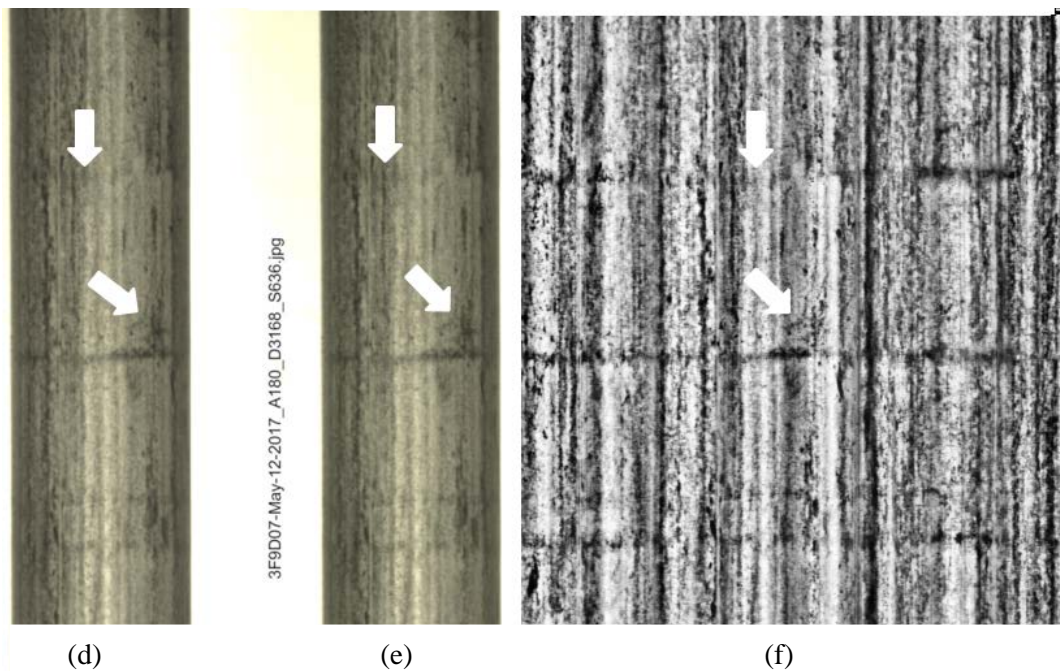
Due to their dark matte black appearance, it is difficult to detect features on the surface of the M5 rods using the interactive images or the raw images. As an illustration, Figure 7(a)(b)(c) shows side by side images of the same rod with an elevation and rotation having a burnishing mark (a very shallow fretting wear mark). The burnishing mark is clearly visible in the flattened and contrast filtered collage, but it is barely discernible in the SWF format. Features on the Zirc-4, LT Zirc-4, and ZIRLO rods are also generally more discernible in the flattened collage format, as well, but some features can become less apparent due to the large format and high contrast filtering used, as illustrated in Figure 7(d)(e)(f).

On the matte black M5 rods above, features such as the fretting mark (as indicated by the arrow) and the circular patches of oxidation become more visible.

On the shiny grey surfaces of the Zirc-4, LT Zirc-4 and Zirlo rods, the flattened and filtered image can make some features such as the pellet-pellet boundaries more visible, while some features, such as the dark patch highlighted with the arrow, become indistinct.

Figure 7. Illustration of Visible Features on an M5 Sister Rod using (a) the Unprocessed Individual Photo, (b) the Interactive SWF, and (c) the Flattened and Filtered Collage and a ZIRLO Sister Rod using (d) the Unprocessed Individual Photo, (e) the Interactive SWF, and (f) the Flattened and Filtered Collage.

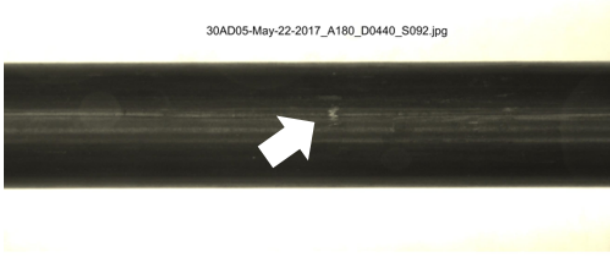
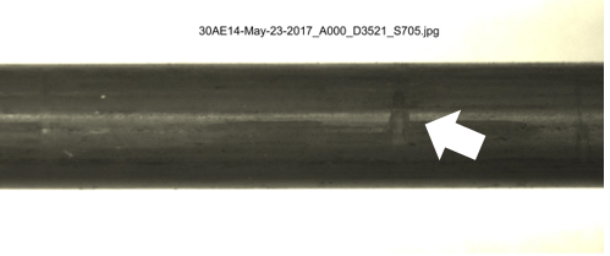
Figure 8 and Figure 9 provide a summary of images representative of the M5 visible features. The M5 rods typically exhibited very light waterside oxide visible in the majority of the images as irregular, somewhat circular patches. Some areas also include an interior circular patch that appears to have peeling oxide, as illustrated in Figure 9(i). Some shallow GTRF marks are visible, along with rod removal scratches. Some localized areas of the M5 rods have thin CRUD layers, presenting with the appearance of a peeling thin skin, as shown in Figure 9(a) and (b). Most of the M5 rods have shallow-to-moderate GTRF marks at the axial locations corresponding to the spacer grid elevations. Also, since not all of the spacer grids in the AREVA-designed assemblies are fixed axially, some GTRF marks have an extended length, as shown in Figure 8(e).

(a) Shallow GTRF.	(b) Shallow GTRF.

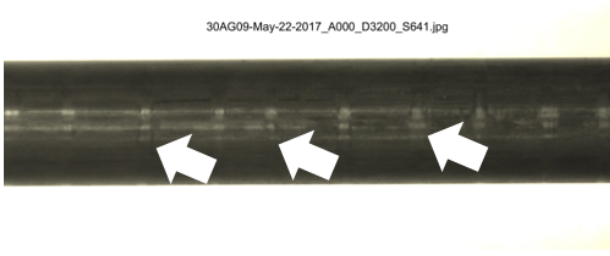
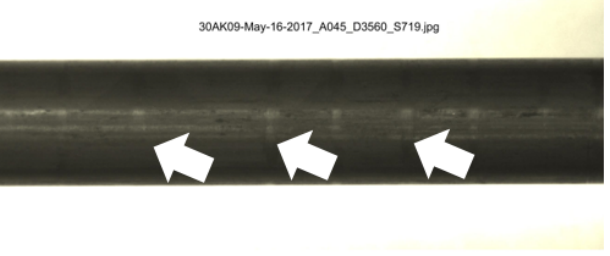
(c) Possible handling marks.	(d) Possible handling marks.

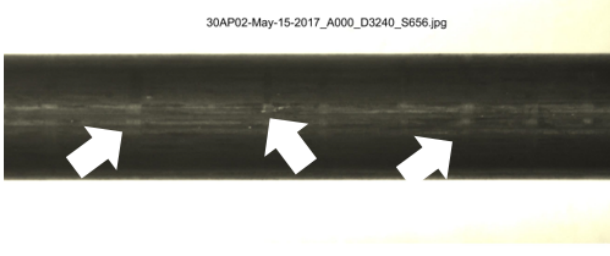
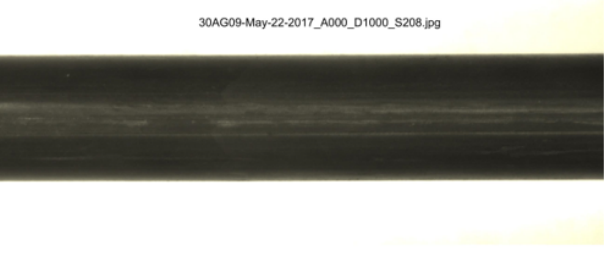
(e) Possible handling marks and a shallow GTRF mark.	(f) Region identified in profilometry as having a slightly increased diameter as compared with adjacent sections of the rod; however, no unusual features are visible.

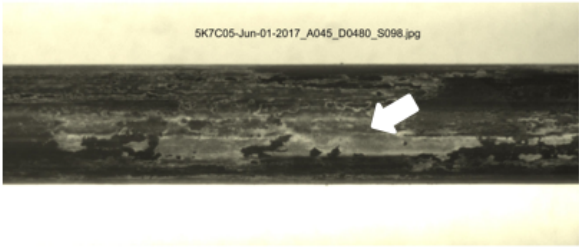
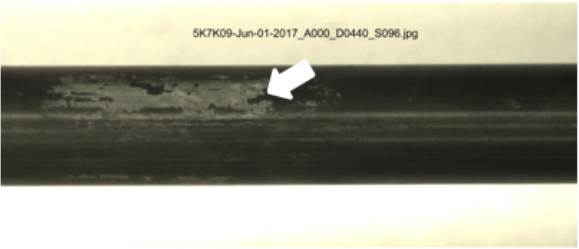
<p>(a) Localized CRUD peeling.</p>	<p>(b) Localized CRUD peeling.</p>

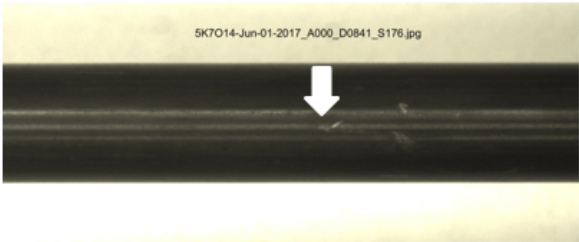
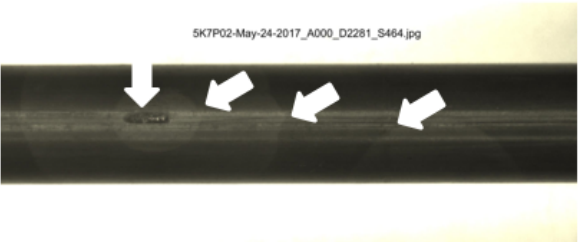
<p>(c) Shallow GTRF</p>	<p>(d) Shallow GTRF with light oxidation in circular patches.</p>

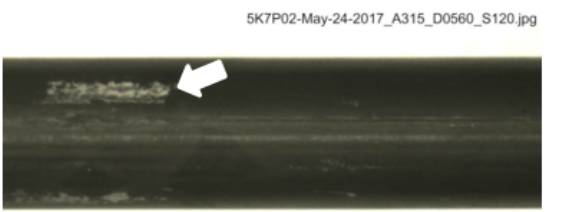
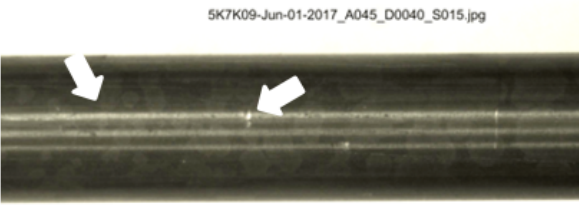
<p>(e) Extended length moderate depth GTRF mark.</p>	<p>(f) Typical light oxidation patches and manipulator scratches.</p>

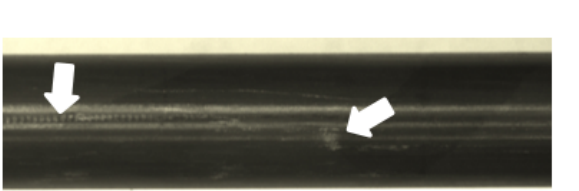
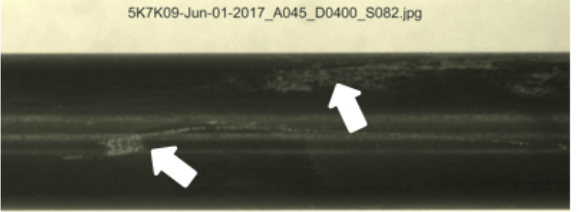
<p>A000_D2002</p>

<p>(g) Typical rod removal scratch and a shallow GTRF mark.</p>	<p>(h) Shallow GTRF with rod removal scratch and peeling CRUD.</p>

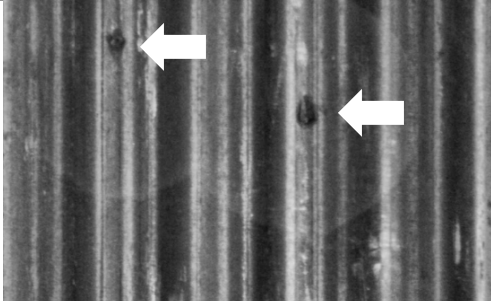
<p>(i) an example of center peeling oxide rings (note the image was extracted from a flattened collage and the axial direction of the rod is oriented perpendicular to the other images shown on this page).</p>

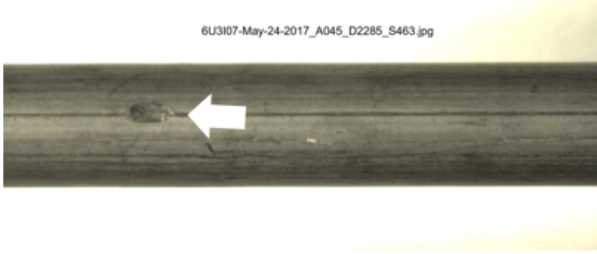
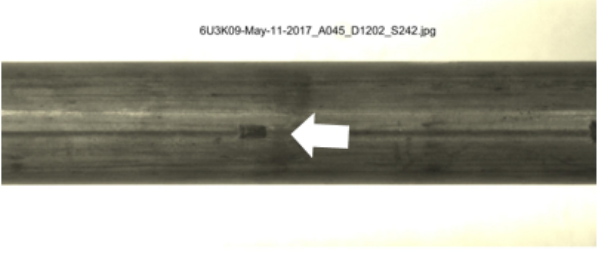
The ZIRLO-clad rods have a moderate-to-heavy oxide layer, with some oxide peeling and spalling observed. GTRF marks are present on most rods and range in severity from shallow to deep. Figures 9 to 11 illustrate these details. No visible signs of through-wall cladding damage were observed. Darker regions are present at grid elevations, indicating either CRUD or possibly a thinner oxidation layer (attributed to better heat transfer in those areas due to flow turbulence). A dark band on rod 6U3P16 is clearly a pellet-pellet gap as identified by gamma scan, as noted in Figure 11(h).

(a) Relatively deep GTRF.	(b) Moderate GTRF.

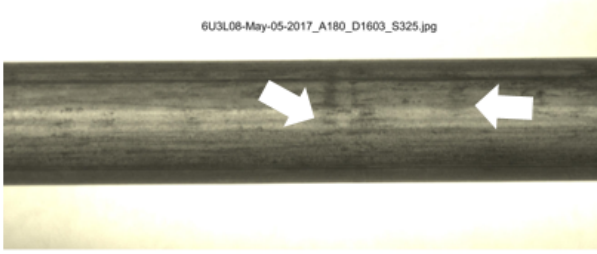
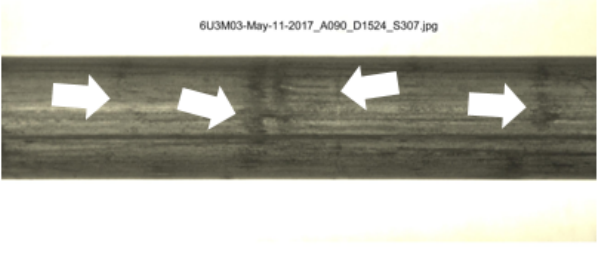
(c) Possible handling marks and pellet-pellet interface bands.	(d) Possible handling marks and pellet-pellet interface bands.

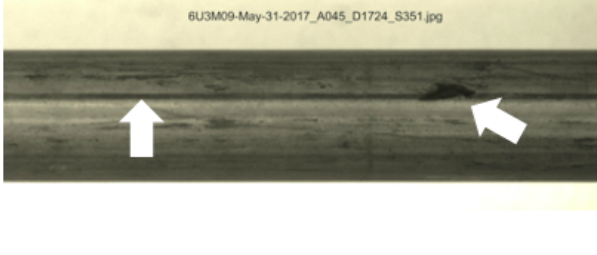
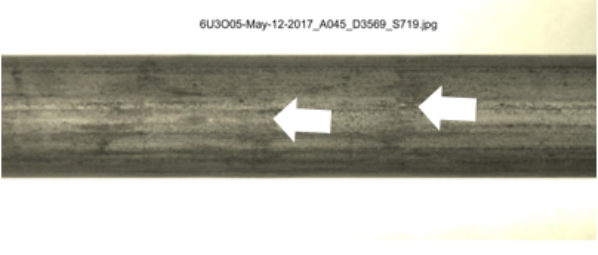
(e) Rod insertion or removal scratch with shallow GTRF.	(f) Possible handling marks.

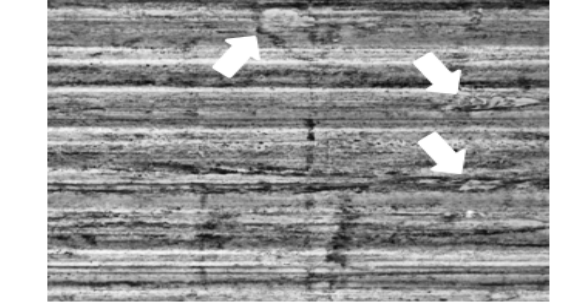
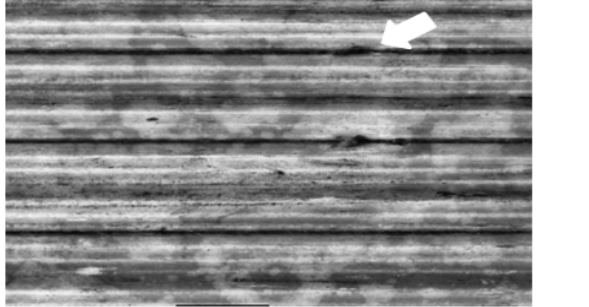
<p>(c) Moderate GTRF, completely oxidized, and a patch of locally heavy oxidation.</p>	<p>(d) Moderate GTRF.</p>

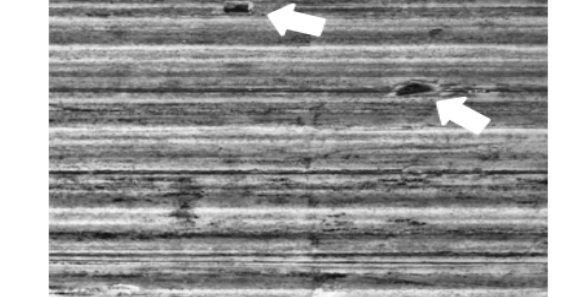
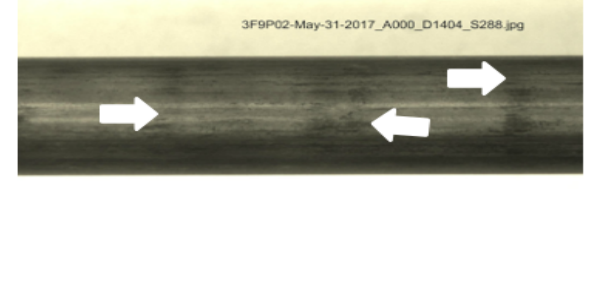
<p>(e) Moderate GTRF that likely occurred during an early cycle since the mark appears to be partially oxidized.</p>	<p>(f) Typical appearance of pellet-pellet interfaces; this section near a gamma scan-reported axial stack gap (~3 mm).</p>

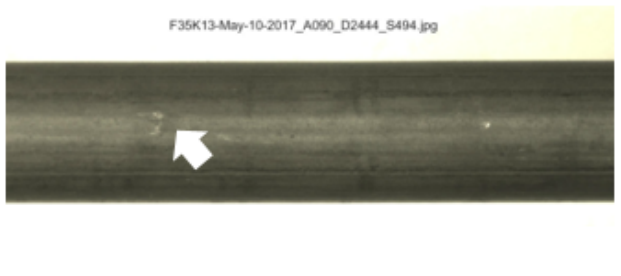
<p>F35K13-May-10-2017_A090_D2444_S494.jpg</p>

Assemblies 3A1 and F35 (Figure 13 and Figure 14) appeared to have the greatest amount of oxide buildup/spalling. No visible signs of through wall damage or large areas of clad degradation were found. A thin layer of CRUD appears to be visible in spalled regions, having the appearance of a black rim around the base of the spalled area, as shown in Figure 13(d). Some areas of significant oxidation have a flake-like appearance, as shown in 14(g) and (h).

<p>F35P17-May-08-2017_A180_D0882_S181,</p>
<p>(c) Shallow GTRF.</p>	<p>(d) Significant oxide spalling with CRUD; an indication of the oxide thickness is visible at the upper edge of the rod image.</p>

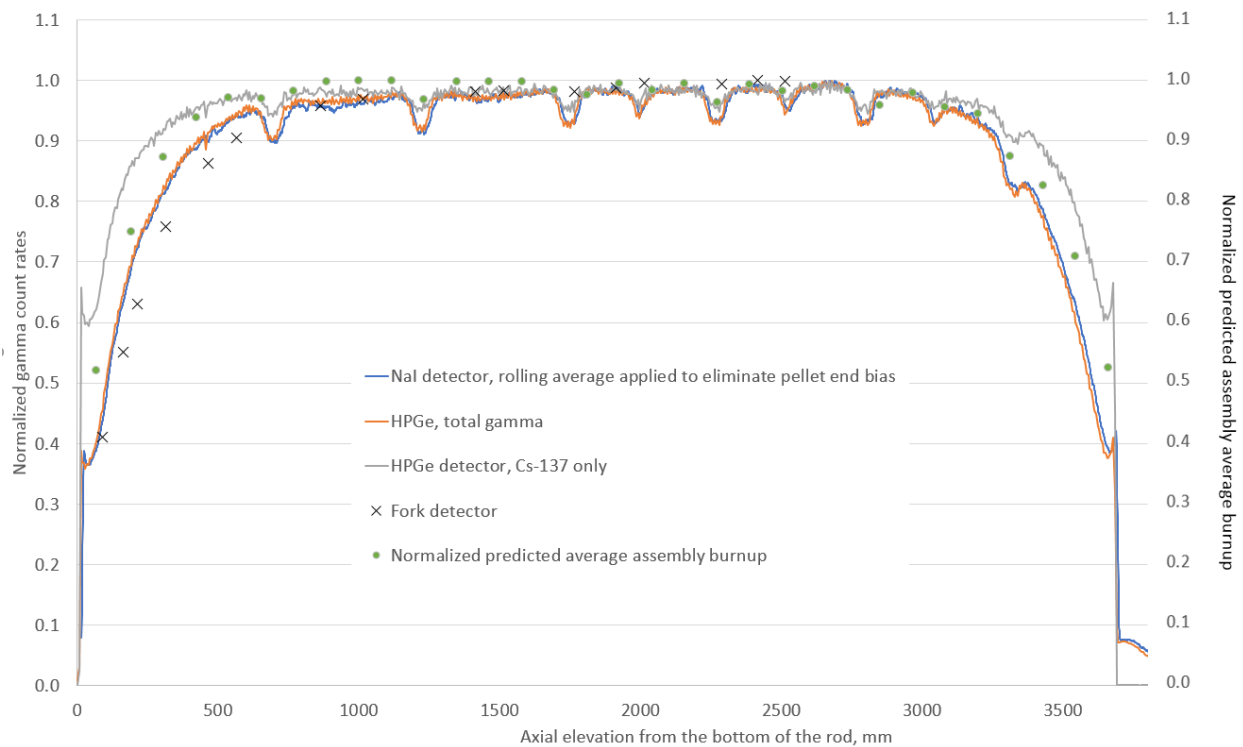
Figure 15 compares the four normalized gamma count rates data sets for sister rod 30AE14 measured using the three different detectors (the HPGe measurements include two gamma counts, ^{137}Cs and total). For reference, the normalized predicted average assembly axial burnup profile is also plotted. There is very good agreement in the general trends and locations of spacer grid burnup depressions. Up to 7% differences were observed between the fork gamma counts and the HPGe total gamma counts near the rod bottom, likely due to the fact that a collimator is not used in the fork measurement, but even so, there is good agreement between all three detectors in the higher burnup regions of the rod. Radiochemical assay of selected rod locations will provide additional definitive (within measurement uncertainty) burnup measurements.

Figure 15. Comparison of Gamma Count Rates Collected by Three Different Detectors for Sister Rod 30AE14: HPGe, fork, and NaI. The Normalized Predicted Average Assembly Axial Fuel Burnup is also Plotted for Reference.
