***Sister Rod
Nondestructive
Examination
Annual Report FY2017***

***Prepared for
US Department of Energy
Spent Fuel and Waste Science and
Technology***

***September 15, 2017
SFWD-SFWST-2017-000003
ORNL/SPR-2017/484***

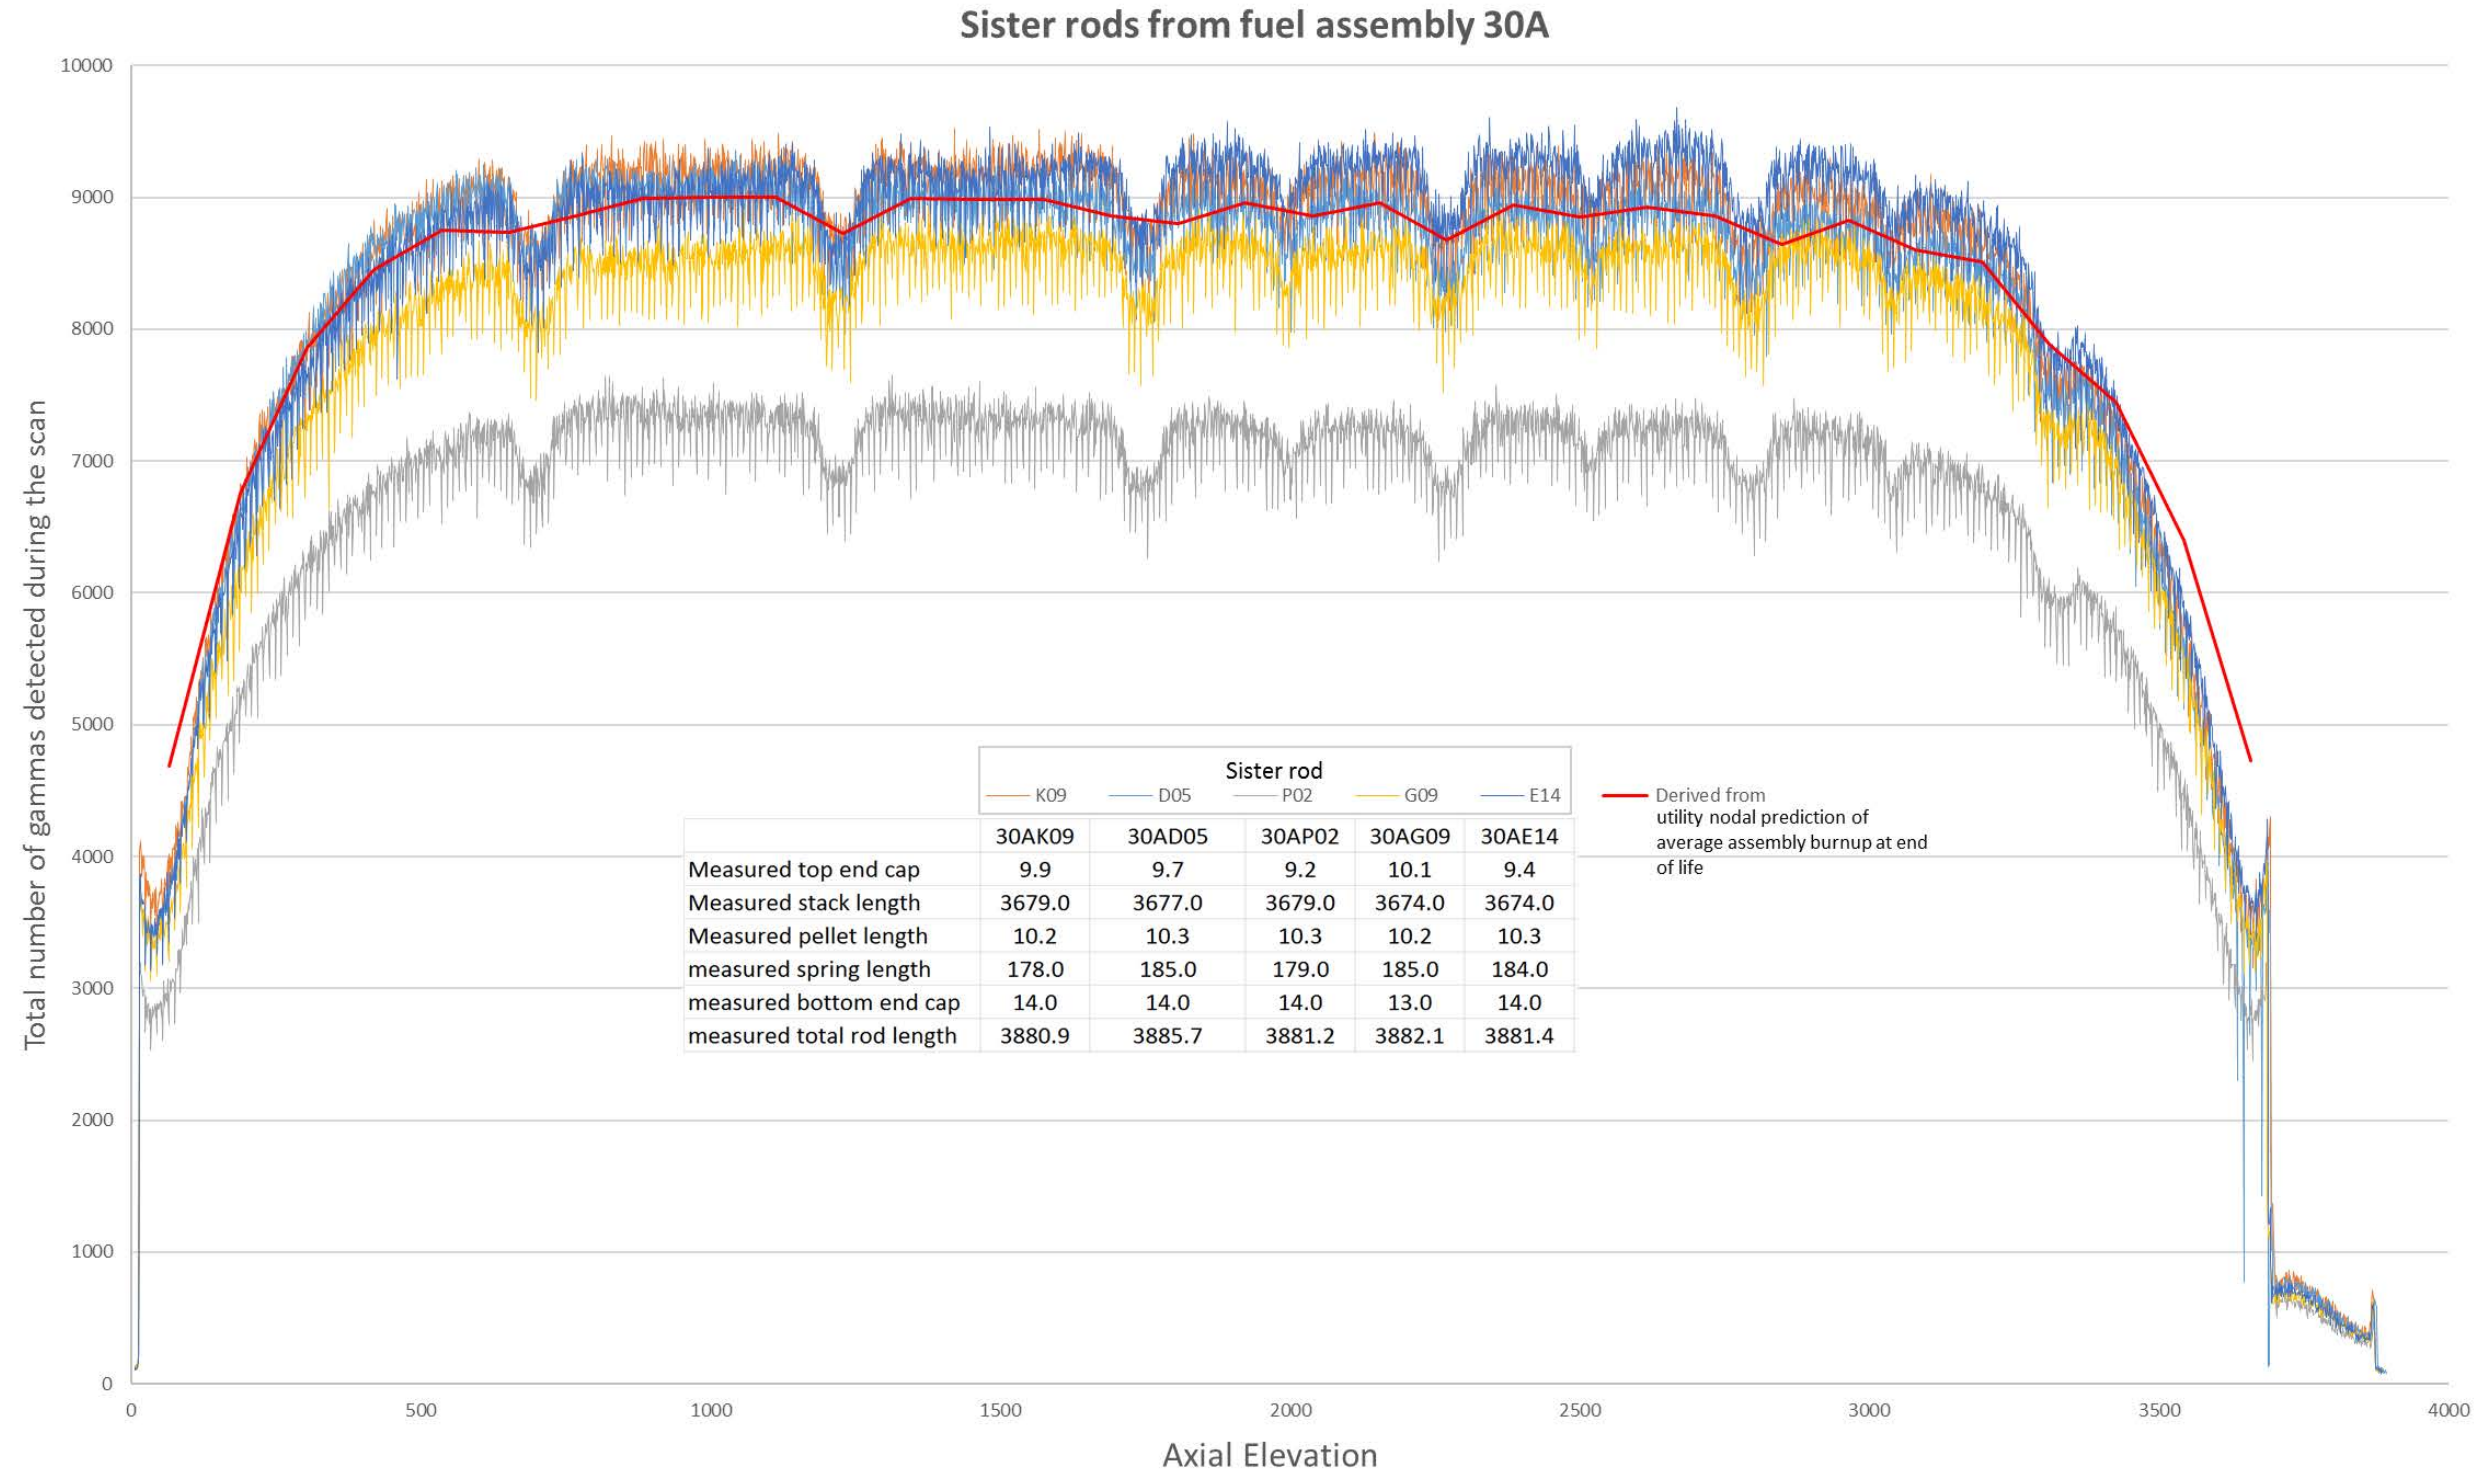
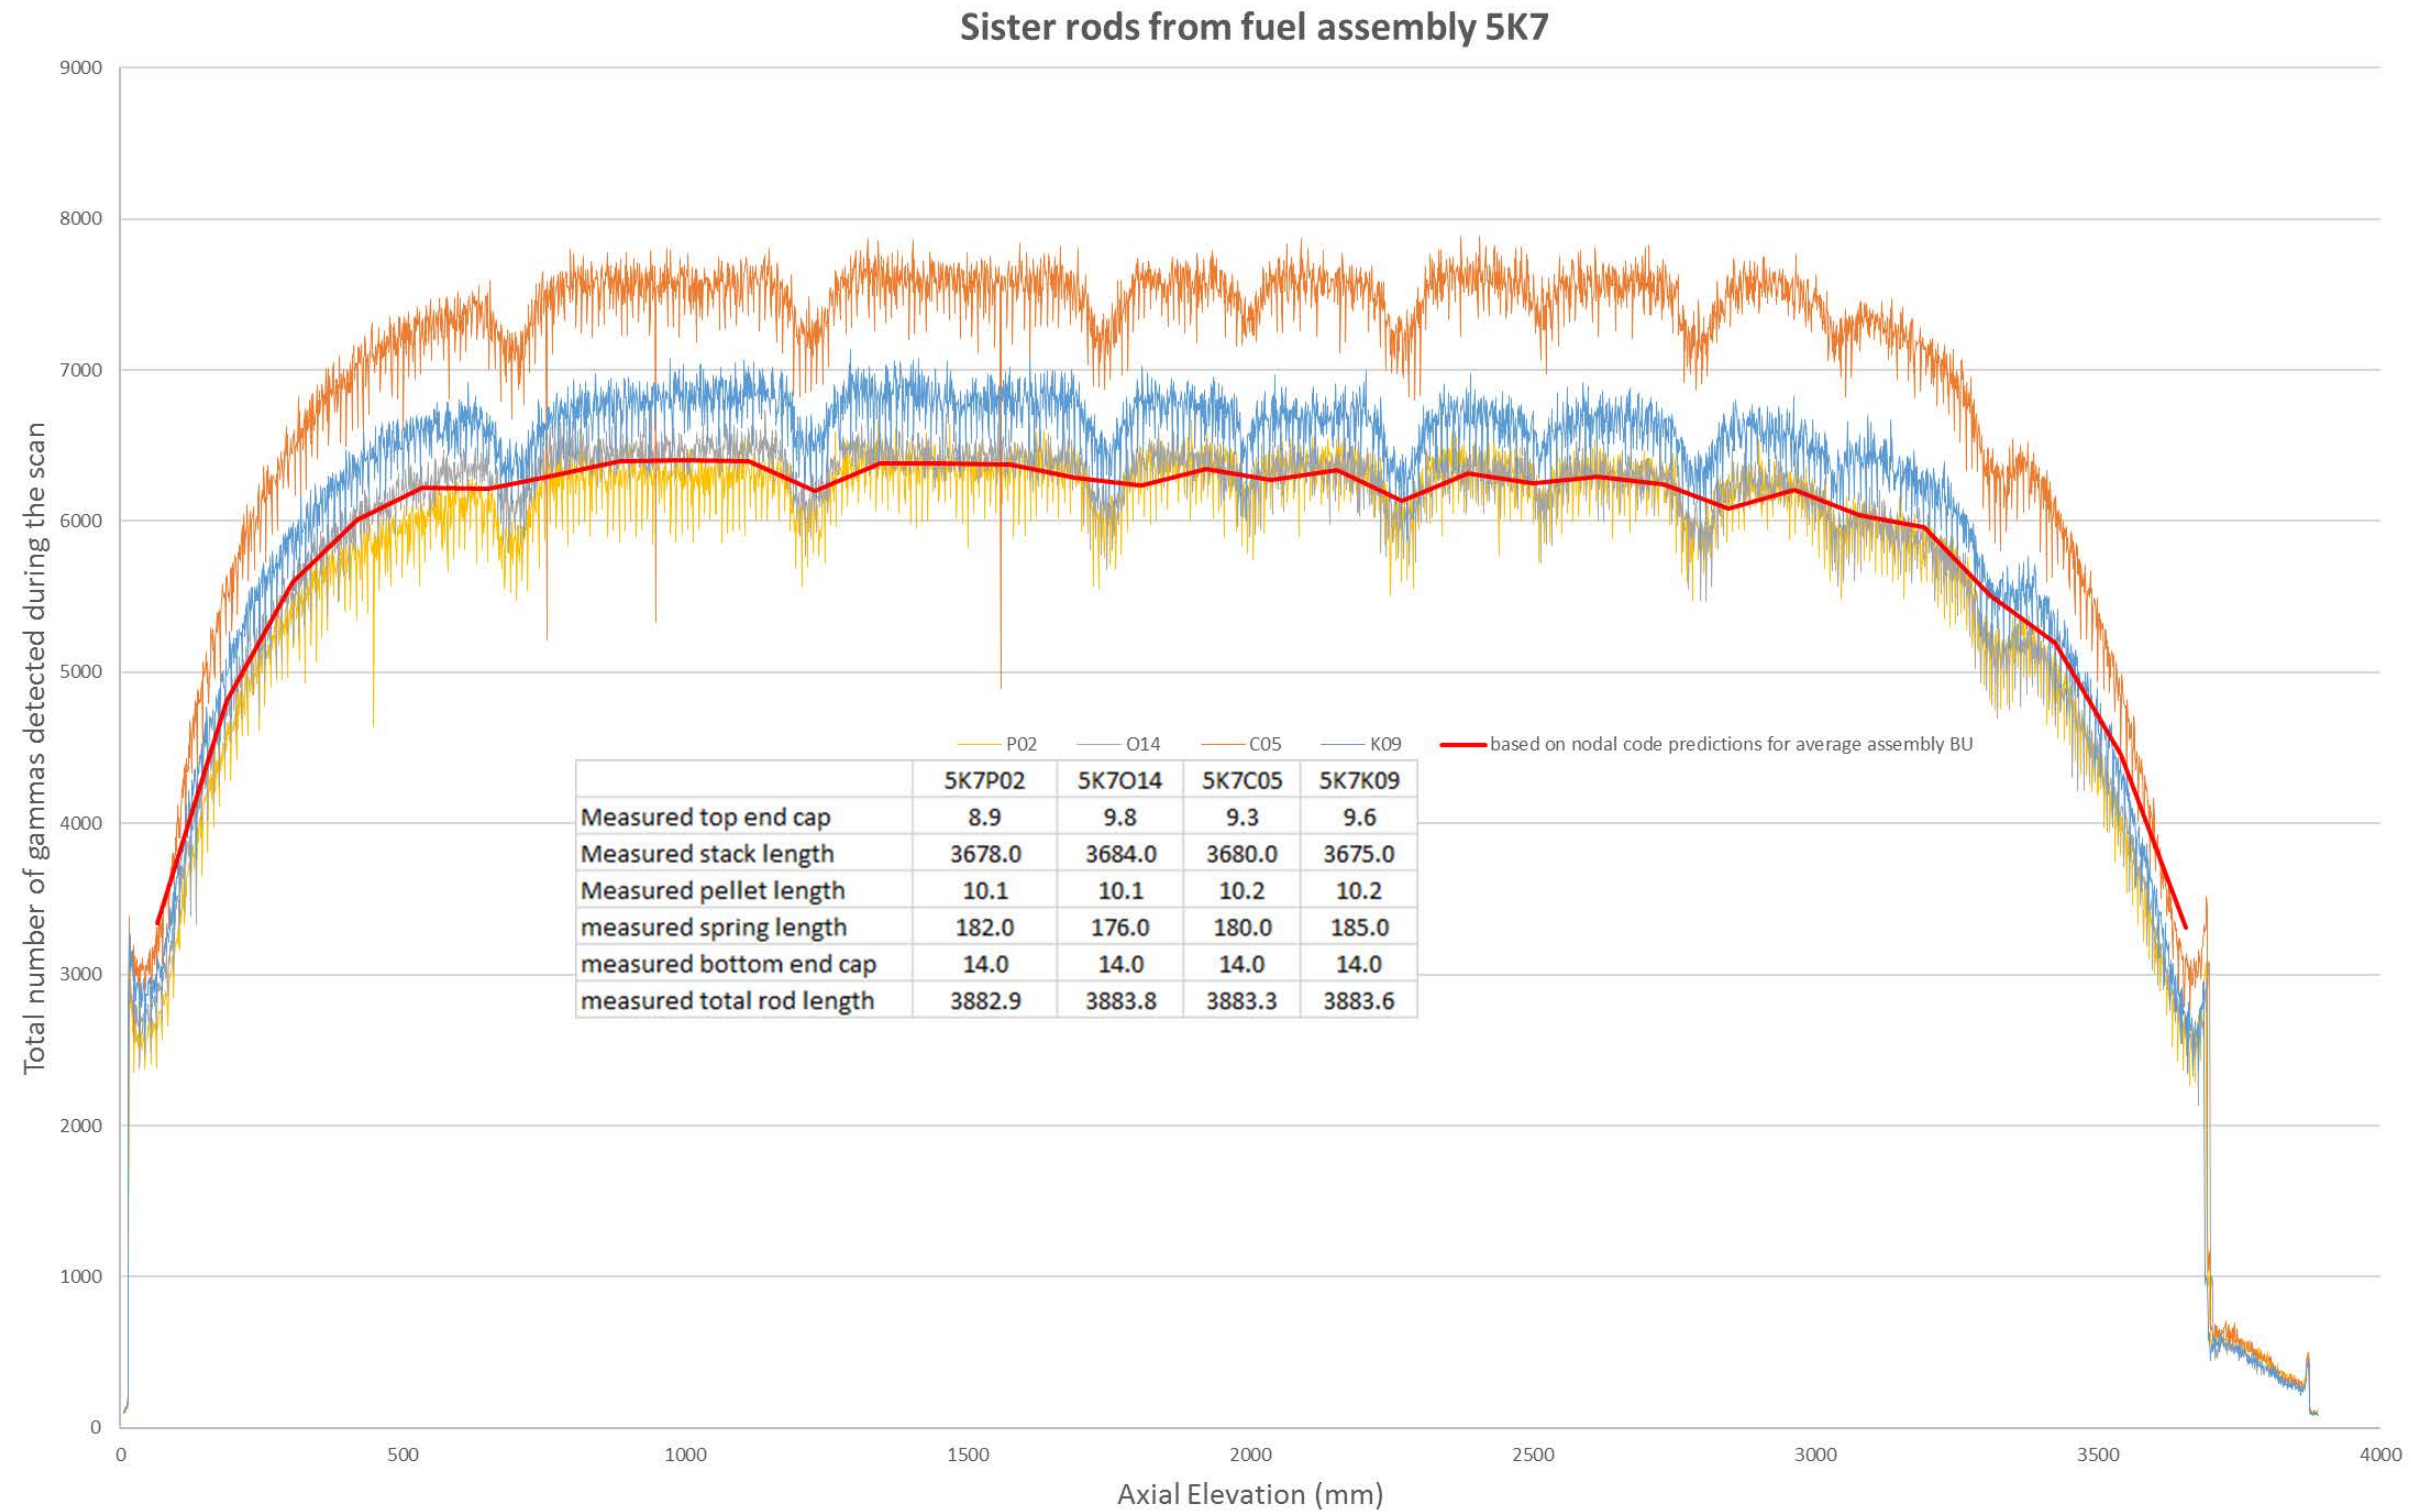
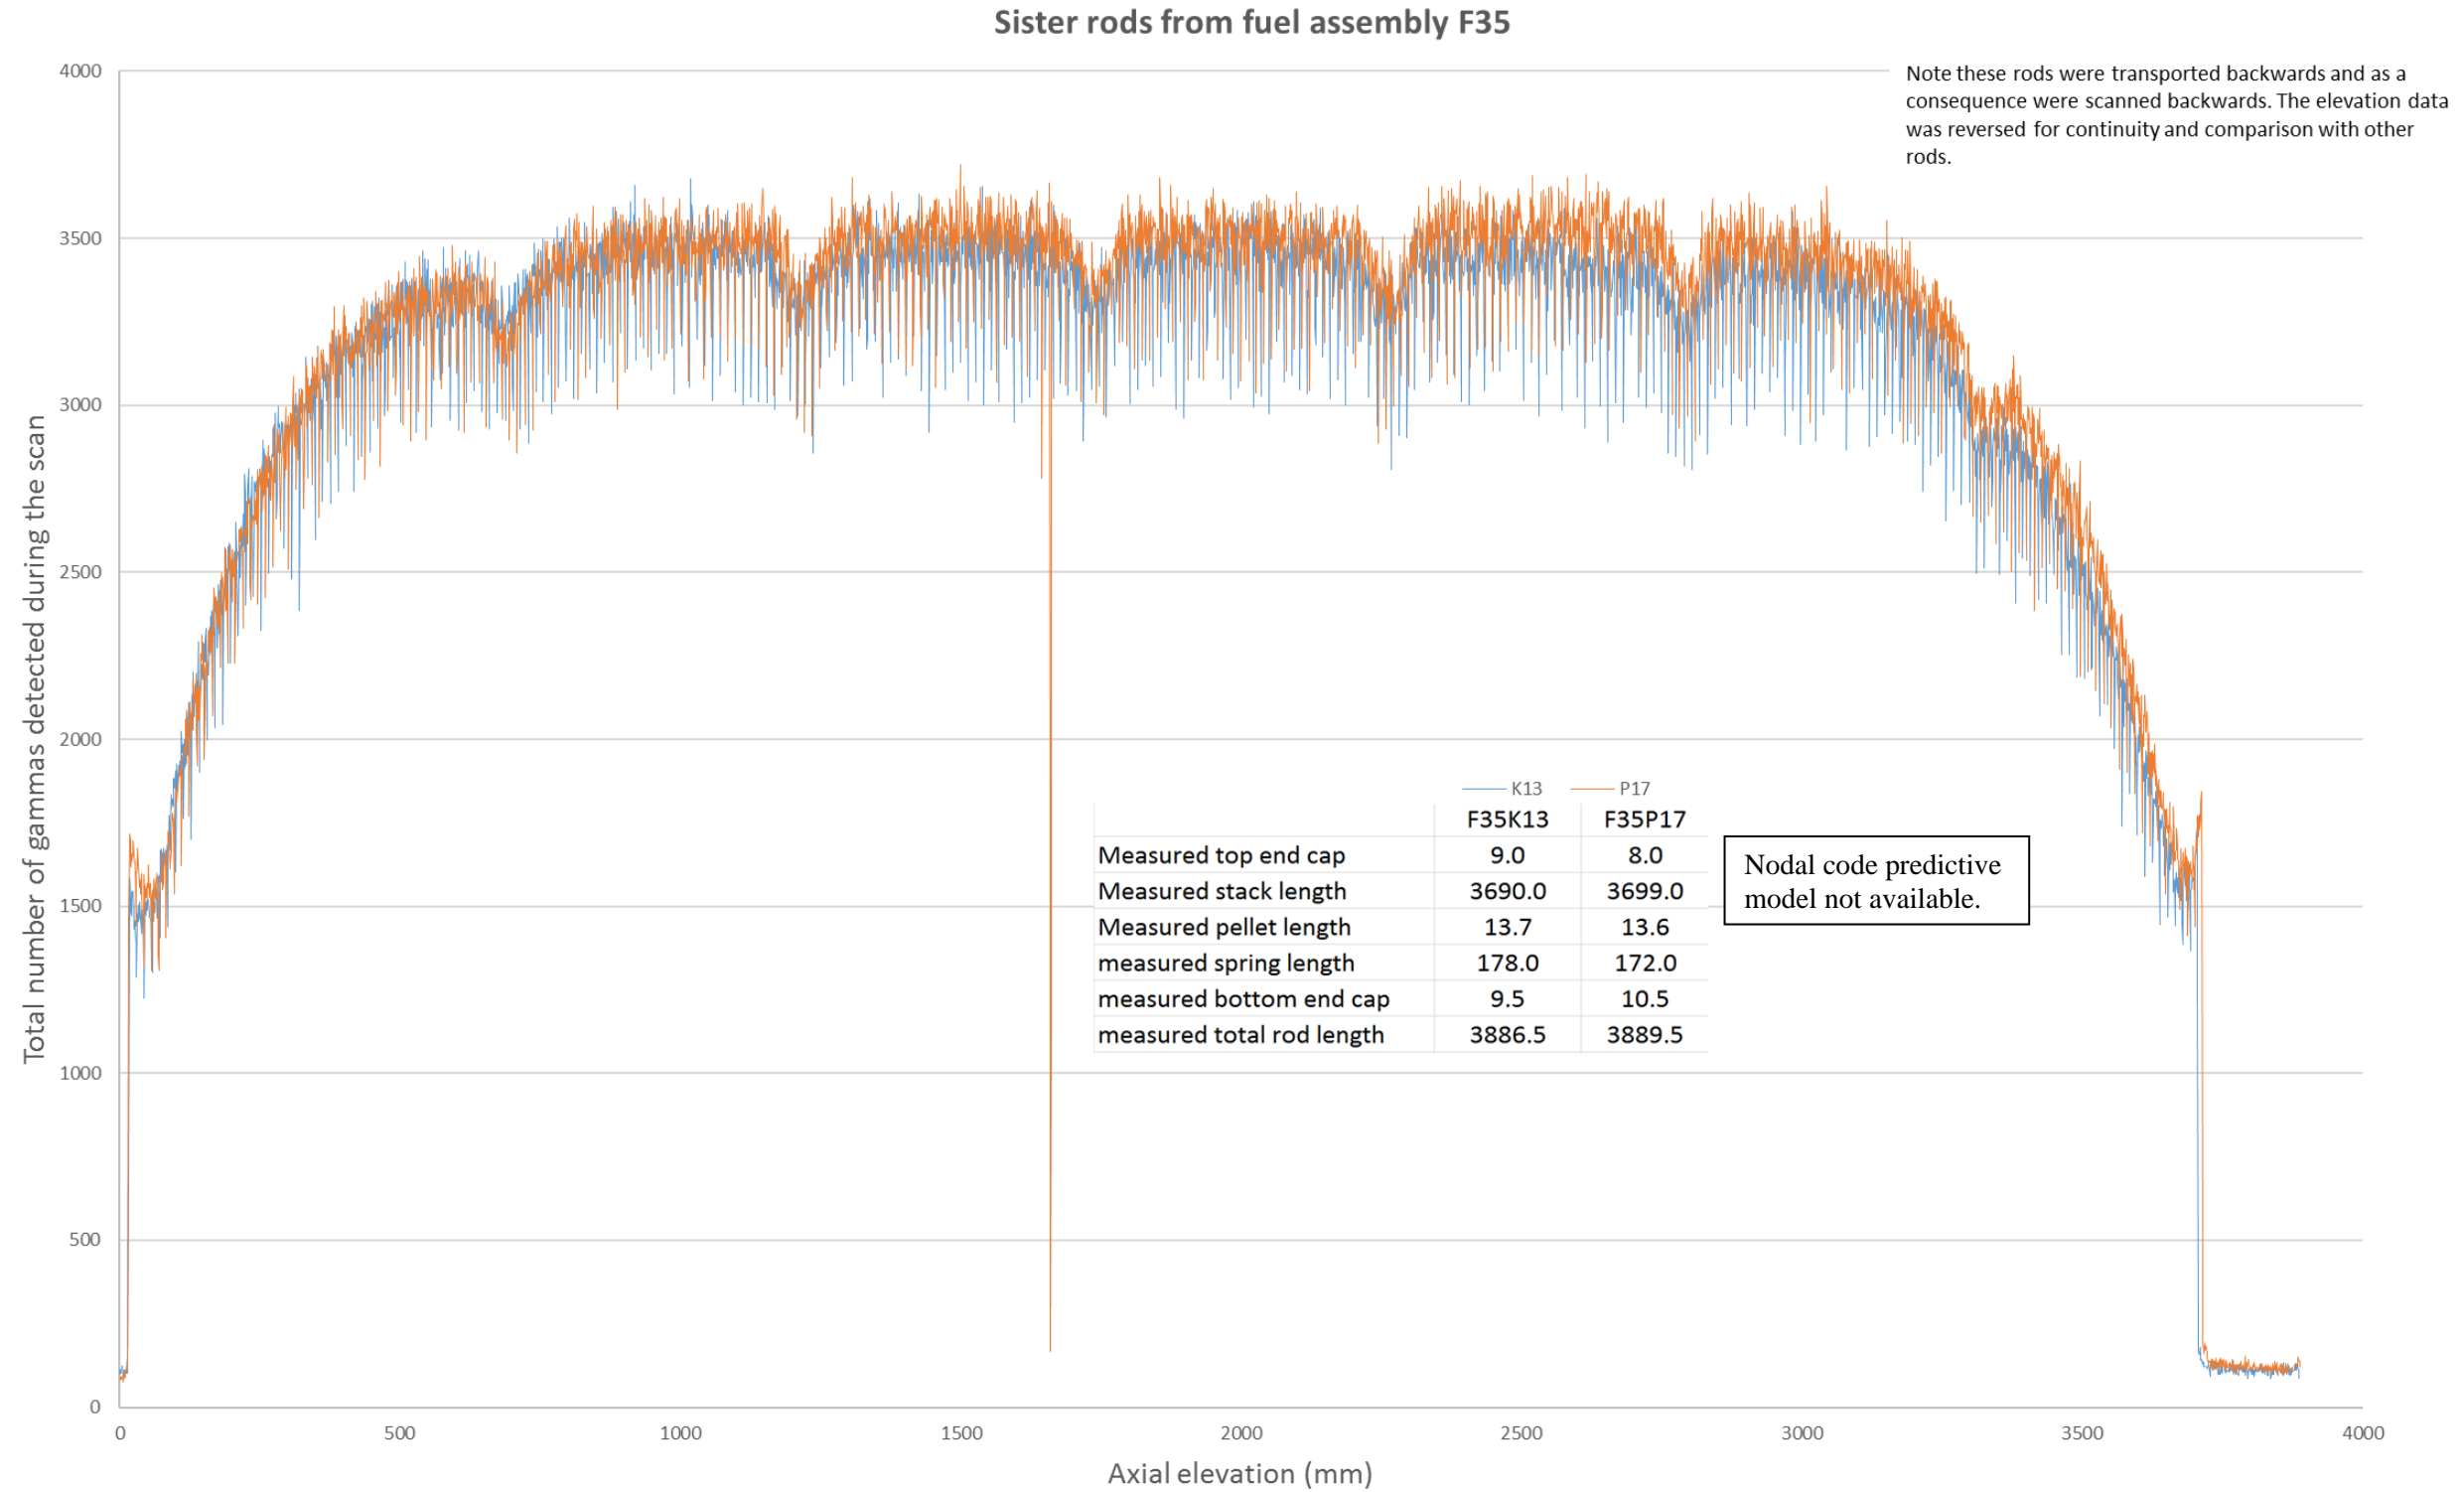
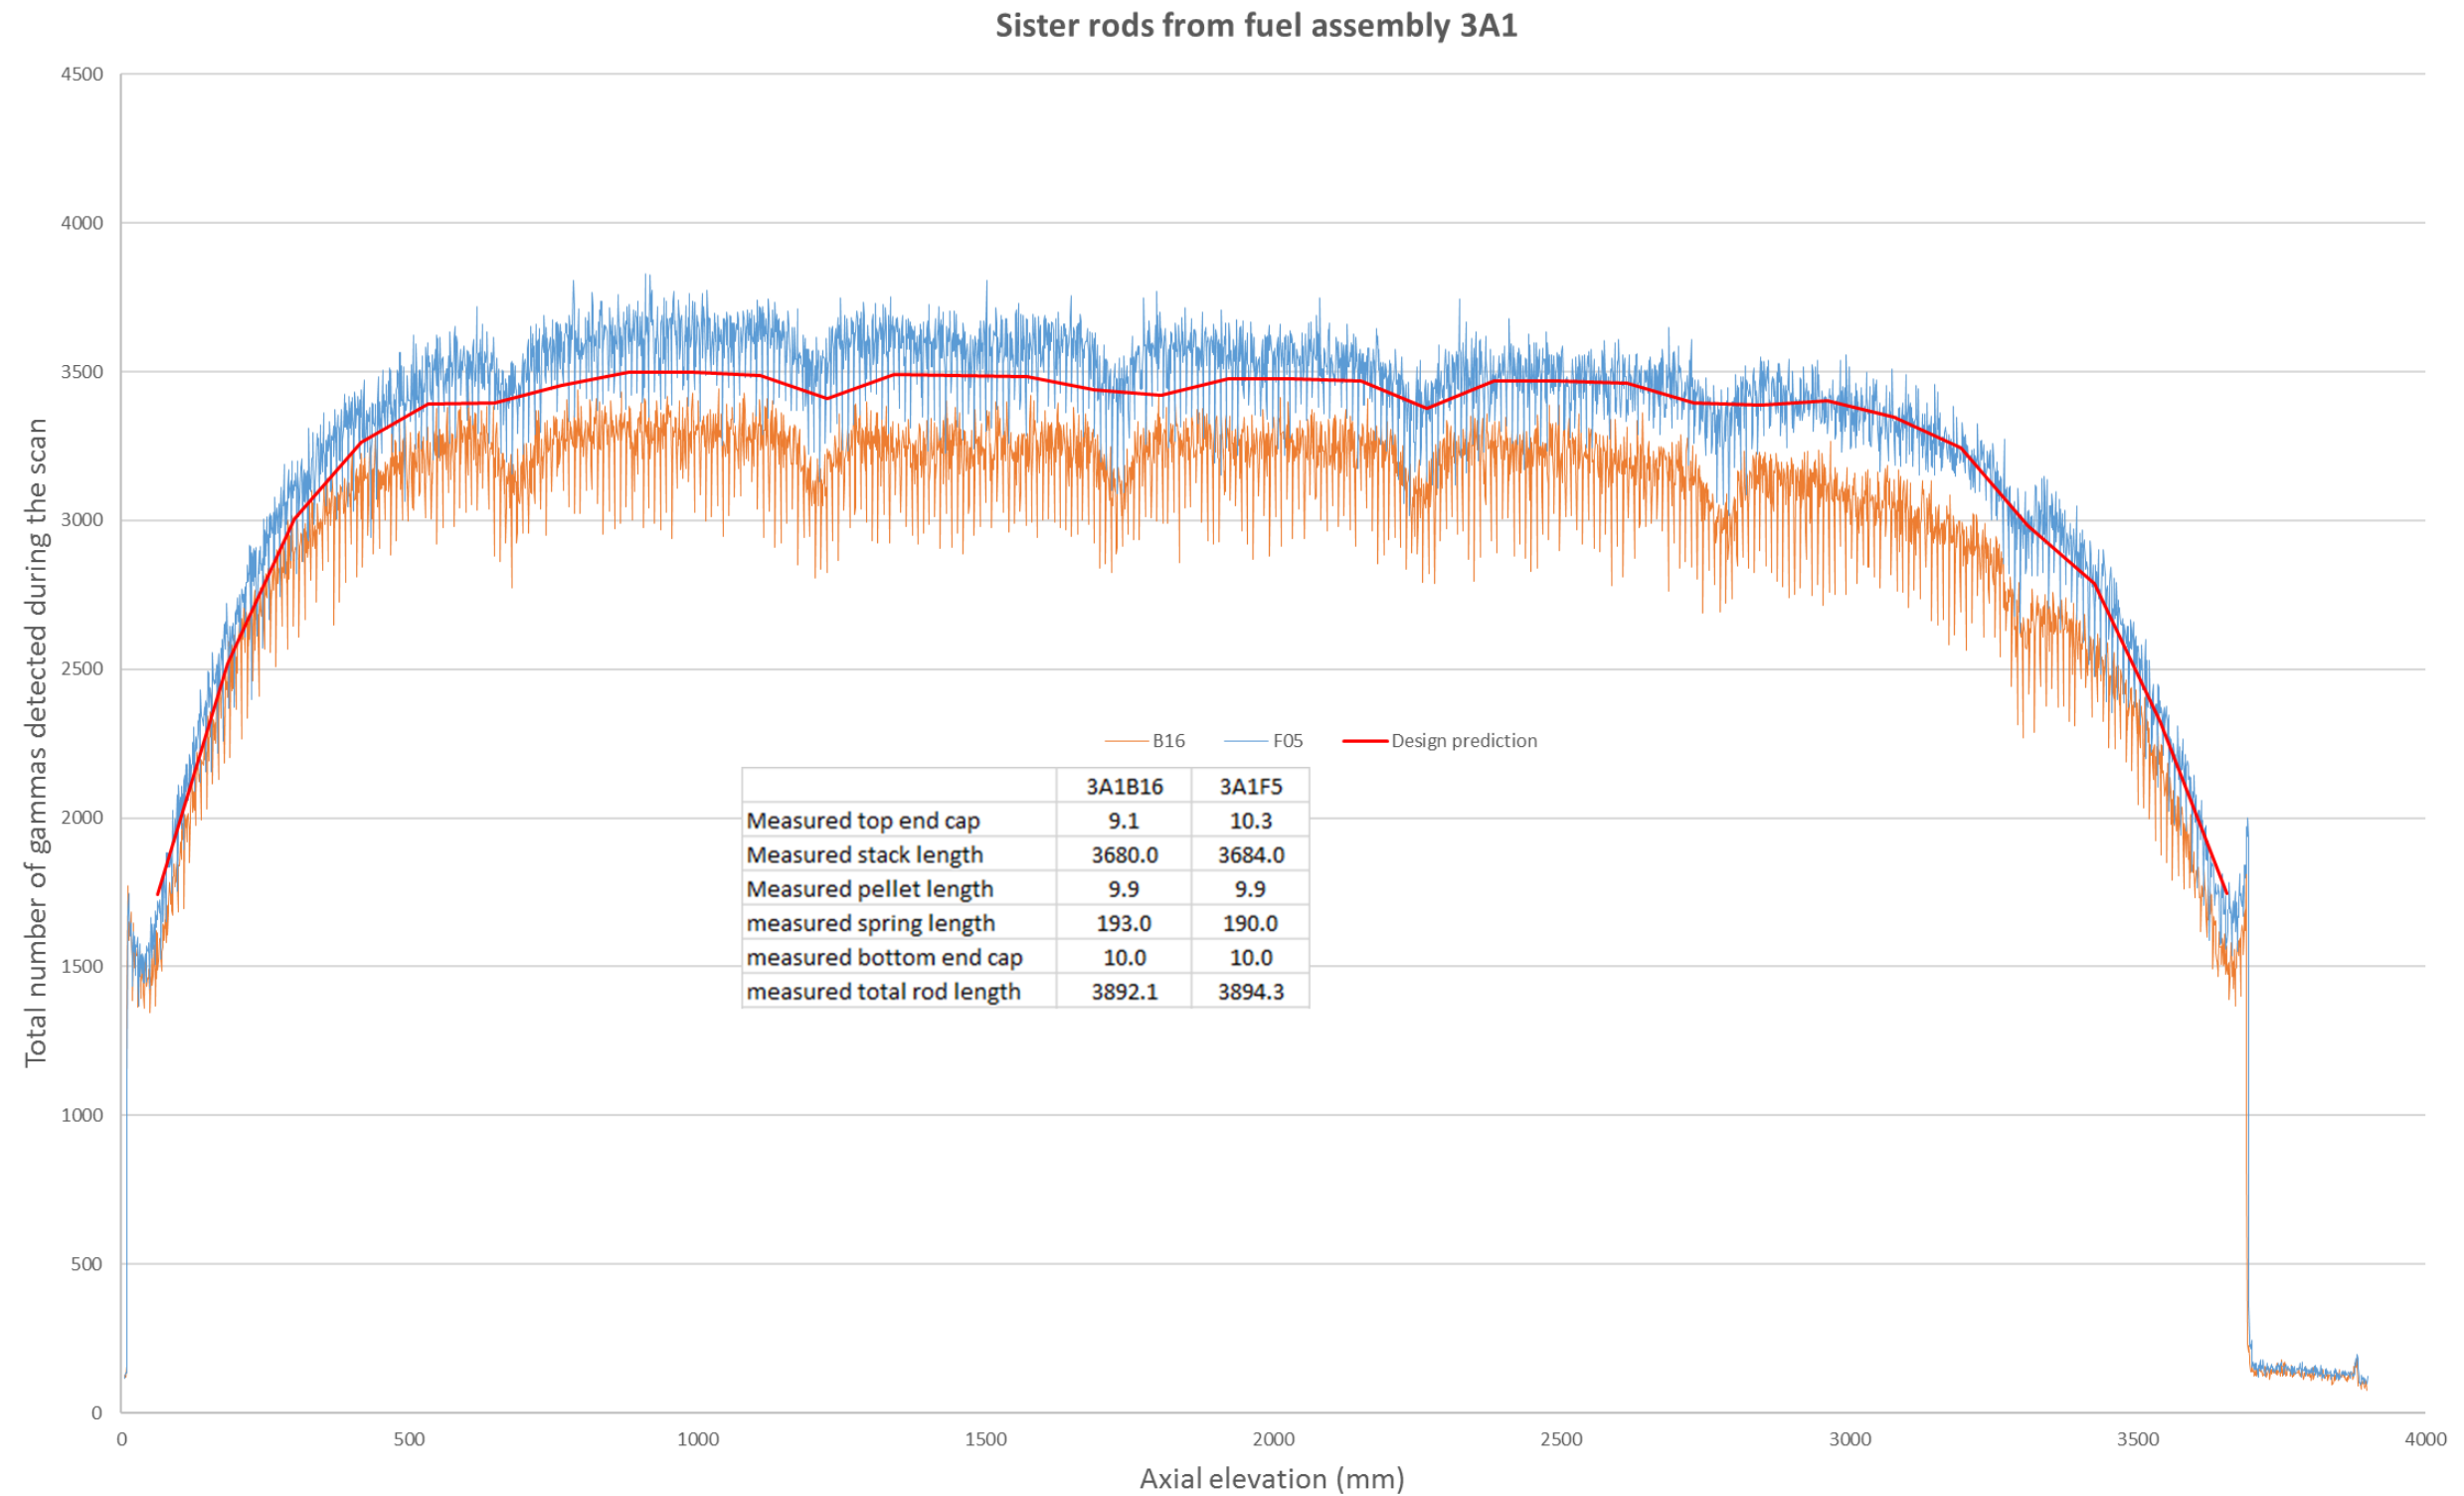
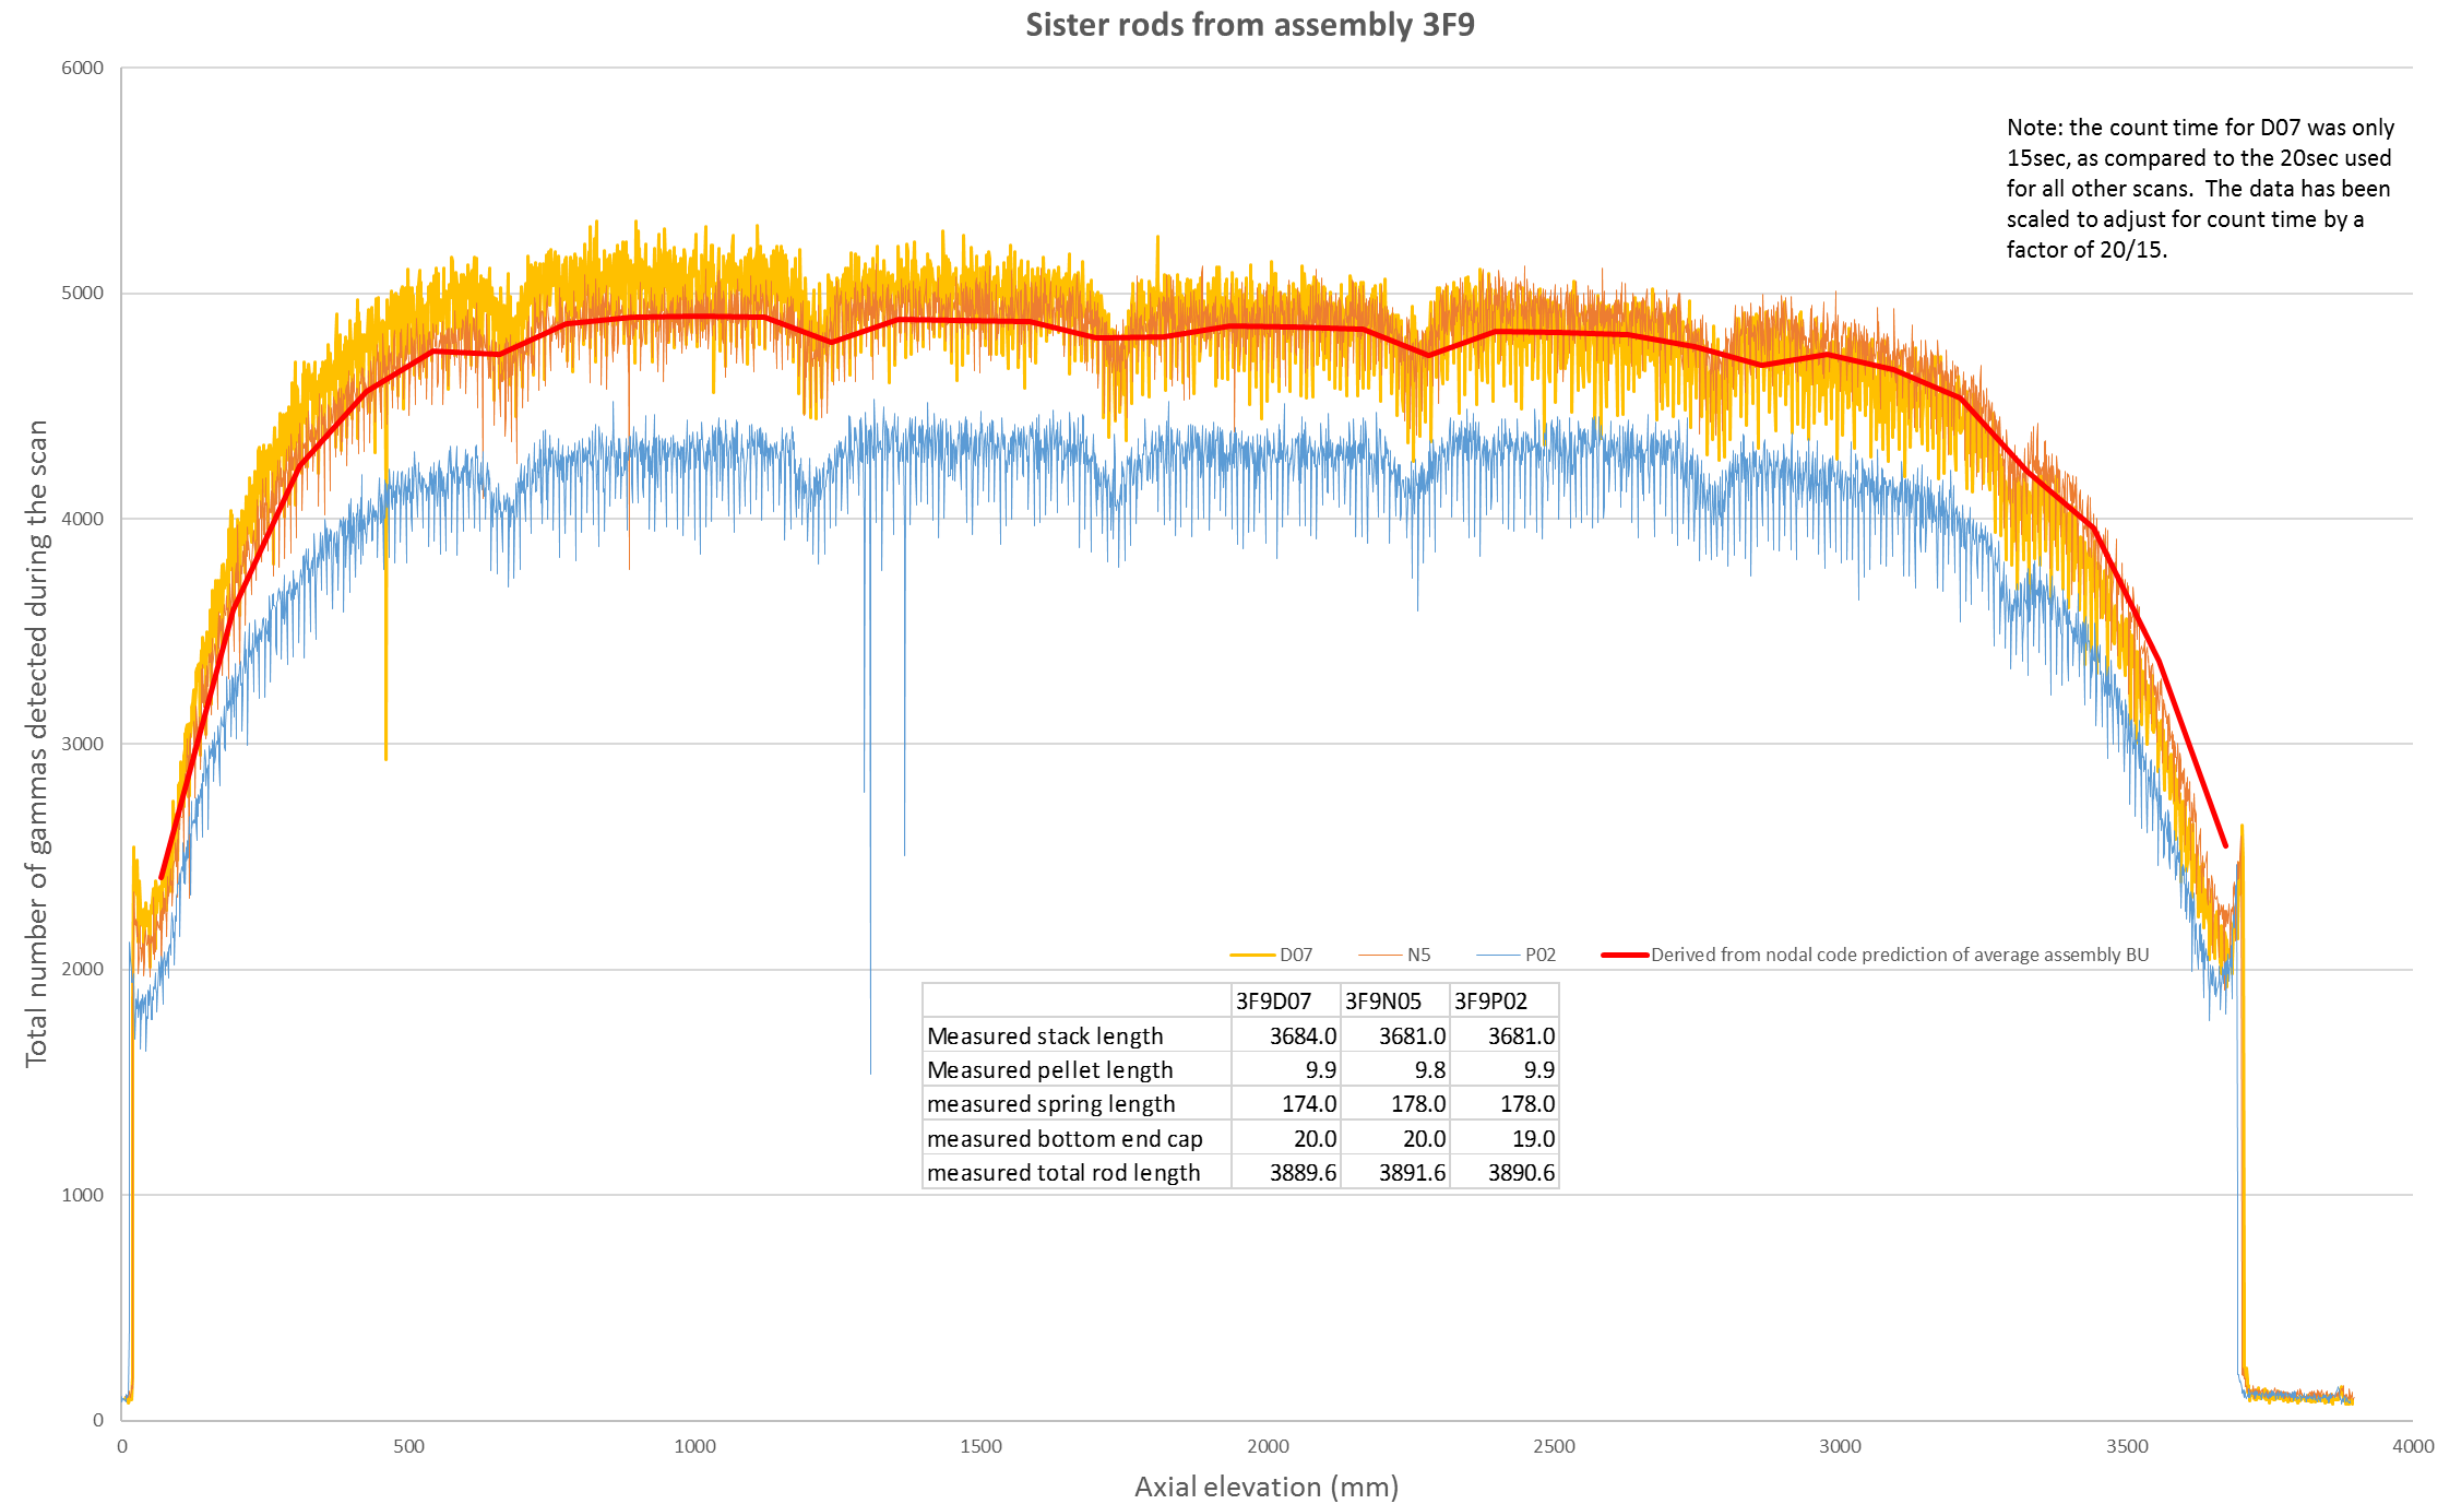
The results of the gamma scanning length measurements are summarized in Table 4. The activity signal exhibited the expected behavior without any sign of fission product accumulation or migration. The axial profile of the rods was as expected, and depressions in burnup were easily observed at the spacer grid locations. Figure 16 through Figure 22 provide graphs of the gamma scanning data and summarize the measurement data obtained for the sister rod. The graphs plot the rod activity as a function of axial length, and although the rod burnup cannot be estimated based on the gamma scans, the axial profile is analogous to the axial burnup of the fuel. In addition to the gross gamma counts measured for each sister rod, the graphs also plot the utility-predicted assembly average burnup (where available), normalized and scaled to a corresponding average gamma count, for comparison with the measured axial profiles. As a first order approximation, the gamma total counts tend to trend with the average pin burnup; however, other factors such as cooling time influence the total gamma counts.

graphs (Figure 16 through Figure 22) as chatter in the data. Zooming into a specific segment of the rod, as illustrated in Figure 23, provides differentiation of each pellet. An estimate of the number of pellets in each fuel rod was determined by spectral methods in which the gamma scanning data were examined for shallow reductions in the fuel stack gamma count associated with pellet end geometry (chamfers and dishes). The average pellet length was determined by dividing the pellet stack length by the number of pellets counted. Since partial pellets are not used, the fractional estimated number of pellets was rounded off to the nearest integer value.

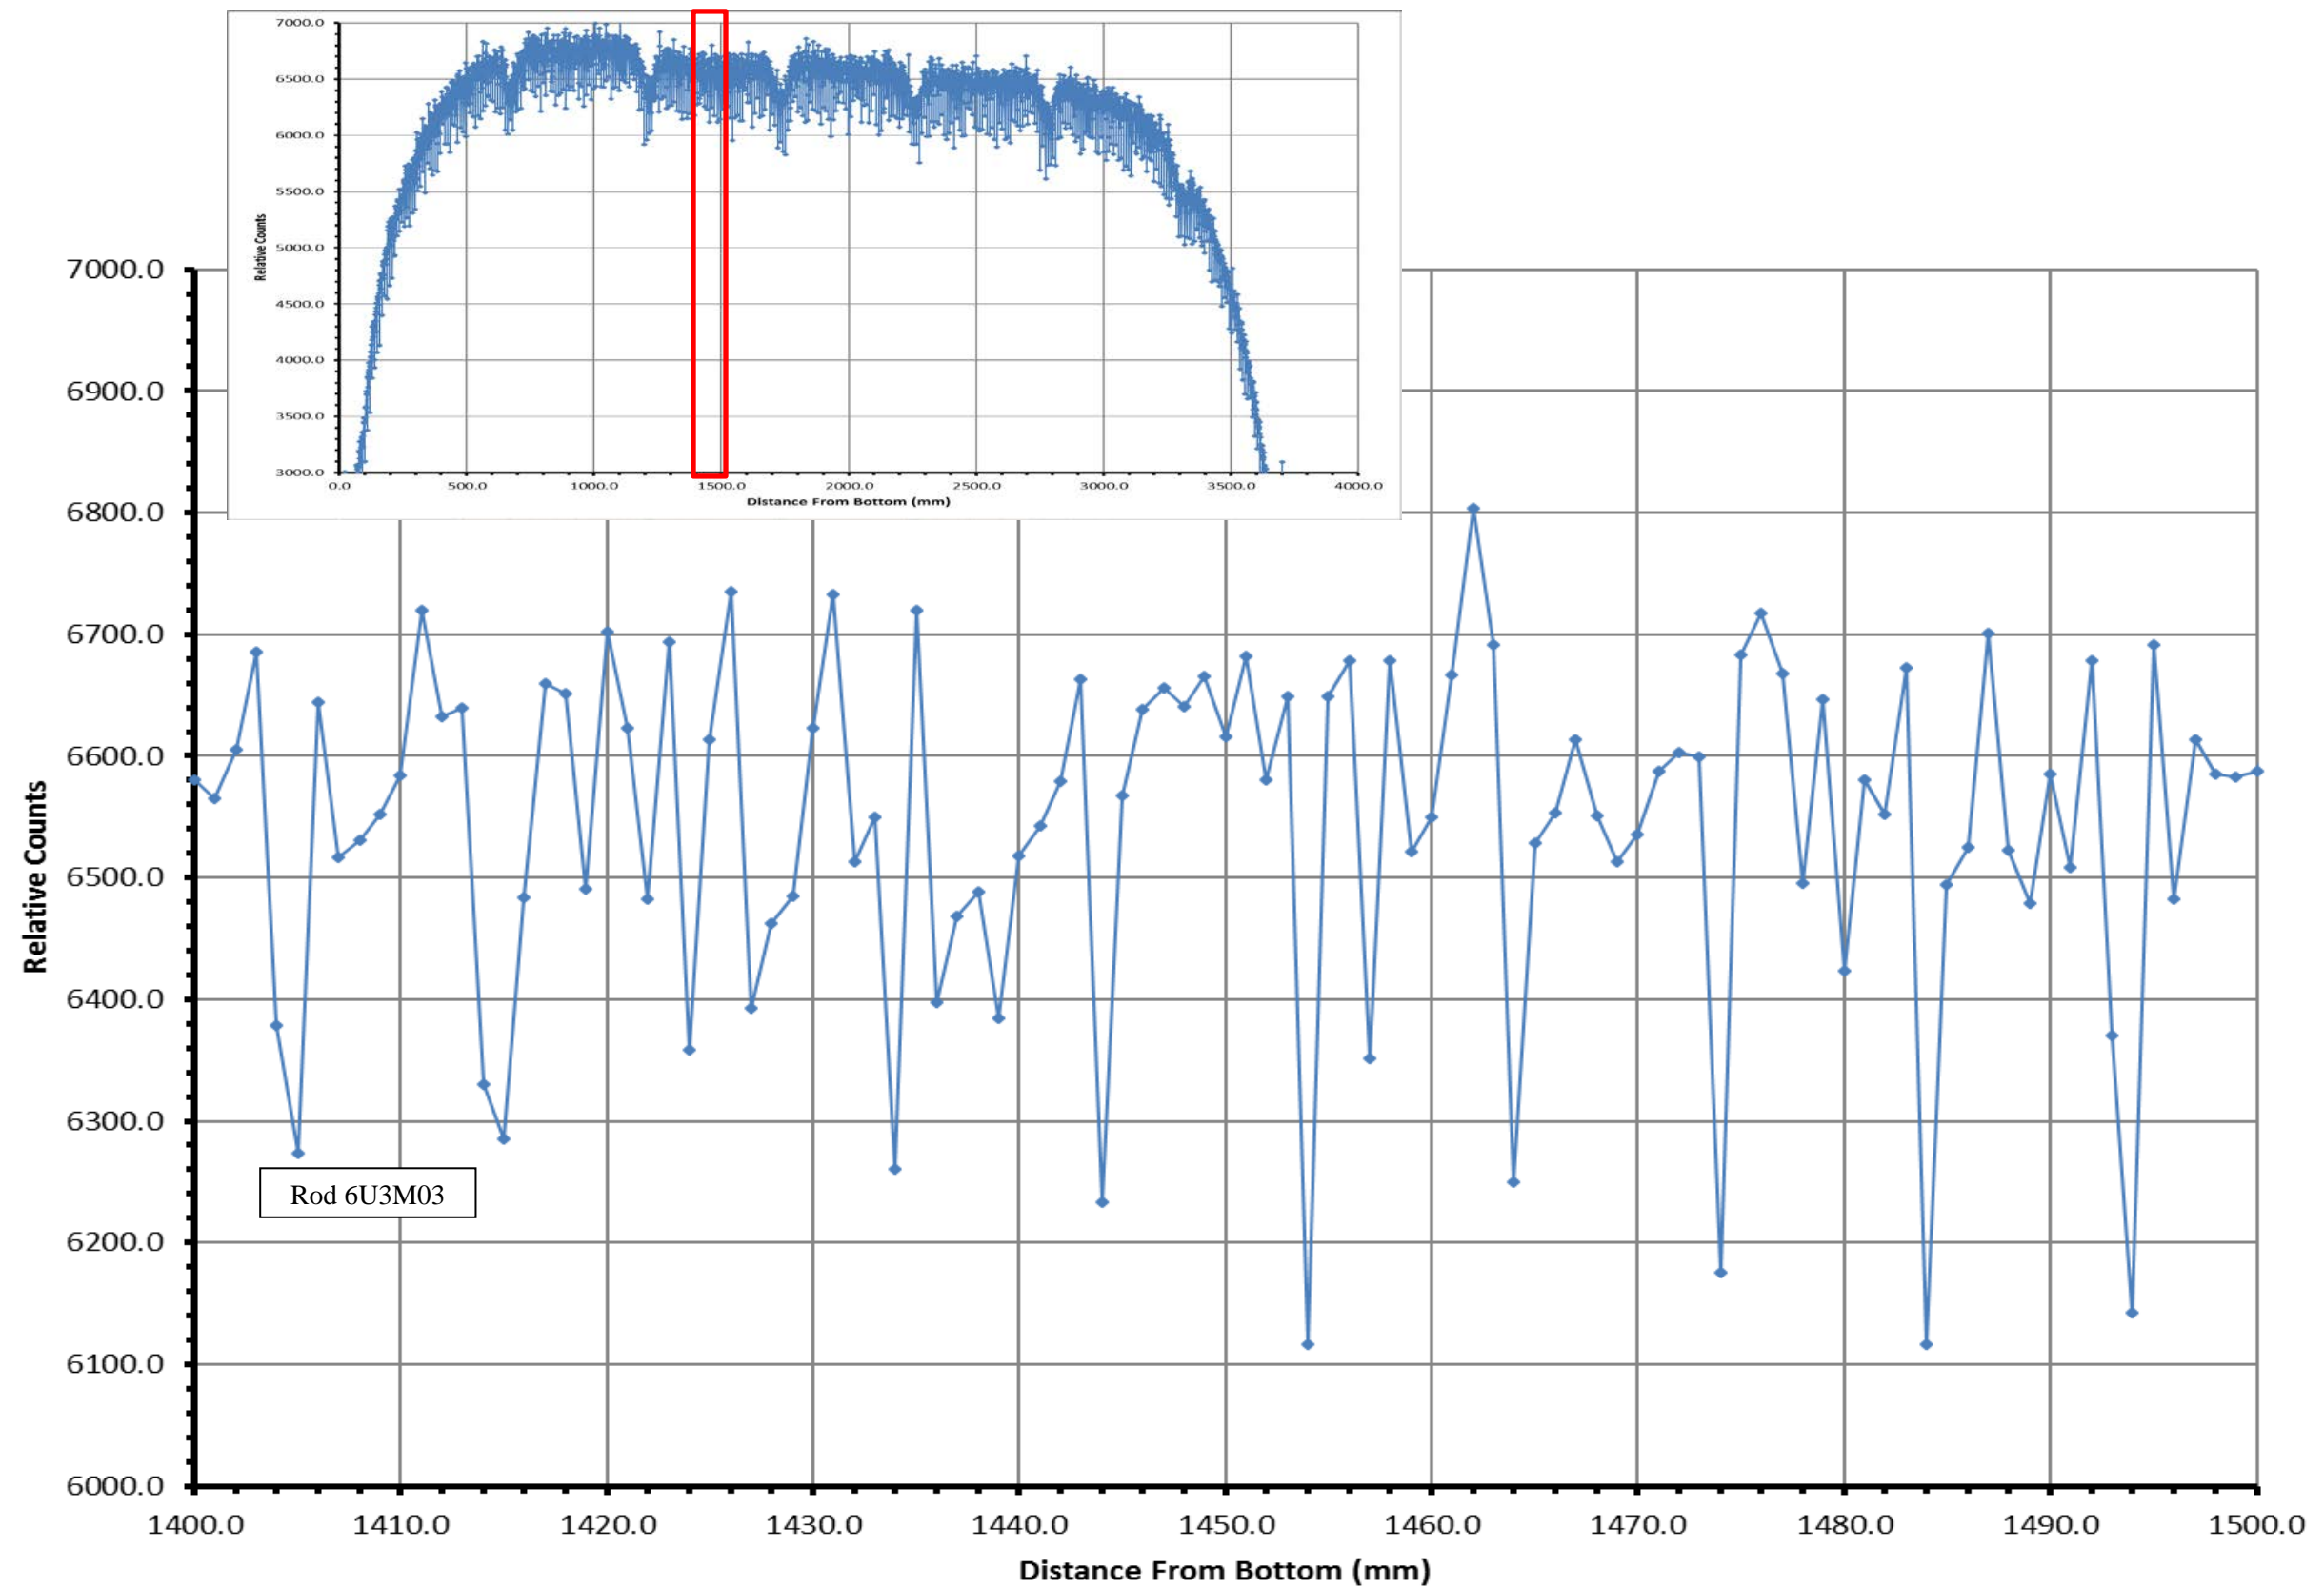
Because each pellet is visible, axial gaps in the stack (either pellet-pellet gaps or pellet end capping, which is material missing from the ends of the pellet resulting from die or handling issues during manufacture) can also be observed, and the gap length can be estimated. Where the gamma count is significantly lower than observed for normal pellet end effects, the data on each side of the count rate reduction were examined, and the length of the pellet-pellet gap was estimated. The results are summarized in Table 5. The uncertainty of the gap measurements is evaluated as ± 1.5 mm since the observation is a product of both rod length and gamma measurements. However, as discussed previously, the ± 0.5 mm resolver uncertainty is distributed over the entire length of the rod, and the local uncertainty for the gap measurement is nearer to ± 1 mm. Since some of stack gaps reported in Table 5 are 1 mm in length, the uncertainty of ± 1 mm implies that these stack gaps may not exist, or they may be as large as 2 mm. Likewise, for all locations where a gap was not indicated, there is a possibility that a 1 mm gap exists but was not detected.

Figure 23. Typical Pellet Ridging on a Fuel Rod Observed Via Gamma Scanning; Scales are Magnified to Show the Detail. The Typical Pellet is Approximately 10mm Long.
