***Sister Rod
Nondestructive
Examination
Annual Report FY2017***

***Prepared for
US Department of Energy
Spent Fuel and Waste Science and
Technology***

***September 15, 2017
SFWD-SFWST-2017-000003
ORNL/SPR-2017/484***

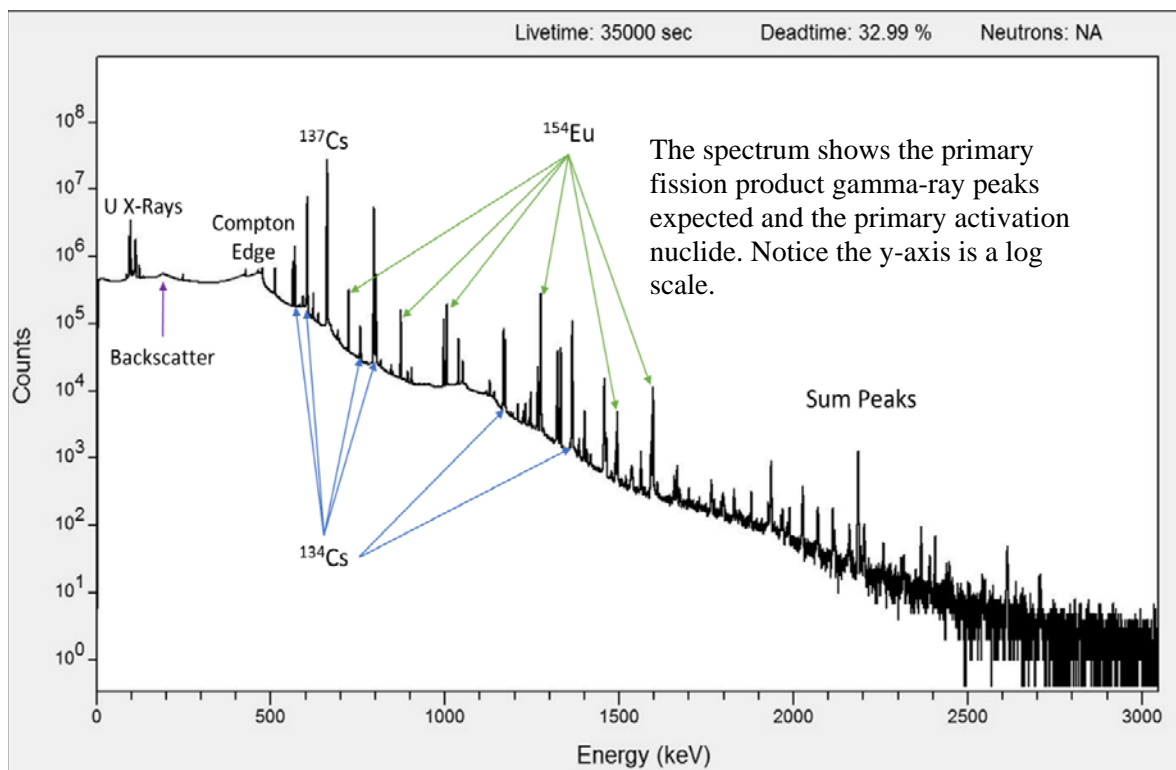
Assembly 30A has average declared burnup of 52 GWd/MTU and was discharged from the reactor core 6–7 years ago. It was expected that the spectra for 30AD05 would be dominated by the three long-lived fission products that emit gamma rays: ^{134}Cs , ^{137}Cs , and ^{154}Eu . Figure 26 illustrates the energy spectrum of a single point selected from the 700 axial point spectra acquired with the HPGe detector along the length of rod 30AD05 using the PeakEasy Software program [5]. The summed spectrum shown in Figure 26 clearly shows these isotopes. Additionally, the radiation-induced x-rays from uranium are clearly visible. Above the 1,596 keV ^{154}Eu gamma ray, the spectrum is dominated by small peaks from random coincidence summing.

Figure 26. HPGe Sum Spectrum of Sister Rod 30AD05.

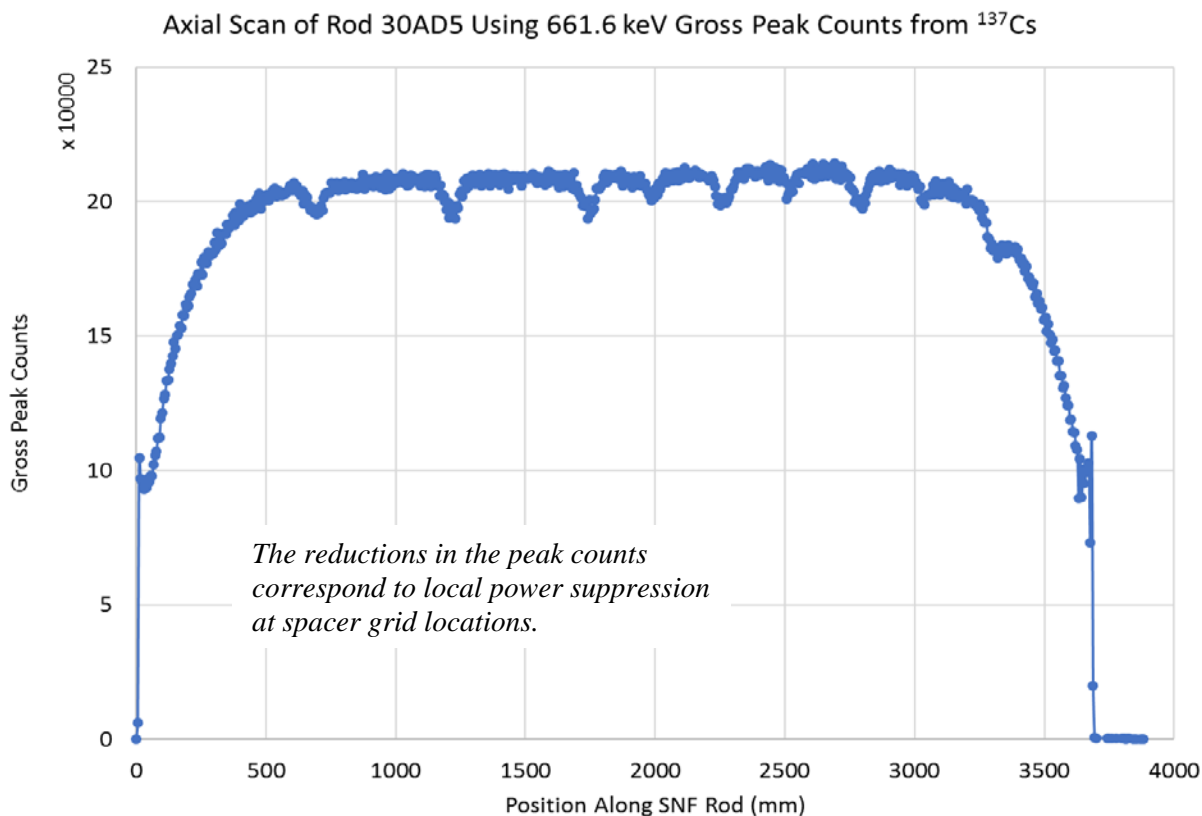
Figure 27 shows the axial scan gross counts for sister rod 30AD05 for a ROI around the 661.6 keV peak from ^{137}Cs . Spacer grid depressions in burnup are visible as reductions in the total count rates. The overall burnup profile measured using the HPGe detector agreed very well with the results achieved using the NaI detector. However, the sliding wedge aperture of the collimator was only opened to 0.04 in (1 mm) for the NaI scans. Because of the narrow width of the collimator used with the NaI detector, count rate reductions could be seen in the data corresponding to the transition between individual fuel pellets (see Section 3.2.1). Because the HPGe detector has a lower efficiency and required a much larger aperture opening, this granularity was not achieved.

Figure 27. HPGe-derived Axial Scan of Sister Rod 30AD05 Using the Gross Peak Counts from the 661.6 keV Peak of ^{137}Cs .

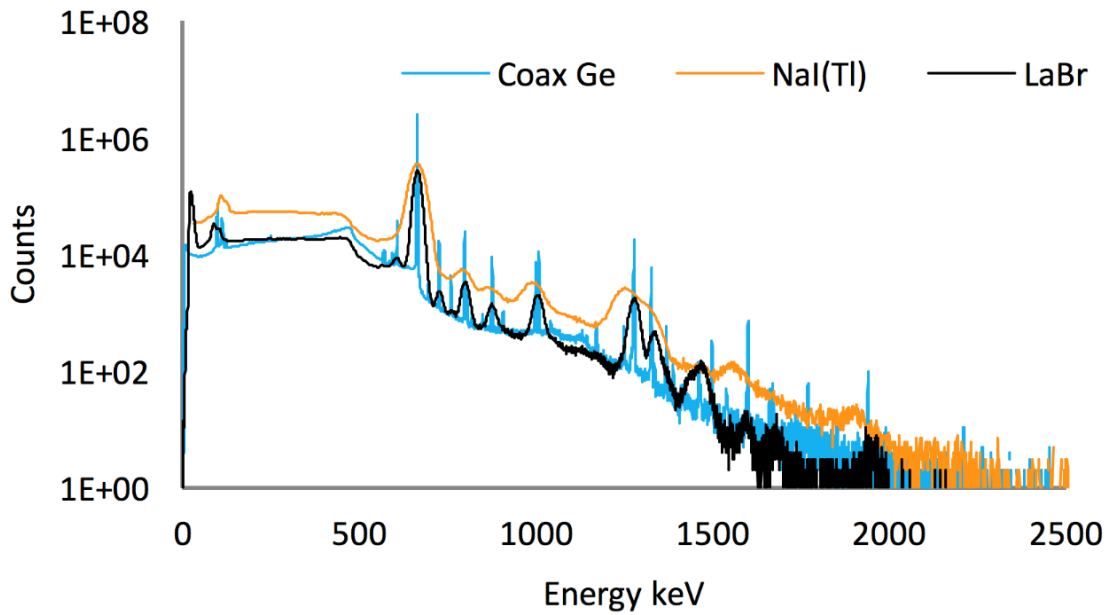
Figure 28 shows the difference in the spectra produced by each detector as analyzed using PeakEasy [5]. The peaks from ^{134}Cs and ^{154}Eu could not be distinguished with the NaI spectra, so quantitative analysis of that spectrum was not possible.

Figure 28. Superimposed Spectra of Coaxial Ge, NaI, and LaBr₃ Detectors.

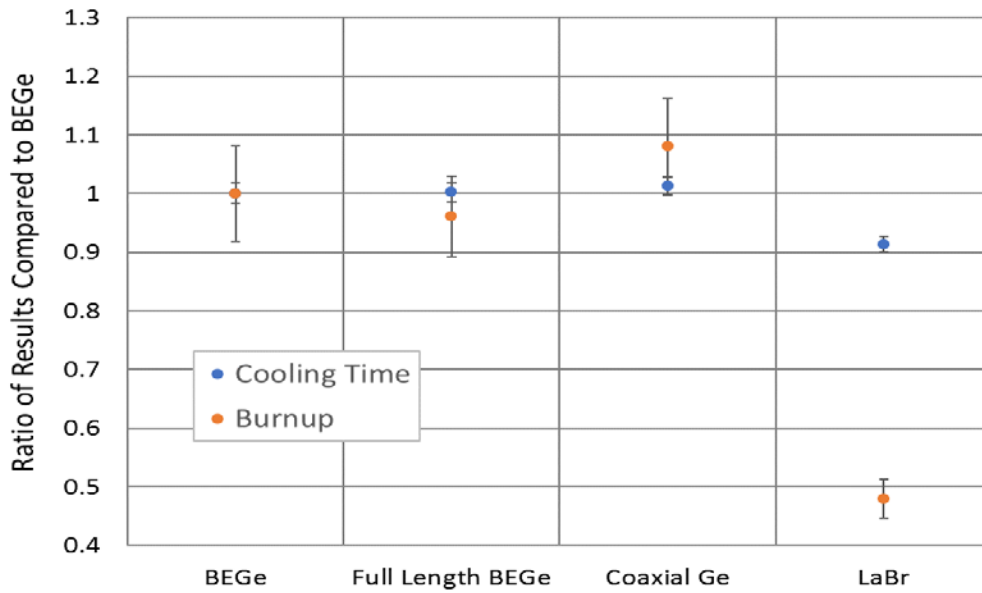
A comparison of the simulation results from INDEPTH using the HPGe 30-minute measurement as the reference is shown in Figure 29. The results from the LaBr_3 detector were not consistent with the results from the HPGe detectors. In particular, the cooling time calculated from the LaBr_3 detector differed by about 50%. The results from the HPGe detectors were consistent, with only a 3% difference for the predicted cooling times and a 9% difference in predicted burnup. A comparison to the known characteristics of the rod will be completed at a later date.

Figure 29. Comparison of the Cooling Time and Burnup of Rod 3D8B2 by Detector Type.

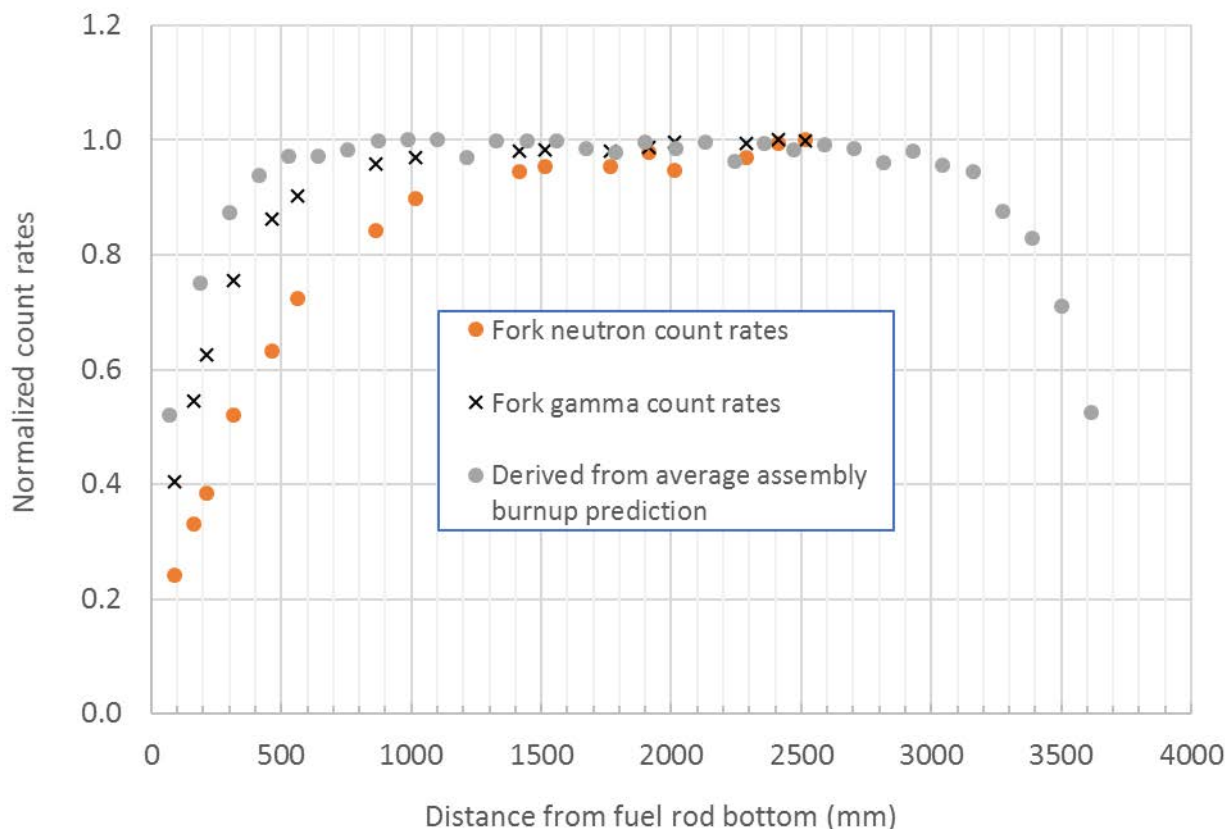
Figure 35 depicts the normalized fork neutron and gamma count rates (with background subtracted) along the length of sister rod 30AE14. The axial burnup profile derived from the average assembly burnup prediction for rod 30AE14's parent assembly was also included for comparison. The axial fuel rod burnup profile is not available. Both the neutron and gamma count rates followed the expected trends, increasing from the bottom of the fuel rod to the center section. Due to space restrictions in the hot cell, the fork detector was not able to reach the upper end of the fuel rod.

There is good agreement between the gamma measurement and the axial burnup in the middle of the fuel rod. Similar trends were observed in other fuel rods. As mentioned previously, SNF neutron emissions trend with the 4th power of the burnup, while gamma emissions are somewhat linear with burnup. This is evident in the steeper neutron slope shown in Figure 35. In theory, there should be a very close agreement between the fork detector gamma count rates and the predicted axial burnup profile. Different factors can contribute to the discrepancies observed, for example: (1) the predicted assembly average axial burnup plotted in Figure 35 is somewhat different from the sister rod burnup and doesn't capture localized neutron spectra differences; and (2) a collimator was not used for the fork measurements, allowing gammas from other sections of the fuel rod to contribute to the signal. During safeguards inspections, fork measurements are usually performed only at the middle of a fuel assembly, without using any collimator.

Figure 35. Normalized Fork Neutron and Gamma Count Rates along the Length of Fuel Rod 30AE14.

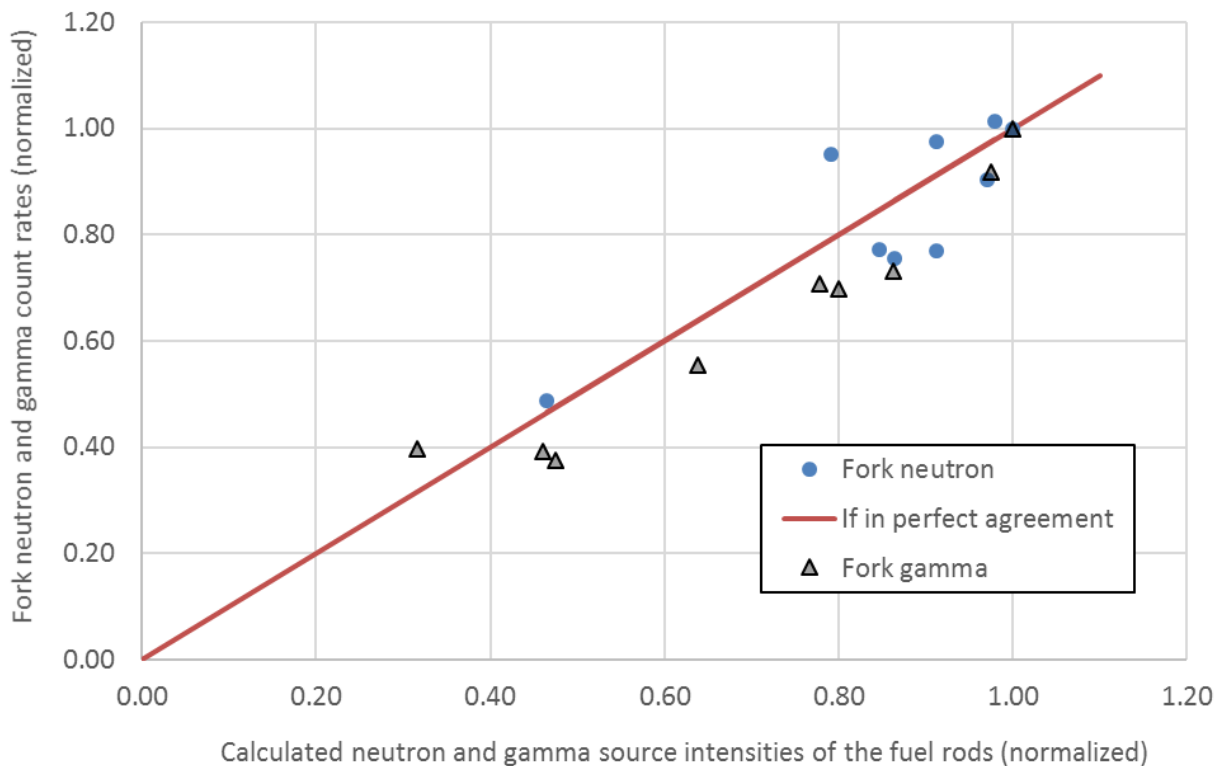
center of the rod. The measured count rates are expected to be linear with the calculated source intensities for all sister rods because the measurement geometry was kept the same for all fuel rods. As seen in Figure 36, the measured fork neutron and gamma count rates trend very well with the corresponding calculated source intensities. The calculations were performed based on the reported fuel burnup and cooling time. These results demonstrate that the fork detector was able to verify fuel burnup and cooling time.

Figure 36. Comparisons between the Fork Gamma and Neutron Count Rates with the Corresponding Calculated Neutron and Gamma Source Intensities in 9 Fuel Rods.

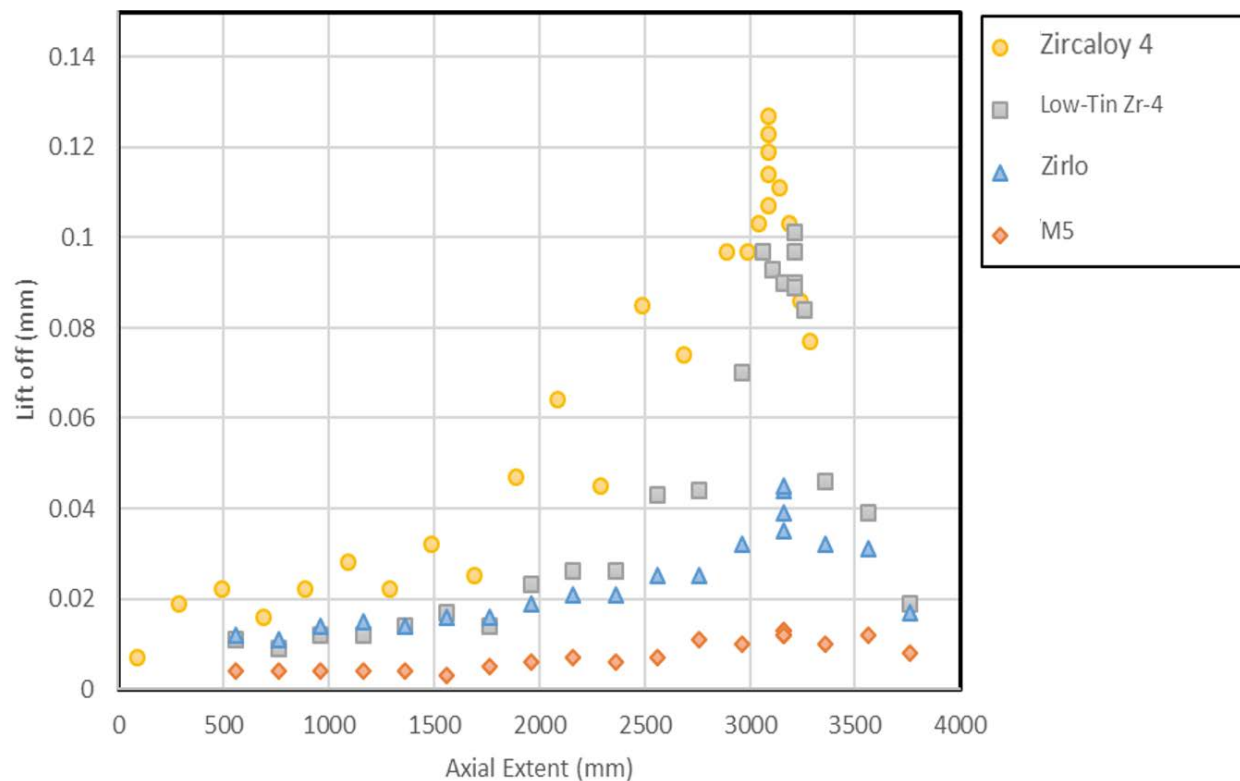
Representative lift-off data for each cladding type are shown in Figure 38. As expected, based on previously published industry data, lift-off varies as a function of cladding material. When the CRUD contains magnetic components, the thickness of the CRUD alone can be estimated. However, for the sister rods, where no magnetic CRUD components were found, the CRUD thickness cannot be separated from the zirconium oxide thickness. The highest lift-off observed was between rod elevations of ~3,100 and ~3200 mm for all clad four types. The Zirc-4 clad sister rods had the highest oxide thickness overall.

Figure 38. Representative Sister Rod Lift-Off Data for Each Cladding Type.

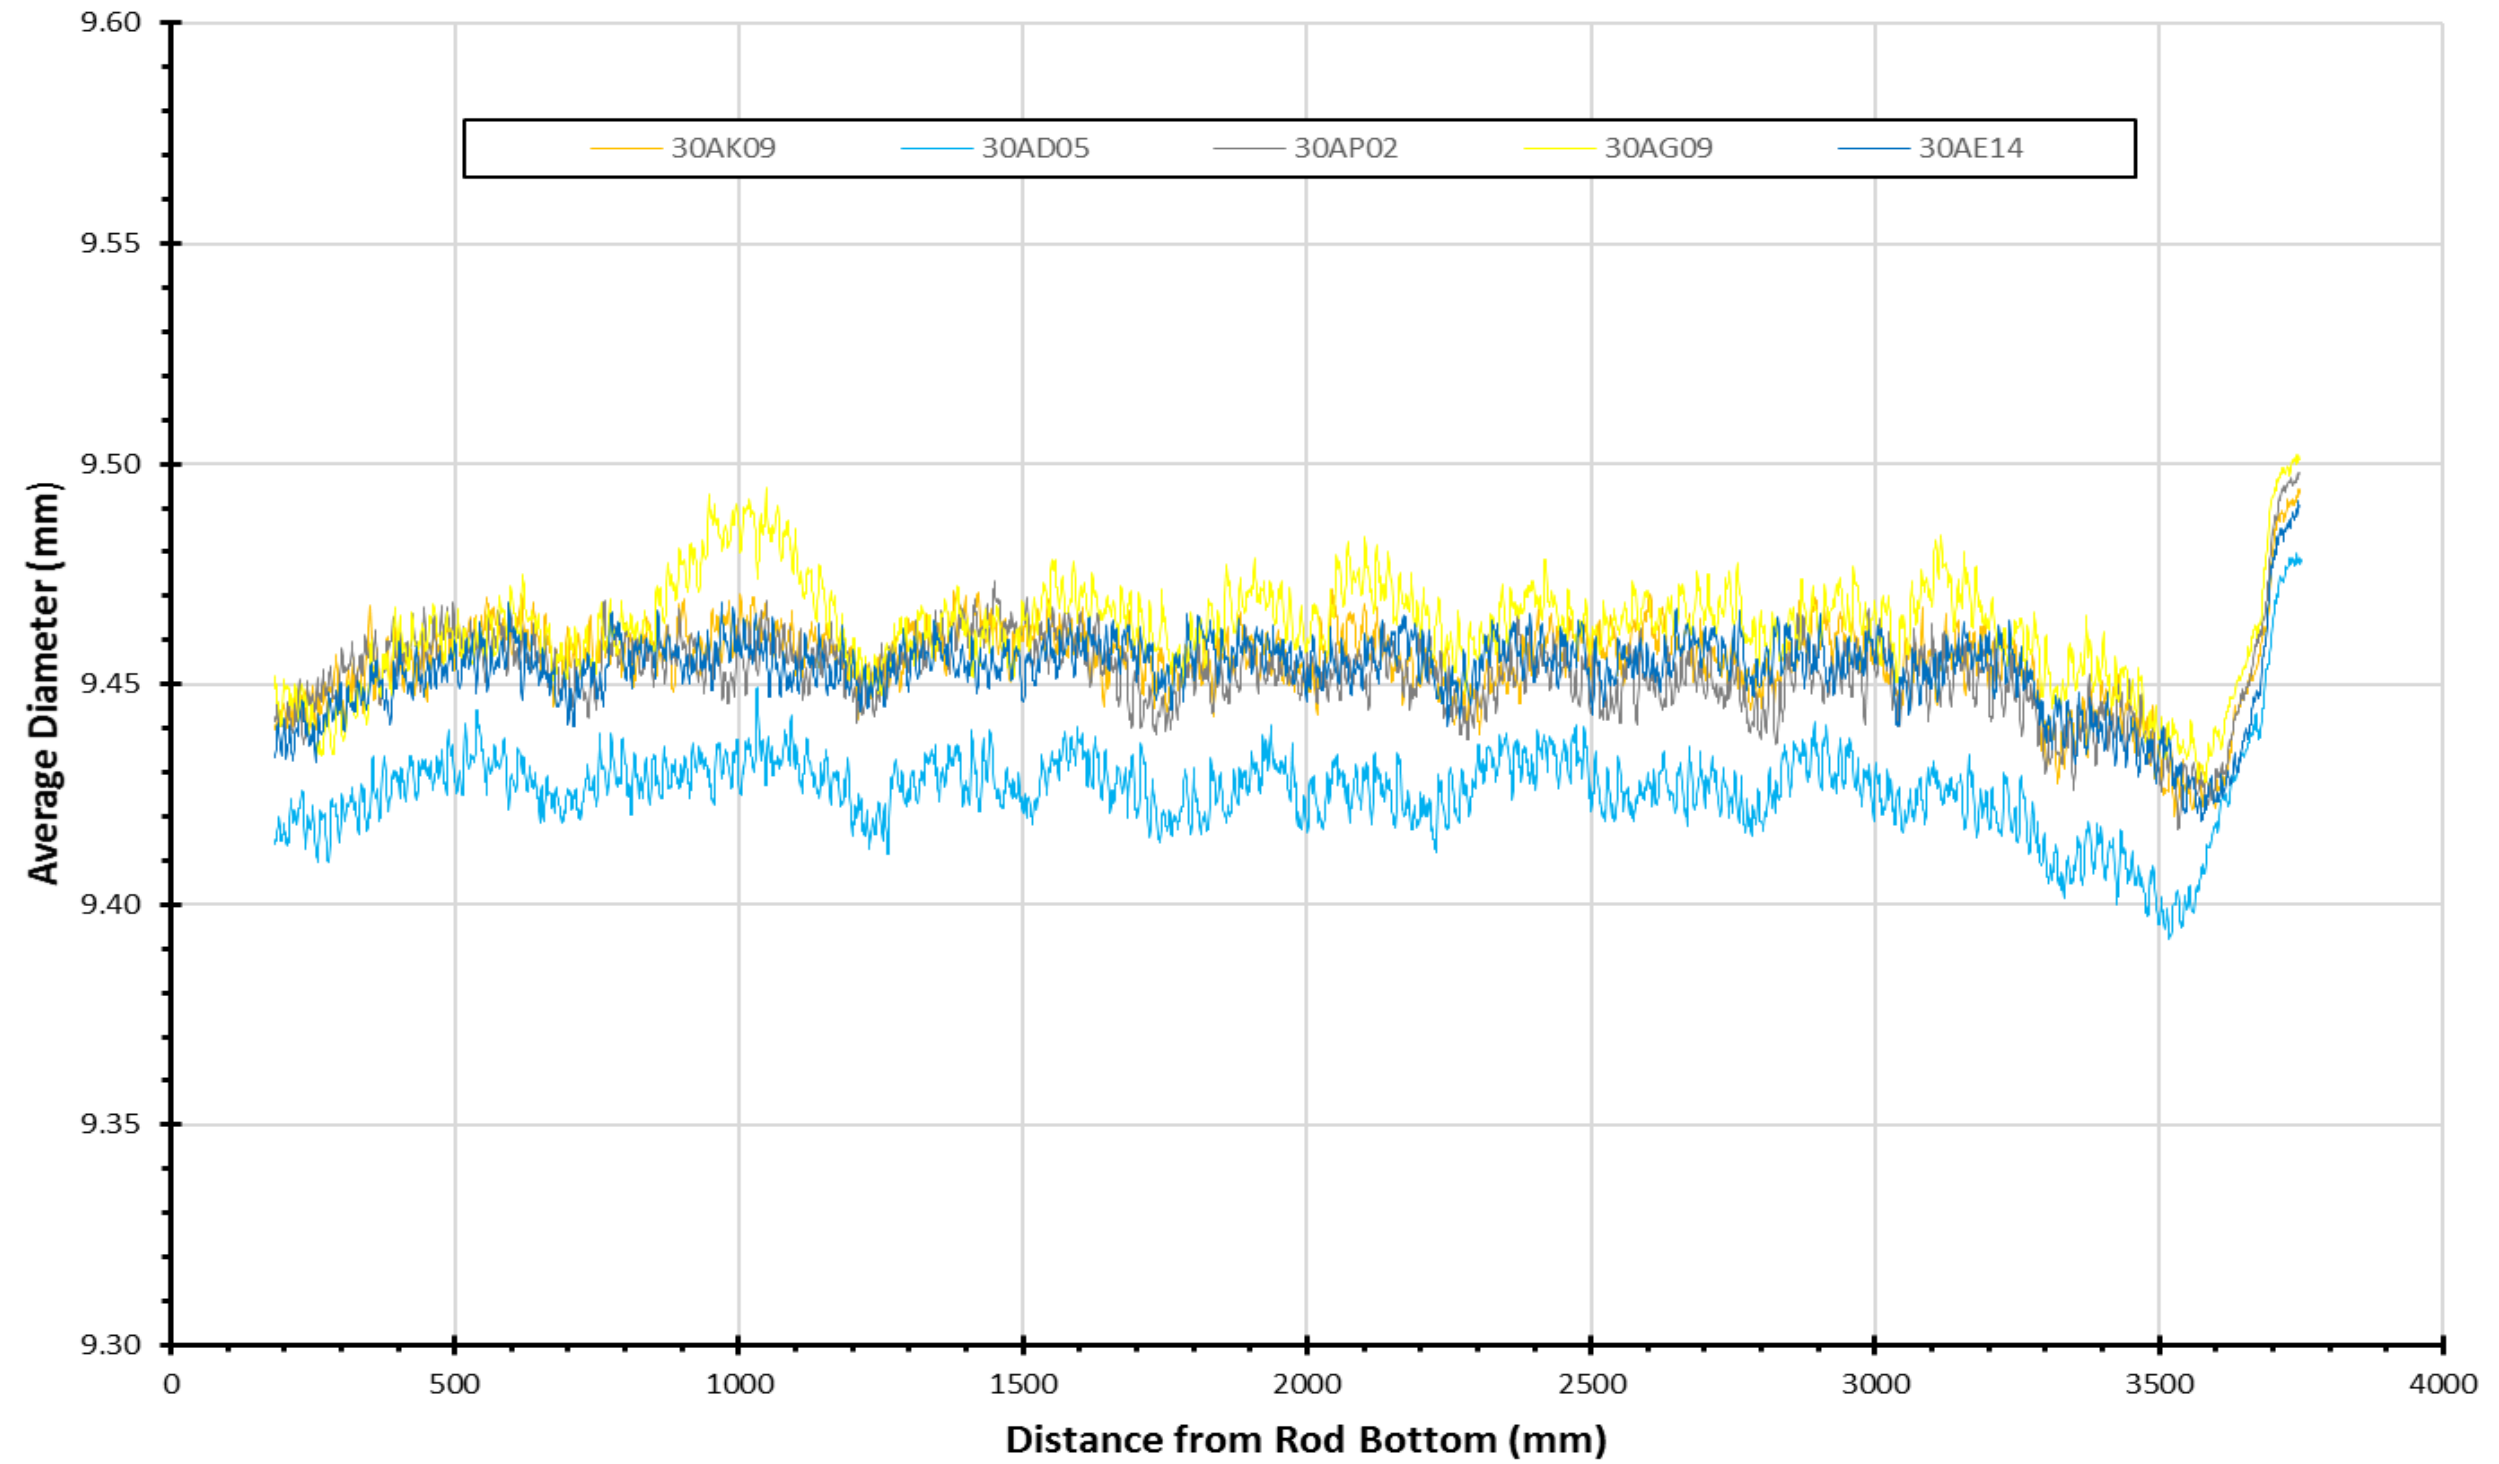
Assembly 30A Average Profilometry

Figure 39 through Figure 45 provide the average measured rod diameter as a function of axial rod location grouped by assembly. Overall, within the accuracy of the device and given the actual surface condition of the rods, none of the rods were found to be significantly out of round (0.04 mm). Generally, the average is sufficient to identify significant diametrical changes, but the measurements from the two pairs of LVDTs can be slightly out of phase, and averaging can eliminate the peaks and valleys associated with the pellet ridging. Localized features such as spalling depth, surface dents, and pellet ridging can be identified using (1) individual LVDT traces, which occur only at 2 orthogonal locations along the length, (2) gamma scans, which provide a cross sectional indication only, and (3) visual profilometry, which can have limited resolution capability. A combination of these measurements can also be used. The traces for both pairs of LVDTs are provided in Appendix A.

There were no indications of significant rod swelling or clad major defects. In general, the expected diametrical trends were observed: the rod's diameter is larger in higher burnup regions and smaller in lower burnup regions. However, given the higher burnup of these rods, it is surprising that not many expanded beyond the as-fabricated rod's outer diameter (OD). Only the Zirc-4 and LT Zirc-4 rods appear to have positive diametrical strains on the order of 1%. Several of the M5 and ZIRLO rods never regained their preirradiation OD. As expected, the diameter of the rod in the plenum region is very near the as-fabricated cladding OD. Although they could not be measured with the LVDTs, the top- and bottom-end cap diameters are also near the as-fabricated end cap diameters (measured using the visual diameter analysis, see Section 3.5.2 and Appendix B).

Figure 39. Profilometry Scans for Assembly 30A.

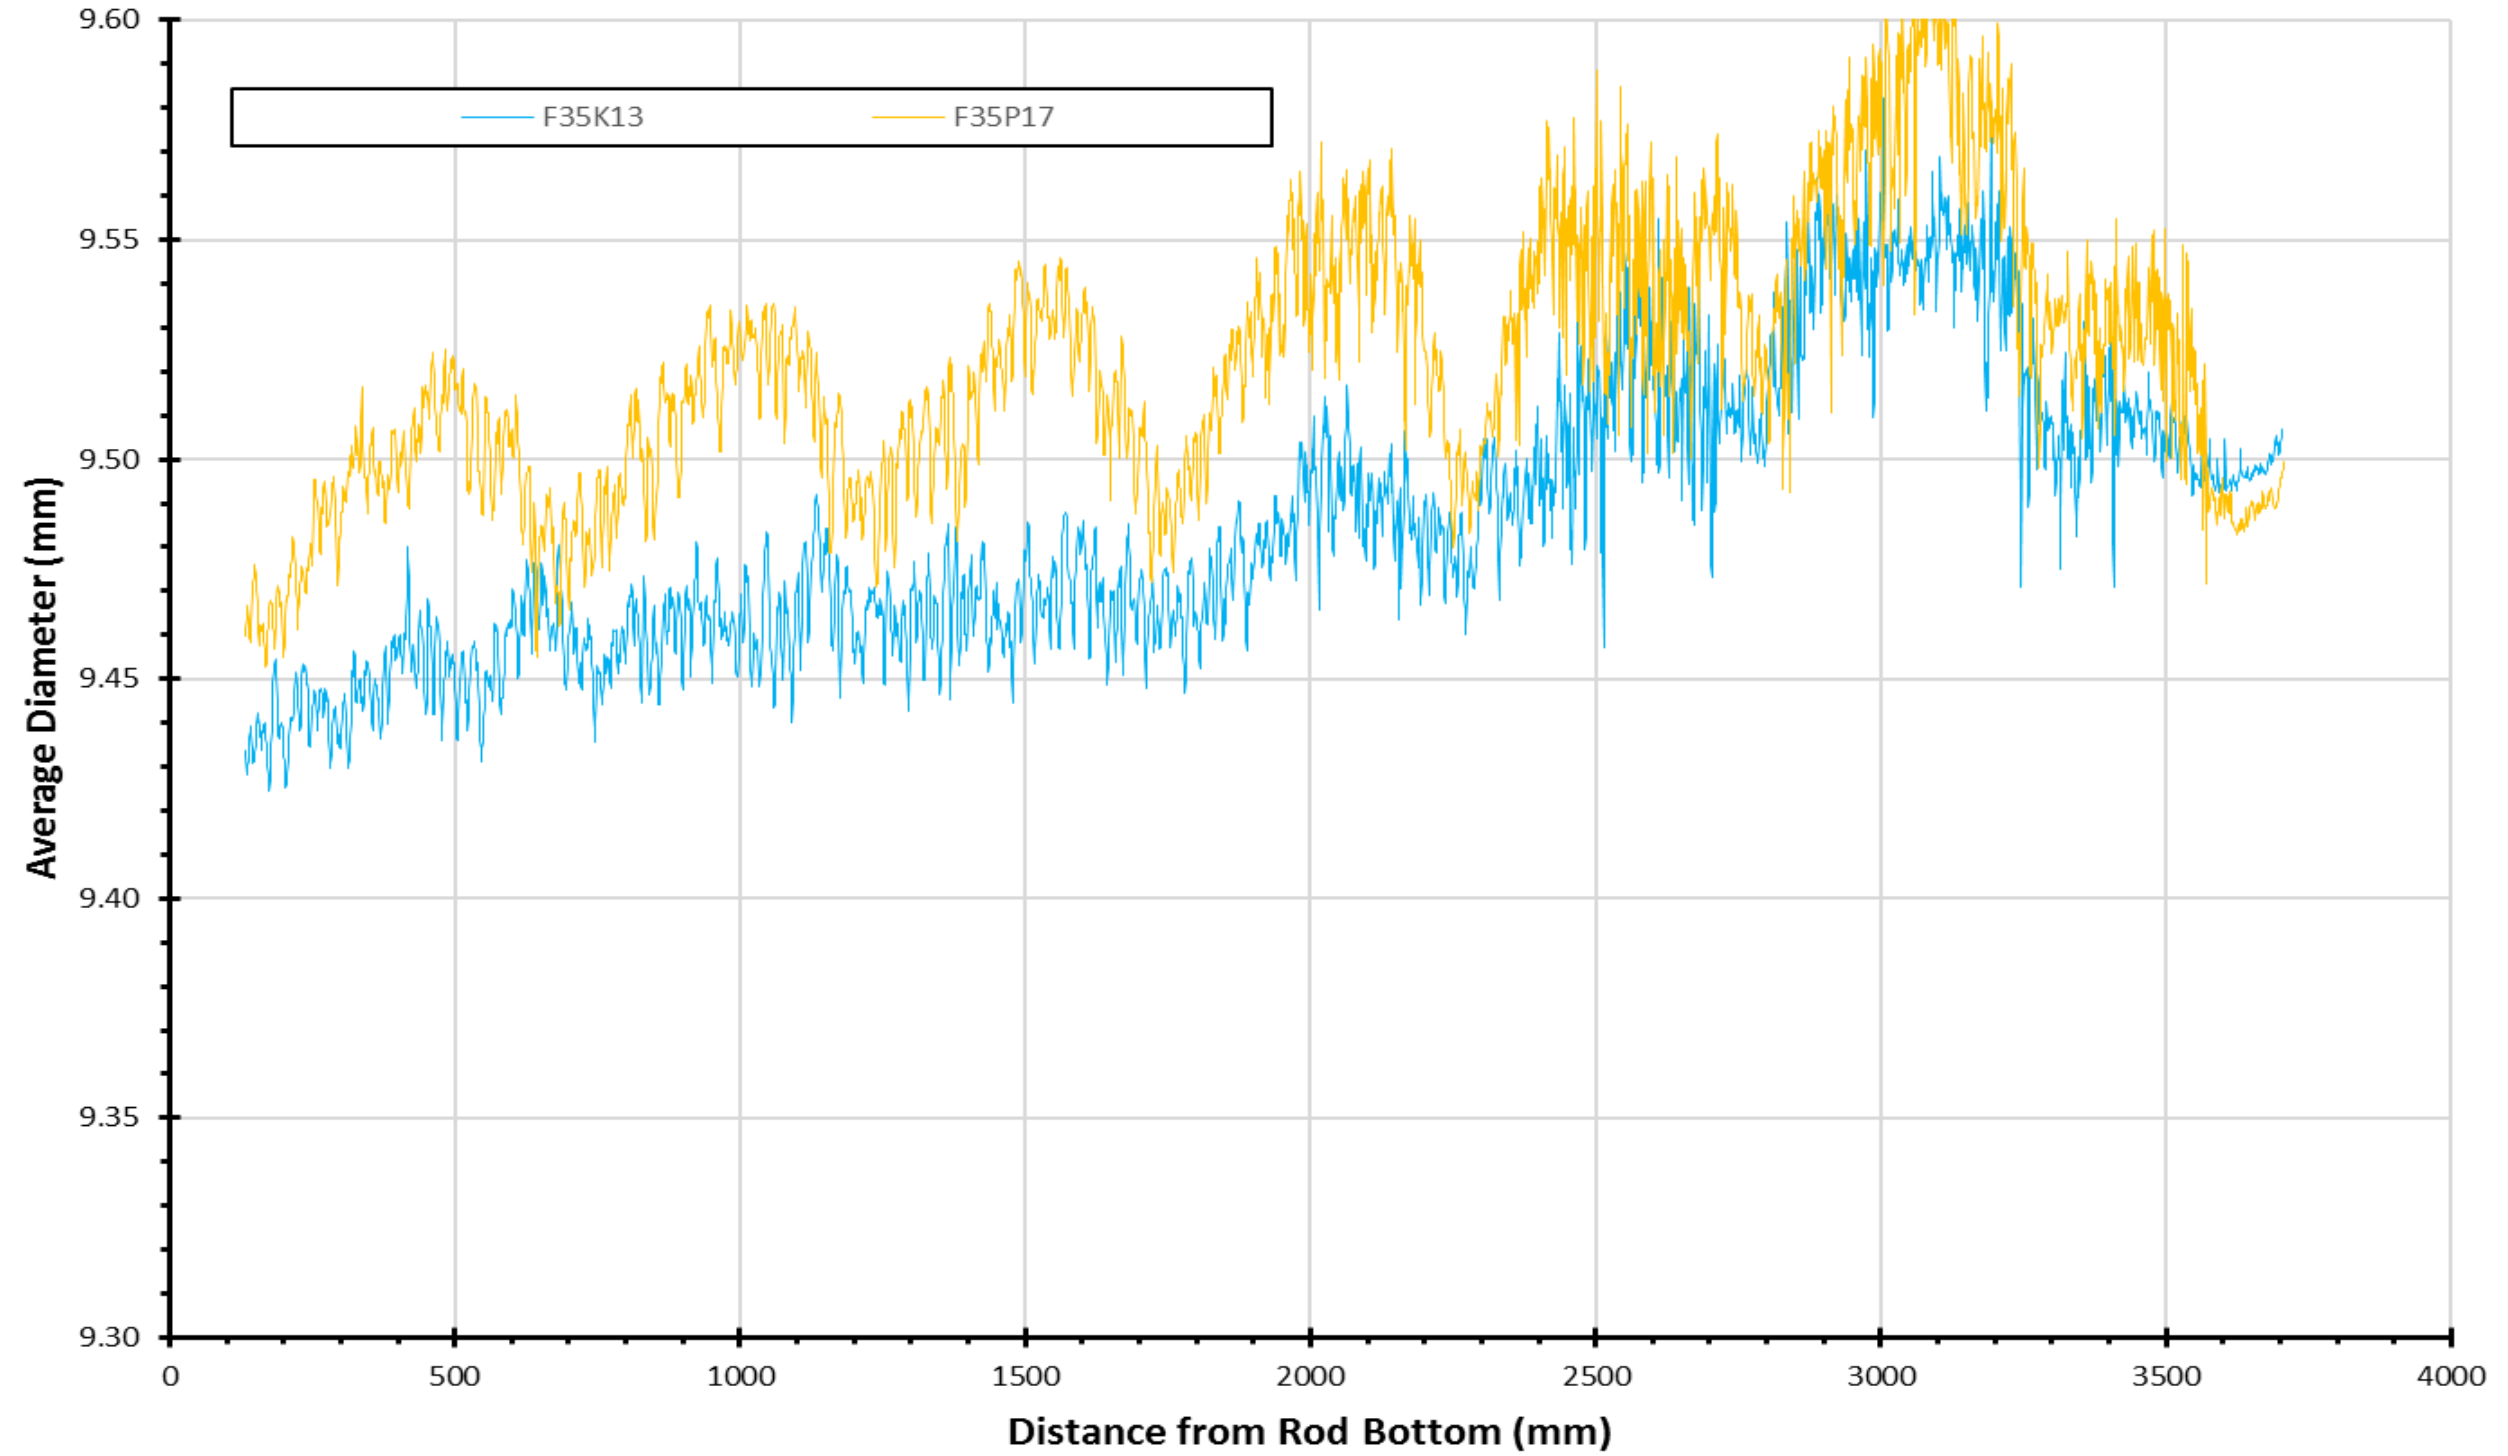
Assembly F35 Average Profilometry

Some rods had very thick oxide layers with large spalled areas (see Section 3.1). Rods with the thickest oxide layers appear to have erratic diameter measurements. In particular, Assemblies 3A1 and F35 show the expected increasing diameter from the bottom to the top of the rod (referenced to the true bottom for the F35 rods), but there is a large amount of point-to-point variation in the higher rod elevations due to the uneven spalling oxide layer.

Figure 41. Profilometry Scans for Assembly F35.

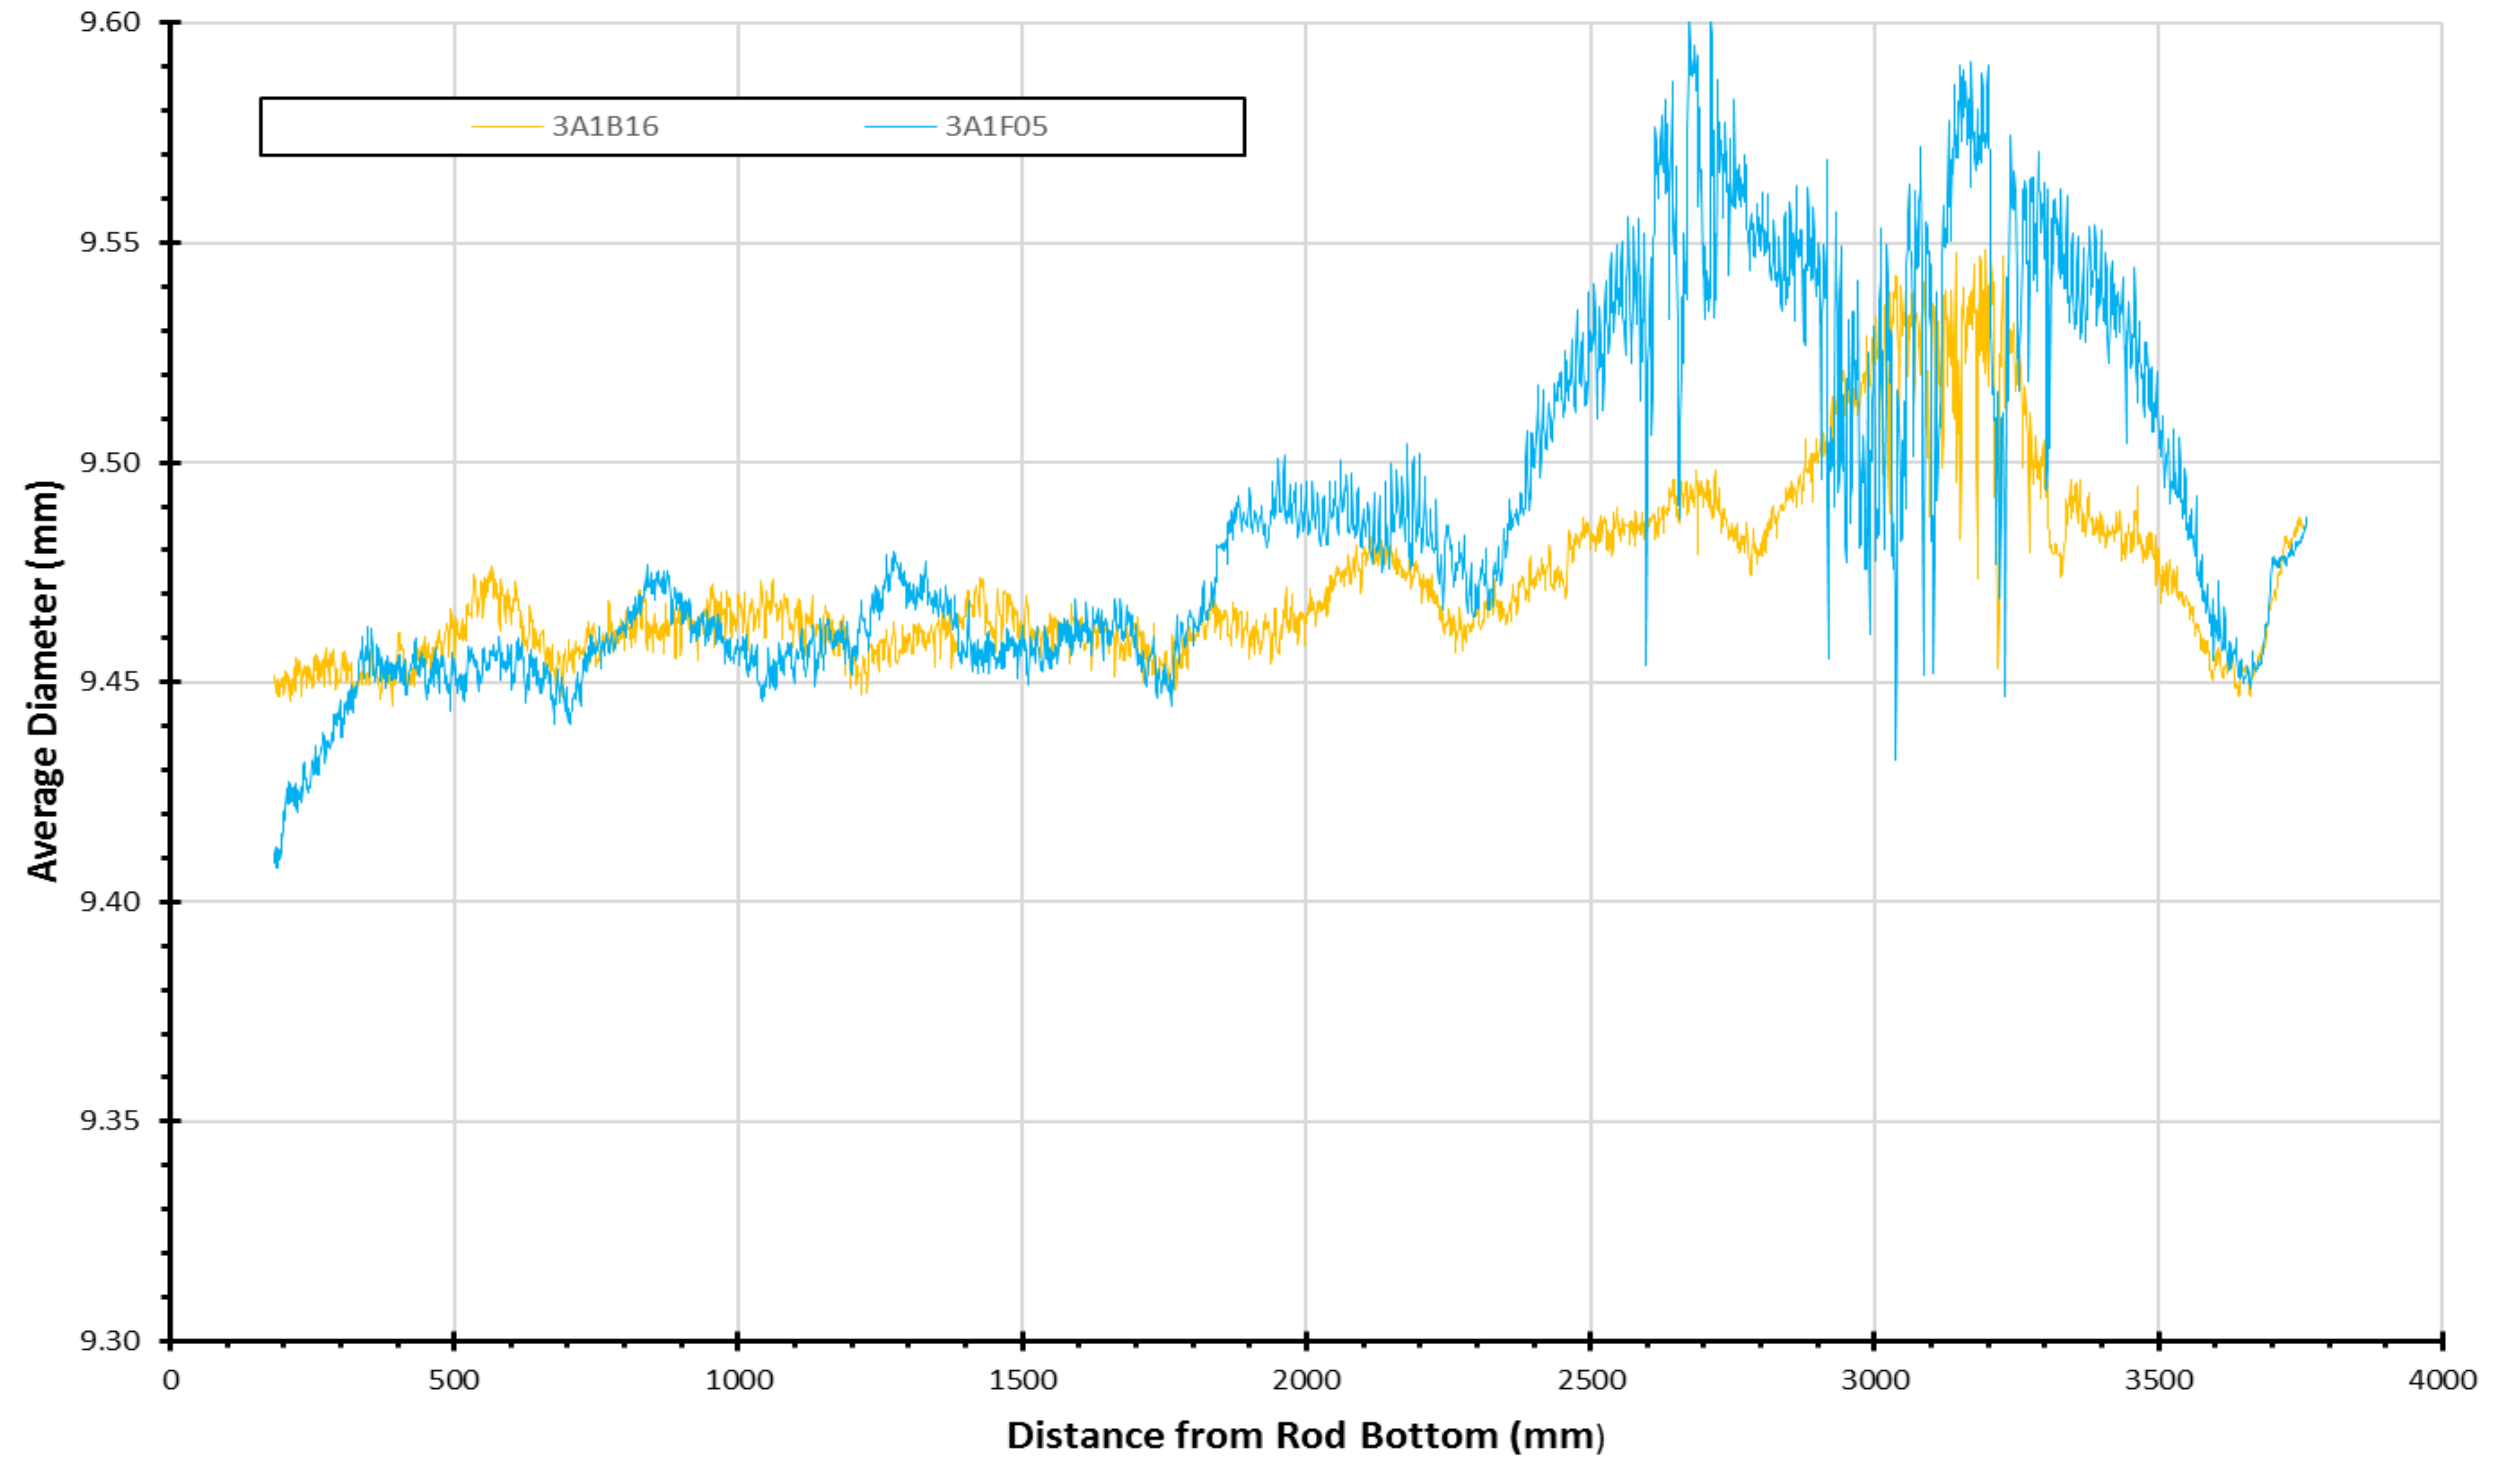
Assembly 3A1 Average Profilometry

Figure 42. Profilometry Scans for Assembly 3A1.
