***Sister Rod
Nondestructive
Examination
Annual Report FY2017***

***Prepared for
US Department of Energy
Spent Fuel and Waste Science and
Technology***

***September 15, 2017
SFWD-SFWST-2017-000003
ORNL/SPR-2017/484***

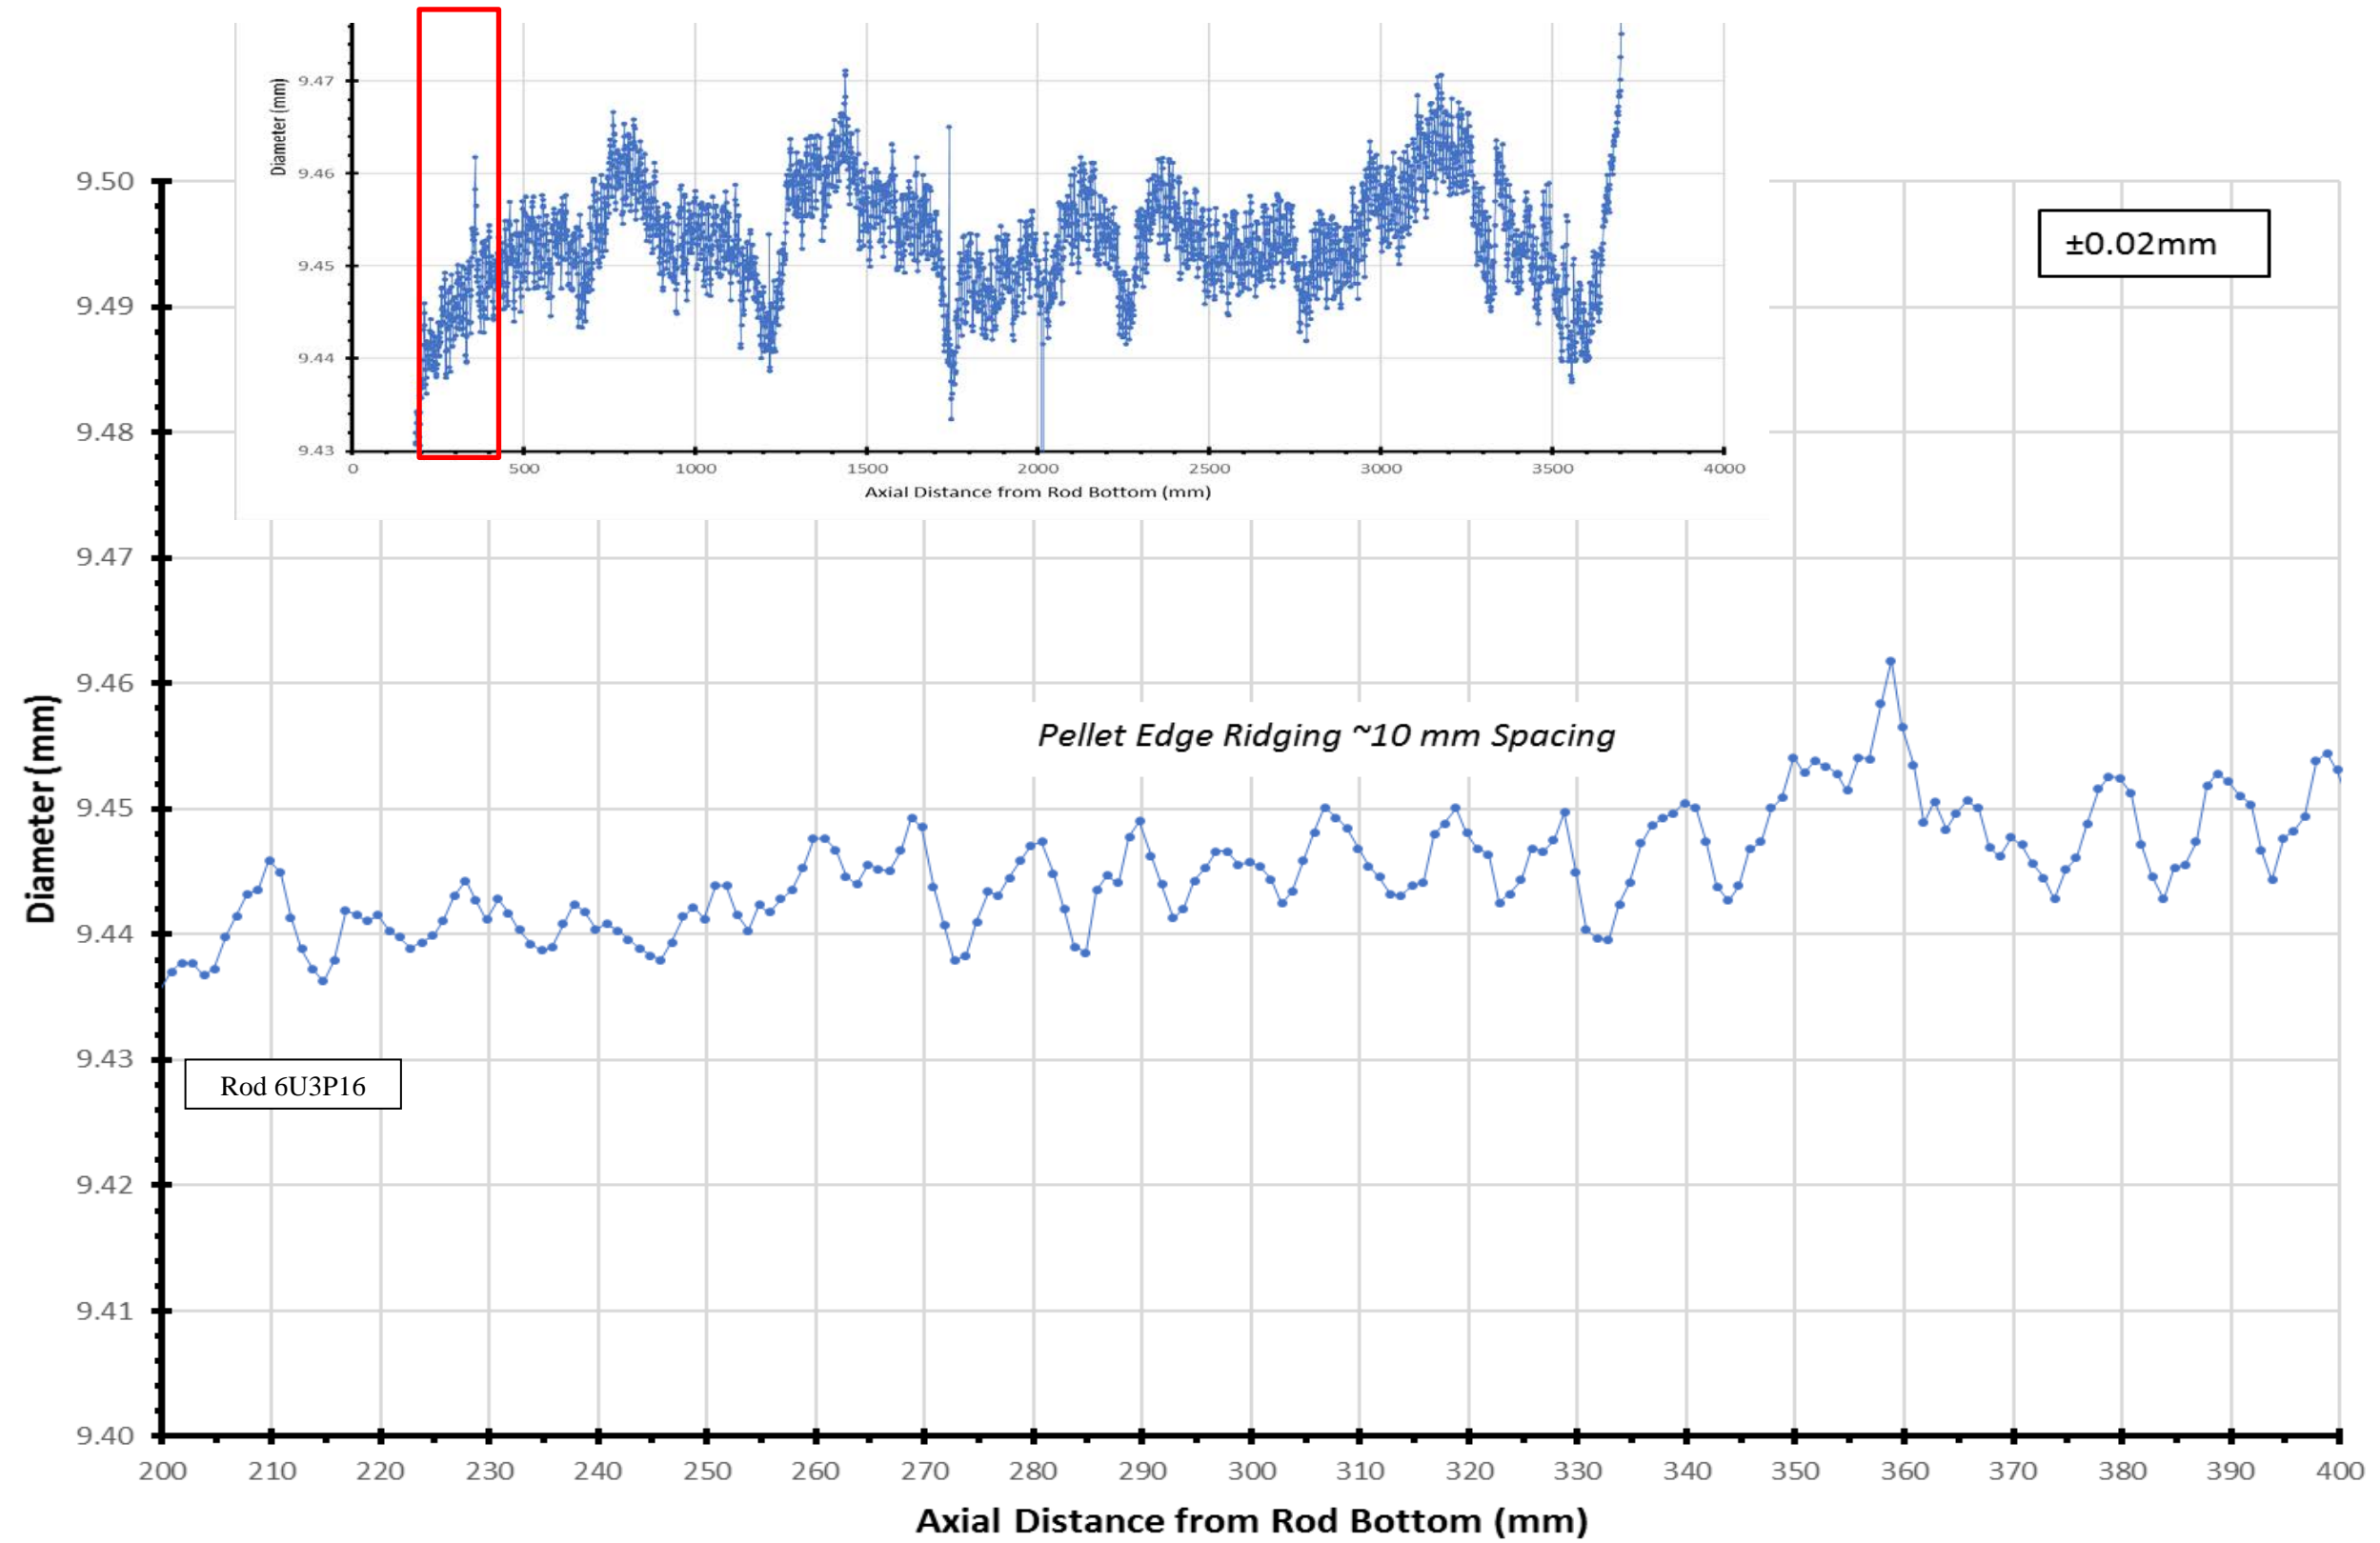
Bambooning, which is a small diameter variation with a period of about 10 mm (the pellet length), was observed in all rods. Figure 46 shows a portion of the bottom region of rod 6U3P16, illustrating bambooning caused by pellet-cladding interaction during operation.

Figure 46. Typical Pellet Ridging on a Fuel Rod via LVDT-Based Profilometry; Scales are Magnified to Show the Detail. The Typical Pellet is Approximately 10mm long.

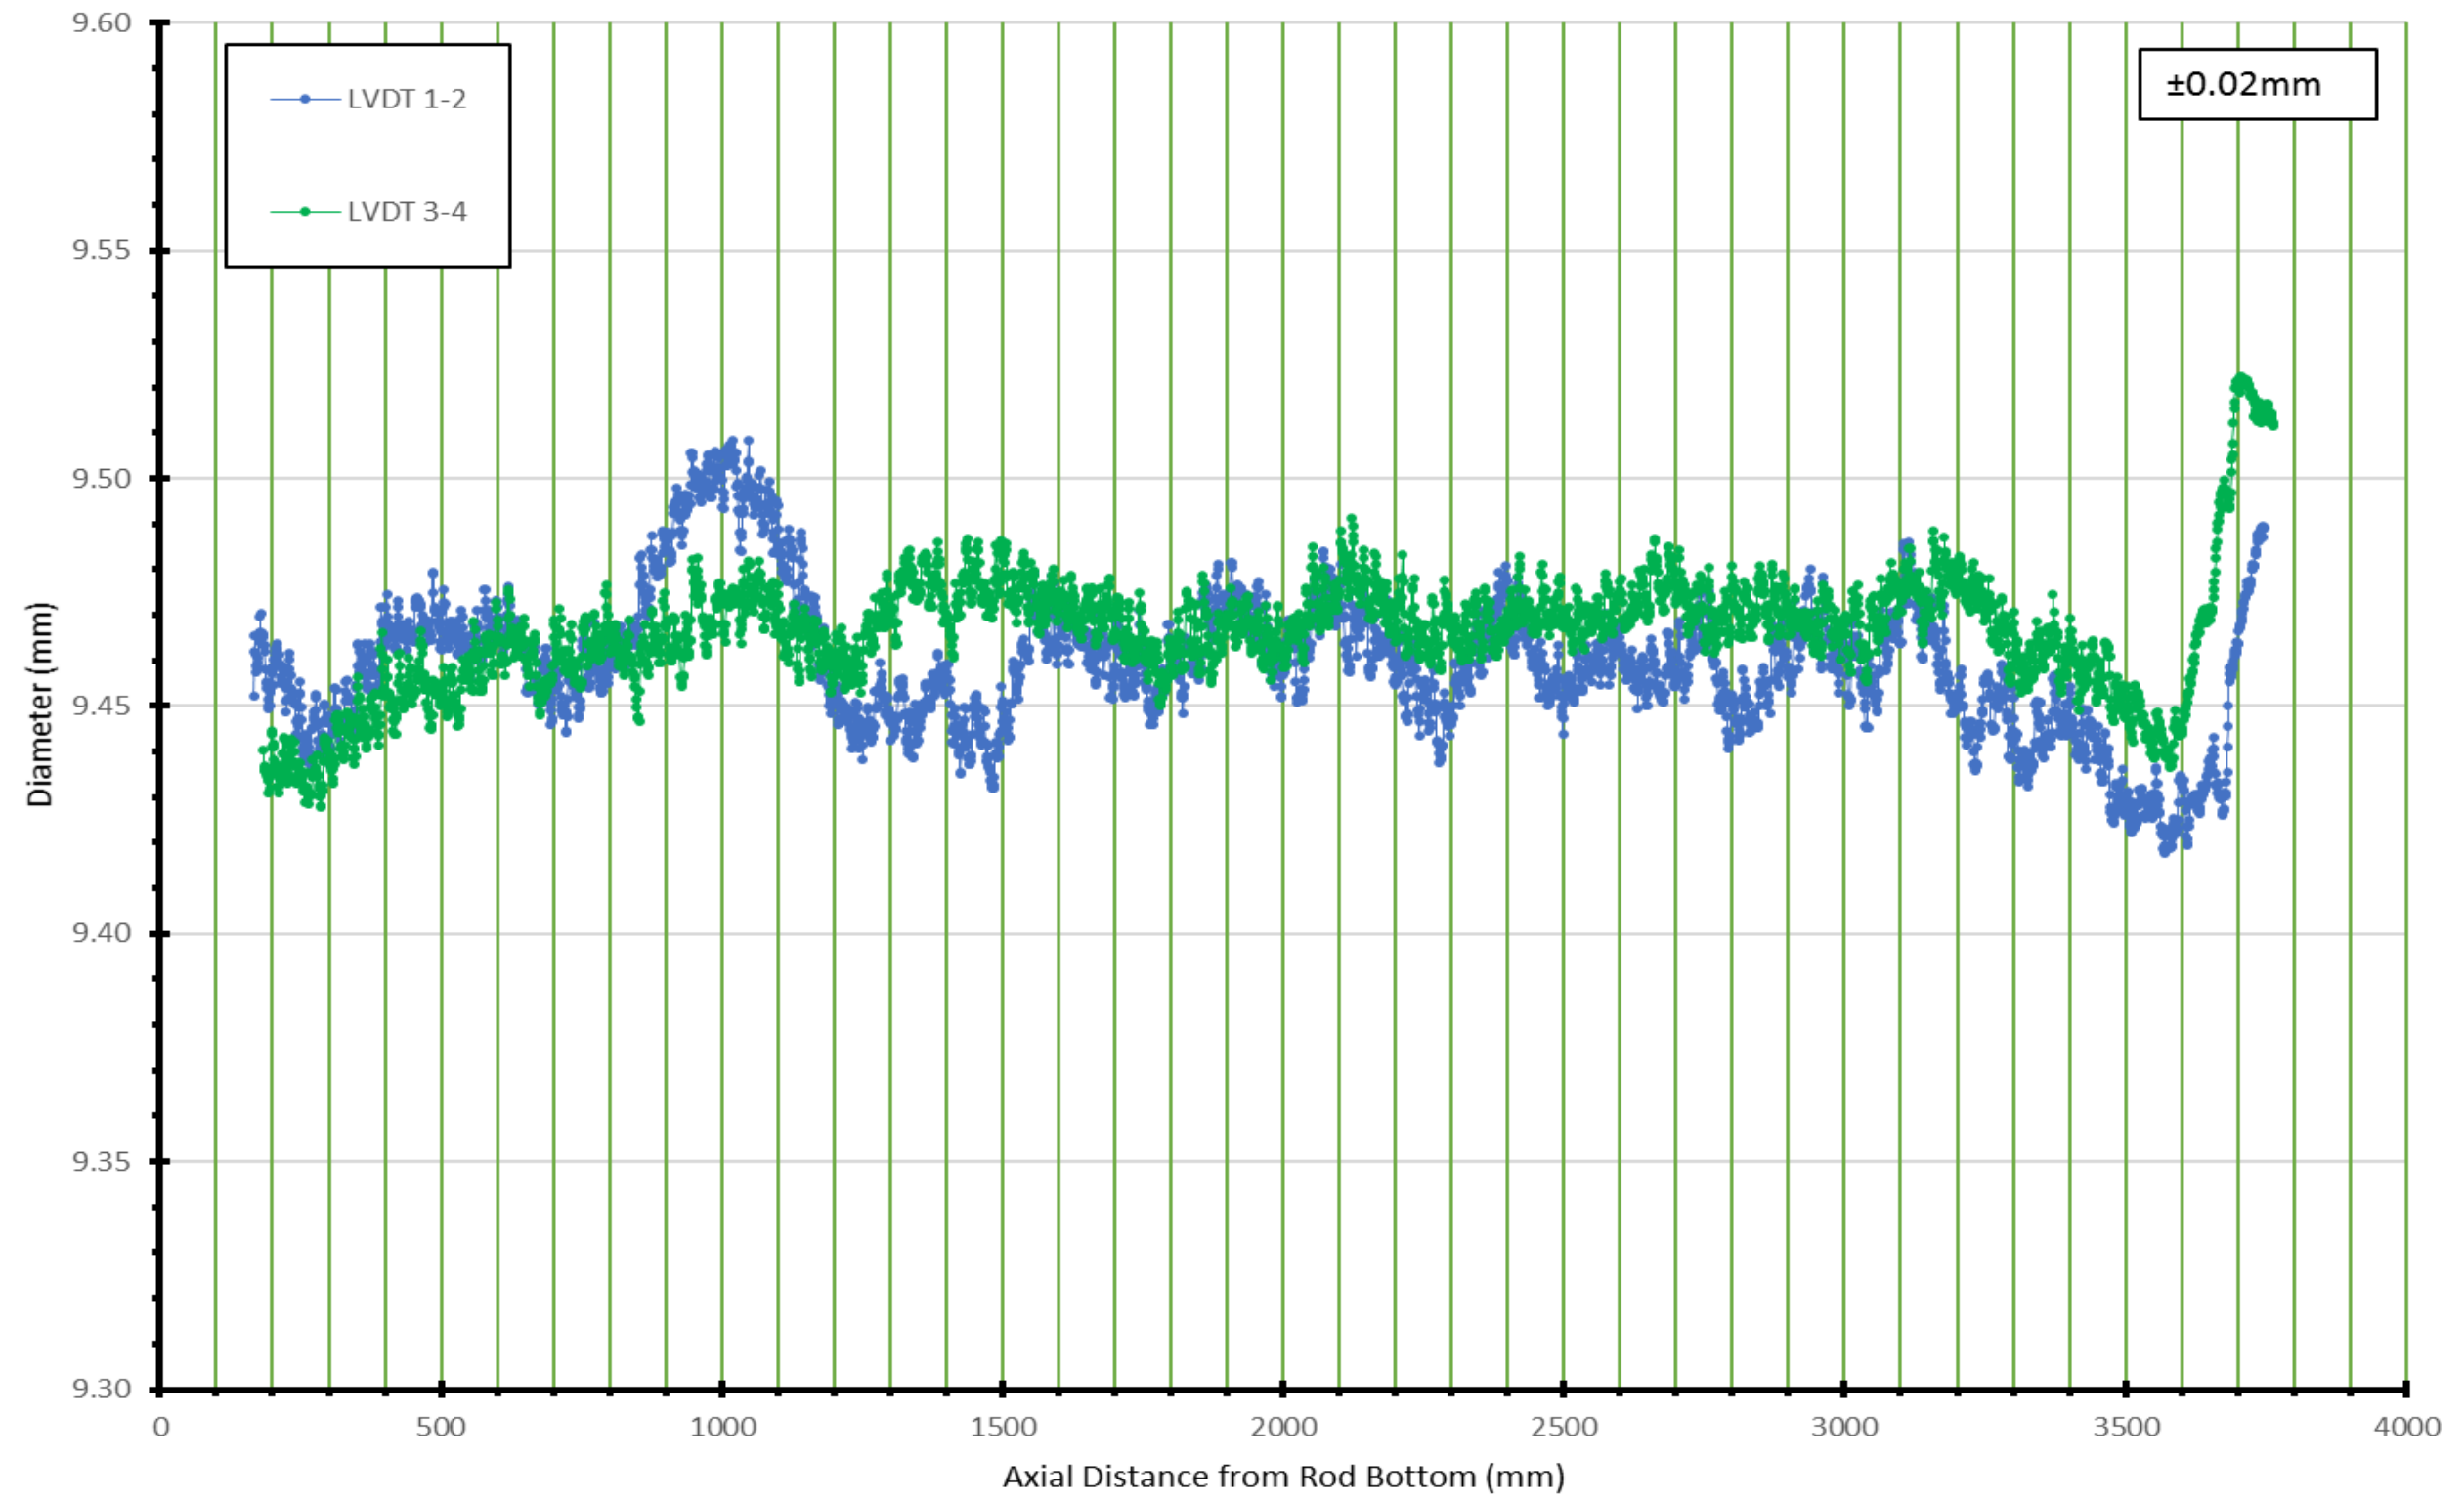
The average LVDT-measured rod diameter for rod 30AG09 displayed a region of increased diameter near 1,000 mm; the visual exam showed nothing unusual in this region. Upon examination of the individual LVDT data shown in Figure 47, it is evident that the spike in diameter was only measured by the LVDT-1/LVDT-2 pair. Inspection of the diametrical data obtained with the visuals (see Section 3.5.2) does not indicate an increased diameter in any direction, but the difference in diameter between the two sets of LVDTs was only about 0.03 mm, which is only marginally larger than the expected accuracy of the pairs. This difference may have come from some small debris that was carried along by the LVDT, momentary sticking of the LVDT, or a larger-than-expected off-center shift of the rod as it went through the LVDTs that moved the rod out of the optimal measuring range. Thus, this particular local diameter increase is considered a spurious measurement.

Figure 47 Individual LVDT Measurements for Rod 30AG09 Illustrating the Difference in Measurements for the Two Pairs between 900 and 1,600 mm.

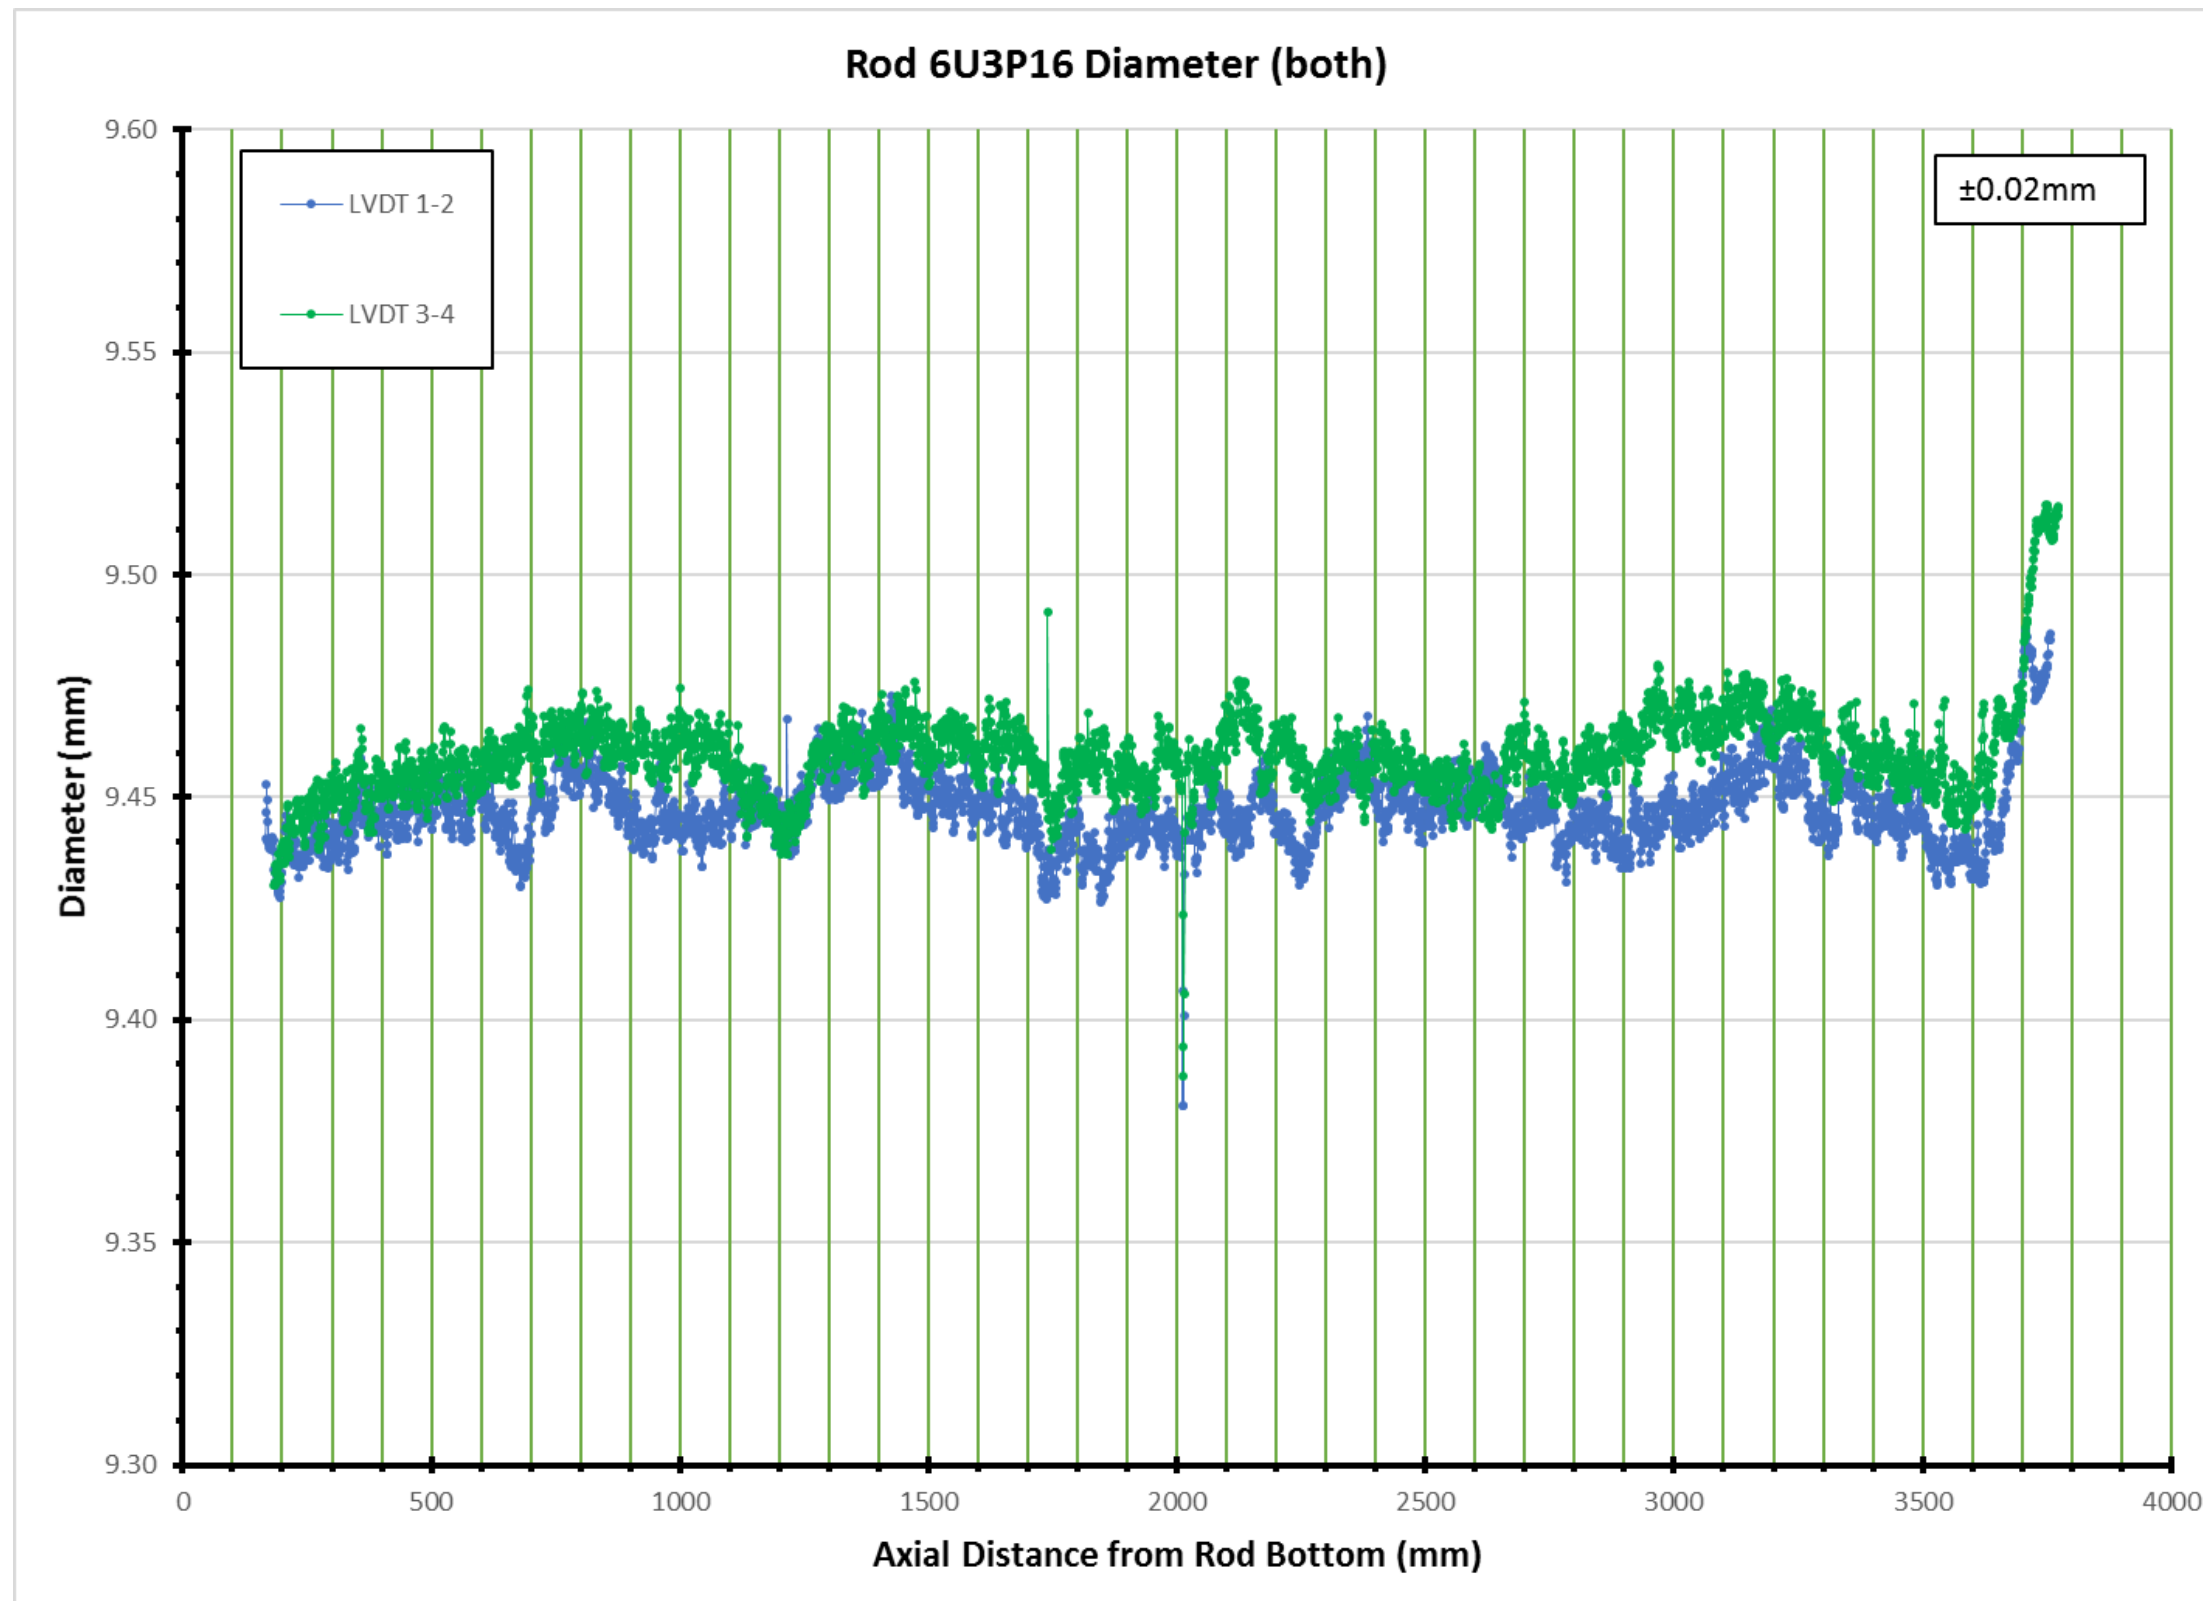
Finally, a fairly large ($\sim\frac{3}{4}$ pellet length) reduced diameter (~ 0.5 mm) region was noted in the profilometry scan for rod 6U3P16, as shown in Figure 48. The reduction was measured by both pairs of LVDTs, but it is not observable in the visual profilometry. This is likely due to the visual method's lower axial resolution, which only has measurements every 40 mm. This reduced diameter region aligns well with the reported gamma scan pellet gap (see Table 5) and is likely the same feature.

Figure A.18. Rod 6U3P16 LVDT Diameter Measurements.

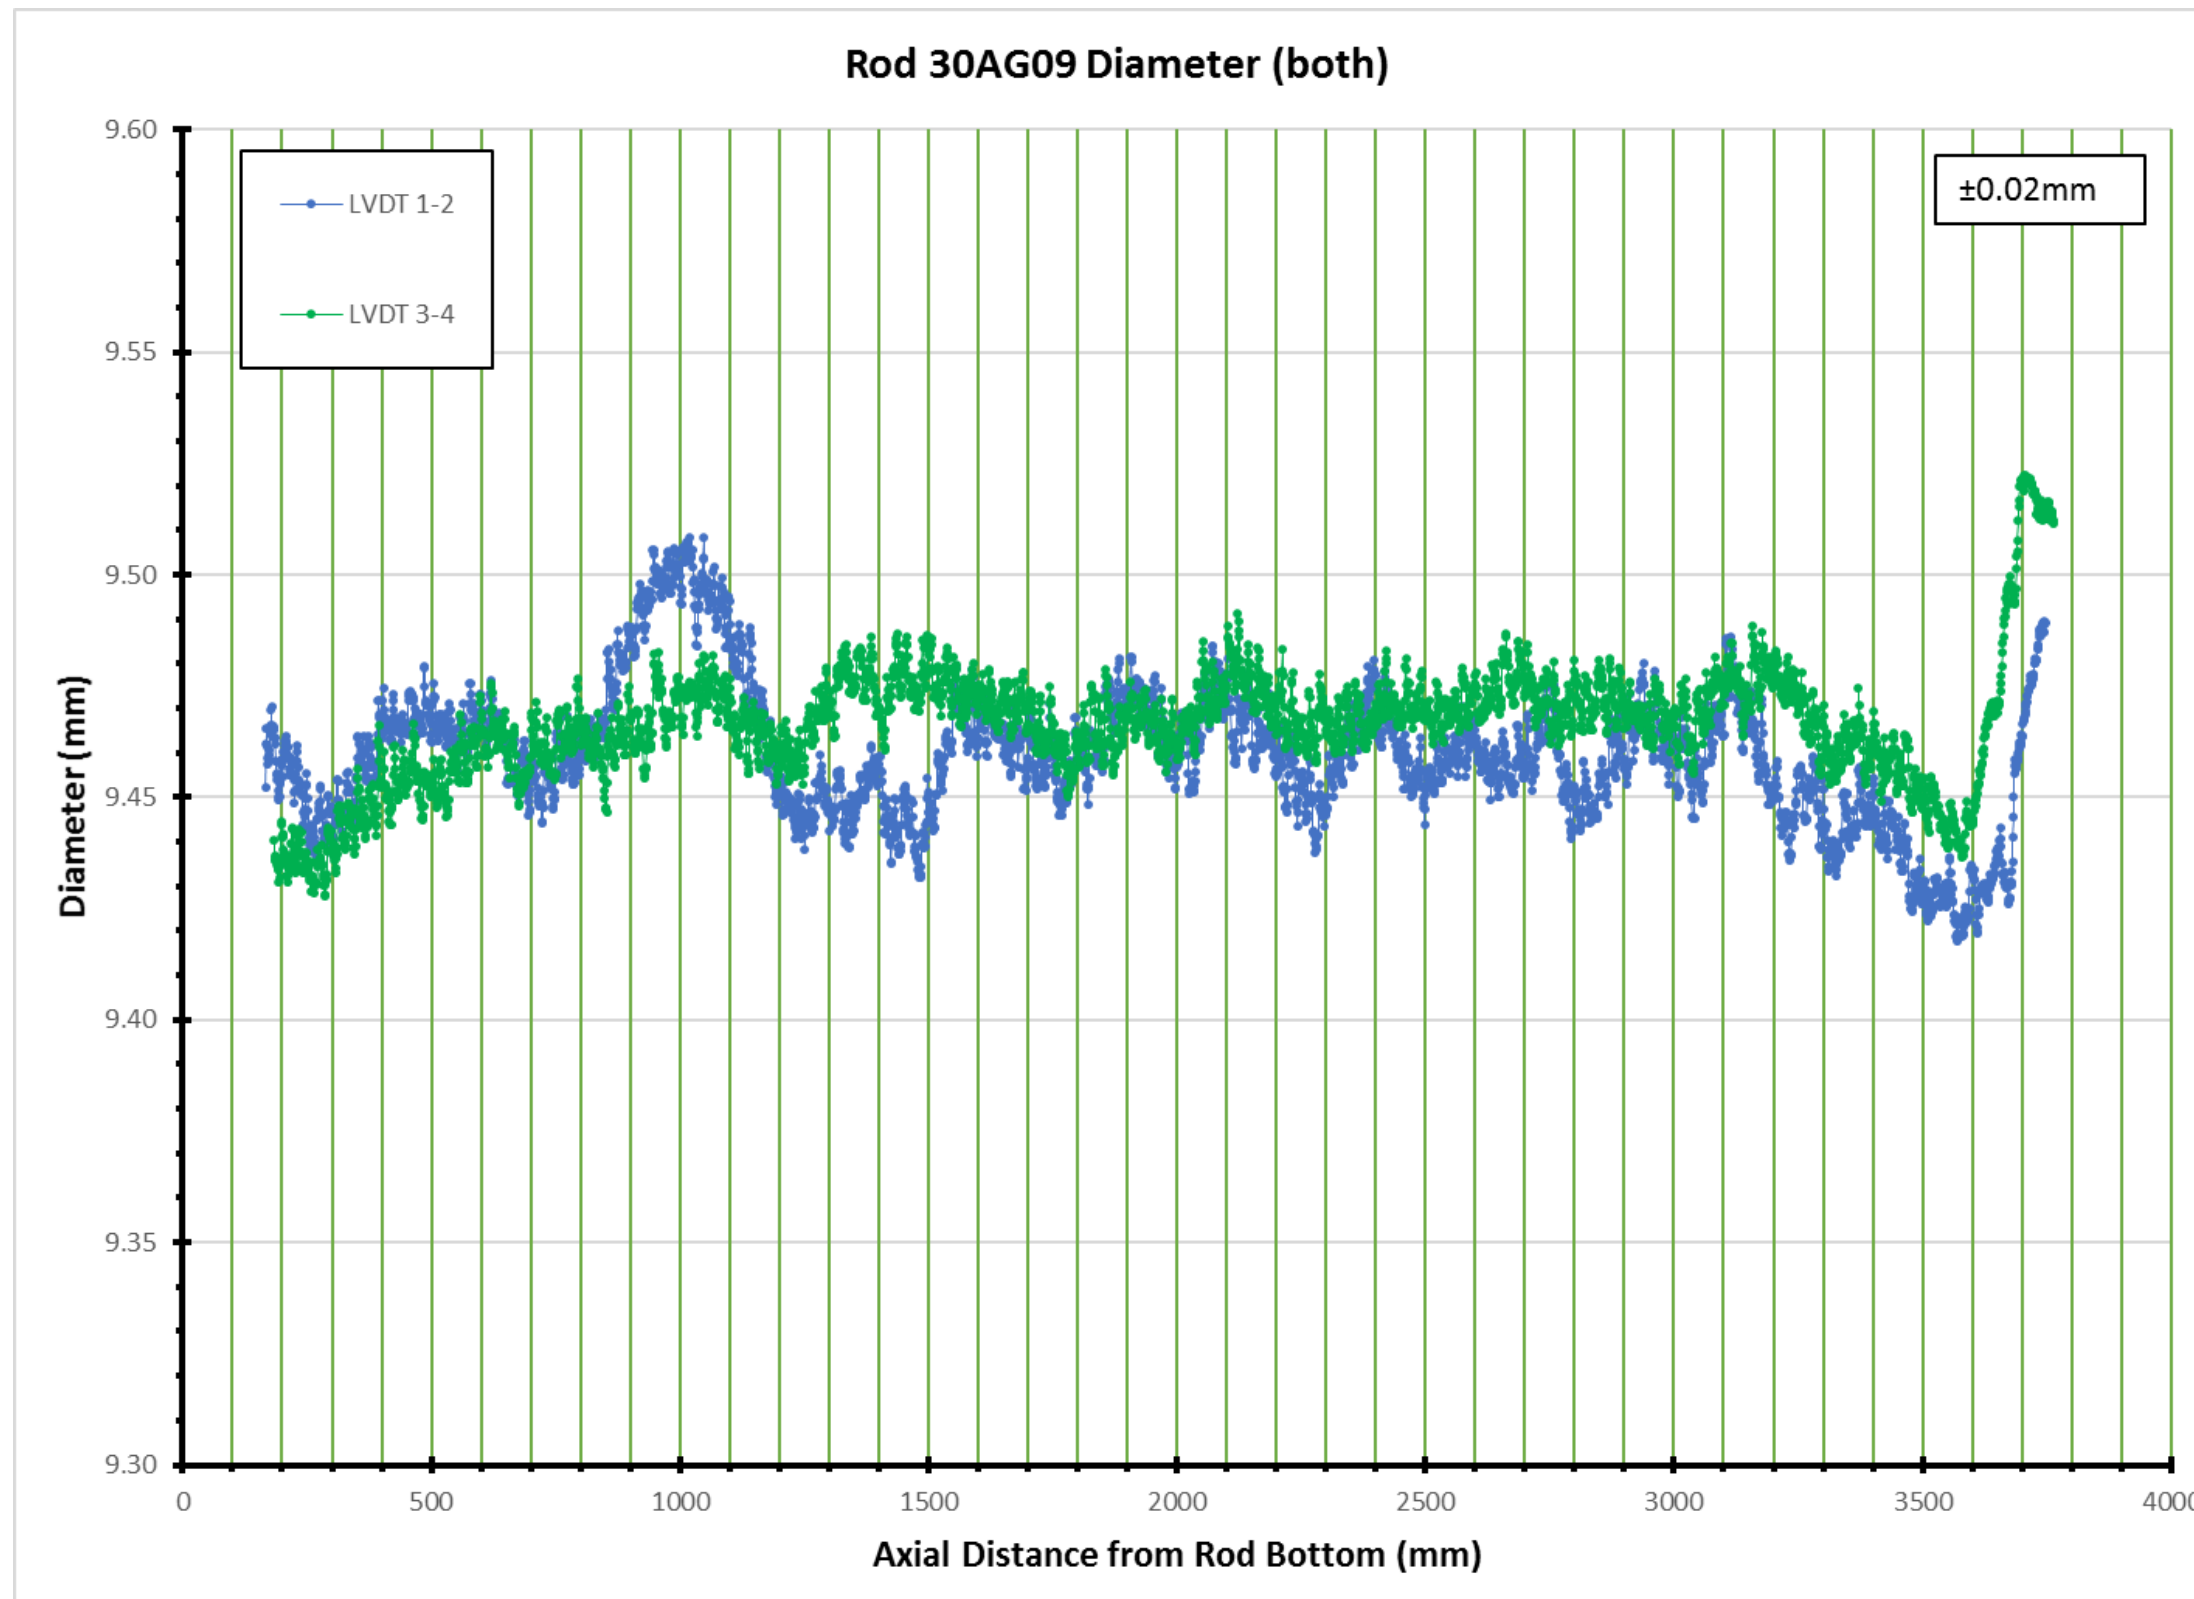
Figure A.21. Rod 30AG09 LVDT Diameter Measurements.
