Fukushima Dai-ichi NPS Defueling Status

May 2013
Hitachi-GE Nuclear Energy, Ltd
Takao Shimura

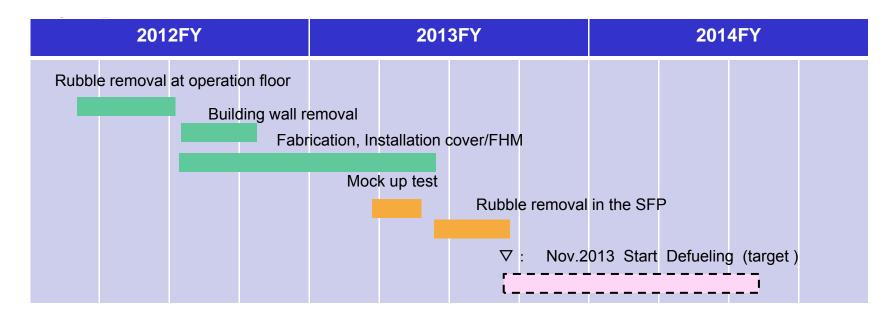
Unit 4 SFP Defueling schedule

- Schedule
 - Rubble removal of upper part of Reactor building: Sep. 2011 to 2012 Summer
 - Installation of Fuel transfer cover/ crane: Apr. 2012 to 2013 Summer
 - Defueling start: Nov. 2013 (target)
- Operation
 - Manual operation at operation floor with considerations to lower dose rate

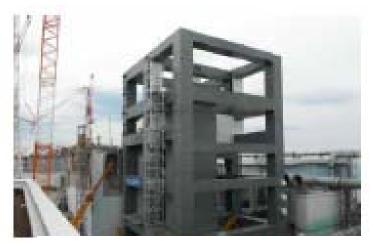
Construction status as of Apr. 10, 2013

Construction progress
